NASON CREEK TRIBUTARY ASSESSMENT Chelan County, Washington

BUREAU OF RECLAMATION TECHNICAL SERVICE CENTER, DENVER, CO, AND PACIFIC NORTHWEST REGIONAL OFFICE, BOISE, ID.

JULY 2008

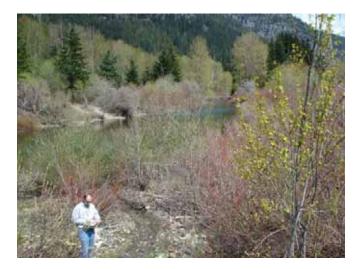
Ponded water has been observed to form in areas where the historical main channel has been cutoff by the railroad and highway embankment, and, in some cases, behind small levees (see cutoff areas on maps 23 and 24 in atlas and Figure 6and Figure 8). As ponded water on the non-river side of the embankment drains during summer months, it may be entering the main channel and elevating water temperatures. During field observations, the amount of ponding varied and appeared to reduce over time throughout the summer months. Water temperatures could be measured in the ponded areas and compared with main channel temperatures during the same time period to further evaluate the potential influence, along with utilizing airborne thermal infrared remote (TIR) sensing (often referred to as forward looking infrared or FLIR) collected in 2001 and 2003 (see Appendix F - Water Quality Synopsis).

Figure 6. View to the north of ponding in the historical channel near RM 13.5. (Reclamation photograph by R. McAffee, May 2, 2007).

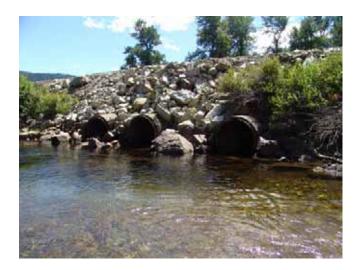
Figure 7. View to the south near RM 9.7 looking at the right river bank with concrete culvert inverts at water surface level. (Reclamation photograph by D. Bennett, August 8, 2007).

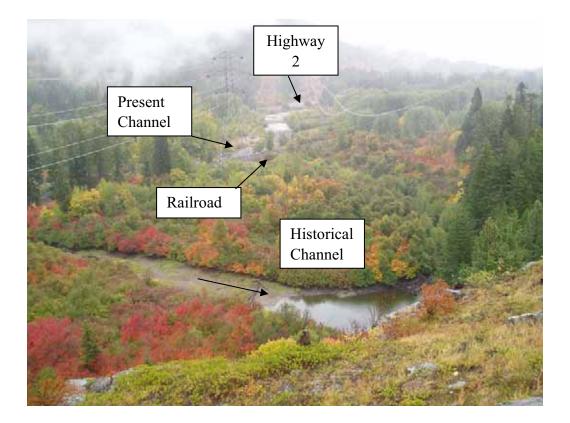
Figure 8. Looking across the valley at ponding in a historical channel of Nason Creek and the present channel between RM 10.7 to 11.1. The ponding has been observed to inundate the majority of the unvegetated historical channel. The river is flowing from left to right in the photograph. (Reclamation photograph by J. Bountry, October 2007)

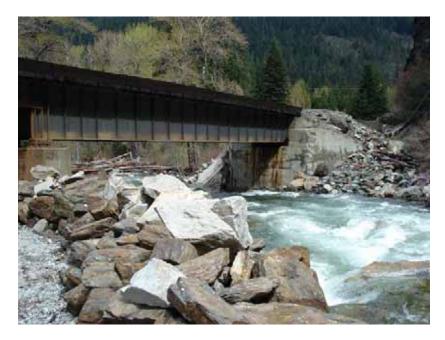
Figure 9. Downstream view to the north at riprap placed along USFS road and White Pine Railroad Bridge abutment near assessment area boundary (RM 14). (Reclamation photograph by R. McAffee, May 2, 2007).

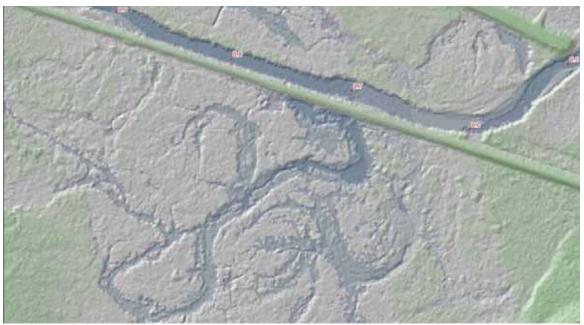
Figure 23. Example of disconnected historical channels and floodplain between RM 9.6 to RM 9.9. Colors represent elevations relative to present main channel elevations, dark blue being the closest and green being the farthest (highest elevations). The railroad embankment can be seen in green running along the present channel identified by red river mile markers, flowing from upper left to right in the image.

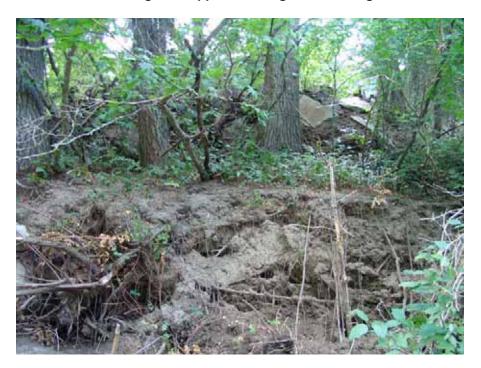
Figure 24. View is to the south looking at the right bank showing original ground level with fill material on top at river bank adjacent to Merritt. (Reclamation photograph by D. Bennett, August 8, 2007).

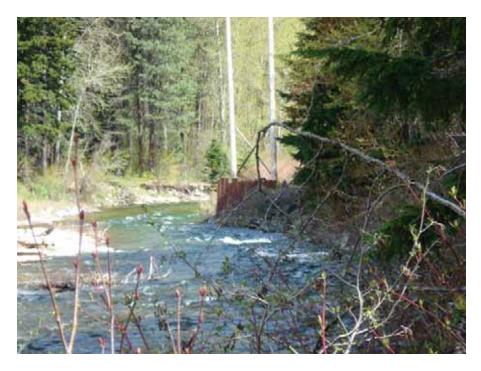
Figure 30. Downstream view to the east of sheet pilings that protect the power pole near RM 13.5

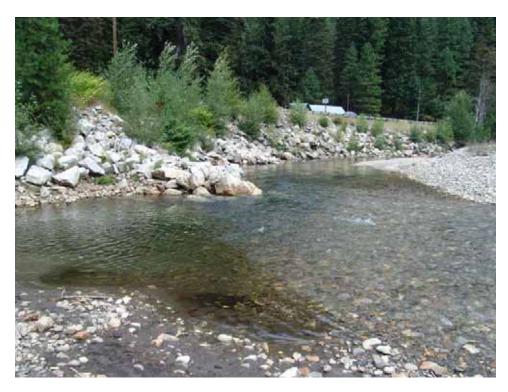
Figure 32. View is to the northeast looking downstream, showing riprap with two rock spurs into channel at RM 13.3. (Reclamation photograph by D. Bennett, August 7, 2007).

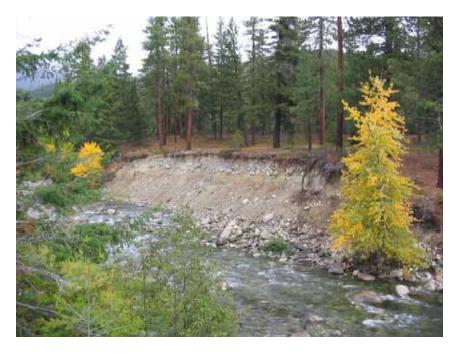
Figure 45. Looking at eroding glacial bank on left side of river in section where highway has cut off the historical meander bend near RM 6.6. (Reclamation photograph by D. Callahan, October 9, 2007).

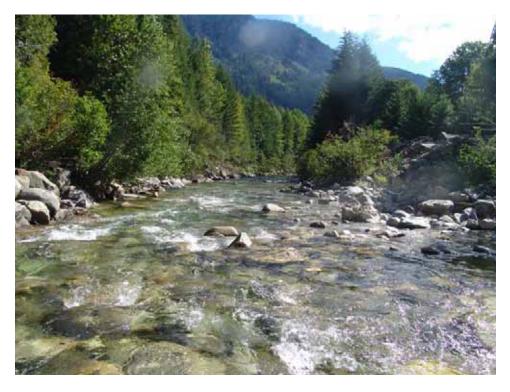
Figure 47. Looking downstream at confined, high energy channel section along railroad embankment near RM 13.9 that provides little to no habitat value. (Reclamation photograph by D. Bennett, August 7, 2007).

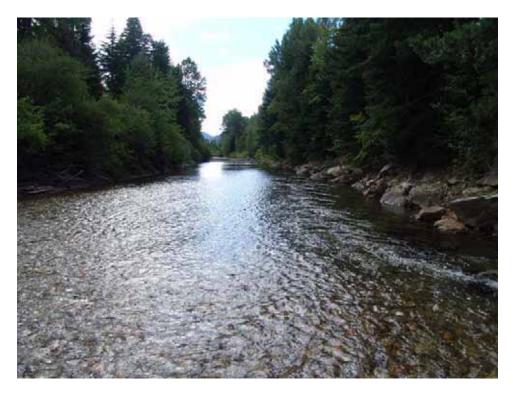
Figure 48. Looking downstream at straightened channel near RM 11.6. (Reclamation photograph by D. Bennett, August 8, 2007).

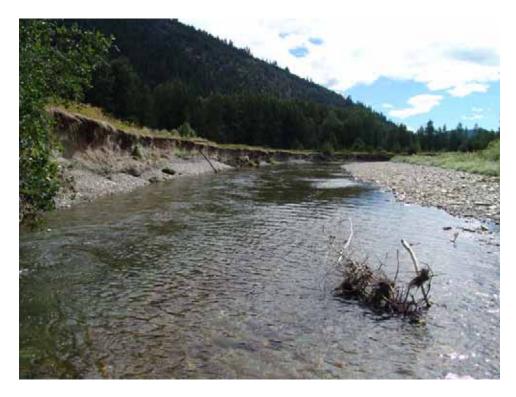
Figure 49. Looking downstream along meandering section near RM 11.2 that is eroding into an unvegetated bank about 8 to 10 feet high. (Reclamation photograph by D. Bennett, August 8, 2007).
