**FY2013 ANNUAL REPORT**  
MARCH 1, 2013 THROUGH FEBRUARY 28, 2014  
YAKAMA RESERVATION WATERSHEDS PROJECT  
*BPA Project #1996-035-01-Contract #35636*

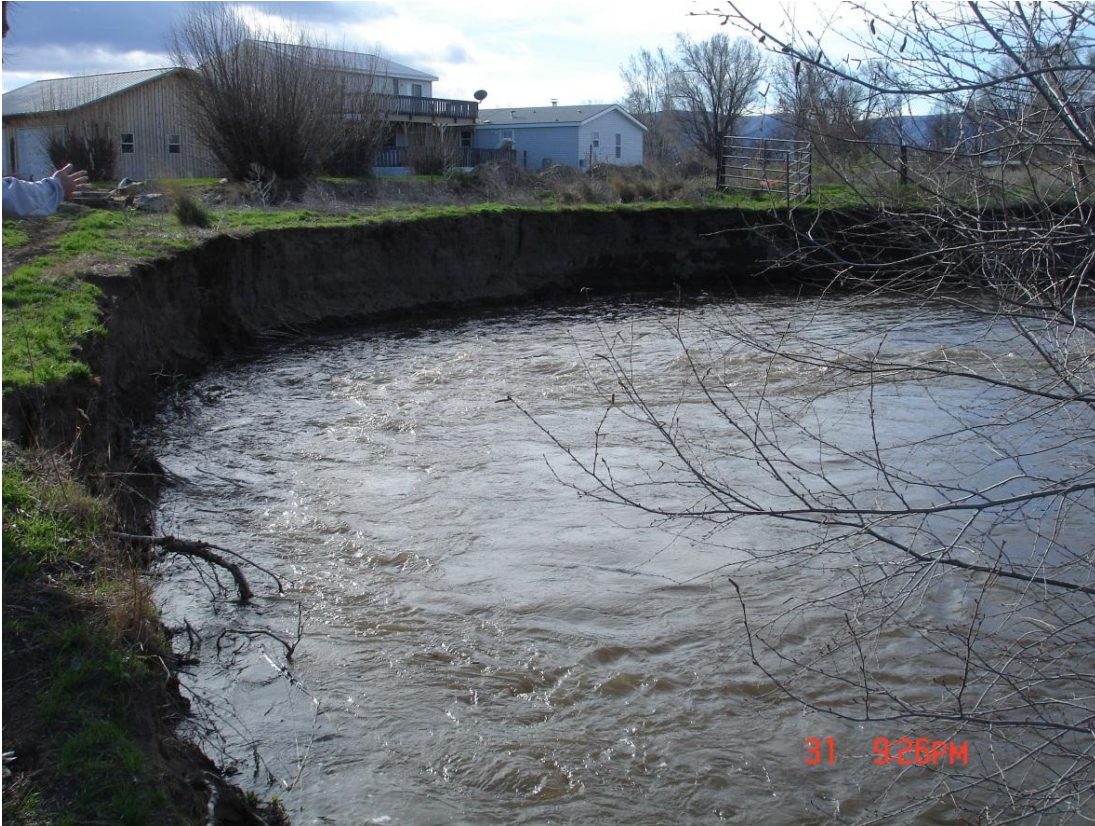
Figure 1. Looking upstream at eroding bank, March 2012

Design conditions included reconstructing the stream bank by adding a rip rap toe, large woody debris, and general fill. However, moving the toe of the existing stream bank does not meet BPA's Habitat Improvement Programmatic (HIP) BiOp with National Fisheries Marine Service (NMFS) criteria to permit this project under the Endangered Species Act (ESA). The project was re-designed so that the toe of the slope does not change, basically eliminating riprap and general fill material. This essentially was not approved for implementation due to liability and safety concerns with the adjacent landowner.

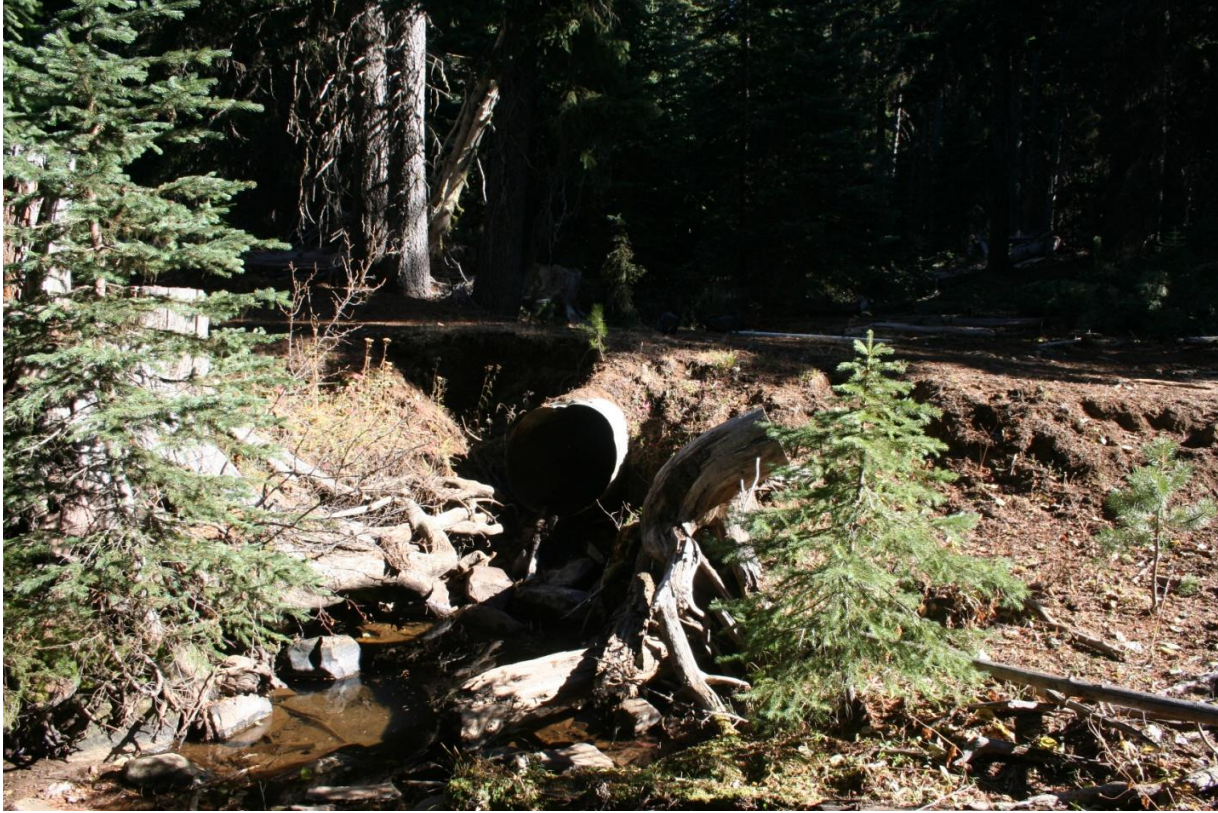
An inoperable culvert (figure 3) was identified in Upper Toppenish Creek near the Toppenish Creek headwaters, Lincoln Meadows. The culvert was clogged at the intake and the creek had avulsed around the culvert. As a result; the road was no longer drivable, fish passage had been blocked and excessive sedimentation was impacting salmonid habitat. Toppenish creek provides habitat for Middle Columbia River Steelhead and Westslope Cutthroat Trout which are among the fish species that are believed to benefit from this project. In the fall of 2013 YRWP staff worked with Yakama Nation Wildlife staff to remove the culvert and install an armored ford in its place. YRWP staff conducted a topographic survey of the site prior to the project implementation to characterize the slope and boundary conditions to aid in the design of the ford that replaced the inoperable culvert (figure 4).

Figure 3. Inoperable culvert at channel crossing prior to implementation. Note: 2' drop at culvert outlet

The inoperable culvert was removed (figure 5), and the ford was installed to the design specifications on October 31, 2013 (see figure 6).

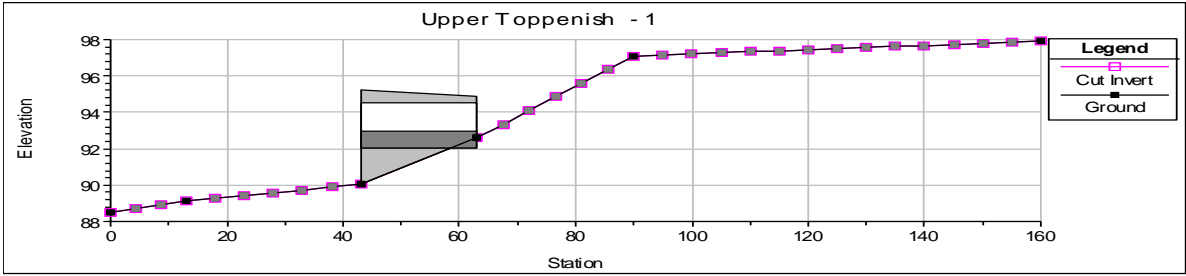
Figure 4. Model of pre-treatment site condition. The gray areas indicate fill to be removed. The dark gray portion indicates the area of the culvert that was plugged with fill.

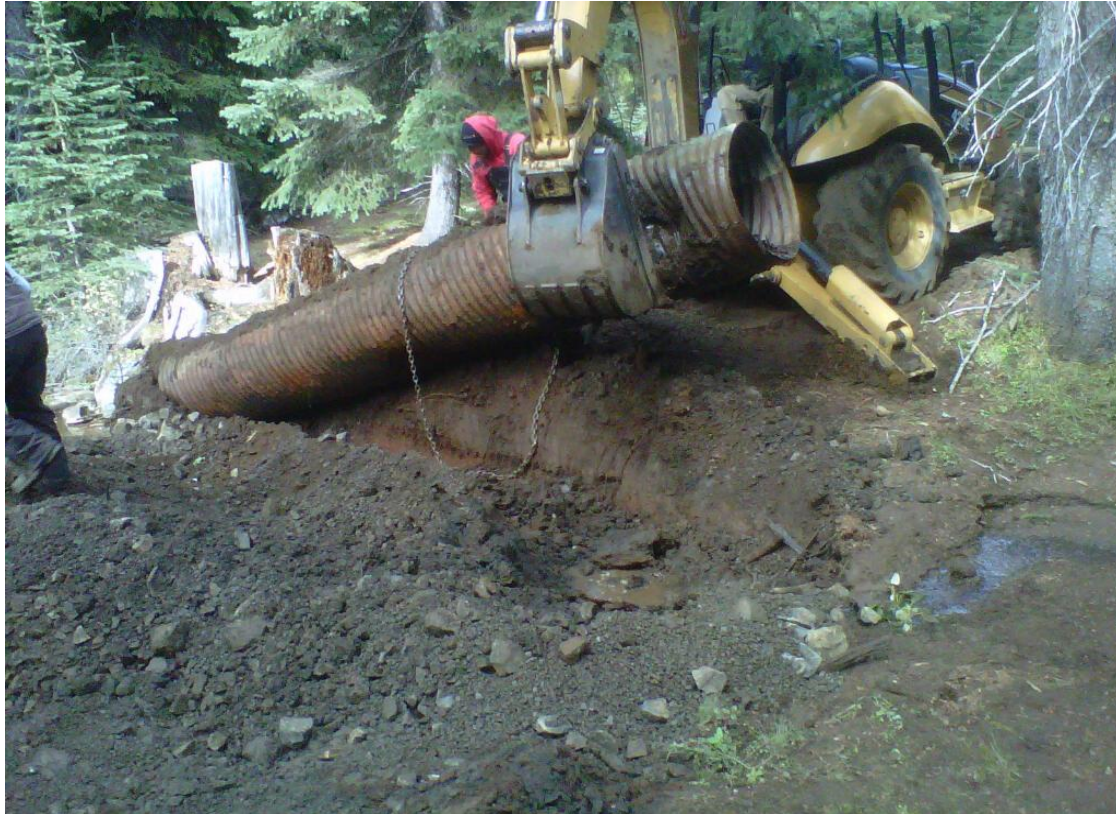
Figure 5. Fish barrier culvert removed.

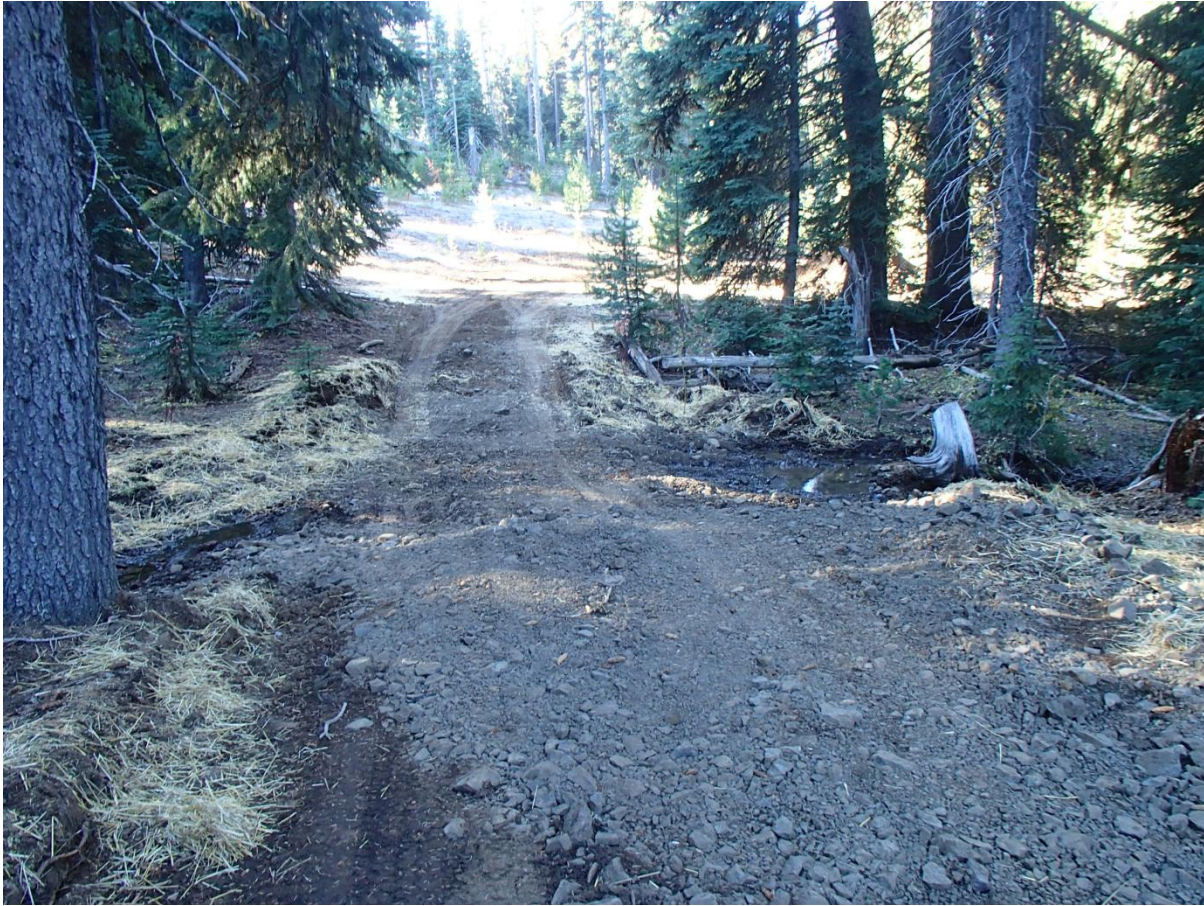
Figure 6. Site condition immediately following construction and revegetation efforts (flow is now perennial through the ford).

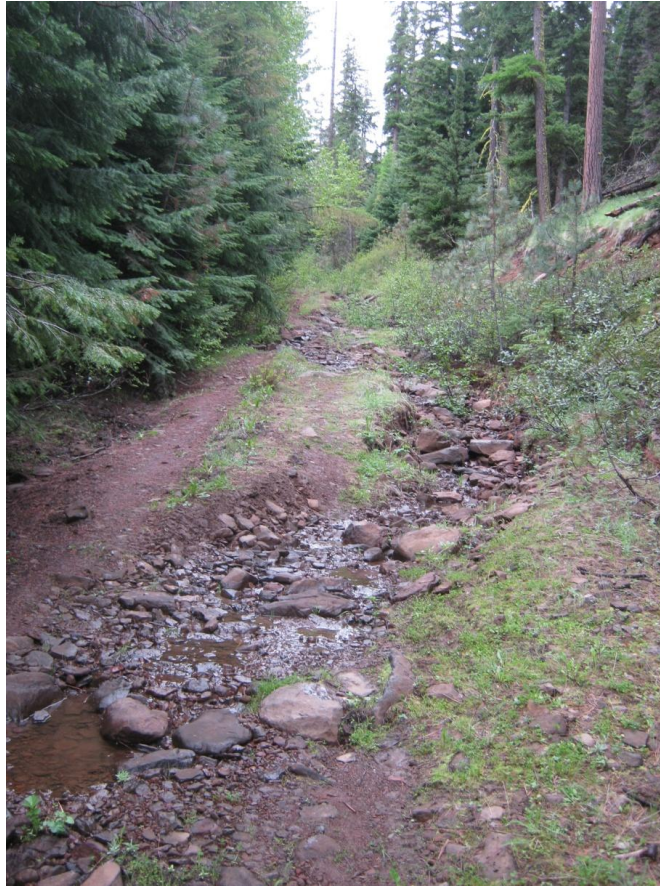
Yakama Nation Fisheries identified a site to restore to benefit Middle Columbia River Steelhead ESU and other ESA listed fish species. An improperly placed and designed logging road was diverting surface water and an ephemeral stream, causing excessive sedimentation and downstream temperature increases in South Fork Ahtanum Creek. A culvert was completely inundated with sediment and debris at the junction of two logging roads which caused the stream alignment to shift from its former channel onto the road where it flowed for approximately  $\frac{1}{4}$  mile before reentering the former channel (figure 7). Surface water runoff and spring derived water sources were being captured by the roadway further down the road as well. The goals of the project were to restore the ephemeral tributary channel alignment and divert surface water sources into the ephemeral tributary closer to their source.

Figure 7. Roadway capturing stream channel pre-treatment.

To efficiently achieve these goals, YRWP staff removed the dysfunctional culvert and installed a ford in its place, reshaped the roadway, and added eight water bars along the roadway in strategic locations. To gain a better understanding of the site and existing topography, YRWP staff performed a simple topographic survey of the channel and adjacent roadway upstream and downstream of the culvert.

The culvert was removed and the ford was shaped in its place. The degraded roadway was reshaped and 8 water bars were installed to allow the roadway to drain directly back to the ephemeral channel. At the extreme downstream extent of the project, the spring, which was formerly flowing down the roadway for ~1/4 mile, was diverted directly to the riparian area adjacent to the ephemeral stream with one of the eight water bars. These actions are hypothesized to improve downstream water temperatures and decrease sedimentation onto spawning habitat. A temperature data logger is collecting water temperature data at the confluence of the ephemeral stream which will provide insight into the success of the project in meeting the objectives to improve water quality for ESA listed fish species in the Ahtanum Creek Watershed.

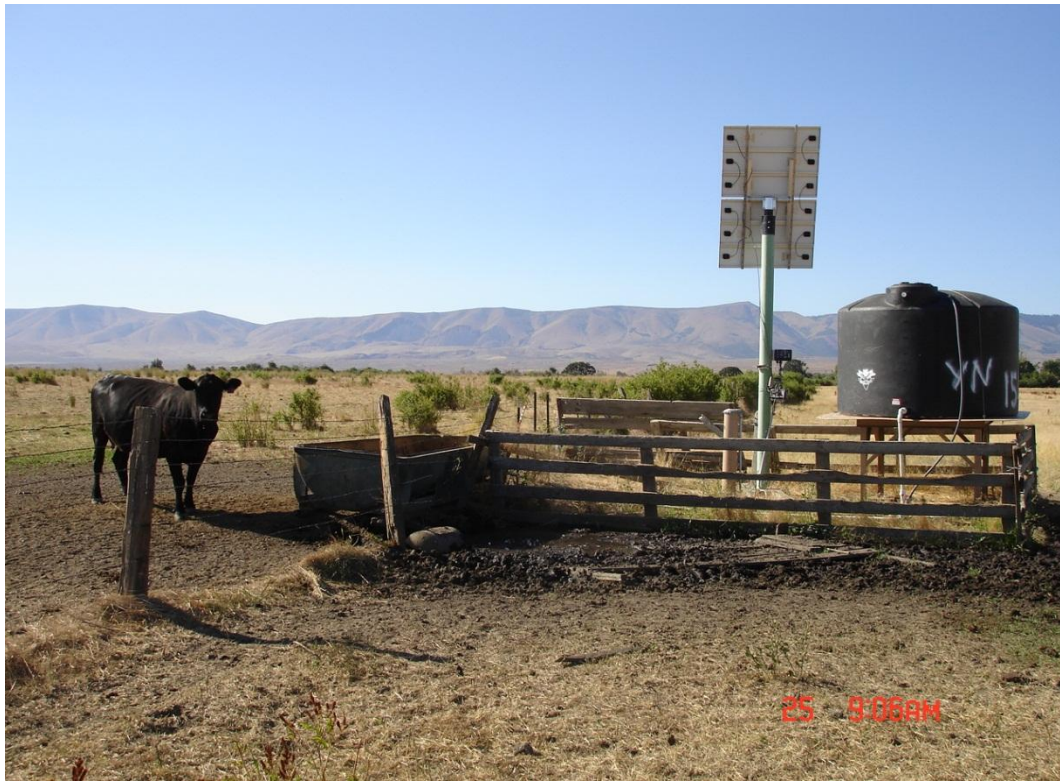
Figure 9. Stock pump and watering trough.

Routine maintenance of these facilities includes fixing a significant amount of broken PVC plumbing (often associated with cattle damage), replacing the electrical pieces of the pump's control systems as they wear out and upgrading the water troughs associated with the pumps.

Project staff have found that most of the infrastructure associated with the watering troughs (hoses, float switches, trough supports etc.) were too lightly built. Over the last year we have been working to upgrade this infrastructure with more rugged float switches, flexible PVC hoses instead of garden-type hoses, more sturdy stanchions for the troughs and gravel aprons around the troughs to prevent soil erosion.

In addition we have found it necessary to replace several of the protective fences surrounding the installations. The original fences were usually standard barbed wire and it has become apparent that a post and pole type fence is more appropriate for this application.
