**FY2014 ANNUAL REPORT**  
MARCH 1, 2014 THROUGH FEBRUARY 28, 2015  
YAKAMA RESERVATION WATERSHEDS PROJECT  
*BPA Project #1996-035-01-Contract #56662-REL 50*

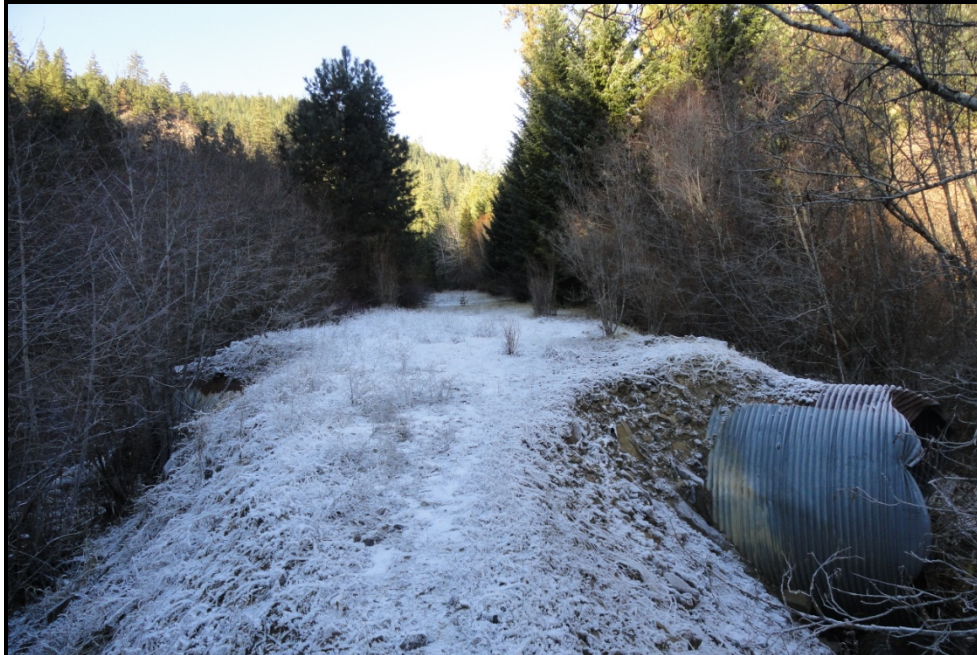
Figure 1. Upstream culvert and road that was later removed. Historic floodplain is to the right of the image and NF Toppenish Creek is to the left.

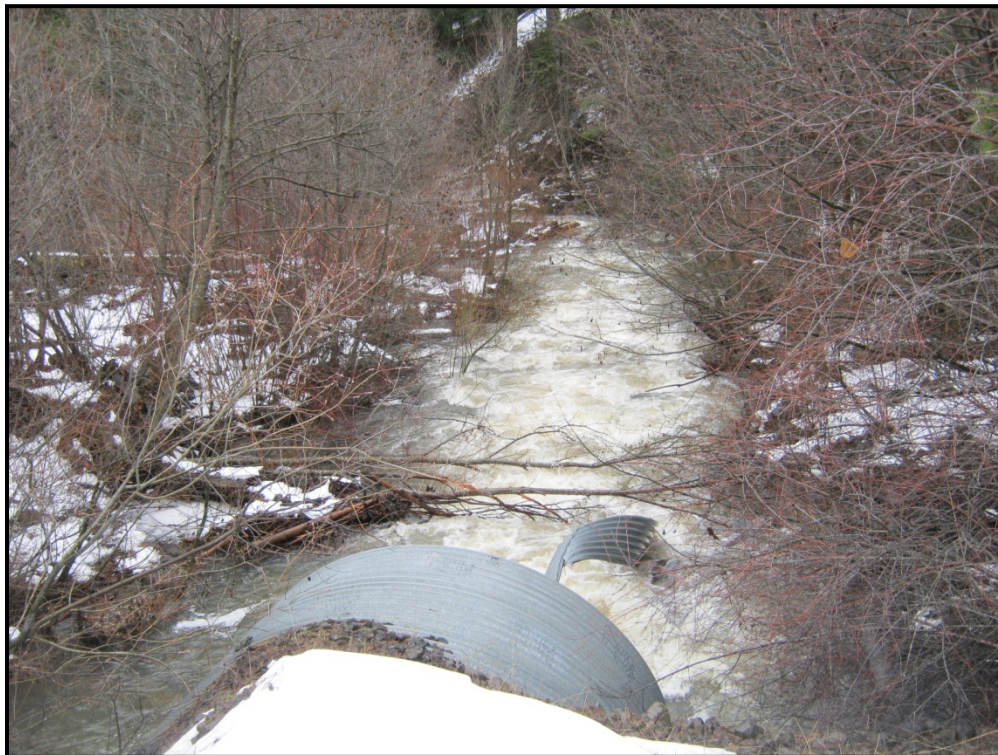
Figure 2. Lower culvert. Photo taken March, 2012

The site is located at the distal end of a sediment transport reach with bedrock near or at the streambed surface. The majority of the spawning habitat upstream of the upstream culvert is naturally confined due to the immature geology of the site. However, at the upper culvert site down to the confluence, the potential for floodplain storage is huge and was cut-off from the channel for most of the season. Diking and other channel modifications/simplification associated with the roadway had disrupted the natural sediment transport regime and water storage potential. As lateral migration had been essentially arrested to varying degrees by the road and associated infra structure, the channel has undergone considerable vertical migration near the confluence with Toppenish Creek.

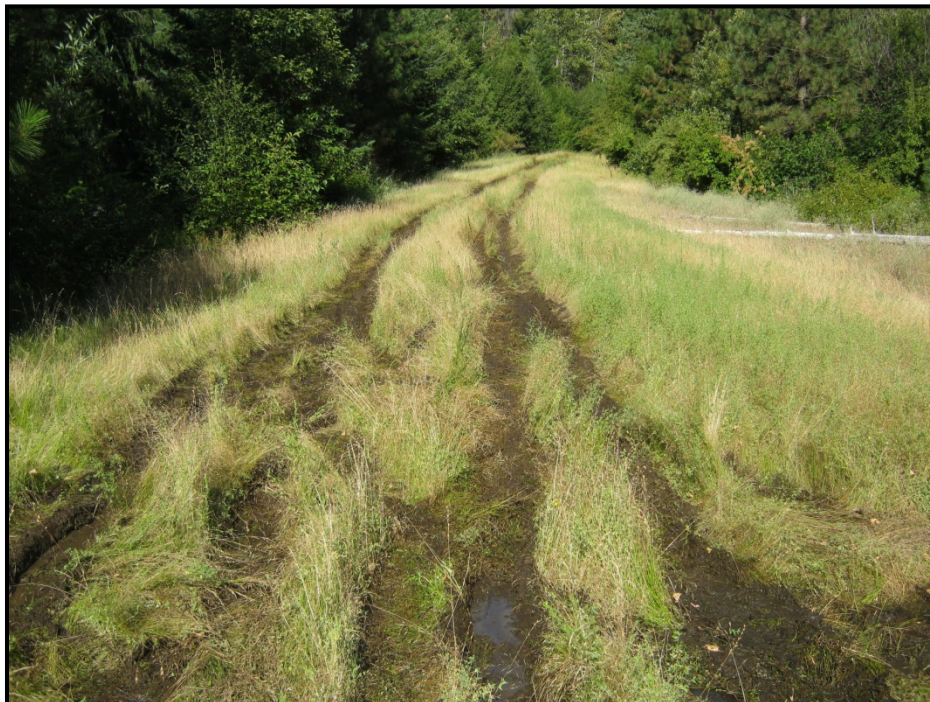
Figure 3. Surface runoff draining to North Fork Toppenish Creek at the lower culvert

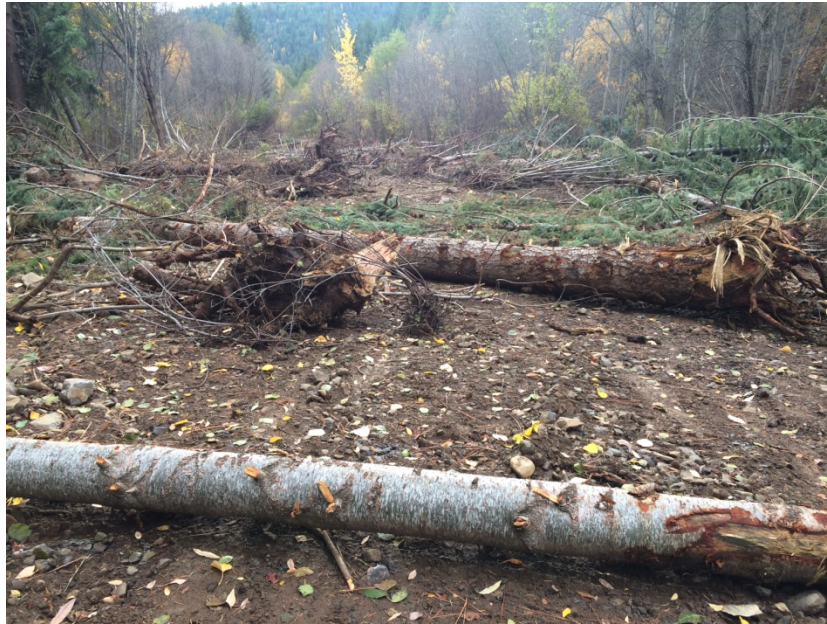
Figure 5. Salvaged logs spread throughout the disturbed area (previous road prism occupation) at the upper culvert site.

A temporary stream crossing was installed to allow equipment access to the upstream culvert site and existing vegetation was grubbed. Excavation began on the road prism and culvert. The culvert invert was just at the edge of water elevation of the active portion of the North Fork Toppenish Creek channel (wetted width). Woody materials salvaged from the roadway and excavation was dispersed over the disturbed areas to provide surface roughness and provide habitat (figure 5).

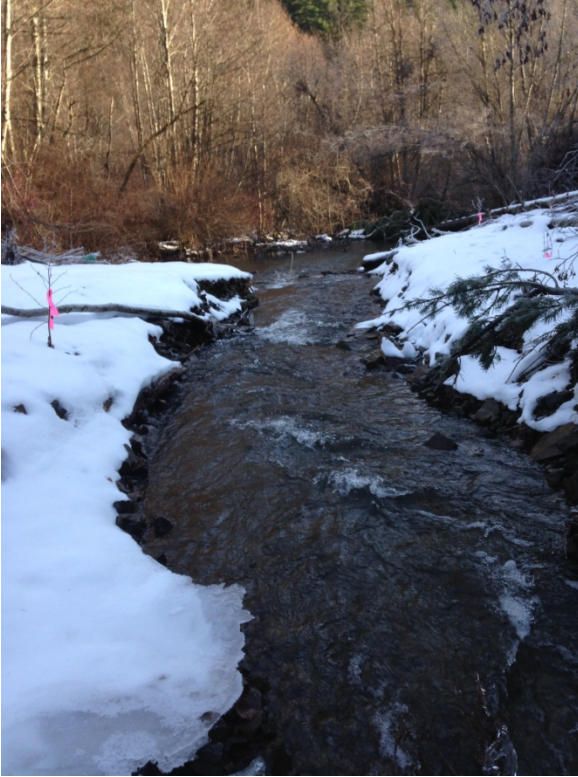
As surface water elevations rose in North Fork Toppenish Creek, the area where the upstream culvert was removed was quickly activated, diverting approximately 50% of the flow into the adjacent floodplain and historic channel network (figure 6). The scour pool at the outlet of the culvert that was removed is filling with cobble, and no passage issues exist. YRWP staff believes that approximately 75% of the flow will be flowing into the restored floodplain by winter's end.

Figure 6. Former upper culvert alignment. The newly connected floodplain is in the background.

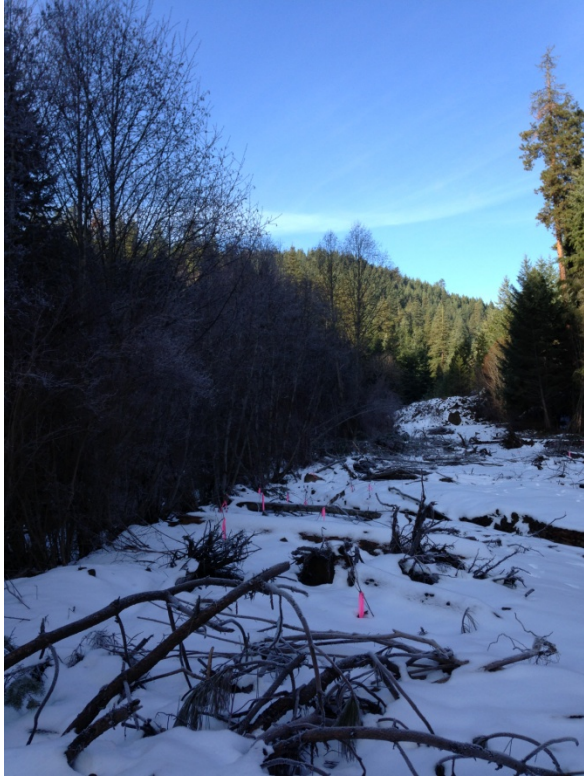
Figure 7. Former road alignment at upper culvert. This photo is the same location as figure 1, post construction.

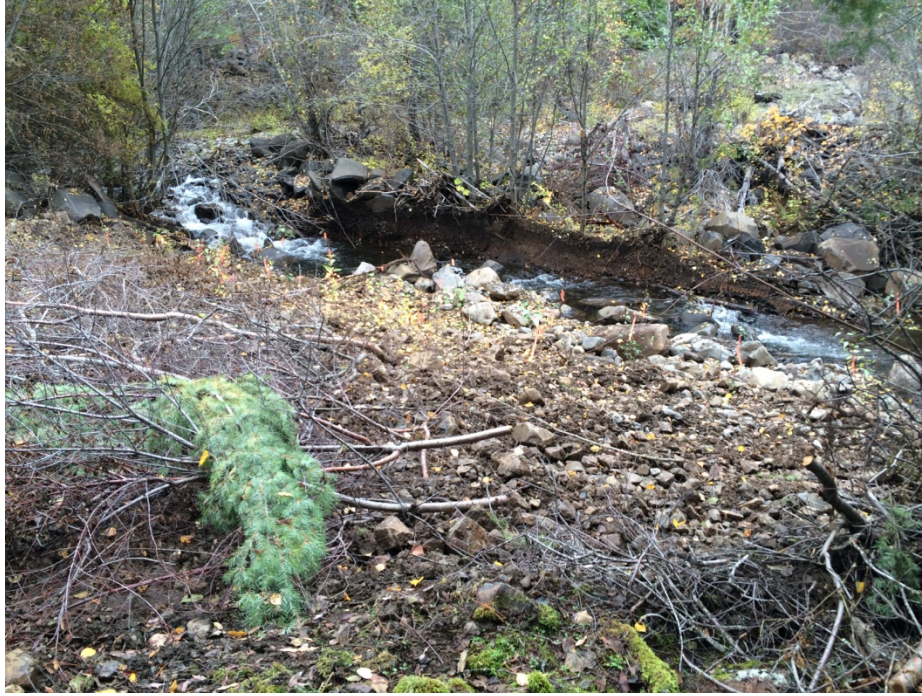
The lower culvert site will now allow unimpeded passage of MCRS, juvenile and adult, at all flows (figure 8). 375 container plants were installed throughout the site depending on species in addition to 50 lbs of native seed mix. Container plantings at each of the culvert sites and the flood plain areas are surviving well thus far and the native seed has sprouted and is helping stabilize the disturbed areas. The road drainage work conducted at the lower culvert area will greatly improve water quality and storage (figure x).

Figure 8. Lower culvert site post construction and revegetation

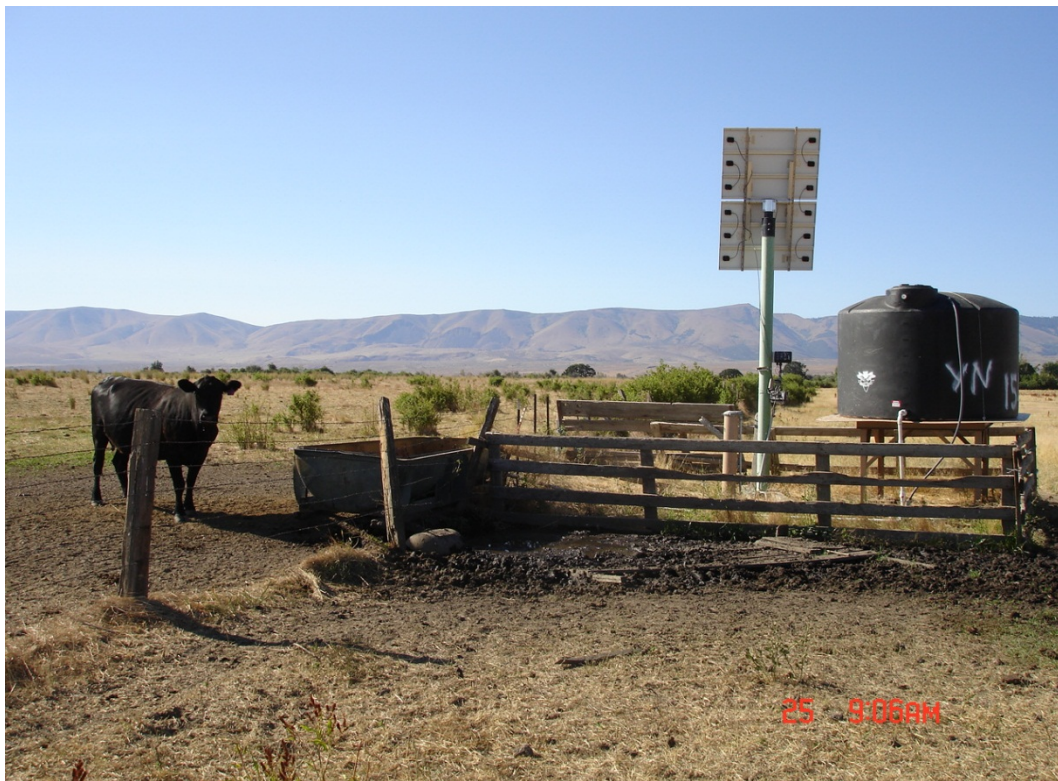
Figure 10. Stock pump and watering trough.

Routine maintenance of these facilities includes fixing a significant amount of broken PVC plumbing (often associated with cattle damage), replacing the electrical pieces of the pump's control systems as they wear out and upgrading the water troughs associated with the pumps.

Project staff have found that most of the infrastructure associated with the watering troughs (hoses, float switches, trough supports etc.) were too lightly built. Over the last year we have been working to upgrade this infrastructure with more rugged float switches, flexible PVC hoses instead of garden-type hoses, more sturdy stanchions for the troughs and gravel aprons around the troughs to prevent soil erosion.
