Chewuch River Reach Assessment

Yakama Nation Fisheries Program

JUNE 2010

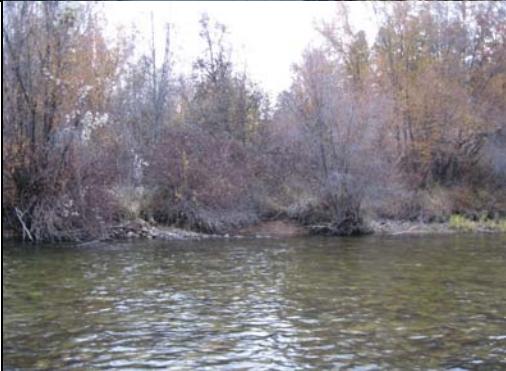
<p>View to the east at the river left bank near RM 2.65 where LWD could enhance in-stream habitat. November 2009.</p>

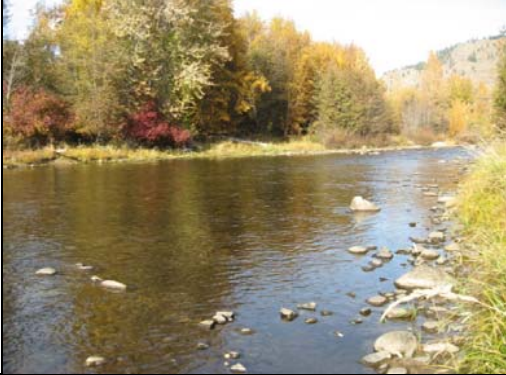
<p>View to the northwest in the upstream direction at a potential LWD location on the river-right bank near RM 6.95. November 2009.</p>
2b	Project RM 7.15L	Inner Zone 1 (IZ-1)	Reconnect Stream Channel Processes	Riprap removal or modification	There are 1,250 ft of riprap along river-left between RM 7.01 and 7.28 which creates a hardened 10-ft bank above the low flow water surface. Channel processes and floodplain connection are impaired by this modification. The riprap could be removed and replaced with LWD to provide bank protection and enhance in-stream habitat. Alternatively, the existing riprap could be enhanced with LWD to increase habitat cover and complexity.

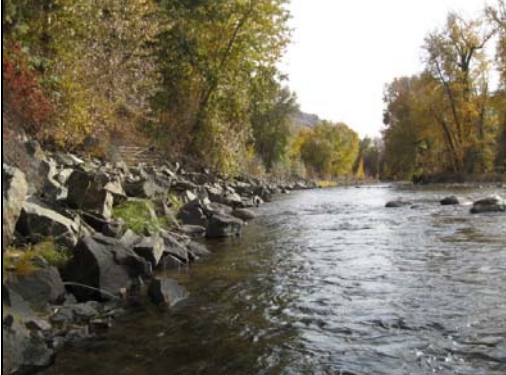
<p>View to the south in the downstream direction along the river-left bank near RM 7.28 where riprap has impaired in-stream processes and habitat. November 2009.</p>

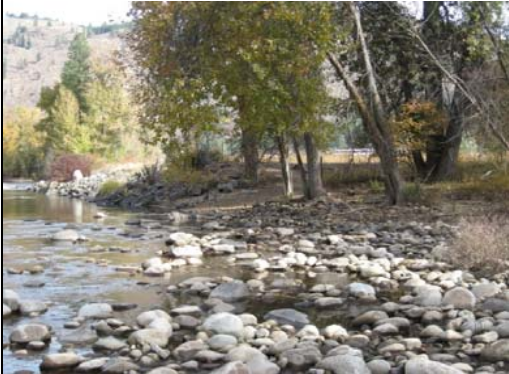
<p>View to the north in the upstream direction where livestock have accessed water along the river-left bank near RM 7.5 (November 2009).</p>
3a	Project RM 7.6L	Inner Zone 2 (IZ-2)	Reconnect Stream Channel Processes	Riprap removal or modification	There is a 400 ft long riprap bank along the river left near RM 7.6 that protects the toe of an eroding terrace. The terrace surface has been converted to agriculture. The riprap could be removed and replaced with log jams to enhance in-stream habitat and continue to provide bank protection. Alternatively, the existing riprap could be enhanced with additions of LWD to increase habitat cover and complexity. This project could be combined with restoration of a forested riparian buffer on the terrace in order to enhance long-term riparian functions including shading and LWD recruitment.

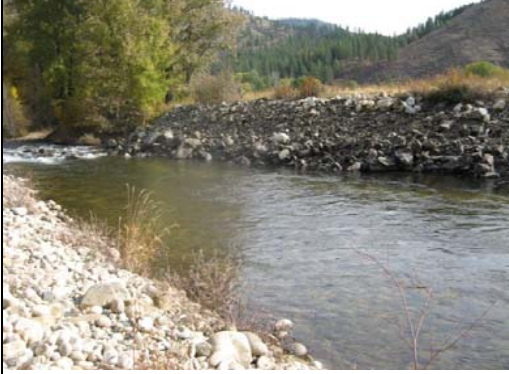
<p>View to the northeast in the upstream direction at riprap along the river-left bank near RM 7.6 (November 2009).</p>

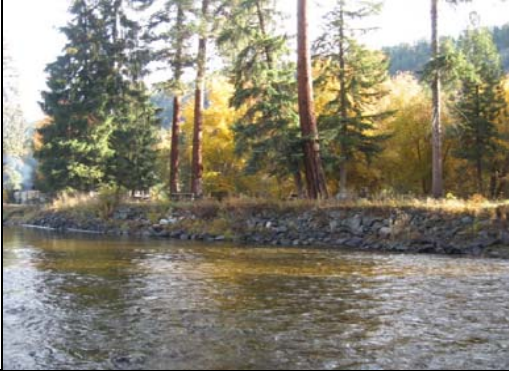
<p>View to the east at riprap and floodplain clearing along the river-left bank near RM 10.46 (November 2009).</p>
4c	Project RM 10.6R	Inner Zone 1 (IZ-1)	In-Stream Habitat Enhancement	LWD enhancement	This project involves LWD placement to increase local habitat quality and cover. This channel section is straight and currently lacks habitat complexity.
