Upper Methow River Reach Assessment

River Miles 61 - 80

SUBMITTED TO
Yakama Nation Fisheries

FINAL - DECEMBER 2015

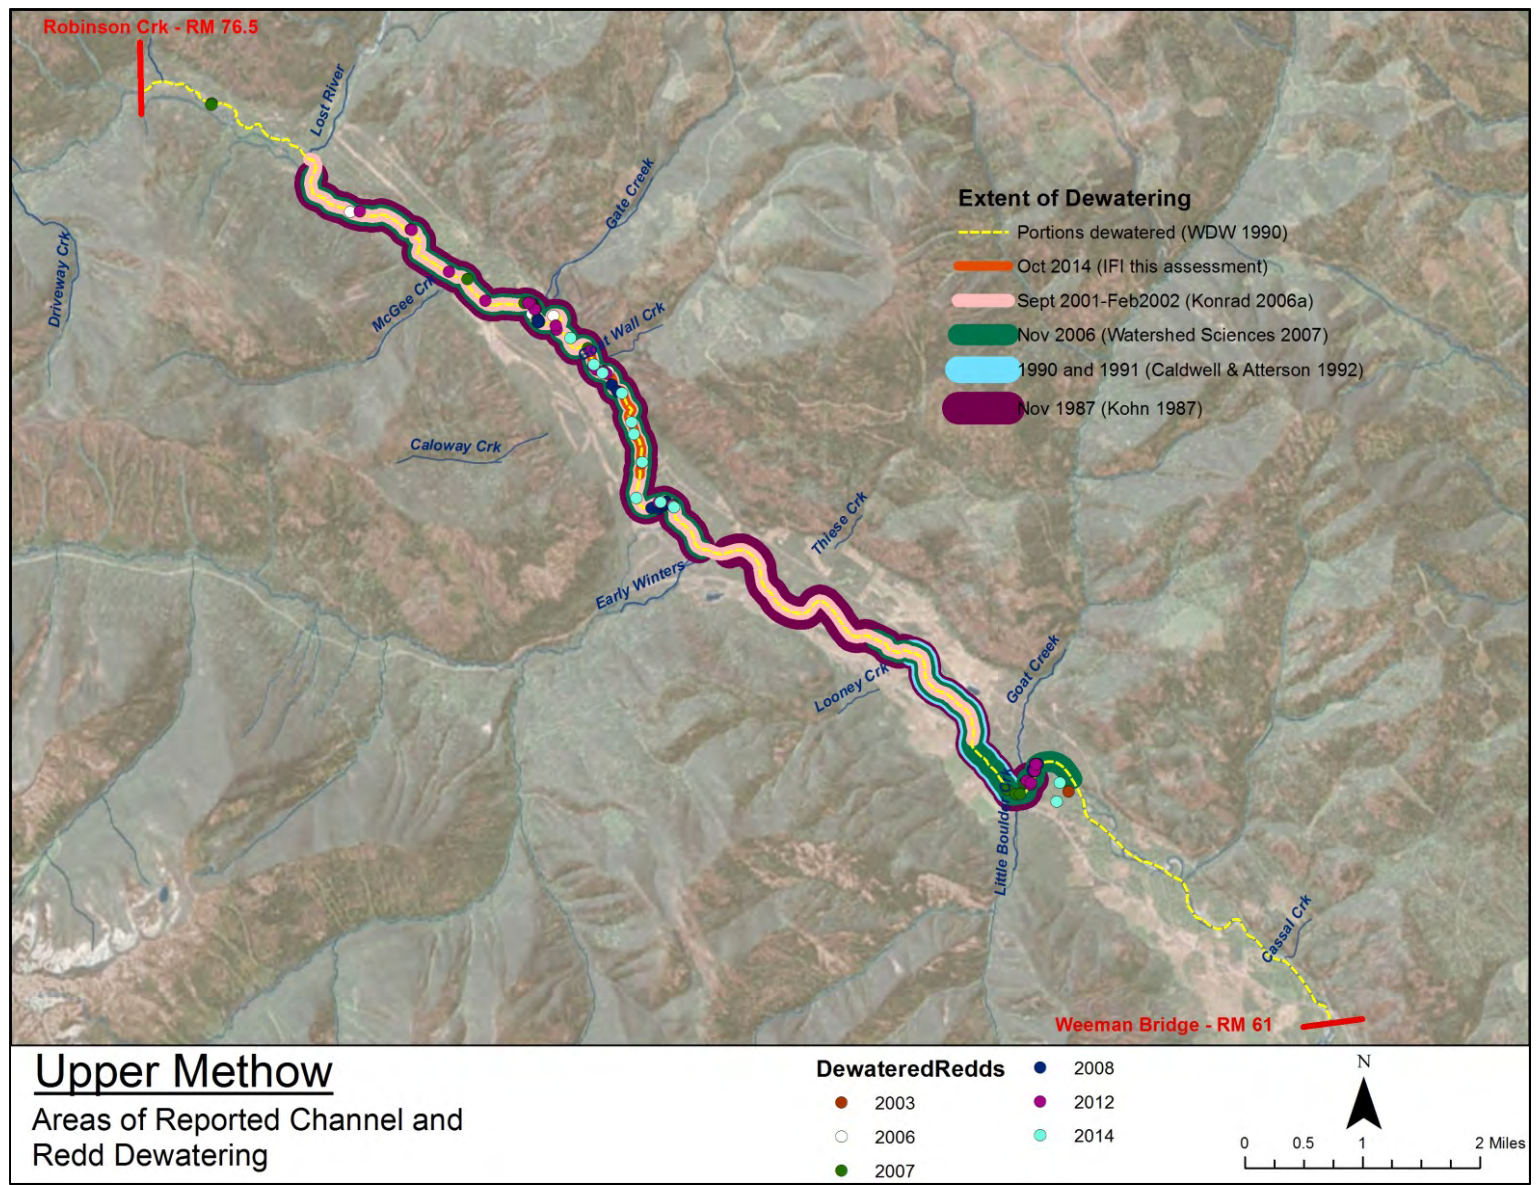
In the Upper Methow, river segments between the confluences of Lost River (RM 75) and Goat Creek (RM 65) often seasonally go dry with only small residual holding pools during late summer and autumn (Andonaegui 2000, Konrad 2003, WDW 1990). In this section of the river, the unconsolidated glacial outwash material is up to ~1,000 feet deep and the groundwater table usually drops below the elevation of the channel bed by late summer. The timing and extent of dewatering in the study area depends on the amount, type, and timing of precipitation that is received during the year for recharging the aquifer. A map that combines records of the extent of observed dewatering, and the location of spring Chinook redds impacted during surveys, is presented in Figure 8. Reports of dewatering or partial dewatering extend from Robinson Creek (RM 76.5) to the Weeman Bridge (RM 61) with persistent pools reported at the confluence with the Lost River, Early Winters Creek, and Goat Creek.

Figure 8. Extent of reported dry-season channel dewatering and observed dry redds. Dewatering includes dry channel beds and partial drying with stranding pools. Redd survey data completed by the Washington Department of Fish and Wildlife and supplied by the Yakama Nation Fisheries Department for this report.

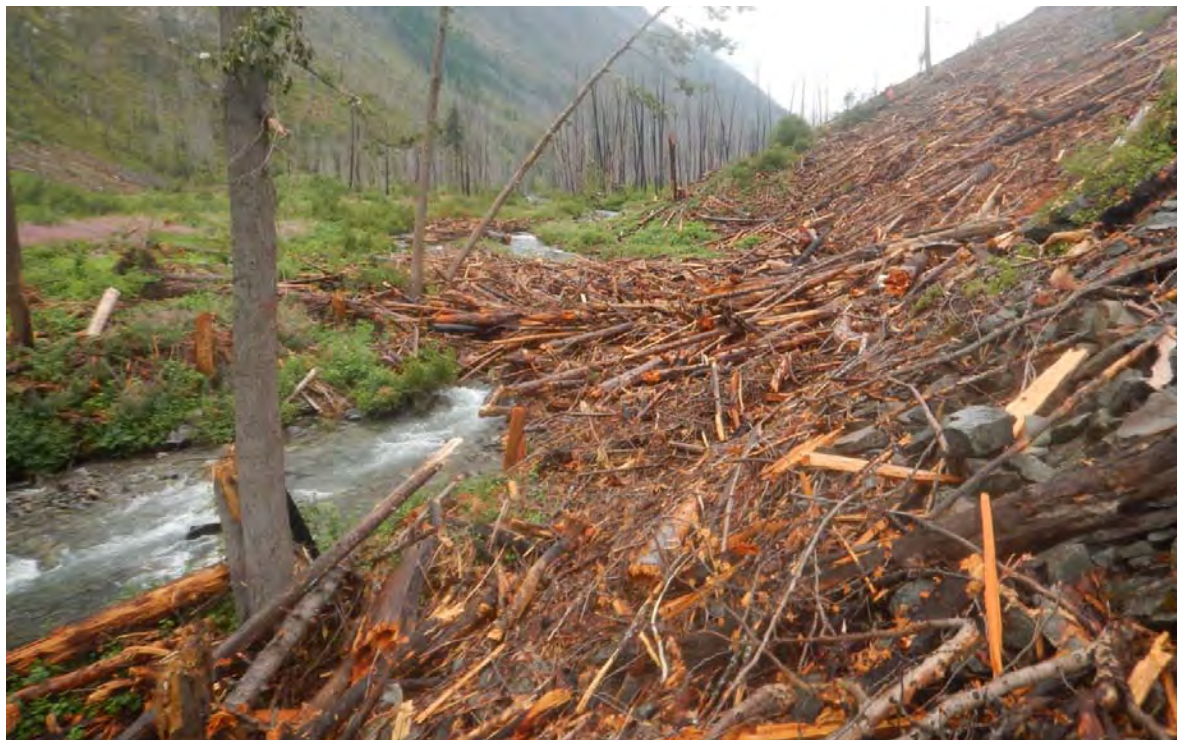
Figure 18. Trees on either side of the Upper Methow River in Reach 9 were burned during the Needles Fire of 2003, leaving upright dead snags. This large log jam at RM 79.75 is believed to be the result of a snow avalanche.

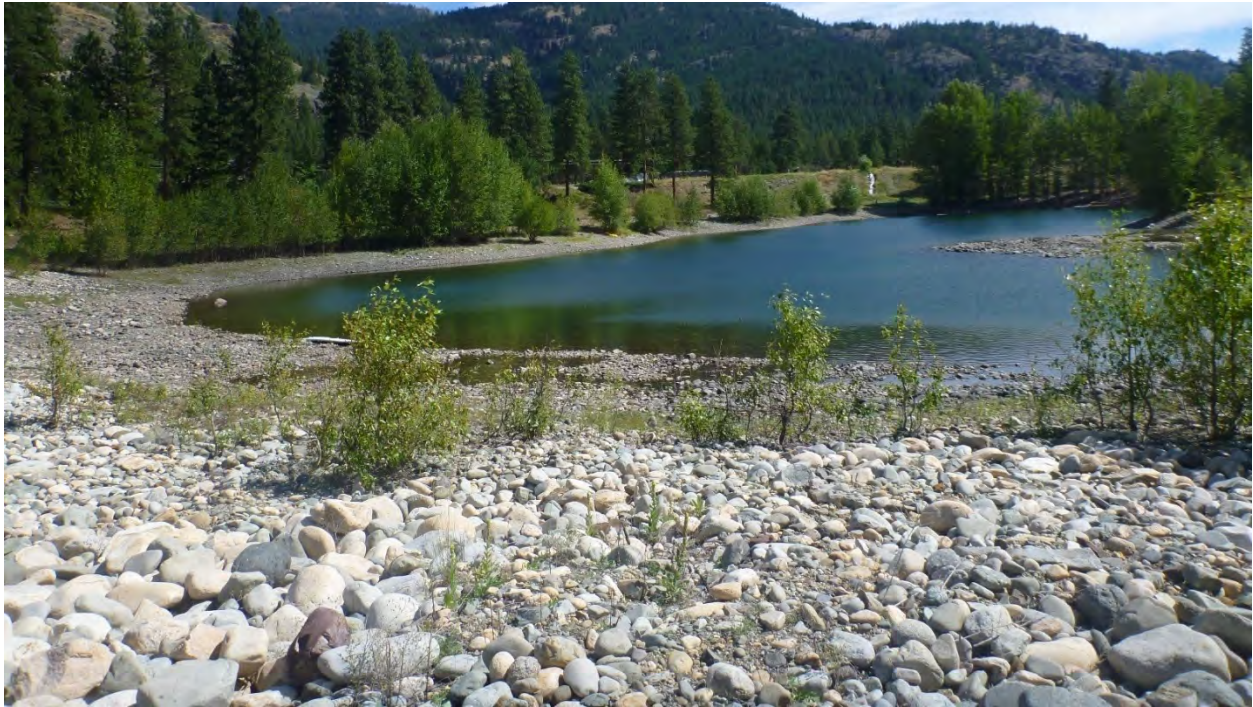
Figure 61. Dug pond and levee (foreground) located in abandoned channel scar on river-left floodplain; upstream border of Reach 3 at RM 66.25. (8/28/2014)

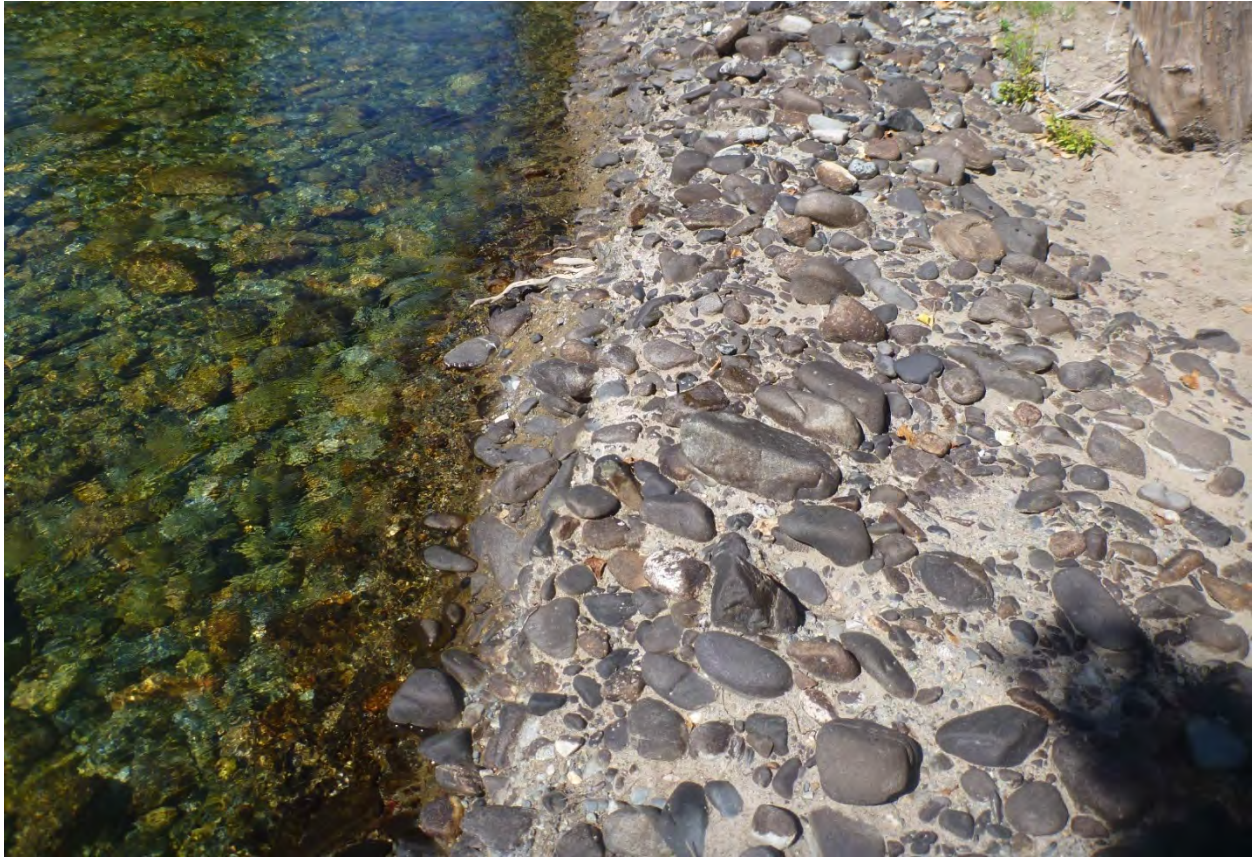
Figure 88. Cobble-sand shelf -- hardened through plucking and armoring (RM 70.3). (8/26/2014)

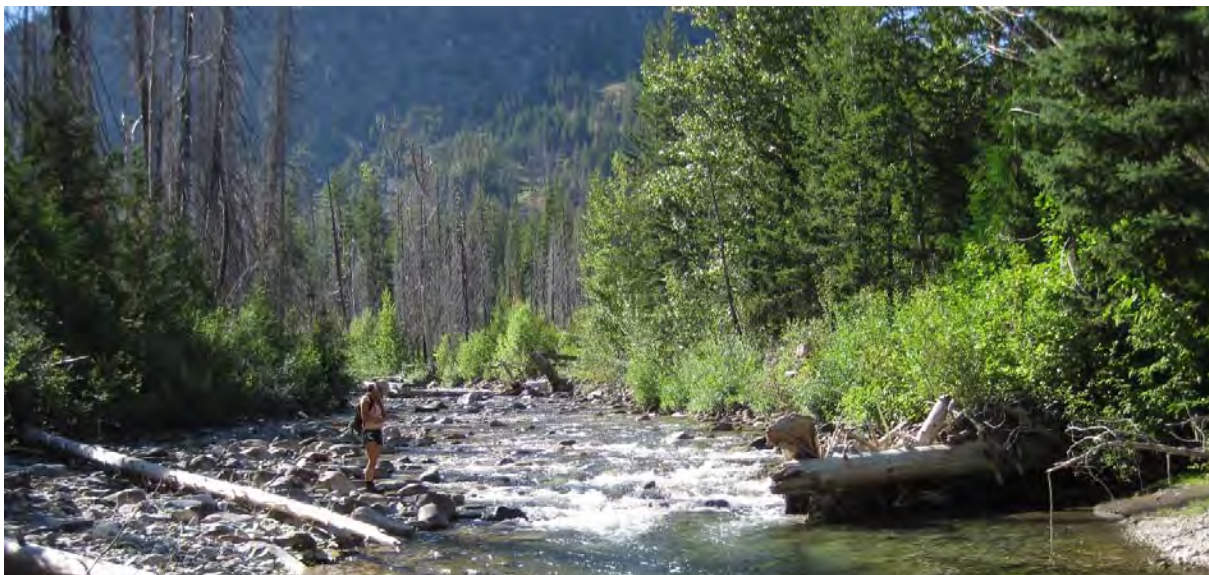
Figure 128. Varied bank vegetation in Reach 8 - burned snags, dense understory, mature conifers; looking upstream at RM 77.5. (9/5/2104)

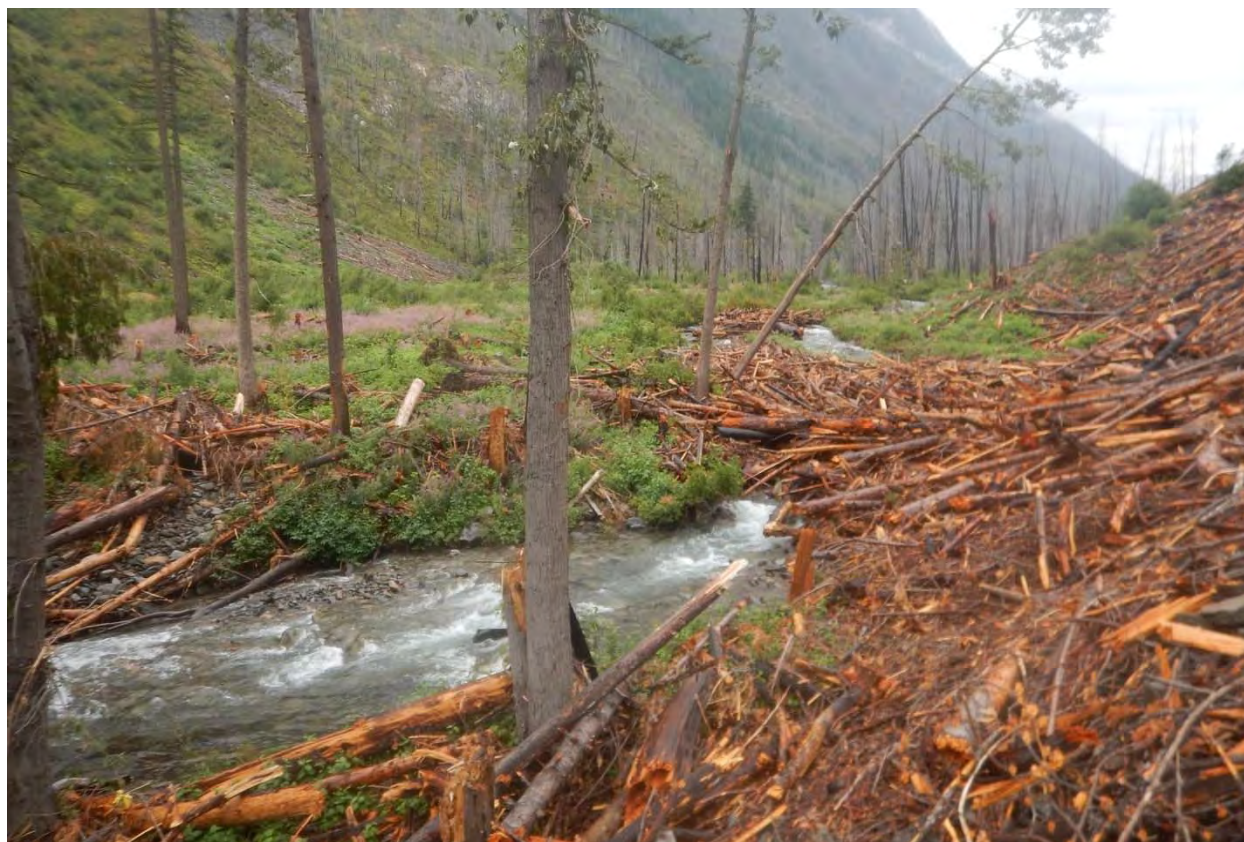
Figure 88. Log jam at RM 79.75 caused by an avalanche in May 2014. Much of the wood was likely dead snags that had burned during the 2003 Needles Fire.
