UPPER NASON CREEK REACH ASSESSMENT

Habitat Conditions and Restoration Opportunities from RM 13.7 to RM 16.2

March 2019

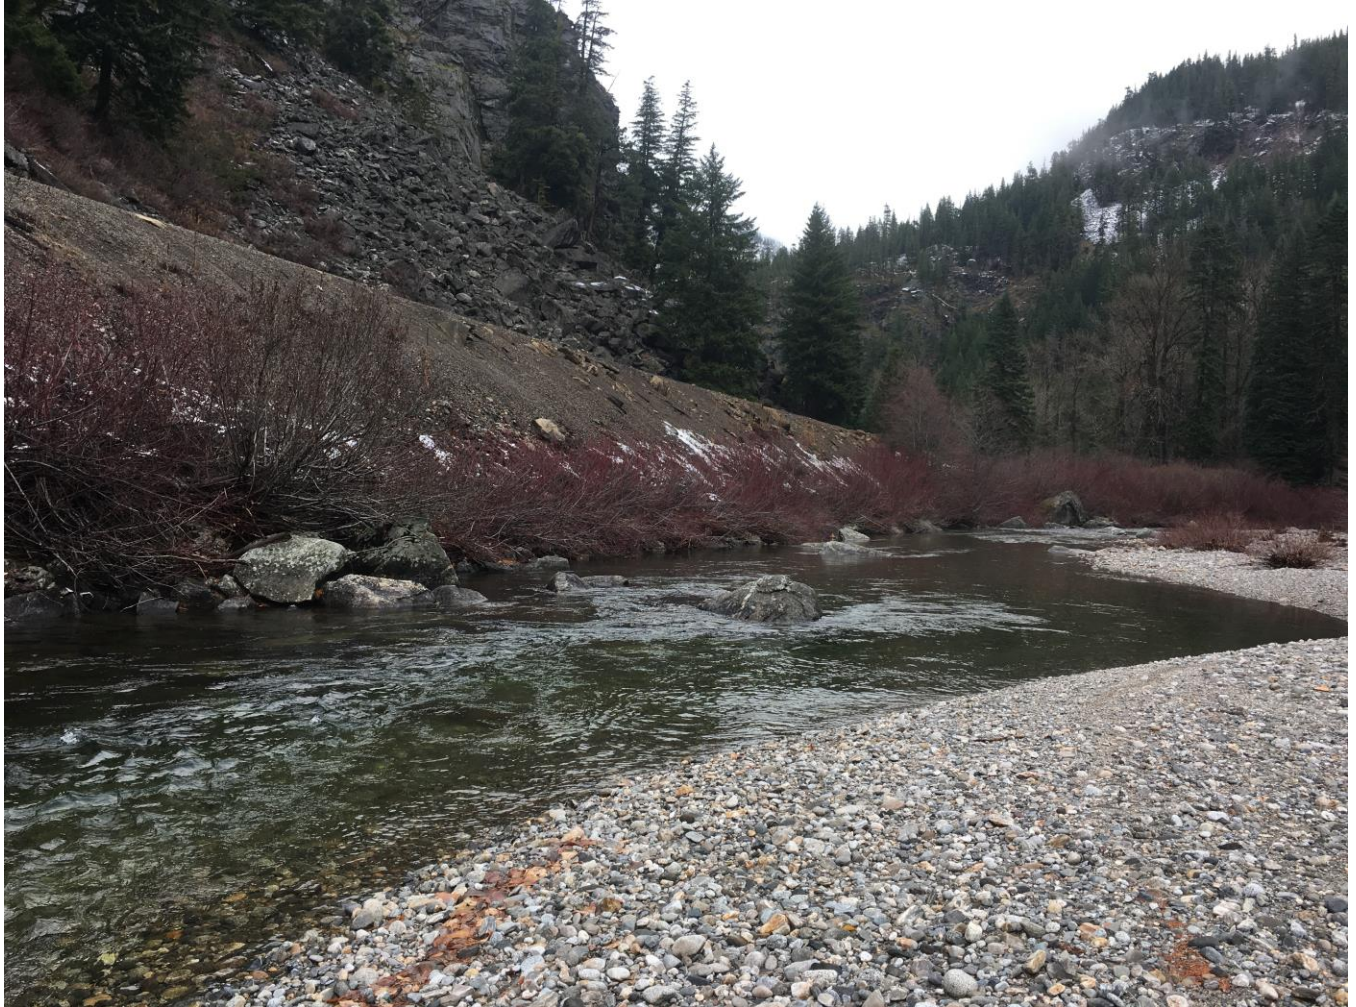
Anthropogenic features include the railroad grade along river left (with a railroad bridge over Nason Creek at RM 13.7), the unpaved Whitepine Creek Road along river right (with a bridge over Nason Creek at RM 13.75), several unofficial/dispersed campsites (mostly clustered near the confluence with Whitepine Creek), and the Cascade Meadows Camp on river right at RM 15. The study area is in a unique stretch of Nason Creek that is removed from all state and federal highway corridors.

Figure 3. Railroad Grade Running Along Nason Creek Within the Upper Nason Reach.

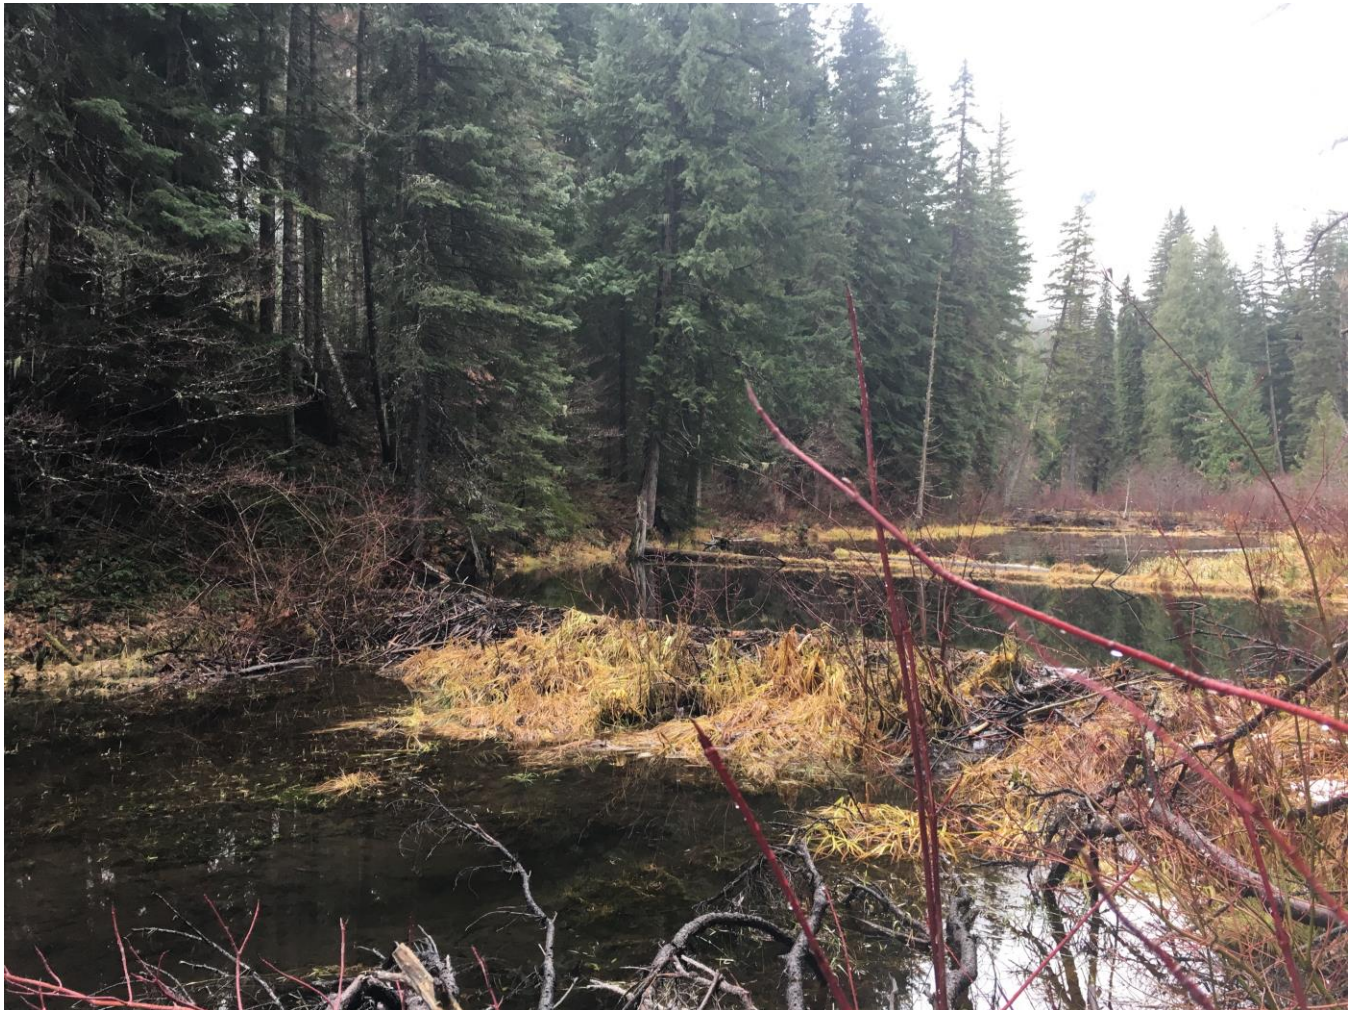
Woody debris is deficient through most of the reach, with only two log jams present in the entire study area. Surveyors recorded 34.2 small (minimum 6in x 20ft) pieces per mile, 19.1 medium (minimum 12in x 35ft) pieces per mile, and 7.0 large (minimum 20in x 35ft) pieces per mile. However, over 38% of total woody debris resources were recorded in the off-channel area of channel unit 44. Mainstem woody debris is low, and excluding the wood from off-channel area, frequencies drop to 21.0 small pieces/mi, 10.5 medium pieces/mi, and 5.8 large pieces/mi. The reach has moderate woody debris resources available for both long-term and short-term recruitment, however the residence time of recruited trees is low due to a lack of key sized trees capable of remaining stable during high flow events. Estimates of key member size based on the bankfull flow depth and width are greater than 60 in DBH and 100 ft long, with rootwad attached (Abbe and Montgomery 2003). The largest trees observed in the channel and along the channel banks approach 48 in DBH and exceeded 100 ft in length, however there are very few trees of this size in the project reach. The vast majority of trees available for recruitment will be mobile during high flow events, and with few obstructions in the channel capable of accumulating wood in transport the residence time of recruited wood will remain low within the project reach.

Figure 8. Large Off-Channel Area. Four Active Beaver Dams and Over 38% of the Total Woody Debris Resources Were Found in this Unit.

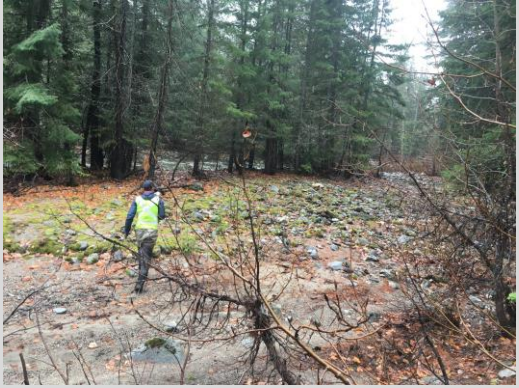
PROJECT LOCATION (RM/BANK)	PROJECT ID ¹	GROUP ²	ACTION TYPE	CONDITION	ACTION	CONSIDERATIONS	PHOTO
RM 16.1/R	UN 1	G1	Install Habitat Structure Floodplain Habitat Reconnection	Location is immediately downstream of the Nason and Whitepine confluence. River left contains a narrow high flow channel. Surrounding floodplain is above the 2-year flood elevation.	Install LWM on river right downstream of the confluence pool to increase flow deflection and activation of the river left side channel.	Project can be combined with UN2 and UN3. Access through White Pine Road to support equipment access and construction.	River left side channel facing upstream.

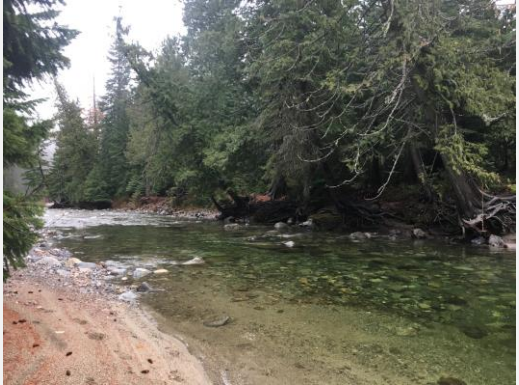
PROJECT LOCATION (RM/BANK)	PROJECT ID ¹	GROUP ²	ACTION TYPE	CONDITION	ACTION	CONSIDERATIONS	PHOTO
RM 16.0/L	UN2a	G1	Protection	River left high flow floodplain terrace. Field assessment indicate that the floodplain surface is higher than the 10-year event.	No action proposed.	No action.	Mainstem near confluence with Whitepine Creek.

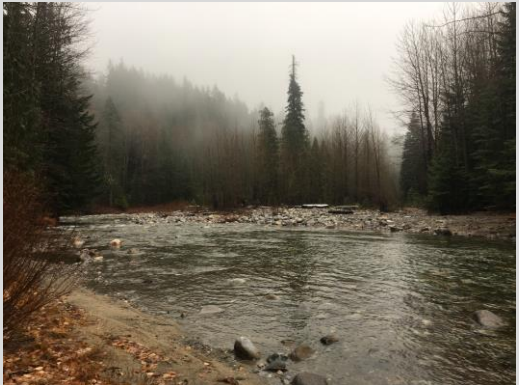
RM 15.95/L and R	UN2	G1	Install Habitat Structure Floodplain Habitat Reconnection	Existing river left and river right side channels.	Install LWM on river left at downstream end of existing side channel to create scour pool and to deflect flows to river right to improve flow connectivity to existing side channel.	Combine action with LWM installation UN 1. Assess flow interaction with UN3 downstream. Access site from upstream and Whitepine Road.	Near location of proposed ELJ, facing downstream. Note side channel on river right.

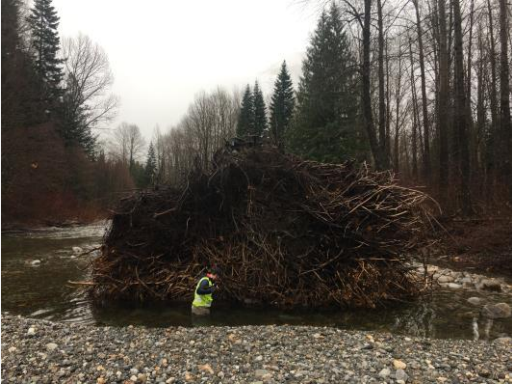
PROJECT LOCATION (RM/BANK)	PROJECT ID ¹	GROUP ²	ACTION TYPE	CONDITION	ACTION	CONSIDERATIONS	PHOTO
RM 15.8/L	UN3	G1	Install Habitat Structure Floodplain Habitat Reconnection	Existing large LWM jam on river left associated with forced channel meander and perennial side channel.	Reinforce existing jam with large wood or posts to increase pool formation, channel migration to river right, and support of existing side channel.	<p>Possible to combine action with UN 1 and UN2.</p> <p>Assess flow interaction with upstream treatments.</p> <p>No direct overland access to site. Use wide gravel bar immediately upstream to support construction/access. May require temporary bridges.</p>	<p>Existing large wood at RM 15.8. Incorporate into proposed ELJ structure.</p>

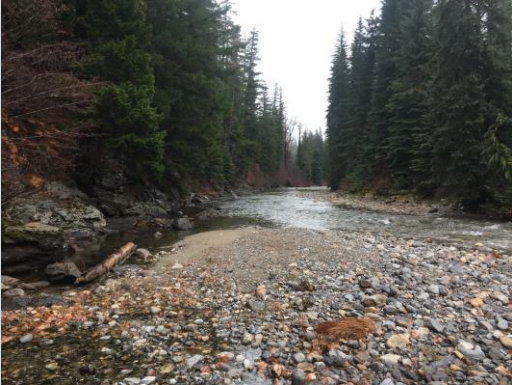
PROJECT LOCATION (RM/BANK)	PROJECT ID ¹	GROUP ²	ACTION TYPE	CONDITION	ACTION	CONSIDERATIONS	PHOTO
RM 15.75/L	UN4	G2	Install Habitat Structure Floodplain Habitat Reconnection	Left bank low vegetated gravel bar with an existing side channel.	Install LWM at head up gravel bar to enhance flow split, improve side channel scour and connectivity, scour pool.	Difficult direct access. Consider helicopter construction to reduce access impacts.	Downstream end of river left side channel terminates at bedrock-scoured pool.

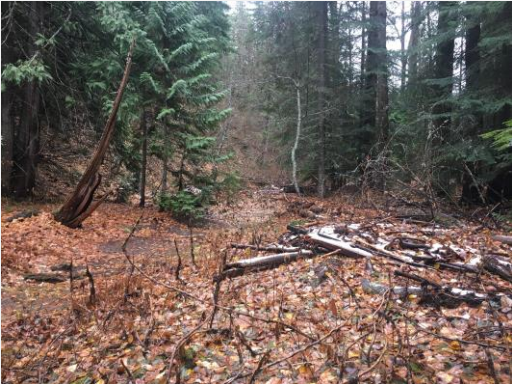
RM 15.75/L	UN4a	G2	Protection	High floodplain on river left with historical evidence of overland flows. Floodplain above 10-year flood elevation.	Low opportunity for improving floodplain connectivity due to high floodplain elevation.	No Action.	High flow channel on river left.

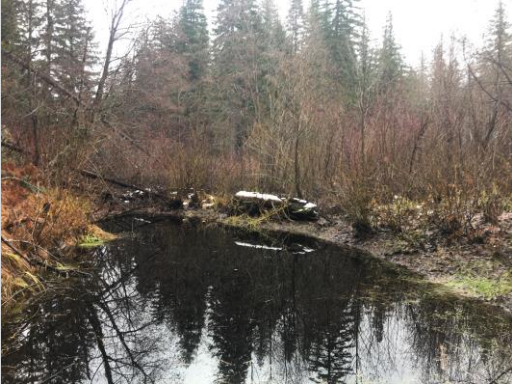
PROJECT LOCATION (RM/BANK)	PROJECT ID ¹	GROUP ²	ACTION TYPE	CONDITION	ACTION	CONSIDERATIONS	PHOTO
Rm 15.50/L R	UN5	G3	Install Habitat Structure Floodplain Habitat Reconnection	River left low terrace with recent flood scour. Beaver ponds along downstream 300'. River right high-flow gravel bar with backbar side channel.	Add LWM structures on river right and left to improve flow deflection into existing side channels.	Difficult direct access. Consider helicopter construction to reduce access impacts	River left beaver ponds.

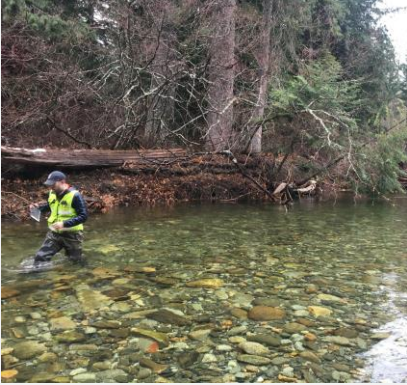
RM 15.45	UN6	G3	Protection	Right bank floodplain is above 10-year flood elevation. A connection to the UN7 beaver pond complex Would require excavation through forested wetland to achieve greater surface water connection to large beaver pond complex.	No action.	An upstream connection channel would require deep excavation through high-quality forested floodplain and wetland habitats. Access is very limited with no existing area onside for staging or spoil materials.	High bank on river right.

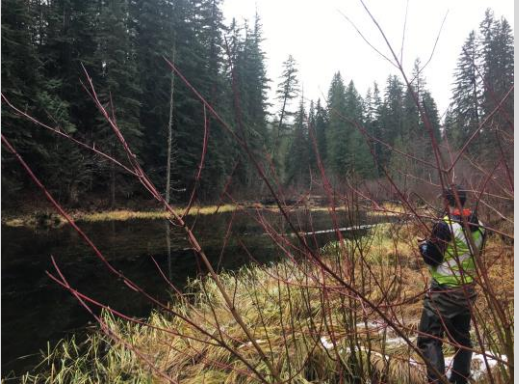
PROJECT LOCATION (RM/BANK)	PROJECT ID ¹	GROUP ²	ACTION TYPE	CONDITION	ACTION	CONSIDERATIONS	PHOTO
RM 15.25/R	UN7	G3	Protection	Large beaver dam complex, ponded year-round with no direct upstream surface water inlet. High quality off channel habitat. Current beaver dams limit low flow fish access.	No action	Beaver complex is properly functioning.	<p>Beaver dam complex.</p>

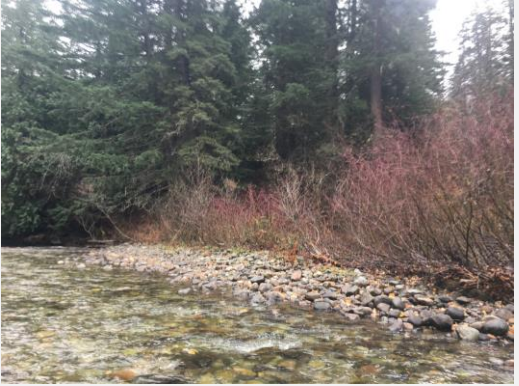
RM 15.10/L	UN7b	G3	Protection	Low forested floodplain with no existing side channel elements.	No action.	No action.	<p>Forested floodplain.</p>

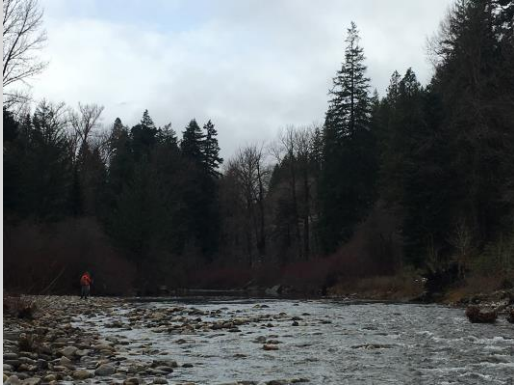
PROJECT LOCATION (RM/BANK)	PROJECT ID¹	GROUP²	ACTION TYPE	CONDITION	ACTION	CONSIDERATIONS	PHOTO
RM14.75/R	UN8	G4	Install Habitat Structure Floodplain Habitat Reconnection	High floodplain terrace on river right; limited opportunity for floodplain connectivity enhancement.	Install LWM structure on river left to force migration to river left. Improve scour, LWM recruitment, possible improvement high flow connectivity.	Opportunity to construct in combination with UN9 and UN 10. Possible construction access through the camp and use of temporary bridges.	View downstream to right bank floodplain.

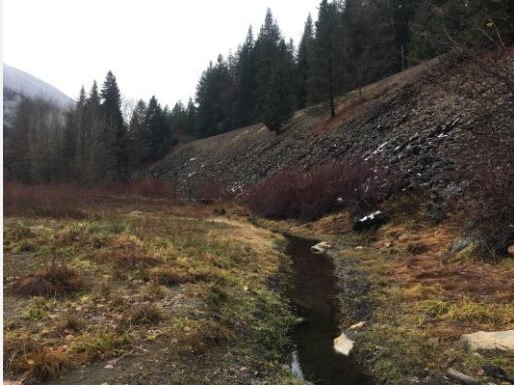
RM14.77/L	UN9	G4	Install Habitat Structure Floodplain Habitat Reconnection	Low elevation gravel bar and side channel on river left.	Install LWM structure at the apex of the bar to split flow and improve side channel flow connectivity.	Opportunity to construct in combination with UN8 and UN10 downstream. Possible construction access through the camp and temporary bridges.	Open side channel on gravel bar.

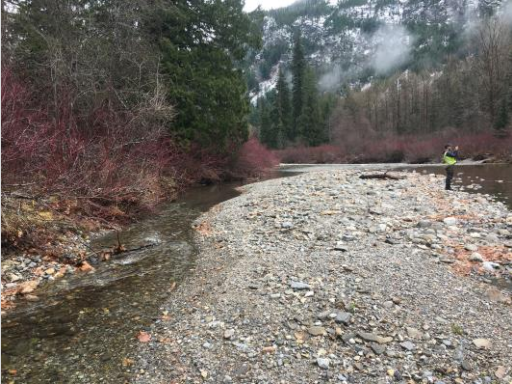
PROJECT LOCATION (RM/BANK)	PROJECT ID ¹	GROUP ²	ACTION TYPE	CONDITION	ACTION	CONSIDERATIONS	PHOTO
RM 14.6/L	UN10	G4	Install Habitat Structure Floodplain Habitat Reconnection	Left bank bar and perennial side channel. High floodplain terrace on immediate left with evidence of debris from recent flow. Existing beaver-controlled channel at downstream end of large bar.	Install LWM structure on river left at head of mid-channel bar to emphasize flow split and connectivity to existing side channel.	Opportunity to construct in combination with UN9 and UN10 downstream. Difficult access for tracked equipment. Possible construction access through the camp and temporary bridges.	River right side channel.

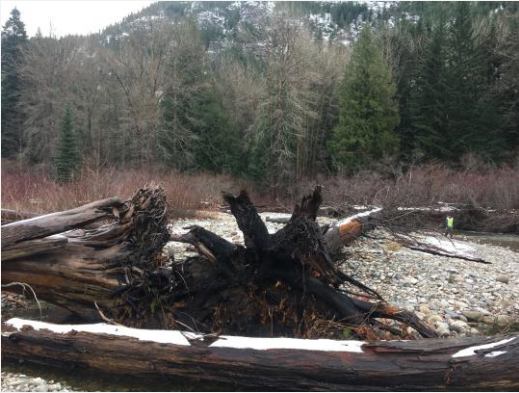
RM 14.25/L	UN11a	G5	Install Habitat Structure Floodplain Habitat Reconnection	Left bank gravel bar forming a mature meander bend. Existing large wood accumulated on gravel bar but mobile during high flows.	Install multiple LWM structures within the bar to stabilize existing wood and create flow splits across the bar. Emphasize channel migration to river right and improve flow connectivity to a flood channel on river right.	Difficult access for tracked equipment. Possible construction access through the camp and temporary bridges.	River left wood accumulation.

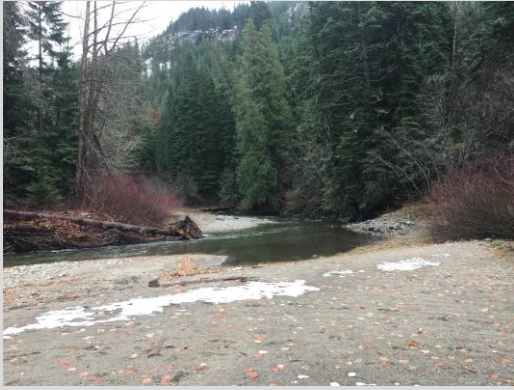
PROJECT LOCATION (RM/BANK)	PROJECT ID ¹	GROUP ²	ACTION TYPE	CONDITION	ACTION	CONSIDERATIONS	PHOTO
RM 14.1/R	UN11	G5	Protection	Right floodplain high terrace. Poned at downstream end with large sand plug. Only connected at very high flow.	No action recommended. High risk area for deposition.		<p>Sand deposition at outlet of alcove.</p>

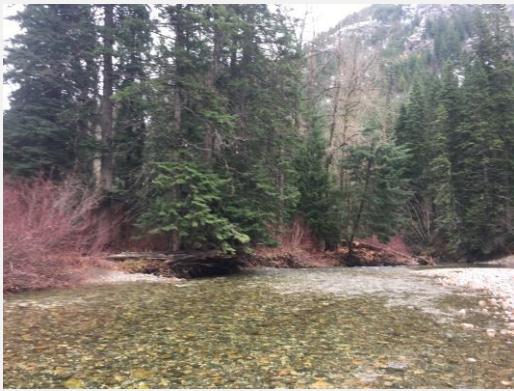
RM 14.11/L	UN12	G5	Install Habitat Structure Floodplain Habitat Reconnection	Left bank inside meander high flow channel.	Install LWM to improve flow split through side channel while forcing flows to river right to improve scour at outlet of UN11 side channel.	<p>Design should consider risk of avulsion through meander.</p> <p>Difficult construction access from Whitepine Rd.</p>	<p>River left avulsion path, facing downstream.</p>

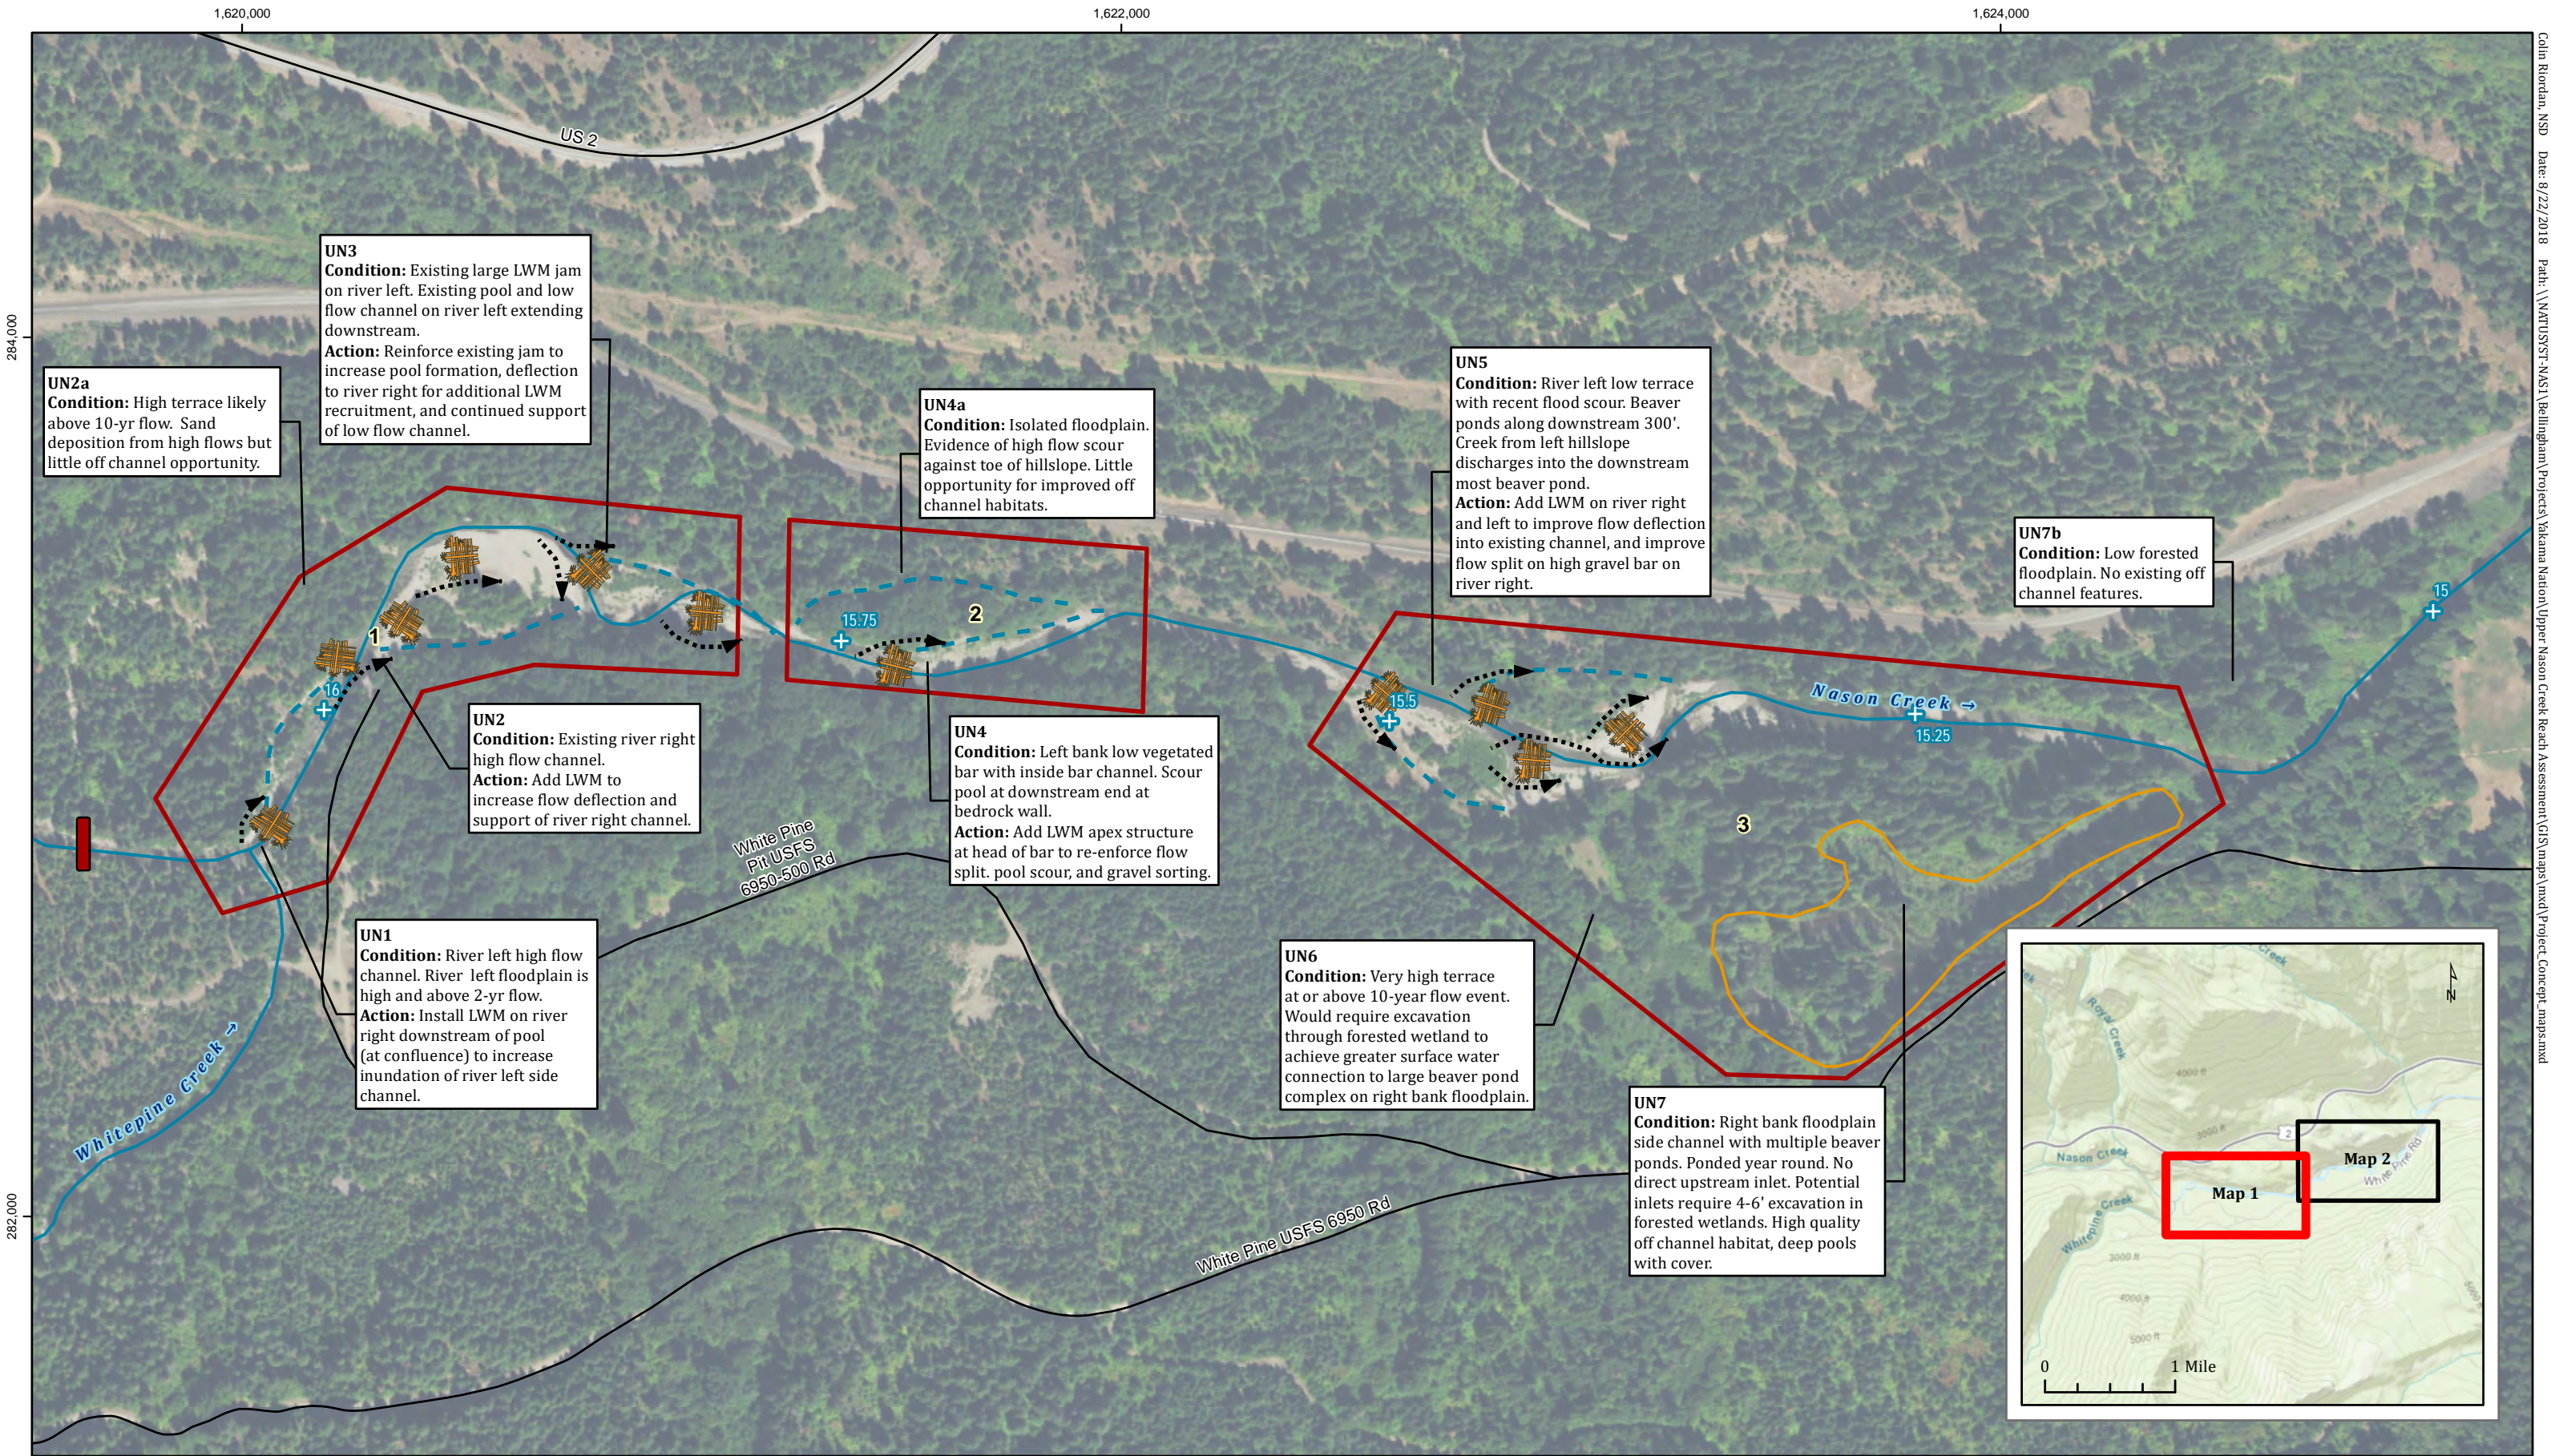
Upper Nason Reach Assessment
Restoration Project Concepts - Map 1

UN2a
Condition: High terrace likely above 10-yr flow. Sand deposition from high flows but little off channel opportunity.

UN3
Condition: Existing large LWM jam on river left. Existing pool and low flow channel on river left extending downstream.
Action: Reinforce existing jam to increase pool formation, deflection to river right for additional LWM recruitment, and continued support of low flow channel.

UN1
Condition: River left high flow channel. River left floodplain is high and above 2-yr flow.
Action: Install LWM on river right downstream of pool (at confluence) to increase inundation of river left side channel.

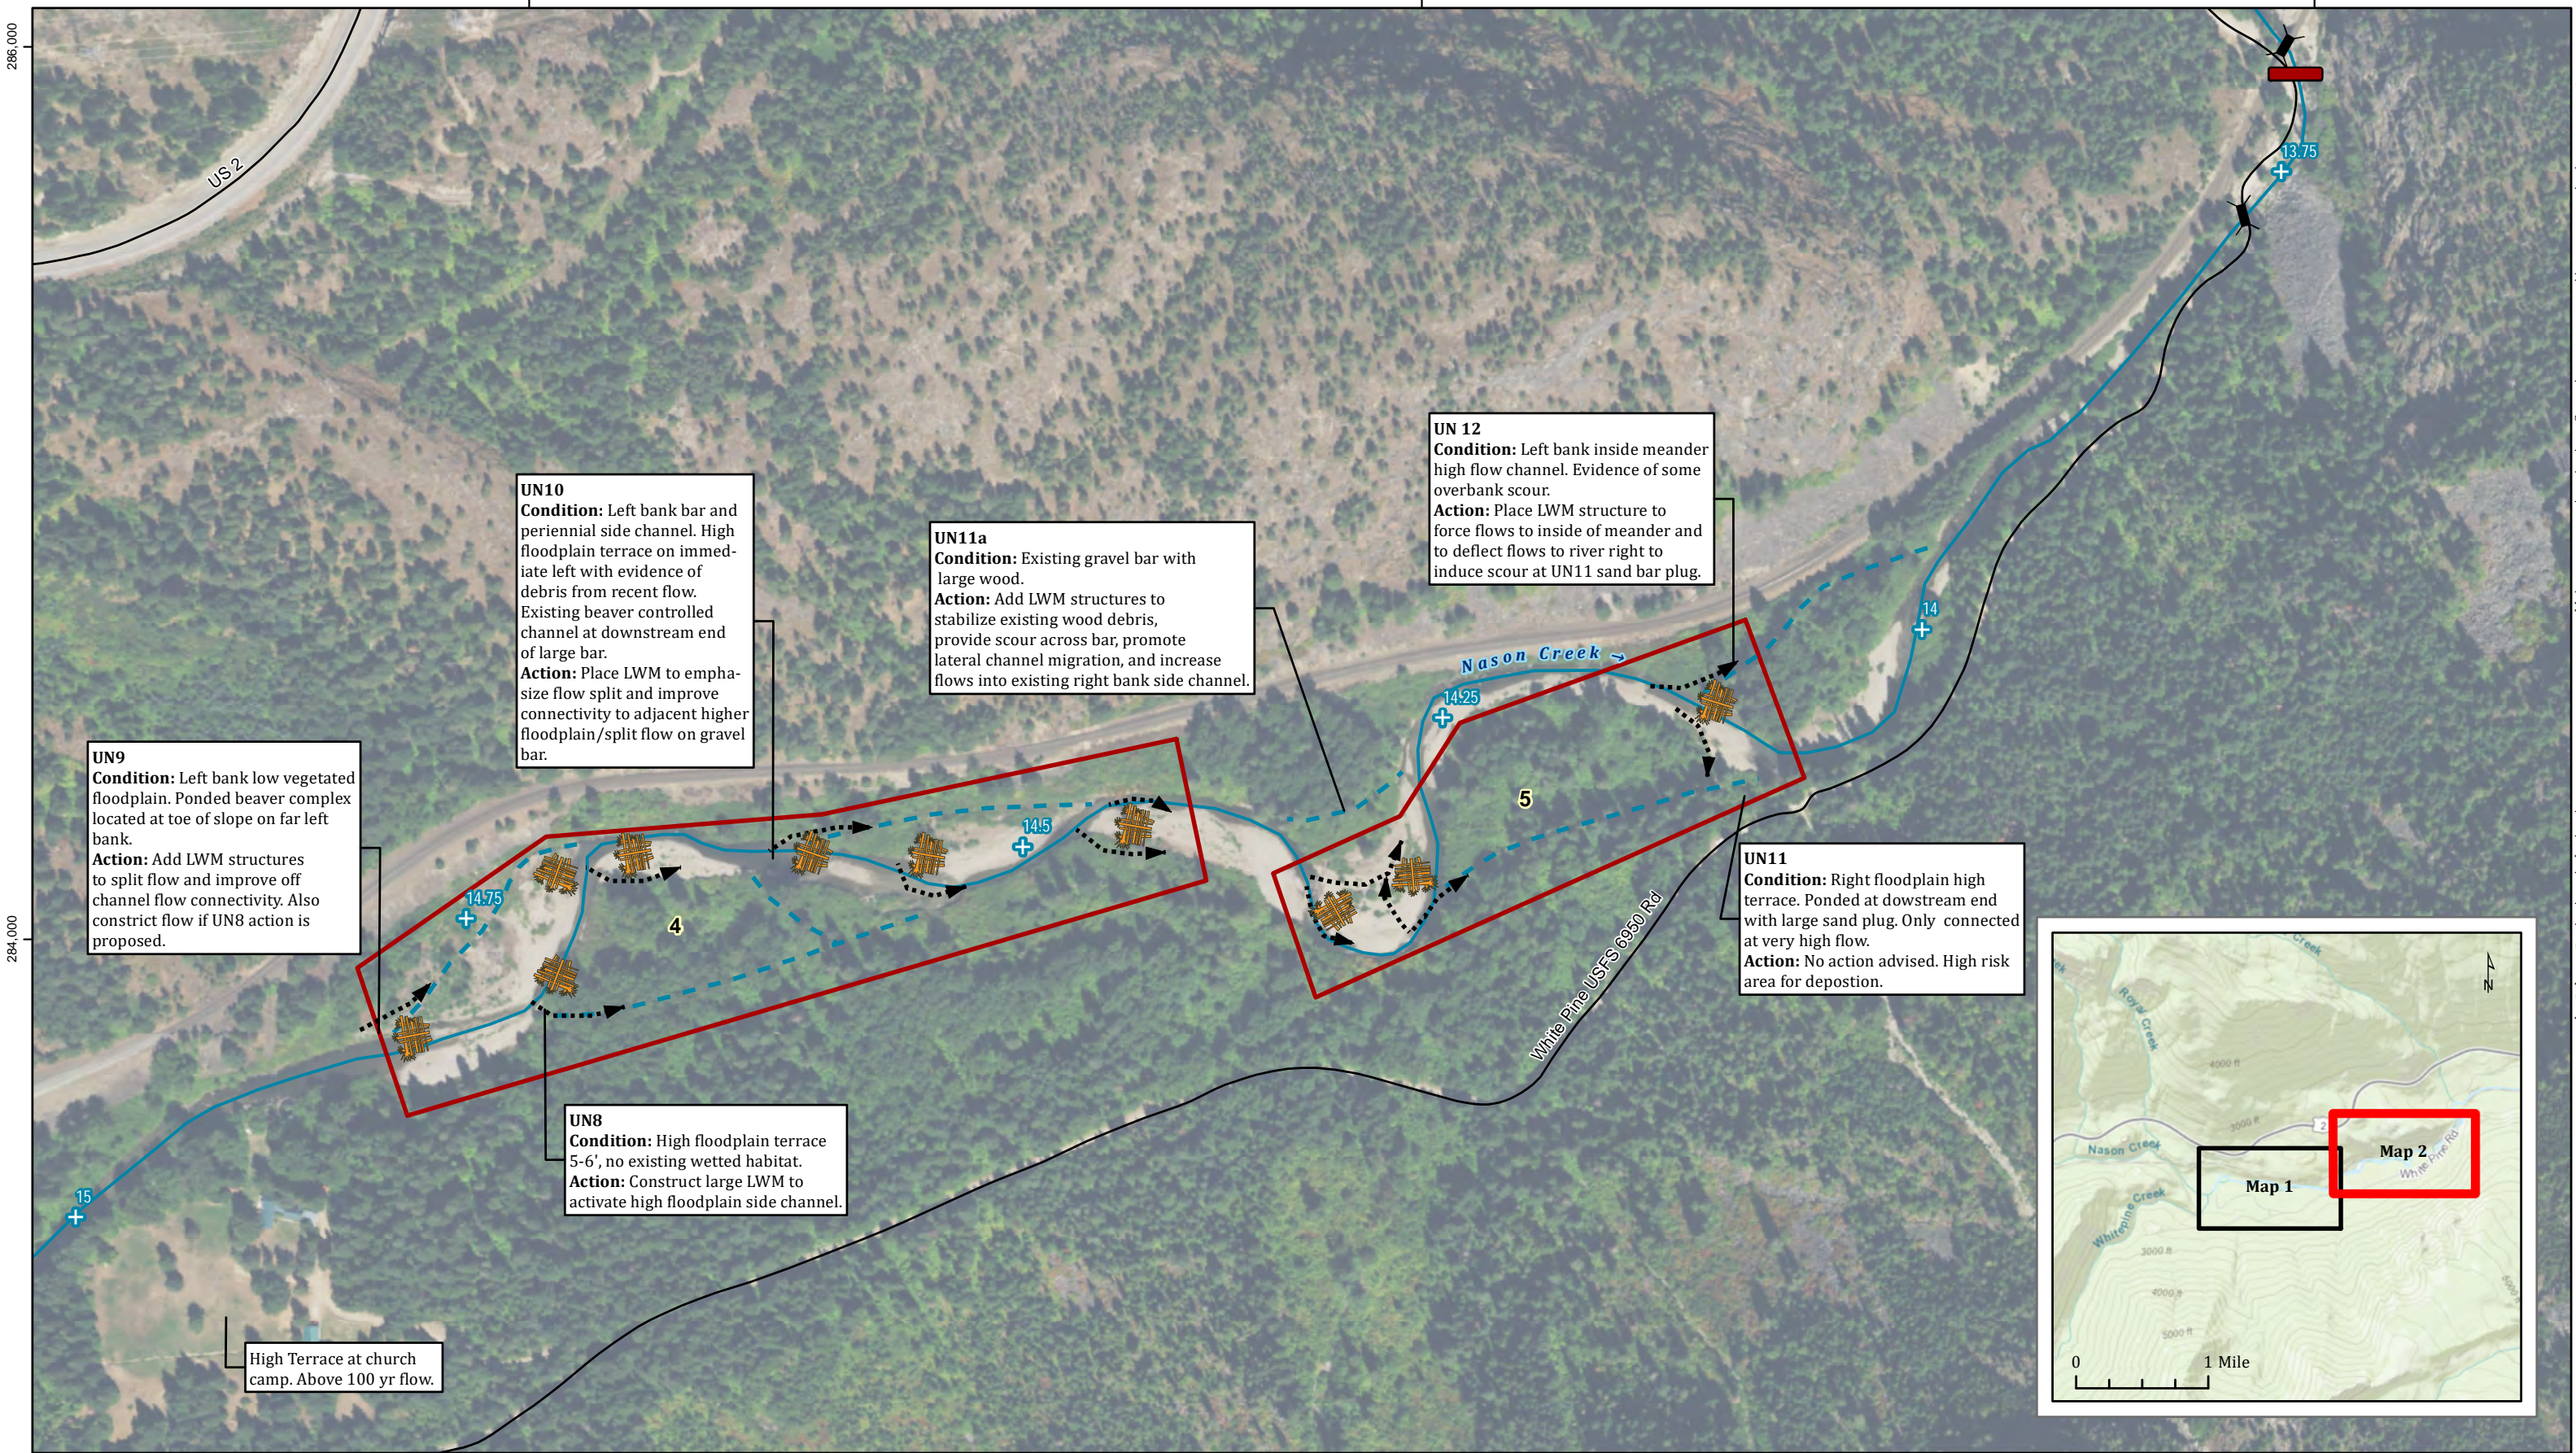
Upper Nason Reach Assessment
Restoration Project Concepts - Map 2

UN9
Condition: Left bank low vegetated floodplain. Pondered beaver complex located at toe of slope on far left bank.
Action: Add LWM structures to split flow and improve off channel flow connectivity. Also constrict flow if UN8 action is proposed.

High Terrace at church camp. Above 100 yr flow.
