Wolf Creek Reach Assessment & Restoration Strategy *Final Report*

DECEMBER 2020

PREPARED FOR
Yakama Nation – Fisheries
Winthrop, WA

PREPARED BY
Inter-Fluve
Hood River, OR

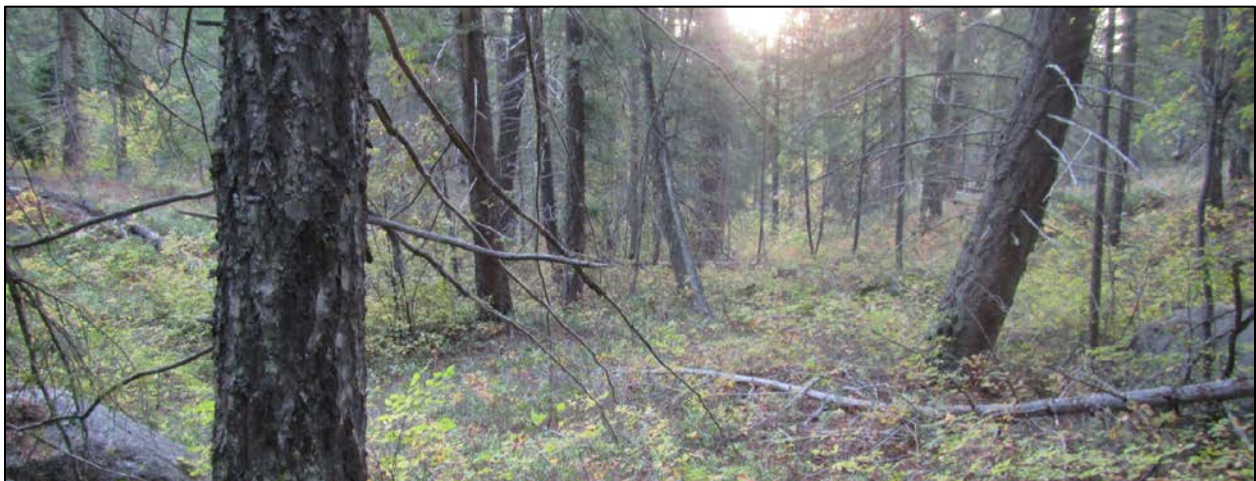
Figure 24. Horizontal terrace surface in Reach 4 (river right) with paleo-channel scar topography (vegetated). (Photo: 10/5/2019)

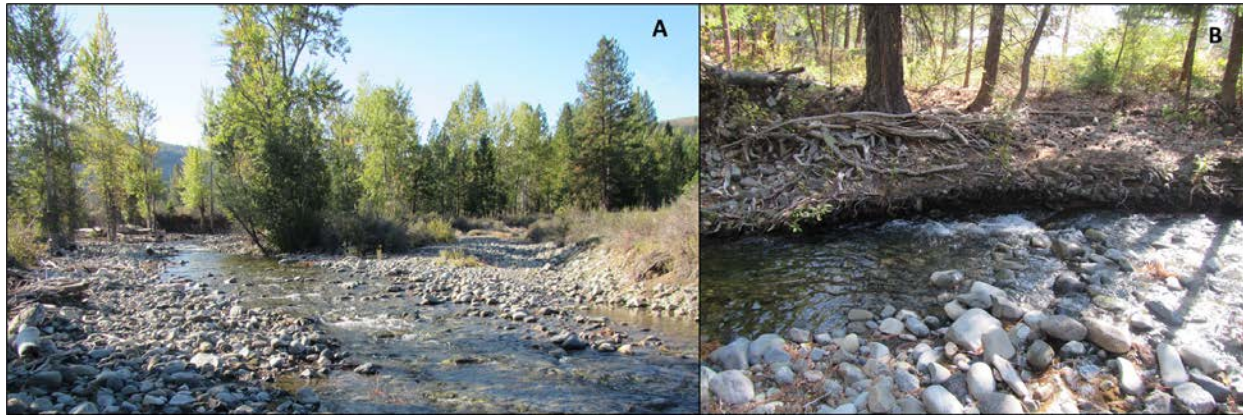
Pine. Alder is the dominant riparian shrub/small tree. Tree roots provide additional bank stability in areas where lateral migration has been limited (Figure 36B). The inset floodplain surfaces support zones of increased riparian vegetation buffer widths. Existing vegetation is expected to provide a partial shade canopy for the channel during the summer. It is probable that all riparian vegetation in Reach 1 was removed at some point in the last 100 years, including when levees were being constructed. The riparian strip that exists today is in the process of maturing but at risk with continued home development.

Figure 36. A) Riparian vegetation at RM 0.15 with inset floodplain. B) Example of root-stabilized bank (RM 0.53). (Photos: 10/1/2019)

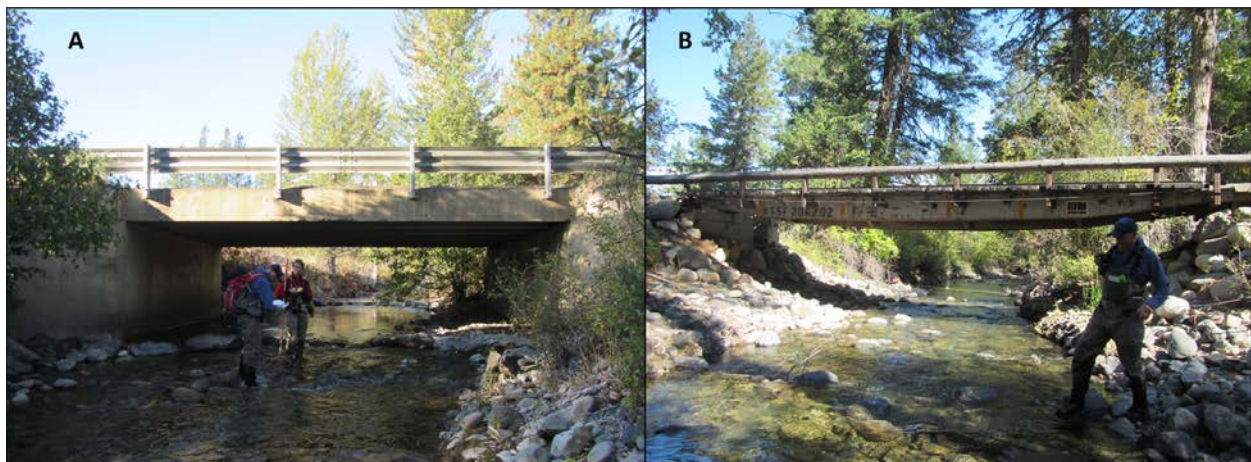
Figure 38. A) Wolf Creek Road (RM 0.03) crossing and related large boulder weirs at and upstream. B) Railroad car bridge with cement footings and large boulder riprap and raised access road prism. (Photos: 10/1/2019)

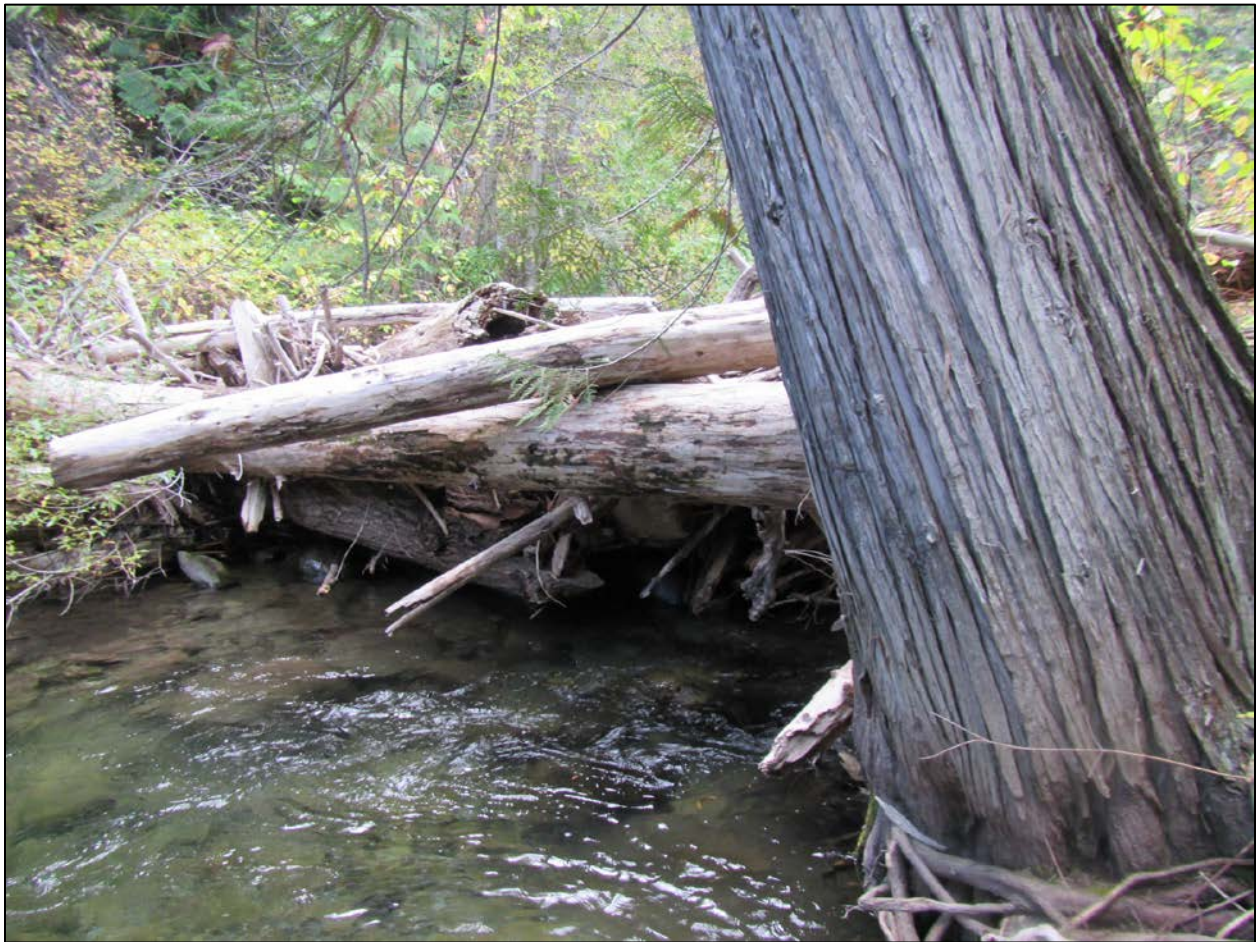
Figure 47. Large wood jam at RM 2.28 in Reach 2 – at downstream side of jam. (Photo: 10/3/2019)

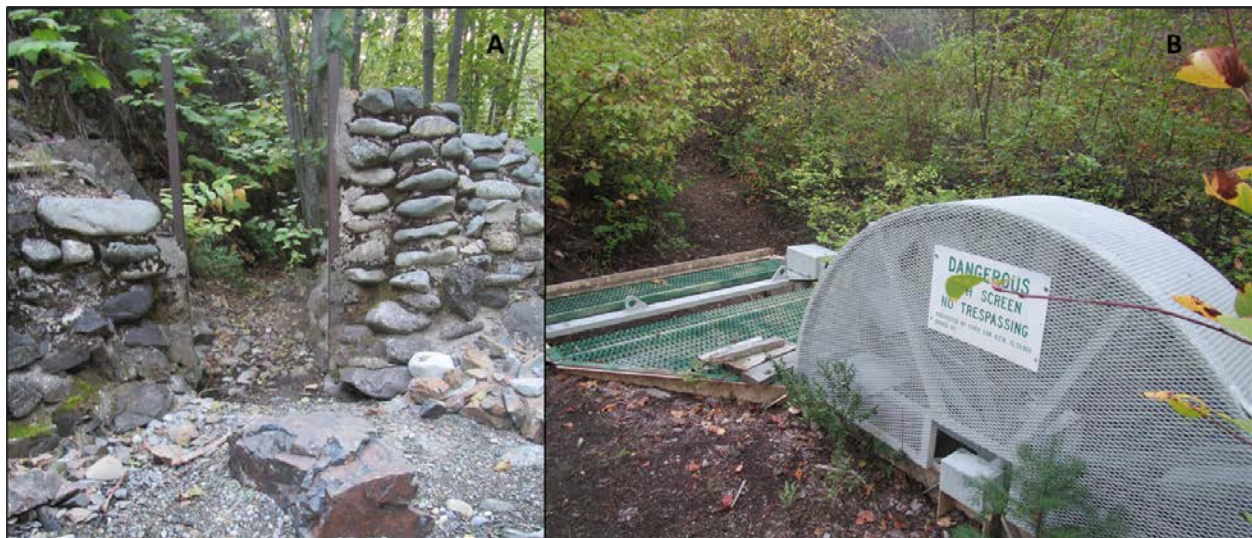
Figure 49. A) irrigation outtake at RM 1.44; B) fish screen associated with irrigation outtake and ditch.

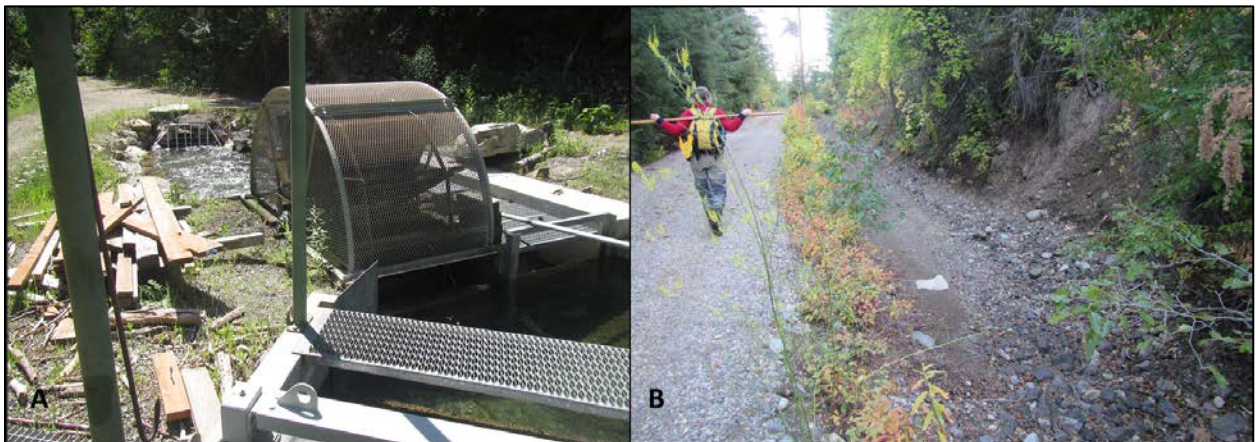
Figure 78. A) Fish screen that leads into Wolf Creek irrigation ditch buried under access road (Photo: 7/8/2020) B) Wolf Creek irrigation open ditch down valley along access road (Photo: 10/5/2019)

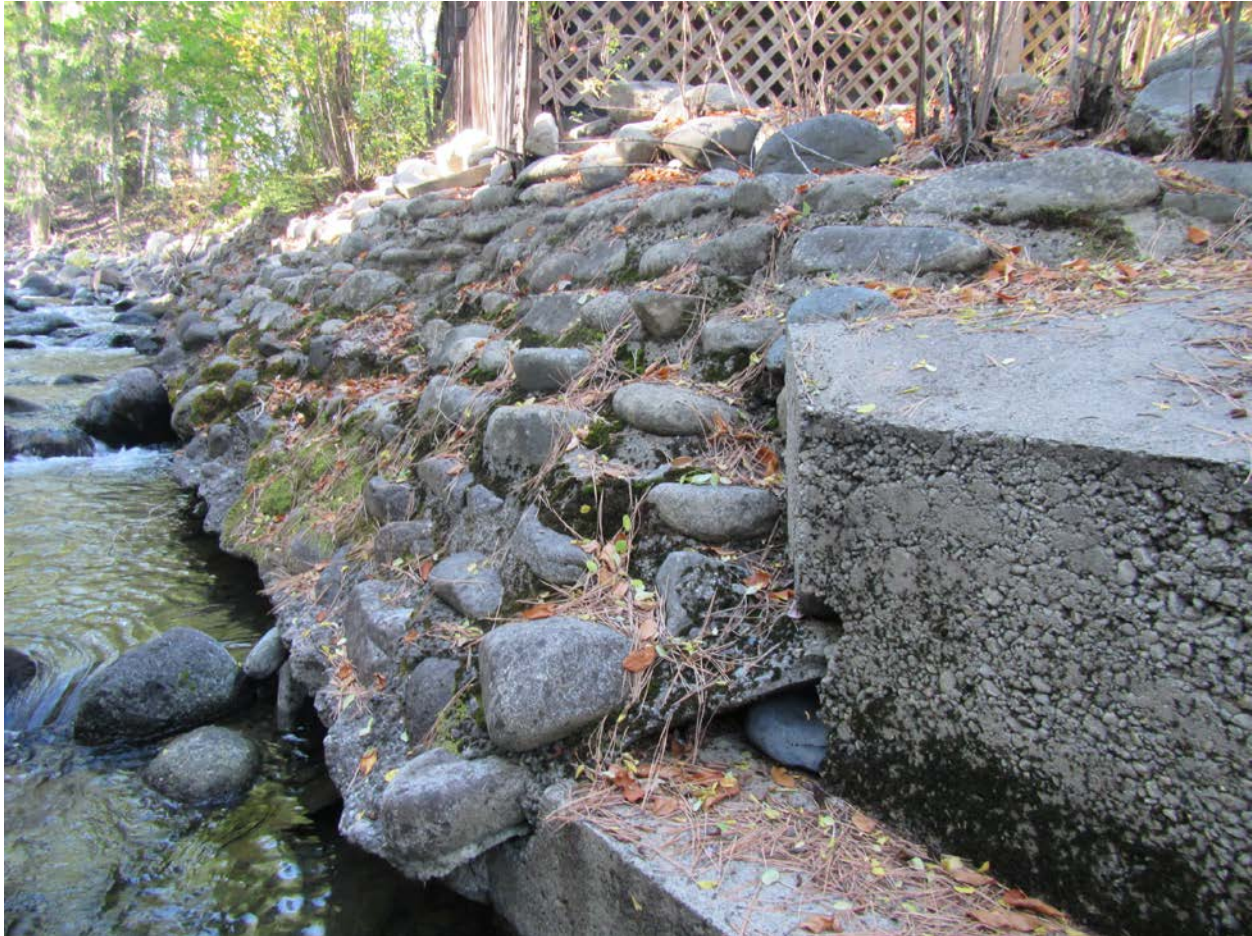
Figure 8. Cement bank armoring and upstream levee on river left near a home in Reach 1 with undercut erosion occurring. (Photo: 10/1/2019)

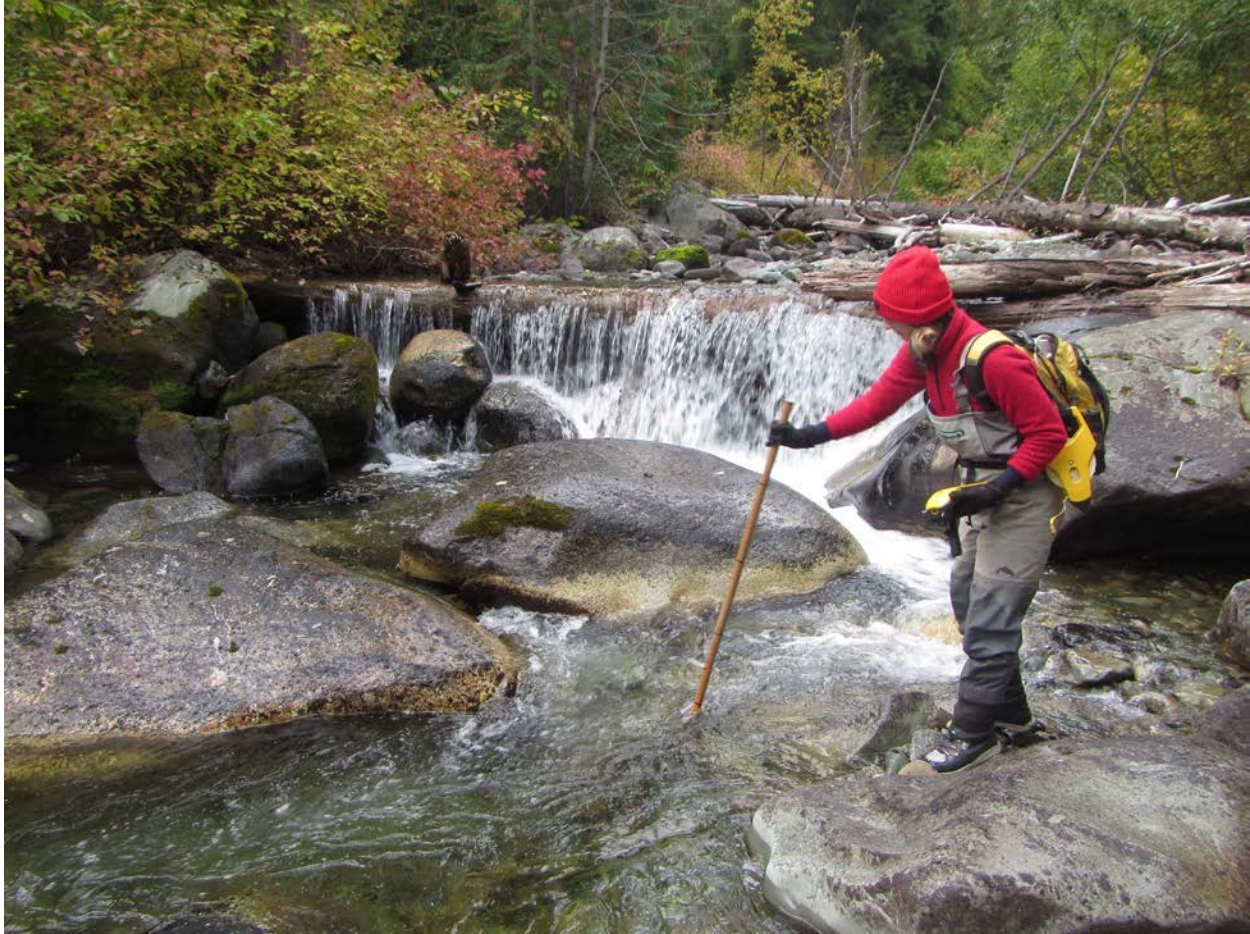
Figure 9. Channel spanning debris jam that creates 4-foot drop in Reach 3.
