Lower Nason
Assessment of Geomorphic and Ecologic Indicators
Nason Creek, Wenatchee Subbasin

Chelan County, Washington

U.S. Department of the Interior
Bureau of Reclamation
Pacific Northwest Region
Pacific Northwest Regional Office, Boise, Idaho

April 2011

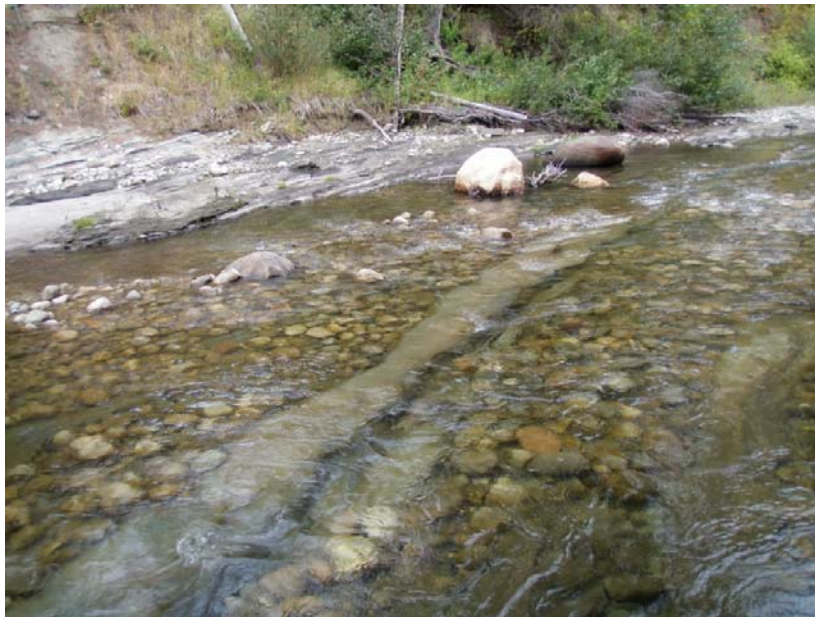
Figure 8. Channel Segment A: View looking at bedrock (Chumstick Formation (Tc)) outcrop near RM 4.15 that restricts lateral and vertical channel migration. Lower Nason Creek, Wenatchee Subbasin, Washington – Bureau of Reclamation Photograph by E. Lyon, September 15, 2010.

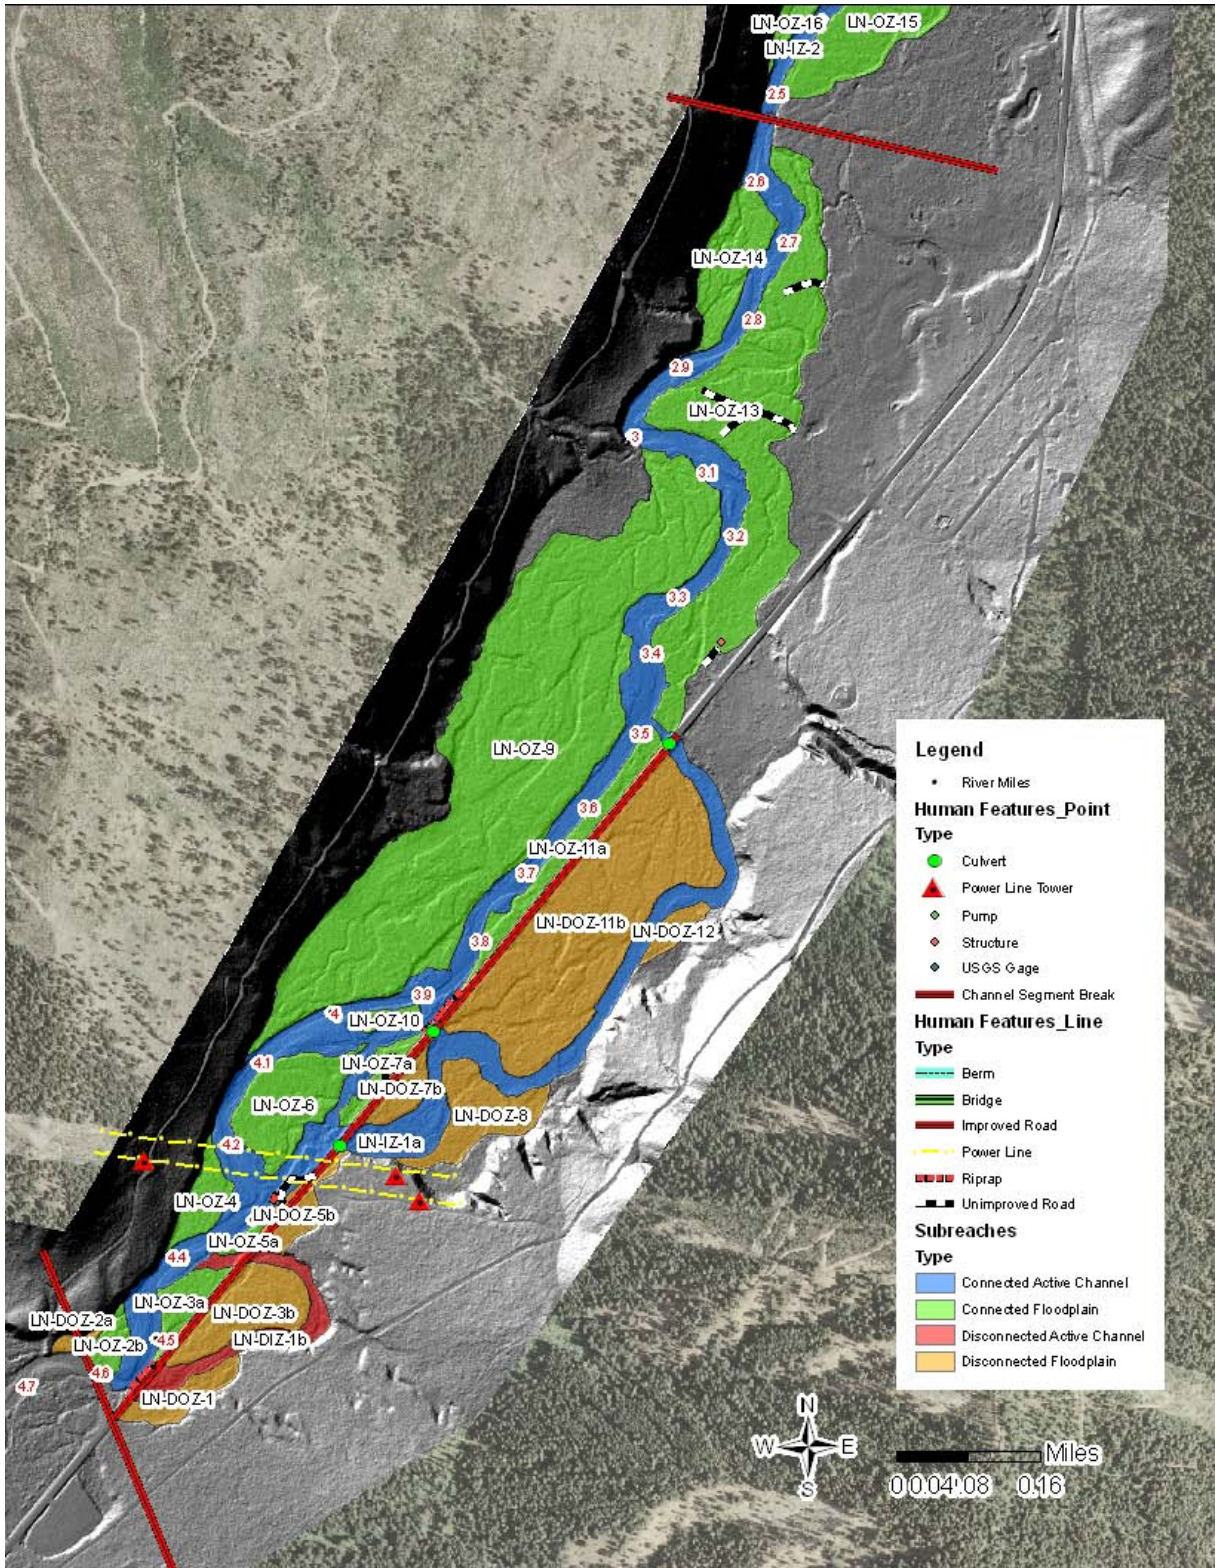
Figure 10. Channel Segment A: Active channel and floodplain connectivity and anthropogenic features

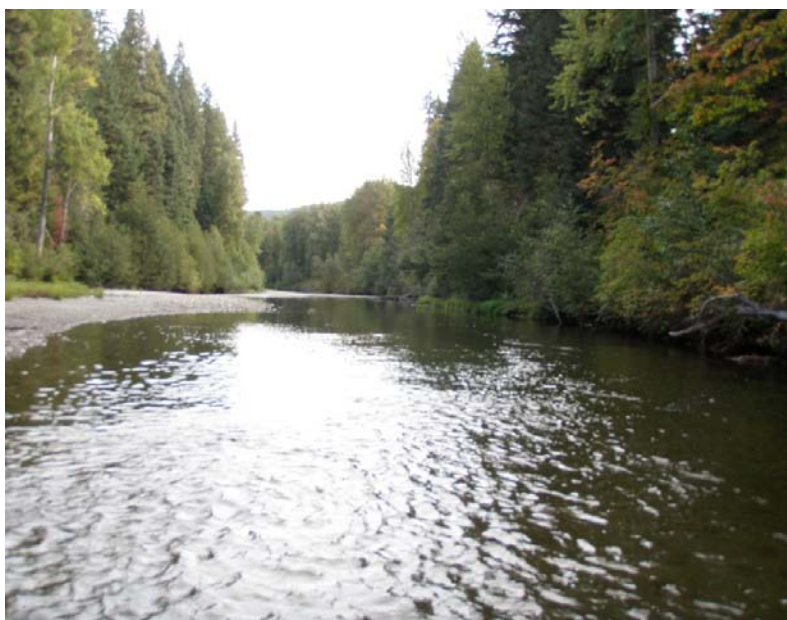
Figure 11. Channel Segment A: View looking downstream at riparian buffer zone near RM 3.70. Lower Nason Creek, Wenatchee Subbasin, Washington – Bureau of Reclamation Photograph by E. Lyon, September 15, 2010.

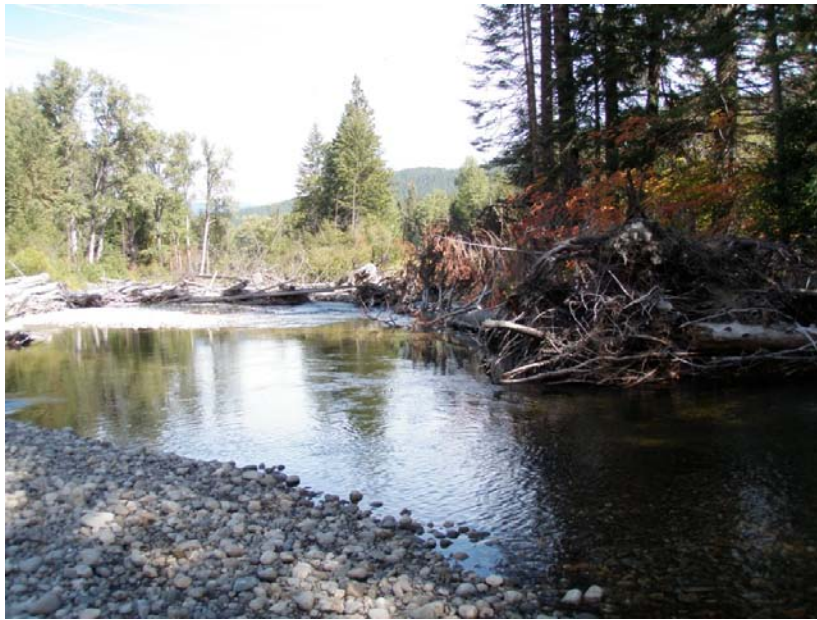
Figure 15. Channel Segment A: View to the northeast looking downstream at lateral scour pool near RM 4.30 along river right and large wood complex. Lower Nason Creek, Wenatchee Subbasin, Washington – Bureau of Reclamation Photograph by E. Lyon, September 16, 2010.

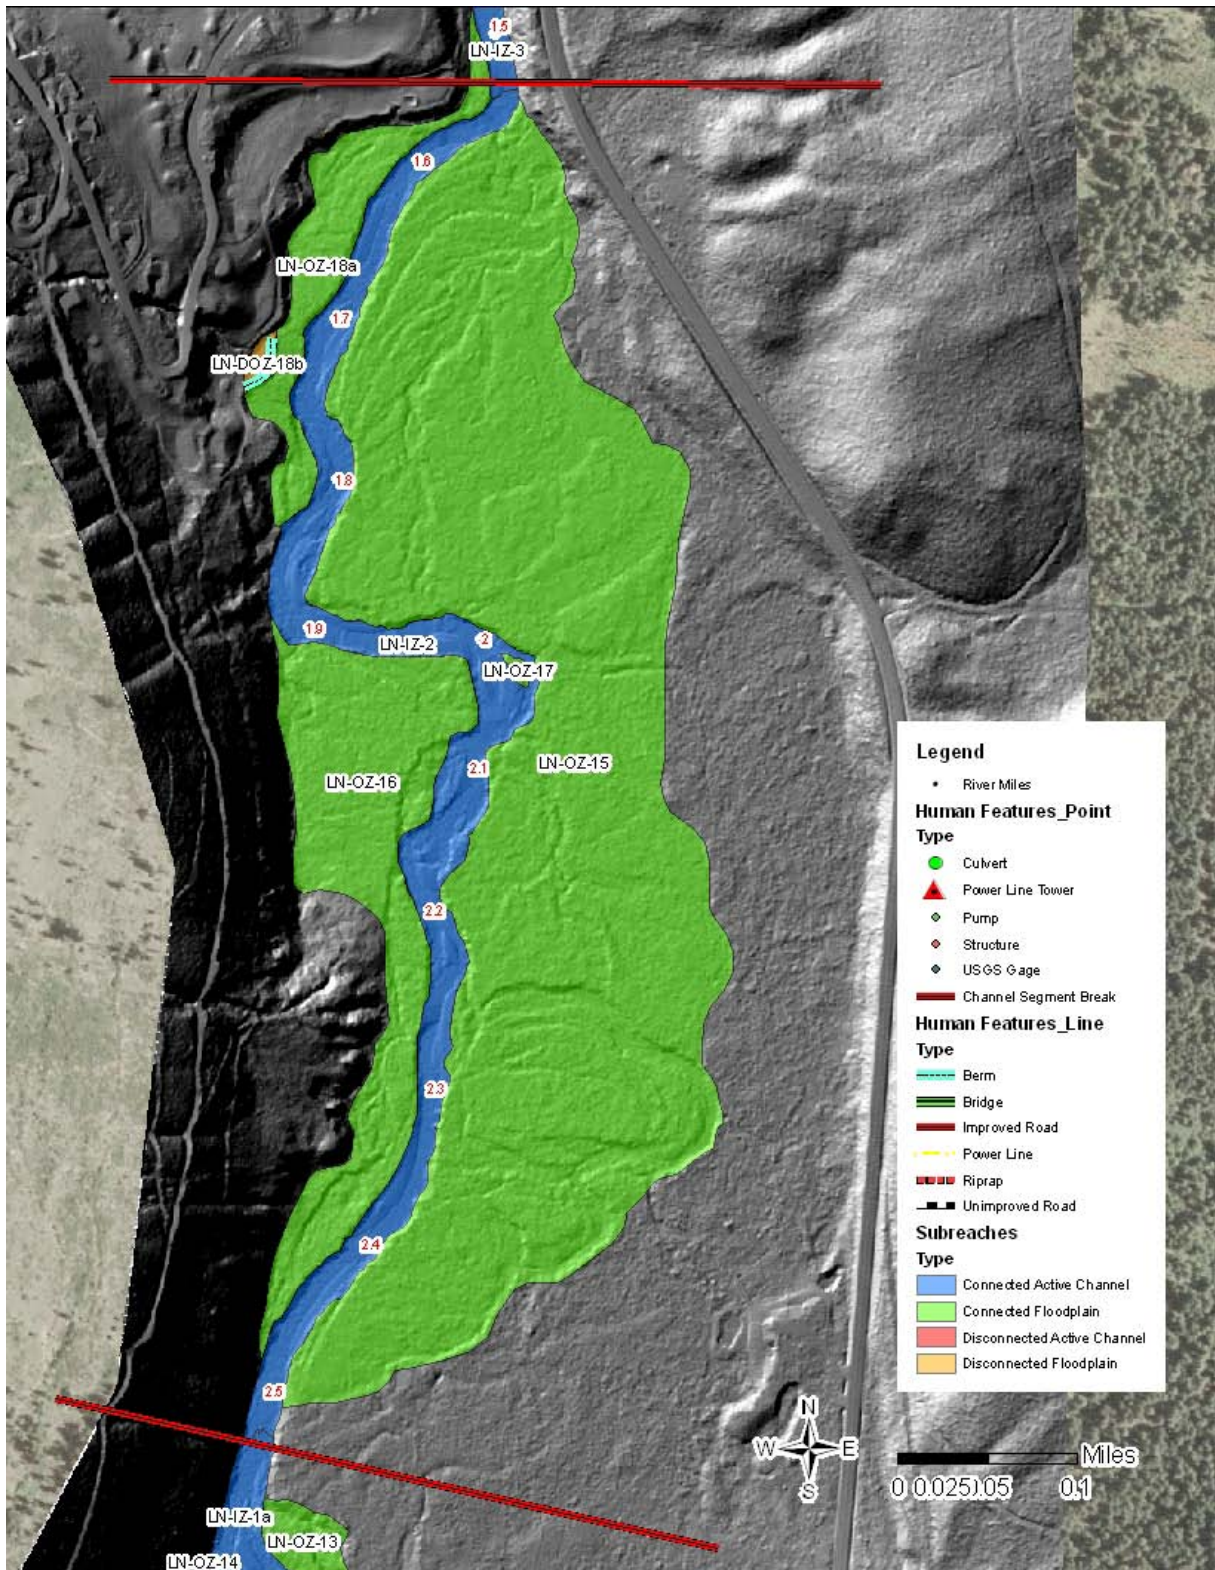
Anthropogenic Feature	Geomorphic Impact	Subreach	Parcel	Acreage	Metric
Berm	Disconnected Floodplain	LN-OZ-18 Complex	LN-DOZ-18b	0.2 acres	180 feet

Figure 19. Channel Segment B: Active channel and floodplain connectivity and anthropogenic features

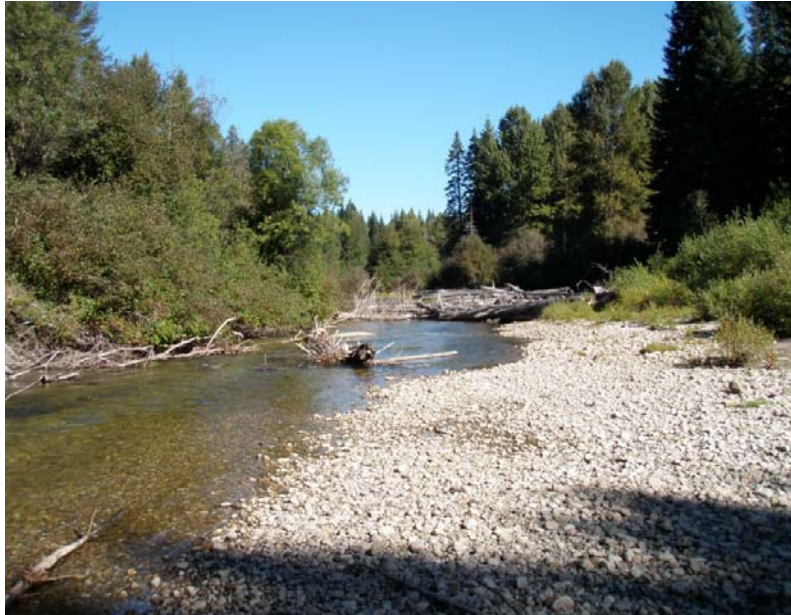
Figure 20. Channel Segment B: View looking downstream at riparian buffer zone and wood complex near RM 2.25. Lower Nason Creek, Wenatchee Subbasin, Washington – Bureau of Reclamation Photograph by E. Lyon, September 14, 2010.

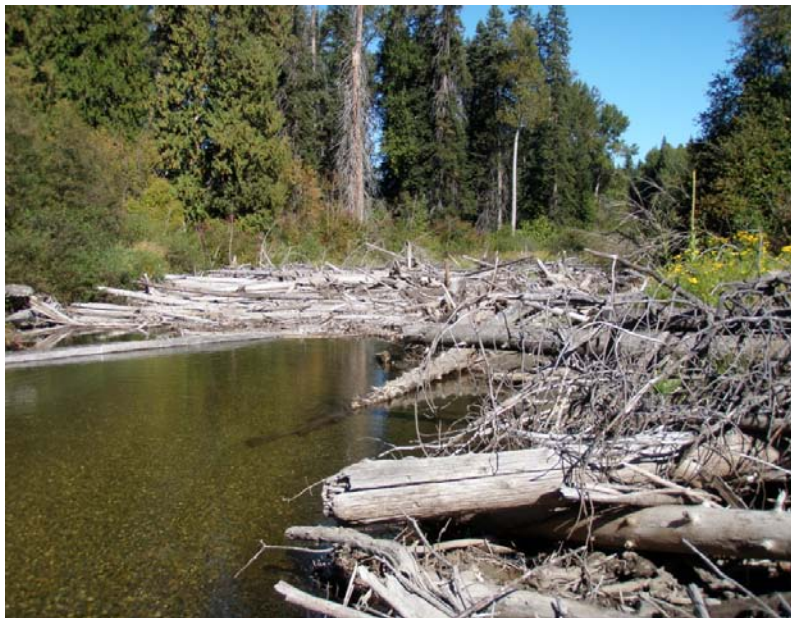
Figure 24. Channel Segment B: View looking downstream at channel spanning wood complex near RM 2.20. Lower Nason Creek, Wenatchee Subbasin, Washington – Bureau of Reclamation Photograph by E. Lyon, September 14, 2010.

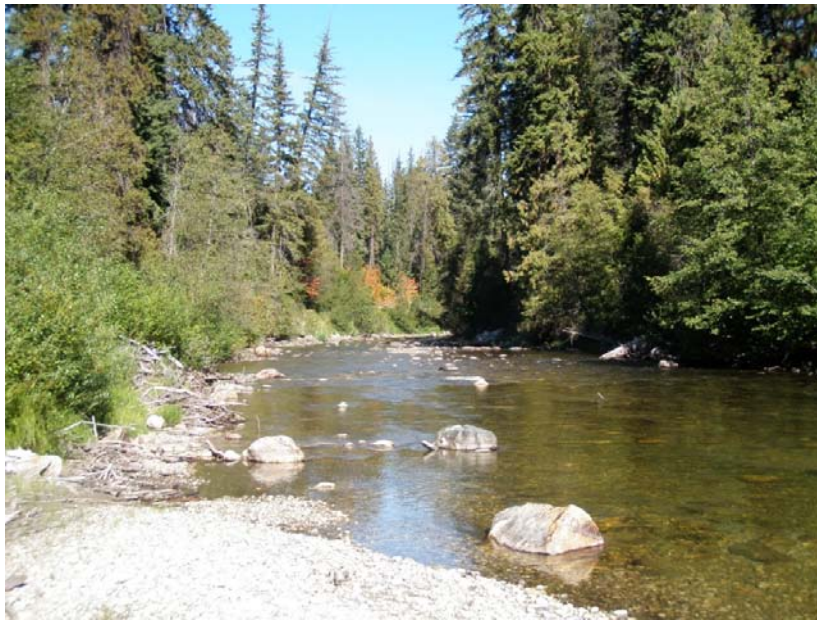
Figure 30. Channel Segment C: View to the north looking downstream at riparian buffer zone near RM 1.52 that is in a large trees condition. Lower Nason Creek, Wenatchee Subbasin, Washington – Bureau of Reclamation Photograph by E. Lyon, September 14, 2010.

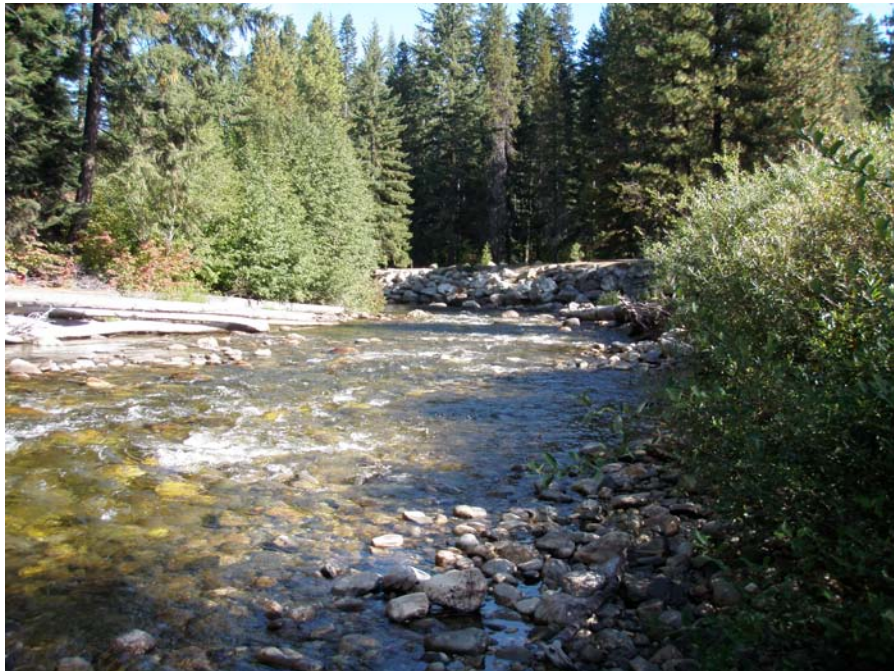
Photograph No. 2. View to the northeast looking downstream at riprap placed along river right. Lower Nason Creek, Wenatchee Subbasin, Washington – Bureau of Reclamation Photograph by E. Lyon, September 13, 2010.

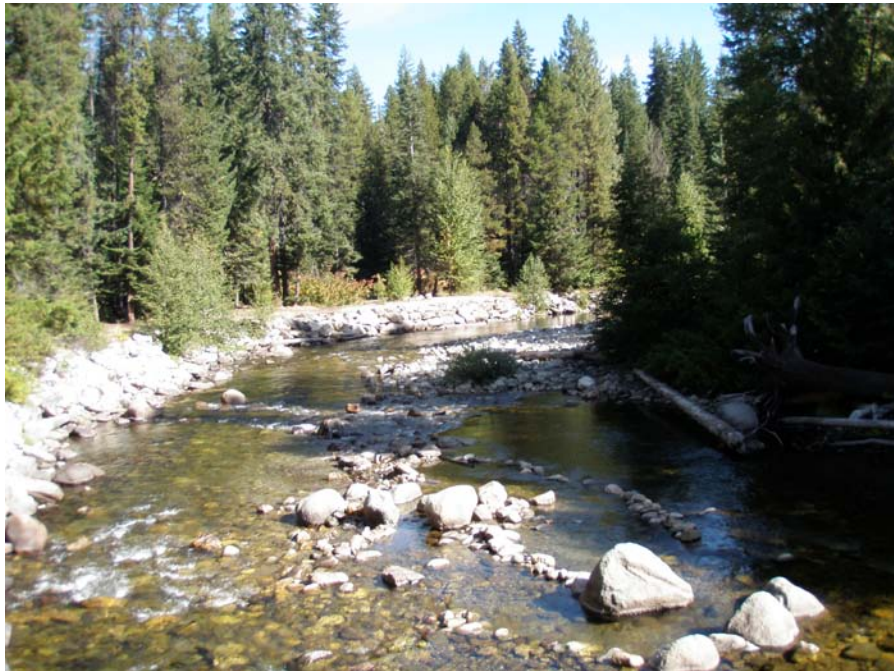
Photograph No. 4. View to the north looking from bridge crossing downstream at riprap protecting campground along river left. Lower Nason Creek, Wenatchee Subbasin, Washington – Bureau of Reclamation Photograph by E. Lyon, September 13, 2010.

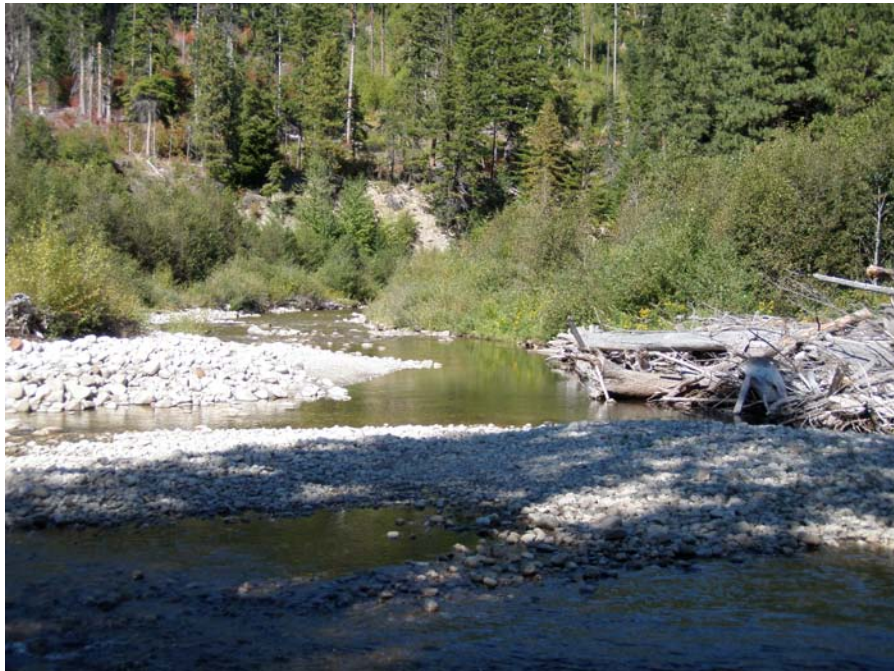
Photograph No. 10. View to the northwest looking downstream where channel is deflected by large wood that is accumulating at the head of a side channel along river right. Lower Nason Creek, Wenatchee Subbasin, Washington – Bureau of Reclamation
Photograph by E. Lyon, September 13, 2010.

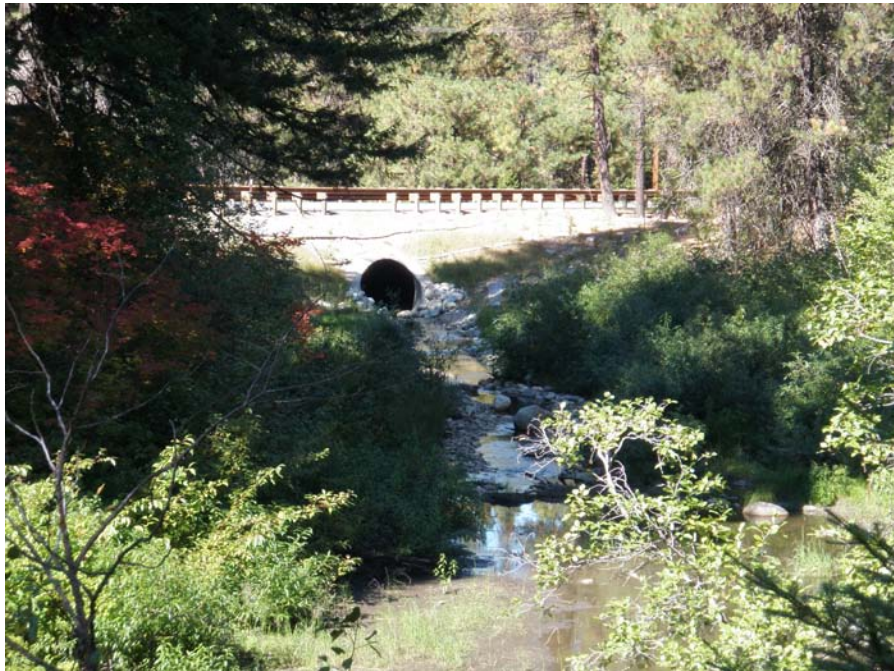
Photograph No. 12. View to the northwest looking downstream at a reconnected side channel through an improved road embankment along river right. Lower Nason Creek, Wenatchee Subbasin, Washington – Bureau of Reclamation
Photograph by E. Lyon, September 13, 2010.

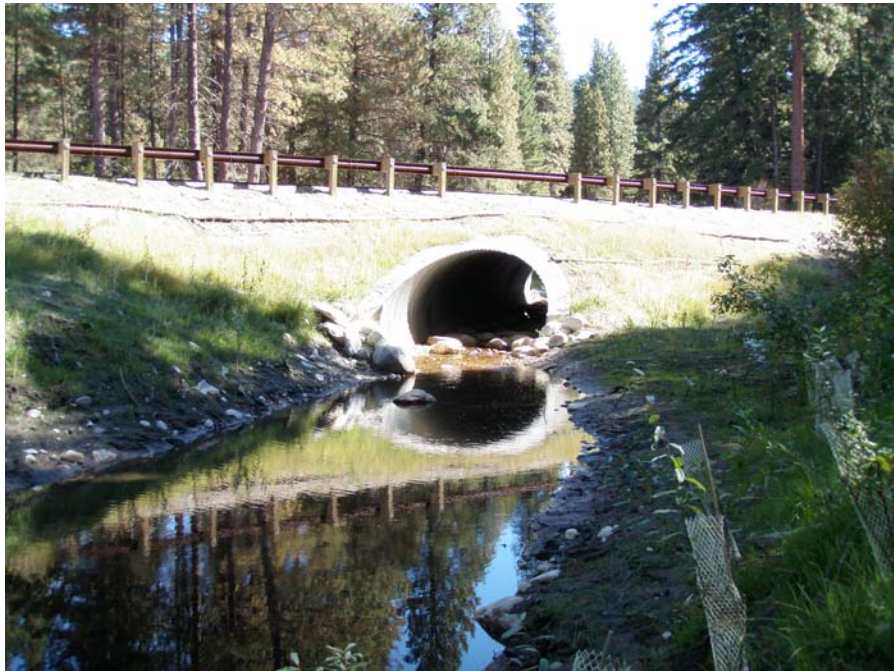
Photograph No. 16. View to the southeast looking upstream at culvert placed through improved road embankment that reconnects side channel. Lower Nason Creek, Wenatchee Subbasin, Washington – Bureau of Reclamation Photograph by E. Lyon, September 13, 2010.

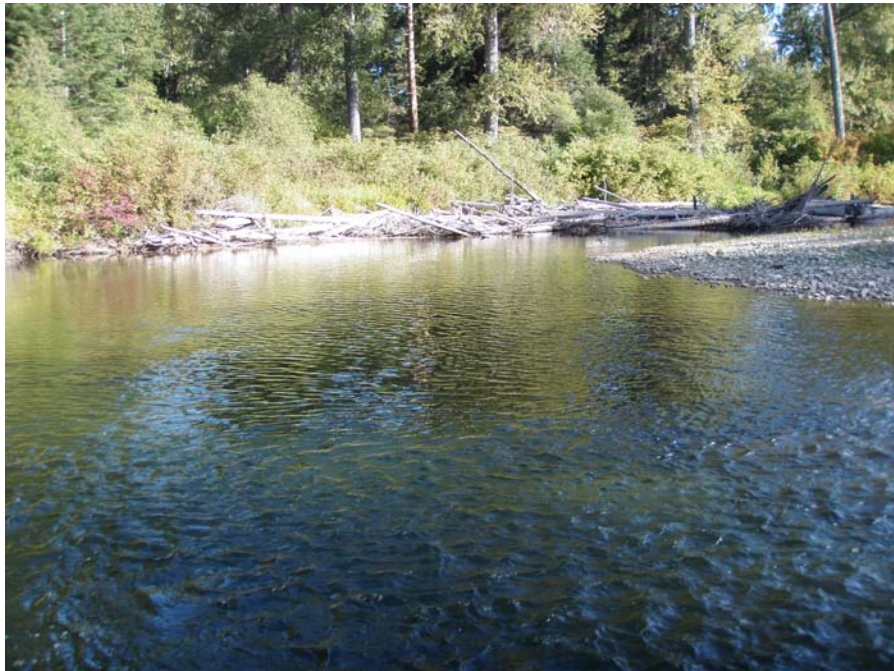
Photograph No. 18. View to the north looking downstream at a lateral scour pool forced by large wood accumulation along river left. Lower Nason Creek, Wenatchee Subbasin, Washington – Bureau of Reclamation Photograph by E. Lyon, September 14, 2010.

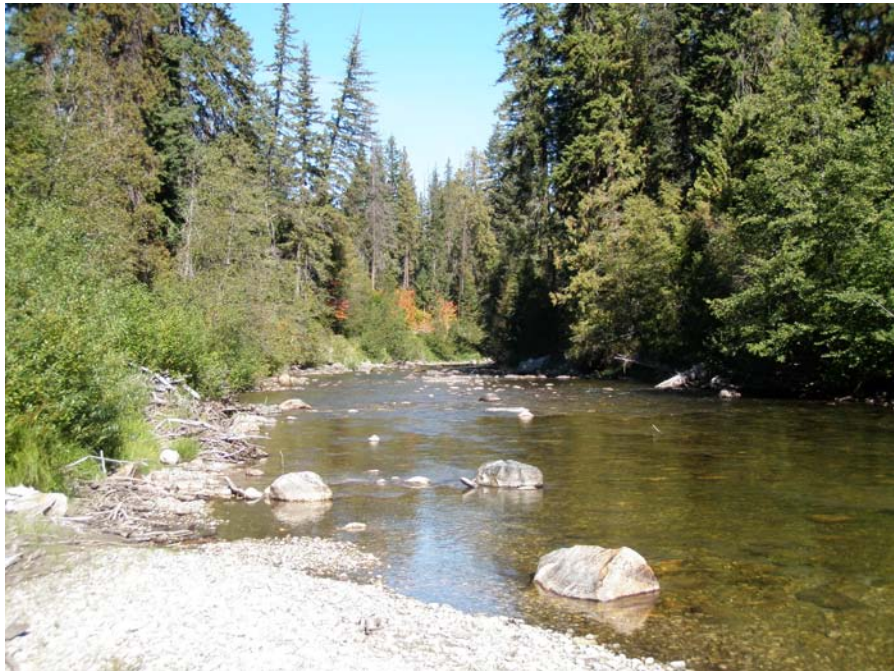
Photograph No. 32. View to the north looking downstream at the confined channel segment that has a higher percentage of cobbles, boulders and gravel sediment. Lower Nason Creek, Wenatchee Subbasin, Washington – Bureau of Reclamation Photograph by E. Lyon, September 14, 2010.

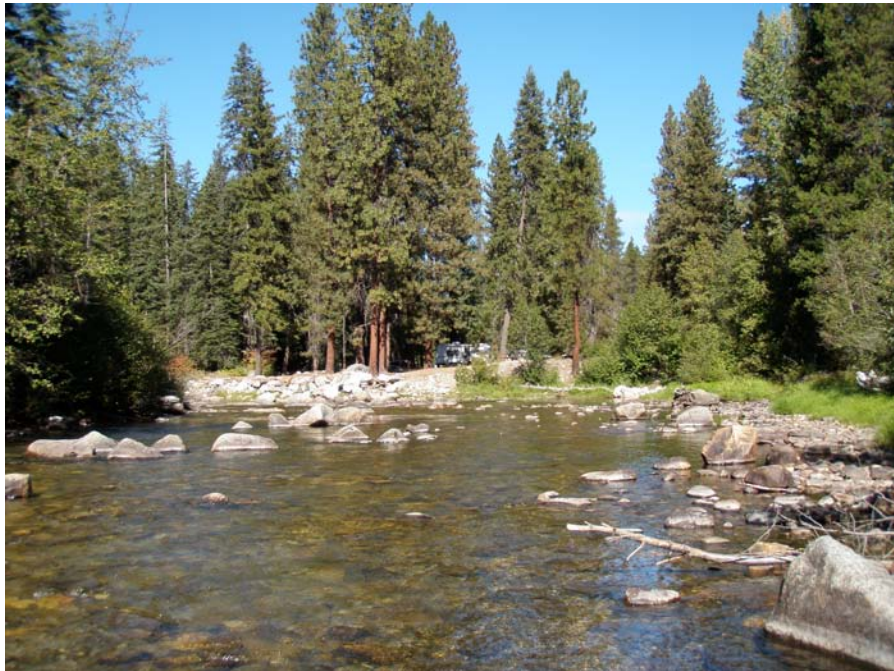
Photograph No. 34. View to the north looking downstream at pocket-pool habitat created by boulders. Also note riprap placed on the outside bend along river right in the distance. Lower Nason Creek, Wenatchee Subbasin, Washington – Bureau of Reclamation Photograph by E. Lyon, September 14, 2010.

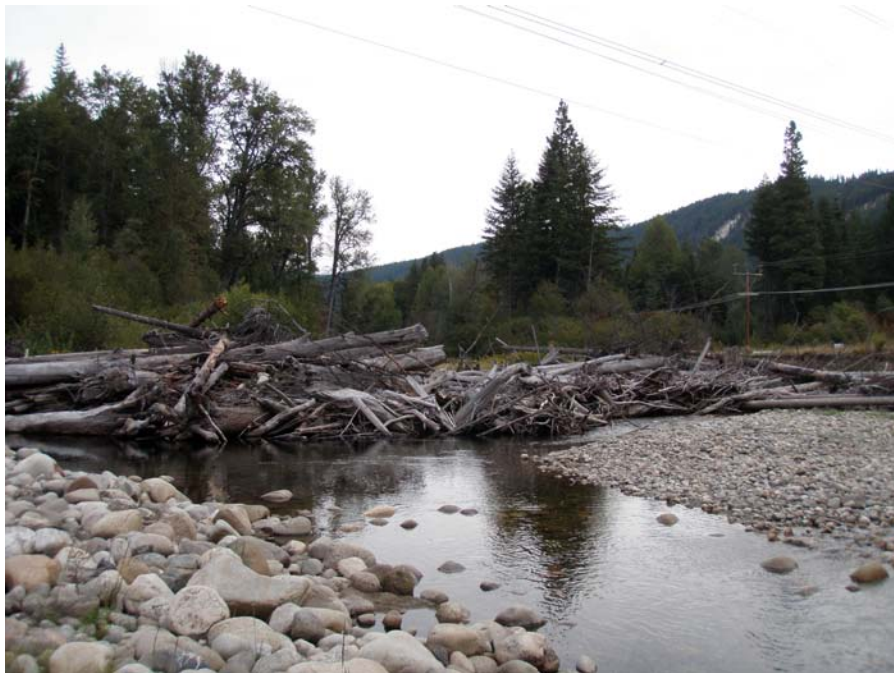
Photograph No. 36. View to the northeast looking downstream at large wood complex at head of side channel that may be contributing to bank erosion along river right. Lower Nason Creek, Wenatchee Subbasin, Washington – Bureau of Reclamation Photograph by E. Lyon, September 15, 2010.

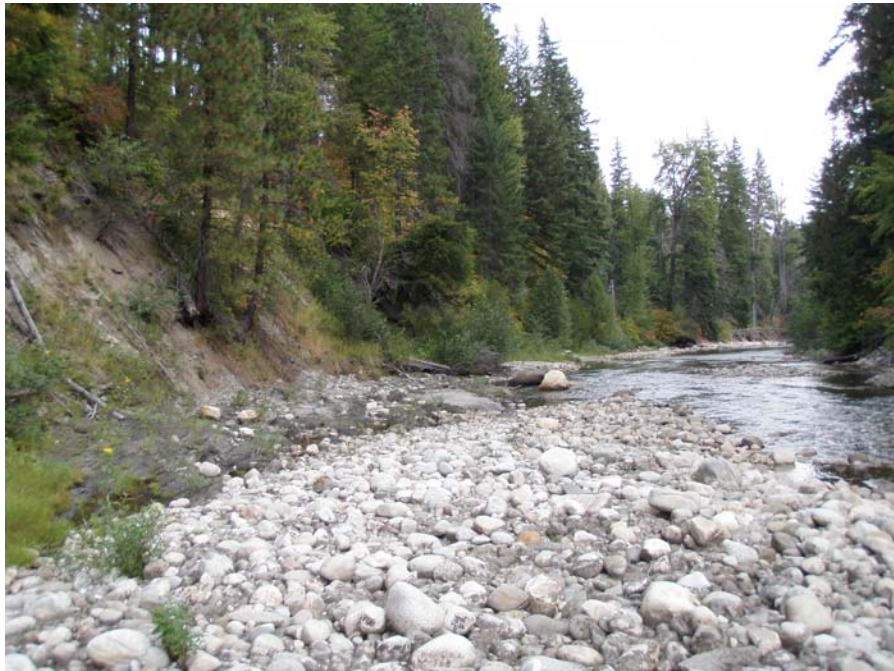
Photograph No. 38. View to the north looking downstream at bedrock (Chumstick Formation (Tc)) that restricts both lateral and vertical channel migration. Lower Nason Creek, Wenatchee Subbasin, Washington – Bureau of Reclamation Photograph by E. Lyon, September 15, 2010.

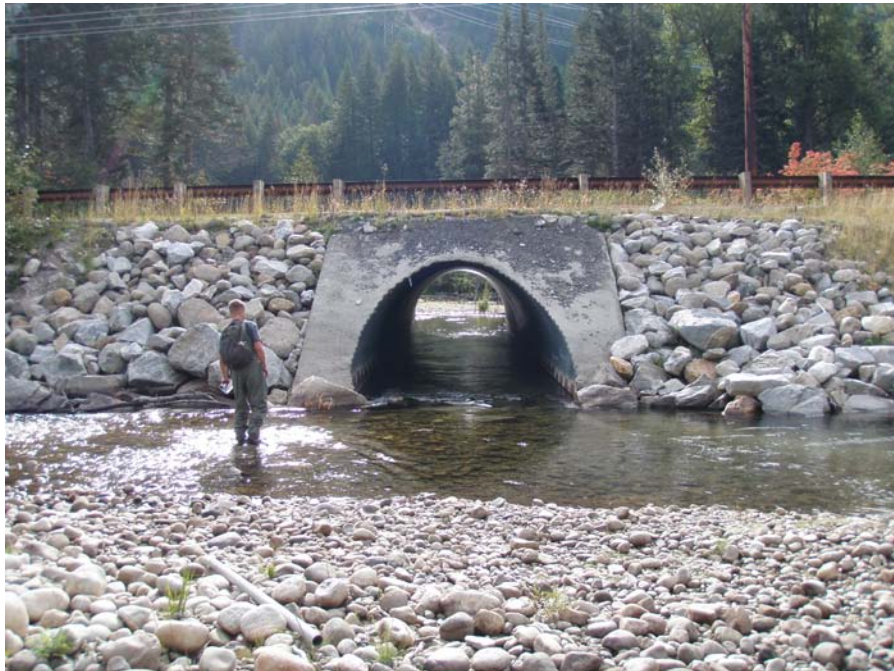
Photograph No. 42. View to the east looking at culvert through improved road embankment that reconnects historic channel path. Lower Nason Creek, Wenatchee Subbasin, Washington – Bureau of Reclamation Photograph by E. Lyon, September 15, 2010.

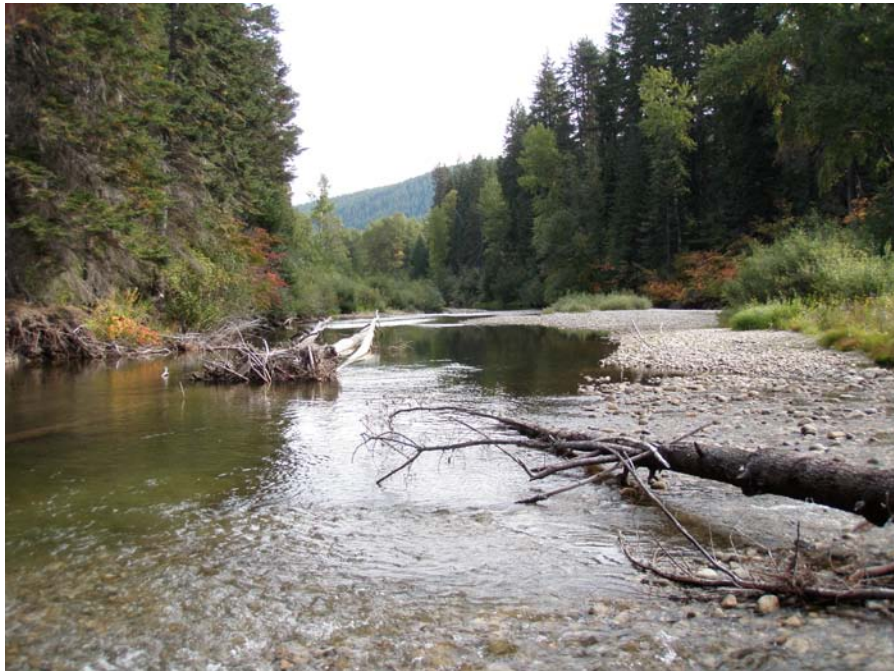
Photograph No. 44. View to the north looking at middle channel scour pool forced by large wood. Lower Nason Creek, Wenatchee Subbasin, Washington – Bureau of Reclamation Photograph by E. Lyon, September 15, 2010.

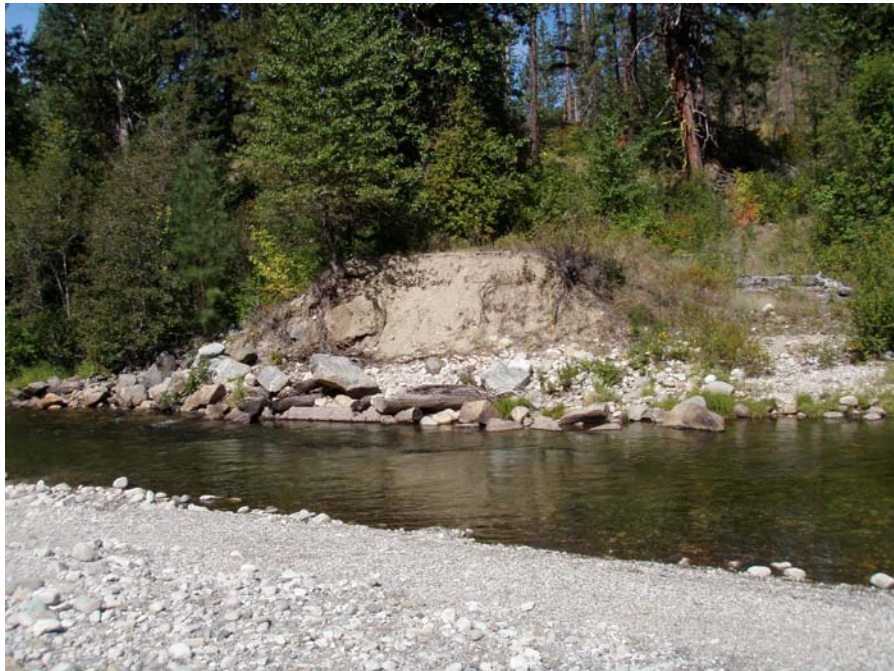
Photograph No. 58. View to the northwest looking at historic bridge abutment along river left. Lower Nason Creek, Wenatchee Subbasin, Washington – Bureau of Reclamation Photograph by E. Lyon, September 16, 2010.
