Lower Peshastin Creek

Tributary and Reach Assessment

Wenatchee Subbasin, Chelan County, WA

June 2010

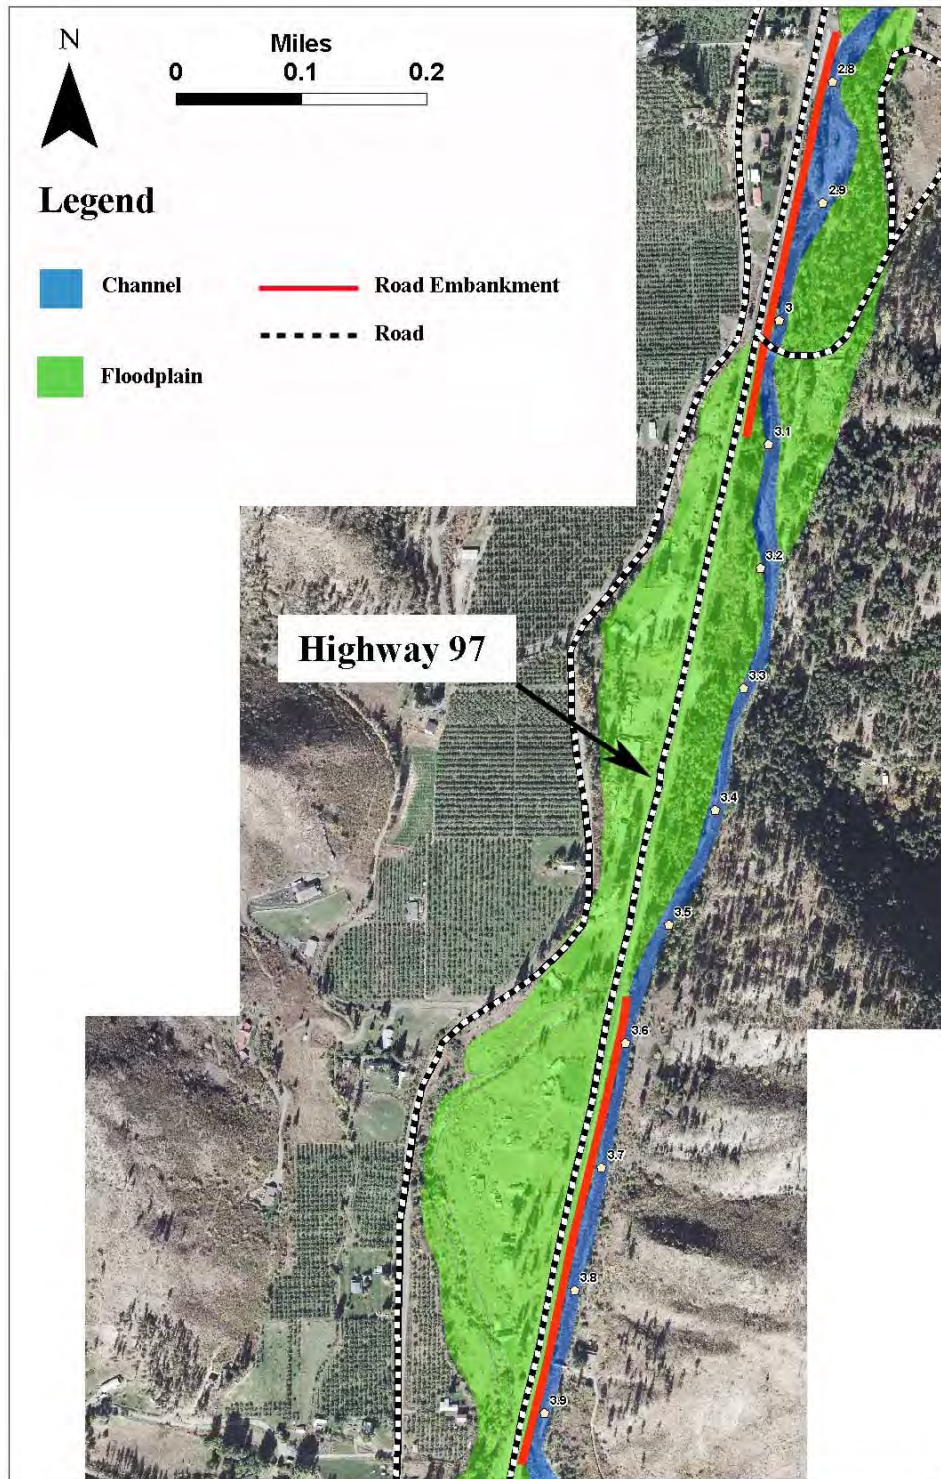
Figure 2. Aerial photo depicting channelization and floodplain disconnection due to Highway 97 between RM 2 and 3.

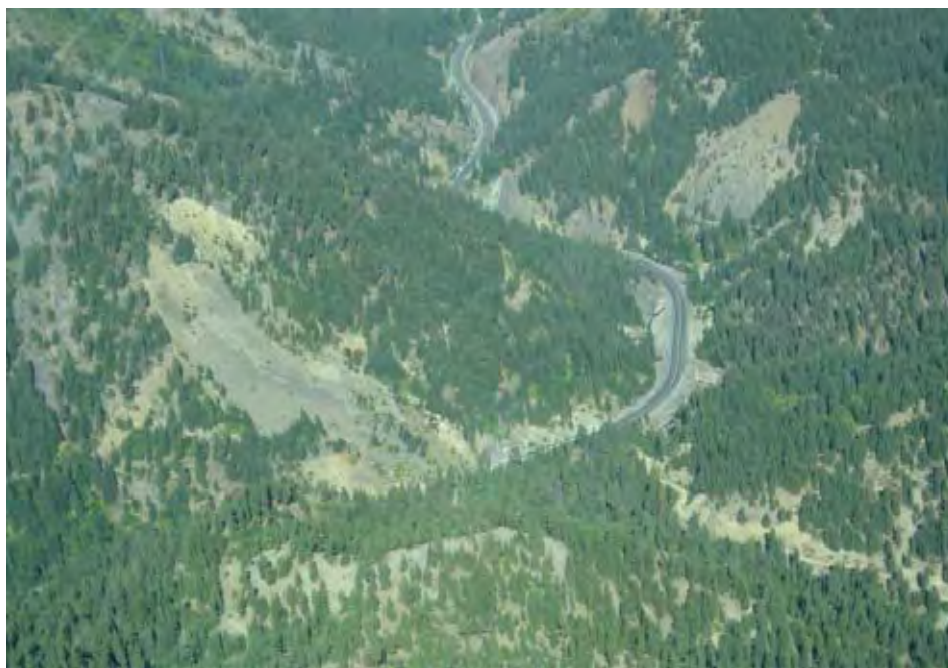
Figure 7. Low elevation aerial photo looking toward the northwest approximately 2.2 river miles upstream of the study area. The obvious slope instability on the left side of the photo is the Ruby Creek Slide.

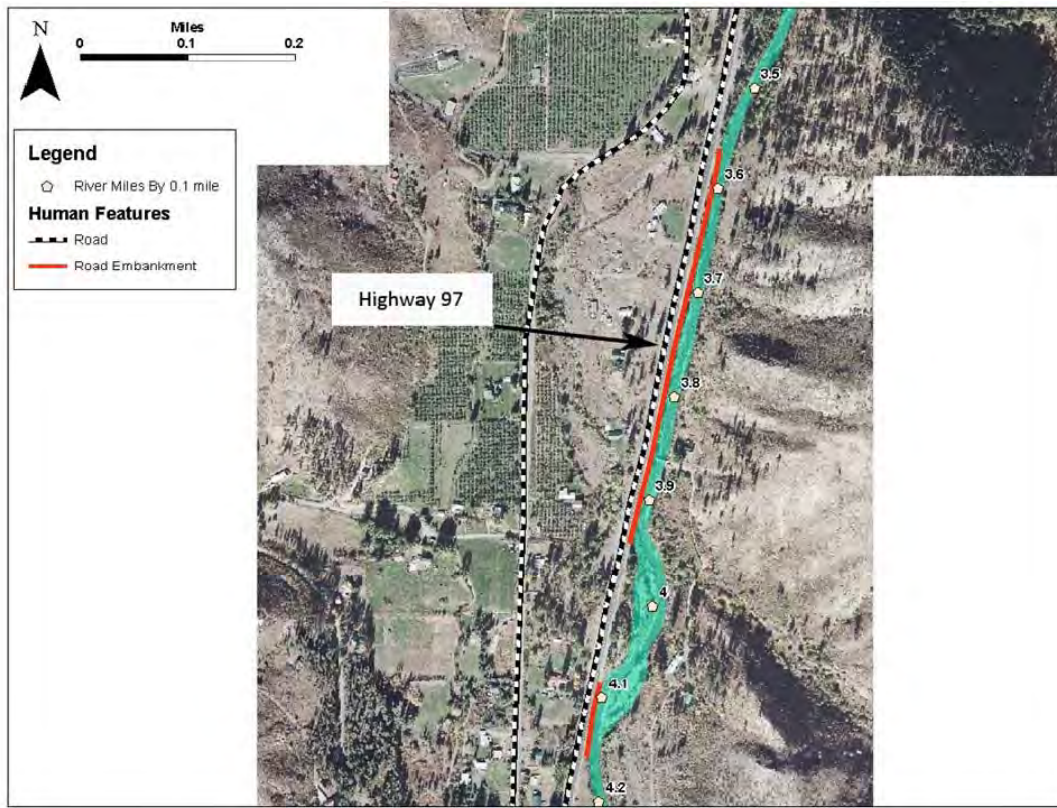
Figure 62. Aerial photo depicting the impact of Highway 97 on channel and floodplain processes for a 0.8 mile portion of Reach 2. Flow is from south to north.

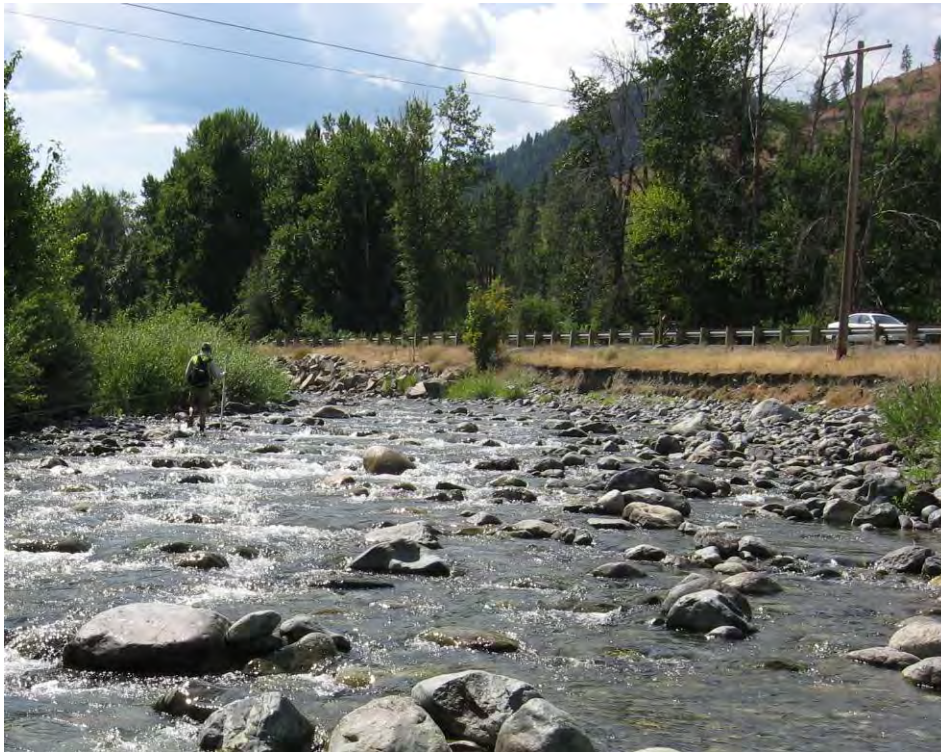
Figure 25. Impacted riparian corridor and rip-rap bank along Highway 97 near river mile 4.1 (river left bank).

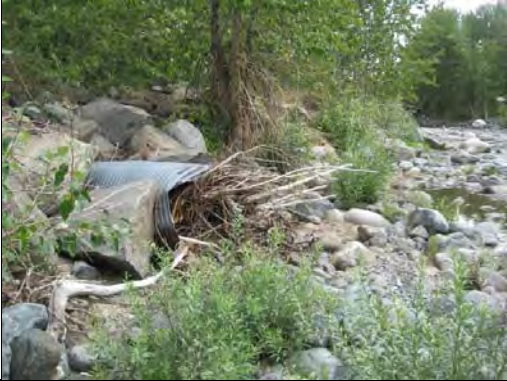
<p>Push-up levee and culvert on river-left bank near river mile 0.85. (August 2009).</p>
1	Inner Zone 1 (IZ-1)	Project RM 0.9L	Reconnect Stream Channel Processes	Rip-rap removal/replacement.	Rip-rap begins on the river left bank at RM 0.85 and extends upstream approximately 400 feet. The rip-rap is associated with the old Highway 97 alignment prior to the reconstruction of the interchange of Highways 2 and 97. Rip-rap limits geomorphic connectivity (e.g. channel migration), riparian function, and habitat complexity. The rip-rap could be removed and replaced with LWD to reconnect long-term channel migration processes, enhance instream habitat cover/complexity, and provide bank stability until a restored riparian forest can provide long-term natural stability (riparian revegetation work is currently underway). This project could be associated with removal of the small push-up levee and culvert removal just downstream (see Project RM 0.8L in DIZ-1).

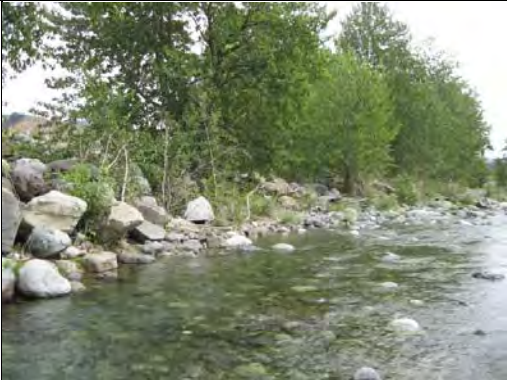
<p>Looking downstream to the east at the river left bank near river mile 0.85 that has been heavily rip-rapped (August 2009).</p>

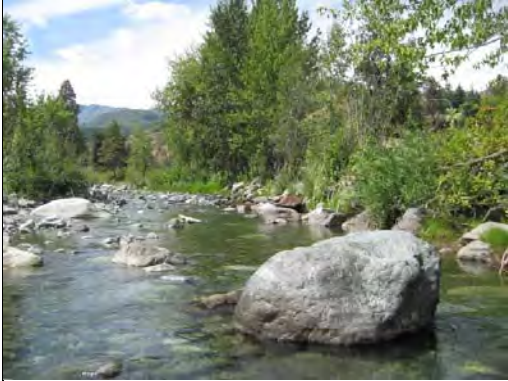
<p>Upstream view near river mile 1.1. Rip-rap associated with old Highway 97 alignment is located on the river left bank (right side of photo) (August 2009).</p>

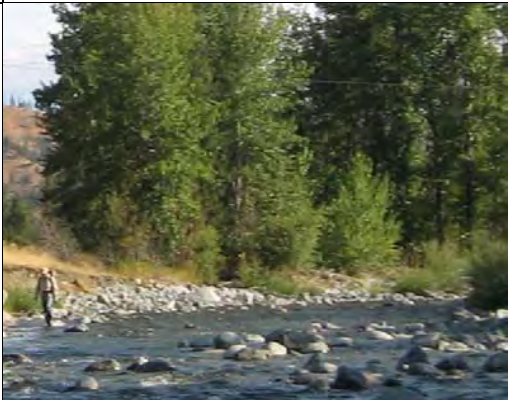
<p>View looking downstream near river mile 4.1 at the potential log jam location associated with Project RM4.1L. (August 2009).</p>

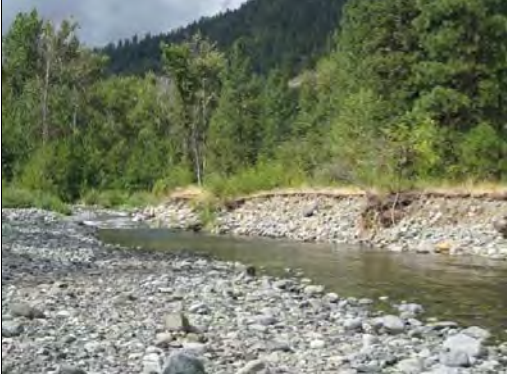
<p>View looking upstream near RM 4.8. Potential log jam placements on river-left bank (right side of photo) to enhance pool complexity and restore natural bank erosion rates. (August 2009).</p>

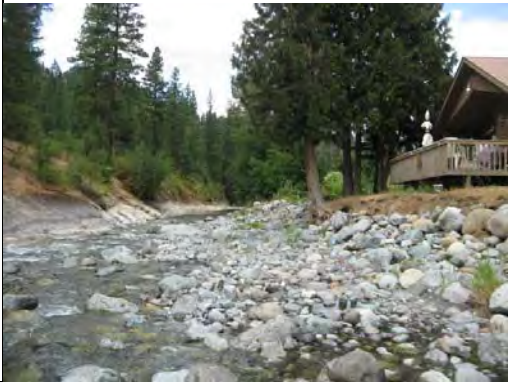
<p>Residential development impacts on riparian function near river mile 5.65, left bank. (August 2009).</p>
3	Outer Zone 1 (OZ-1)	Project RM 5.8L	Protect and Maintain	Riparian and floodplain habitat protection	This undeveloped floodplain surface is important for protection due to the limited acreage of undeveloped floodplain in this reach. Protect and allow no further degradation of geomorphic, hydrologic, and vegetative function. Evaluate existing protections and, if necessary, look for opportunities to purchase conservation easements on the property.

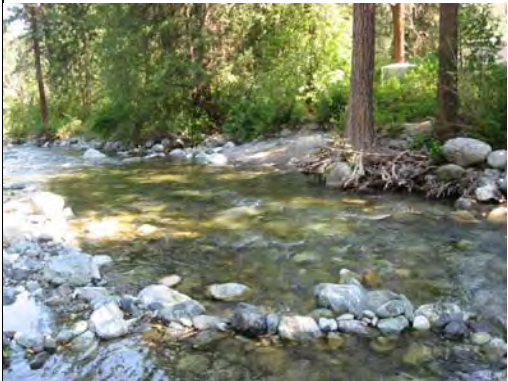
<p>View looking downstream at access area associated with RV Park on river-right bank. There is only a narrow forested riparian buffer along this segment. (August 2009).</p>
5a	Inner Zone 1 (IZ-1)	Project RM 8.15R	Reconnect Stream Channel Processes	Rip-rap removal and LWD habitat enhancement	There is an approximately 100 ft long grouted rip-rap wall on the river-left bank near river mile 8.15 that protects private property from erosion. Investigate opportunities to remove the rip-rap and replace with LWD jams that would provide bank stability as well as aquatic habitat cover, complexity, and pool formation. Re-plant the riparian area in order to provide long-term stability and riparian functions.

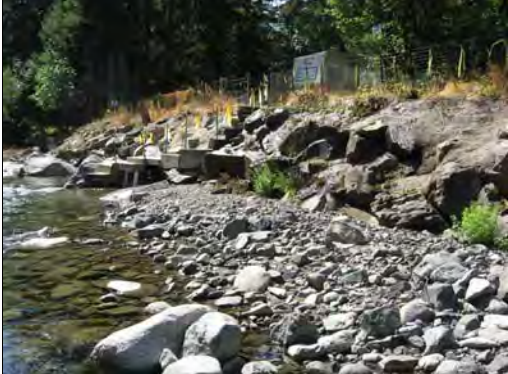
<p>View looking upstream near river mile 8.15 at a grouted rip-rap bank and concrete access stairway along private property. (August 2009).</p>

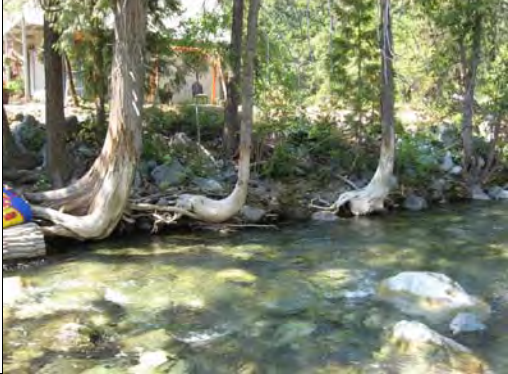
<p>Narrow riparian buffer associated with residential development near river mile 8.3. This condition is typical along much of Reach 5. (August 2009).</p>
5b/6	Disconnected Outer Zone 3 (DOZ-3)	Project RM 8.65R	Riparian Restoration	Riparian revegetation	This project responds to similar impacts and shares similar goals with Project RM 8.9R. This area has been disconnected by Highway 97, and subsequently cleared. Revegetation would ideally occur in tandem with larger-scale stream channel and floodplain reconnections in this reach

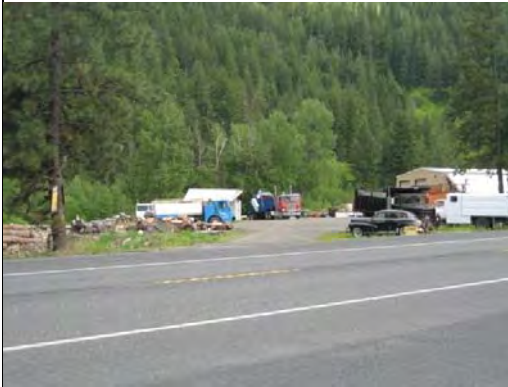
<p>View to the southeast at industrial development of the former floodplain east of Highway 97. (May 2010).</p>
