Lower White Pine Reach Assessment

Nason Creek Chelan County, Washington

U.S. Department of the Interior
Bureau of Reclamation
Pacific Northwest Region
Boise, Idaho

February 2009

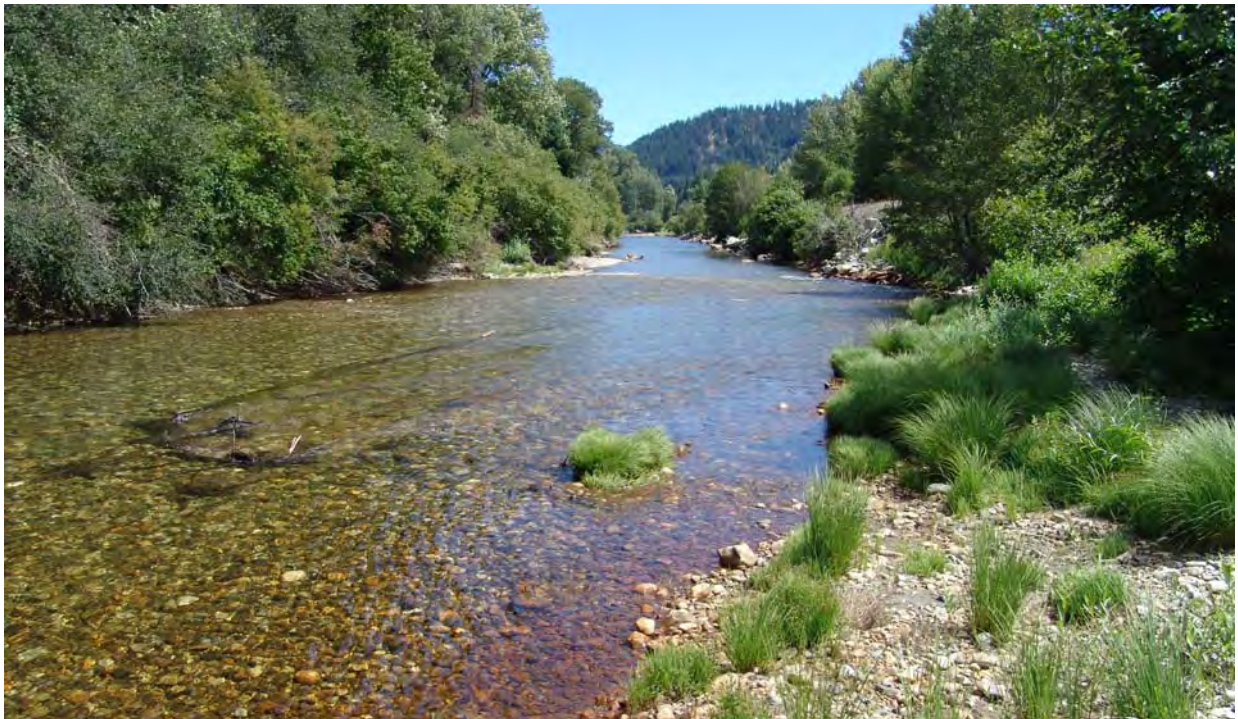
Cover Photograph – A riffle in the straightened section of the active channel with the railroad grade acting as the right bank; view looking downstream to the east.

Lower White Pine Reach; Subreach LWP IZ-5, Nason Creek - Wenatchee Subbasin, Washington. Bureau of Reclamation Photograph by D. Bennett; August 8, 2007.

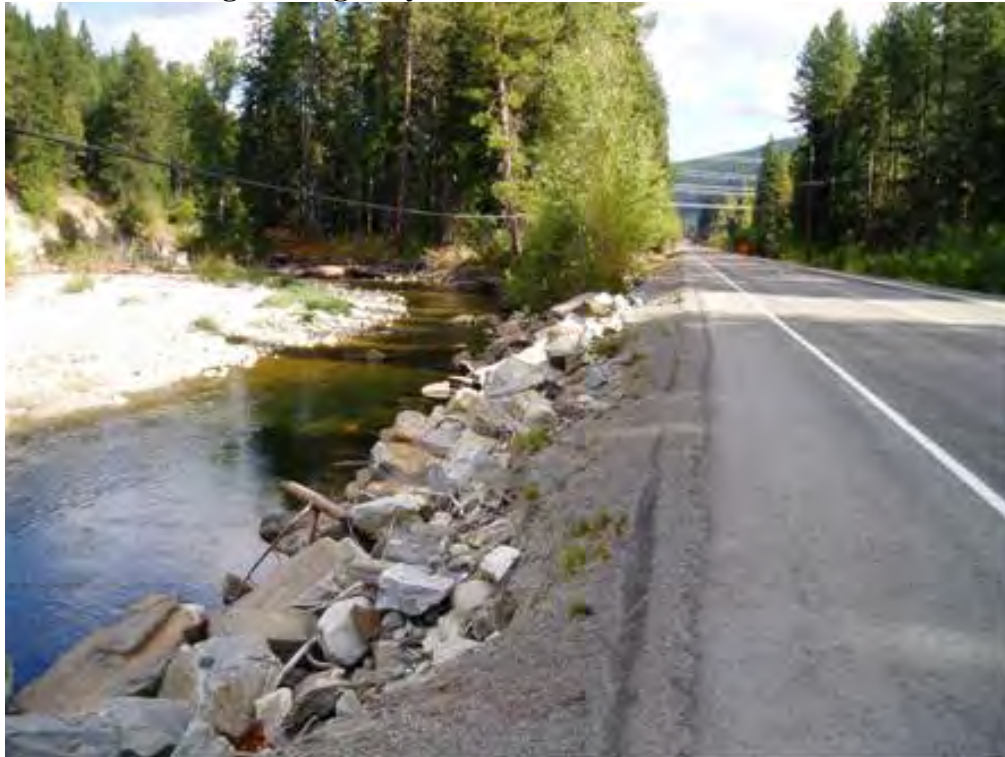
Bank erosion from power line crossing at RM 6.2

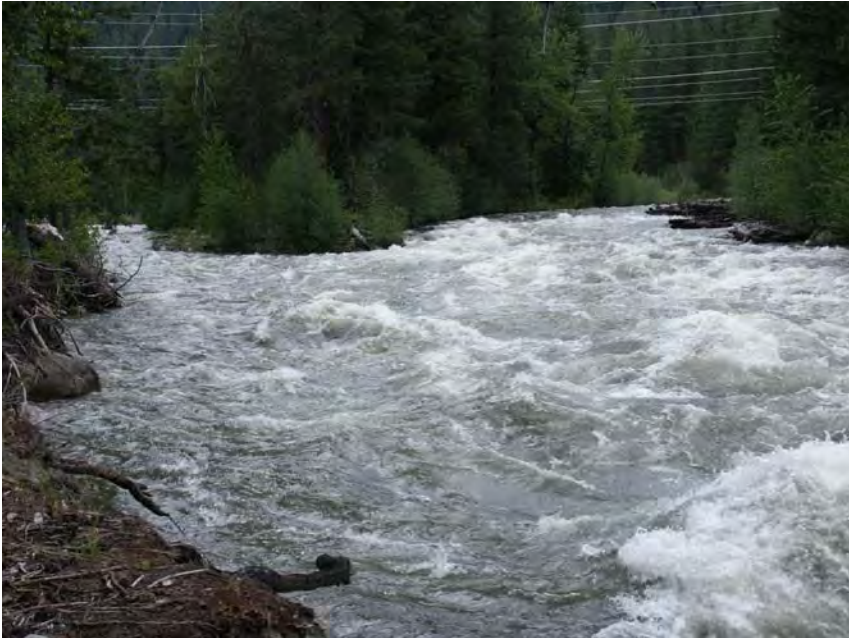
Figure 18. Looking upstream at May 2006 flood from locations shown in previous figure (near RM 6.6).
