# UPPER WENATCHEE RIVER STREAM CORRIDOR ASSESSMENT AND HABITAT RESTORATION STRATEGY

August 2012

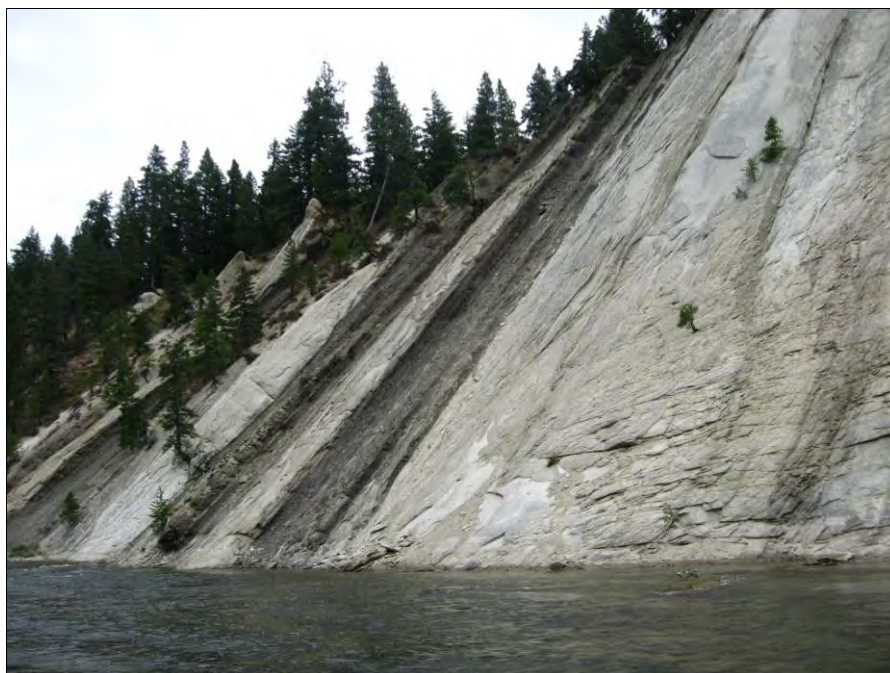
**Figure 27.** Bedrock outcrop along the channel in the study area (Chumstick Formation). Note that tilting of stratigraphy has resulted in steep dip-slopes toward the channel that can result in planar failures along weak bedding planes.

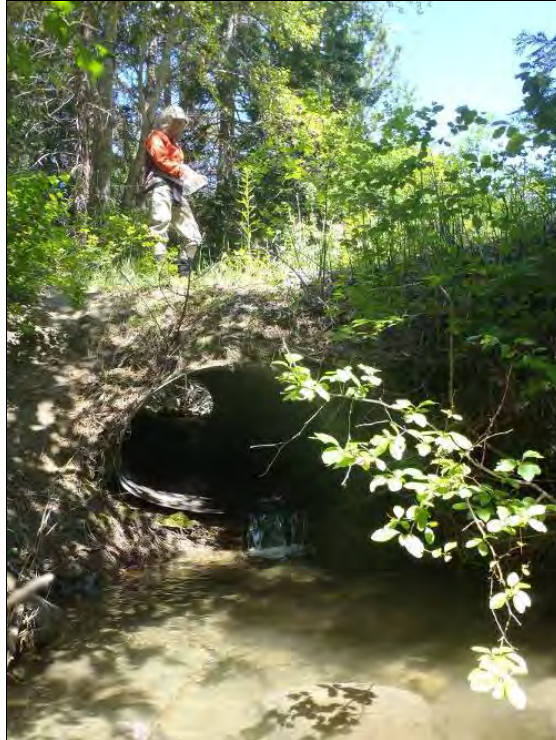
**Figure 45. Perched culvert in Deadhorse Creek (RM 38.6). Surface water connection was present on day of survey (July 26, 2011).**

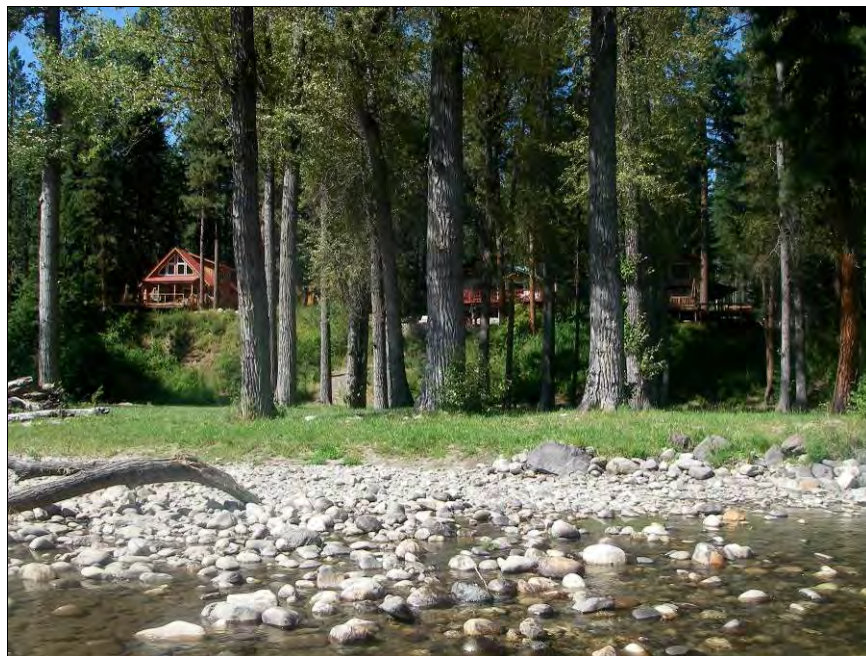
**Figure 45. A low elevation floodplain surface along river-right affected by clearing and residential impacts (RM 40.1).**

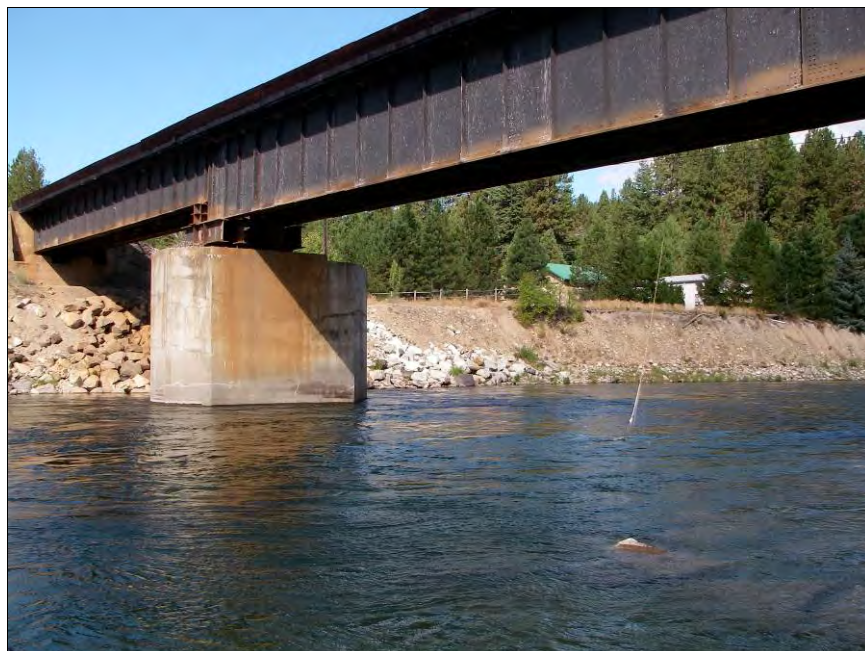
**Figure 64.** View looking upstream towards the right bank terrace, riprap armoring, and Burlington Northern Railroad Bridge at RM 41.9 (August 2011).

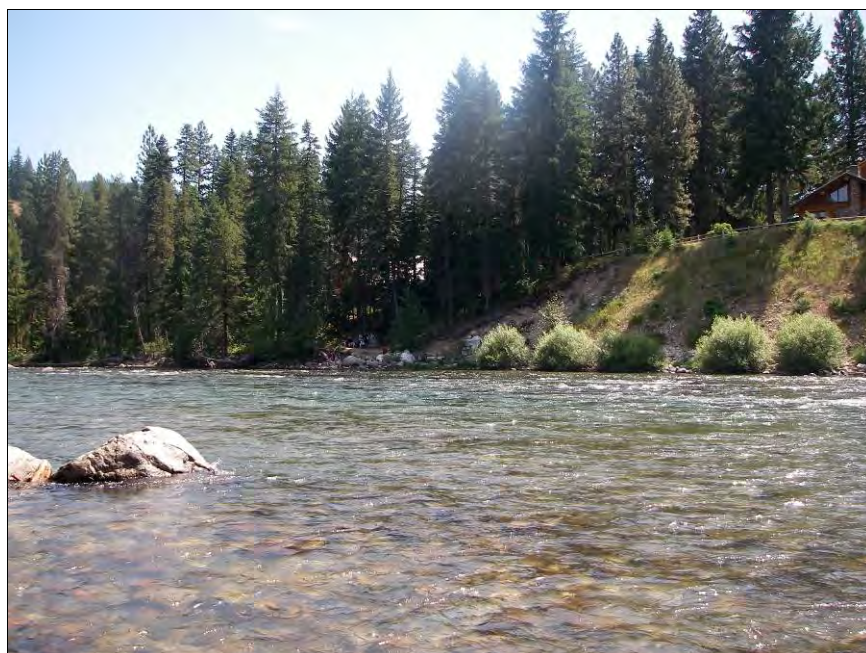
**Figure 84. Vegetation clearing and river access impacts riparian buffers at residential properties in Reach 6 (August 2011).**

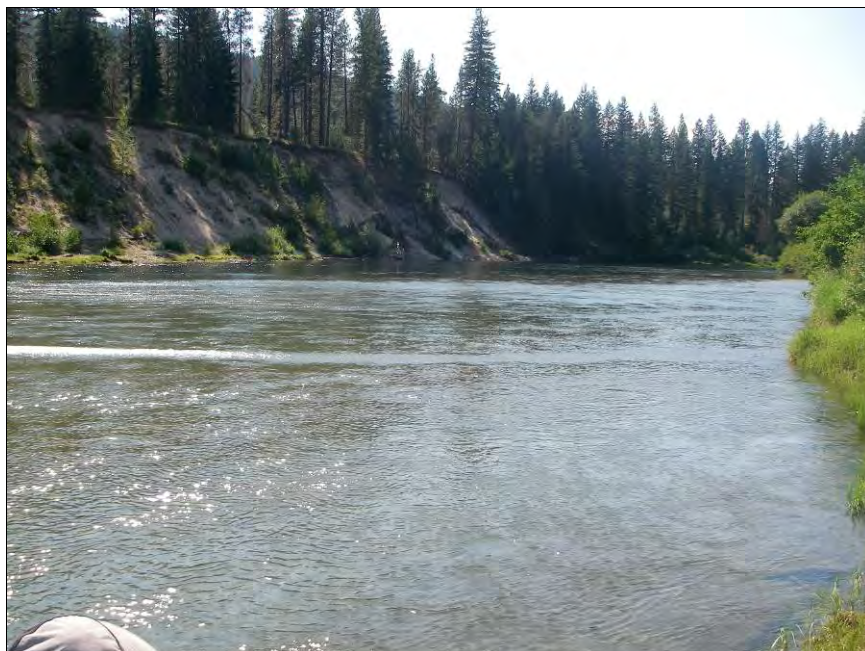
**Figure 112. Bank instability was observed along many of the steep terrace banks throughout Reach 9 (August 2011).**

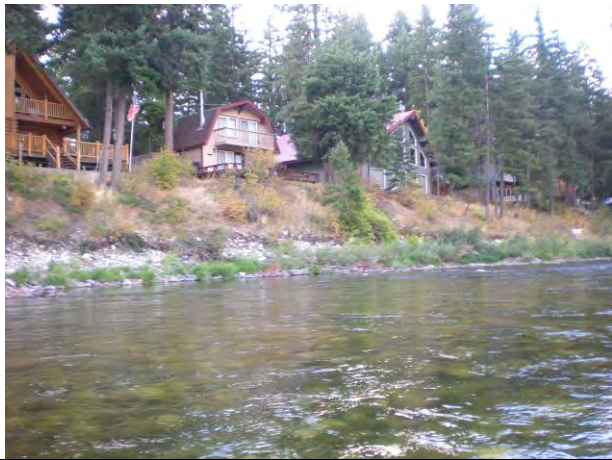
Residential impacts to riparian conditions in the Ponderosa Estates development.
5	Project RM 43.7R	River Road Channel Margin Enhancement	Habitat reconnection via removal/modification of bank armoring, levees, roadways, or fill  Riparian restoration	There is discontinuous riprap and rock spurs along River Road along the river-right bank. Look for opportunities to modify bank armoring to include bioengineering approaches and log jams. There are good meander bend log jam opportunities through here (4-6 jams total, between riprap sections) that would enhance local pool scour, cover, and complexity.

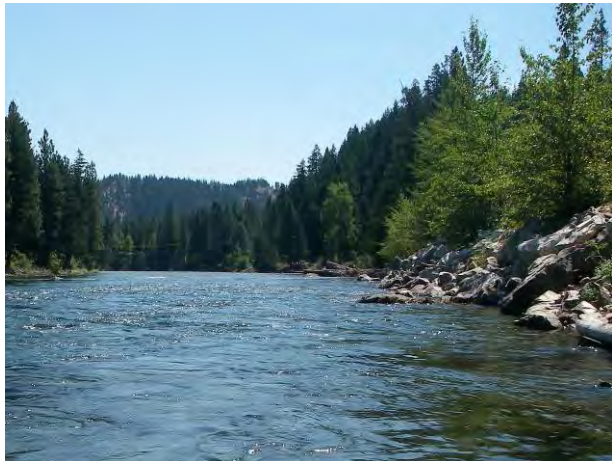
View of riprap bank along river-right near RM 43.8.

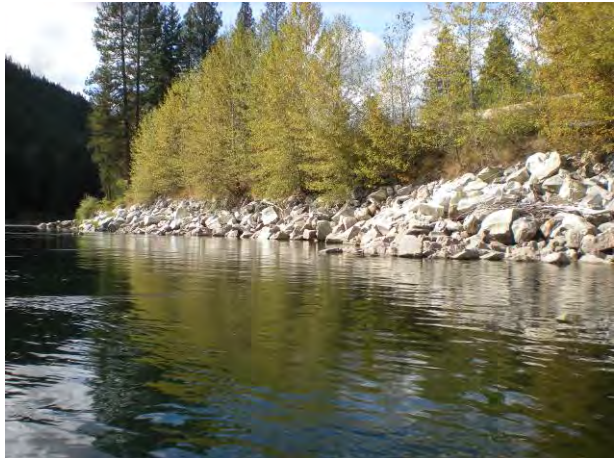
<p>Oblique aerial view of river-right bank with riprap and rock spurs near RM 40.7.</p> <p>View looking downstream at ripraped river-right bank near RM 40.7.</p>
3	Project RM 40.5L	RM 40.5 Alcove Enhancement	Off-channel habitat enhancement  Placement of structural habitat elements including large wood, log jams, or boulders	There is an existing alcove on river-left at the outside of the bend at RM 40.5. Wood could be added to the existing alcove to enhance habitat cover and complexity. There may be additional potential off-channel work on this low surface but the surface is relatively high and there is a lot of bedrock; further investigation would be necessary to evaluate additional off-channel potential.

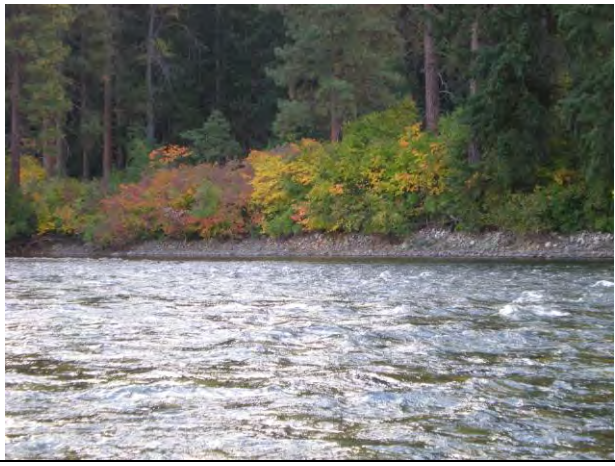
View of river-left bank near RM 40 that lacks channel margin complexity.
