Beaver Creek

REACH ASSESSMENT

December 2017

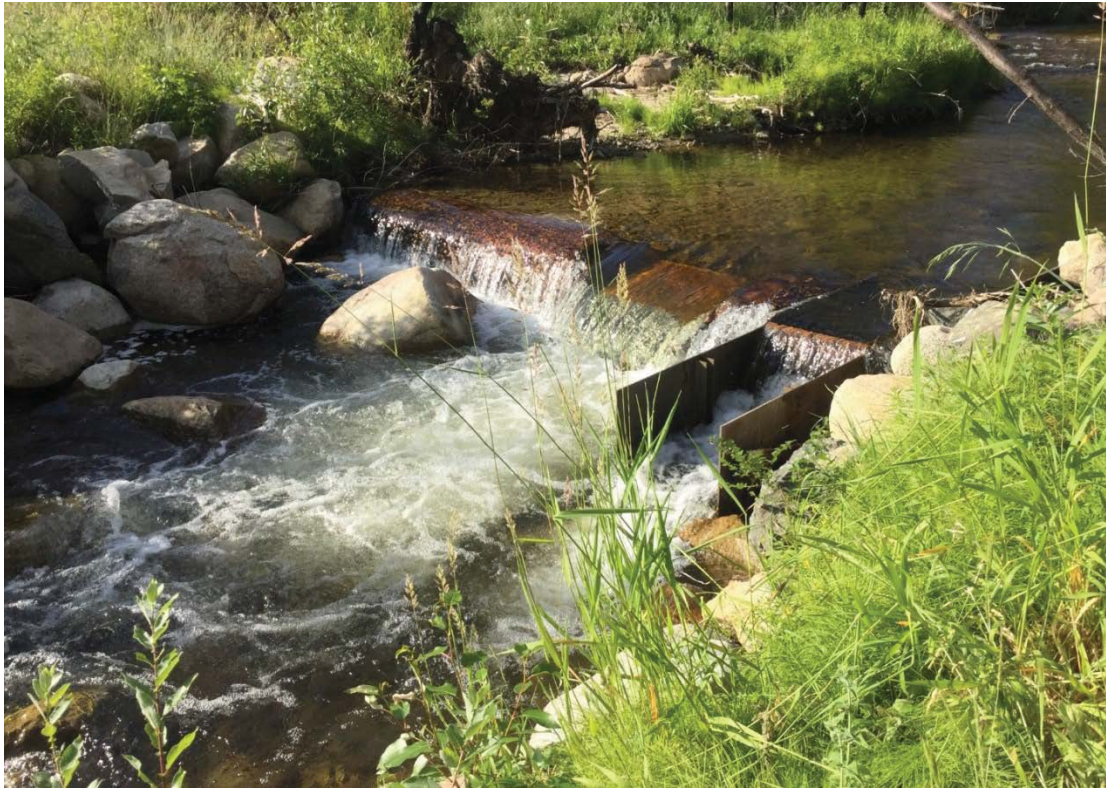
Many diversions presented full or partial passage barriers to adult and juvenile salmonids for many years, although the Methow Subbasin Plan reported that all diversions in Beaver Creek had been screened (NPCC 2005) and many have been altered or replaced to provide passage. The Okanogan Conservation District and USBR partnered with local landowners to replace seven diversions within the Survey Area that were known fish passage barriers on Beaver Creek (USBR 2013a). Although the primary aim of the passage improvements was to reconnect habitat for salmonids, the projects also included related improvements including culvert removal, pump and headgate replacement, additional diversion replacement, piping, and water acquisition actions (USBR 2013a). Ongoing maintenance and monitoring of irrigation diversion structures is needed to ensure continued passage of fish at all life stages. Figure 2-3 shows a recent photograph of the log weir and fish ladder structure at the Batie Diversion near RM 6.3.

Figure 2-3. Photograph of Log Weir and Ladder Structure near RM 6.3 at Batie Diversion

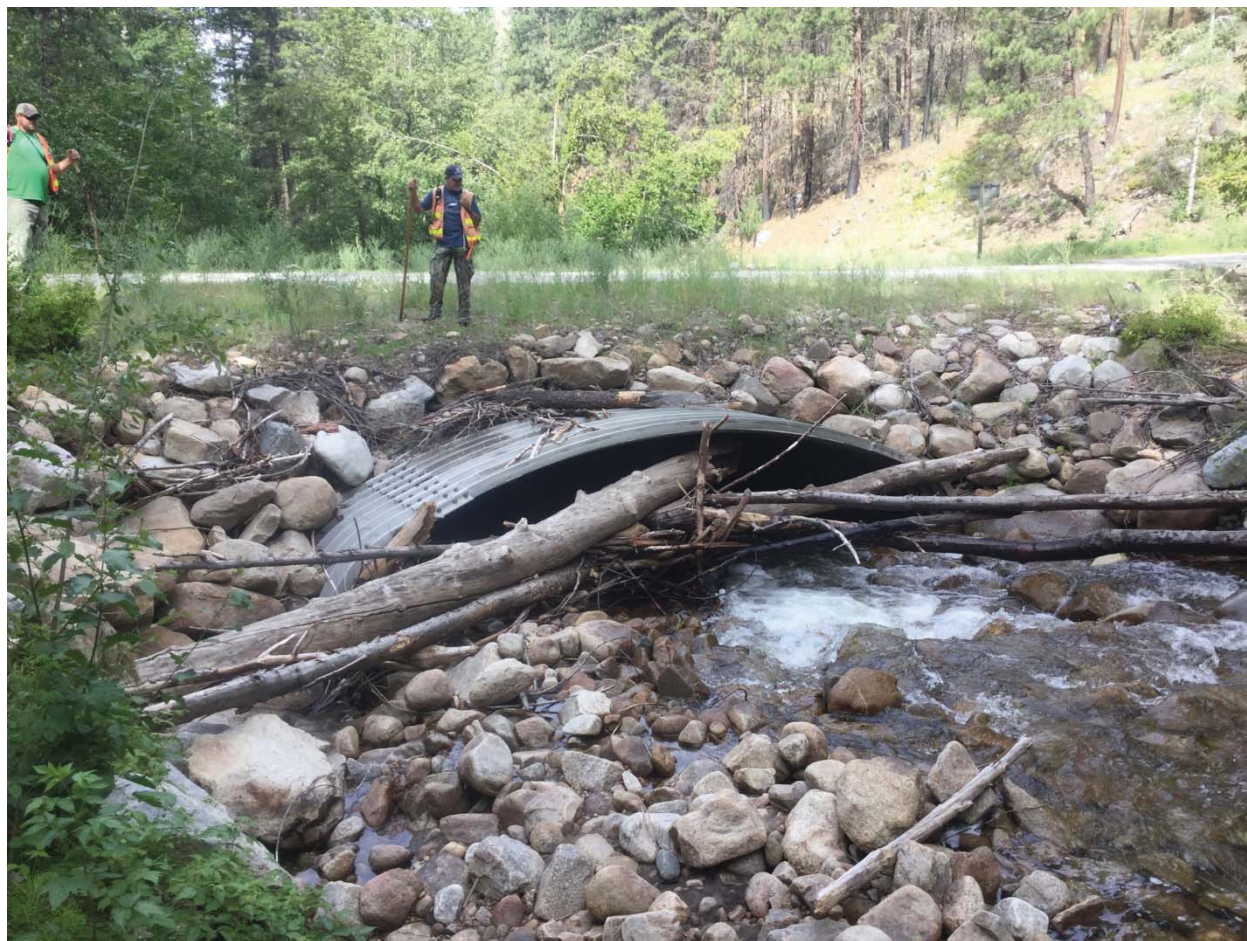
The NF-4225 road culvert crossing of Beaver Creek near RM 9.5 also poses a considerable risk of catastrophic failure due to a high potential for plugging. The photograph in Figure 2-6 shows sediment deposition and wood racking at the inlet of the culvert.

Figure 2-6. Photograph of Wood Racking at Culvert Crossing Inlet on NF-4225 Road near RM 9.5

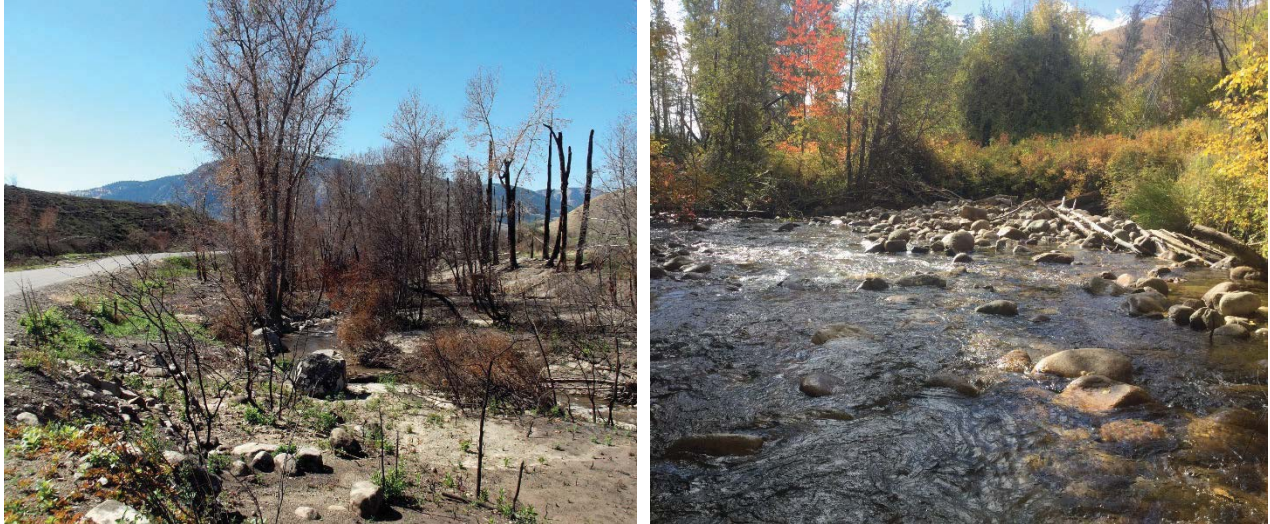
Figure 2-8. Photograph of Burned Riparian Area in Reach 2 Following the 2014 Carlton Complex Fire (Source: BAER 2014) (left), and Regrowth of Riparian Understory in 2017 (right); (photos are representative and were not taken in the exact same location)

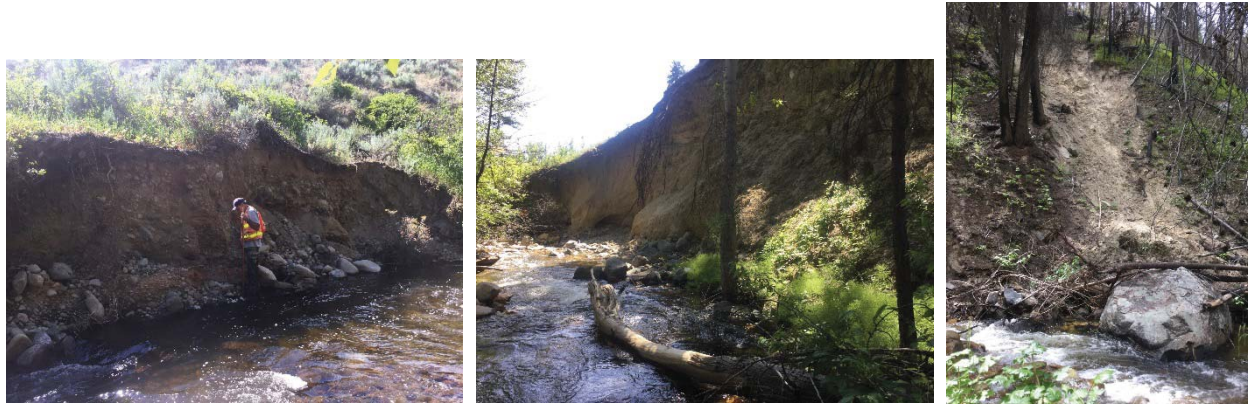
Figure 4-5. Photographs of Typical Eroding Areas Including Bank Erosion near RM 0.6 in Reach 2 (left), Glacial Terrace Erosion near RM 7.9 in Reach 5 (center), and a Stream-adjacent Landslide near RM 10.1 in Reach 6 (right)

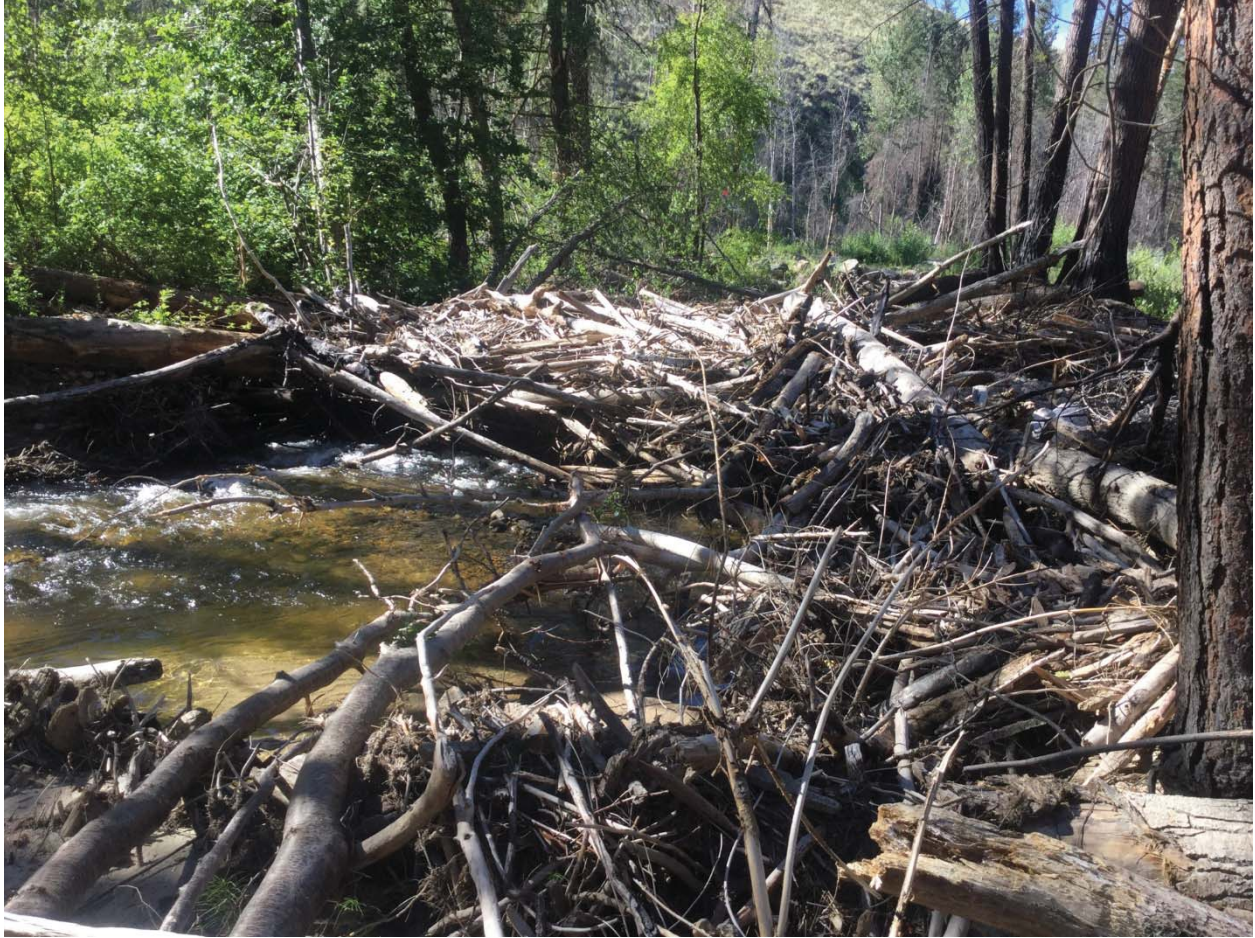
Figure 4-11. Photograph of Large Natural Log Jam near RM 6.5 in Reach 4

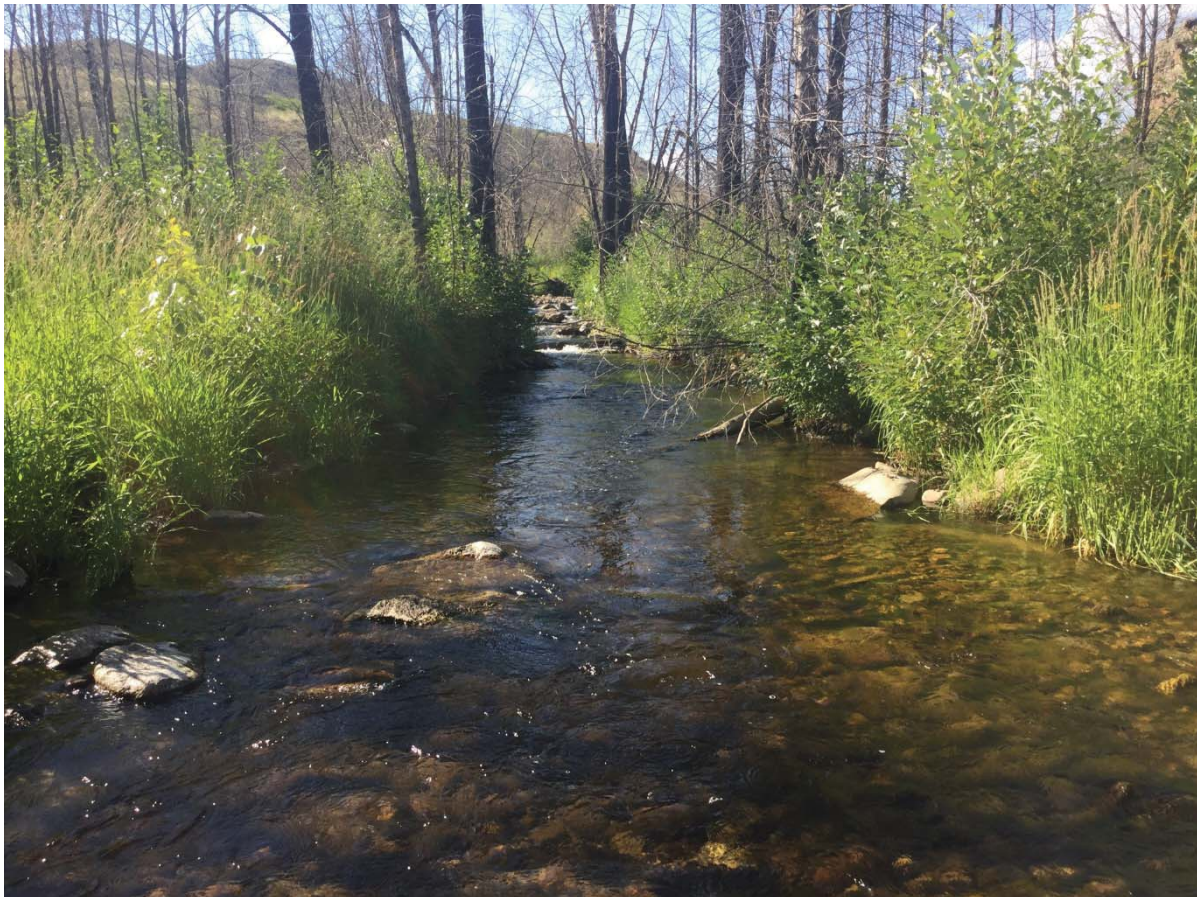
Figure 4-16. Photograph of Burned Riparian Vegetation and Dense Understory Growth near RM 3.5 in Reach 3
