Chewuch River Reach Assessment

Yakama Nation Fisheries Program

JUNE 2010

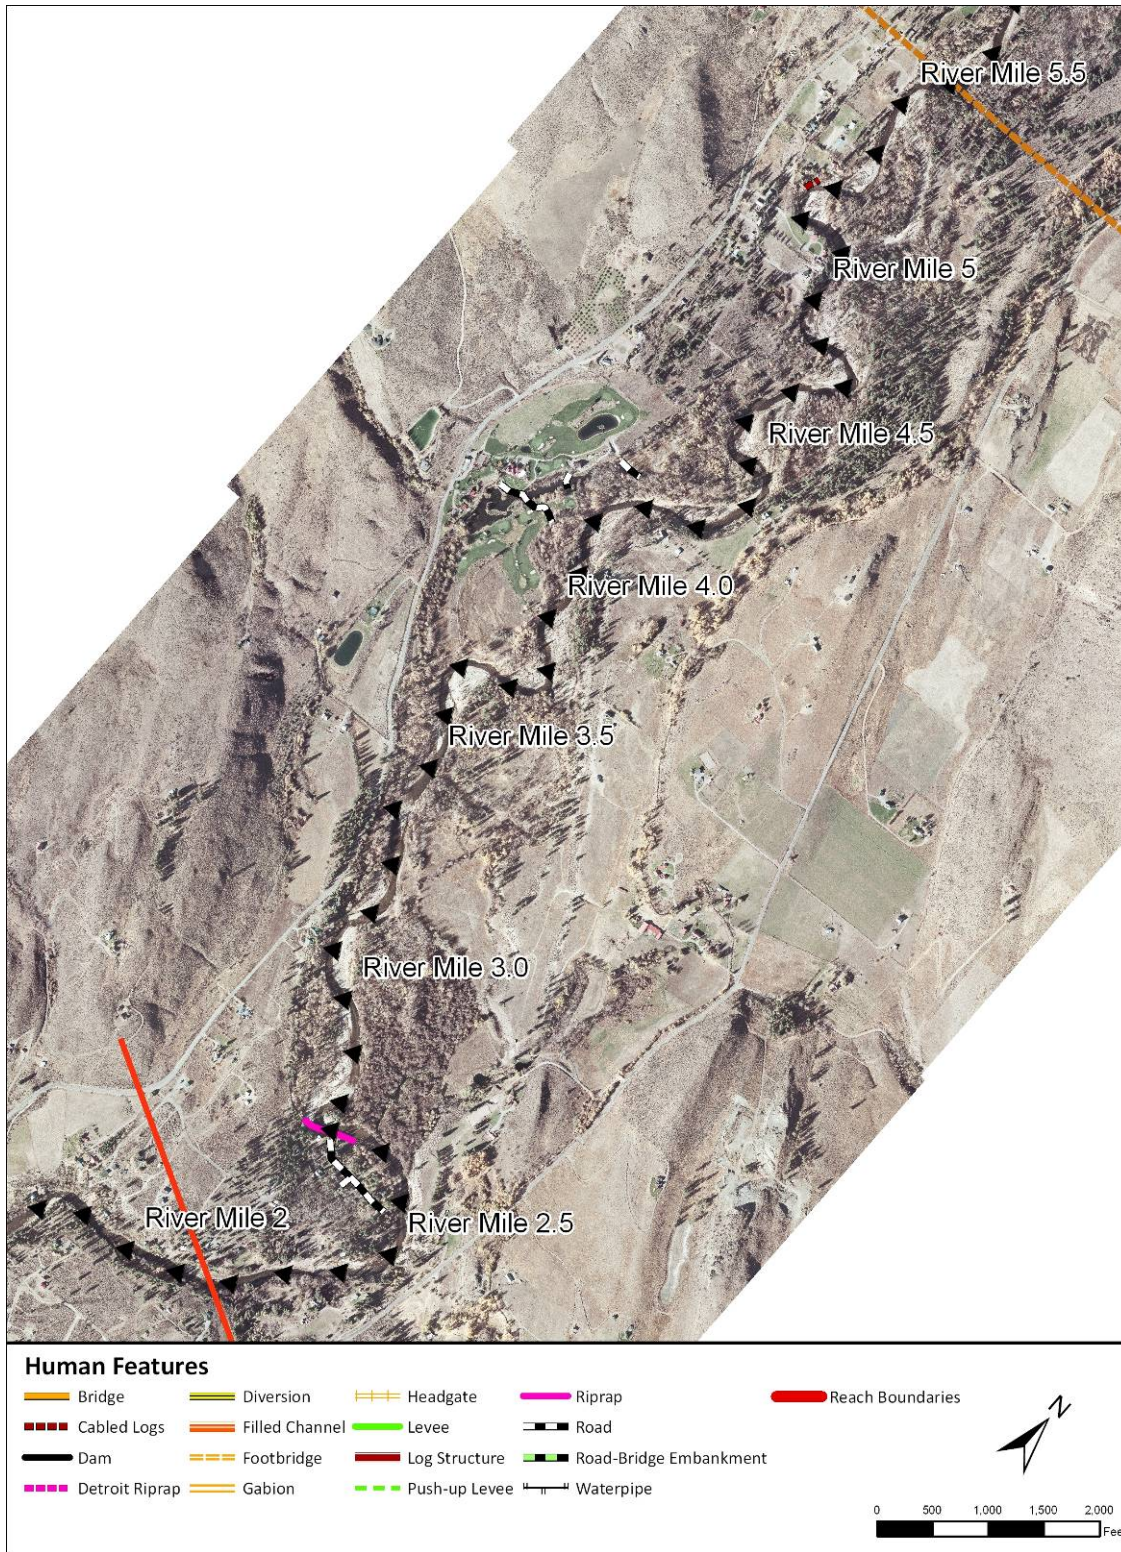
Anthropogenic influence on the river corridor is minor in Reach C2a (Figure 3). Major roadways are set back along the toe of bounding hillslopes, outside of the low surface area. Development has been concentrated between RM 2.2 and 2.7 and between RM 3.6 and 4.3 along the west side of the valley. In the downstream area, there is moderate residential development with associated roadways and fill. A 460 ft section of riprap protects houses at the upstream end of this area near RM 2.7. Only small patches of riparian forest clearing have taken place as part of this rural development. At the upstream golf course development, the riparian area has been completely cleared and artificial wetlands have been constructed. The former floodplain surface has been filled and graded, leaving no evidence of high flow channels or off-channel habitat.

Figure 3. Aerial photo showing human features in Reach C2a. Flow is from north to south.

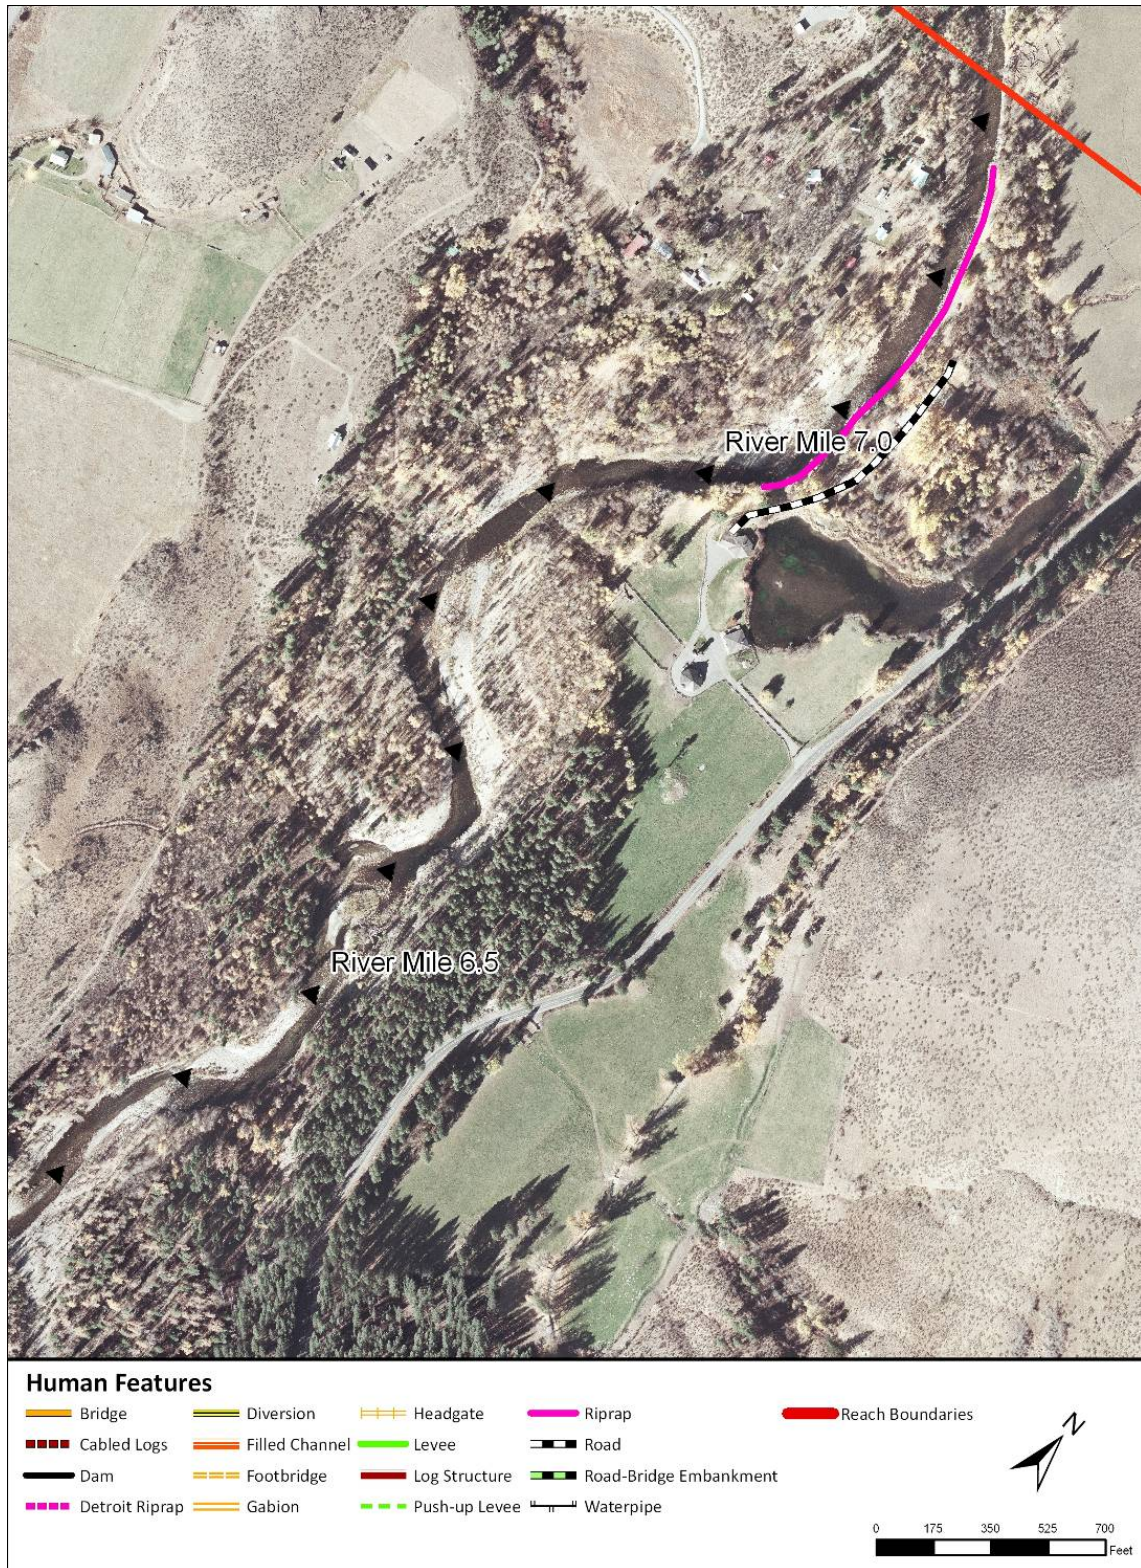
Few alterations have been made to the channel and floodplain in Reach C2b (Figure 8, Figure 9). At the upstream end of the reach there are 1,240 ft of riprap along the east side of the channel between RM 7.01 to 7.27. This riprap blocks a historical channel that now contains a large wetland on a private ranch. On the other side of the valley, there is recreational development near the channel adjacent to residential development on the alluvial terrace. Downstream of this, floodplain surfaces are free of development and channel form and channel banks have not been modified.

Figure 9. Aerial photo showing human features in the upstream portion of Reach C2b. Flow is from north to south.

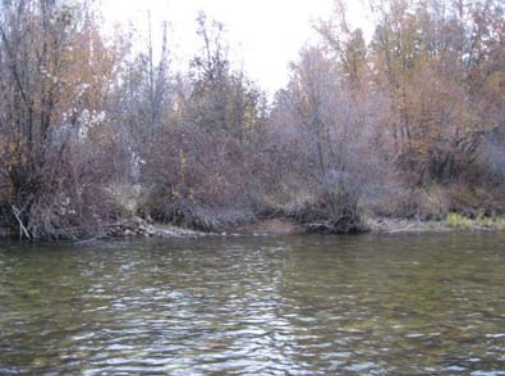
<p>View to the east at the river left bank near RM 2.65 where LWD could enhance in-stream habitat. November 2009.</p>

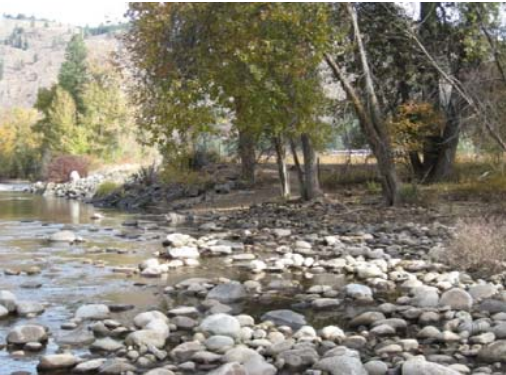
<p>View to the north in the upstream direction where livestock have accessed water along the river-left bank near RM 7.5 (November 2009).</p>
3a	Project RM 7.6L	Inner Zone 2 (IZ-2)	Reconnect Stream Channel Processes	Riprap removal or modification	There is a 400 ft long riprap bank along the river left near RM 7.6 that protects the toe of an eroding terrace. The terrace surface has been converted to agriculture. The riprap could be removed and replaced with log jams to enhance in-stream habitat and continue to provide bank protection. Alternatively, the existing riprap could be enhanced with additions of LWD to increase habitat cover and complexity. This project could be combined with restoration of a forested riparian buffer on the terrace in order to enhance long-term riparian functions including shading and LWD recruitment.

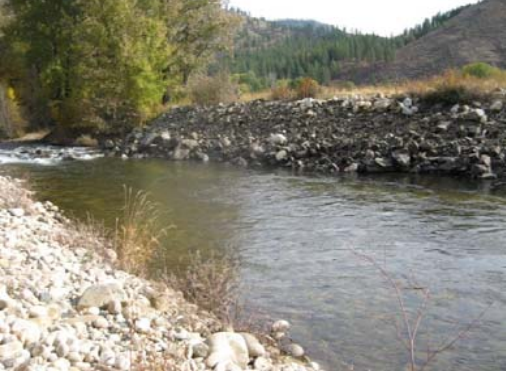
<p>View to the northeast in the upstream direction at riprap along the river-left bank near RM 7.6 (November 2009).</p>

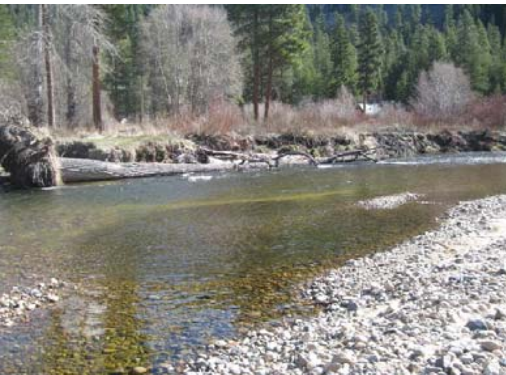
<p>Downstream view at the river-left bank where it is eroding near RM 10.37 (March 2010).</p>

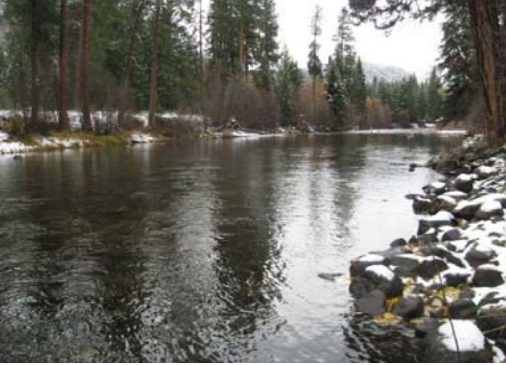
<p>View to the south in the downstream direction at a river section near RM 11 that has low habitat complexity (November 2009).</p>

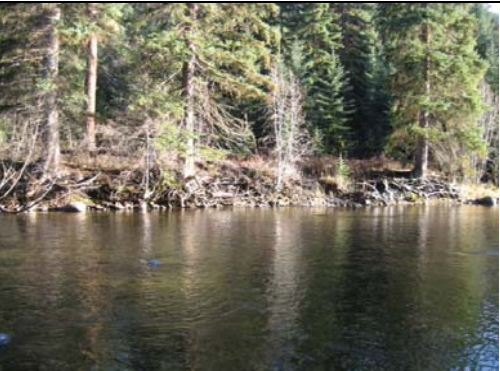
<p>View to the east at exposed root masses along the river-left bank near RM 17.5 (November 2009).</p>
8	Project RM 17.95C	Inner Zone 1 (IZ-1)	Reconnect Stream Channel Processes	LWD placement to enhance habitat and connectivity	This project area includes the potential for several large log jams on both sides of the channel between RM 17.98 to RM 17. This area, as with most locations in the study area, is low in wood density in comparison to undisturbed conditions. An overarching goal of all of these placements is to re-establish natural LWD loading and provide the habitat complexity and cover that is generated by LWD. At the upstream end of this project site, there are two locations with high eroding banks where streambank log jams would enhance habitat cover and complexity. At the downstream end of the project area, there is a mid-channel bar and riffle-pool sequence that provides a location for a bar apex jam and large wood complexes in the downstream pool to enhance lateral connectivity (i.e. encourage split flow) and habitat.

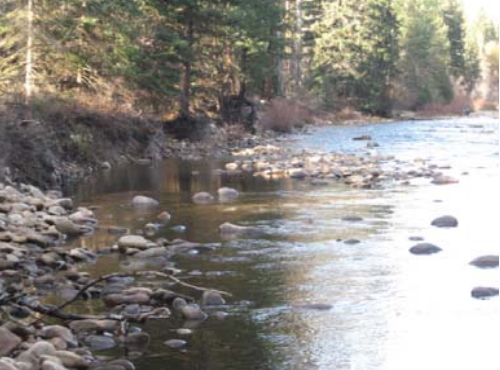
<p>View to the northwest in the upstream direction at an example of a potential streambank LWD jam project location near RM 17.97. A similar location is found on the opposite bank near RM 17.98 (November 2009).</p>
