LOWER LIBBY CREEK REACH ASSESSMENT

Prepared for **YAKAMA NATION FISHERIES** | PO BOX 15, FORT ROAD | TOPPENISH, WA 98948

Prepared by
INTER-FLUVE, INC.
1020 WASCO STREET, SUITE I | HOOD RIVER, OR 97031
541.386.9003 | www.interfluve.com

July 2012

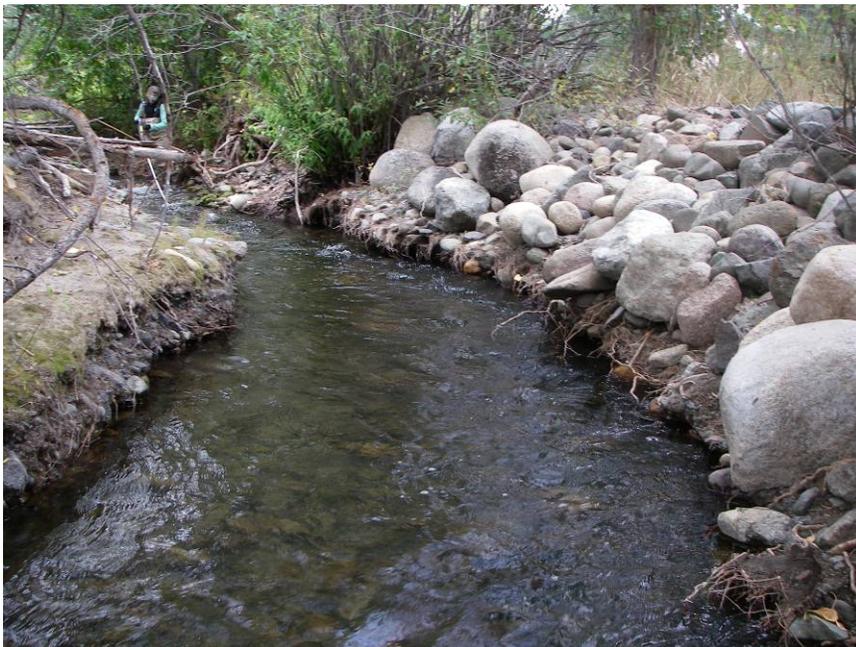
Figure 11. Bank armoring and scour along lower Libby Creek (September 2011).

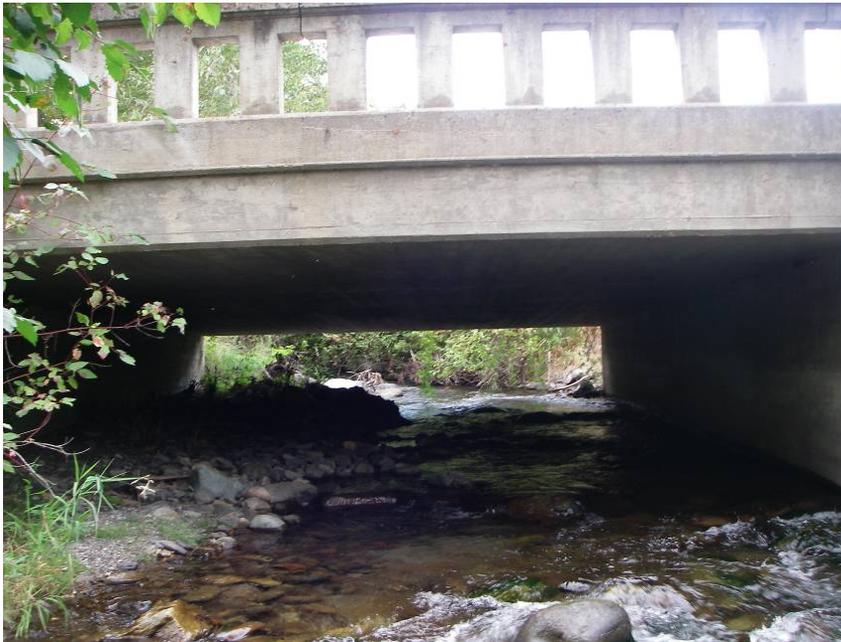
Figure 12. Habitat alteration and channel confinement at the Hwy 153 Bridge (RM 0.3).

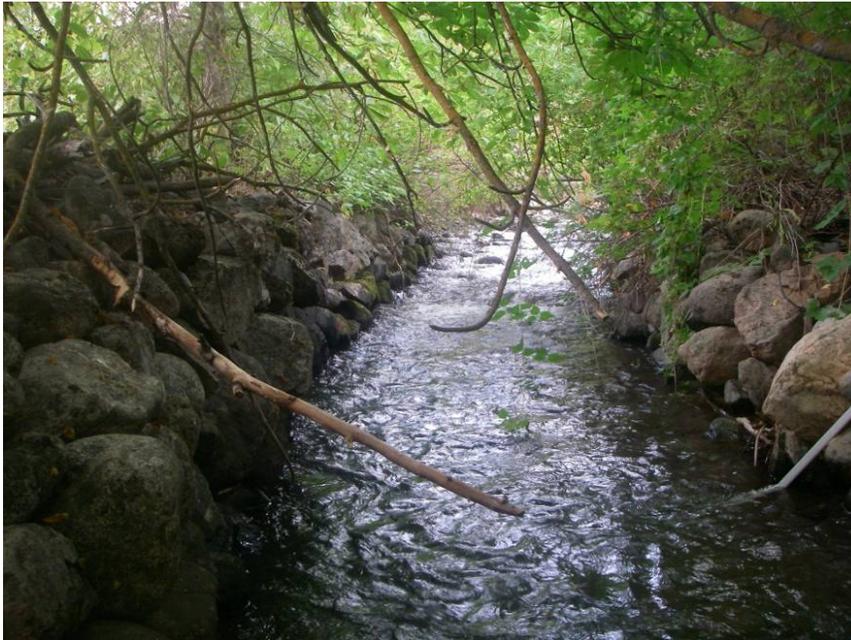
Figure 23. Riprap armoring limits floodplain connectivity and lateral channel dynamics near RM 0.3, Reach 1 (September 2011).

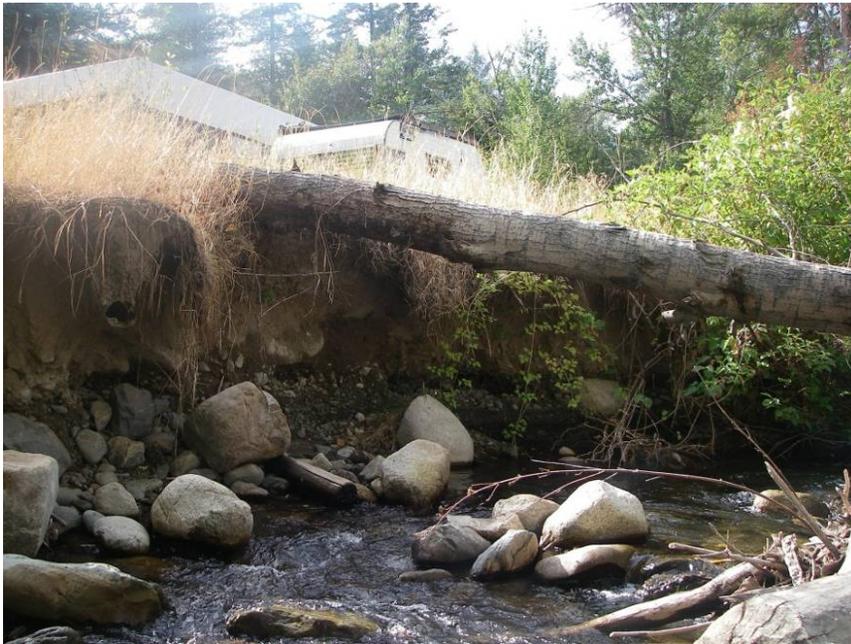
Figure 24. Vegetation clearing and development in the riparian zone near RM 0.5, Reach 1 (September 2011).

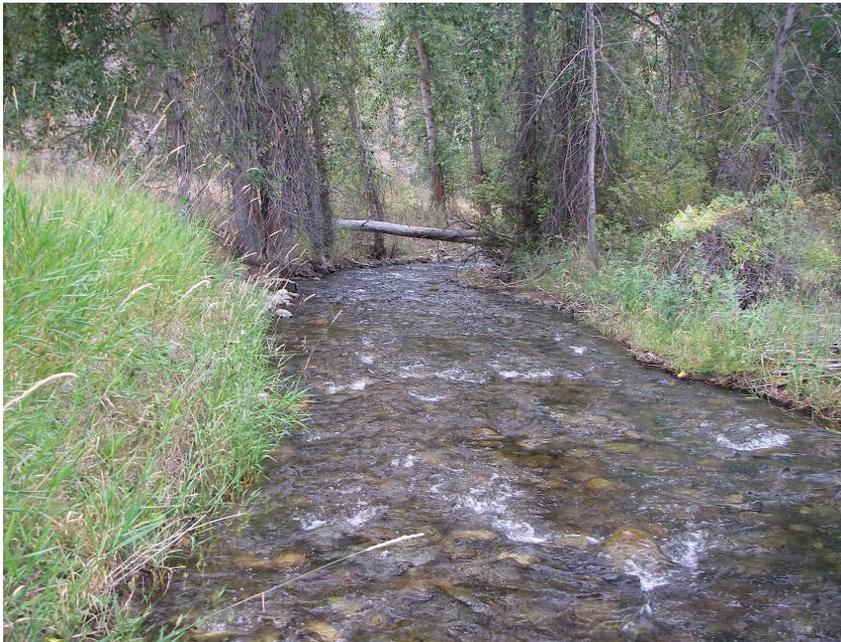
Figure 25. Riffle habitat in Reach 1 with sparse canopy cover and embedded substrate (September 2011).

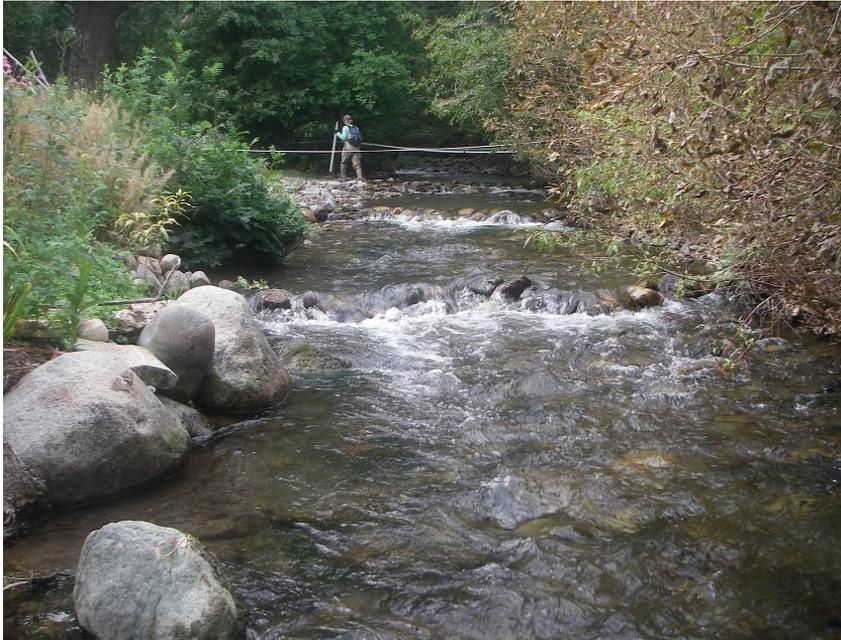
Figure 27. Rock weirs (located at RM 0.35) may prevent upstream colonization by juvenile fish during low water years (September 2011).

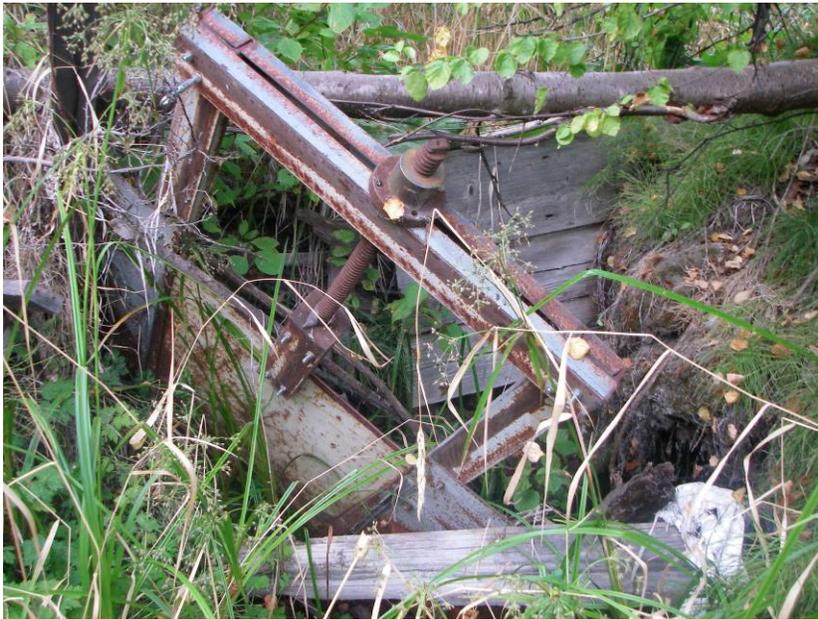
Figure 34. Headgate in an abandoned irrigation diversion at RM 0.7 (September 2011).

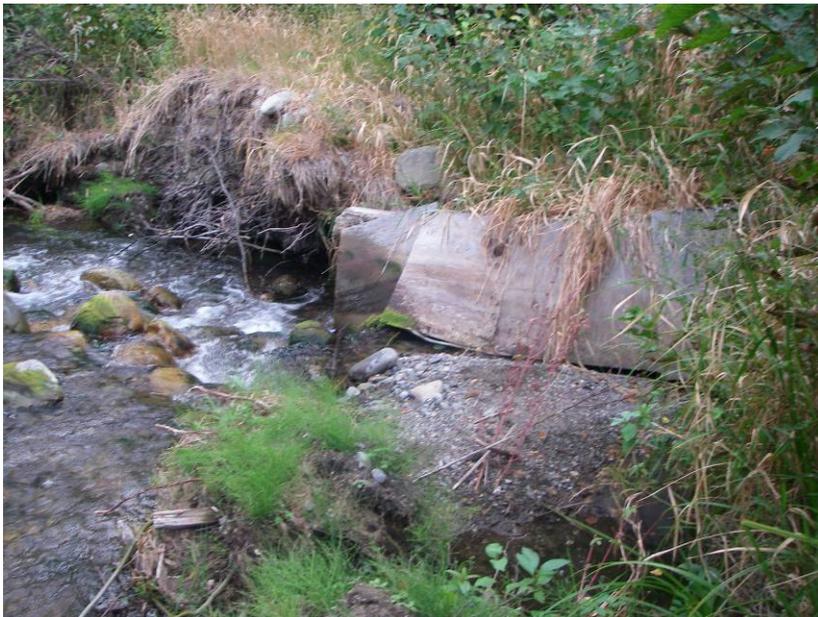
Figure 35. Plywood armoring along river-right near the downstream end of Reach 2 (September 2011).

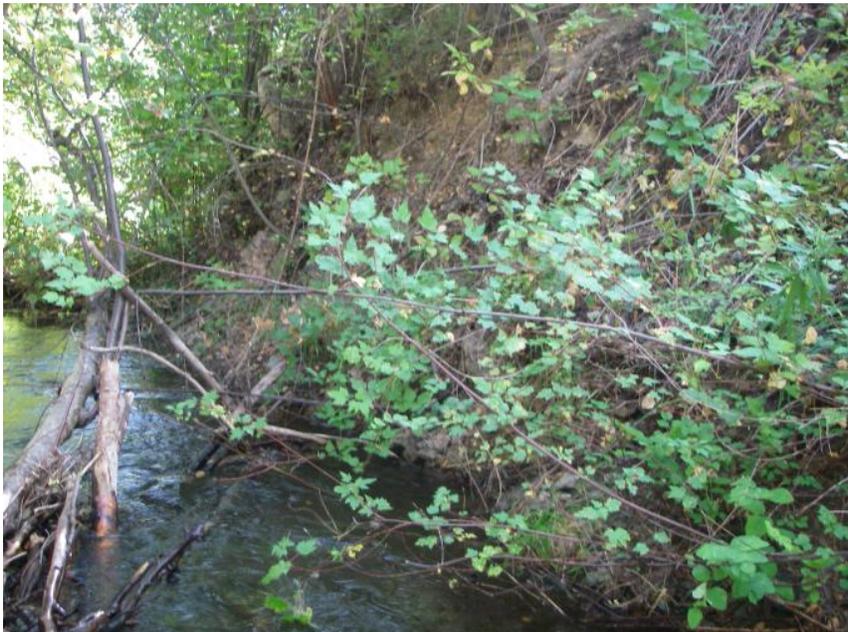
Figure 44. Channel incision observed in the upper portion of Reach 2 (September 2011).

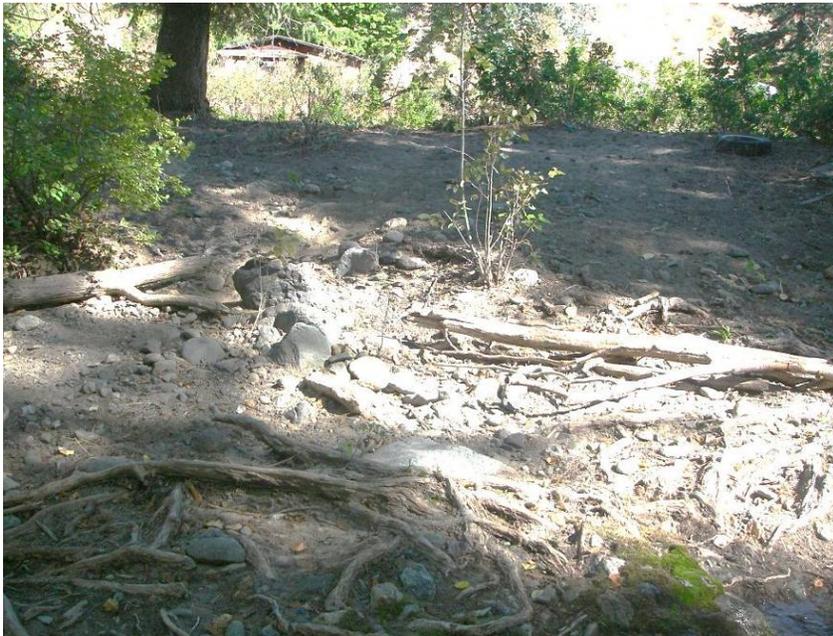
Figure 45. Riparian grazing, Reach 2 (September 2011).

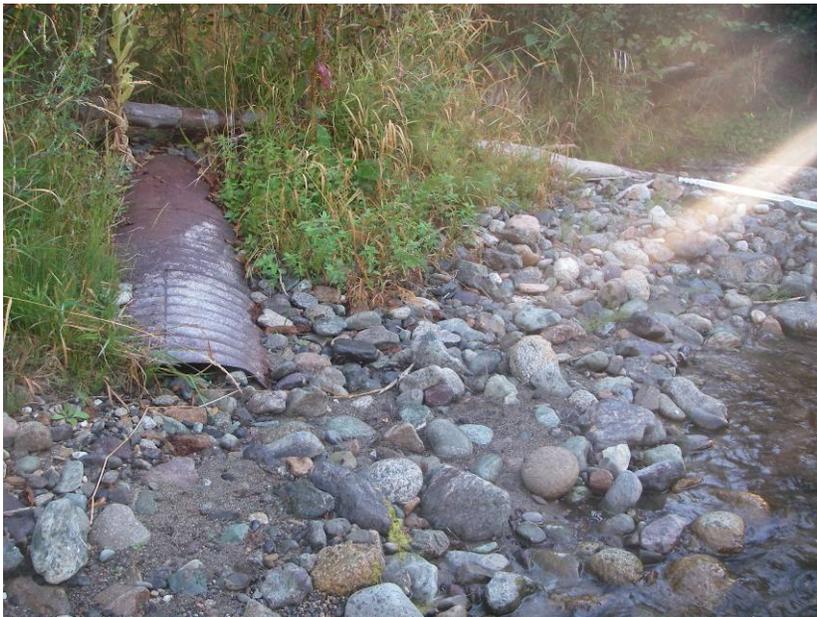
Figure 46. Remnant culvert in Reach 2 (September 2011). This culvert may have been used to drain the river-left wetland at RM 0.7.

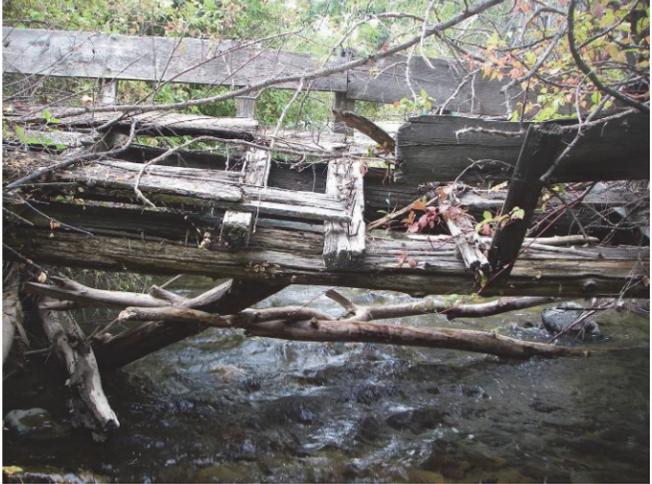
1	IZ-08	Project RM 0.29	Reconnect Stream Channel Processes	Replace Highway 153 Bridge	The existing Highway 153 bridge is undersized – it is currently only equivalent to 1.25 channel widths at low flow. The bridge is acting as a hydraulic constriction and limiting lateral migration of the channel. Additionally, it is causing scour downstream of the bridge. The bridge should be replaced with a wider and higher structure to allow for the lateral and vertical expansion of Libby Creek.

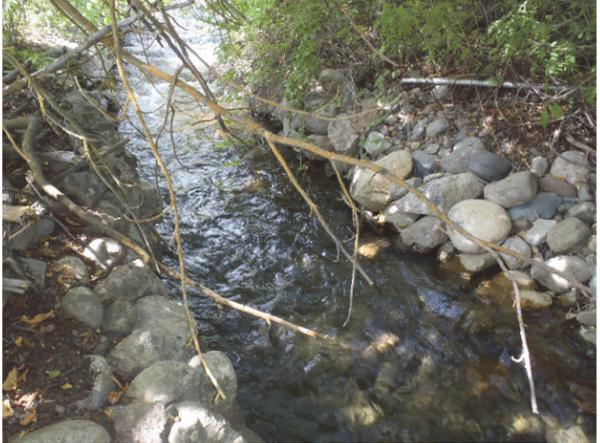
1	IZ-06	Project RM 0.33	Reconnect Stream Channel Processes	Transverse Bar Construction	Instream alterations have been made to create a step-pool sequence. These alterations extend 100 feet upstream of the riprap at RM 0.3. The steps could be removed and replaced with constructed transverse riffles/bars to improve habitat conditions for spawning, rearing, and insect production. This would introduce more lateral movement within the stream and would promote scour pool development. Large wood could be added for habitat enhancement within the pools. It would be necessary to work closely with the landowners to ensure maintenance of aesthetics and adjacent uses.

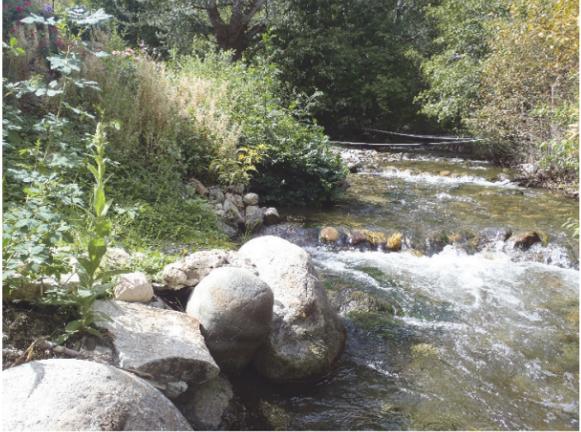
1	OZ-03	Project RM 0.38	Reconnect Floodplain Processes	Floodplain Reconnection	The incision of Libby Creek has resulted in extremely limited connected floodplain throughout the survey reach. This location presents adequate space to lower floodplain surfaces on either side and install alternating large wood jams. This would promote increased hydraulic and hydrologic connectivity with floodplain surfaces on either side, as well as provide habitat diversity throughout the reach.

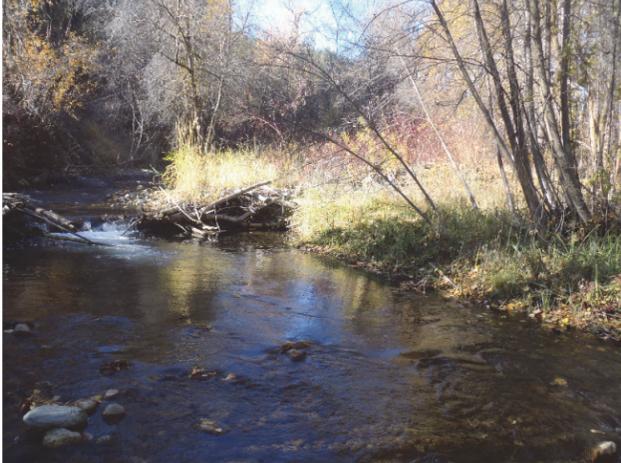
2	DOZ -04	Project RM 1.07	Riparian Restoration	Riparian Restoration	The right bank is sparsely vegetated from RM 1.07 to RM 1.14. The shoreline has been altered, regraded, and cleared for residential development along the banks. This project would replant banks with native riparian seedlings and regrade where necessary.
