Lower Twisp River Reach Assessment

Provided for:

Yakama Nation Fisheries Program

JUNE 2010

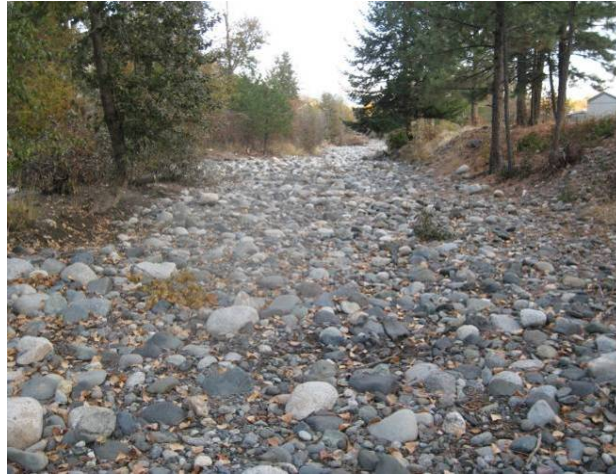
Figure 5. High-flow channel that was mapped as active side-channel in 1985 (November 2009).

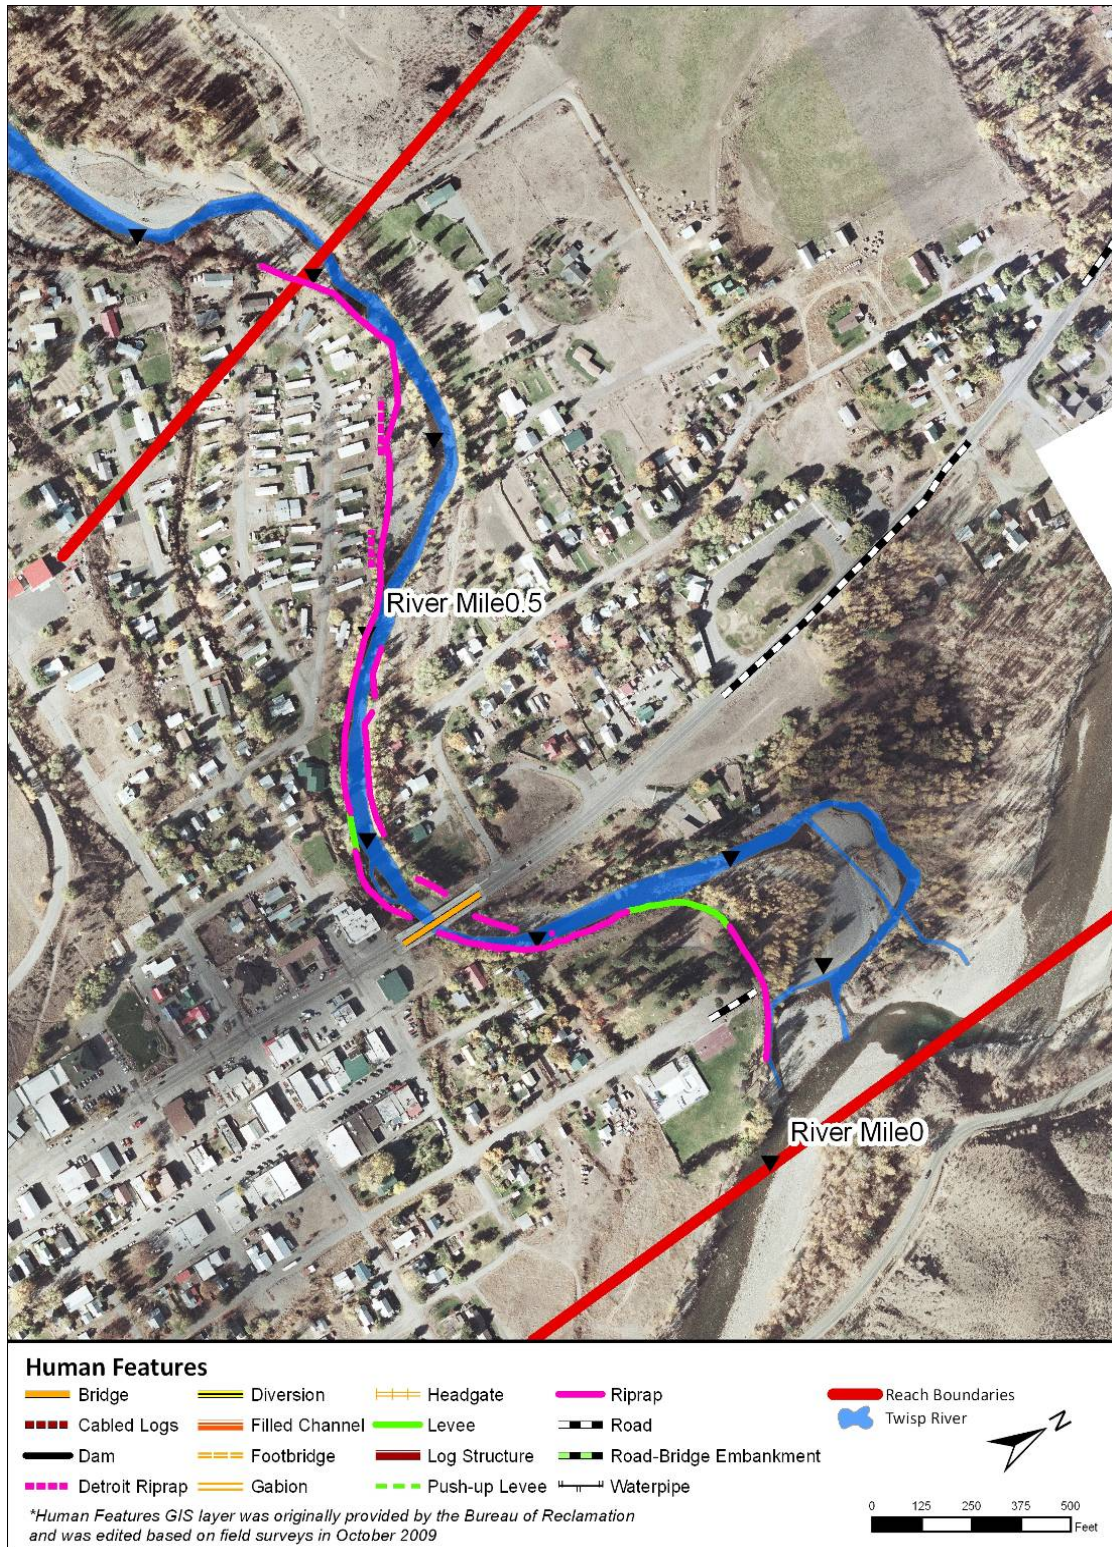
Figure 7. Aerial photo showing human features in Reach T1. Flow is from west to east. Processes are hindered by roadway encroachment, bank hardening, a bridge crossing, and floodplain development.

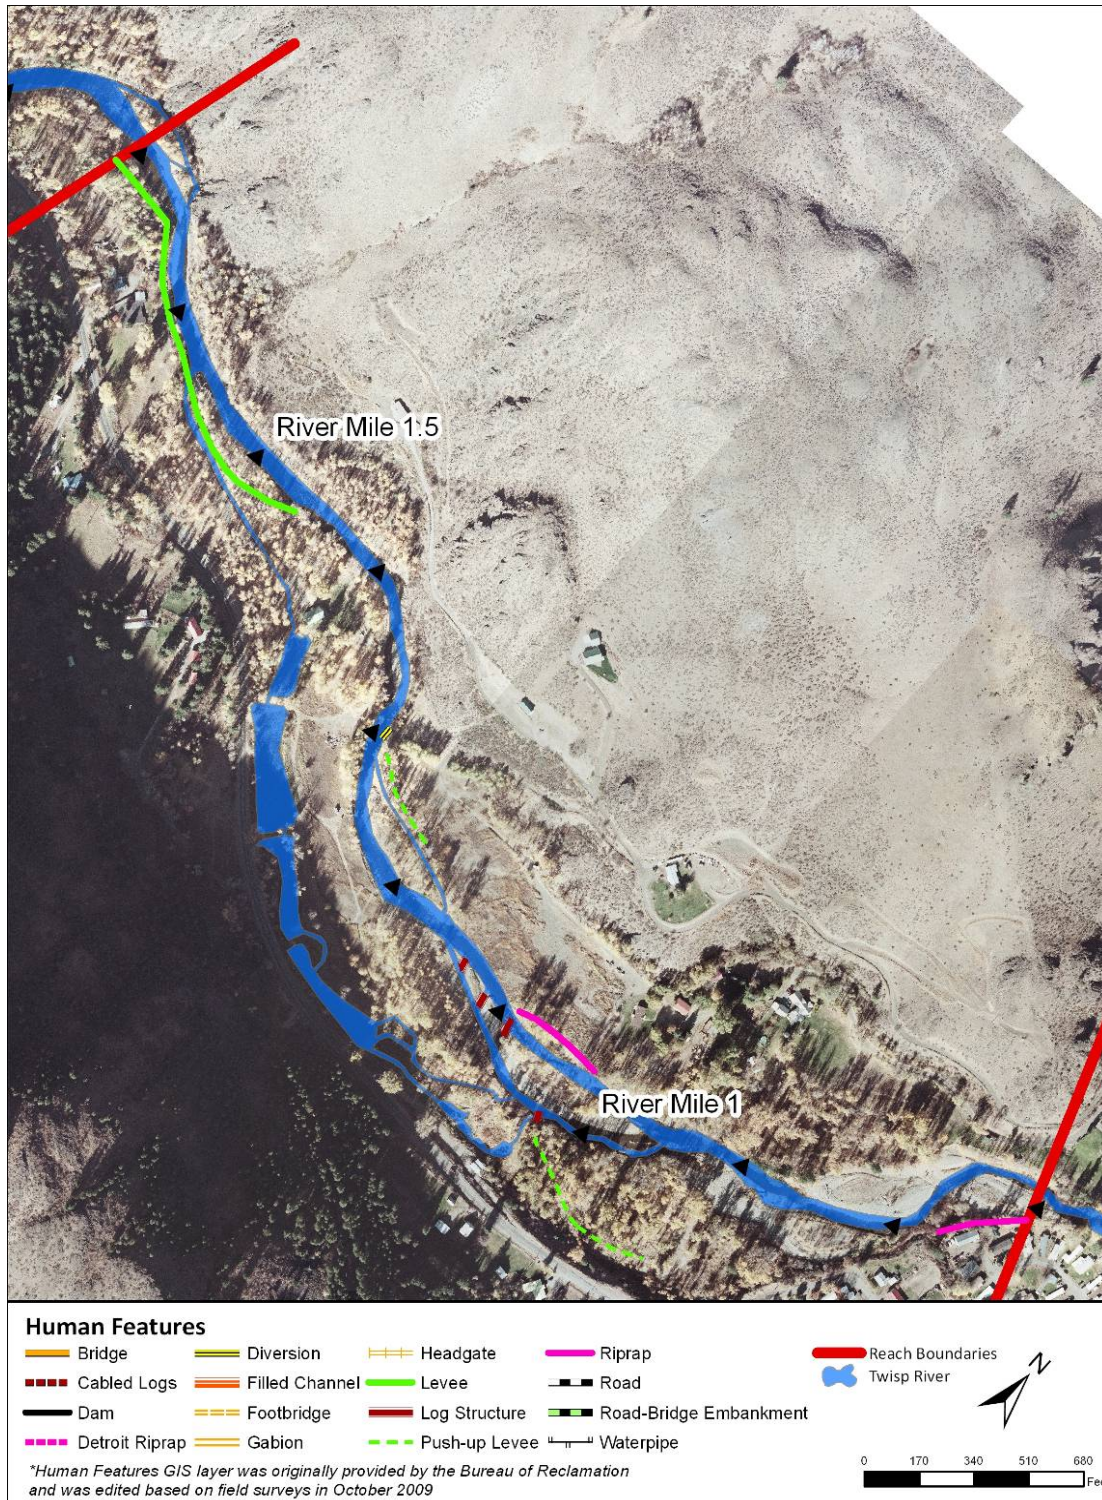
Figure 15. Aerial photo showing human features in Reach T2a. Flow is from west to east. Processes are hindered by bank hardening and development within the floodplain.

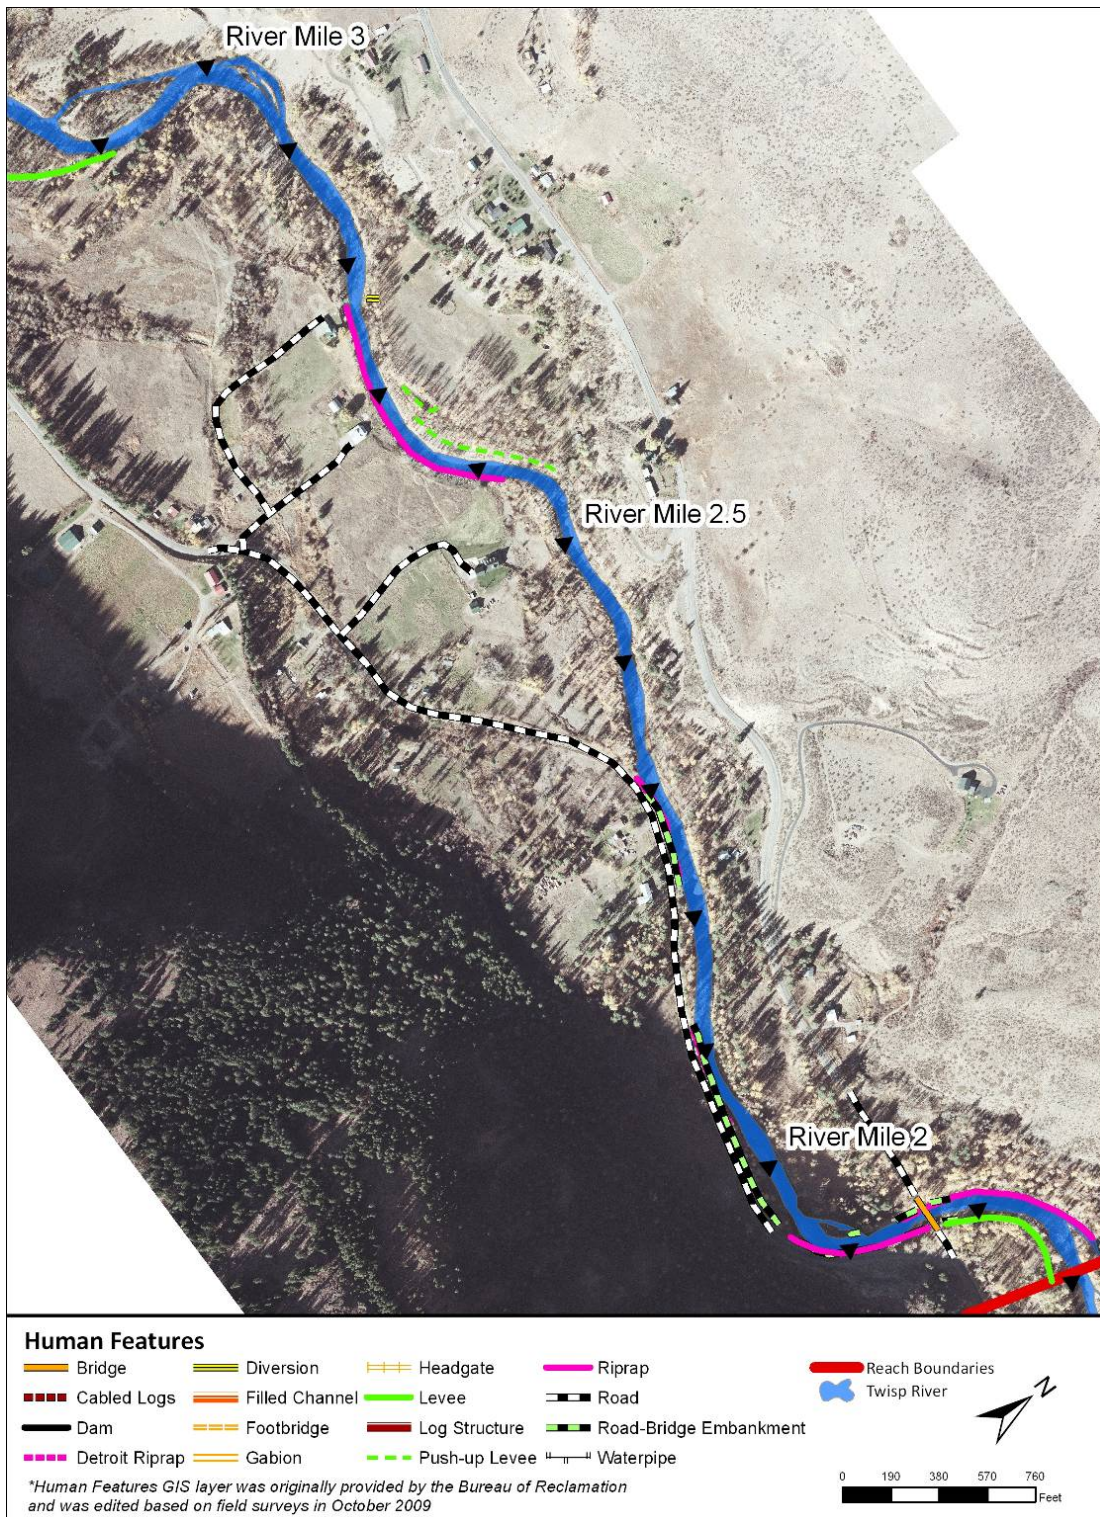
Figure 23. Aerial photo showing human features in Reach T2b in the downstream portion of the reach. Flow is from west to east. Constraints here include roads, a bridge crossing, bank hardening, and floodplain development.

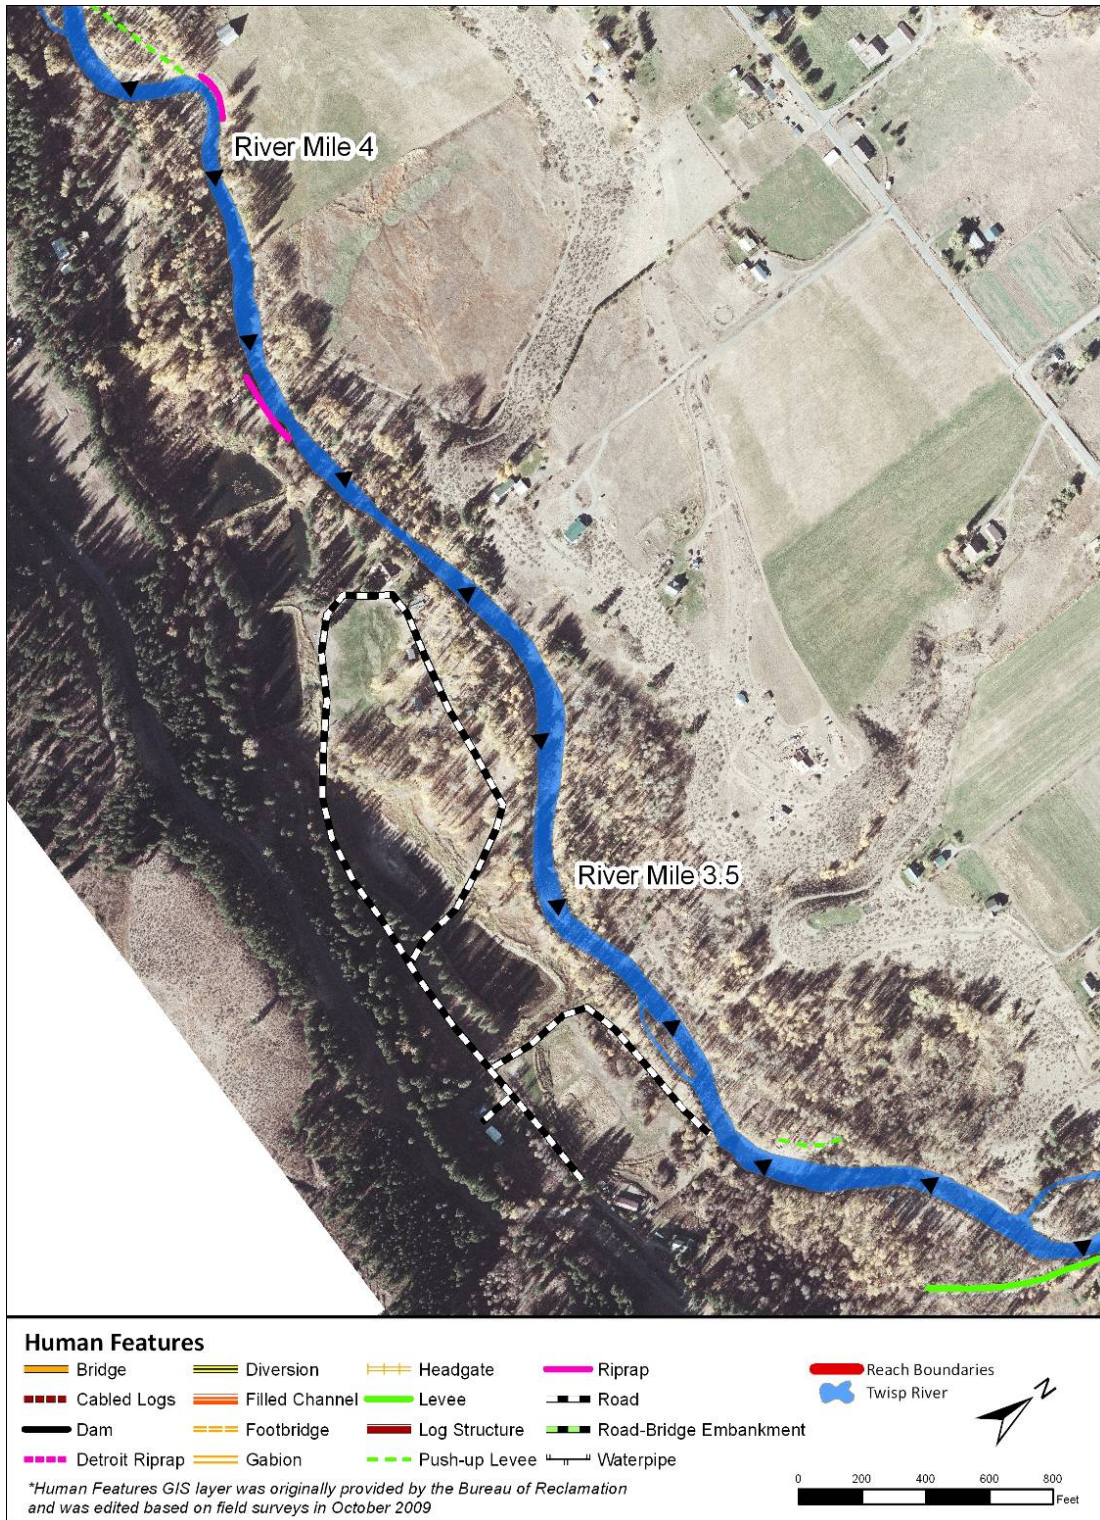
Figure 24. Aerial photo showing human features in Reach T2b in the middle of the reach. Flow is from west to east. Constraints here include roads, bank hardening, and floodplain development.

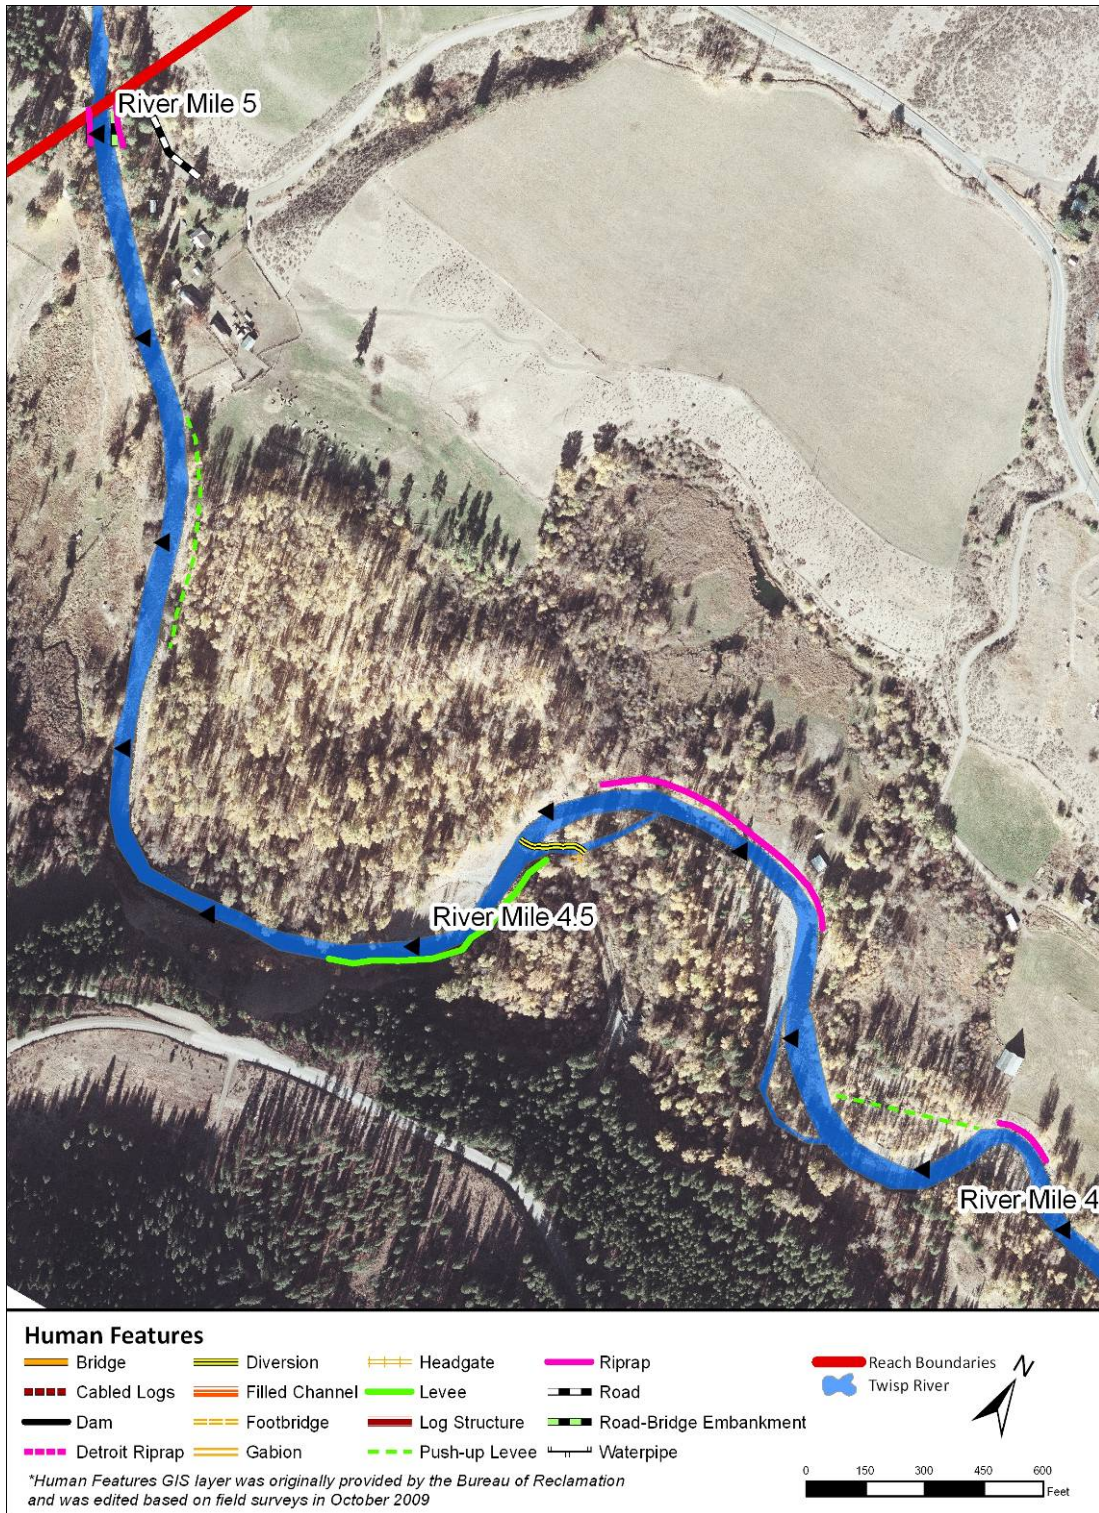
Figure 25. Aerial photo showing human features in Reach T2b at the upstream end of the reach. Flow is from west to east. Constraints here include bank hardening, a diversion, and floodplain development.

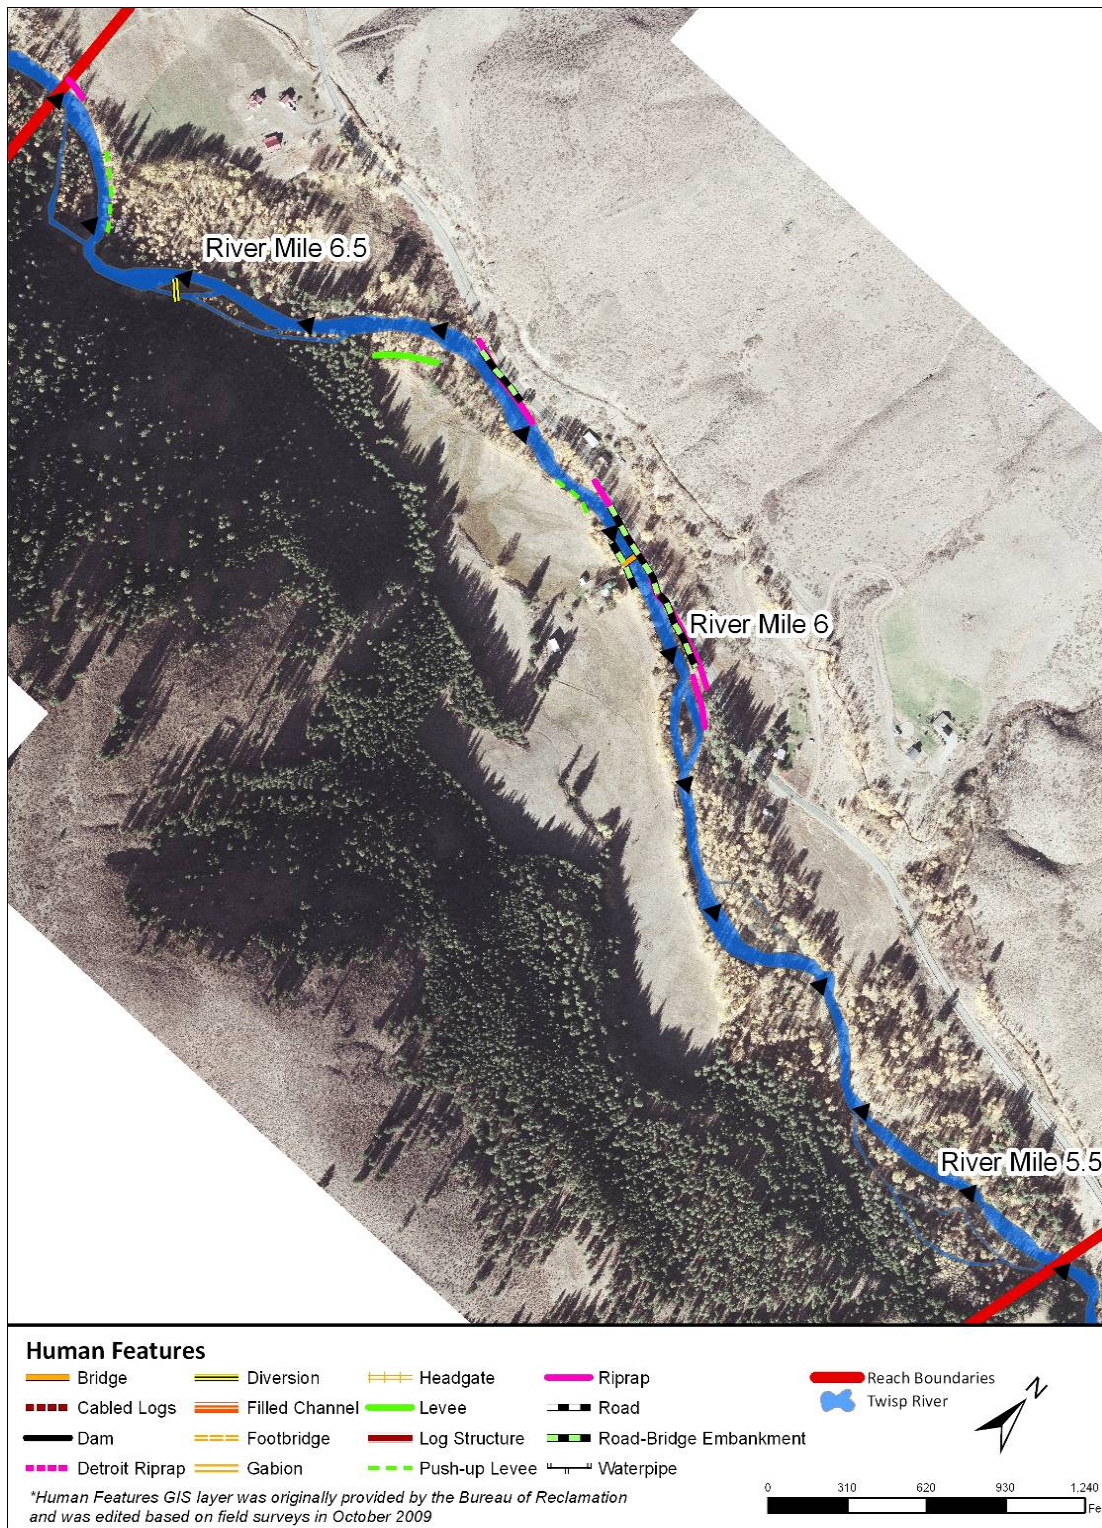
Figure 37. Aerial photo showing human features in Reach T3b. Flow is from west to east. Constraints include roads, a bridge crossing, bank hardening, and floodplain development.

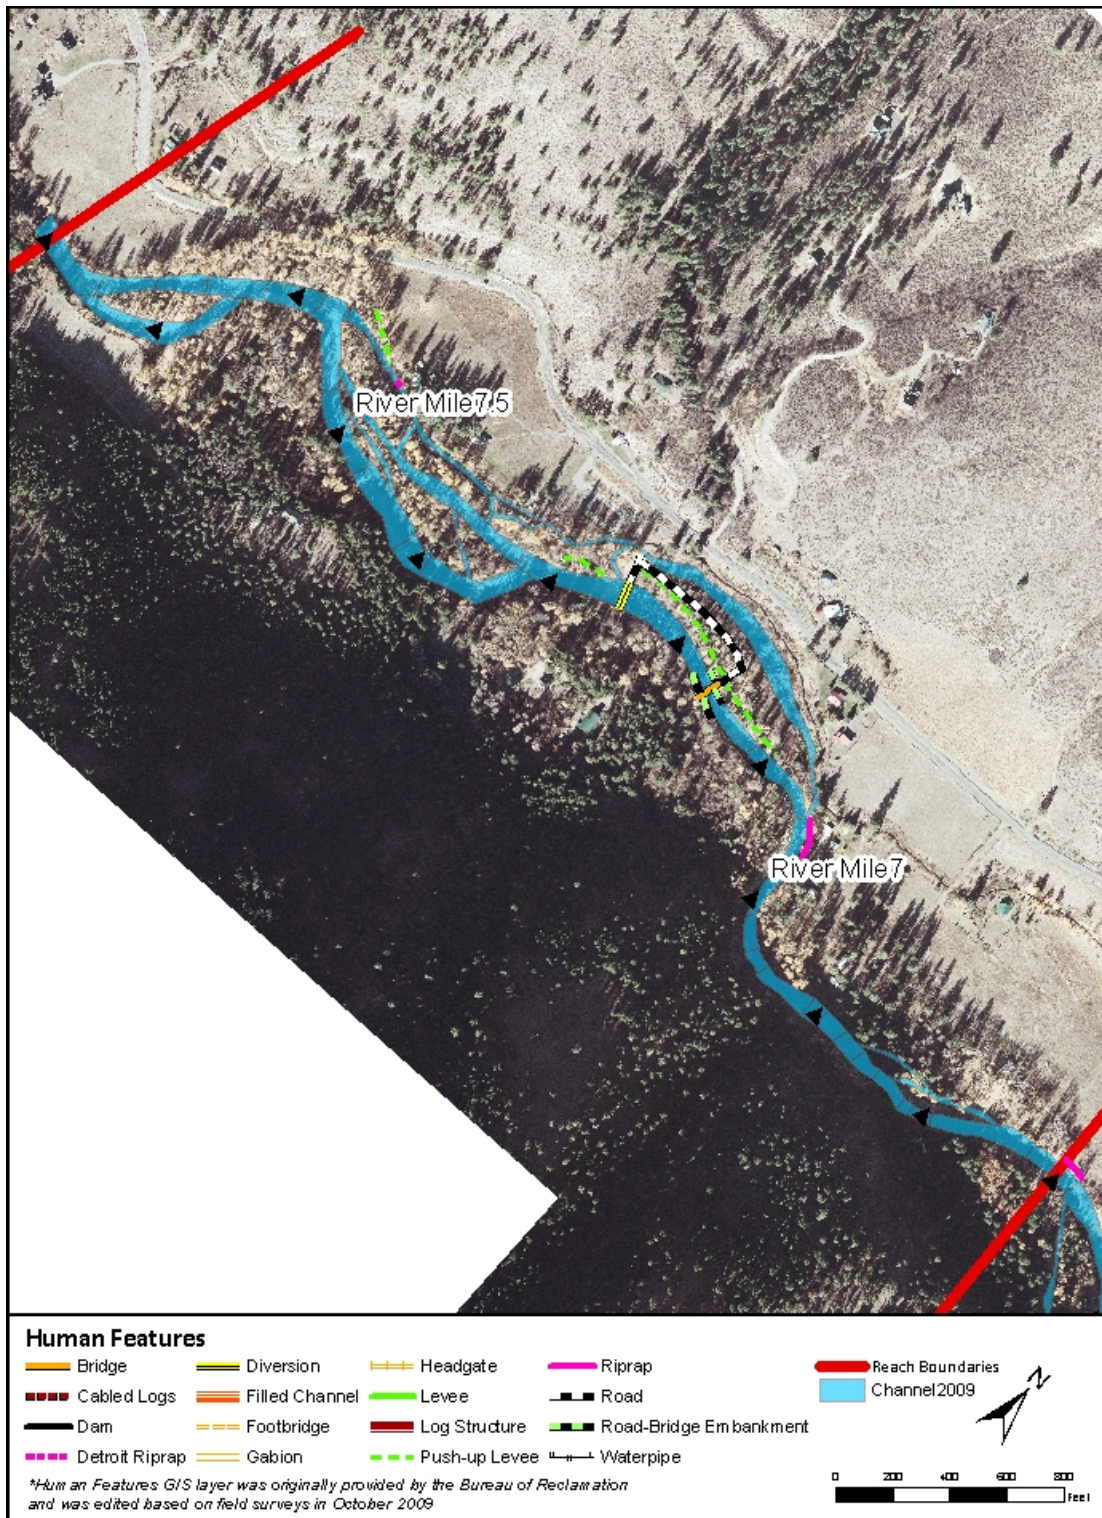
Figure 41. Aerial photo showing human features in Reach T3c. Flow is from west to east. Constraints include roads, levees, bank hardening, a diversion, and floodplain development.

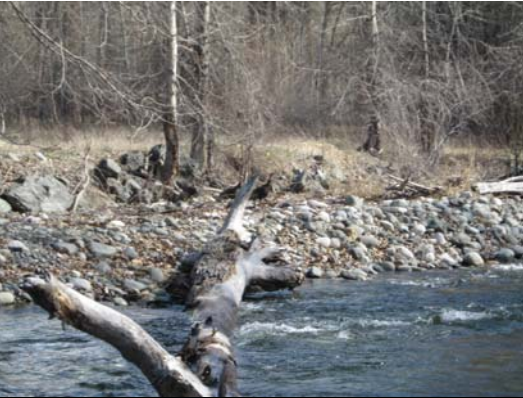
<p>View looking towards the left bank at a levee near RM 1.05 (October 2009).</p>
2a	Project RM 1.15L	Inner Zone 2 (IZ-2)	In-Stream Habitat Enhancement	LWD enhancement	This project would involve the placement of several log jams along the river-left bank in order to control erosion and provide cover to improve habitat quality.

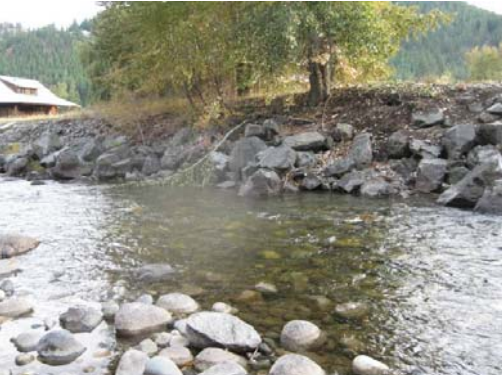
<p>Southeast view in the downstream direction at a portion of the riprap that extends along river right between RM 2.58-2.75 (October 2009).</p>
2b	Project RM 2.7L	Disconnected Inner Zone 3 (DIZ-3)	Reconnect Stream Channel Processes	Levee removal and side-channel reconnection	This project involves removing anthropogenic features to reconnect inner zone processes. A portion of the high flow channel is currently ditched, lined, and routed into a catch basin near RM 2.7. There are also two push-up levees in this area that limit connectivity of channel and floodplain processes. These features could be removed to enhance floodplain and side-channel connectivity.

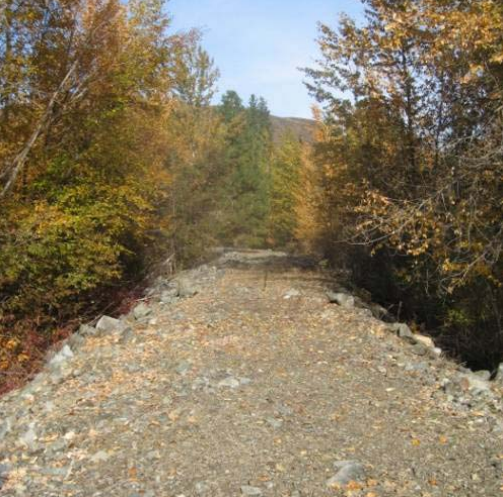
<p>Northeast view along the top of the levee near RM 3.2 that creates an ecological and physical barrier between multiple floodplain sub-units (October 2009).</p>

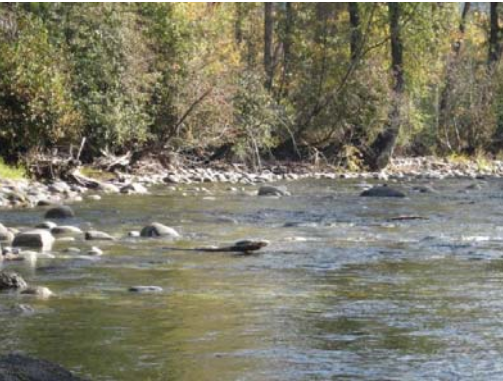
<p>East looking view of the river left bank of the channel near RM 3.6 where a LWD structure would enhance habitat and re-establish inner-zone processes (October 2009).</p>
2b	Project RM 3.7R	Disconnected Outer Zone 3 (DOZ-3)	Off-Channel Habitat Enhancement	Wetland habitat enhancement	The overall goal of this project is to re-connect the “Chain of Lakes”, a large area of off-channel habitat, and re-establish hydrologic and geomorphic connection between DOZ-3 and the main channel. Fish access to this off-channel habitat would be enhanced by developing up and downstream surface connections and by improving culvert passability between wetlands to create a well-connected longitudinal system. The upstream surface connection could be developed off an active side-channel near RM 4.05. This side-channel is proposed for enhancement under Project RM 4.1C. Culvert passability through 6 dikes would need to be addressed to ensure flow-through connection between each of the ponds. Currently there are several downstream drainage points. Some of the ponds appear completely blocked at the downstream end and surface flow is diverted to the channel. This occurs at RM 3.85 and 3.9. Neither of these outflows provides habitat connection between the channel and off-channel locations. The downstream-most outlet locations are at RM 3.32 and 3.45. One or all of these outlets would be enhanced to allow connection to the channel. Water quality and presence of non-native fish would be of concern.

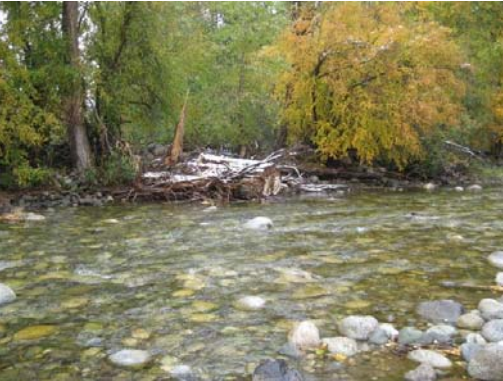
<p>LWD jam on river left near RM 4.8. Enhancement of this LWD could encourage overbank flow into DIZ-1, as well as improve pool habitat (October 2009).</p>

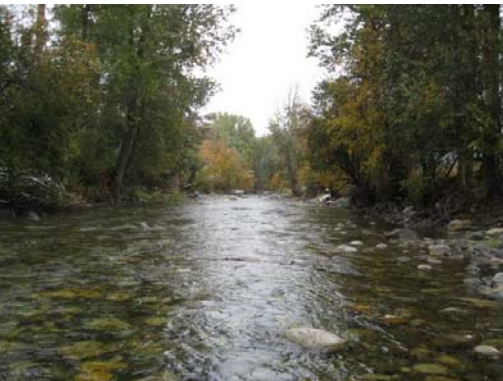
<p>Looking toward the southeast in the downstream direction where LWD placements on both sides of the channel could increase habitat quality and diversity (October 2009).</p>
3a	Project RM 5.23L	Inner Zone 1 (IZ-1)	In-Stream Habitat Enhancement	LWD enhancement	There is an existing boulder step-pool and bedrock outcrop in the channel. The pool has good residual depth but lacks cover. This project entails placing a meander-bend LWD jam to increase the amount of cover and quality of habitat provided in this deep pool.

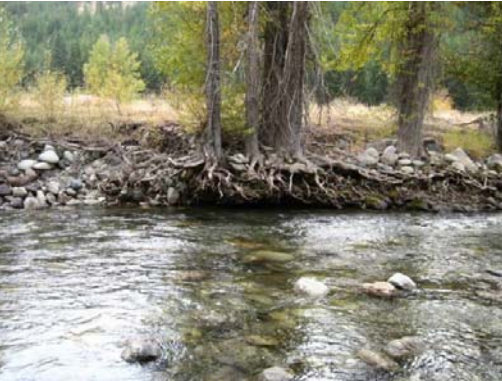
<p>View to south at the right bank of the channel near RM 6.18. The undercut root mass could be enhanced to provide increased habitat quality and enhance inner-zone processes (October 2009).</p>
3b	Project RM 6.3L	Disconnected Outer Zone 1 (DOZ-1)	Off-Channel Habitat Enhancement	Wetland habitat enhancement	This project is described in the DIZ-1 sub-unit summary, but also involves habitat found in DOZ-1. There are wetlands in DOZ-1 that would provide valuable off-channel habitat if access were created. As part of Project RM 6.65L, surface connection between inner-zone side-channels and outer-zone off channel habitat could be enhanced. This would require some excavation to create channels providing low-flow pathways.

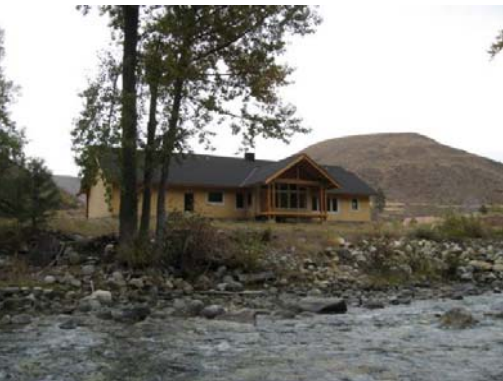
<p>View to the north in the downstream direction at a short section of riprap that could be enhanced with LWD (October 2009).</p>
3c	Project RM 6.8L	Inner Zone 2 (IZ-2)	Reconnect Stream Channel Processes	Re-establish channel LWD dynamics	This site consists of a left-bank high-flow side channel between RM 6.78 and 6.8. Placement of bar apex jams at this location would enhance lateral channel dynamics and side-channel activation at lower flows.

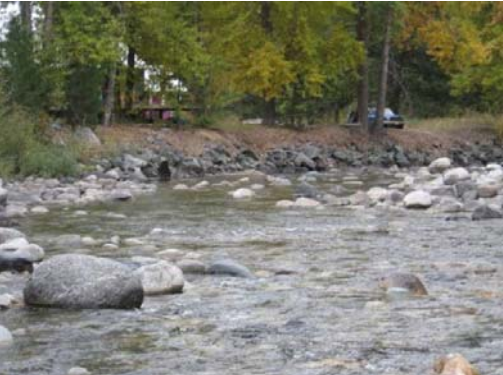
<p>View to the east in the downstream direction at riprap along the river-left bank near RM 7.05 (October 2009).</p>
3c	Project RM 7.15L	Disconnected Inner Zone 1 (DIZ-1)	Off-Channel Habitat Enhancement	Off-channel habitat enhancement	The oxbow wetlands in this sub-unit provide the potential for valuable habitat that is rare in Reach T3c. This project would re-establish/enhance the connection between the wetlands and main channel habitats while maintaining protection of the irrigation diversion, fisheries facilities, and residential access. Improved culverts at the upstream road crossing could provide a stronger high-flow connection with the main channel. Culverts under the access road are either completely overgrown or non-existent. The downstream outlet could be enhanced to ensure low flow fish access to the ponds.

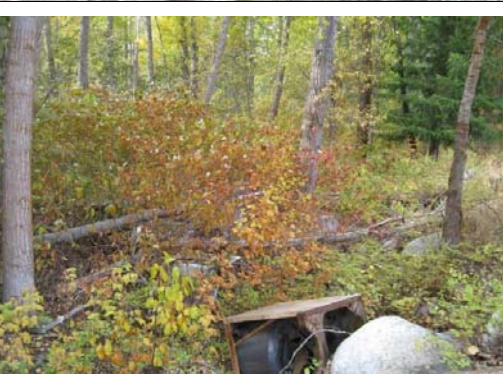
<p>View of an older, vegetated push-up levee near RM 7.6 that could be removed to re-connect channel/floodplain processes (October 2009).</p>
3c	Project RM 7.7R	Inner Zone 1 (IZ-1)	In-Stream Habitat Enhancement	LWD alcove enhancement	This project involves placing LWD along river-right near RM 7.7. The placement is in a backwater just upstream of a break in slope where the channel steepens. Some large trees have been cut down and cleared along the stream edge. Installing LWD could replace some of the bank stability and habitat complexity lost by the riparian clearing.
