# Inner-Zone Project Identification

January 18, 2011

Nason Creek  
Lower White Pine Reach  
Chelan County, Washington

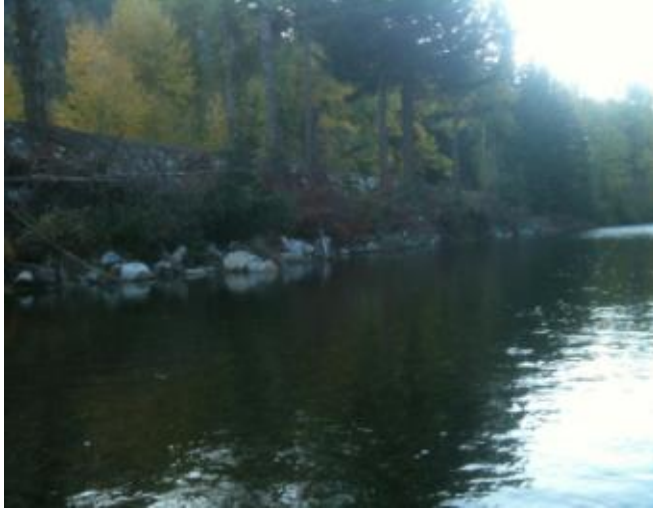
Project Group	USBR Reach Assessment Priority Habitat Action Category	Project Number	Strategy Category	Project Name	Description	Photo
Group 1	<p><u>LWP IZ-1</u> (USBR 2009; Pg 84-88):</p> <ul style="list-style-type: none"> <li>Riparian Rehabilitation (Options 1, 2, 5)</li> <li>Reconnect Habitat (short term) (Options 1, 3, 4)</li> </ul>	RM 11.5C	Instream Habitat Enhancement	LWD and riparian bank margin enhancement	Between RM 11.6 and RM 11.45, river right is lined with riprap to protect the adjacent railroad grade. There are deep scour pools along the riprap, but little to no cover. The right bank could be enhanced by wood placement at multiple locations. Due to the proximity of the railroad grade, a bank could be created by placing logs in the channel and back-filling behind them, therefore allowing for the establishment of a riparian buffer between the railroad prism and the channel. The channel would be shifted slightly northward to accommodate this alteration. Bank jams on the left bank through this area would create bar and pool features. The straightened channel and altered hydraulics may preclude the creation of alternating riffle-pool sequences.

<p>View looking upstream at the river right bank near RM 11.5. The channel has been straightened and vegetation cleared along the railroad. October 2010.</p>

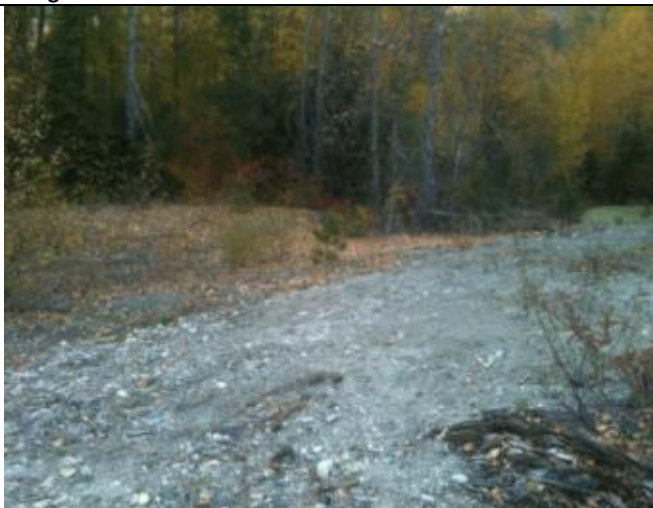
Group 1	<p><u>LWP OZ-1</u> (USBR 2009; Pg 34-36)</p> <ul style="list-style-type: none"> <li>Riparian Rehabilitation (Options 1,2)</li> </ul> <p><u>LWP IZ-1</u> (USBR 2009; Pg 84-88):</p> <ul style="list-style-type: none"> <li>Riparian Rehabilitation (Options 1, 2, 5)</li> <li>Reconnect Habitat (short term) (Options 1, 3, 4)</li> </ul>	RM 11.35L	Reconnect Stream Channel Processes	Side-channel reconnection	Between RM 11.5 and RM 11.25, there is a network of high-flow channels on valley left. These channels are currently connected to inner zone processes as evidenced by sand and gravel deposits and high-flow channel topography. However, successional vegetation and muted channel topography suggests that flood scour is relatively infrequent. Channel straightening and related incision of the mainstem may be contributing to disconnection. Several options exist for restoring connections between the side-channel and main channel habitat, including select excavation and installation of LWD complexes. All option would include riparian revegetation in impacted areas.

<p>View in the downstream direction at gravel and sand deposits in a high-flow channel on river left near RM 11.4. October 2010</p>

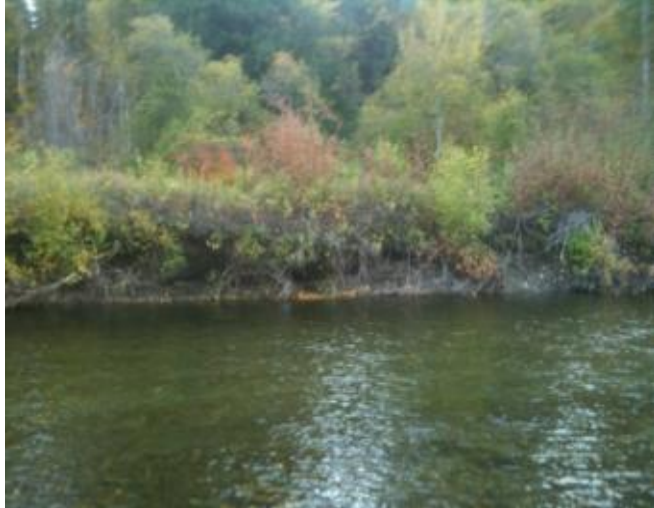
Project Group	USBR Reach Assessment Priority Habitat Action Category	Project Number	Strategy Category	Project Name	Description	Photo
Group 1	<p><u>LWP IZ-1</u> (USBR 2009; Pg 84-88):</p> <ul style="list-style-type: none"> <li>Riparian Rehabilitation (Options 1, 2, 5)</li> <li>Reconnect Habitat (short term) (Options 1, 3, 4)</li> </ul> <p><u>LWP IZ-2</u> (USBR 2009; Pg 65-69):</p> <ul style="list-style-type: none"> <li>Riparian Rehabilitation (Options 4, 6)</li> </ul> <p><u>LWP OZ-2</u> (USBR 2009; Pg 32-34):</p> <ul style="list-style-type: none"> <li>Riparian Rehabilitation (Option 1, 2)</li> </ul>	RM 11.35R	Instream Habitat Enhancement	LWD enhancement	As the river turns left away from the railroad grade near RM 11.4, the outside of the bend is a high, vertical bank with areas of active slumping. Multiple log jams could be placed along the bank to increase hydraulic roughness, slow velocities, decrease erosion, and provide habitat cover and complexity. Backwater effects could increase floodplain connection near 11.35L, and coordination of these 2 projects would be beneficial. Also, the tortuous sinuosity of the downstream bend is indicative of impending meander cut-off which could occur via avulsion at or near this location. A cut-off would decrease sinuosity in a reach that already suffers from significant channelization and therefore may be undesirable. Addition of floodplain roughness through placement of wood in potential cut-off paths could be used to decrease the potential for avulsion.

<p>View in the upstream direction at the river right bank near RM 11.35 where incision has left a tall slumping bank. There is a lack of vegetation that provides LWD or cover. October 2010</p>

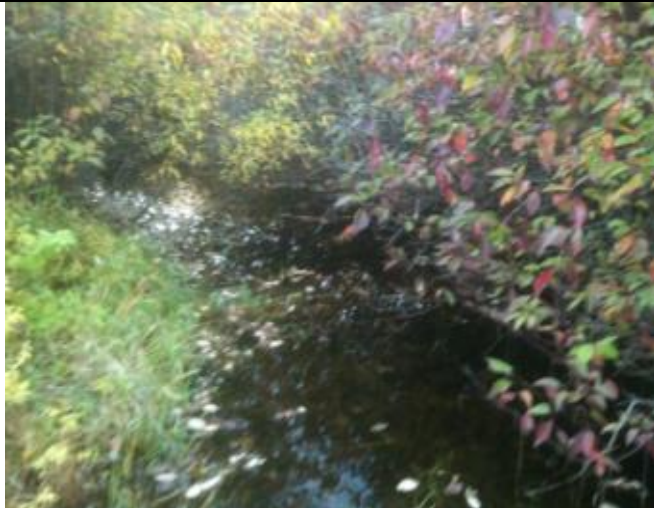
Group 1	<p><u>LWP IZ-2</u> (USBR 2009; Pg 65-69):</p> <ul style="list-style-type: none"> <li>Riparian Rehabilitation (Options 4, 6)</li> </ul> <p><u>LWP OZ-1</u> (USBR 2009; Pg 34-36)</p> <ul style="list-style-type: none"> <li>Riparian Rehabilitation (Options 1,2)</li> </ul>	RM 11.25L	Off-Channel Habitat Enhancement	Alcove habitat enhancement	A wetland complex outlets near RM 11.25 on river left. Currently, there is no low flow connection to this off-channel habitat. A mound of soil approximately 3.5 ft high and 25 ft wide separates the channel from the mainstem. An alcove could be created by removing this barrier to connect the active channel and provide a backwater for juvenile rearing. Water surface elevations in existing wetlands should be maintained. There is existing vegetation cover on the bank. Redds were observed in a riffle just downstream.

<p>A small wetland occupies a meander scar on river left near RM 11.25. The wetland could be enhanced to provide alcove habitat. October 2010</p>

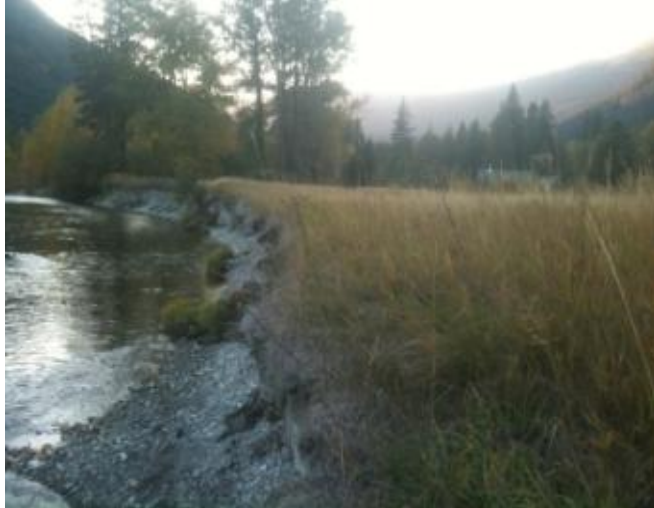
Project Group	USBR Reach Assessment Priority Habitat Action Category	Project Number	Strategy Category	Project Name	Description	Photo
Group 1	<p><u>LWP IZ-2</u> (USBR 2009; Pg 65-69):</p> <ul style="list-style-type: none"> <li>Riparian Rehabilitation (Options 4, 6)</li> </ul>	RM 11.2L Alternative 1	Riparian Revegetation	Revegetate cleared floodplain	On river left between RM 11.25 and 11.15, all riparian forest vegetation has been cleared from the floodplain. The bank along this section is actively eroding. Revegetation of this bank and adjacent floodplain area would improve bank stability, provide cover, shade, and a source for future recruitment of LWD. Currently, the bank is well above the water level at low flow. Restoration would include re-establishment of native vegetation communities appropriate to the soil and moisture conditions at the site. Revegetation could be conducted in conjunction with other potential habitat restoration elements at the site.

<p>View in the upstream direction along river left at riparian clearing along an actively eroding bank near RM 11.2. October 2010</p>

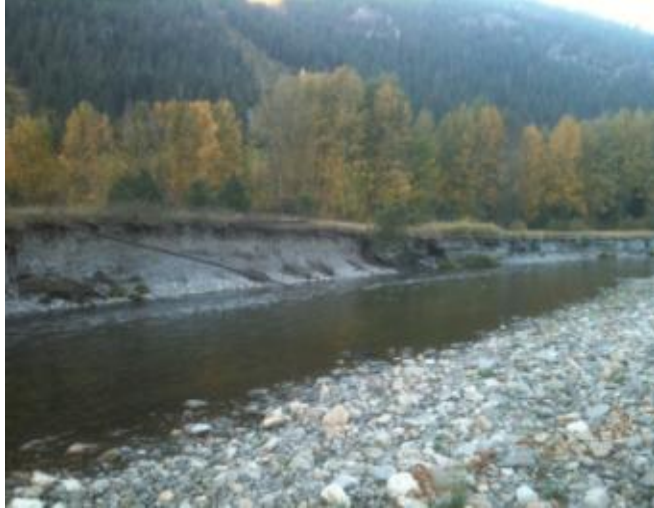
Group 1	<p><u>LWP IZ-2</u> (USBR 2009; Pg 65-69):</p> <ul style="list-style-type: none"> <li>Riparian Rehabilitation (Options 1, 2, 3, 4, 5, 6)</li> </ul>	RM 11.2L Alternative 2	Instream Habitat Enhancement	LWD enhancement and restoration of natural rates of channel erosion	The river left bank between RM 11.25 and 11.15 is a 10 ft high, actively eroding, vertical bank composed of unconsolidated alluvium with no riparian forest to provide natural rates of channel erosion. There are large slumps of material and no woody vegetation. Continued rapid erosion will likely result in a channel avulsion across the large interior point bar, which would reduce meander length in a reach that has already experienced considerable straightening. Several log jams along the bank would increase hydraulic roughness, decrease velocity, and decrease erosion while planted vegetation matures. Log jams would be used to increase near-term stability until planted vegetation matures and is able to provide long-term natural rates of channel erosion and LWD recruitment. LWD would also provide habitat cover and complexity. Even with construction of log jams to slow the rapid erosion of this bank, there will remain a considerable risk of channel avulsion across the interior point bar (neck cutoff). This alternative would include riparian revegetation.

<p>View in the downstream direction at the actively eroding bank near RM 11.2. October 2010</p>

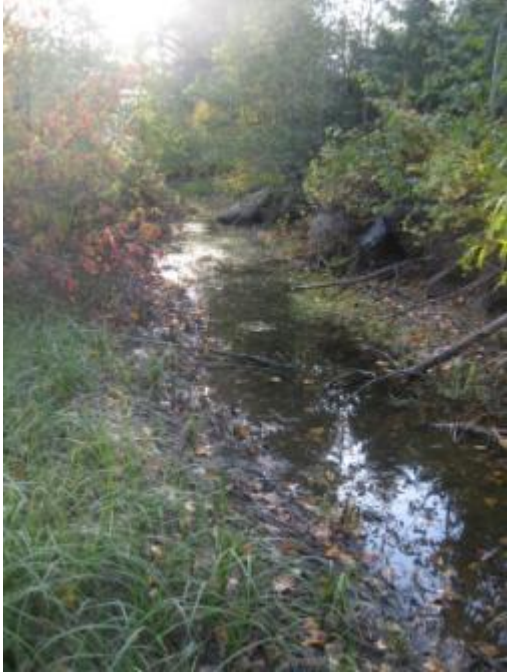
Project Group	USBR Reach Assessment Priority Habitat Action Category	Project Number	Strategy Category	Project Name	Description	Photo
Group 1	<p><u>LWP IZ-3</u> (USBR 2009; Pg 89-94):</p> <ul style="list-style-type: none"> <li>• Reconnect Habitat (Short Term) (Options 3, 5)</li> </ul> <p><u>LWP OZ-2</u> (USBR 2009; Pg 32-34):</p> <ul style="list-style-type: none"> <li>• Riparian Rehabilitation (Option 1, 2)</li> </ul>	RM 11.05R	Off-Channel Habitat Enhancement	Alcove habitat enhancement	<p>The river turns left at RM 11.05. There is a high-water channel against the railroad grade that outlets near this location. There is currently no low-flow connection. An alcove could be excavated to provide off-channel habitat connected to the main channel. Water surface elevations in existing wetlands would need to be maintained. The excavated site would need to be protected to deter channel avulsion along the railroad prism. These protection measures may include buried logs and rocks to hold grade through the alcove and hinder a head-cut, and floodplain roughness elements in the alcove and throughout the bar to decrease overbank flow velocities. The potential for sedimentation of the alcove will need to be investigated as part of project design.</p>

<p>View in the upstream direction at a wetland that runs along the base of the railroad grade on river right near RM 11.05. October 2010</p>

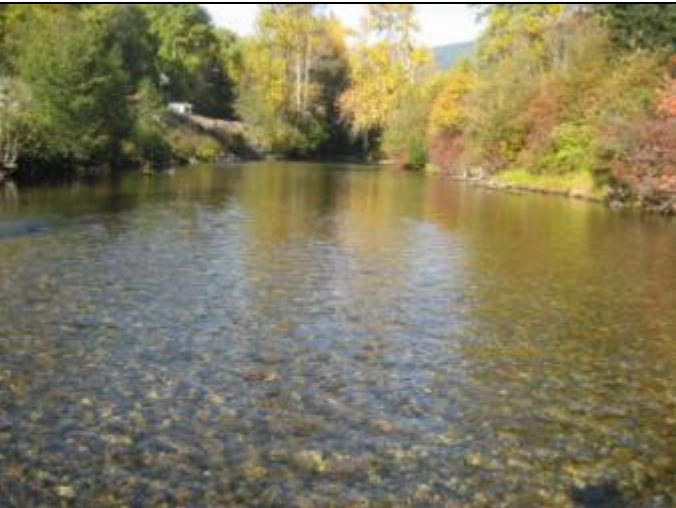
Project Group	USBR Reach Assessment Priority Habitat Action Category	Project Number	Strategy Category	Project Name	Description	Photo
Group 2	<p><u>LWP IZ-3</u> (USBR 2009; Pg 89-94):</p> <ul style="list-style-type: none"> <li>Riparian Rehabilitation (Options 1, 2, 4, 6)</li> <li>Reconnect Habitat (short term) (Options 1, 3, 4 5)</li> </ul>	RM 10.9C	Instream Habitat Enhancement	LWD and riparian enhancement	Between RM 11.05 and 10.7, the channel has been straightened along the railway grade. Field evidence suggests that the result has been incision and channel simplification. Several channel margin log jams could be placed on both sides of the river through this area to increase habitat complexity, cover, and pool availability/quality. Due to the proximity of the railroad grade, a bank could be created by placing logs in the channel and back-filling behind them, therefore allowing for the establishment of a riparian buffer between the railroad prism and the channel. The channel would be shifted slightly northward to accommodate this alteration. This work would need to be coordinated with ongoing reconnection efforts for areas south of the railroad being pursued by USBR.

<p>View in the upstream direction at a straightened channel section near RM 10.9. October 2010</p>

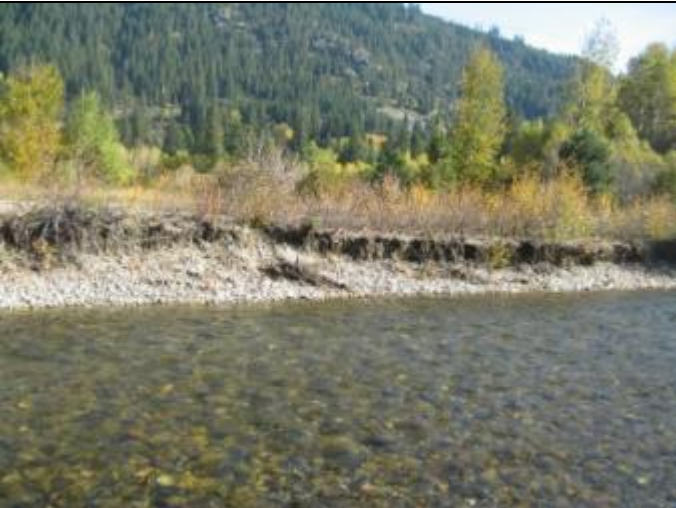
Group 2	<p><u>LWP IZ-3</u> (USBR 2009; Pg 89-94):</p> <ul style="list-style-type: none"> <li>Riparian Rehabilitation (Options 1, 2, 4, 6)</li> </ul>	RM 10.8L Alternative 1	Riparian Revegetation	Riparian revegetation	The river left stream bank between RM 10.9 and 10.75 is actively eroding. The bank has been cleared of native riparian forest vegetation that is necessary to provide natural stability. There is a cleared powerline corridor that parallels the bank within 50 to 60 ft of the stream. This alternative would revegetate the bank and riparian area with low-growing native shrub vegetation in order to accommodate the power lines yet provide important riparian functions. This work would need to be coordinated with ongoing reconnection efforts for areas south of the railroad being pursued by USBR. This alternative may be favored if existing infrastructure must be maintained in its current configuration. Accessibility to utilities would need to be maintained.

<p>View in the downstream direction at the eroding bank on river left near RM 10.8. There is very little vegetation supporting the bank. October 2010</p>

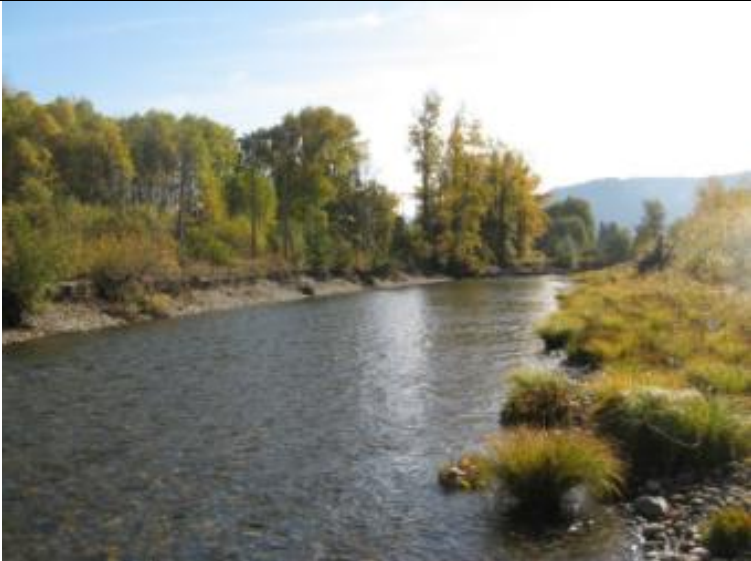
Project Group	USBR Reach Assessment Priority Habitat Action Category	Project Number	Strategy Category	Project Name	Description	Photo
Group 2	<p><u>LWP IZ-3</u> (USBR 2009; Pg 89-94):</p> <ul style="list-style-type: none"> <li>Riparian Rehabilitation (Options 1, 2, 4, 6)</li> <li>Reconnect Habitat (short term) (Options 1, 3, 4 5)</li> </ul> <p><u>LWP IZ-4</u> (USBR 2009; Pg 69-73):</p> <ul style="list-style-type: none"> <li>Reconnect Processes (Options 1, 2, 4)</li> <li>Riparian Rehabilitation (Options 1, 3, 5)</li> </ul> <p><u>LWP OZ-4</u> (USBR 2009; Pg 31-32):</p> <ul style="list-style-type: none"> <li>Riparian Rehabilitation (Options 1, 2)</li> </ul>	RM 10.8L Alternative 2	Re-Establish Stream Channel Processes	Restore channel topography	This alternative would increase sinuosity between RM 10.9 and 10.7 by excavating portions of new channel north of the current alignment. The new planform would include riffle-pool sequences and placement of LWD. The goal would be to increase channel/floodplain connections and re-establish channel processes to the extent possible through an artificially confined and straightened reach. Consideration would have to be given to protection of the railroad, powerline, and private structures. Potential re-location of the powerlines should be pursued. This work would need to be coordinated with ongoing reconnection efforts for areas south of the railroad being pursued by USBR.

<p>View in the downstream direction near river mile 10.8 where channel complexity could be enhanced by excavating toward river left, and building the bar on river right. October 2010</p>

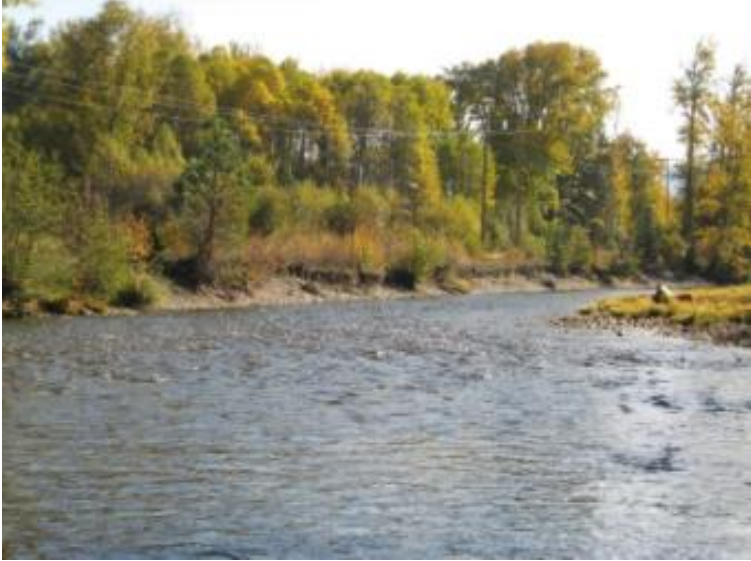
Group 2	<p><u>LWP IZ-3</u> (USBR 2009; Pg 89-94):</p> <ul style="list-style-type: none"> <li>Riparian Rehabilitation (Options 1, 2, 4, 6)</li> <li>Reconnect Habitat (short term) (Options 1, 3, 4 5)</li> </ul> <p><u>LWP OZ-4</u> (USBR 2009; Pg 31-32):</p> <ul style="list-style-type: none"> <li>Riparian Rehabilitation (Options 1, 2)</li> </ul>	RM 10.8L Alternative 3	Instream Habitat Enhancement	LWD enhancement	If revegetation or channel re-alignment are not viable due to existing infrastructure or geomorphic constraints, then a third alternative would be to add multiple channel margin log jams between RM 10.9 and 10.7. Wood placements would increase hydraulic roughness, decrease water velocity, and restore natural bank stability in the long-term. Habitat quality would also be increased. This work would need to be coordinated with ongoing reconnection efforts for areas south of the railroad being pursued by USBR.

<p>View in the downstream direction at the river left bank between RM 10.9 and 10.7 that is actively eroding. Multiple log jams could be placed along the bank to decrease velocity. October 2010</p>

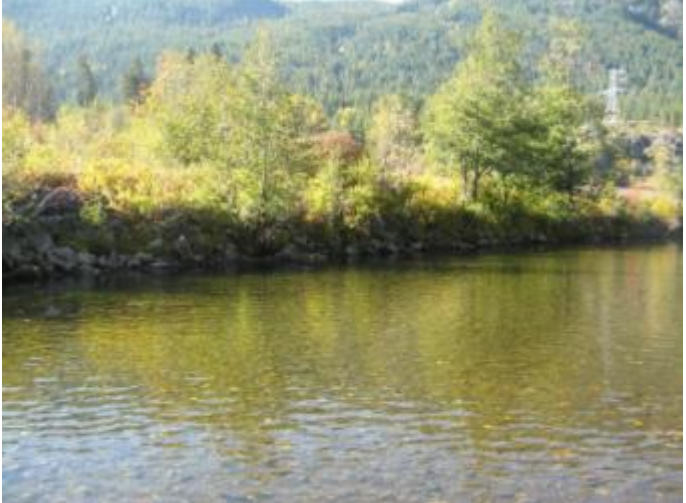
Project Group	USBR Reach Assessment Priority Habitat Action Category	Project Number	Strategy Category	Project Name	Description	Photo
Group 3	<p><u>LWP IZ-3</u> (USBR 2009; Pg 89-94):</p> <ul style="list-style-type: none"> <li>Reconnect Habitat (short term) (Options 3, 5)</li> </ul>	RM 10.65R	Instream Habitat Enhancement	LWD enhancement	At this location, the river turns left and pulls away from the railroad grade. The riprap, however, persists downstream along the right bank. A high-tension transmission tower is located back from the bank, and is being protected by the riprap. Large wood jams could be placed along the bend in order to increase habitat quality and pool scour while maintaining protection of infrastructure.

<p>View in the upstream direction at the river right bank near RM 10.6 where older riprap could be enhanced by LWD. October 2010</p>
Group 3	<p><u>LWP IZ-3</u> (USBR 2009; Pg 89-94):</p> <ul style="list-style-type: none"> <li>Riparian Rehabilitation (Options 1, 2, 4, 6)</li> <li>Reconnect Habitat (short term) (Options 1, 3, 4 5)</li> </ul> <p><u>LWP IZ-4</u> (USBR 2009; Pg 69-73):</p> <ul style="list-style-type: none"> <li>Reconnect Processes (Options 1, 2, 4)</li> <li>Riparian Rehabilitation (Options 1, 3, 5)</li> </ul> <p><u>LWP OZ-4</u> (USBR 2009; Pg 31-32):</p> <p>Riparian Rehabilitation (Options 1, 2)</p>	RM 10.6L Alternative 1	Re-Establish Stream Channel Processes	Channel re-alignment	There is an abandoned high flow channel and wetlands between RM 10.75 and 10.55 along river left. There is a high bank at the upstream end of the high flow channel. Upstream straightening and incision appears to have reduced the frequency of activation of the high flow channel. This alternative would excavate the high-flow channel to re-meander the channel where it has lost sinuosity following placement of the railroad. New channel topography, LWD, and riparian revegetation would be included in this alternative. Appropriate channel and floodplain configuration given existing geomorphic and social constraints would be considered during the design process. Powerlines in this area provide a potential constraint.

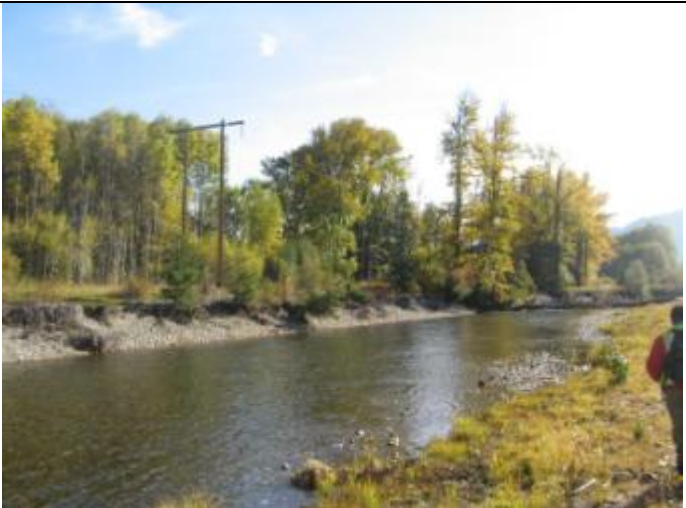
<p>View in the downstream direction from RM 10.8 toward river left at the upstream end of a potential channel re-meander project. The new channel would trend toward the power lines, which represent a major constraint. October 2010</p>

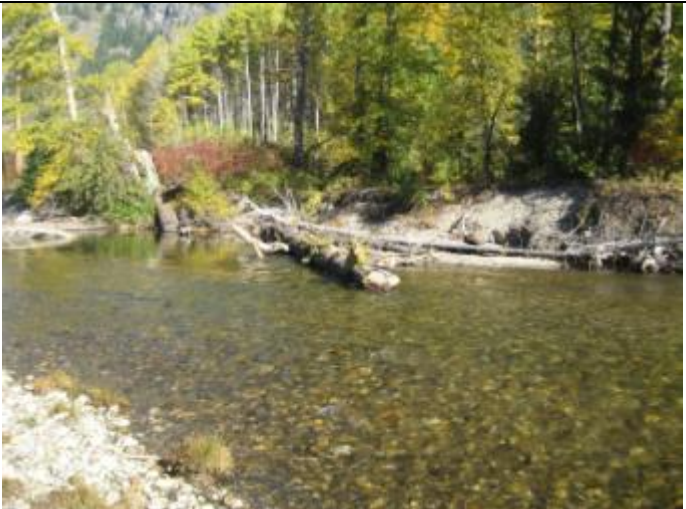
Project Group	USBR Reach Assessment Priority Habitat Action Category	Project Number	Strategy Category	Project Name	Description	Photo
Group 3	<p><u>LWP IZ-3</u> (USBR 2009; Pg 89-94):</p> <ul style="list-style-type: none"> <li>Riparian Rehabilitation (Options 1, 2, 4, 6)</li> <li>Reconnect Habitat (short term) (Options 1, 3, 4 5)</li> </ul> <p><u>LWP IZ-4</u> (USBR 2009; Pg 69-73):</p> <ul style="list-style-type: none"> <li>Reconnect Processes (Options 1, 2, 4)</li> <li>Riparian Rehabilitation (Options 1, 3, 5)</li> </ul> <p><u>LWP OZ-4</u> (USBR 2009; Pg 31-32): Riparian Rehabilitation (Options 1, 2)</p>	RM 10.6L Alternative 2	Re-Establish Channel and Floodplain Processes	Enhance side- channel and floodplain connections	This alternative would use select excavation and LWD jams at the upstream and downstream ends of the abandoned high flow channel to create a perennial side-channel or a seasonal high-flow channel. Riparian revegetation is included in this alternative. Powerlines in this area provide a potential constraint.

<p>View in the upstream direction at the river left bank near RM 10.7. This is a potential location to enhance LWD and lower the bank to increase high-flow inundation of the adjacent floodplain. October 2010</p>

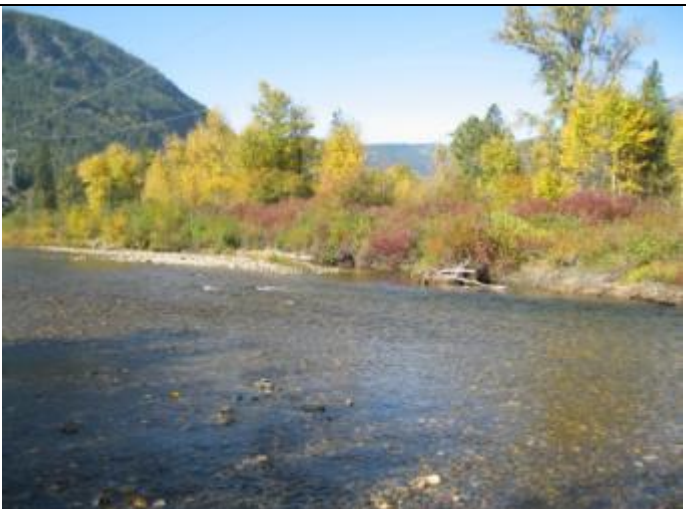
Group 3	<p><u>LWP IZ-4</u> (USBR 2009; Pg 69-73):</p> <ul style="list-style-type: none"> <li>Reconnect Processes (Options 1, 2, 4)</li> <li>Riparian Rehabilitation (Options 1, 3, 5)</li> </ul> <p><u>LWP OZ-4</u> (USBR 2009; Pg 31-32)</p>	RM 10.55L	Off-Channel Habitat Enhancement	Alcove habitat enhancement	Near RM 10.55, there is an outlet to an abandoned high-flow channel. There is currently open water but no surface connection. This alternative would create alcove habitat by excavating through the bank. This action would be an addition or alternative to potential side-channel work in project RM 10.6L Alternative 2. There is potential for accumulation of fine sediment at this location. Sediment transport continuity, and potential maintenance issues will need to be considered as part of project design.

<p>View in the upstream direction at the river left bank near RM 10.55 where a potential backwater alcove could be excavated into an existing floodplain depression. This would also be a potential location for the downstream end of RM 10.6L Alternatives 1 and 2. October 2010</p>

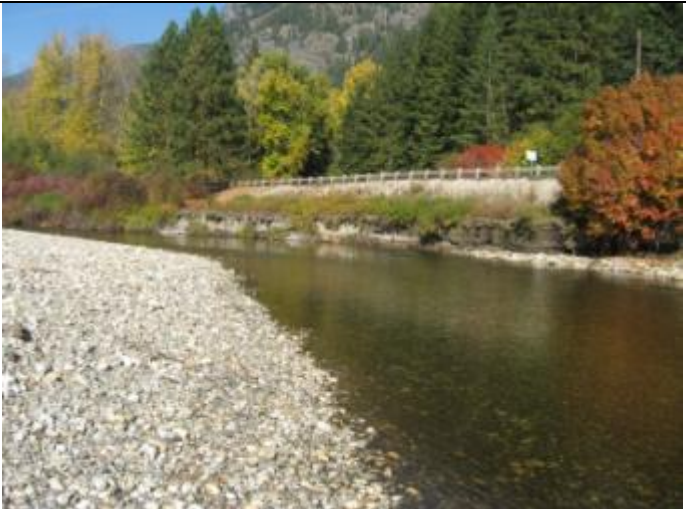
Project Group	USBR Reach Assessment Priority Habitat Action Category	Project Number	Strategy Category	Project Name	Description	Photo
Group 3	<u>LWP IZ-4</u> (USBR 2009; Pg 69-73): <ul style="list-style-type: none"> <li>• Reconnect Processes (Options 1, 2, 4)</li> <li>• Riparian Rehabilitation (Options 1, 3, 5)</li> </ul>	RM 10.45L	Instream Habitat Enhancement	LWD enhancement	On river left between RM 10.5 and 10.4, there is an actively eroding 5 ft high bank composed of unconsolidated alluvium. Several meander bend LWD jams could be placed along this bank to decrease water velocity, slow bank erosion while riparian vegetation recovers, and provide habitat cover and complexity. There are riffle-pool sequences in the channel that could be enhanced by this action, including adding cover to an existing deep pool near RM 10.4. At the downstream end of this bank, erosion is threatening the Highway 2 embankment. This action could also protect the roadway while avoiding the impending use of rip-rap.

<p>View in the upstream direction toward river left at an actively eroding bank along the toe of the road embankment of Highway 2 near RM 10.4. October 2010</p>

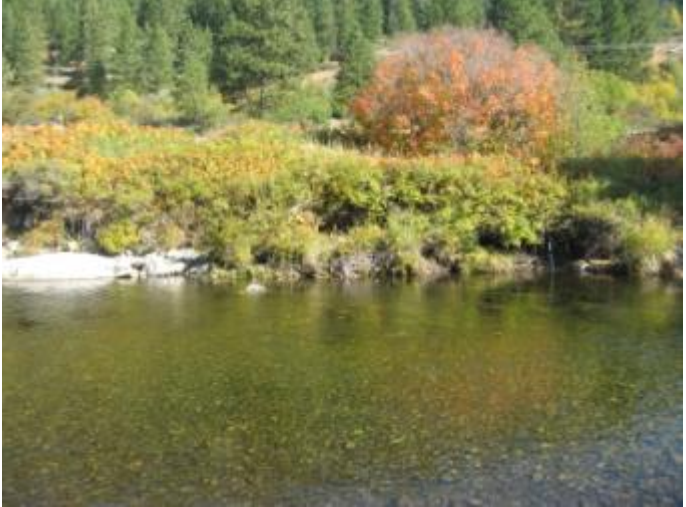
Group 3	<u>LWP IZ-4</u> (USBR 2009; Pg 69-73): <ul style="list-style-type: none"> <li>• Reconnect Processes (Options 1, 2, 4)</li> <li>• Riparian Rehabilitation (Options 1, 3, 5)</li> </ul>	RM 10.4L	Instream Habitat Enhancement	LWD enhancement	There is a 10 ft high eroding bank on river left on the outside of a tight meander. There is considerable depth in the pool on the outside of the bend, but very little cover. Adding a LWD jam could provide cover and increased habitat quality, while slowing rapid bank erosion that is related to an absence of mature forest vegetation and LWD. Wood jams here would also provide a good alternative to the potential future use of rip-rap if the roadway becomes threatened.

<p>View of the river left bank near RM 10.38, which is actively slumping. The bank is on the outside of a bend where there is a deep pool that would benefit from increased cover. October 2010</p>

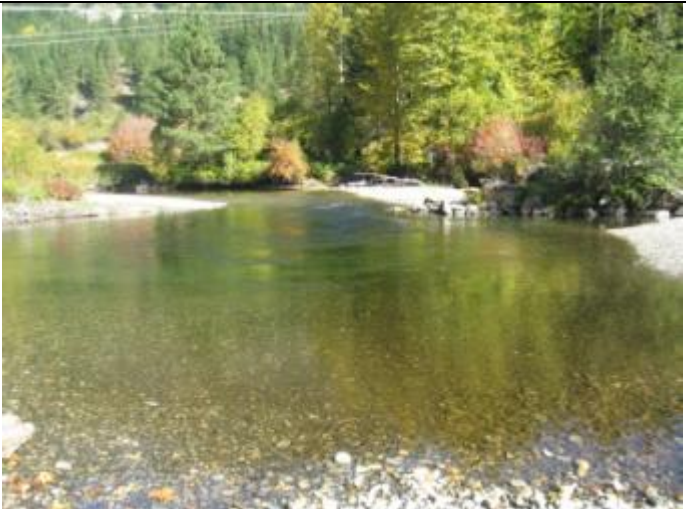
Project Group	USBR Reach Assessment Priority Habitat Action Category	Project Number	Strategy Category	Project Name	Description	Photo
Group 3	<p><u>LWP IZ-4</u> (USBR 2009; Pg 69-73):</p> <ul style="list-style-type: none"> <li>• Reconnect Processes (Options 1, 2, 4)</li> <li>• Riparian Rehabilitation (Options 1, 3, 5)</li> </ul> <p><u>LWP OZ-5</u> (USBR 2009; Pg 77-79)</p> <p><u>LWP OZ-6</u> (USBR 2009; Pg 79-81)</p>	RM 10.3C	Reconnect Stream Channel Processes	LWD to re-establish channel dynamics	Between RM 10.35 and 10.25 channel complexity increases with riffle-pool sequences, bar formation, and increased sinuosity. This area is downstream of a tight meander and just upstream of a hard left turn in the stream. The area is depositional, resulting in active bar formation. However, LWD densities are low in comparison to natural conditions. LWD complexes could be constructed at bar apexes, at locations where there are currently rock groins protecting the left bank, and on the outside of meanders. The jams would be designed to encourage channel movement, pool scour, and sinuosity. Consideration of incoming LWD load would also be considered in the design process, with the potential for designing structures to capture fluvial wood. Consideration would need to be given to the proximity of private residences on the river left floodplain.

<p>View in the upstream direction near RM 10.3 at a large, deep pool that could accommodate a substantial LWD complex. On river left (right side of the photo) is a rock groin that is eroding, and could be replaced or enhanced with wood. Downstream of this location are several gravel bars and pool-riffle sequences where the addition of in-channel LWD would benefit process and habitat. October 2010</p>

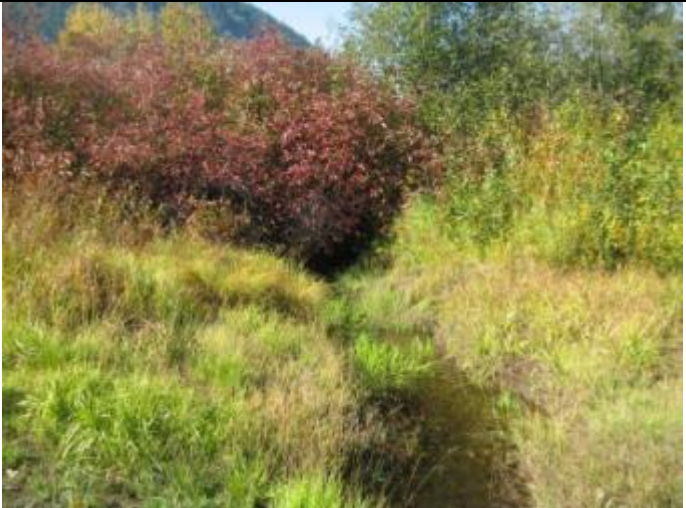
Group 3	<p><u>LWP IZ-4</u> (USBR 2009; Pg 69-73):</p> <ul style="list-style-type: none"> <li>• Reconnect Processes (Options 1, 2, 4)</li> <li>• Riparian Rehabilitation (Options 1, 3, 5)</li> </ul> <p><u>LWP OZ-5</u> (USBR 2009; Pg 77-79)</p>	RM 10.25R	Off-Channel Habitat Enhancement	Alcove habitat enhancement	At RM 10.25 on river right, there is an outlet to a floodplain wetland and high-flow channel complex. There is open water along the base of the railroad grade, but no surface connection. Excavation of a 2 ft high bank over a length of about 50 ft would be required to create an alcove at this location. There is potential for accumulation of fine sediment at this location. Sediment transport continuity and potential maintenance issues would need to be considered as part of project design.

<p>View of a backwater channel extends into the river right floodplain with an outlet near RM 10.25. Moderate excavation would be necessary in order to create an alcove at this location. October 2010</p>

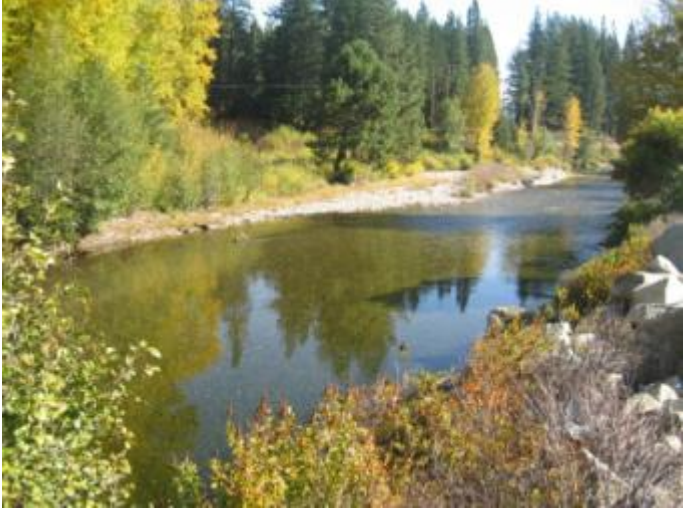
Project Group	USBR Reach Assessment Priority Habitat Action Category	Project Number	Strategy Category	Project Name	Description	Photo
Group 4	<p><u>LWP IZ-5</u> (USBR 2009; Pg 94-101):</p> <ul style="list-style-type: none"> <li>• Reconnect Habitat (Short Term) (Options 1, 3, 4, 5)</li> <li>• Riparian rehabilitation (Options 1, 2, 4, 6)</li> </ul> <p><u>LWP OZ-6</u> (USBR 2009; Pg 79-81)</p>	RM 10.15C	Reconnect Stream Channel Processes	LWD to re-establish channel dynamics	Just downstream of RM 10.1 the hillslope on valley left and the railroad on valley right form a channel constriction that has resulted in bar deposition near RM 10.15. This project would include an LWD jam at the apex of the bar to encourage pool scour and increase channel complexity. Excavation of a river left split flow channel may be necessary in order to maintain channel conveyance and not increase hazard to the adjacent railroad grade. There are houses on the hillslope on valley left that would also need consideration as part of engineering design.

<p>View in the downstream direction at the river left bank near RM 10.15 where there is potential to place an apex jam at the upstream end of the gravel bar and excavate a secondary channel to the left. October 2010</p>

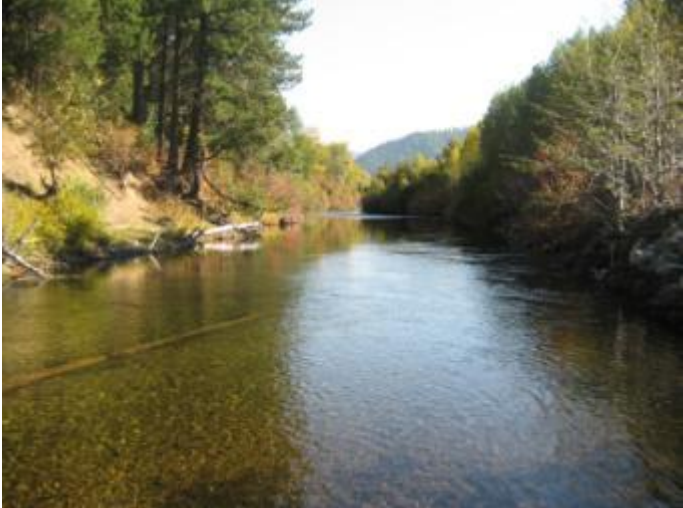
Group 4	<p><u>LWP IZ-5</u> (USBR 2009; Pg 94-101):</p> <ul style="list-style-type: none"> <li>• Reconnect Habitat (Short Term) (Options 1, 3, 4, 5)</li> <li>• Riparian rehabilitation (Options 1, 2, 4, 6)</li> </ul>	RM 10.05L	Instream Habitat Enhancement	LWD enhancement	This project would entail placing several small log jams along the river left bank between RM 10.05 and 10.0 in order to increase cover, local pool scour, and habitat complexity. The railroad grade on river right places a constraint on the degree of hydraulic alteration that would be possible in this area.

<p>View in the downstream direction near RM 10.05 where multiple log jams could be placed along river left to provide increased habitat quality. October 2010</p>

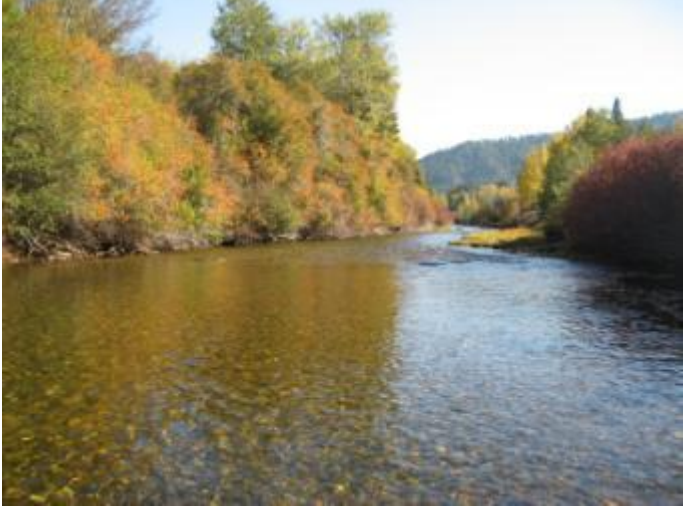
Project Group	USBR Reach Assessment Priority Habitat Action Category	Project Number	Strategy Category	Project Name	Description	Photo
Group 4	<p><u>LWP IZ-5</u> (USBR 2009; Pg 94-101):</p> <ul style="list-style-type: none"> <li>• Reconnect Habitat (Short Term) (Options 1, 3, 4, 5)</li> <li>• Riparian rehabilitation (Options 1, 2, 4, 6)</li> </ul>	RM 9.85C	Instream Habitat Enhancement	LWD enhancement	Between RM 10.0 and 9.6, the channel has been straightened to accommodate the railroad grade. A small amount of sinuosity exists within the confines of the current channel alignment where low-gradient riffles and shallow pools have formed. Several channel margin jams could be placed on both sides of the channel to enhance the existing bed topography, increase pool scour, and provide bank cover. The need to protect the railroad grade would limit the amount of hydraulic alteration that could occur. On river right along the railroad, an acceptable option may be to place jams in the existing channel, excavate along river left and place fill behind the logs in order to build the bank away from the railroad and to increase sinuosity to the extent possible. Alternative sources of fill may be investigated in order to preserve riparian habitat along river left.

<p>View in the downstream direction on a straightened channel section near RM 9.85 where gravel deposition has resulted in riffle-pool development. Small margin log jams on both sides of the river could be used to enhance the existing channel. October 2010</p>

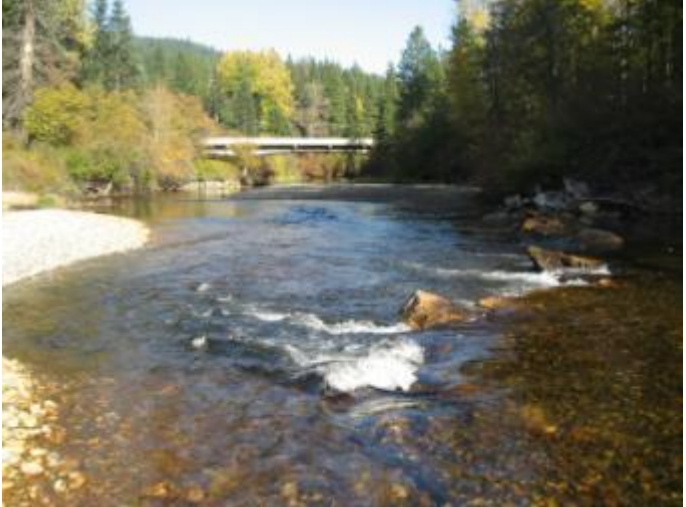
Group 4	<p><u>LWP IZ-6</u> (USBR 2009; Pg 73-77):</p> <ul style="list-style-type: none"> <li>• Reconnect Processes (Options 1, 2, 4)</li> <li>• Riparian rehabilitation (Options 1, 3, 5)</li> </ul>	RM 9.55C	Instream Habitat Enhancement	LWD enhancement	Near RM 9.55, riprap/boulders have been eroded and exposed in the channel, effectively creating a weir across the channel. A deep scour pool has formed downstream of the weir, but the pool quality is limited by lack of cover and complexity. The riprap could be replaced by a large log jam spanning most of the channel, or the existing rock could be enhanced with wood. The jam would maintain pool scour while increasing habitat quality.

<p>View in the downstream direction near RM 9.55 where a boulder weir extends across the channel. A deep scour pool has formed immediately downstream, but lacks cover. The rock could be replaced or enhanced with LWD to maintain pool depth and provide cover. Adequate ballasting of materials would be necessary to protect the bridge downstream. October 2010</p>

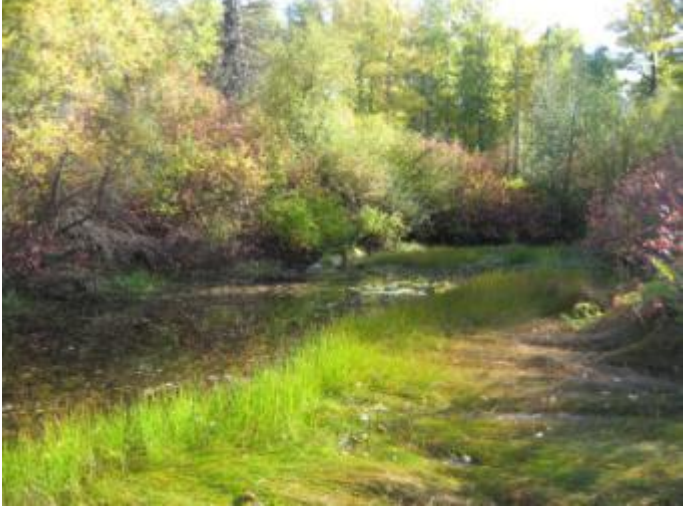
Project Group	USBR Reach Assessment Priority Habitat Action Category	Project Number	Strategy Category	Project Name	Description	Photo
Group 4	<p><u>LWP IZ-6</u> (USBR 2009; Pg 73-77):</p> <ul style="list-style-type: none"> <li>• Reconnect Processes (Options 1, 2, 4)</li> <li>• Riparian rehabilitation (Options 1, 3, 5)</li> </ul> <p><u>LWP OZ-7</u> (USBR 2009; Pg 27-29)</p>	RM 9.5L	Off-Channel Habitat Enhancement	Alcove habitat enhancement	On river left near RM 9.5 a culvert drains a wetland that occupies a meander scar. The wetland complex is bisected by Highway 2. On the south side of the highway, the bank could be excavated to create an open surface-water connection to an off-channel backwater. North of the highway, the wetland appears to be functioning well, and should be protected.

<p>View of a wetland that occupies a meander scar on valley left. The wetland is drained by a culvert along river left near RM 9.5. The bank could be excavated to create a connected backwater alcove at this location. October 2010.</p>

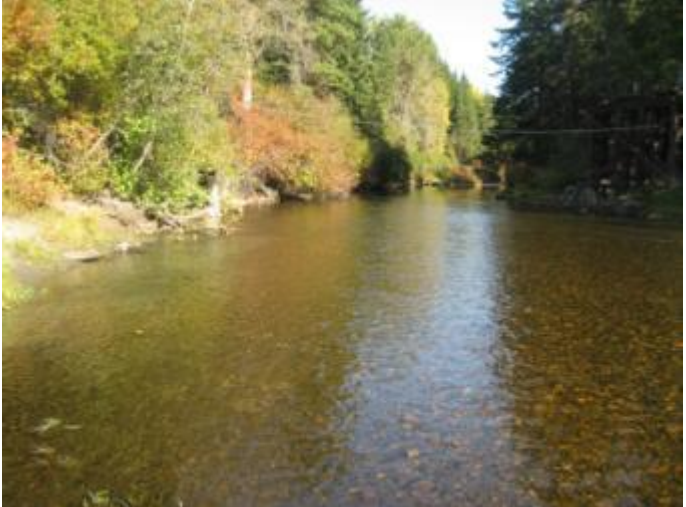
Group 4	<p><u>LWP IZ-6</u> (USBR 2009; Pg 73-77):</p> <ul style="list-style-type: none"> <li>• Reconnect Processes (Options 1, 2, 4)</li> <li>• Riparian rehabilitation (Options 1, 3, 5)</li> </ul>	RM 9.4C	Instream Habitat Enhancement	LWD enhancement and abandoned bridge abutment removal	There are old bridge abutments on both sides of the river near RM 9.4. Log jams could be placed along the channel margin on both sides of the river near these abandoned bridge abutments in order to increase cover and complexity. The abandoned bridge abutments are providing some pool scour, however, they may be limiting riparian function and could be removed and replaced with LWD jams and riparian plantings. The value of removing the abutments needs to be evaluated further.

<p>View in the downstream direction near the location of abandoned bridge abutments on both sides of the channel near RM 9.4. LWD could be used to enhance habitat quality in this area, and the bridge abutments could be removed. October 2010</p>
