Technical Memorandum

To: Chris Clemons, Yakama Nation
From: Inter-Fluve Inc.
Date: October 29th, 2014
Re: Results of Natapoc Soil Pits

Yakama Nation Fisheries
 Natapoc
 Survey: September 29, 2014

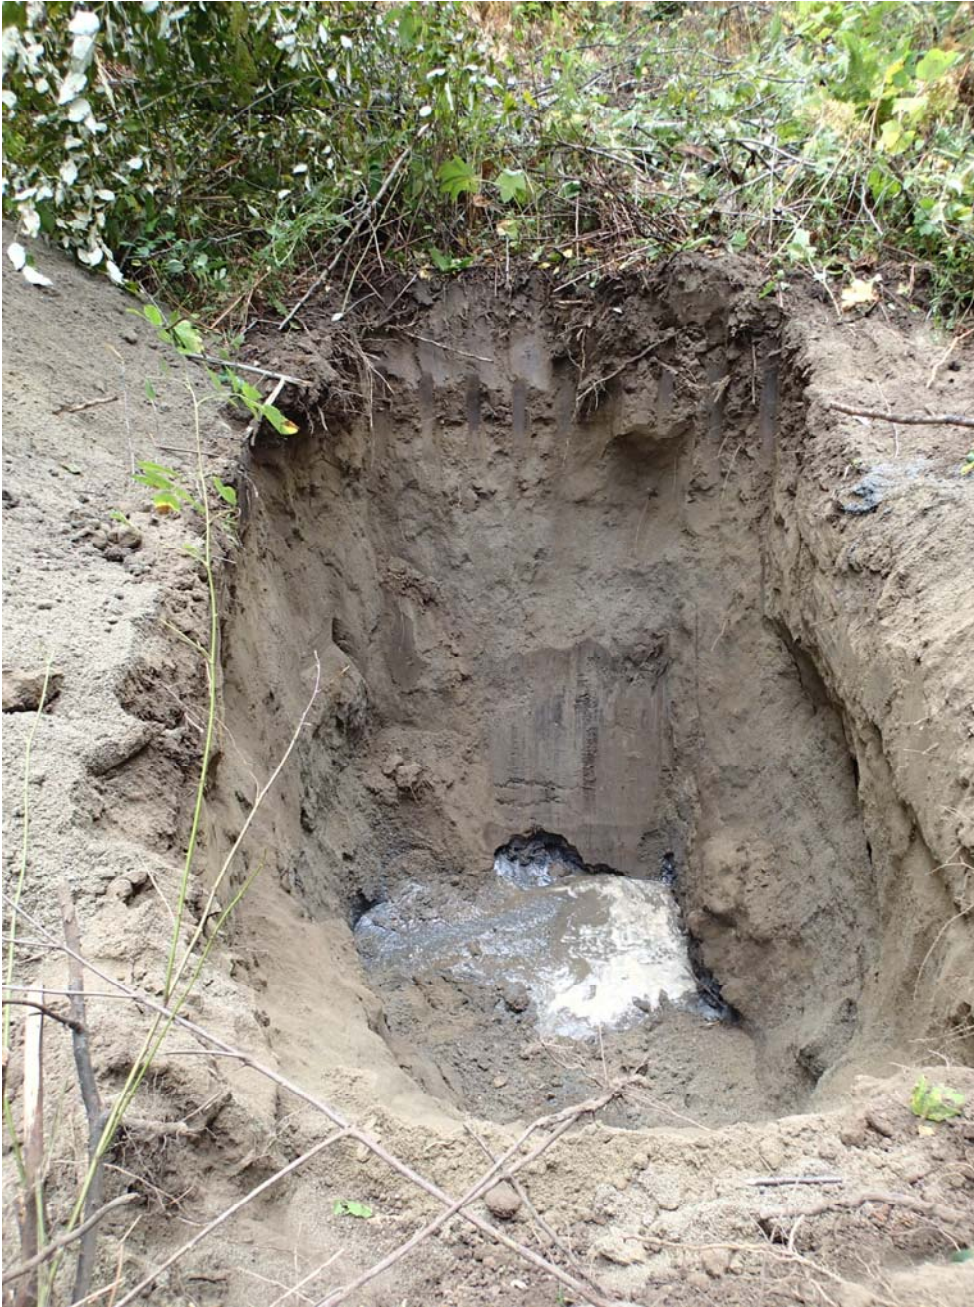
Figure 2 Representative photo of soil pit 1.

Soil Pit 1 was dug to a depth of 12 feet. Soils were predominantly silts and sand. Saturated conditions were observed at 7 feet below ground with standing water observed at 8 feet. As the pit was dug, material along the sides of the pit walls continued to collapse inward.

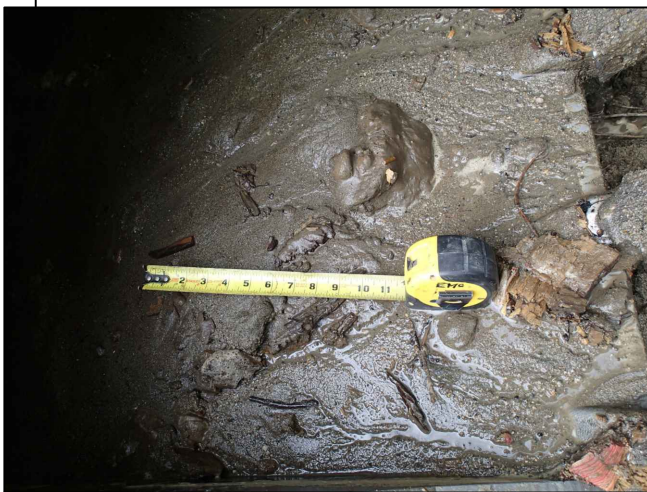
FIGURE 1 - 7' DEPTH

DEPTH, FT	SYMBOL	DESCRIPTION	DEPTH, FT	NOTES
0'				
0.1'		ORGANIC MATTER		
0.8'		SILTY LOAM		
1.8'		SILT		
5'		SAND		
5.6'		LOAMY SAND	7'	FIGURE 1
8.2'			8'	WATER
10'		GRAVELLY SAND		
12'				
15'

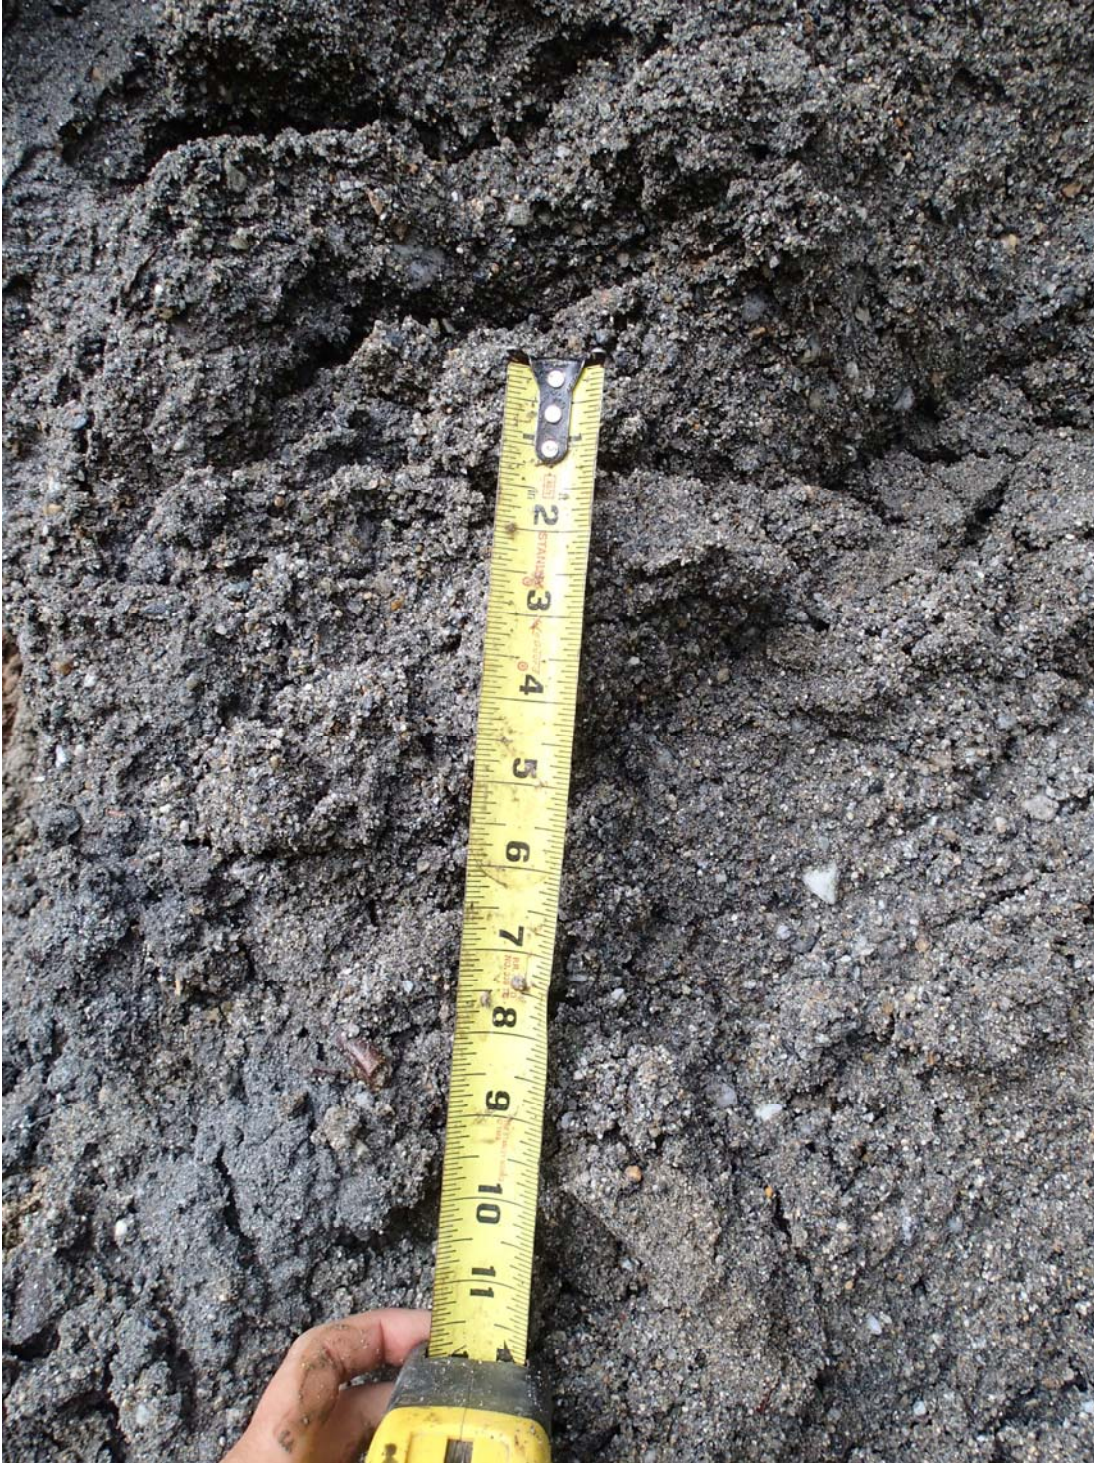
Soil Pit 2 was excavated to 12.1 feet depth. Soils were sands to 3.3 feet below ground and predominantly sand to the pit bottom. Water was observed at 8 feet.

Figure 3 Non-cohesive sandy soils from Test Pit 2

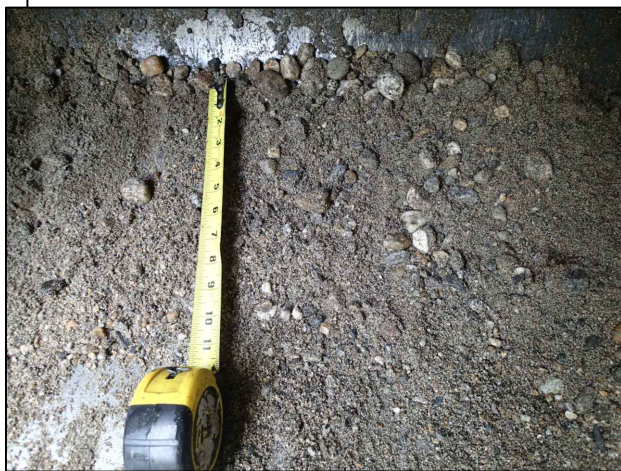
FIGURE 1 - 9' DEPTH

DEPTH, FT	SYMBOL	DESCRIPTION	DEPTH, FT	NOTES
0'				
0.2'		SAND		
		SANDY LOAM		
1.8'				
		SAND		
3.3'				
5'				
		COARSE SAND WITH SPARSE GRAVELS		
8'				(NON-COHESIVE) WATER
9'				FIGURE 1
10'				
12.1'				
15'

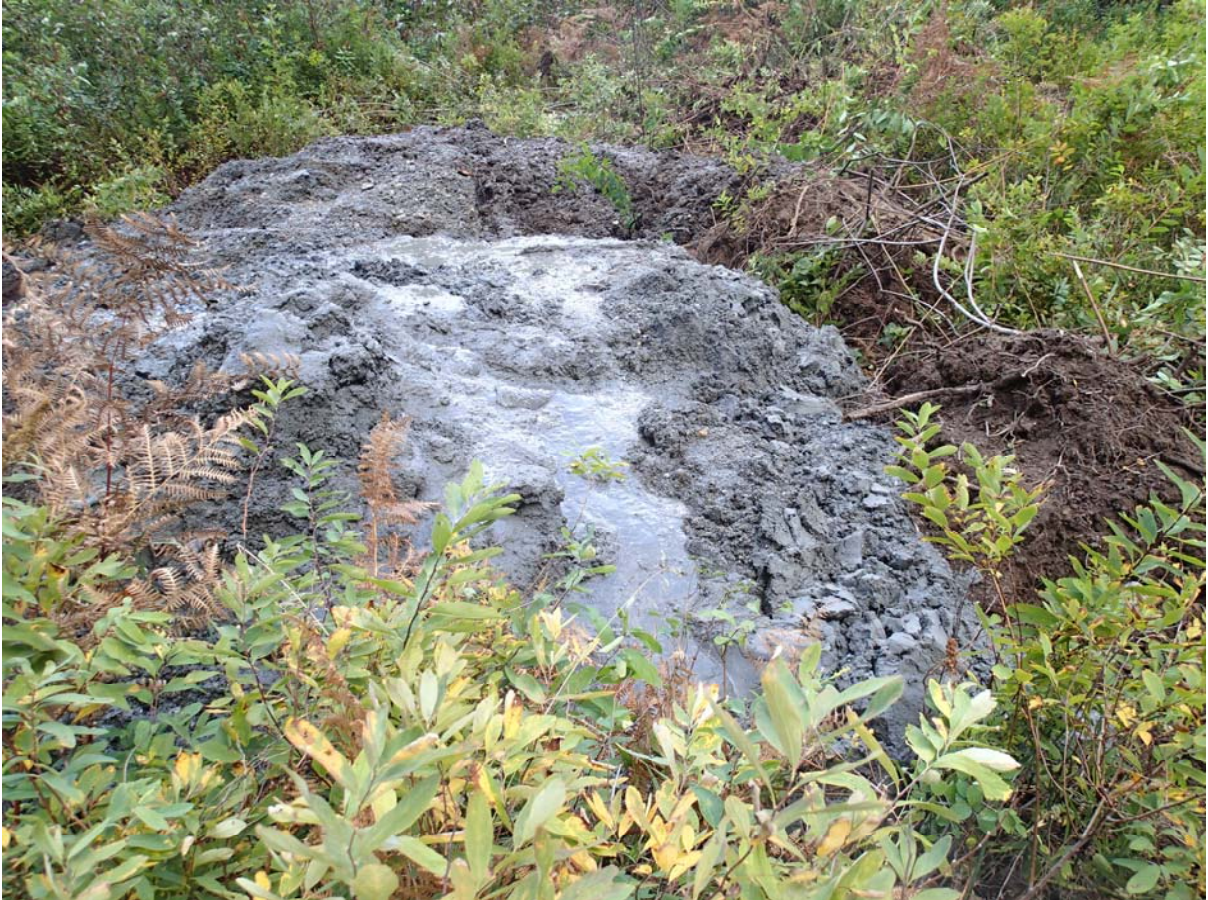
Soil Pit 3 was excavated to 12 feet depth. Soils were cohesive silts to 3 feet below ground, cobbly gravel from 3 to 6 feet, gravelly sand from 6 to 9 feet and cohesive sandy loam to the pit bottom. Water was observed at 7 feet. As the pit was dug, material along the sides of the pit walls continuously collapsed inward.

Figure 4 Offcast material from Soil Pit 3.

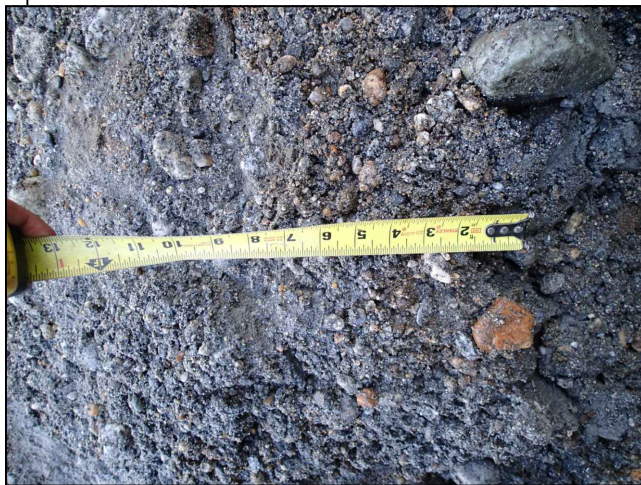
FIGURE 1 - WATER AT 7' DEPTH

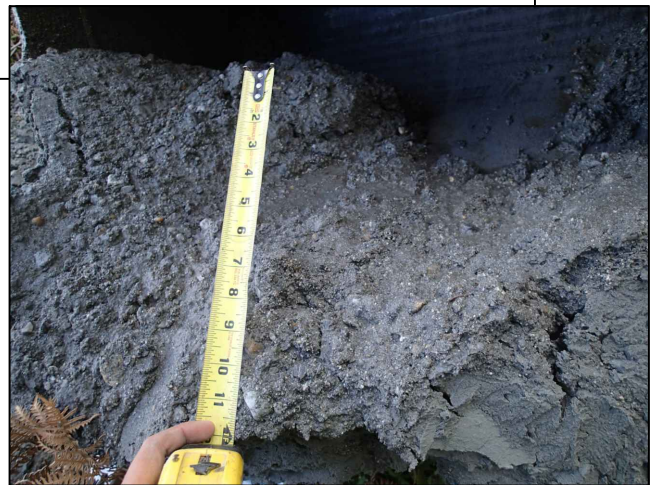
DEPTH, FT	SYMBOL	DESCRIPTION	DEPTH, FT	NOTES
0'				
0.2'		ORGANIC MATTER		
		COHESIVE SILT		
3'				
5'		COBBLY GRAVEL		
6'			7'	WATER
		GRAVELLY SAND		
9'			9.5'	FIGURE 2
10'		COHESIVE SANDY LOAM		
12'				
15'

FIGURE 2 - SANDY LOAM
