UPPER CHEWUCH HABITAT ASSESSMENT

Habitat Conditions and Restoration Opportunities on the Upper Chewuch River,
Boulder Creek, Twentymile Creek, Lake Creek, and Andrews Creek

**Yakama
Nation
Fisheries**

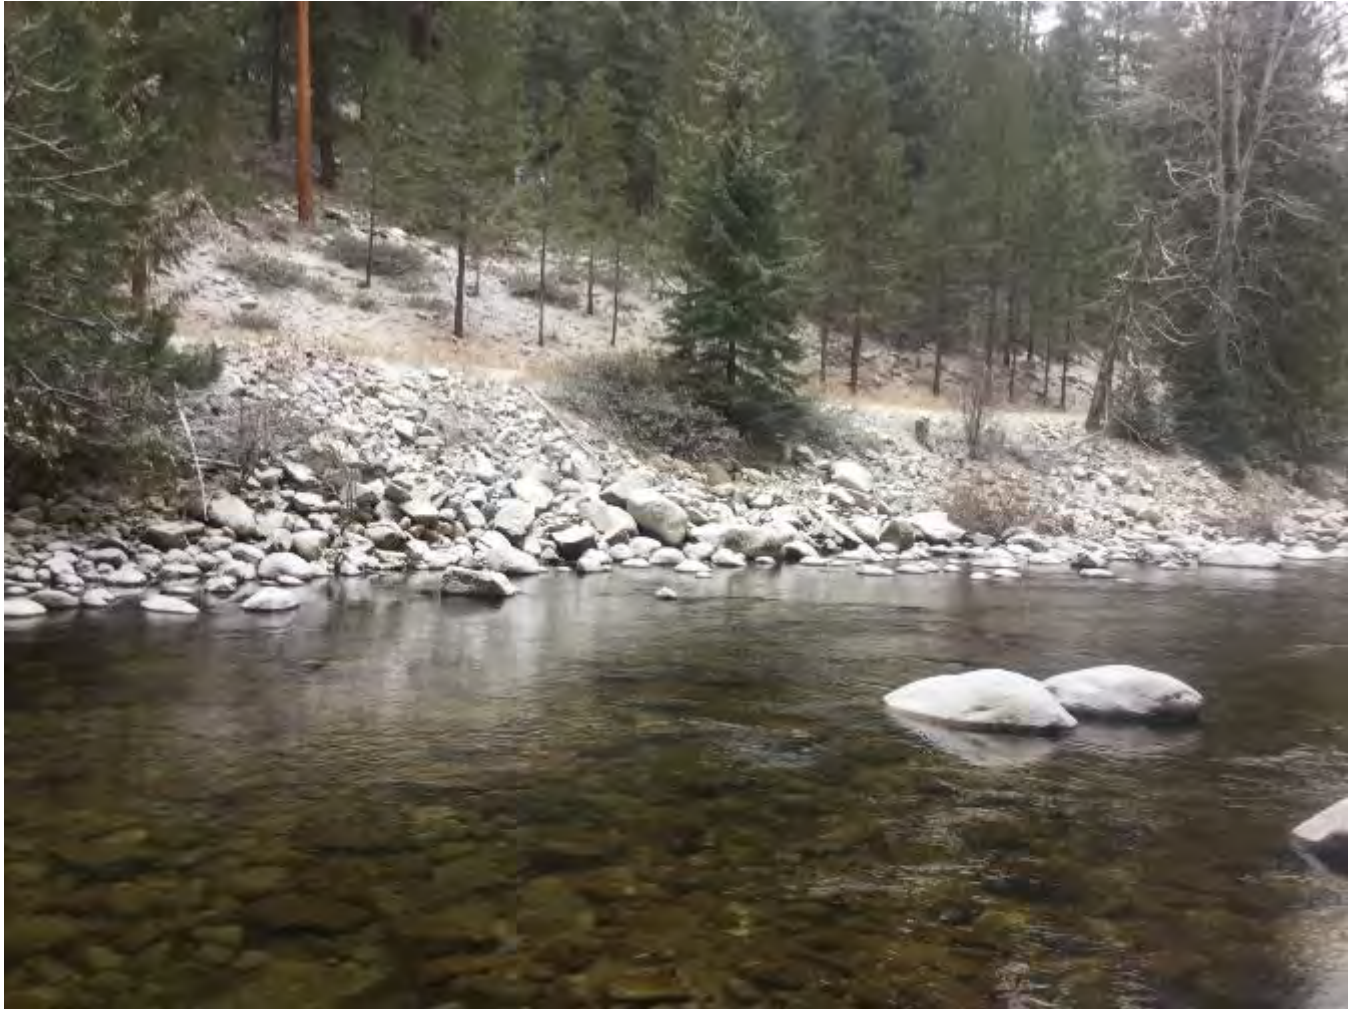
Figure 8. USFS Road 5160 limits river migration and riparian function along some stretches of the upper Chewuch River.

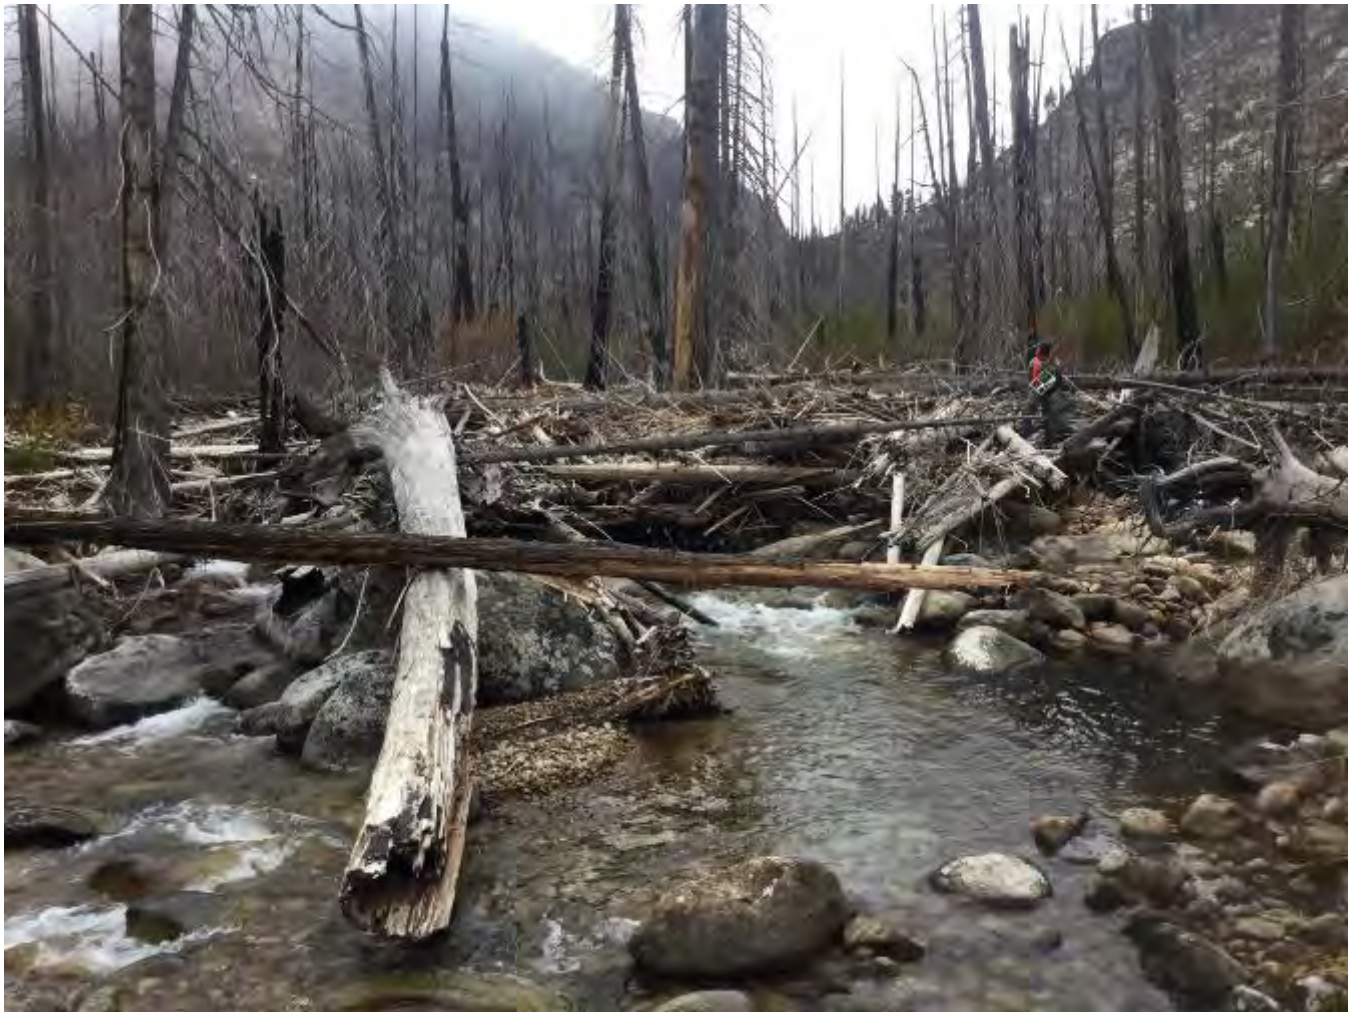
Figure 12. The 2003 Farewell Fire burned large sections of riparian forest along Lake Creek, which has led to an influx of riverine large wood and natural creation of numerous logjams.

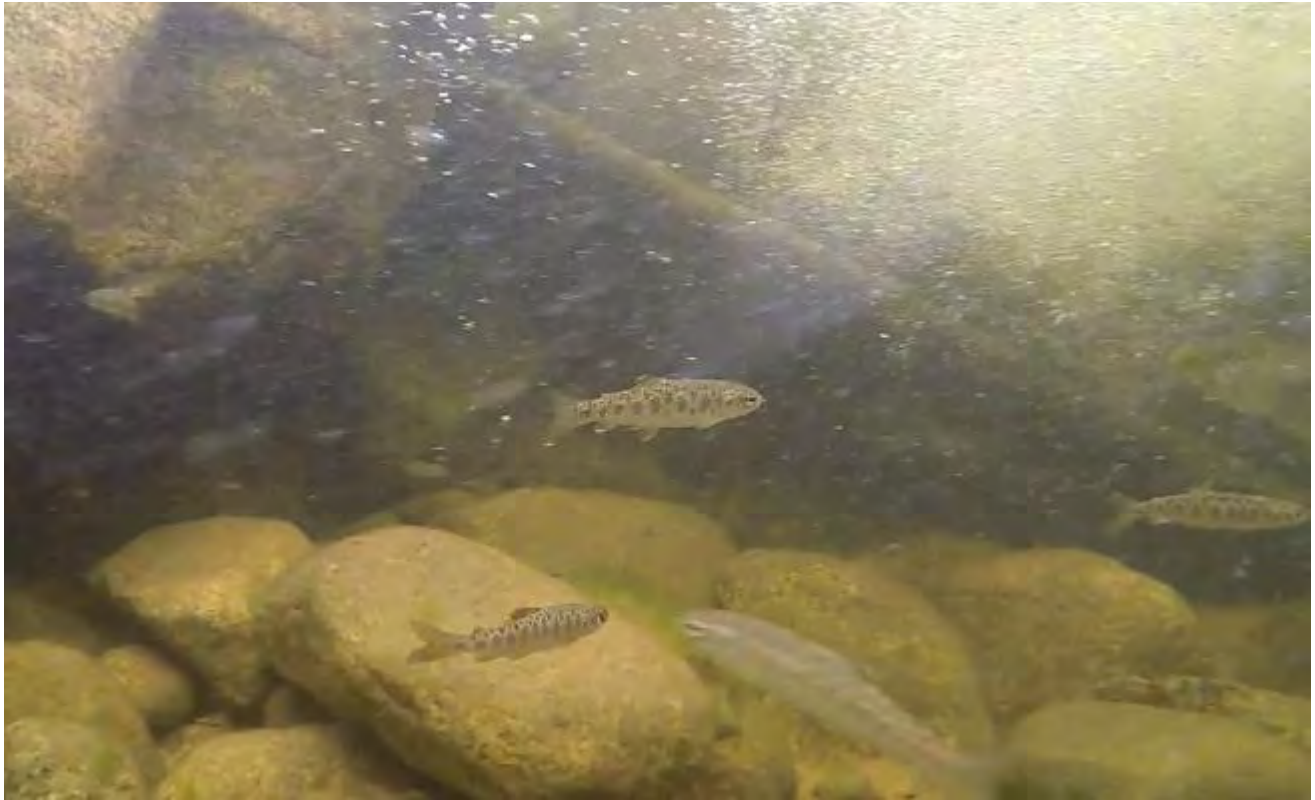
Figure 15. Juvenile Chinook and *O. mykiss* observed in Twentymile Creek just upstream of the partial fish passage barrier at the USFS Road 5010 ford (July 2016).

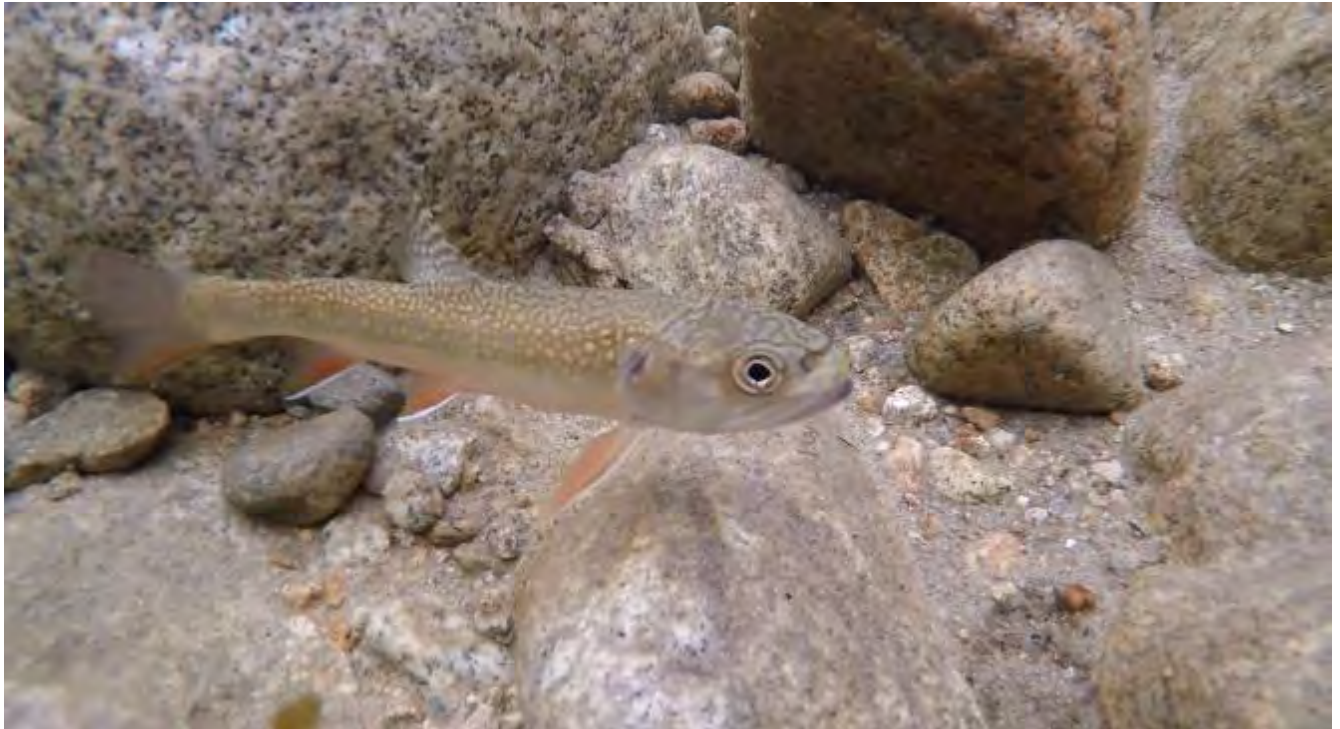
Figure 17. Brook Trout observed in Twentymile Creek just upstream of the partial fish passage barrier at the USFS Road 5010 ford (July 2016).

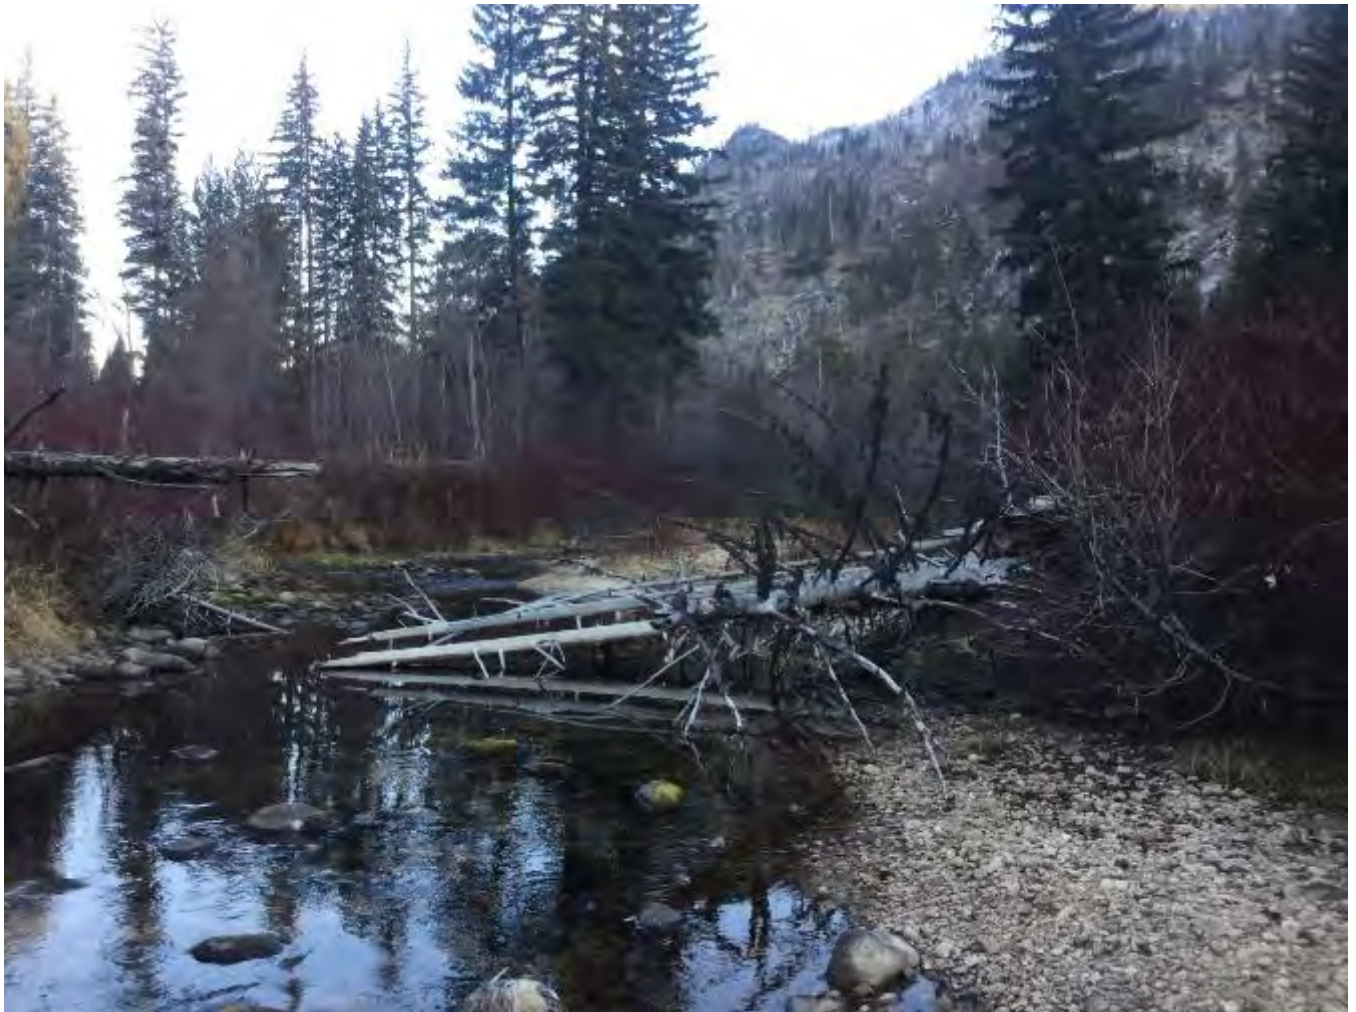
Figure 24. High quality juvenile salmonid rearing habitat in the No Snake Side Channel.

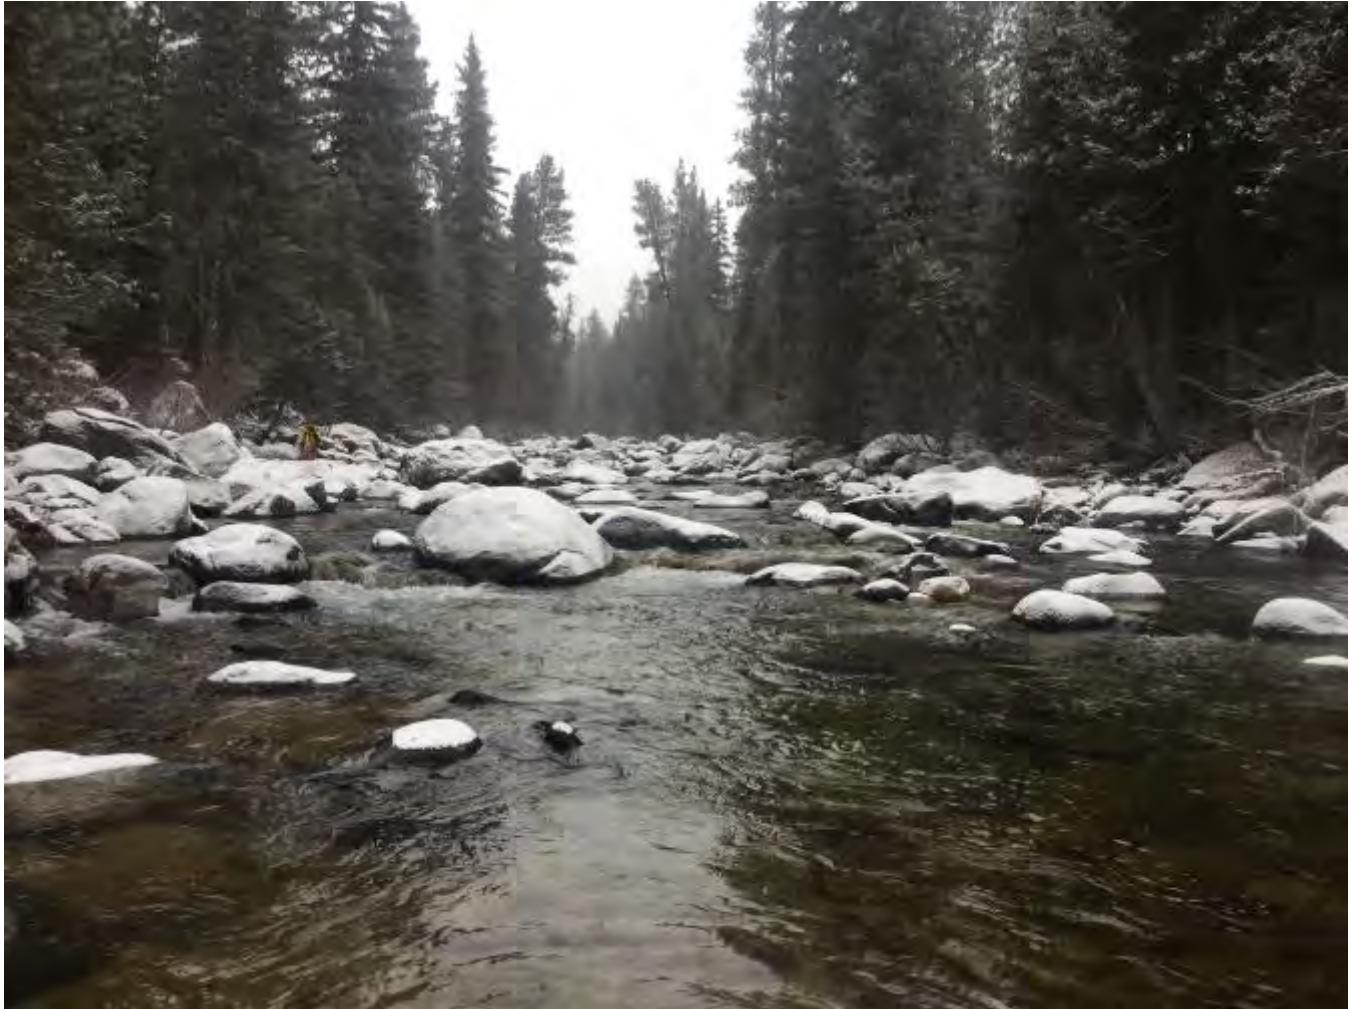
Figure 25. Boulder-dominated substrate and uninterrupted riffle habitat in Reach C10.

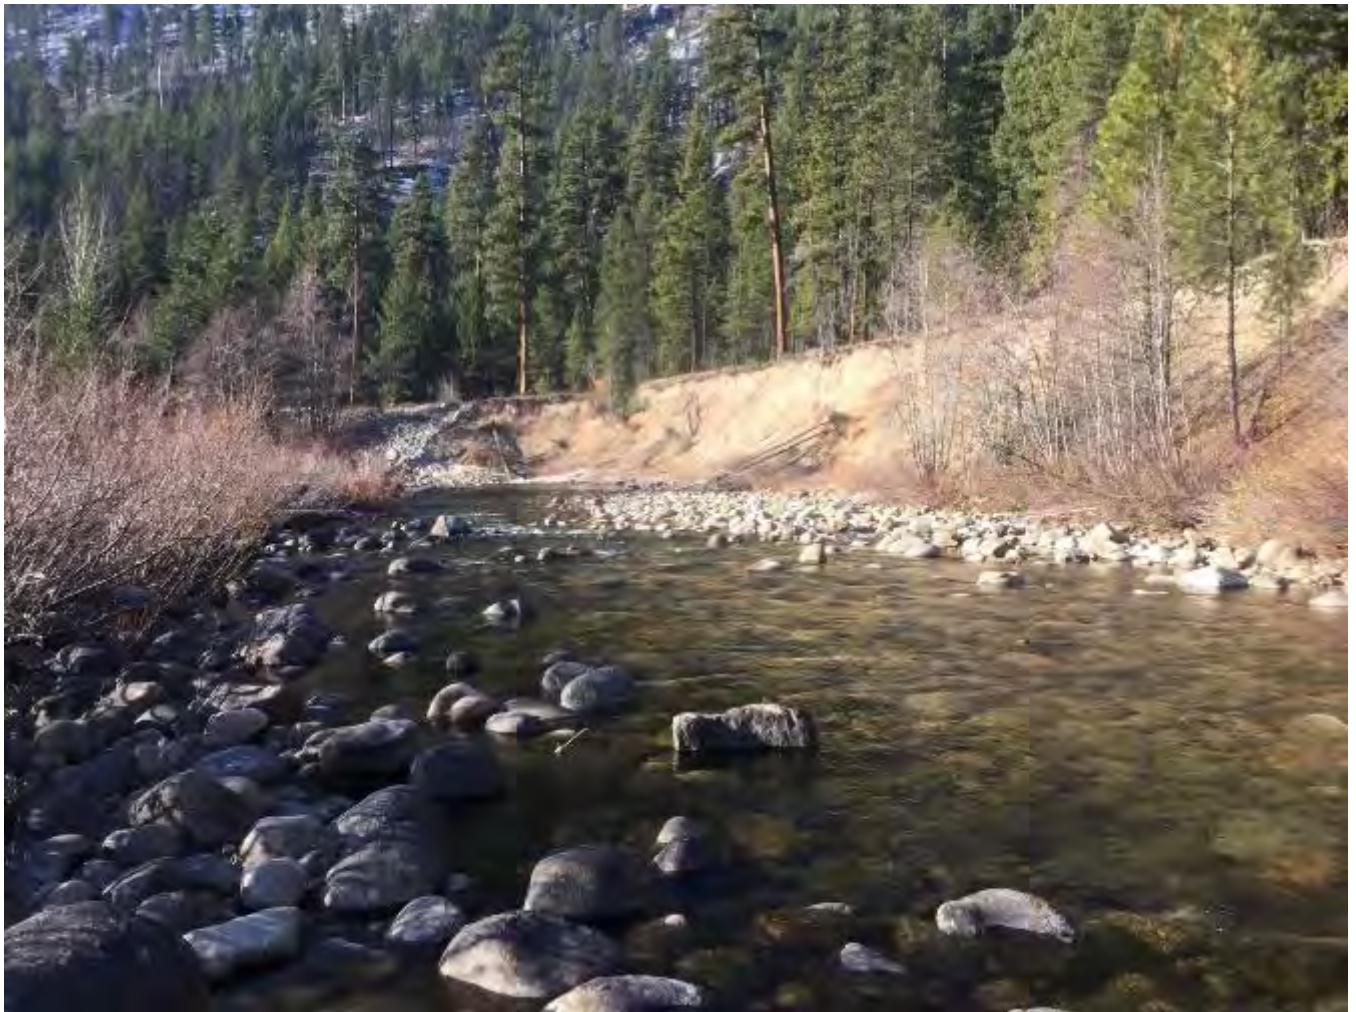
Figure 27. Significant active bank erosion at RM 21.8 threatens USFS Road 5160.

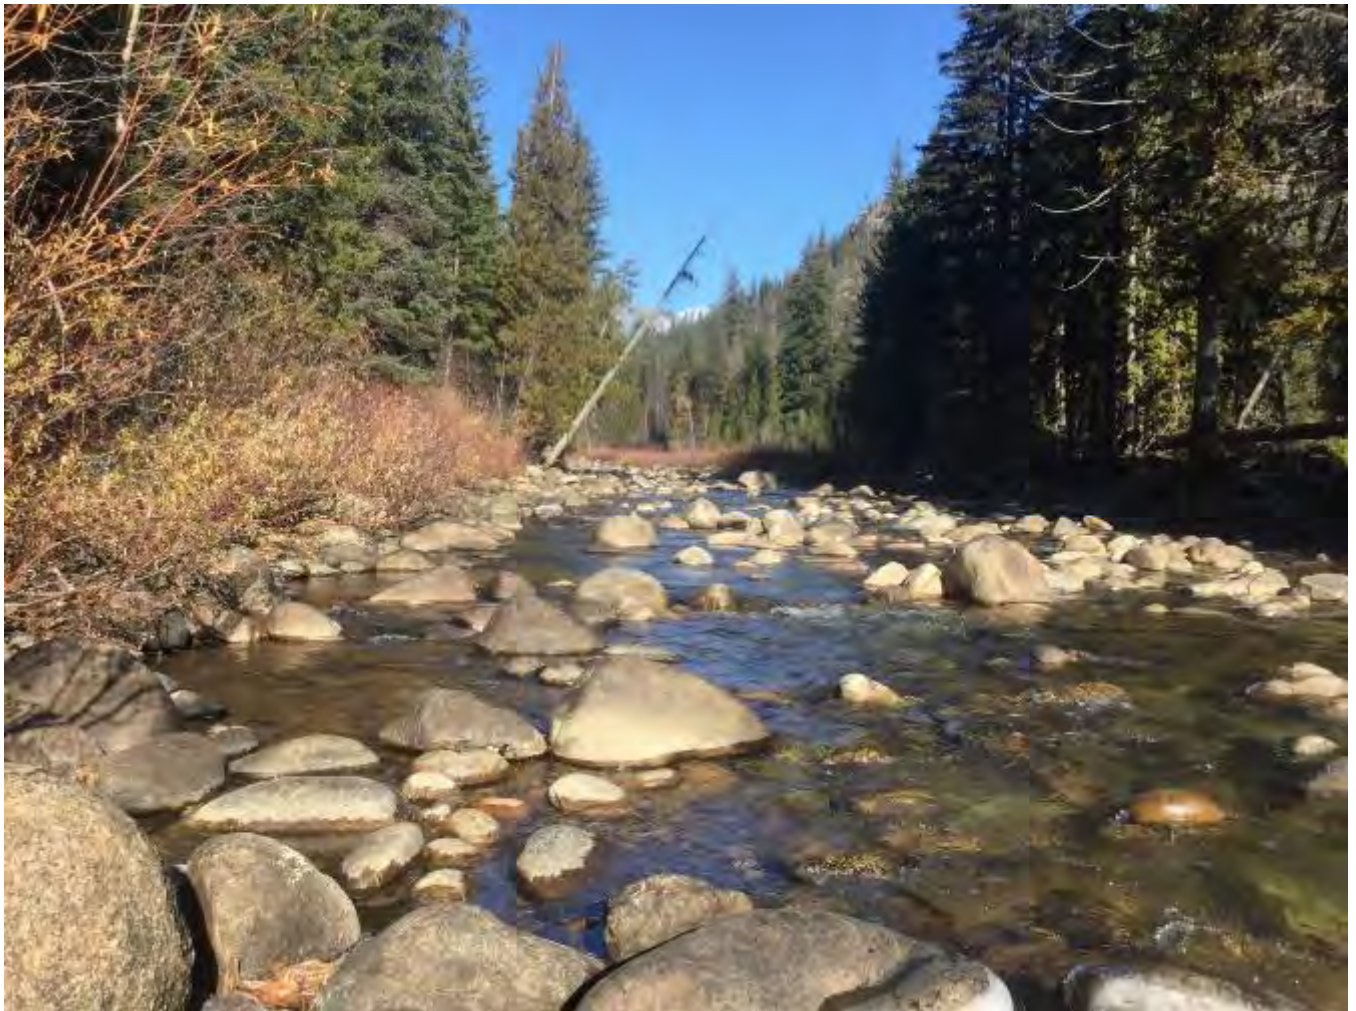
Figure 29. Extended riffle habitat typical of Reach C11.

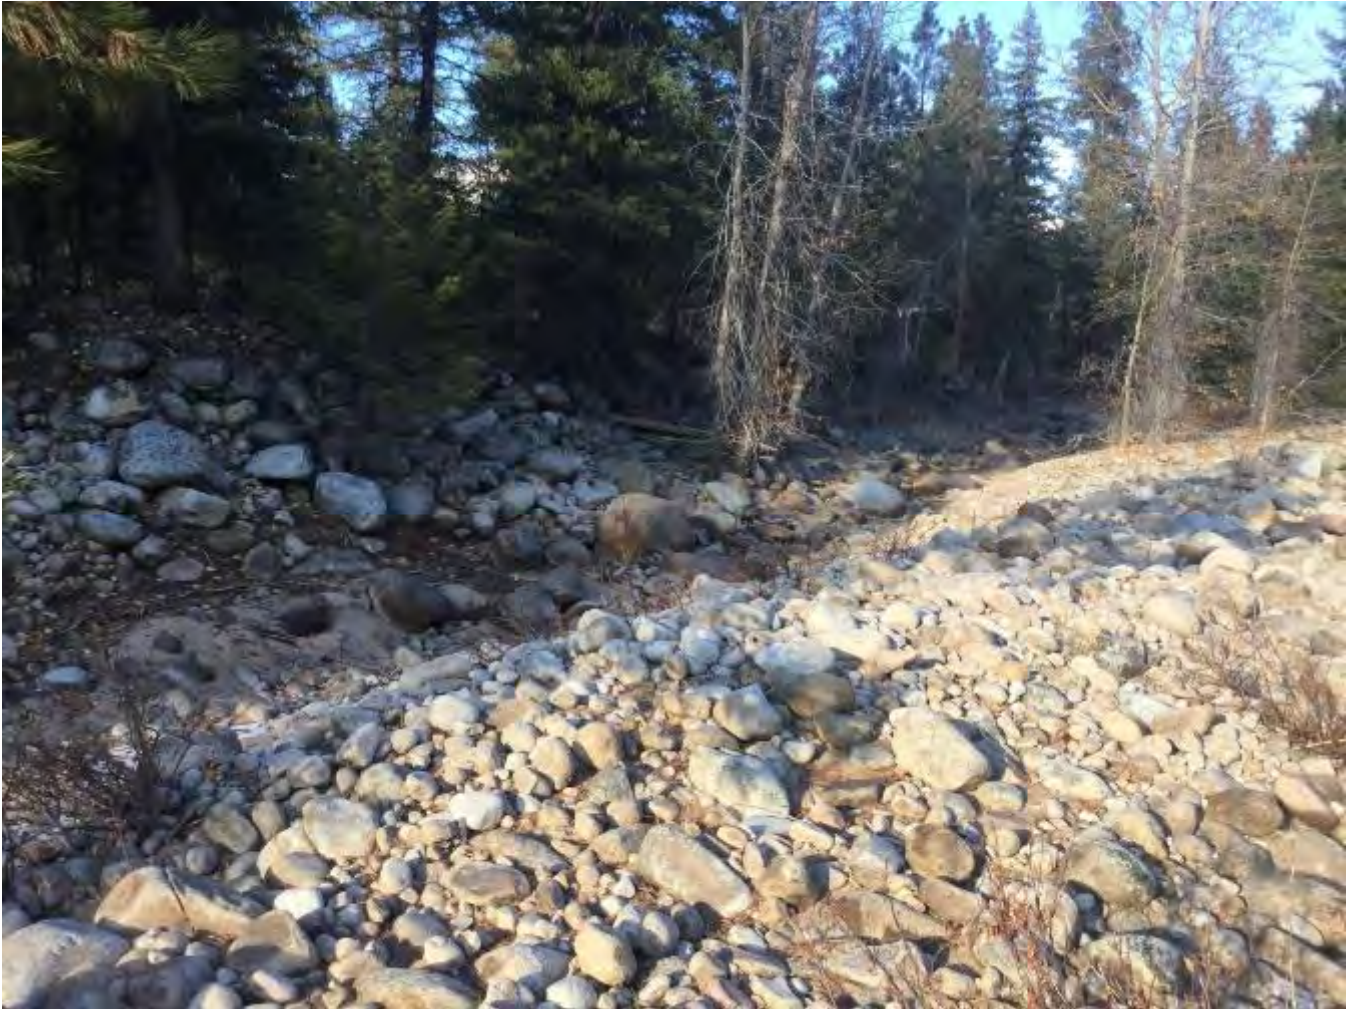
Figure 30. One of numerous fastwater side channels in Reach C11 that were dry under low flow survey conditions.

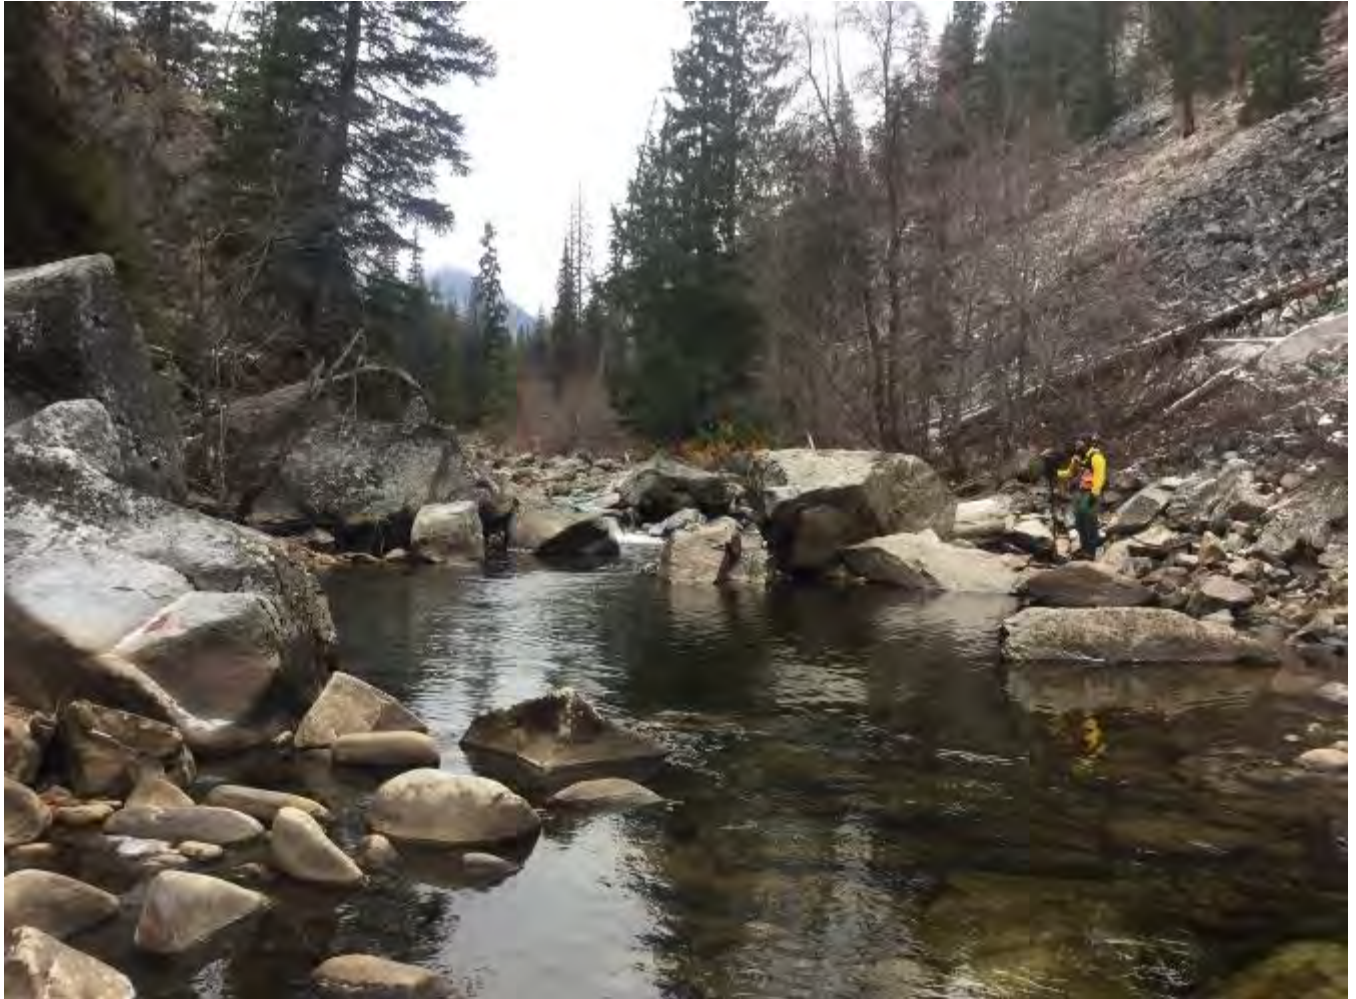
Figure 33. The Chewuch River runs through a deep gorge in Reach C12, confined by high hillslopes and rock cliffs.

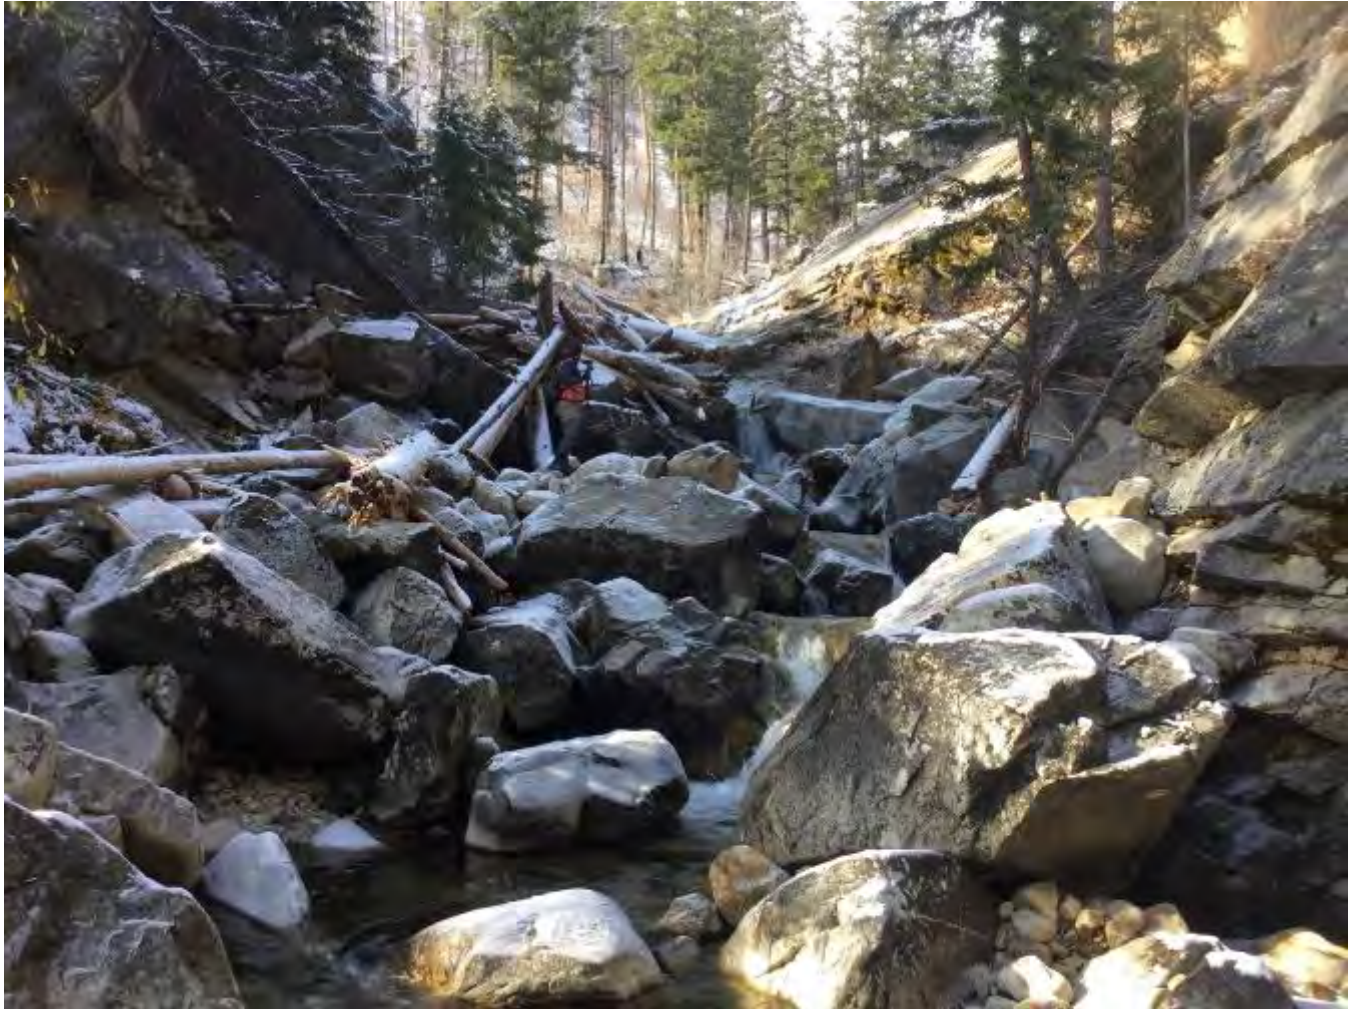
Figure 39. This series of falls form a barrier to anadromous fish migration at RM 0.5 on Andrews Creek.

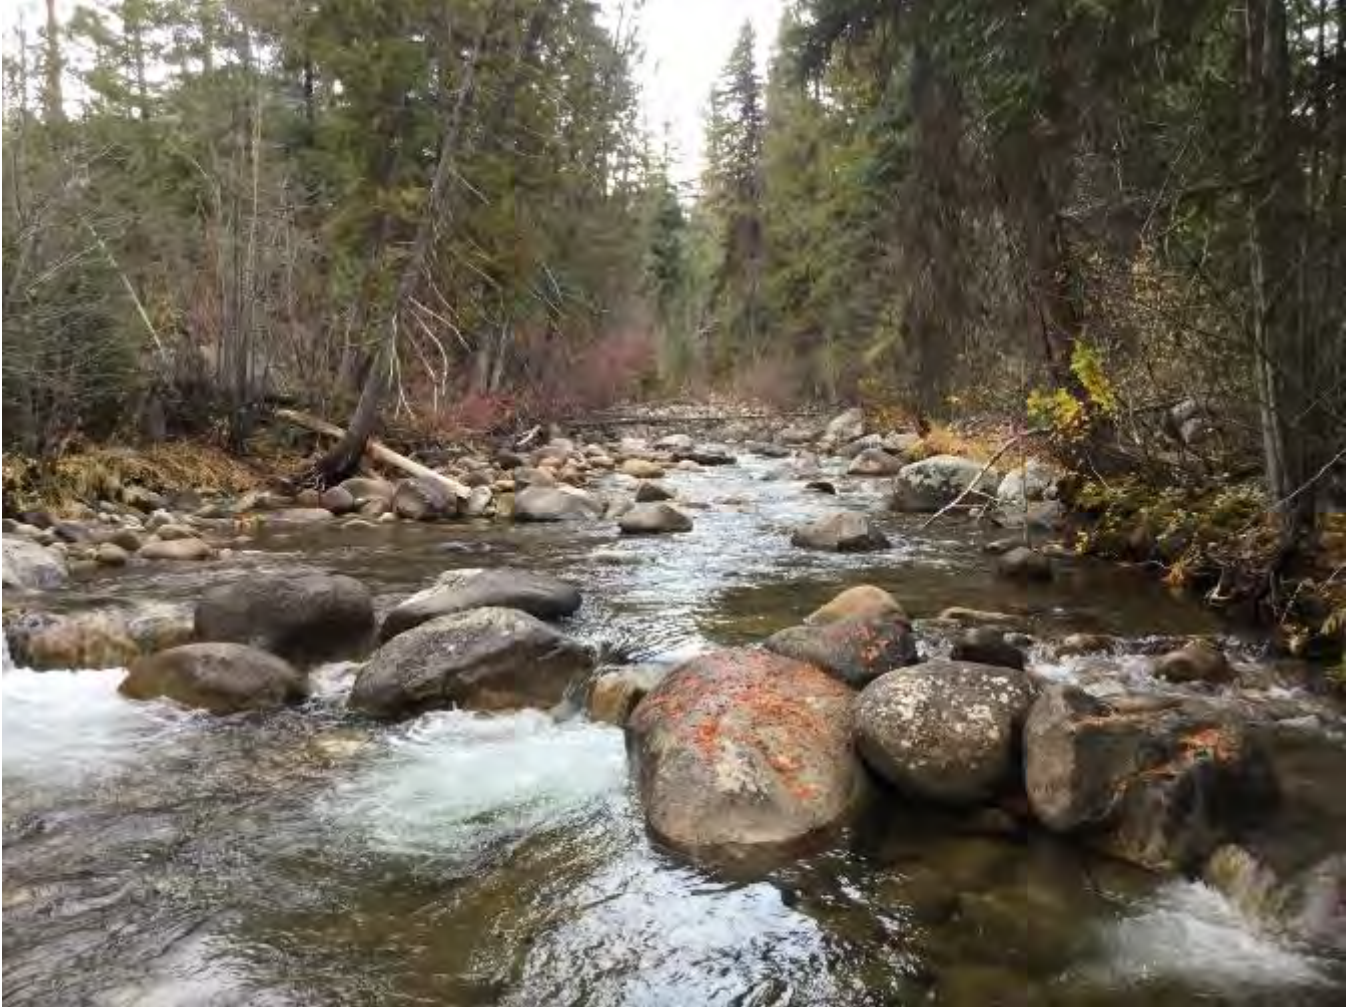
Figure 42. Instream conditions at RM 0.1 in Reach L1 showing boulder and cobble substrate and shallow pools.

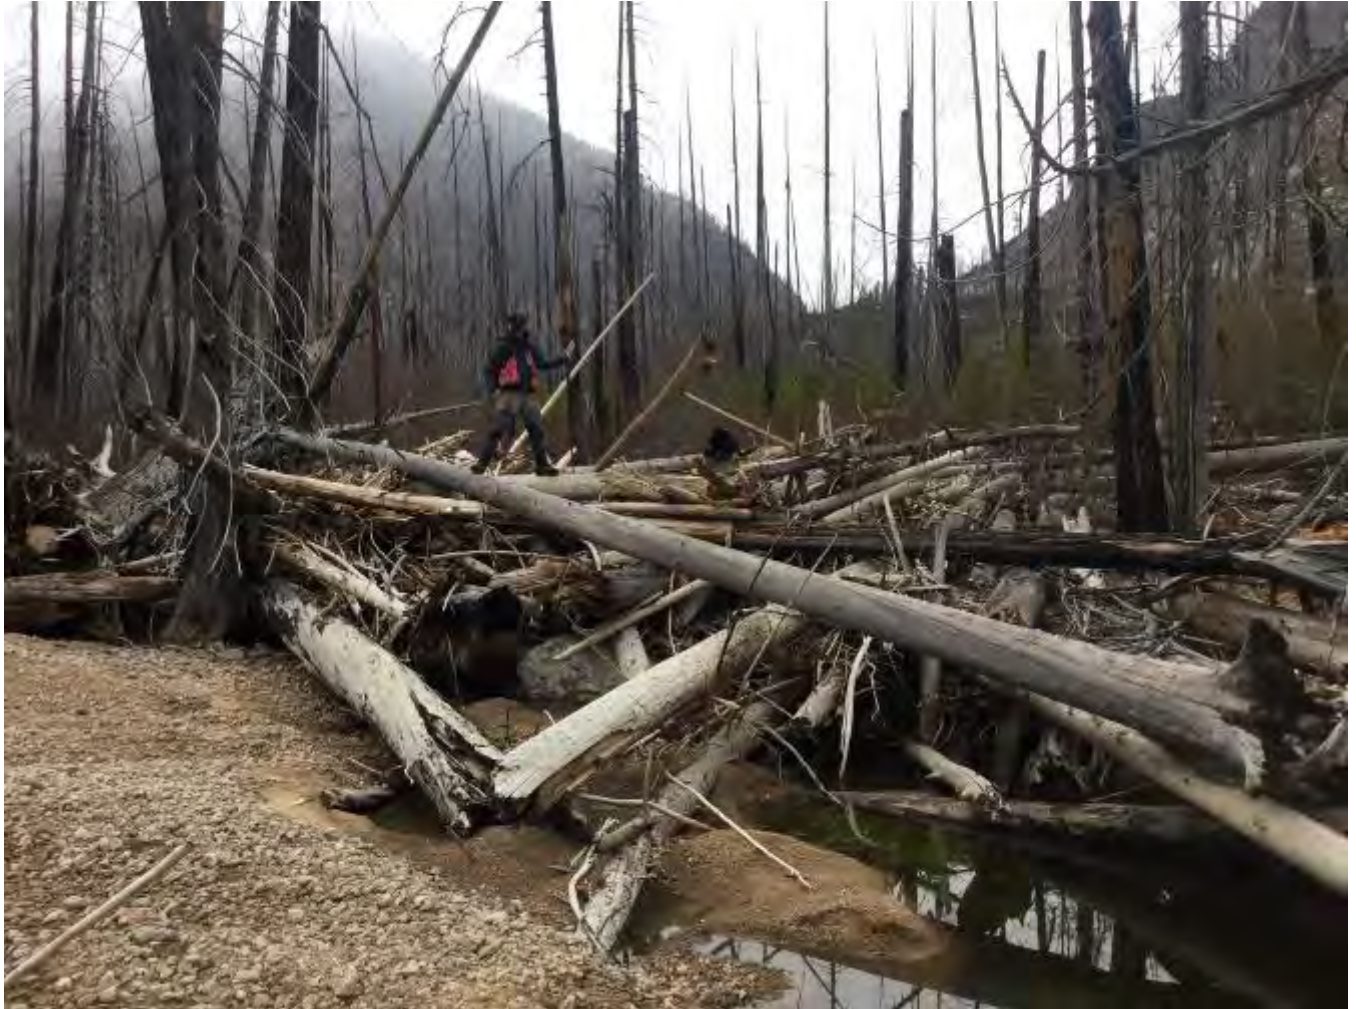
Figure 44. Significant LW resources are present at the upstream end of Reach L2, where the Farewell Fire burned in 2003.

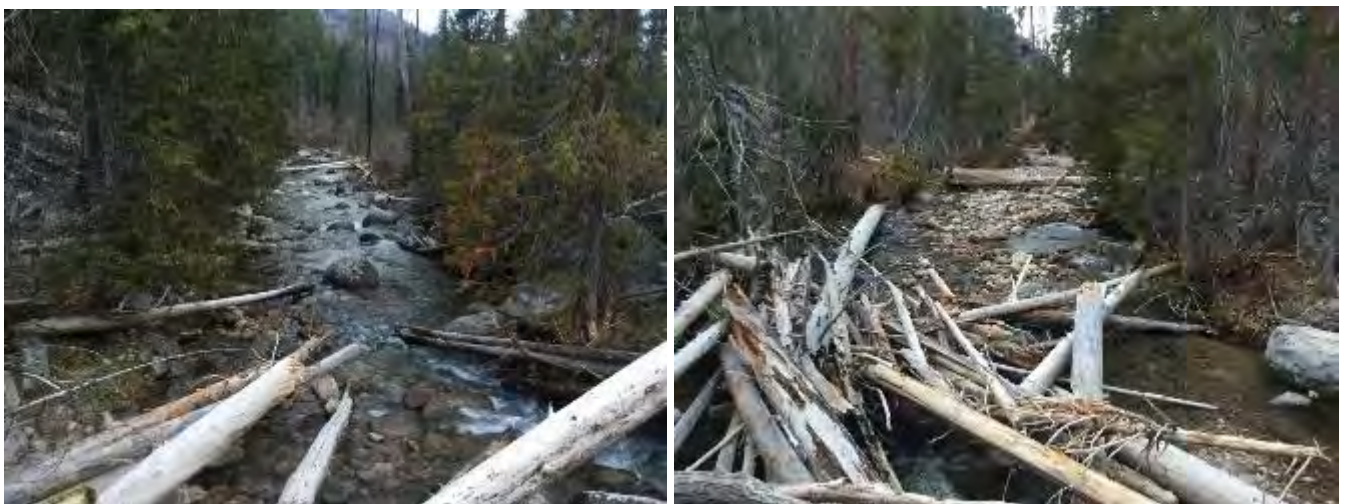
Figure 45. The view looking downstream (left) and upstream (right) from a channel-spanning logjam in Reach L2, showing retention of finer substrates and streambed aggradation above the jam.

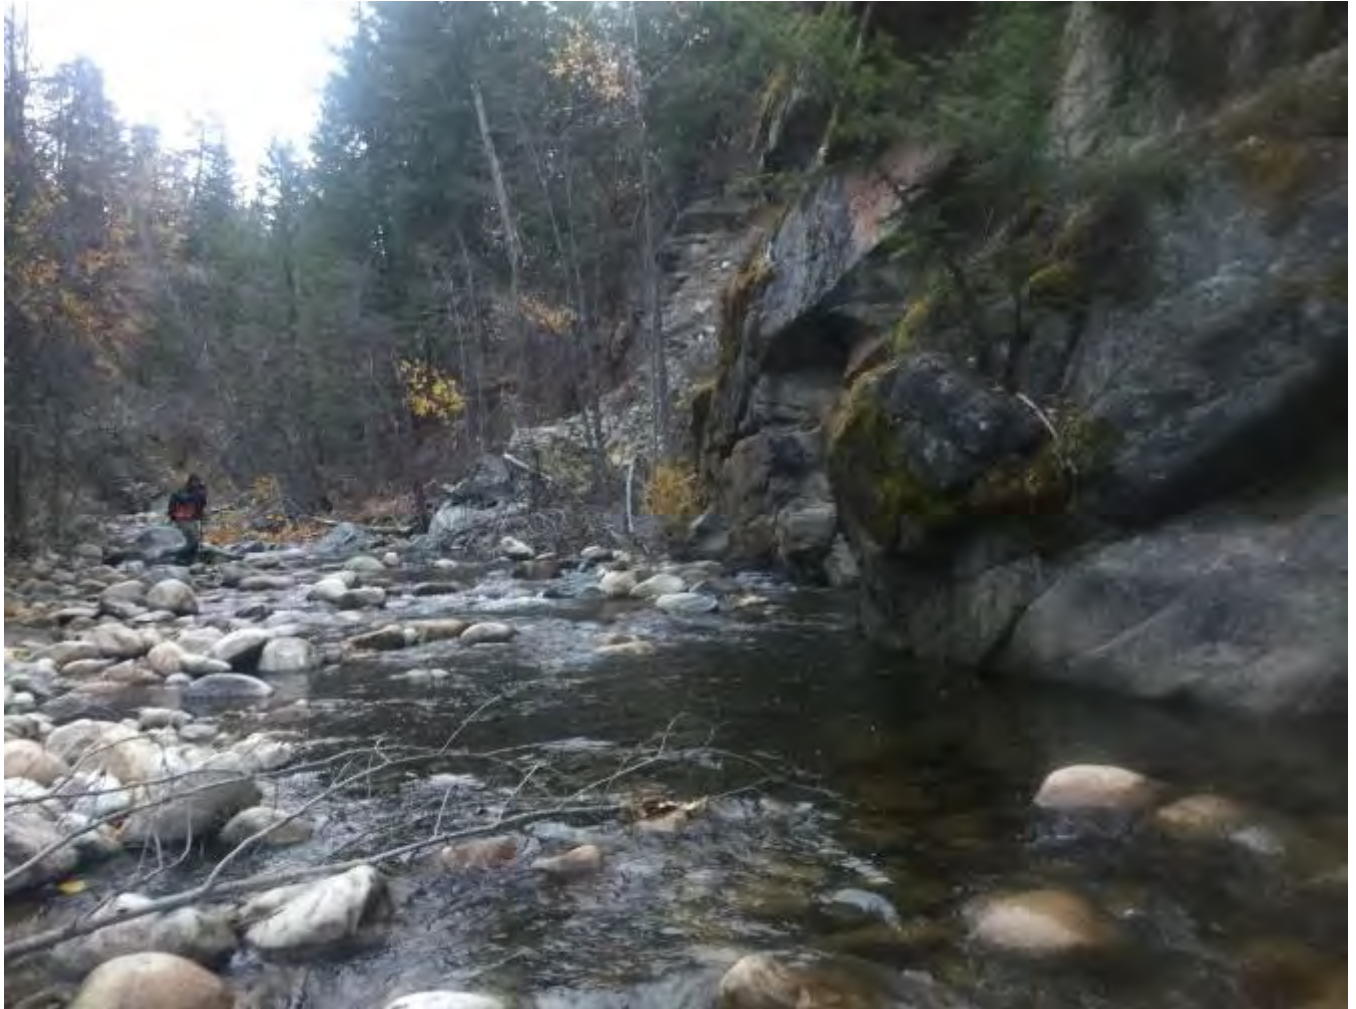
Figure 53. Boulder Creek confined by bedrock walls in the upper half of reach B1.
