FY2007 ANNUAL REPORT

YAKAMA RESERVATION WATERSHEDS PROJECT

BPA Project #1996-031-01-Contract #25127

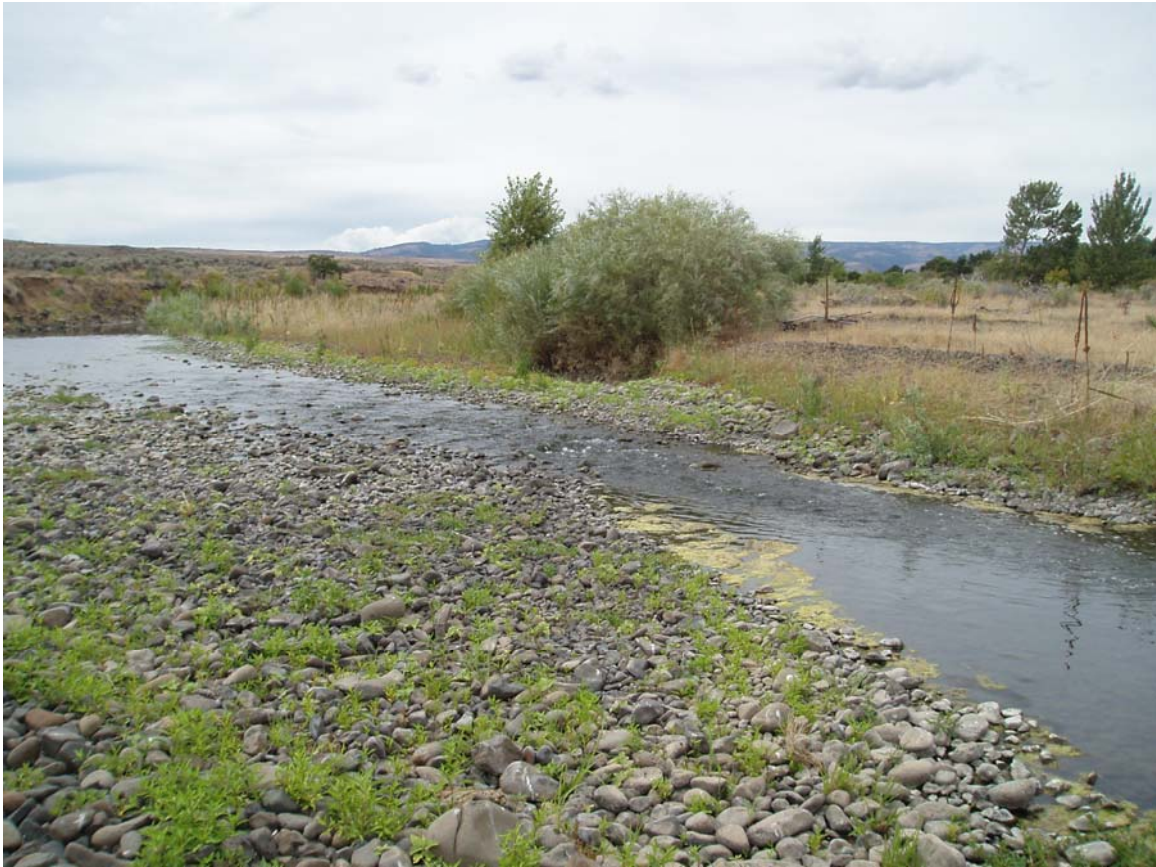
Figure 2 . Toppenish Creek below the three way where flow often goes subsurface during the summer.

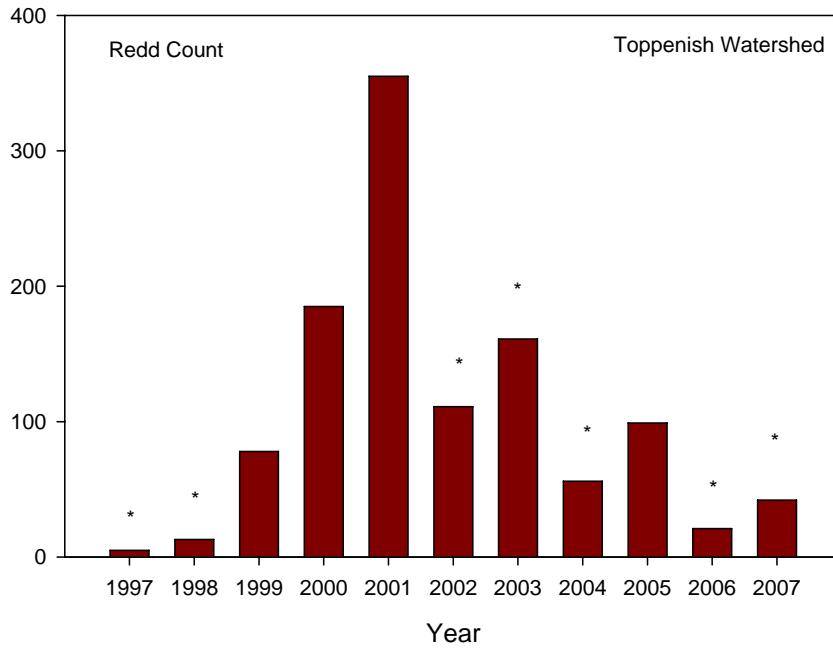
Figure 4. Number of redds in the Toppenish Creek watershed for past 10 years

We identified more redds in 2007 (42) than we found in 2006 (21)(Table 12.) Survey effort and conditions in 2007 were similar to 2006, although the upper portion of Toppenish Creek where the best steelhead habitat is located was not accessible in 2006 until later in the season. This may have accounted for the difference in number of redds

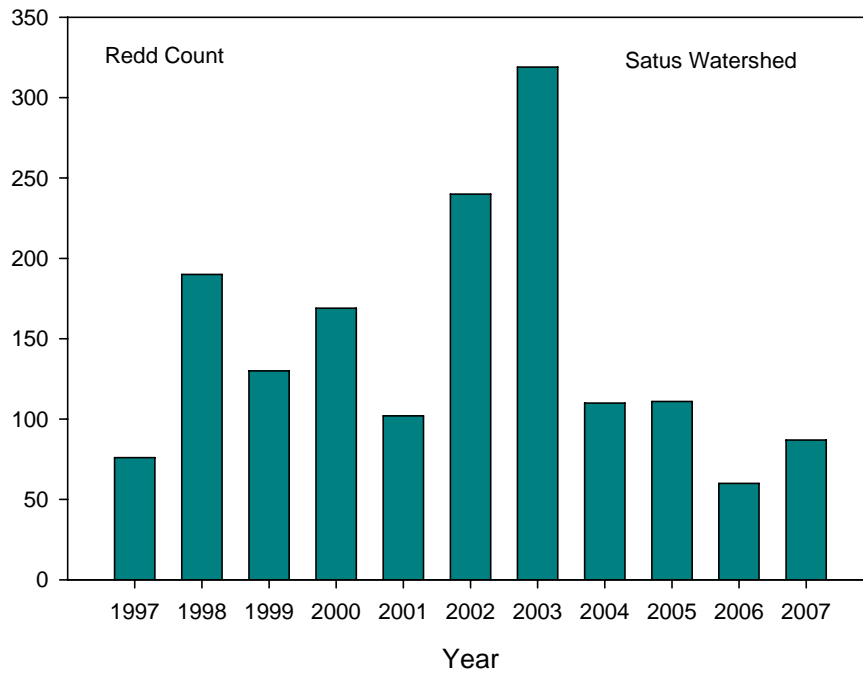
Figure 5. Number of redds in the Satus Creek watershed for the last 10 years

Eighty-seven steelhead redds were identified in the Satus Creek watershed in 2007 compared to 60 in 2006 (Table 13.) It is likely that these counts reflect an increase in steelhead spawning activity in the Satus watershed in 2007 over 2006 because conditions were similar. Although in 2006 only two passes could be conducted on Satus, Dry and Logy Creeks because of manpower constraints.

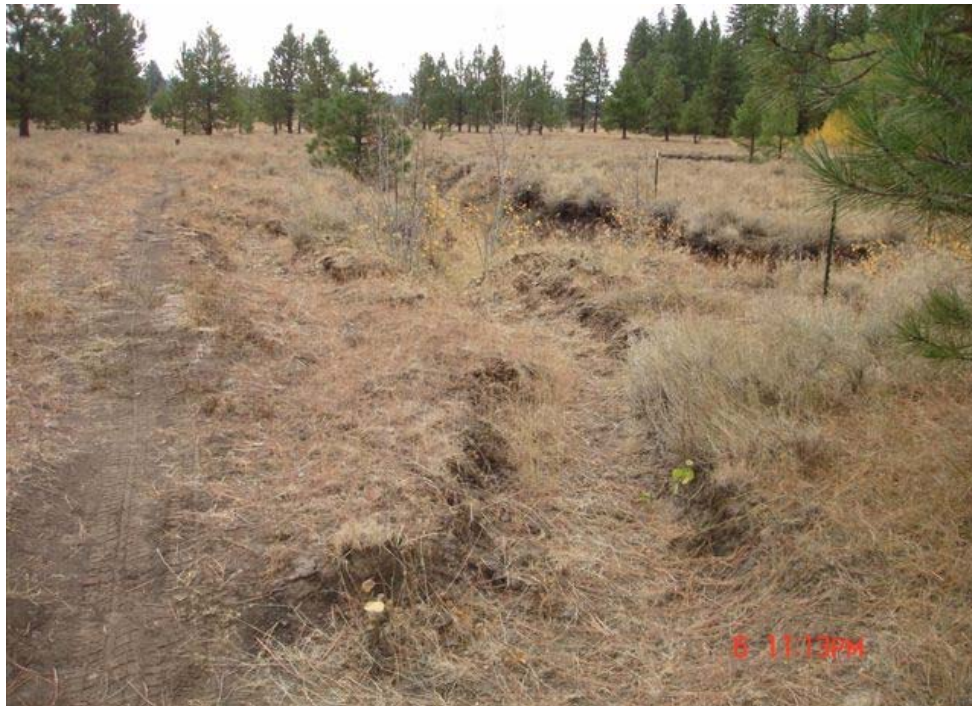
Figure 6. Road vectoring water into incised channel

The Yakama people have historically used this area for root gathering and hunting. Cultural artifacts have been documented in numerous locations within this area. Through the years YRWP staff has been notified by Yakama people complaining about the cattle in the area. Cattle, horses, deer and elk have all played a role in the degradation of this sensitive area. Livestock trails have often served as vectors for runoff that which in turn erode new channels throughout the meadow area (Figure 6.)

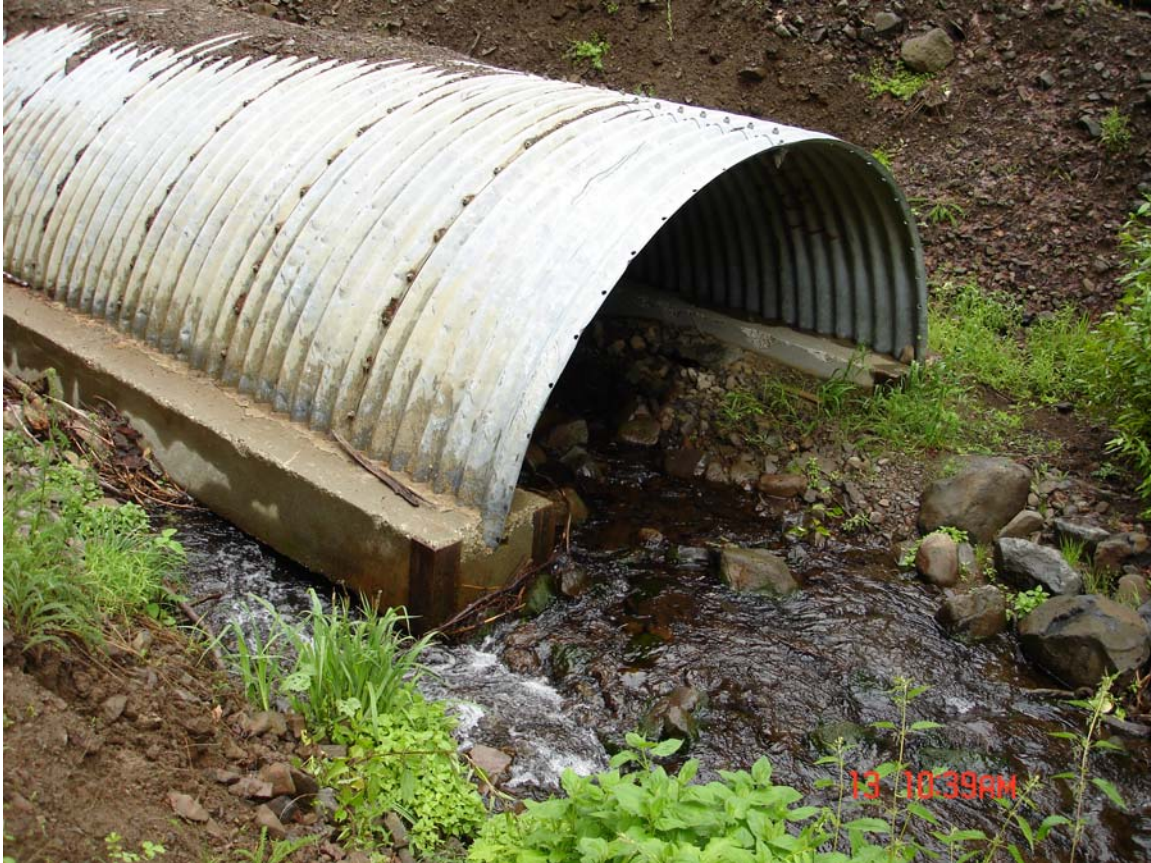
Figure 8. Upper culvert with exposed footings

YRWP staff proposed to remove both culverts and replace them with armored stream fords. The uppermost culvert was already a complete loss (Figure 8); the stream had completely undermined the footing, and is currently flowing outside of the culvert on the left side bank. The lower culvert is still functioning as it was intended, although the stream had undermined a small portion of the right side on the downstream end. The assistance of a professional engineer was employed during the planning phases of this project and a set of construction plans was produced by that engineer.

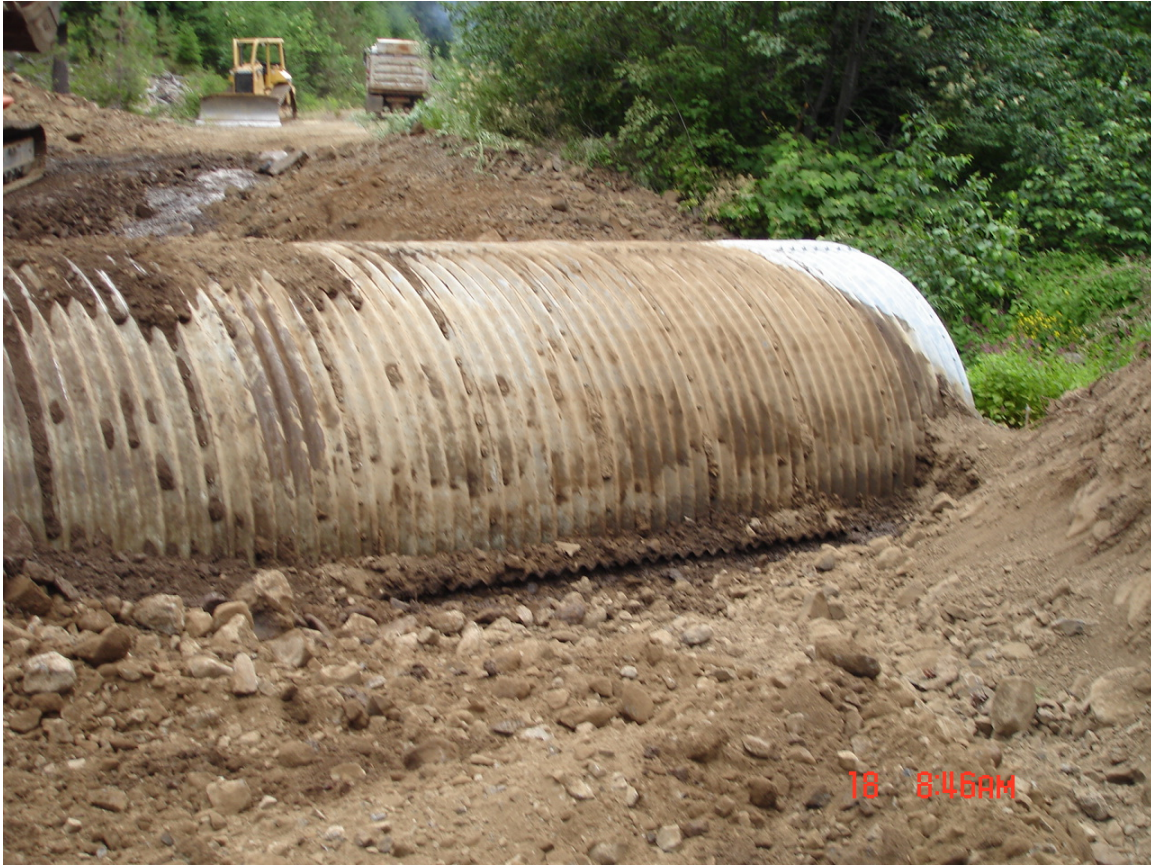
Figure 9. Lower culvert exposed by excavation

Both culverts were removed using a 300 series tracked excavator. The culvert fill was removed until the culvert's structural bolts and concrete footing were exposed (Figure 9.) The bolts were then removed and the culvert was separated from its concrete footing with a cutting torch. The culvert was then removed in pieces in a manner that will allow it to be used again. Care was taken at all times to keep sedimentation of the stream to a minimum.

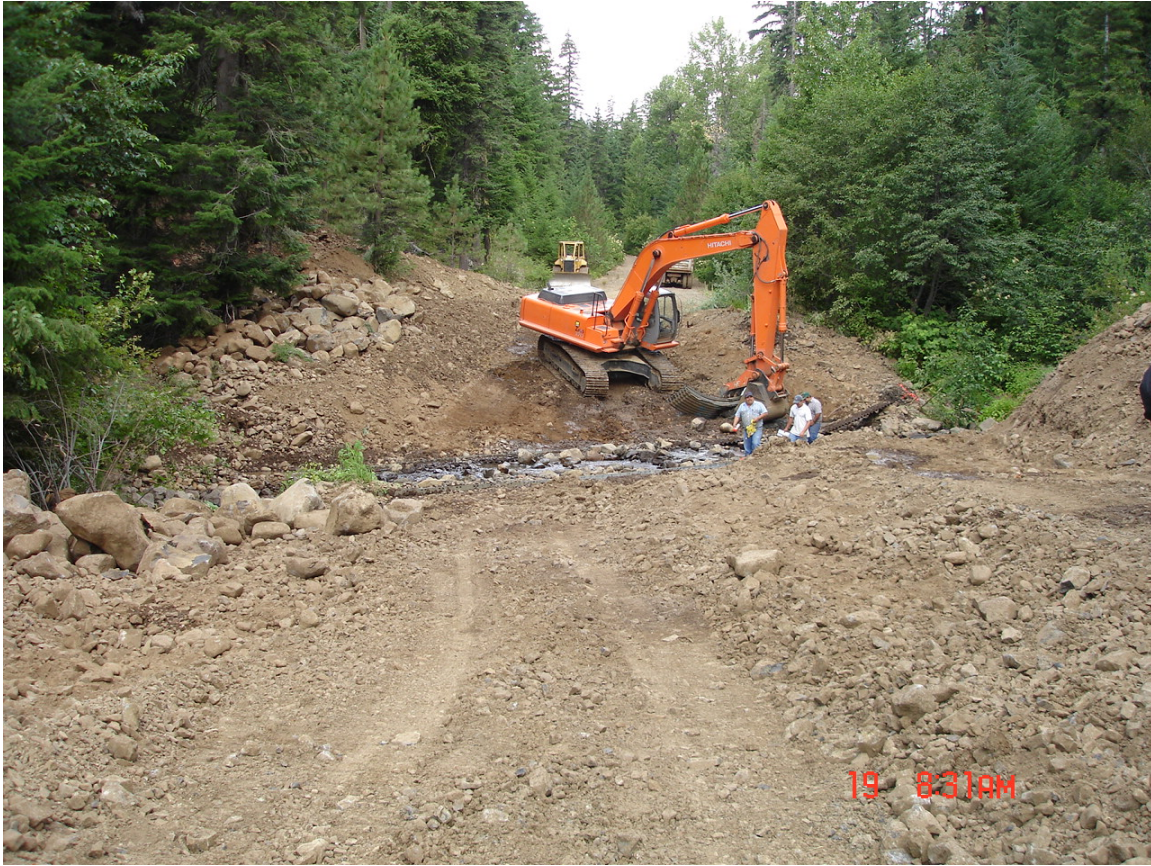
Figure 10. Construction of the new crossing approach

Once the culverts were removed, construction of the new road approaches began (Figure 10.) Our plan was to make the crossings passable for wildland firefighting vehicles. The existing road approaches were sloped back to create an incline that large vehicles can climb out of under a load.

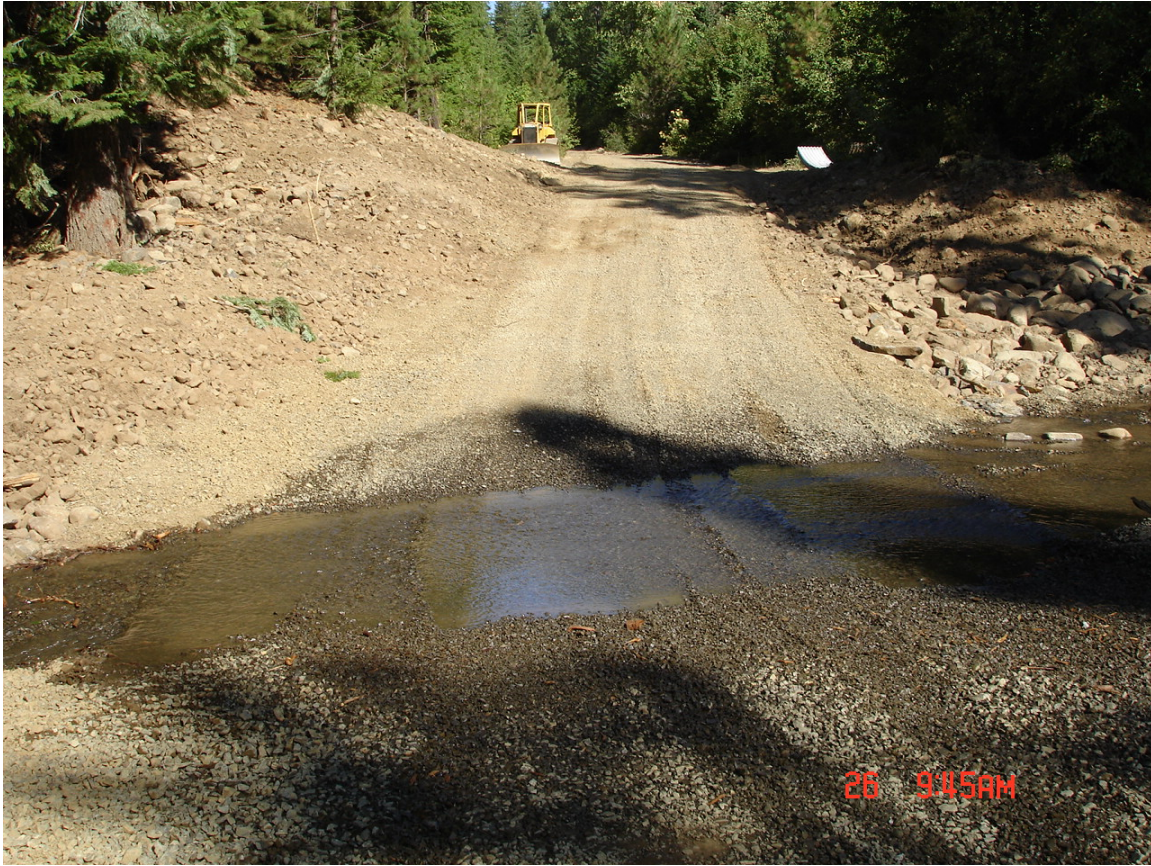
Figure 11. New armored crossing topped with 5/8 minus crushed gravel. Armor rocks are seen on the right.

After the approaches were set, the final task of constructing the armored ford began. 844 cubic yards 2'x3' columnar basalt was hauled in from a quarry approximately 2 miles away. The existing streambed was excavated to a depth of approximately 2' and the basalt was placed so that the upward facing side was flush with the surrounding stream bed grade (the ford does not impound water.) This process was repeated as per the construction plans until both fords were complete (Figure 11.)

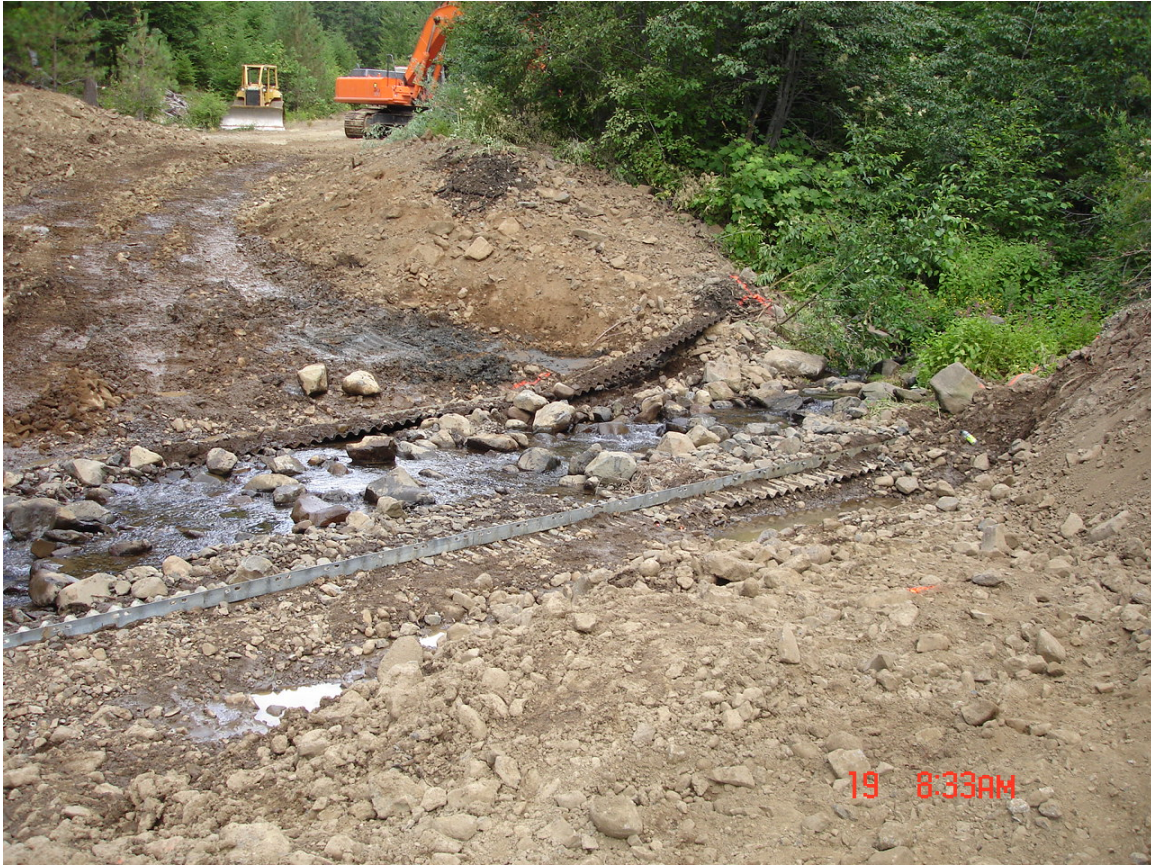
Figure 12. Spring that had been hidden by culvert fill (top left of photo)

The first was our discovery of a small, likely ephemeral, spring (Figure 12) that had been hidden by the culvert fill. The spring was a surprise and a problem because it discharged directly onto the new road surface, making it very soft. Our solution to this problem was to excavate more of the dirt from the roadway and replace it with large rock. This allowed the spring water to infiltrate into the interstitial spaces around the large rock, below the surface grade of the road. The large rock was covered with crushed top-course rock to create a smoother finished road surface.

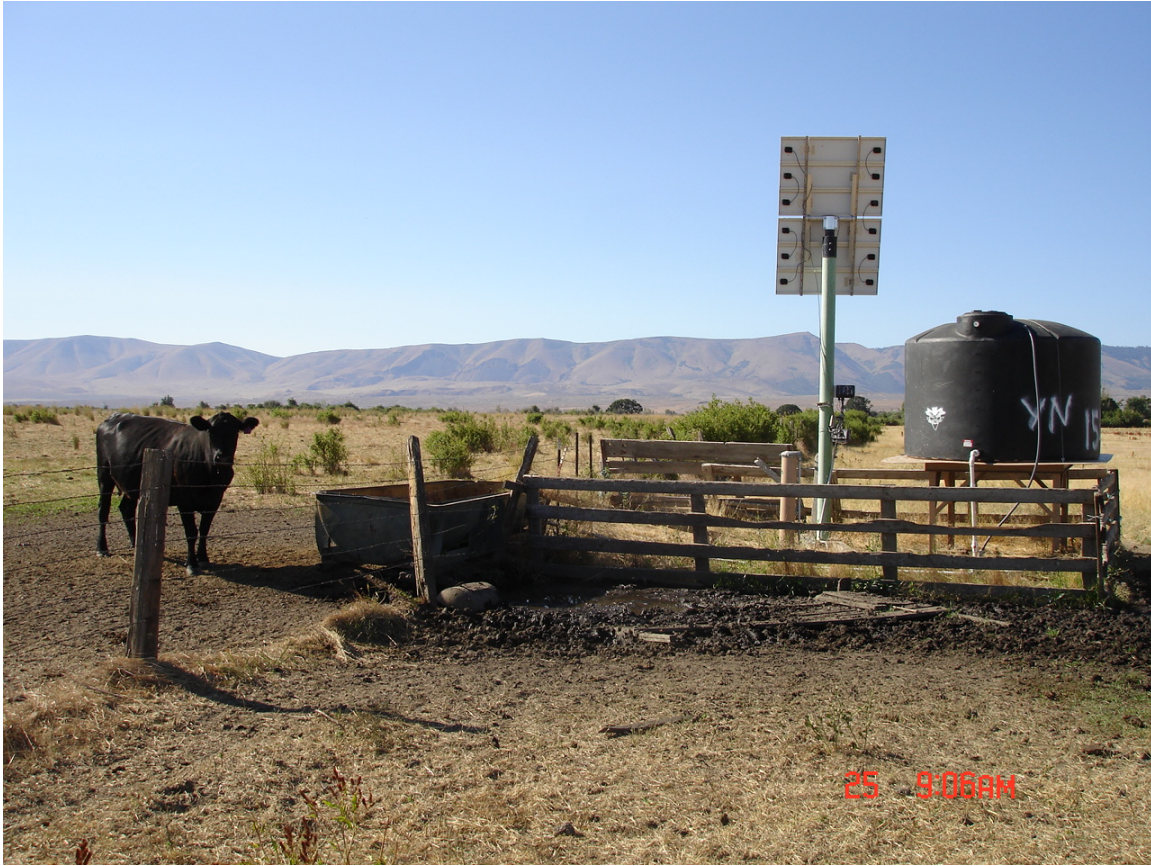
Figure 14. Stock pump and watering trough.

YRWP staff repair and maintain 33 solar powered stock pumps (Figure 14) and 3 stock water pipelines in the Ahtanum and Toppenish Watersheds. These pumps and pipelines are used to provide stock water when YN minimum instream flow criteria mandate the cessation of irrigation. It is necessary to have many wells because there are many individual cattle operations, several of which may not always be served by a single well. Operating these wells has been a difficult task which we are still in the process of perfecting. Project staff anticipate constructing more stock pipelines that will be associated with the existing stock pumps. This will better meet multiple users' needs while only using one stock pump.

Routine maintenance of these facilities includes fixing a significant amount of broken PVC plumbing (often associated with cattle damage), replacing the electrical pieces of the pump's control systems as they wear out and upgrading the water troughs associated with the pumps.

Project staff have found that most of the infrastructure associated with the watering troughs (hoses, float switches, trough supports etc.) were too lightly built. Over the last year we have been working to upgrade this infrastructure with more rugged float switches, flexible PCV hoses instead of garden-type hoses, more sturdy stanchions for the troughs and gravel aprons around the troughs to prevent soil erosion.
