**Yakama Nation**  
**Upper Columbia Habitat Restoration Project**  
**ANNUAL REPORT**

JANUARY 1<sup>ST</sup>, 2014 THROUGH DECEMBER 31<sup>ST</sup>, 2015  
*BPA Project #2009-003-00-Master Agreement #56662*  
*Releases 2, 3, 4, 27, 58, 65, & 88*

**Attachment 1 – Constructed Projects As-Builts**

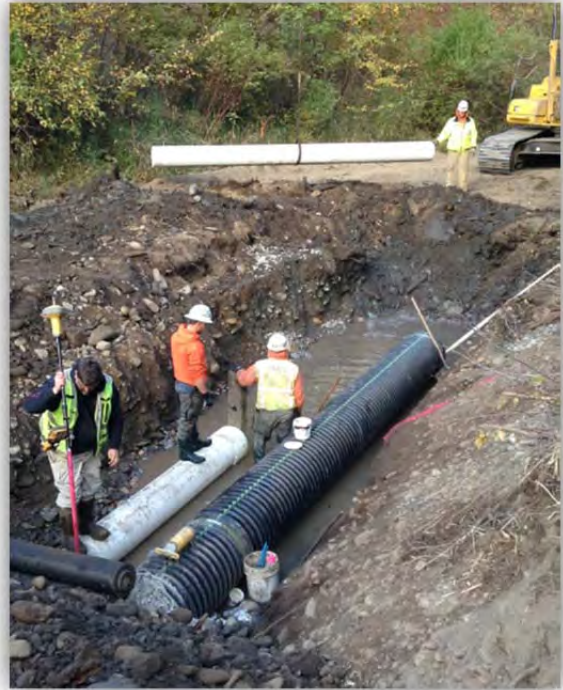
This project used a groundwater infiltration gallery to create 2,000 linear feet of new perennial flow alcove side channel connected to the Methow River. The project was first conceived of in 2009, but the project was postponed for implementation until 2015, following the Yakama Nation/WDFW MOU for habitat projects on WDFW lands. This project has already been used by juvenile spring Chinook salmon as winter and summer low flow rearing habitat. In the summer of 2016, a spring Chinook redd was marked within the side channel. Currently the infiltration gallery is producing about 4.2 cubic feet per second flow into the top end of the alcove side channel. Stream temperatures have maintained roughly seven degrees Celsius better than main channel conditions during low water times of year (summer and winter).

2,000 linear feet of perennial flow alcove side channel was created.  
21 large wood structures with associated scour pools were installed within the side channel.

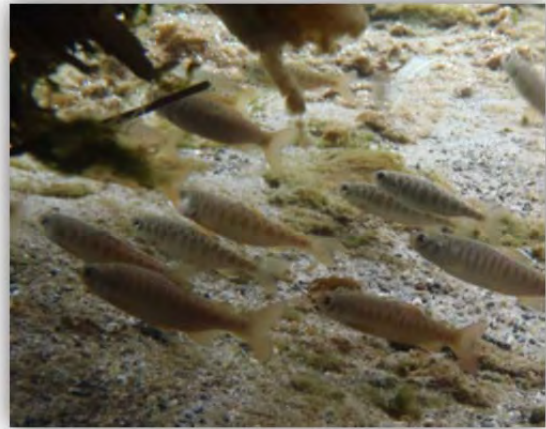
This project used a groundwater infiltration gallery to create 4,500 linear feet of new perennial flow alcove side channel connected to the Methow River. The project was implemented in 2014 and involved 12 private landowner and/or local government participants. The new perennial flow alcove side channel is already being used by thousands of juvenile salmonids as rearing habitat and temperature refuge. Steelhead routinely spawn in the channel in spring, and coho salmon spawn in the channel in the fall.

4,500 linear feet of perennial flow alcove side channel was created. 56 large wood structures with associated scour pools were installed within the side channel.

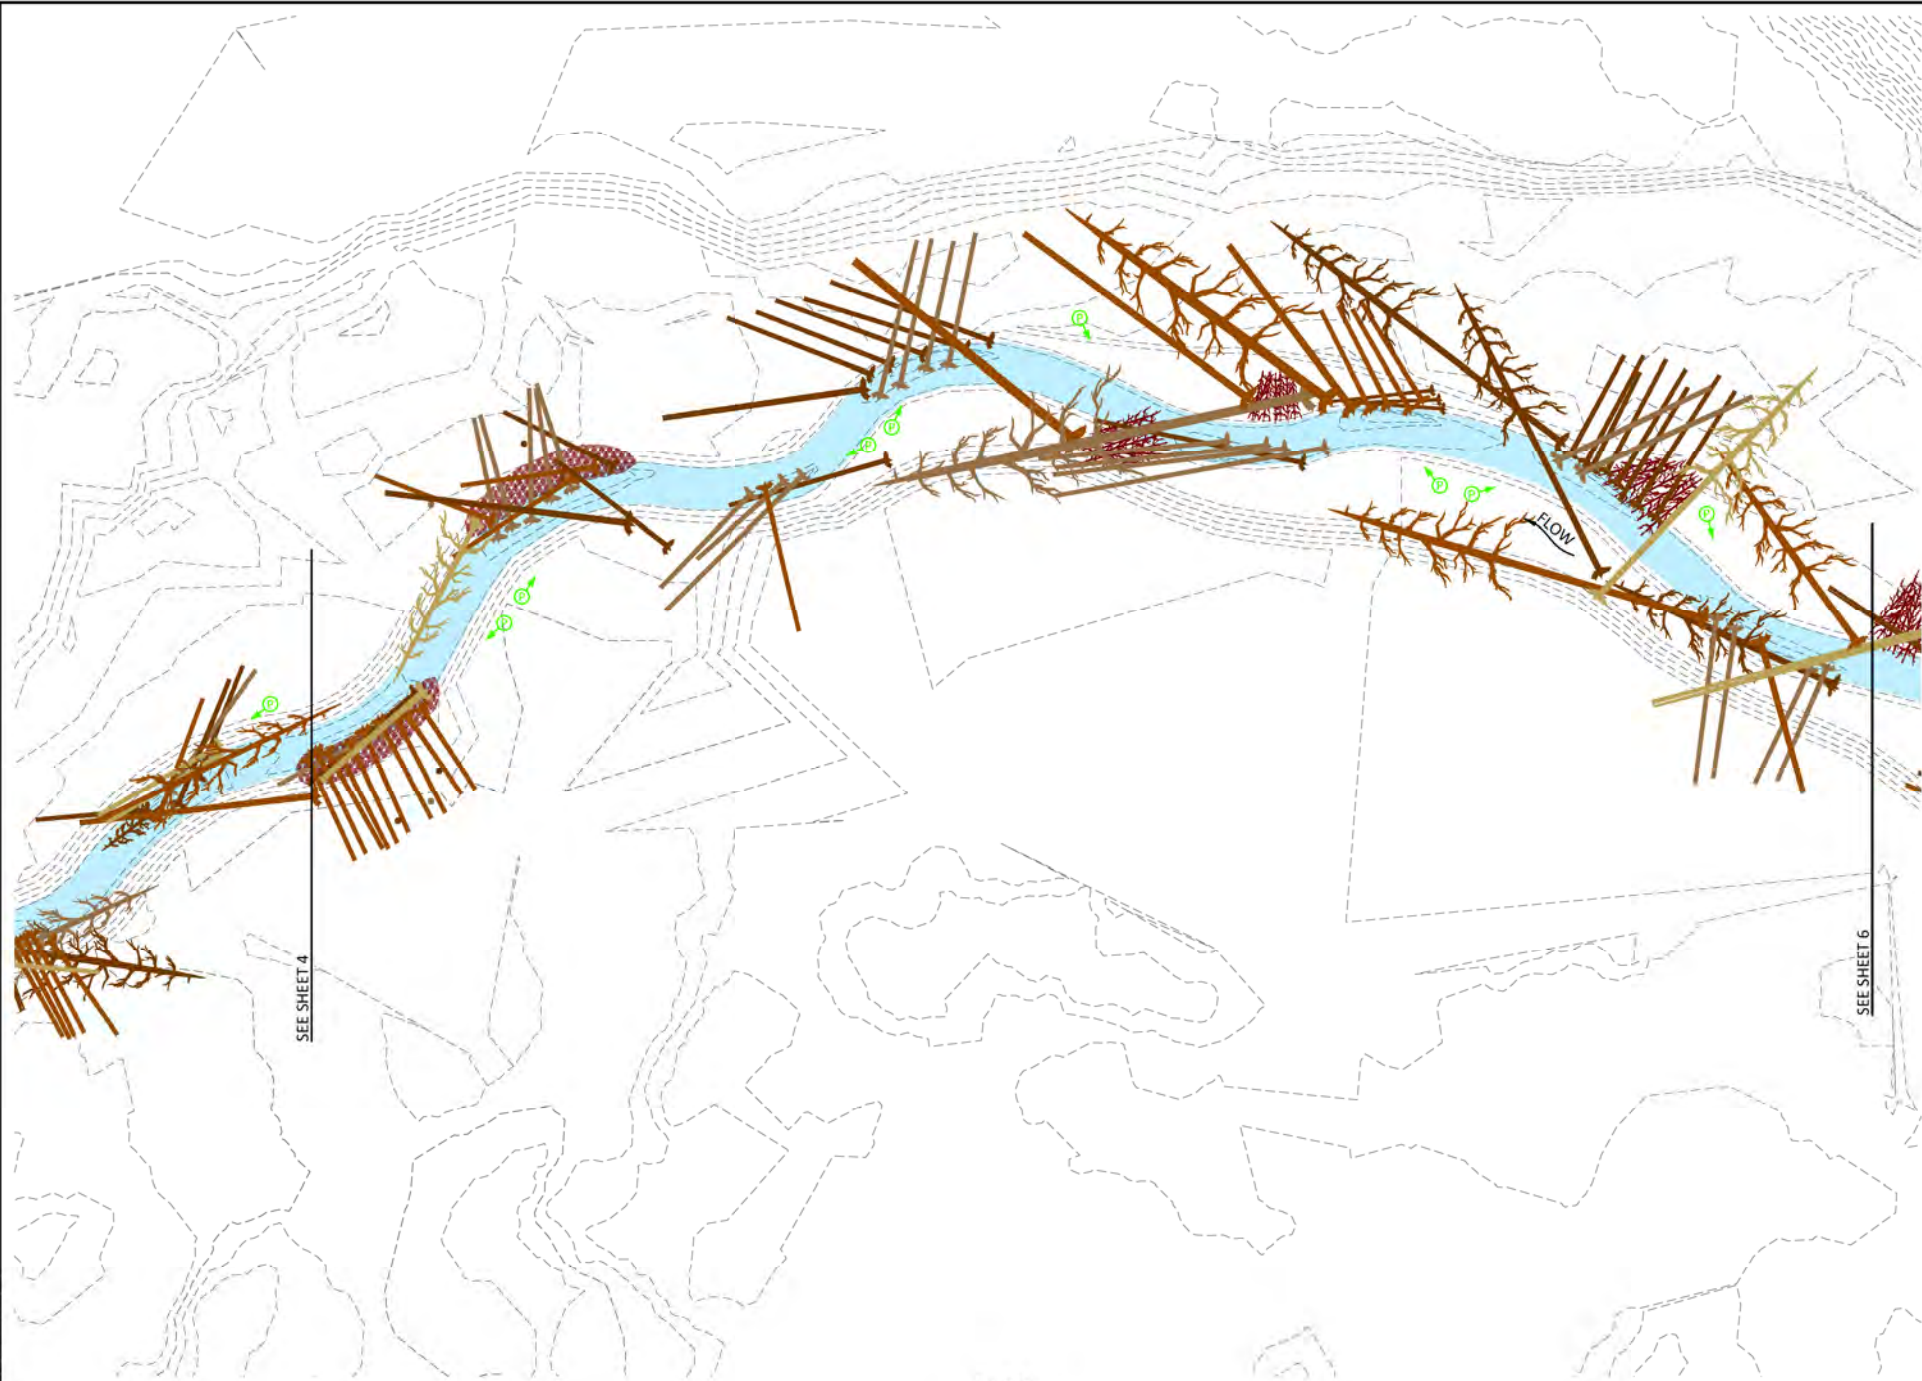
1. EACH LOG WAS STABILIZED BY PARTIAL BURIAL OR ATTACHMENT TO ADJACENT LOGS AND EXISTING TREES.
2. SALVAGED SLASH WAS INCORPORATED INTO THE VOIDS BENEATH AND BETWEEN THE LOGS.

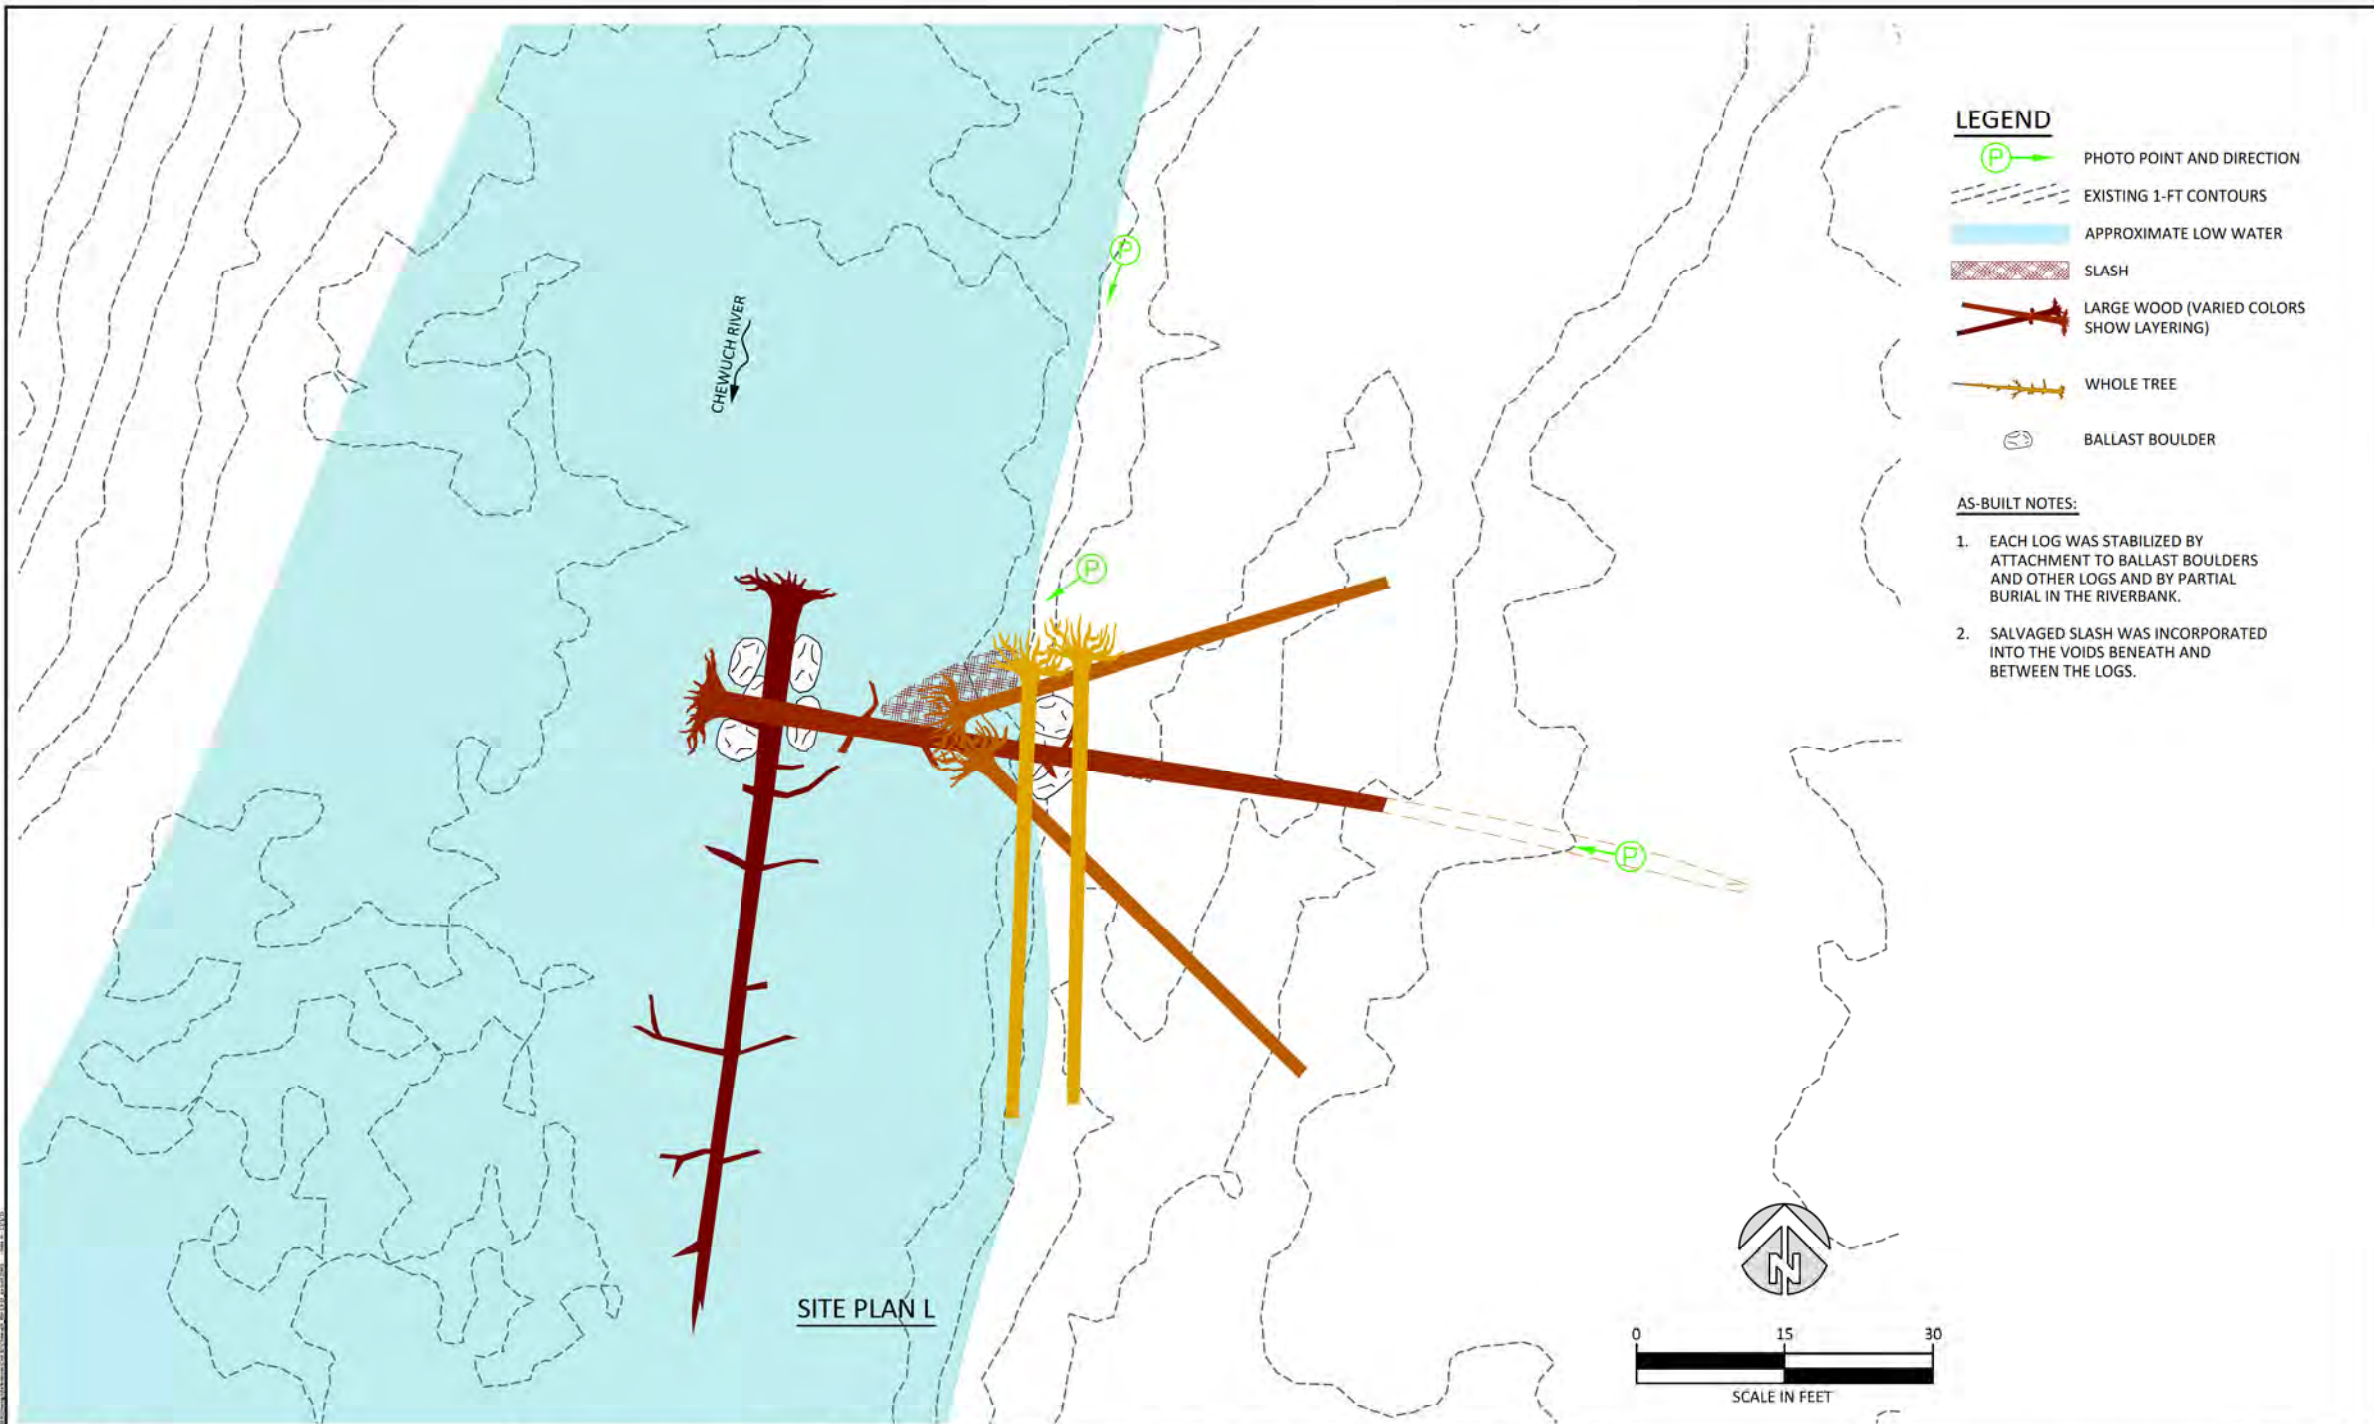
SITE L MONITORING

- AS-BUILT NOTES:**
1. EACH LOG WAS STABILIZED BY ATTACHMENT TO BALLAST BOULDERS AND OTHER LOGS AND BY PARTIAL BURIAL IN THE RIVERBANK.
  2. SALVAGED SLASH WAS INCORPORATED INTO THE VOIDS BENEATH AND BETWEEN THE LOGS.
