FY2015 ANNUAL REPORT

MARCH 1, 2015 THROUGH FEBRUARY 28, 2016
YAKAMA RESERVATION WATERSHEDS PROJECT
BPA Project #1996-035-01-Contract #35636

A. Lakebeds Meadow Road Decommission Project

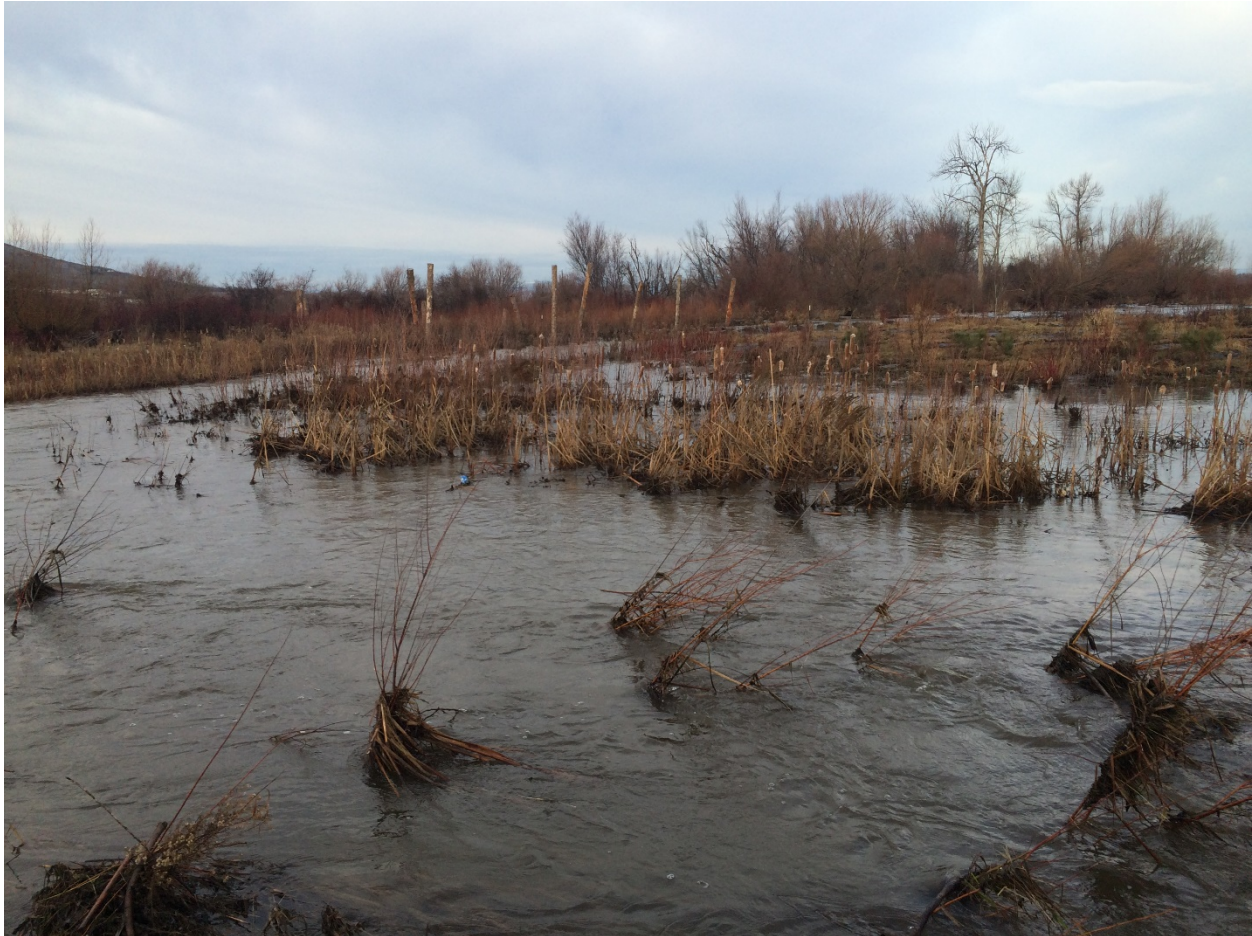
Lasalle Flood plain reconnection and bank stabilization project (Photo 2015).

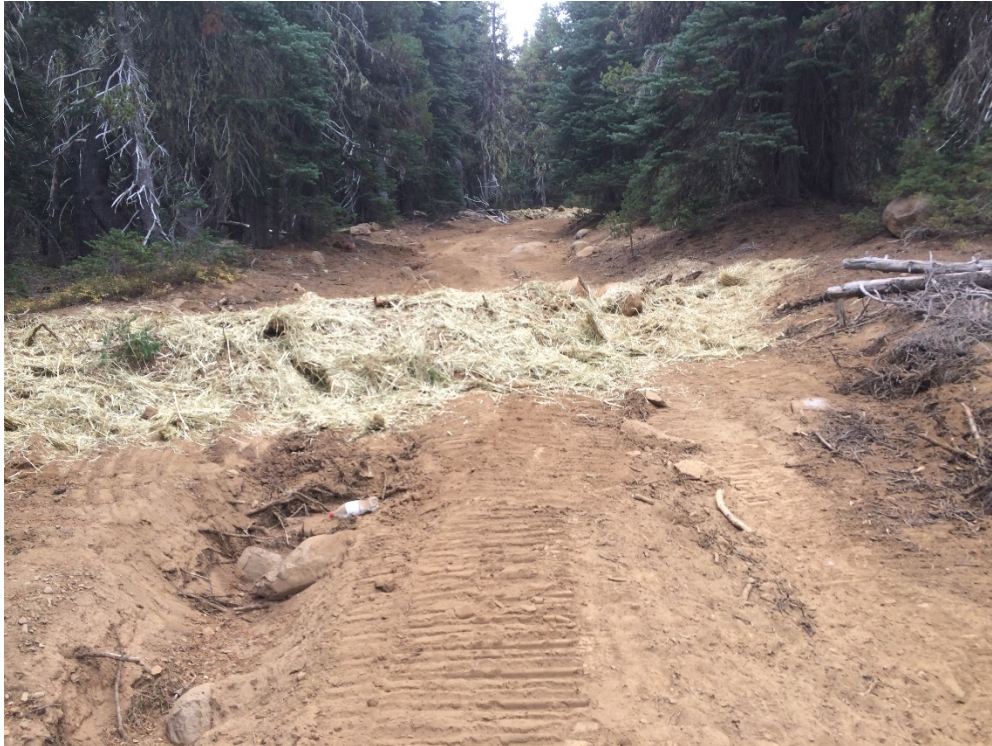
road to drain properly. Four water bars total were constructed, with the furthest south water bar constructed to prevent access by motorized vehicles. The disturbed areas were seeded and covered with certified weed free straw to mitigate erosion and sedimentation (Figure 3).

Figure 3 Lakebeds road disturbed areas that was seeded and covered with weed free straw.

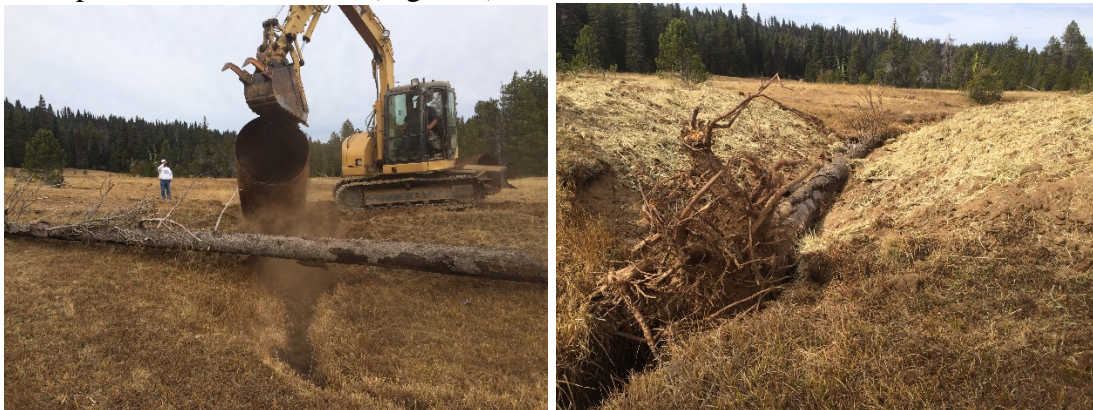
The culvert within the meadow (Logy Creek) was then removed and disposed. The cultural resources monitor authorized the sloping back of the banks where the culvert had previously been and also authorized the placement of a wind-blown log with root wad in place of the culvert to help stabilize the channel (Figure 4).

Figure 4 Removal of culver and wind-blown debris with root wad placed in channel

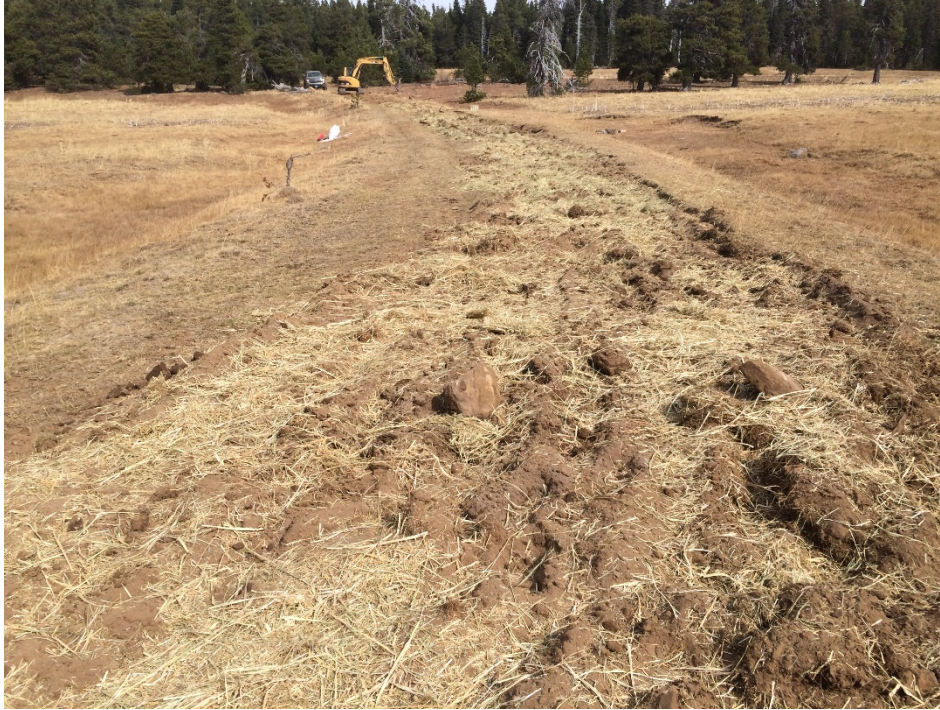
The road prism was then ripped with a tooth on the excavator bucket, seeded, and straw mulch was applied to the exposed surfaces (Figure 5).

Figure 5 Ripped road resseeded.

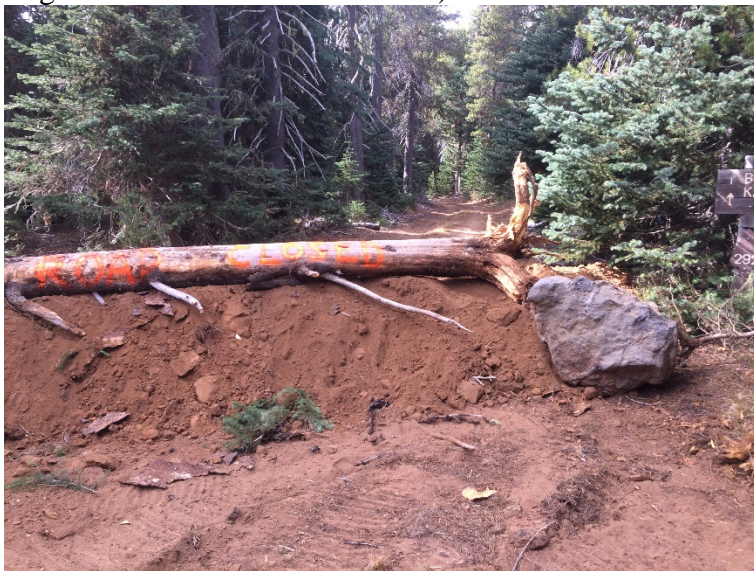
A berm at the North side of the meadow was then constructed to exclude vehicles and close the road entirely (Figure 6). Another undersized culvert was then removed further east that bisected the Boundary Road and was intended to convey Satus Creek flows (Logy Creek and Satus Creek originate from Lakebeds Meadow).

Figure 6 Closed road from allowing vehicles to enter the meadow.

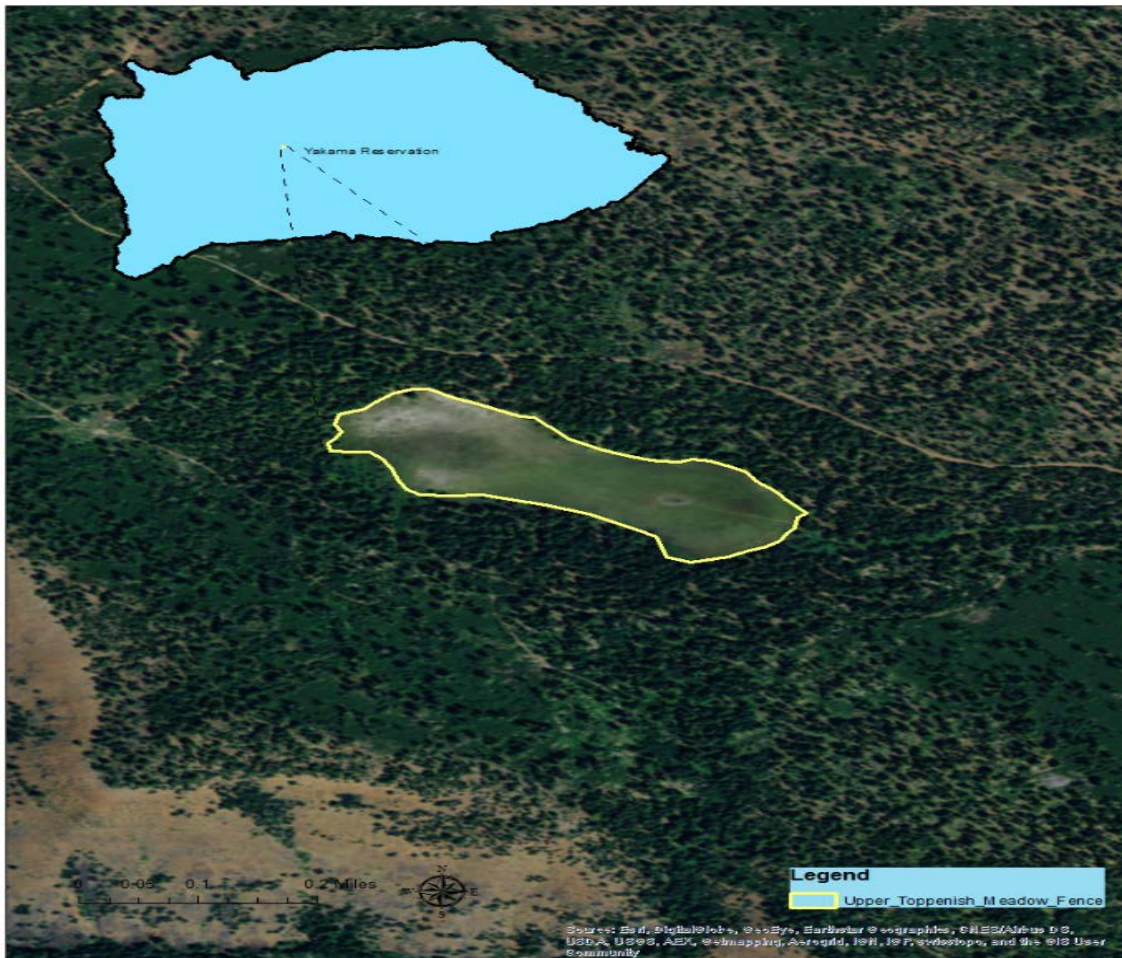
Upper Toppenish Meadow Buck and Pole Fence is 75% completed. The cougar creek fire closed the forested area slowing down the progress of the fence (Figure 7). Once the fire was contained and the closed area was open staff tried to finish the fence, but weather played a factor in the ability to access the site. Plans to finish the fence will begin once access is attainable.

Figure 7. Upper Toppenish Meadow buck and pole fence line. Entire perimeter fence will be completed once accessible in 2016.

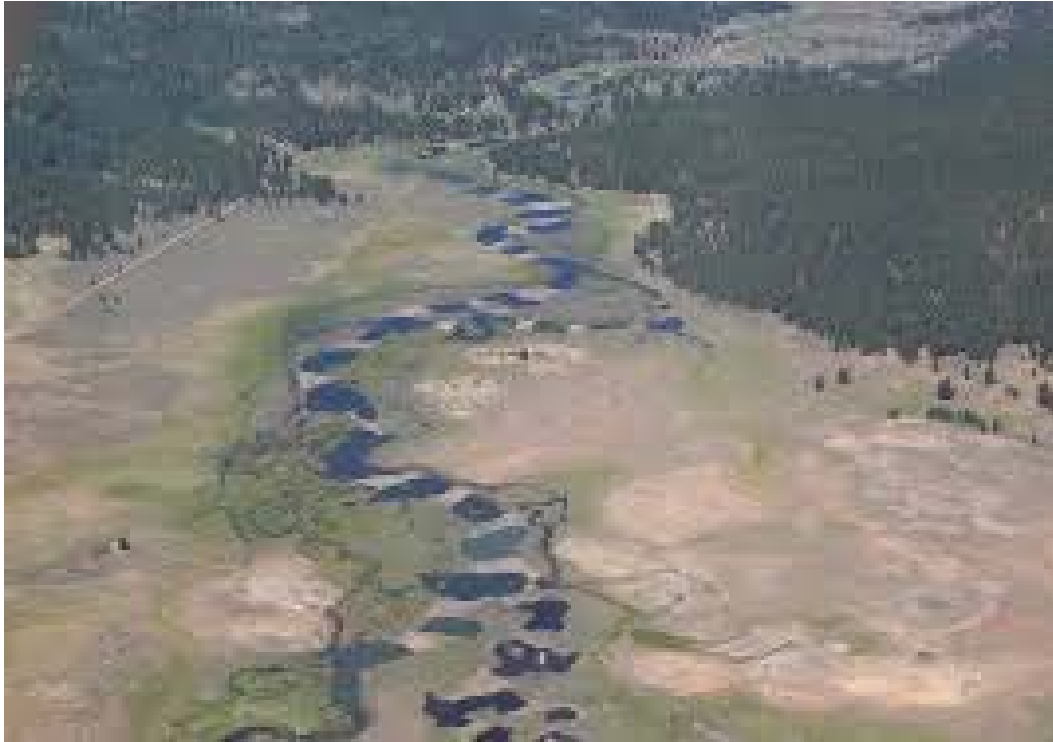
YN DNR staff met on the alternatives and came to an agreement to extend the fence line to circumference the entire starvation flats meadow to prevent further degradation by ungulates and to develop an engineered plan to construct the pond and plug method (Figure 10). The pond and plug method would have the most benefits to salmonid habitat by raising the water table for groundwater storage, support native vegetation, restore degraded gullies, thus allowing for cooler release flows during the summer. This final engineer design of the pond and plug method will be completed by the end of February.

Figure 10. Example of the pond and plug method photo is from Plumas National Forest report (USFS 2010, Photo: Jim Wilcox).
