**Yakama Nation**  
**Upper Columbia Habitat Restoration Project**

**ANNUAL REPORT**

JANUARY 1<sup>ST</sup>, 2016 THROUGH DECEMBER 31<sup>ST</sup>, 2016

*BPA Project #2009-003-00*  
*Master Agreement #56662 - Releases 58, 88, 111, and 119*

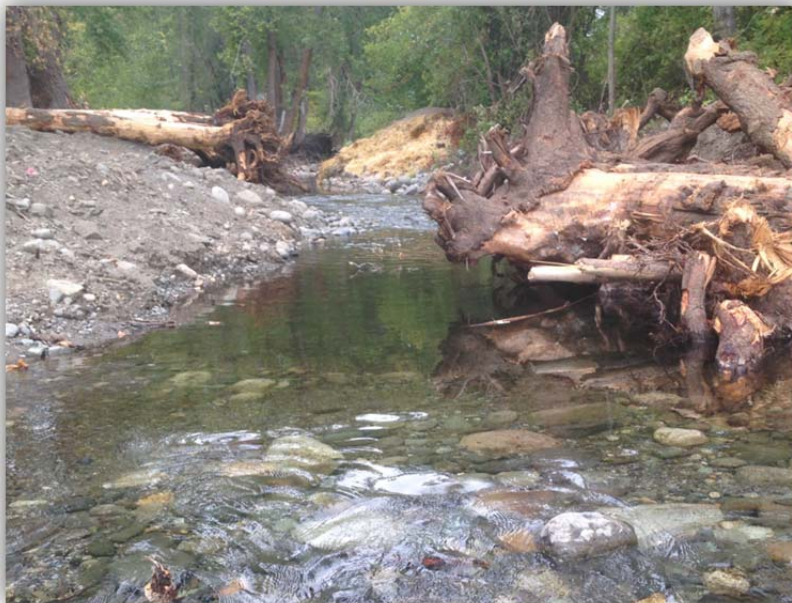
600 linear feet of groundwater fed alcove channel was created with a downstream connection to the Twisp River.

5 acres of highly disturbed floodplain area were planted with native trees, shrubs, and herbaceous species.

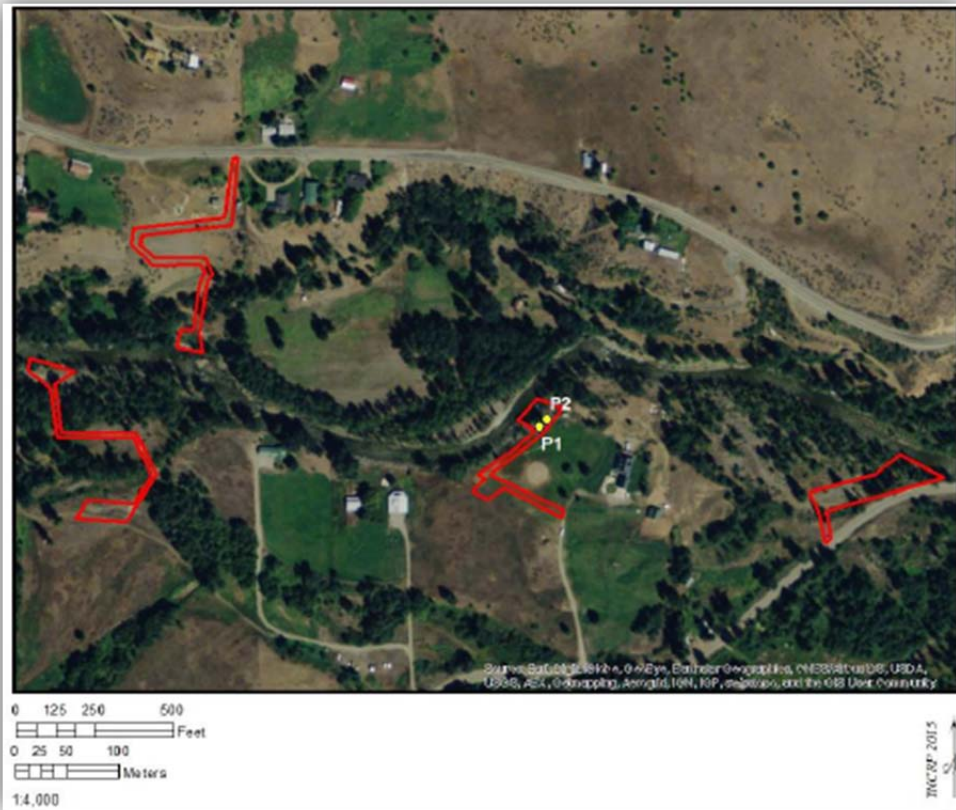
In 2016 we decided to indefinitely postpone this project as a stand alone restoration action due to an engineer's concerns about boater safety, ballasting limitations, and private property access. Elements of the postponed project will be incorporated into future work being developed in the Lower Twisp Assessment Unit that involves more off-channel habitat restoration.

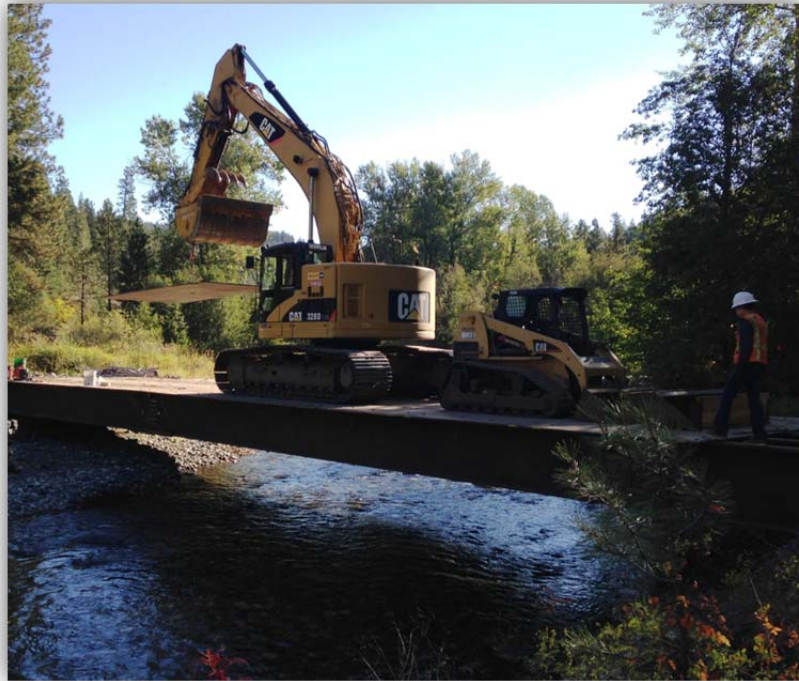
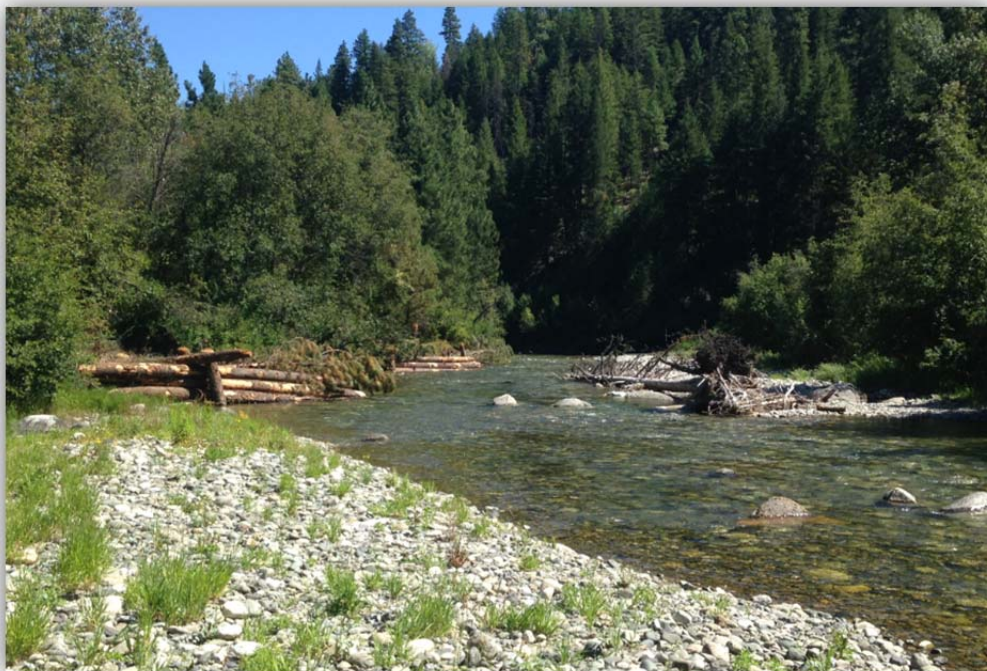
4 main channel margin large wood structures installed consisting of 60 imported logs with roots and 5 whole trees salvaged from the nearby floodplain.

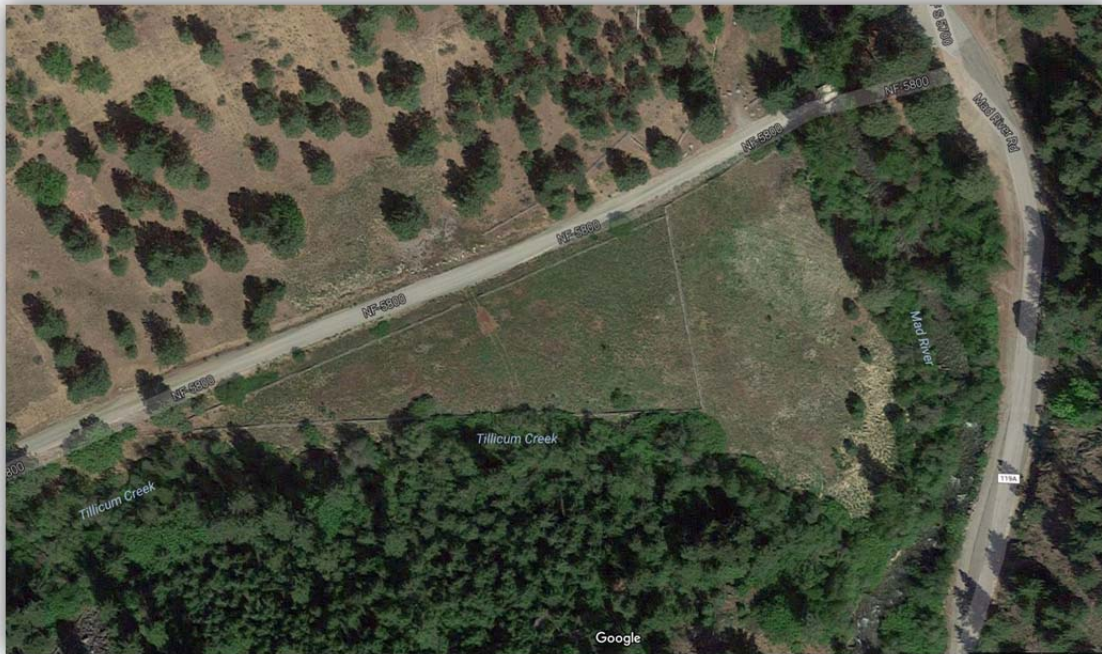
Tillicum Fan is located off of FS-5800 in the Wenatchee National Forest at the confluence of Tillicum Creek and the Mad River (tributary to the Entiat River). The site is the location of an old homestead and currently used as a seasonal sheep grazing site. Tillicum Creek is highly incised and does not regularly come in contact with the floodplain. As recent as late summer/fall 2015, it has been used as a sheep grazing pasture and has some old plantings of alfalfa. The YN is partnering with the USFS to reengage the creek with the floodplain, plant with native riparian species, and discontinue use of sheep grazing in the area. In 2016 we collected survey data of the site and began creating restoration concepts in partnership with the Forest Service. Additional design work is planned to take place in 2017, with project implementation scheduled for 2018.

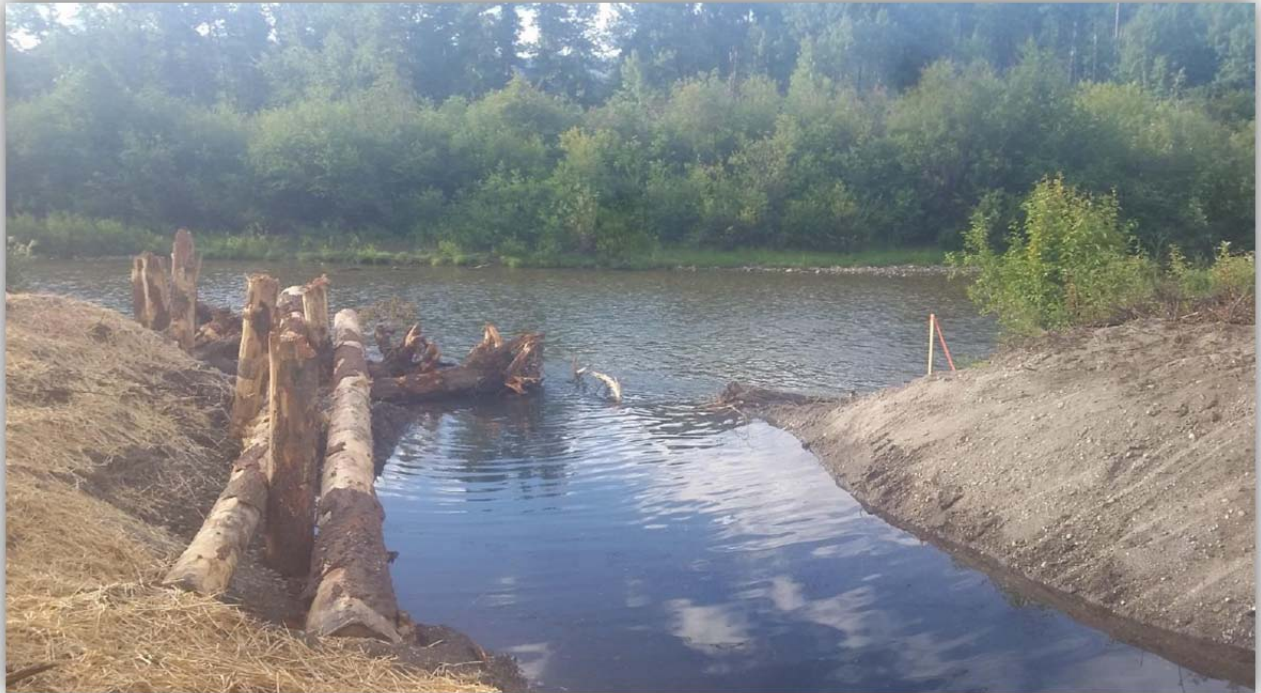
For details about the location of differing project elements on the site please refer to Attachment 1 – Constructed Projects As-Built.

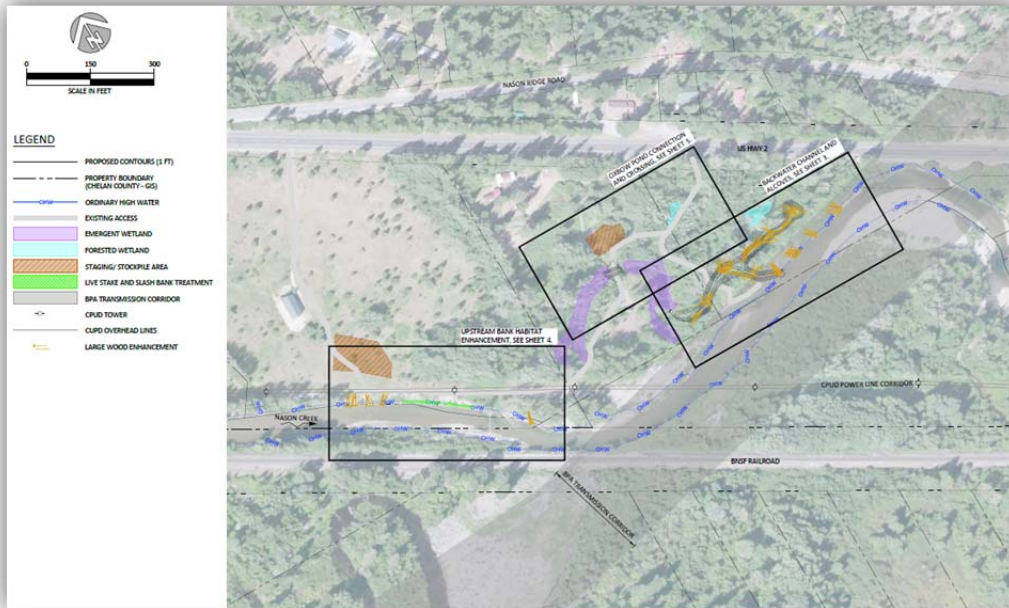
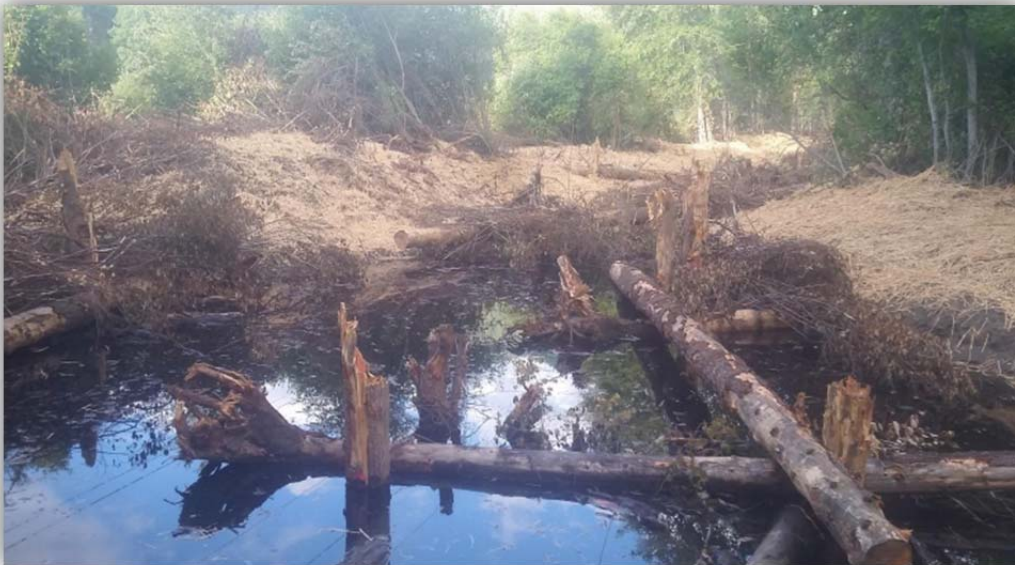
240 linear feet of live stake and slash bank treatment.

200 cubic yards of floodplain trash removed.

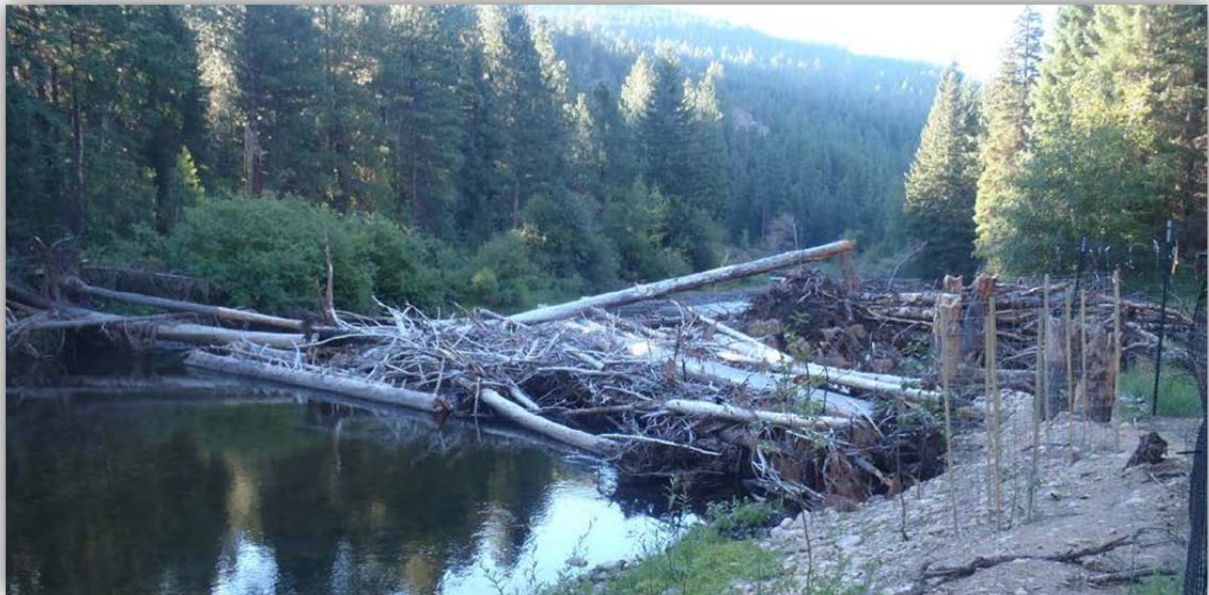
This project was implemented in 2015 on WDFW lands near river mile 12 on the Chewuch River. In April 2016, seven months after project completion, a peak flow runoff event caused a large spruce tree from the opposite bank from the project site to fall perpendicular to the main Chewuch River channel, causing the top of the tree to become lodge against the upstream face of the constructed River Right bar apex log structure. Naturally recruited large wood and slash moving down the flooded Chewuch River then collected against the spruce tree, forming a channel spanning log jam.

During the flood, the Chewuch River responded to the lost hydraulic capacity of the main channel in two ways. First, it sent a large percentage of flood flow down the constructed side channel that would not have occurred otherwise. Second, the flows vertically scoured beneath the accumulating large wood, creating a roughly 10 foot deep pool below the structure. The high water flowing down the side channel shifted some habitat wood at 3 locations, causing scoured banks and pools to increase. At one of the sites the water moved 2 short pieces of habitat wood in such a way as to block the channel. It was recommended that 2 of the pieces of wood be pulled back to open up the channel in order to prevent a full blockage and sediment aggradation. The action of pulling the two pieces of LWD back took place using a man powered cable wench in November 2016.

Habitat value as a result of the project implementation in 2015 and the formation of the channel spanning log jam in 2016 is considered outstanding. It is now estimated that because of the hydraulic impacts of the channel spanning log jam, 30% of the low flow volume of the Chewuch River now runs down the restored side channel. At this time WDFW and our program have decided to continue monitoring the impacts and response of the channel spanning log jam to the habitat and structural stability of the River Right project. No further active interventions are proposed.

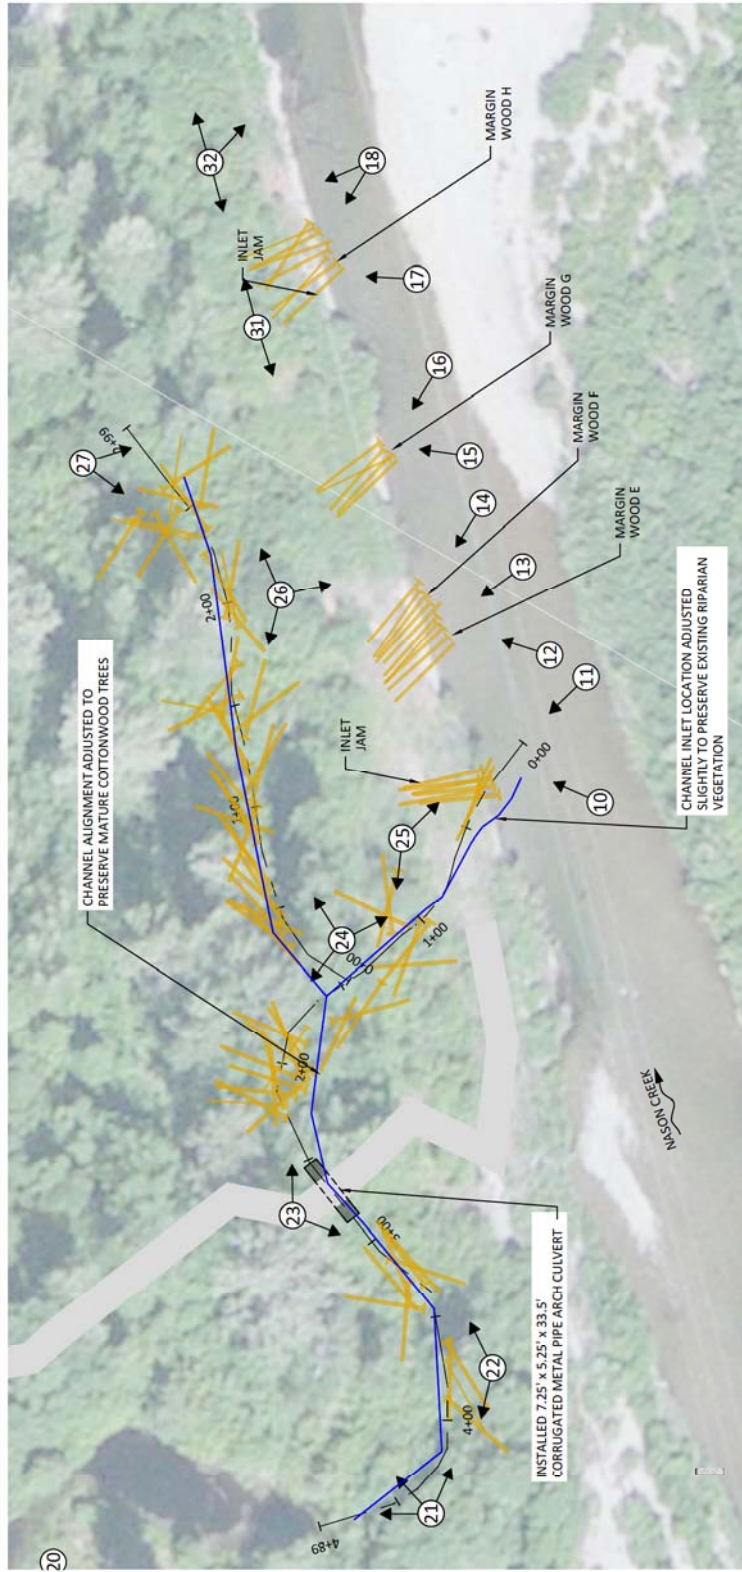
### 1 PLAN - BACKWATER CHANNEL AND ALCOVES

- EXISTING PRE-PROJECT CONTOURS (UDAR, 1 FT)
- EXISTING ACCESS
- PROPOSED ALIGNMENT
- AS-BUILT ALIGNMENT
- LARGE WOOD, APPROXIMATE CONFIGURATION
- PHOTO MONITORING POINT
