# **Yakama Nation's Wetlands and Riparian Restoration Project**

Project Number 1992-06200

## **Fiscal Year 2007 Annual Report Part 2**

**NAWCA GRANT**  
**Lower Yakima Wetlands Protection/Restoration II**  
**Annual Report**

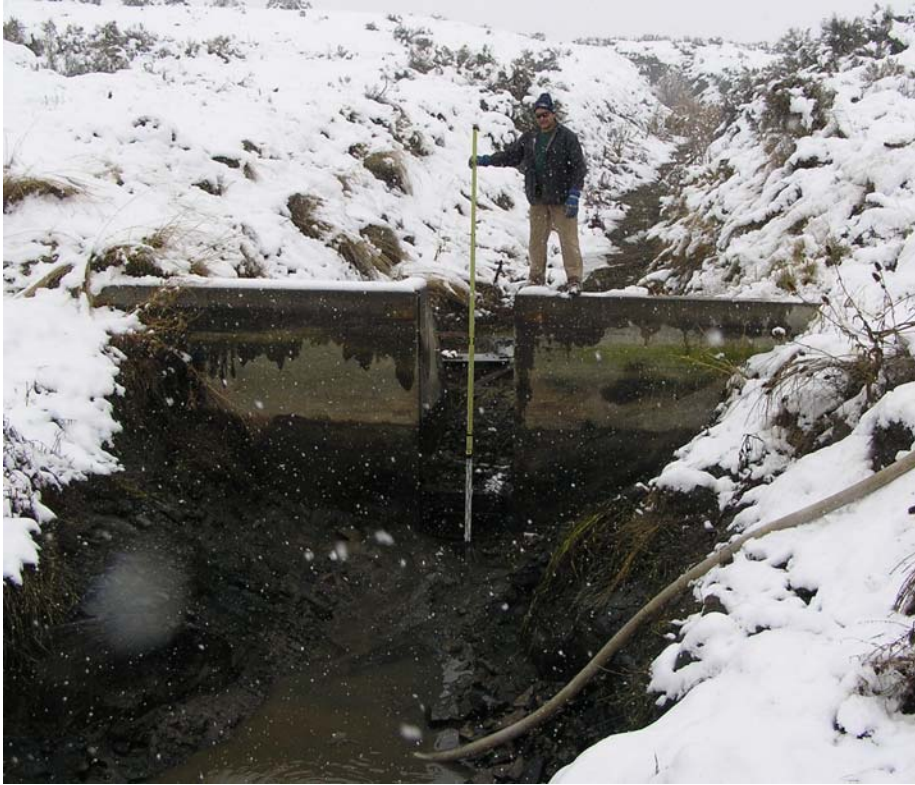
**Byron head works at full drawdown and before installation of new control gate**

The third and final phase of Byron enhancement was the installation of a new control gate on an existing concrete headwall. This 3-panel slide gate controls the water elevation in the entire Byron Pond system, impounding water to, and beyond Bus Road, over 1.5 miles away. This new water control replaced the original structure, which was installed in 1947 and had failed completely. The structure will offer better water level control for current

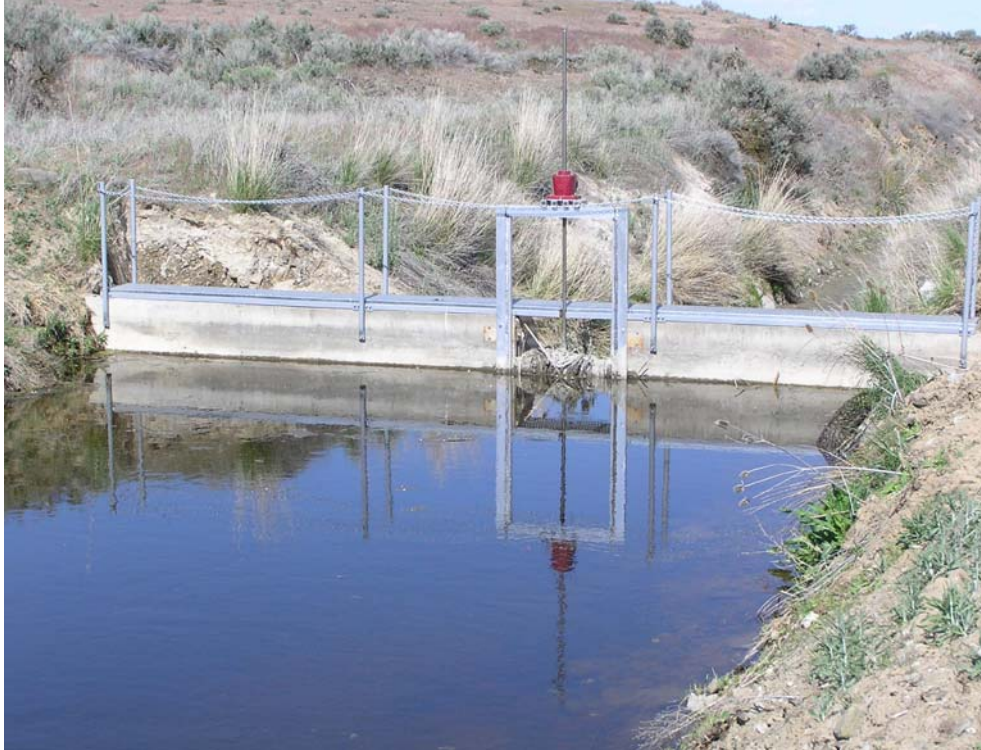
**New control gate at nearly full pool**

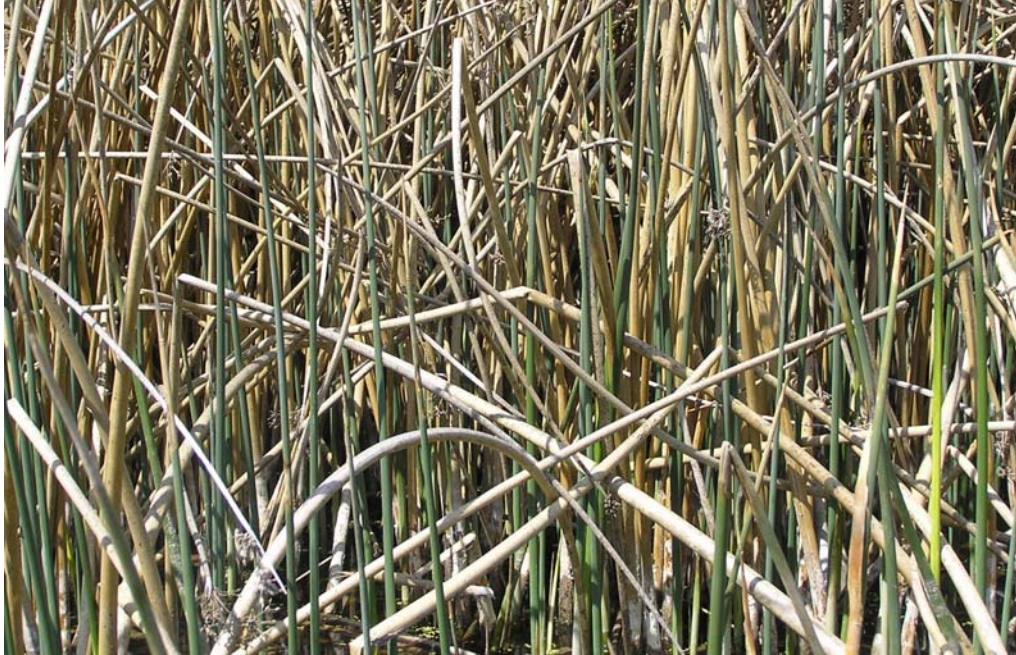
Typical shoreline view of Byron Ponds before treatment

The creation of the Byron Ponds nearly 60 years ago flooded some areas with just a few inches of water. Those areas became rank stands of bulrush and cattail with marginal value to waterfowl. Approximately 40 acres were aerially sprayed, and that area, along with 20 additional acres, was burned to remove decadent emergent vegetation. The area was then re-flooded. This process has set succession back and created more diverse habitat conditions with open water, new emergent growth and an influx of smartweed in these shallow areas.

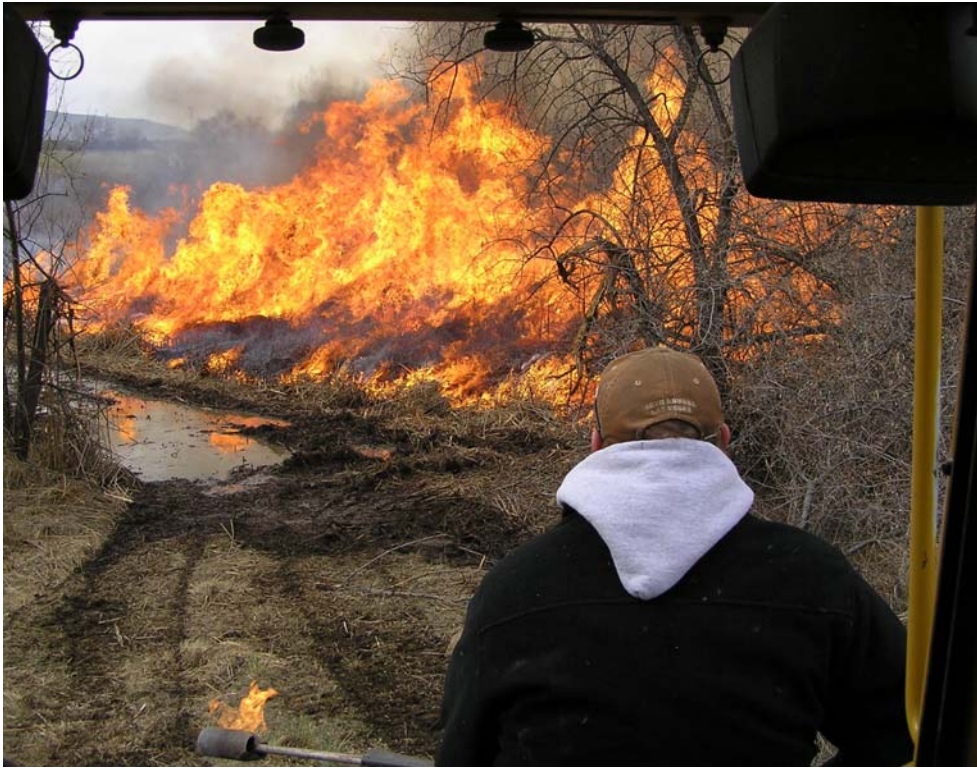
**Controlled burn in progress**

The local fire district assisted in the controlled burn by supplying both staff and equipment over a two-day period. The Fire district staff was instrumental in focusing the fire in the emergent zone and protecting the adjacent grass for nesting cover.

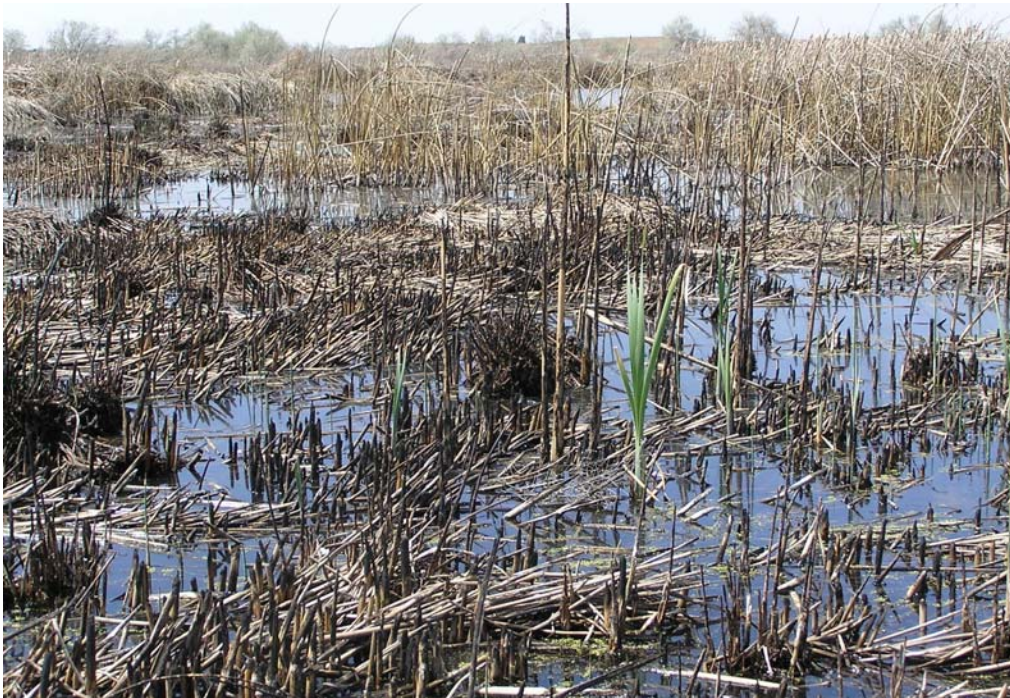
Shoreline view of Byron Ponds after controlled burn

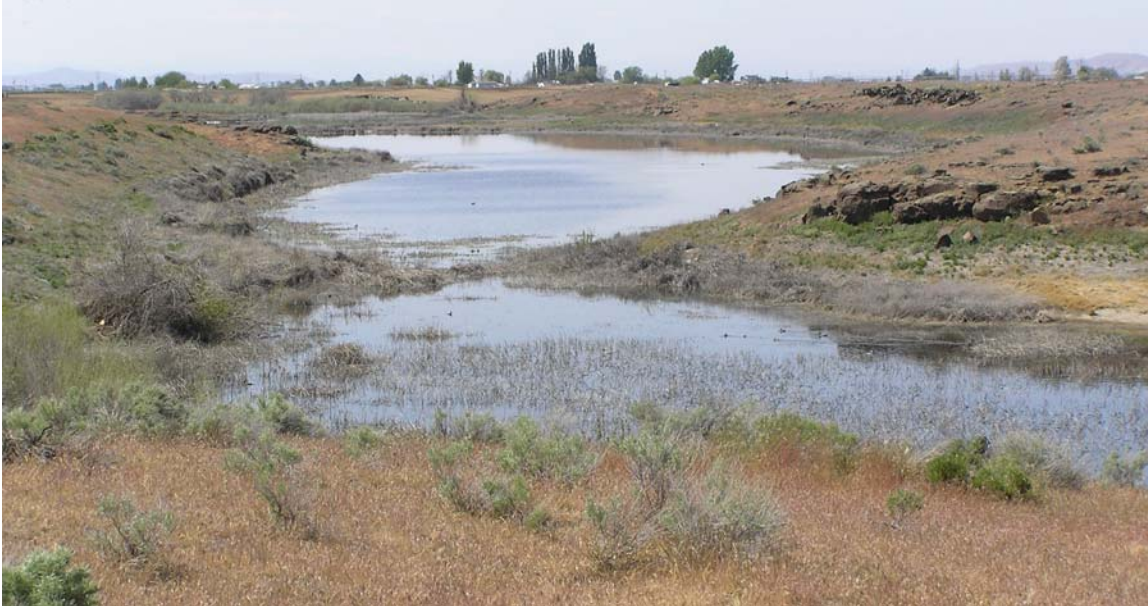
One of many ephemeral ponds filled by the City of Grandview's Water Treatment Facility

The City of Grandview (COG) operates a water treatment facility adjacent to the north boundary of the Byron Unit. Typically, between February and April, the facility releases effluent into a myriad of small swales, creating nearly 100 permanent and ephemeral ponds on 1,778 acres of COG and Department of Fish & Wildlife lands. The COG released 49 million gallons of water into these ponds in 2006 and 35 million gallons in 2007. Due to an influx of industry into the community, COG was able to release over 80 million gallons of effluent in 2008, a record for a spring release. All pond basins were filled to capacity, creating approximately 121 acres of open, shallow water habitat.

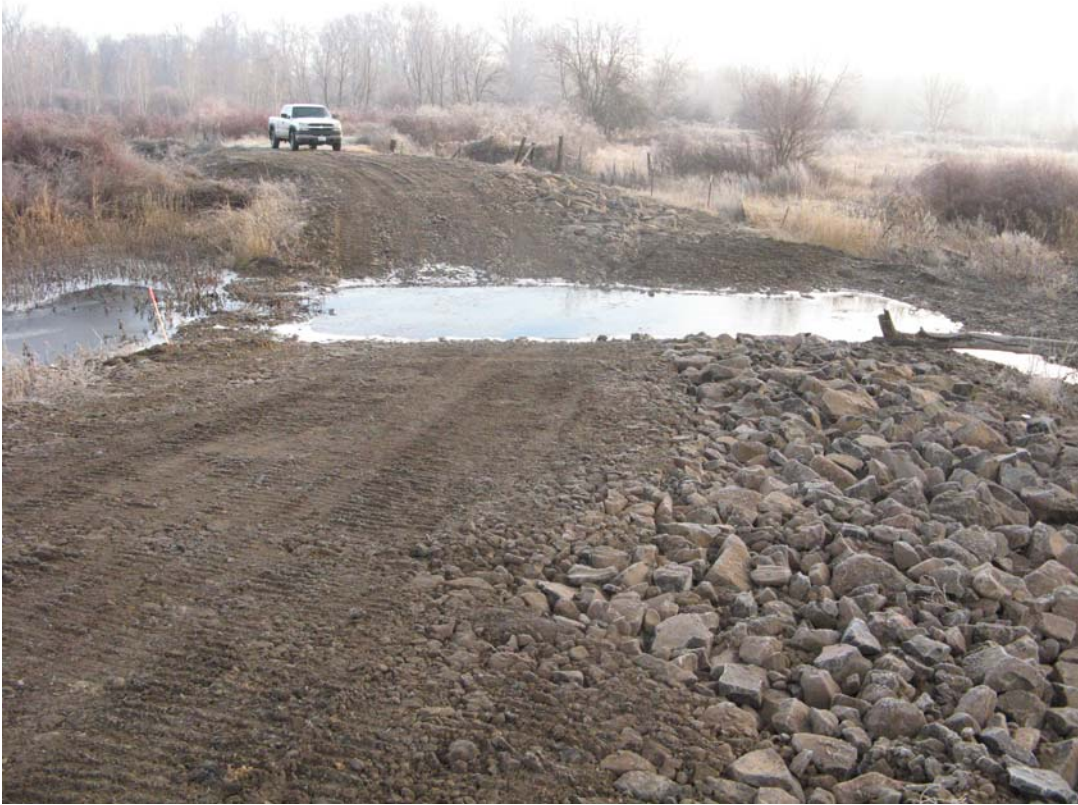
Completed reconnection, Menenick Wildlife Area.

This activity involved the restoration of a Yakima River side channel that was disconnected by a levee in the 1940's. The levee was constructed originally to protect farm and grazing lands from Yakima River floods. The land previously protected is now in protected and managed by the Yakama Nation for wildlife and cultural resource benefits. Restoration involved breaching of the levee where the channel historically crossed it. Because the levee also is used as an access road to the property, it was not totally removed. The channel was stabilized at the breach site with large basalt rock (3-6 foot diameter). A rock roadway was constructed over the large rock to allow for seasonal vehicle crossing. Reconnection occurred during December 2007. As soon as the project was complete, water flowed across the levee site, providing hydrologic reconnection to the channel and wetland areas below. Students and faculty from Central Washington University have been monitoring pre-project hydrologic conditions. They will continue the monitoring activities during the coming year to document hydrologic response to the restoration.

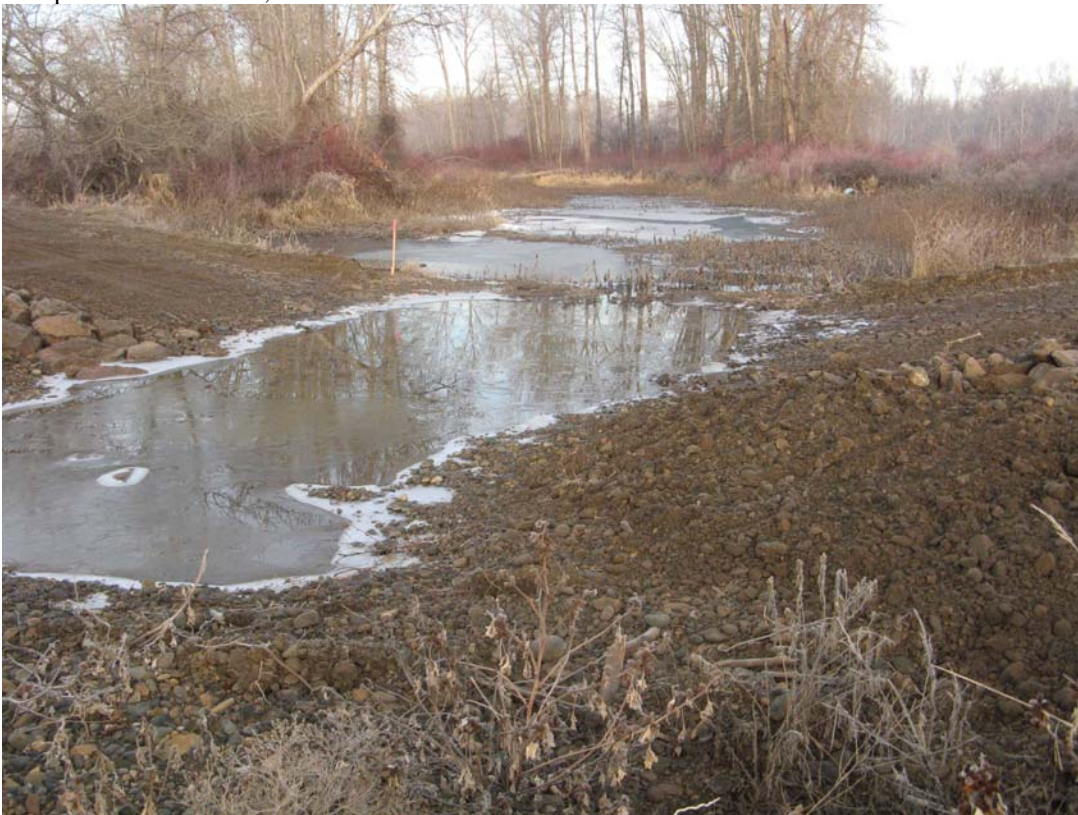
View of channel looking upstream.

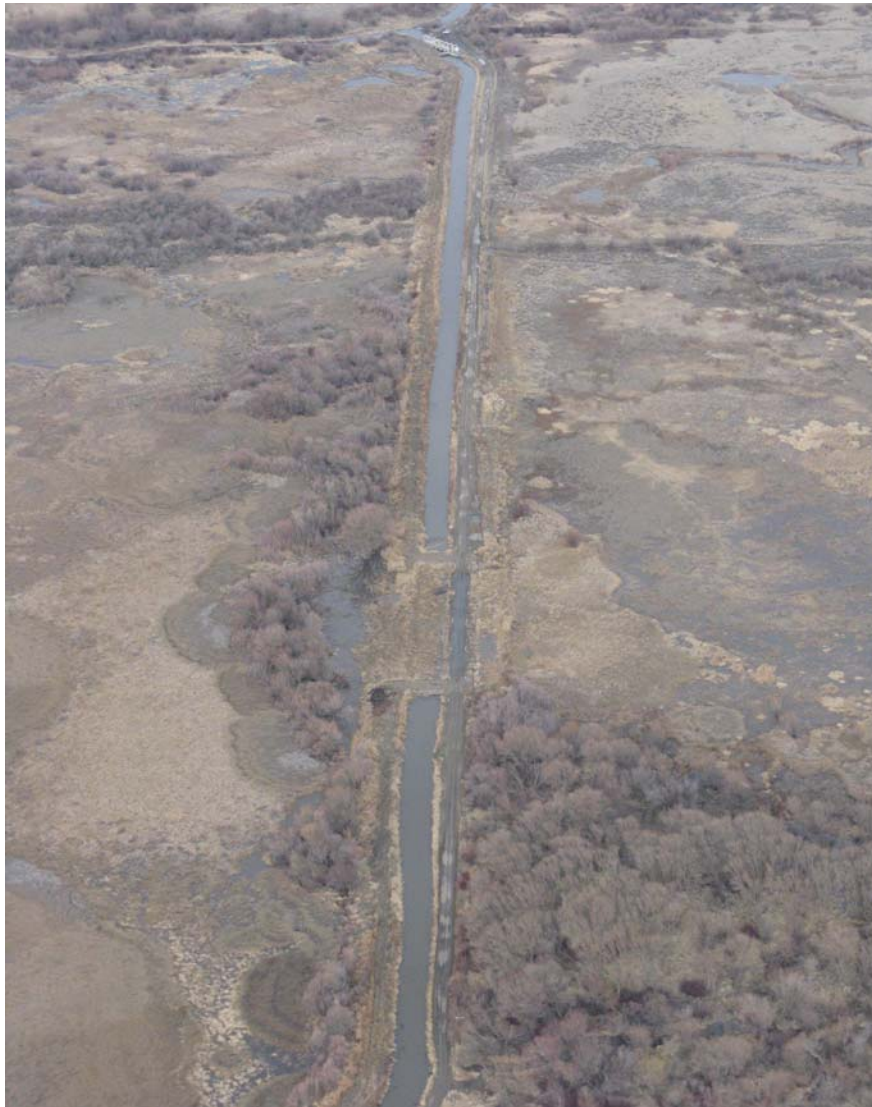
Aerial view of Toppenish Creek Pumphouse Wildlife Area spillway.

The spillway development of this project was completed in the early 2007. This involved the piping of a large irrigation delivery canal that was impeding floodwater passage through the wildlife area. Three large pipes were installed in the canal. A large spillway was then constructed over the pipes. The spillway elevation is low enough to pass flood flows, but high enough to allow for wetland water level management on the upstream side. The spillway has allowed flood passage across this area for the first time since the 1930's. The structures necessary for wetland water level control will be installed in early to mid 2009. This project will need a time extension to complete this activity.

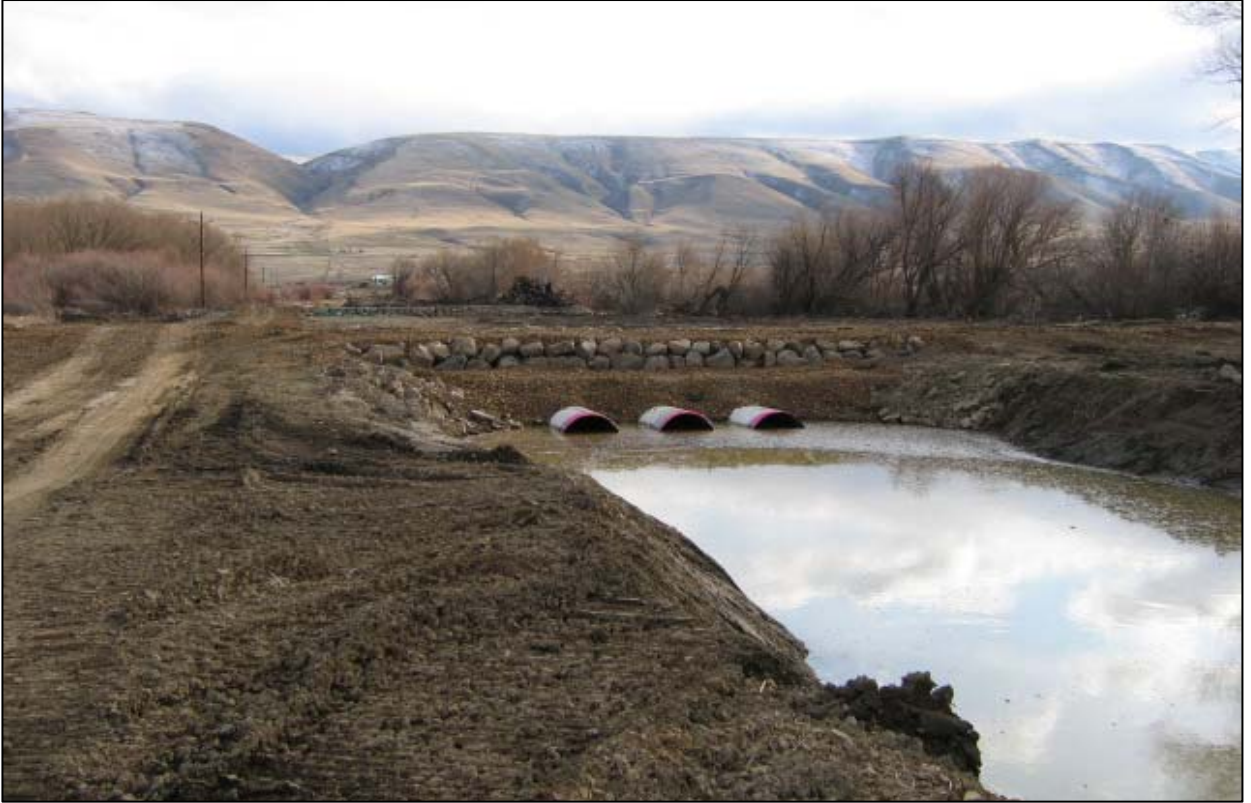
Completed spillway.

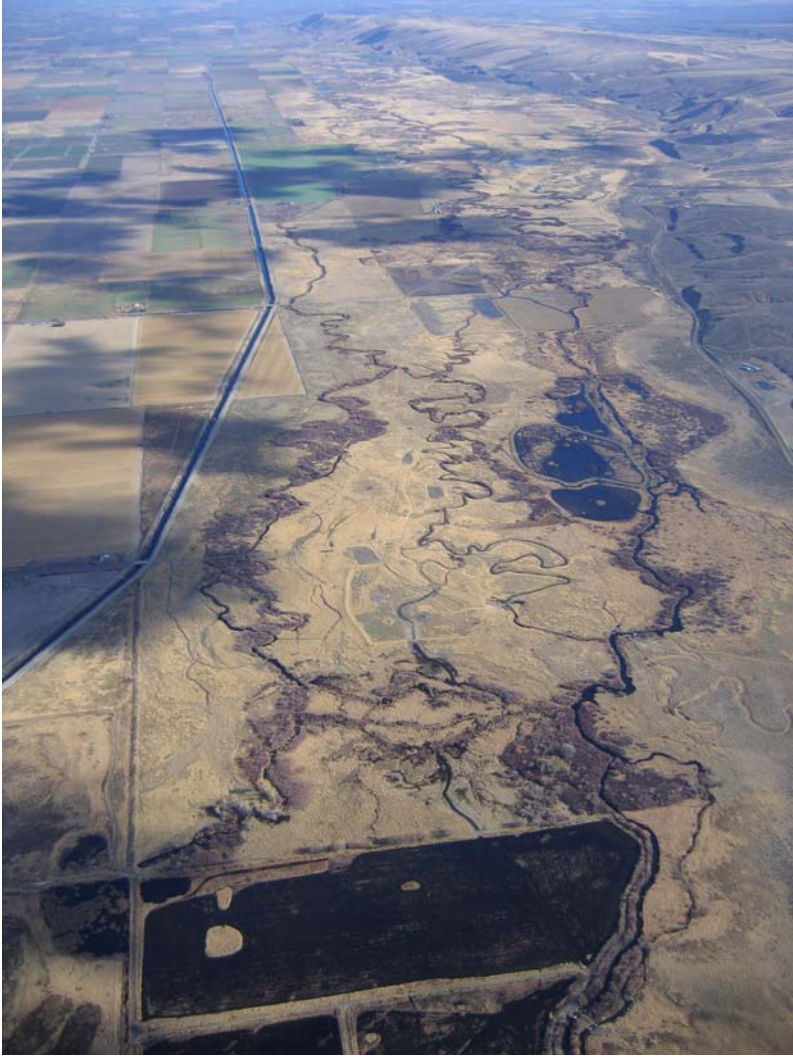
Aerial view of Mid\_Toppenish Creek restoration project.

This project was implemented in 2006. It involved the installation of 28 large rock grade control structures. Over 25 miles of creek channel reconnection occurred, with over 1,400 acres of wetlands restored. This project has received much publicity. An article written by staff from the Natural Resources Conservation Service is attached to this report. Native grasses were planted to a portion of the project area in the fall of 2007 using Pheasants Forever funds. Groundwater and wildlife monitoring activities are ongoing on this site. Monitoring activities are being conducted by the Yakama Nation, The Yakima Valley Audubon Society, and The Washington Waterfowl Association.

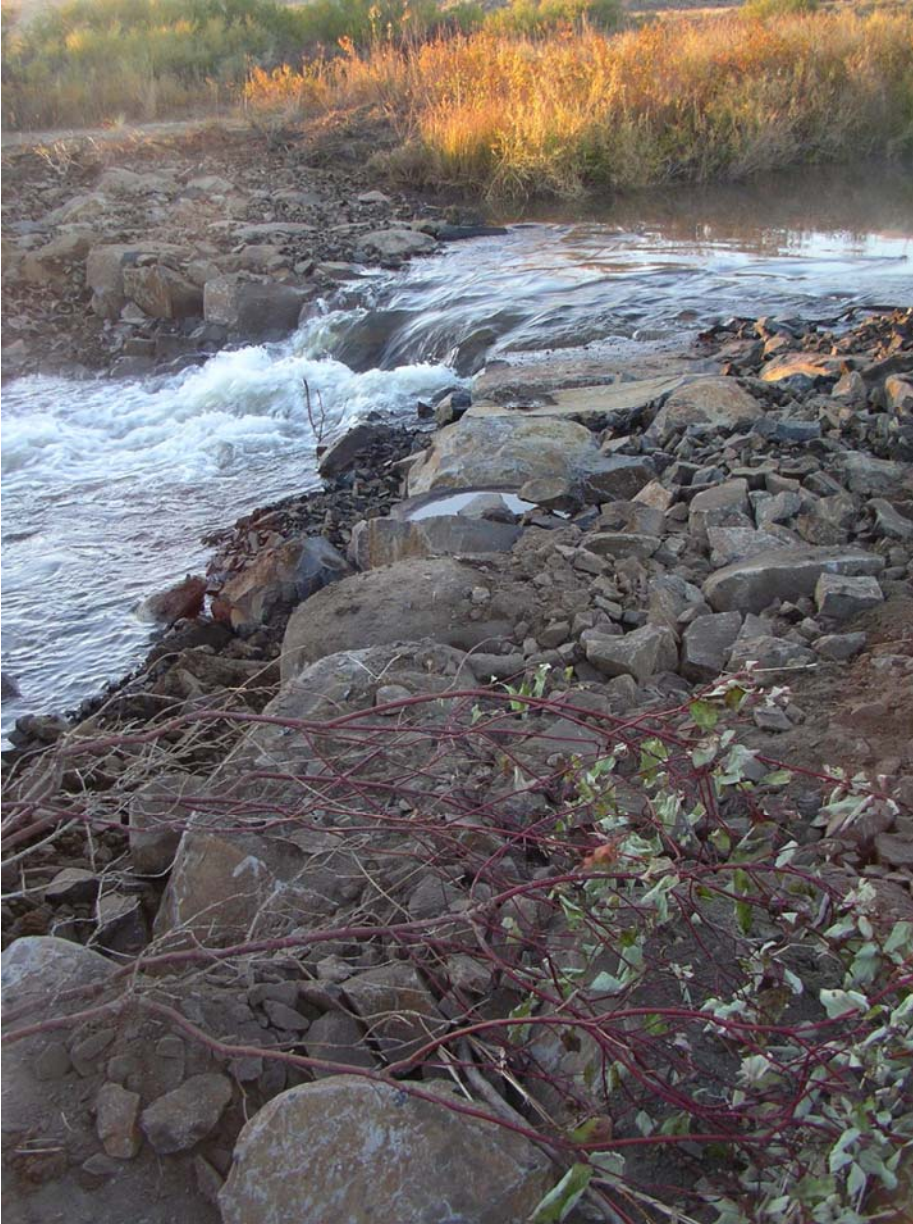
Grade control structure – Mid-Toppenish Creek Restoration Project

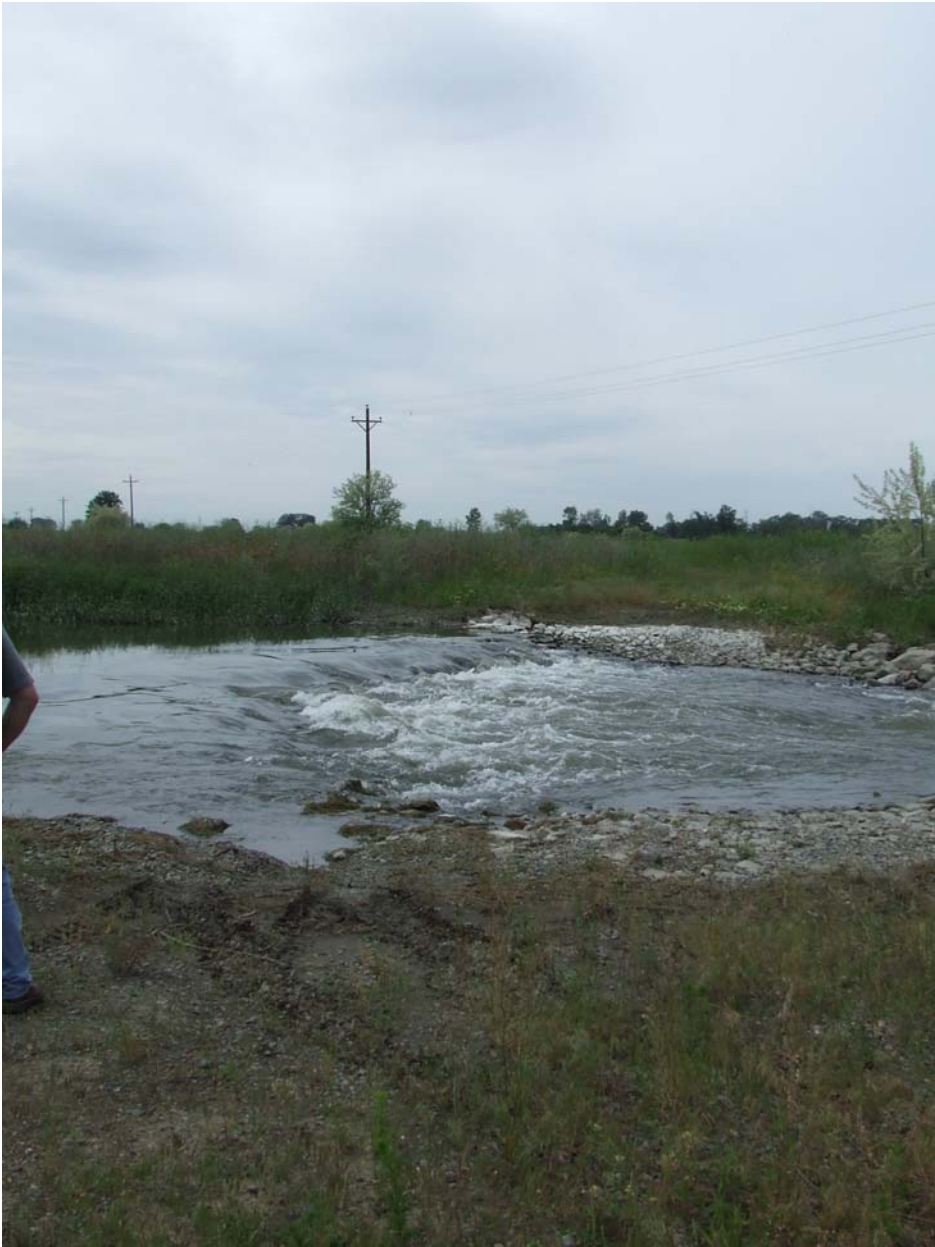
***Grade control structure at North Satus Wildlife Area.***

This project involved the construction of a grade control structure in an incised side channel of the Yakima River. This structure allows stable hydrologic reconnection to the Satus Wildlife Area. This work was completed in 2006.

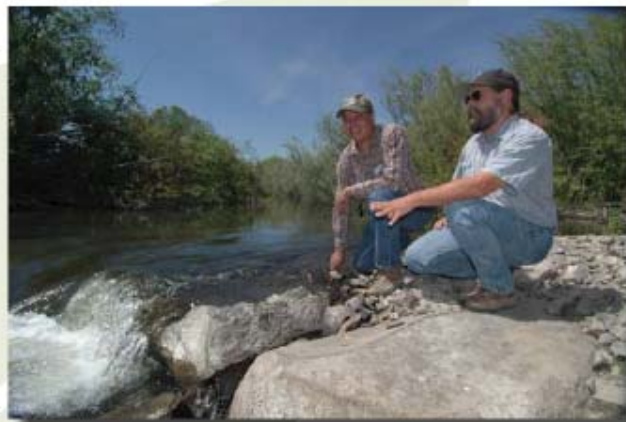
*Tribal Wildlife Biologist Tracy Hames, right, and NRCS Tribal Liaison Roger Amerman, pause near one of the 28 engineered grade control structures that have helped restore the natural hydrology to Mid-Toppenish Creek.*

**A kinder and gentler structure**  
"They look like real simple structures, but there's a lot of engineering in them," Mr. Hames says standing atop a row of the columnar basalt rocks, which comprise the structure and stretch across

the stream. "The rock is taken from a place here on the reservation and the structures are engineered such that they form and inverted 'V' so the point of the 'V' faces upstream, forcing the flow toward the middle of the stream to reduce bank erosion. They also act like natural cascades, making it much easier for the

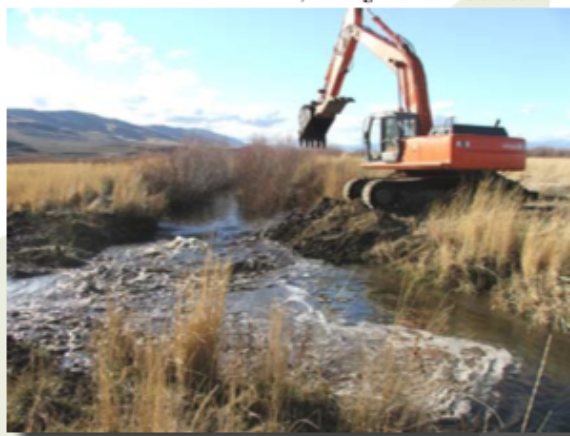
*With the grade control structures in place, a backhoe operator breaches a temporary de-watering dam, allowing water from Mid-Toppenish Creek to flow along its historic channel. (Photo courtesy Tracy Hames.)*

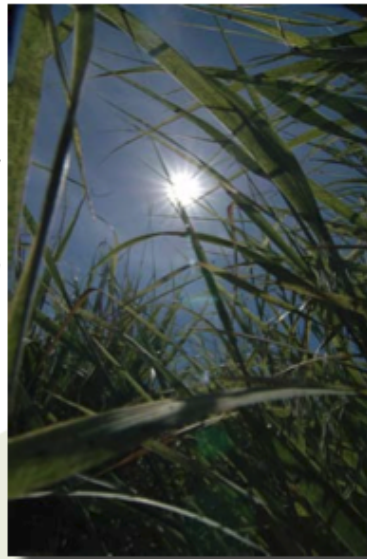
*In addition to restoring wetland hydrology, upland plantings, like this stand of basin wild rye, were established to enhance wildlife habitat throughout the restoration project.*

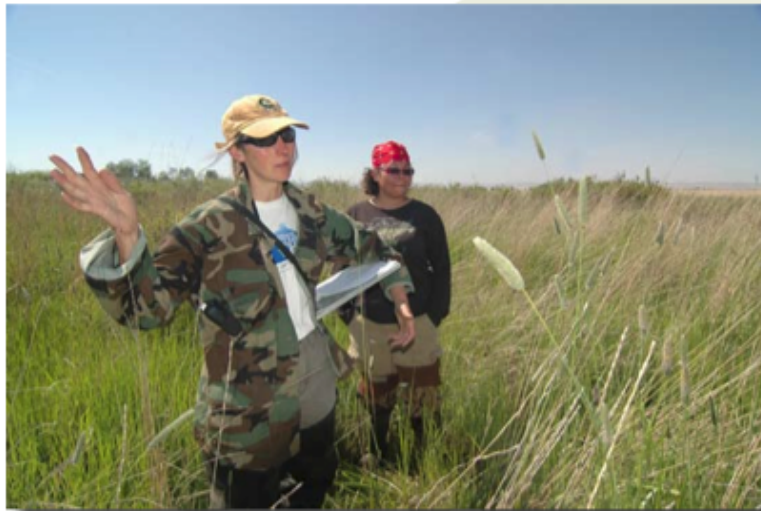
*Above, Katrina Strathmann, restoration biologist, (left) and Camella George, vegetation technician, are conducting plant inventories throughout the riparian corridors of the project to determine the effects of restoration activities on plant communities.*

The Yakama Nation is also monitoring wildlife response, and have vegetation transects, photo points, and flow gages in place – all to monitor and evaluate the restoration impacts.
