Klickitat Watershed Enhancement Project

Annual Report for January 1, 2009 – December 31, 2009

BPA Project # 1997-056-00

Yakima – Klickitat Fisheries Project
Yakama Nation Fisheries Resource Management Program
P.O. Box 151
Toppenish, WA 98948

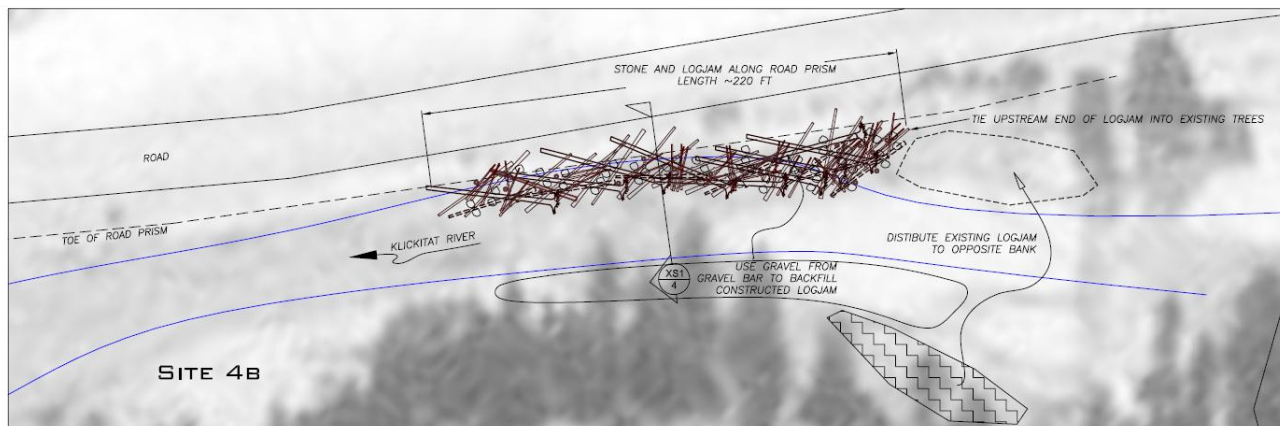
Figure 1. Plan view design of Site 4B of the Upper Klickitat River In-Channel and Floodplain Enhancement Project (Phase 2).

- *Channel reconnection* occurred at site 4 where approximately 200’ of channel was constructed to reconnect a roughly 4000’ long side channel. Excavated materials were used for backfill of LWD structures as well as graded into a nearby talus slope.

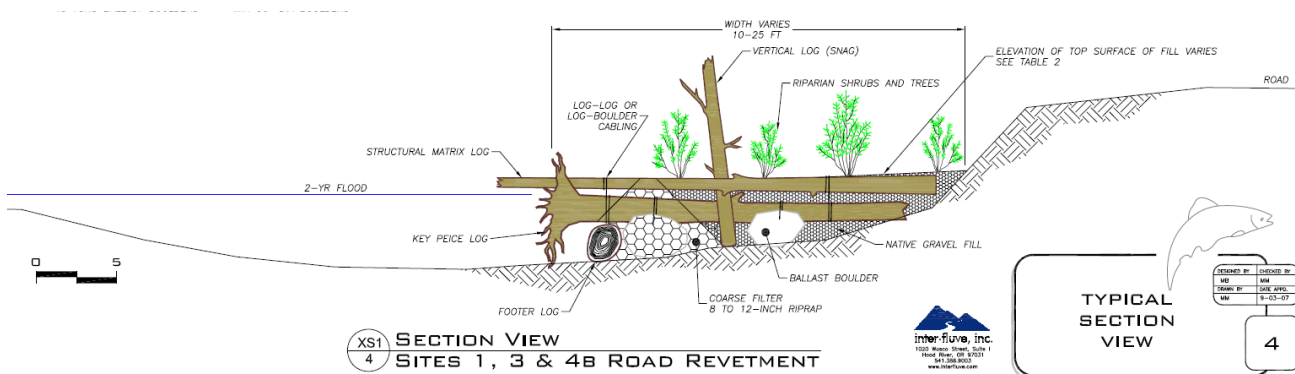
Figure 2. Typical design cross-section for construction of floodplain benches in the Upper Klickitat River In-Channel and Floodplain Enhancement Project (Phase 2).

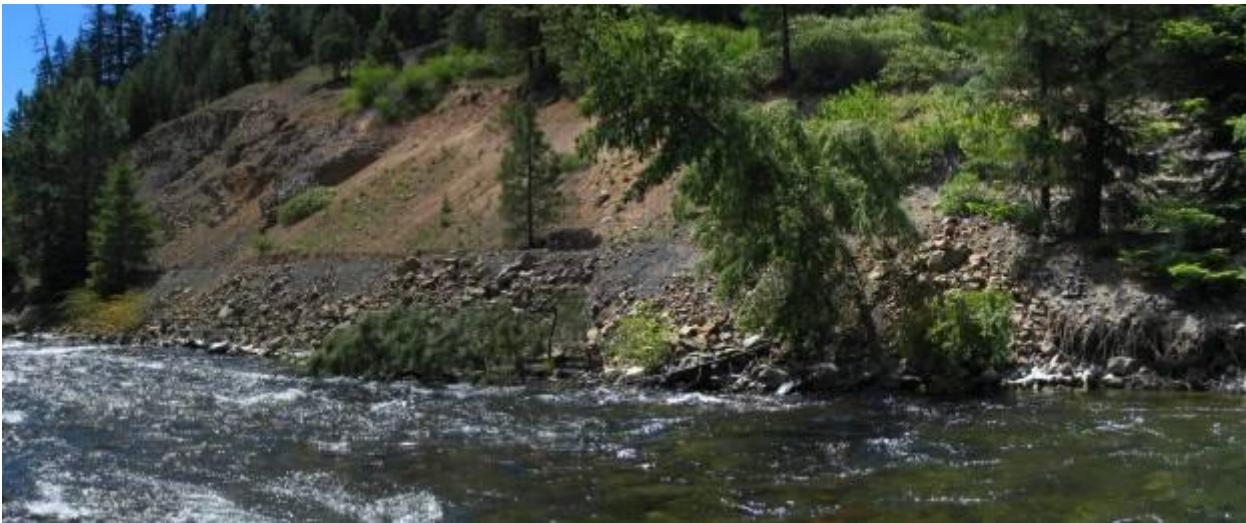
Figure 3. Site 4 pre-treatment (June 13, 2005)

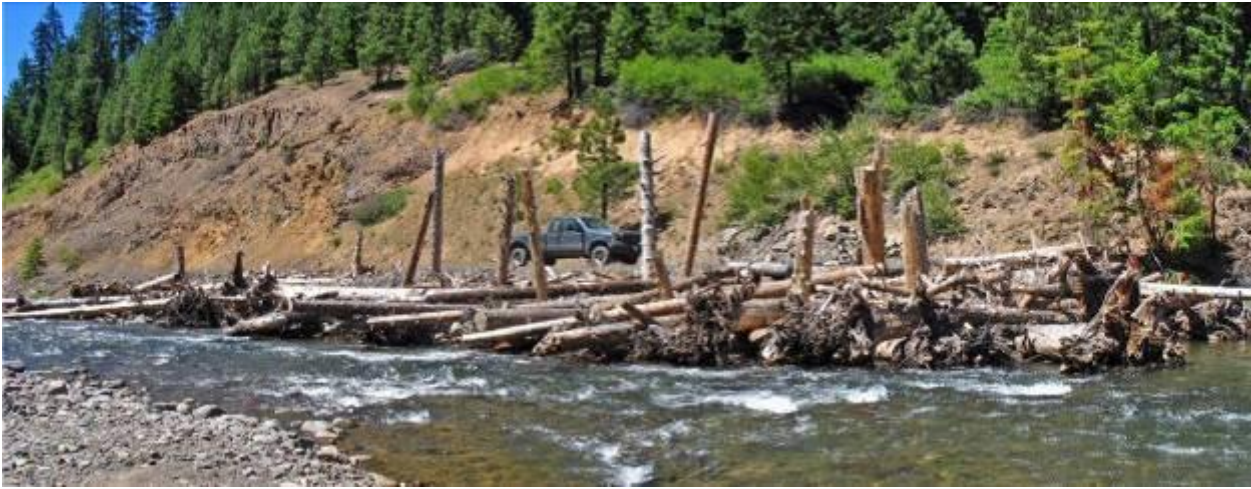
Figure 4. Site 4 post-enhancement (July 23, 2010).

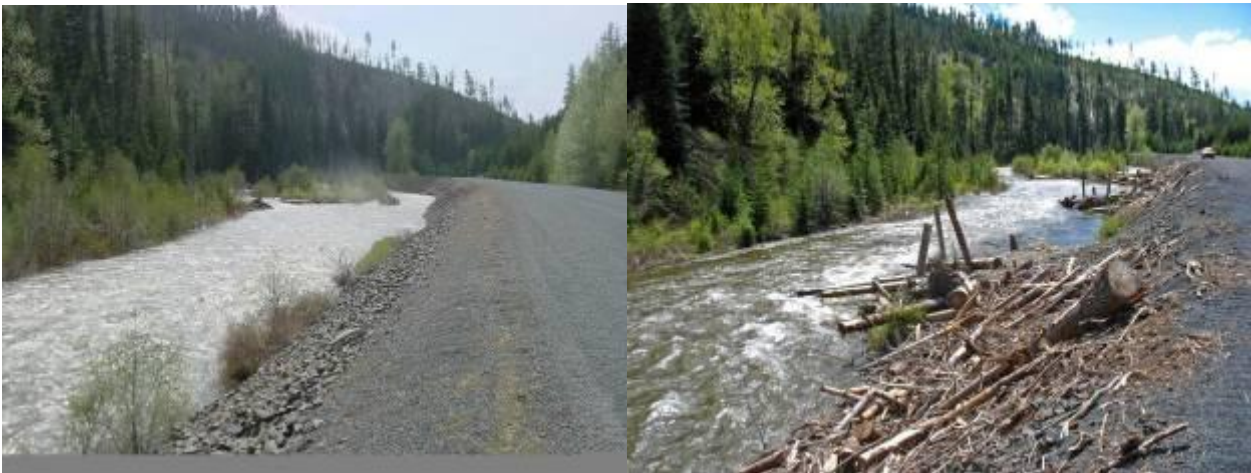
Figure 5. Site 2 at springtime flows pre- (left) and post-enhancement (right).

- *Debris “barbs”* with adjacent pools were constructed at Site 2 instead of a continuous floodplain bench to conserve materials and budget (Fig. 5).

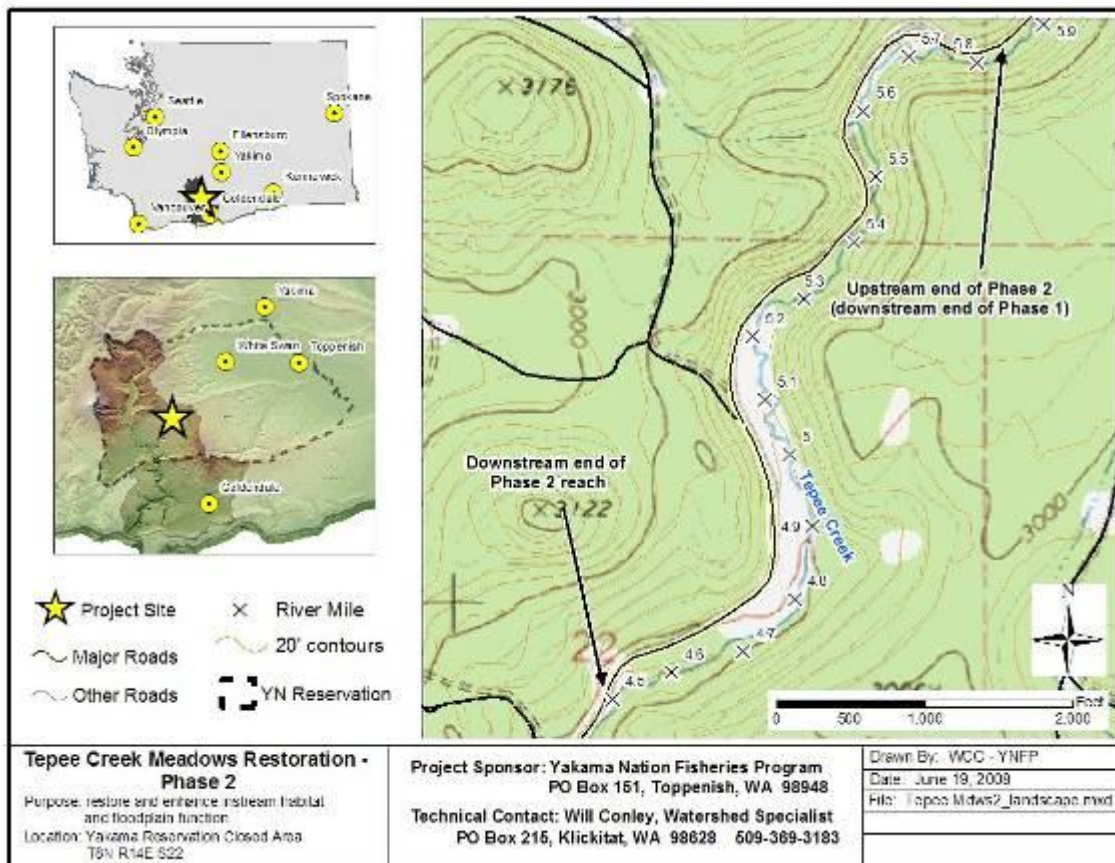
Figure 6. Map of Tepee Creek Meadows Restoration – Phase 2.

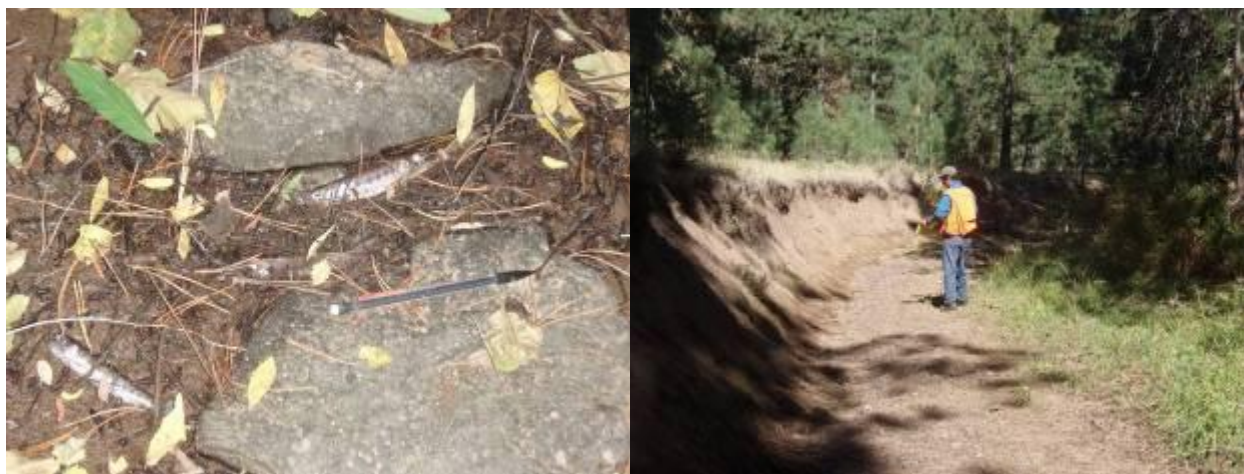
Figure 7. Deceased *O. mykiss* in dry streambed (left) and typical late-summer conditions (right).

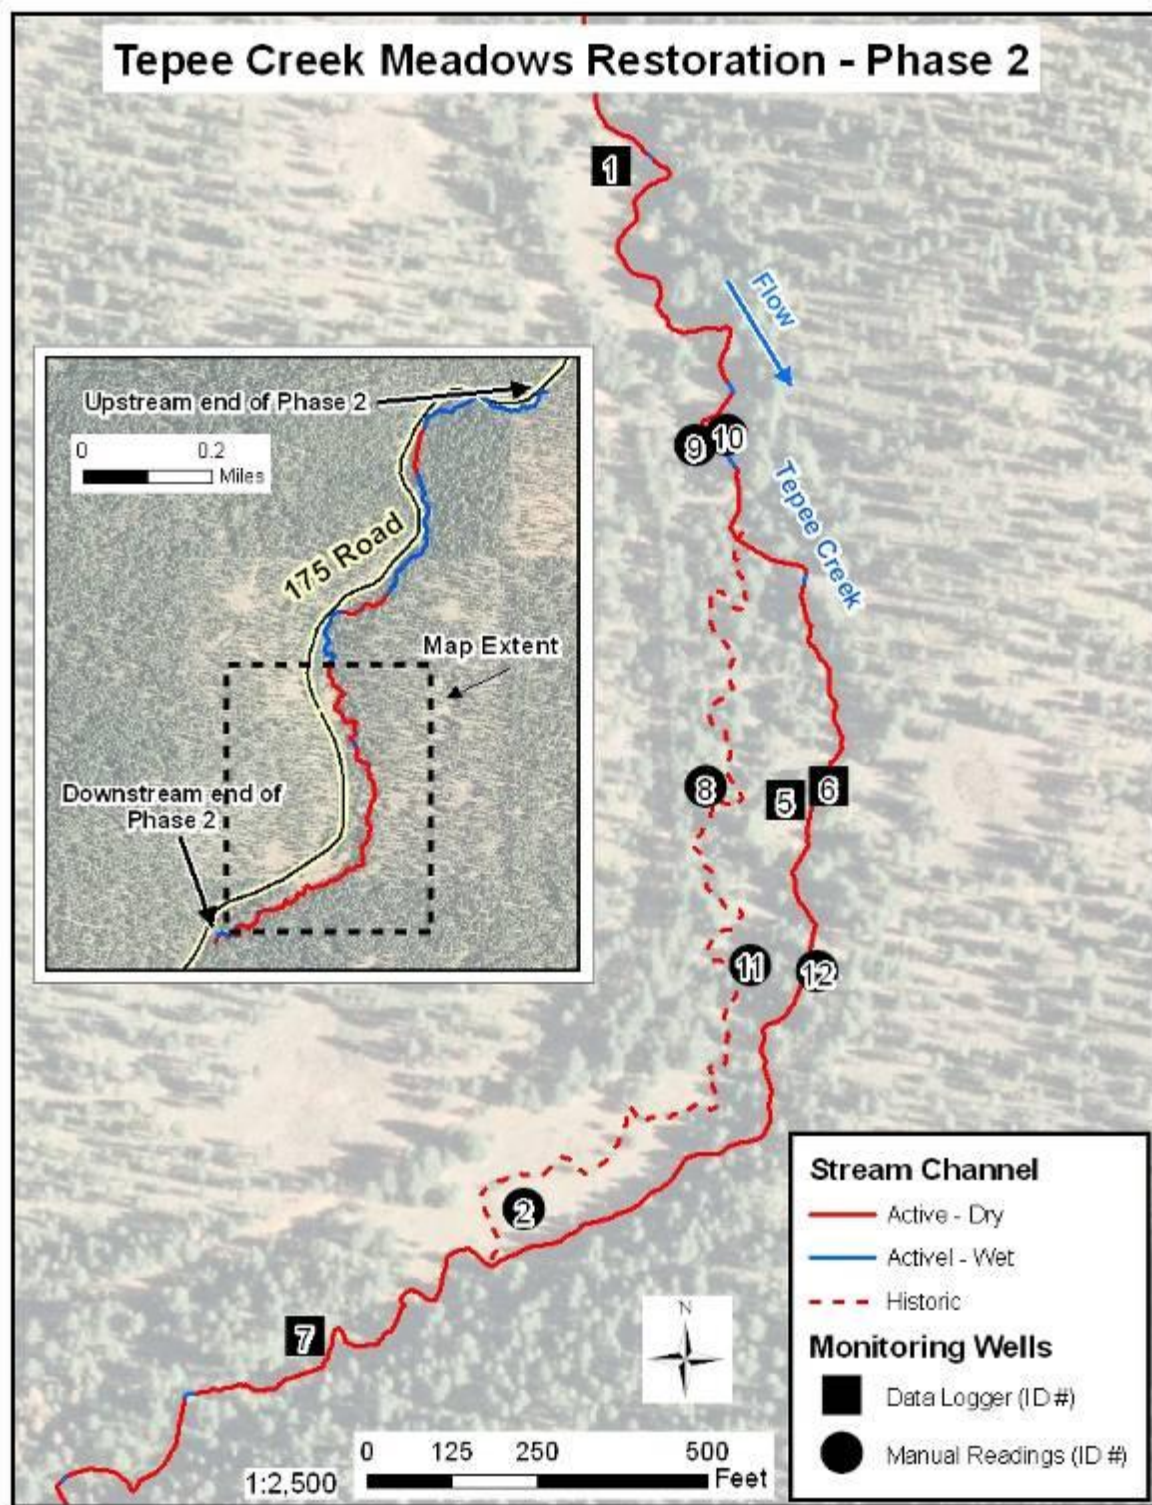
Figure 8. Distribution of monitoring wells and the portions of Tepee Creek with perennial water as observed on September 21, 2009.

- Spatial distribution of streamflow: In September 2009, the 7851' project reach was mapped based on wetted or dry channel conditions observed using a Trimble GeoXT GPS unit and Hurricane external antennae. The timing of data collection corresponded to portion of the year when lowest streamflows typically occur. Field was quality controlled in the office to remove erroneous points due to poor GPS coverage or multipath. A polyline feature class was created in ArcGIS to document the spatial distribution of subreaches known to have gone dry. Given the timing of data collection, subreaches exhibiting flow are assumed to be indicative of perennial distribution. This survey depicting available perennial habitat at the limiting time of year will provide a baseline for post-project comparisons (Fig. 8).

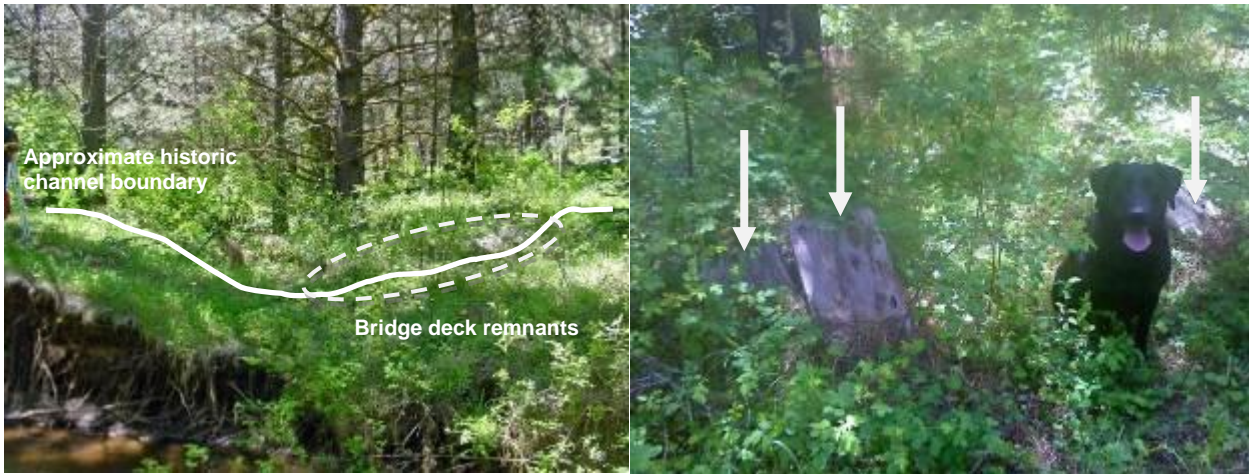
Figure 9. Inlet to historic channel (left). Arrows indicate bridge deck remnants (right).

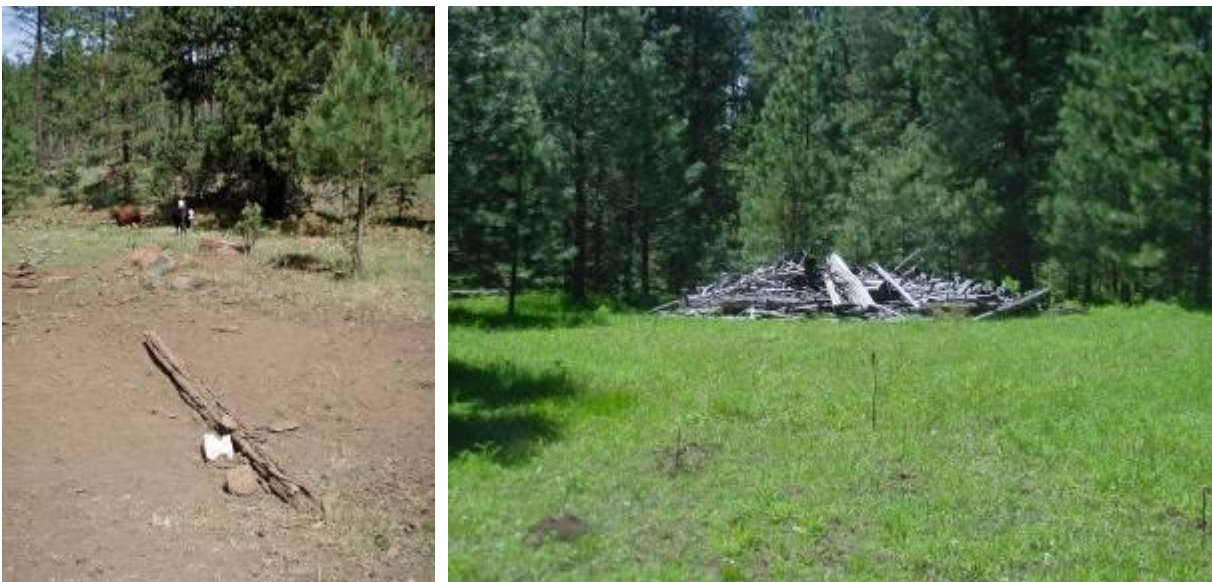
Figure 10. The reach has been used as a livestock salting area (left). A slash pile (right) indicates local historic forest practices activity.

Livestock grazing (in the form of altered riparian vegetation, bank erosion, and channel incision) may have also pre-disposed the site to its response (Fig. 10 and 11). These site-based effects coupled with watershed scale management responses are the most probable causes of currently observed conditions. Hydrologic modeling (nhc 2003) indicated increased stormflow and volume in the upper White Creek and Tepee Creek watersheds due to density and drainage characteristics of forest roads.

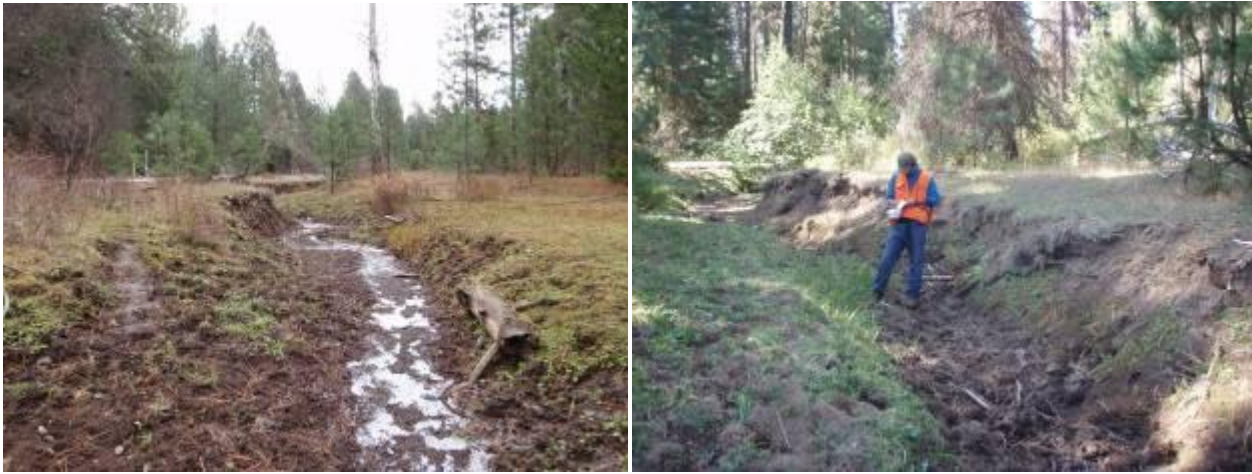
Figure 11. In-stream cattle trampling near the bottom (left) and top (right) of the reach.

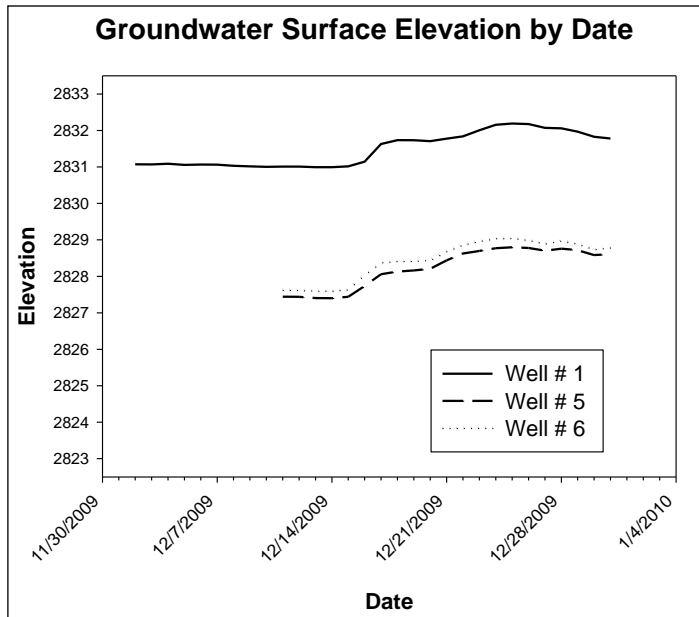
Figure 12. Groundwater surface elevations by date for wells 1, 5, and 6.

- Groundwater: Twelve shallow (~6.5’ deep) wells were installed to characterize existing groundwater conditions. They will be used for post-project effectiveness monitoring if future funding permits. Two wells are located outside of the project reach as controls (one upstream and one downstream). The remaining ten wells are dispersed strategically throughout the project reach to characterize local geohydrology (Fig. 8). Six wells (including both controls) have sensors that measure and record water level once every hour; data are downloaded several times per year using a field computer. KWEP staff take manual measurements of water level with an e-tape at the remaining six wells approximately once per month (on average). Preliminary data results from 3 wells are presented in Figure 12.

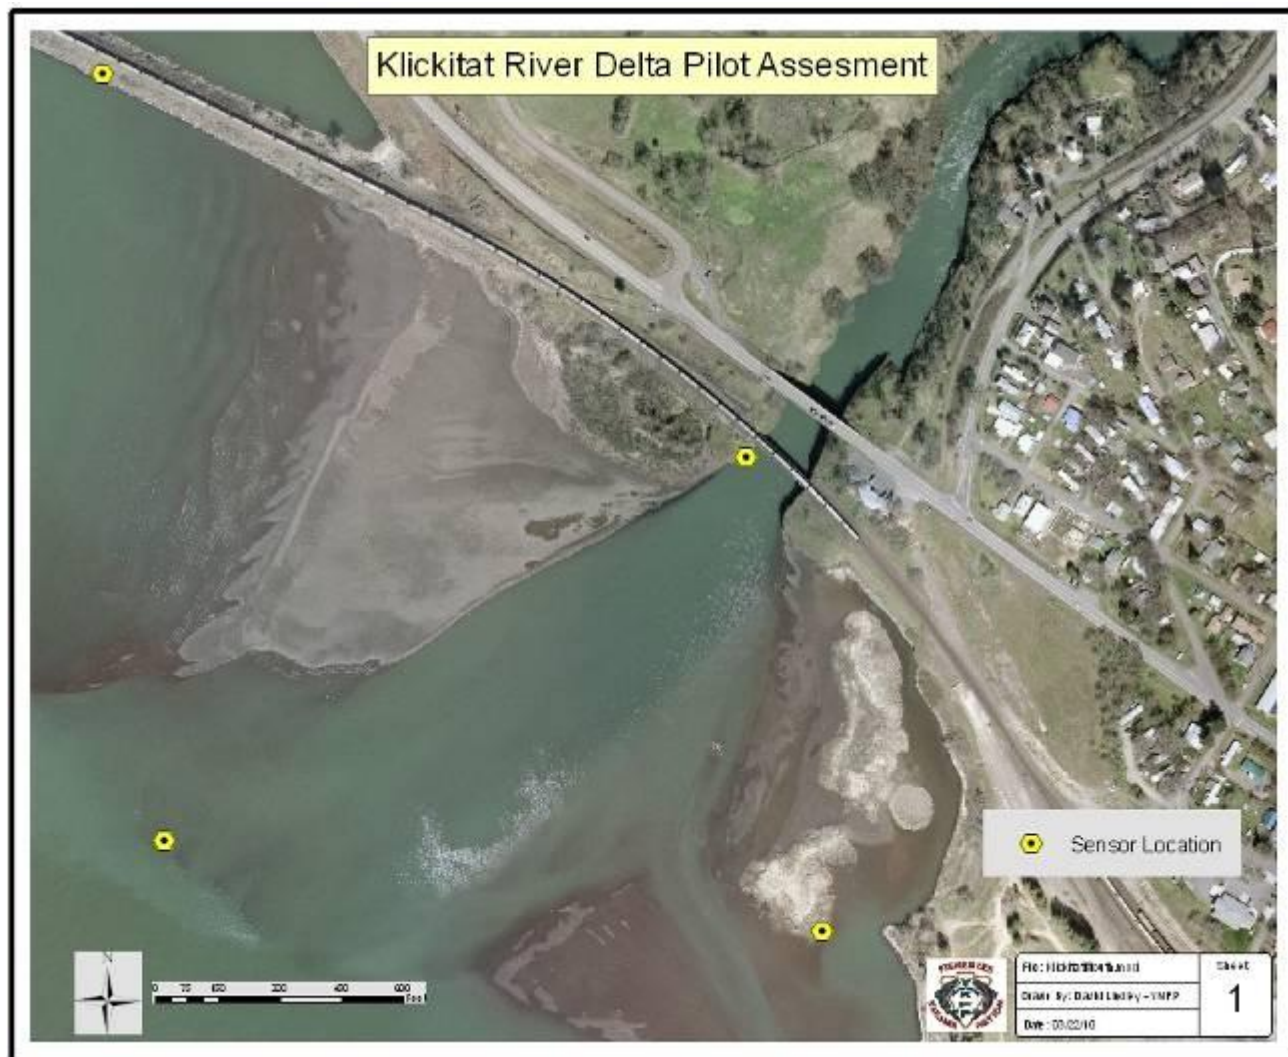
Figure 13. Sampling locations for the Klickitat River delta.

2009 Activity: Over the course of two days (8/24-8/25/2009), four sensors were installed around the delta to collect water depth and temperature data (Fig. 13). An anemometer was also installed at one

location to assess wind influence on the other parameters being sampled. The sensor network was designed to facilitate the transfer of data via radio frequency from three of the sensors to one central hub. The fourth sensor is built into the central hub, which receives and then transmits all of the data collected via a cell phone modem. From this ftp site KWEP staff has been monitoring collected data remotely to check for discrepancies/errors that may dictate site visits for troubleshooting purposes. Currently each sensor is on its own (relative) vertical datum. All gages will be surveyed to a common vertical datum in the future.

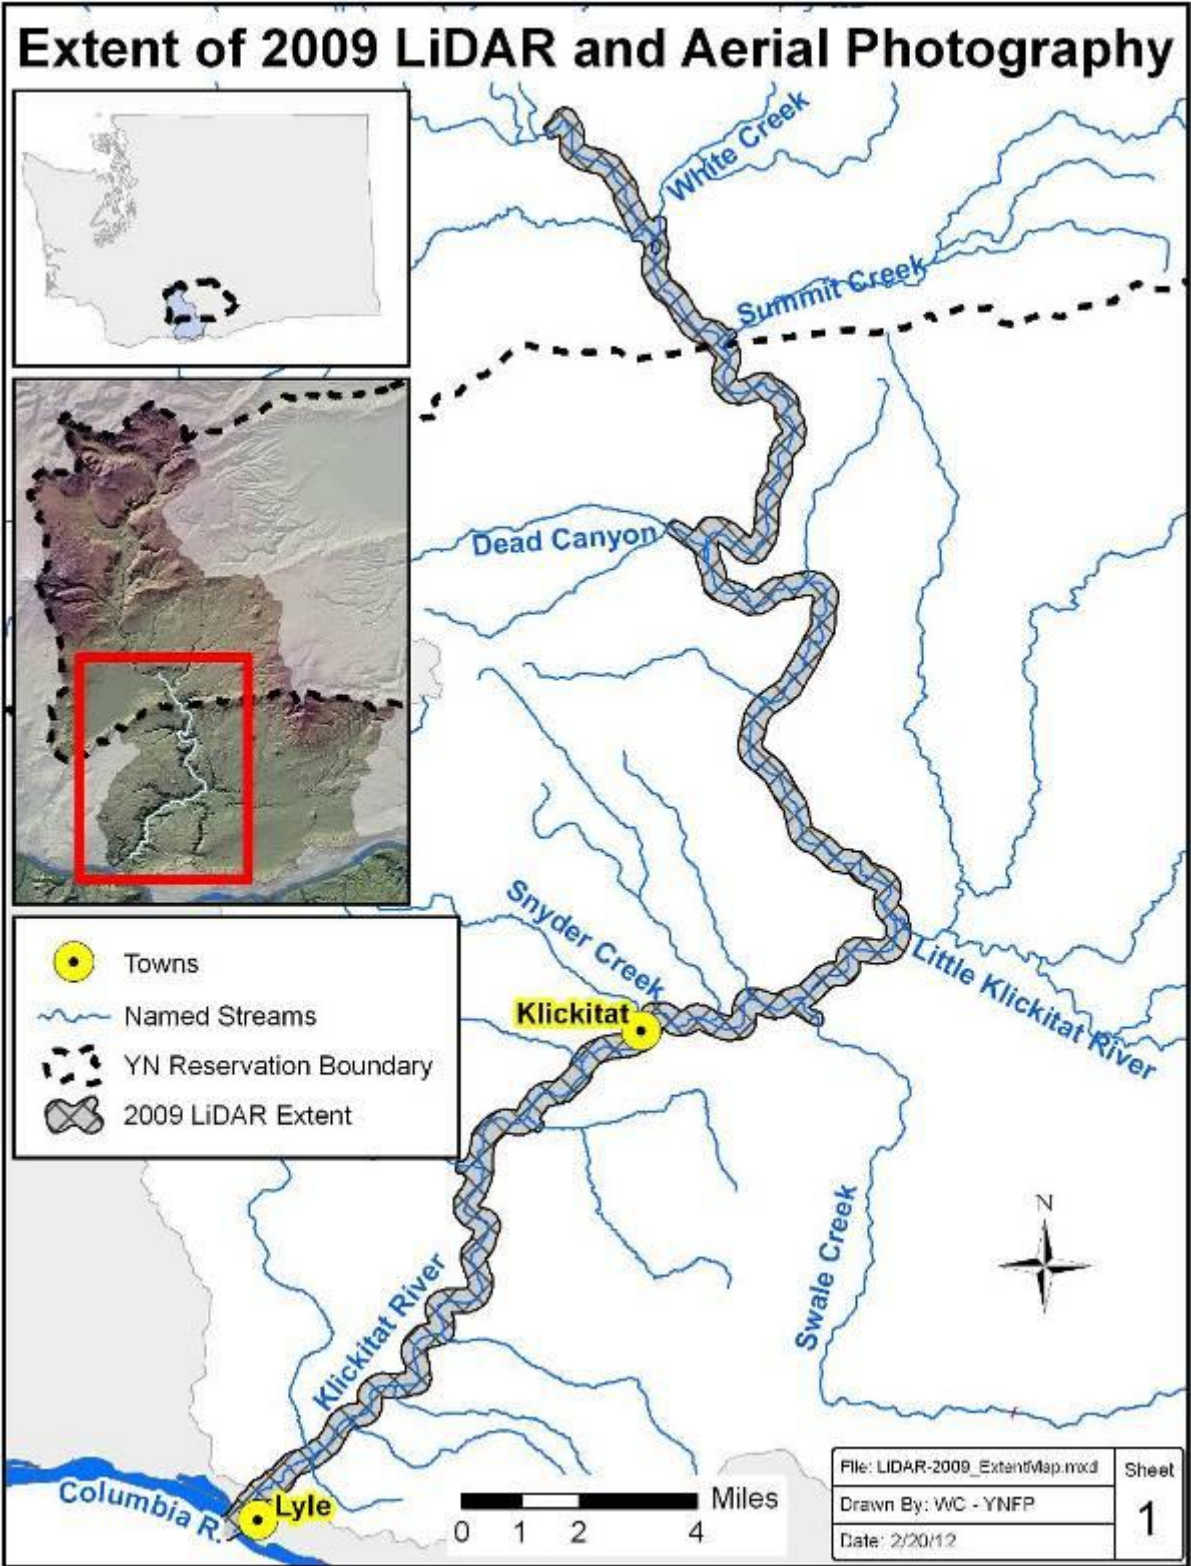
Figure 14. Spatial extent of 2009 LiDAR and high-resolution aerial photography.

In April 2009, the KWEP commissioned a flight to collect high resolution LiDAR and true-color orthophotography for the lower 42 miles of the Klickitat River and its valley bottom (Fig 14). The flight swath averaged approximately 2100 wide from the mouth to the salmon hatchery. Bare-earth topography (in DEM format), breaklines (in polyline format), and a summary report (Watershed Sciences 2009) were generated as deliverables and are on-file at the Klickitat Field Office of the Yakama Nation Fisheries Program. Draft data was delivered to KWEP staff in mid-May 2009. Three-

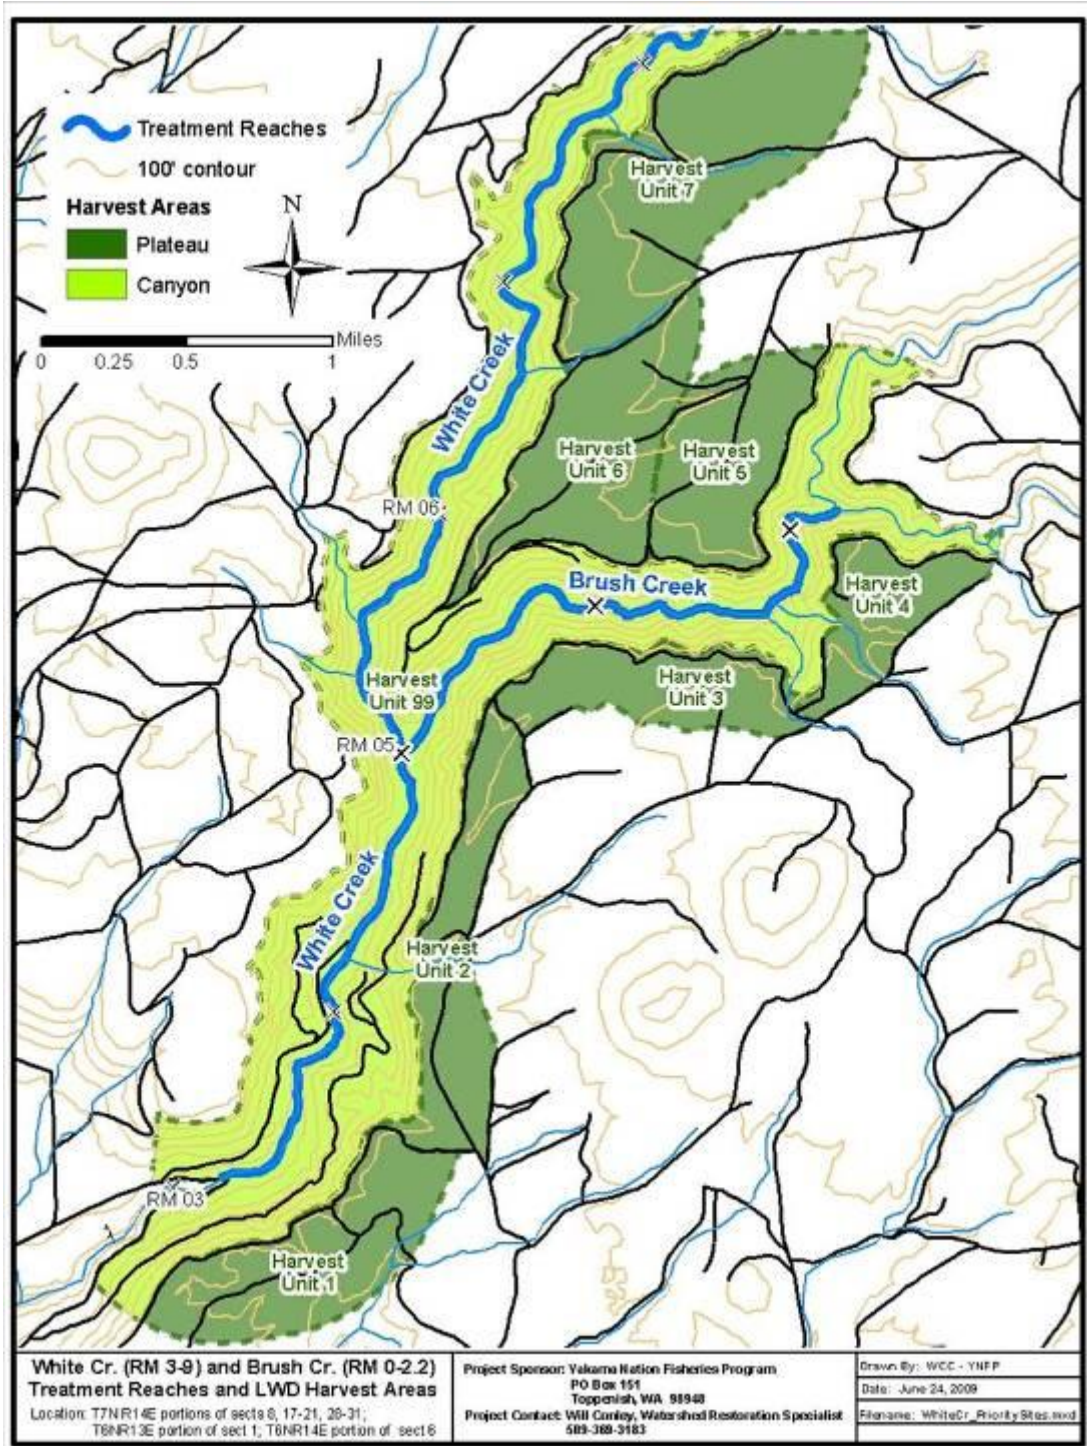
Figure 15. Proposed harvest areas and their proximity to treatment reaches.

Based upon review of aerial photos and topography, several suitable stands in vicinity of the eastern canyon rim appeared to be suitable given their location and apparent size distribution of trees. Ground verification was conducted by staff to evaluate road access and qualitatively assess stand conditions. This was followed by a simple timber survey of the most promising stand in T7N R 14E S30. This basic survey sampled 145 trees (Ponderosa Pine and Douglas Fir) for diameter at breast height and total tree height. The intent of this survey was to document whether the stand contained a suitable amount of trees that met diameter and height parameters needed for LWD treatment. Additional field visits were conducted throughout the summer of 2009 to inventory road accessibility, locate additional suitable stands, and locate potential landing areas for the stockpiling of LWD. In addition to these field surveys, maps of potential harvest areas were created to aide in both internal planning (YN) and environmental compliance documentation (Fig. 15).

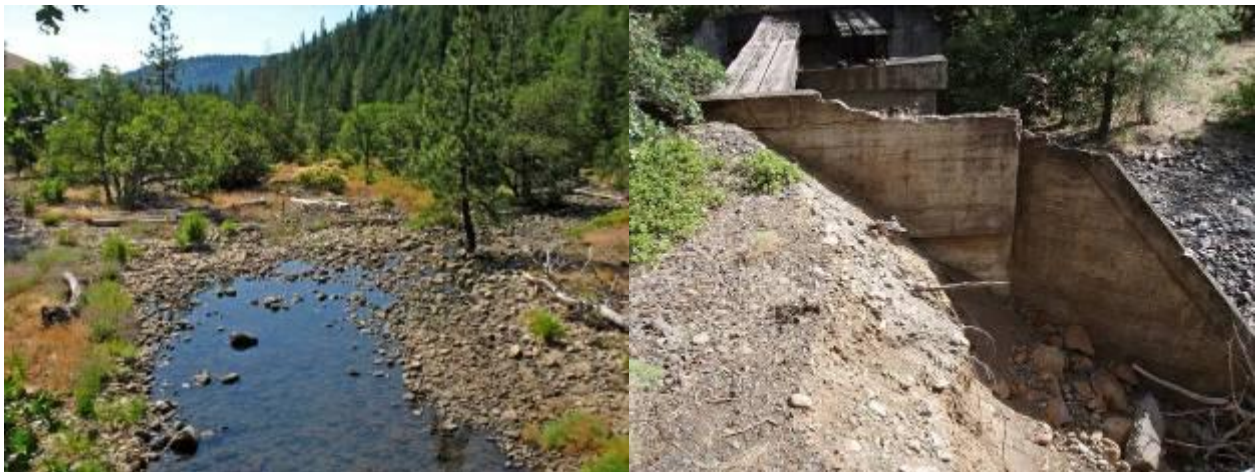
Figure 16. Tail-out of scour pool created by trestle (left) and embankment erosion (right).

The pre-project condition involved a cross-valley fill (570 lineal feet) and 30' wide trestle with a mid-span abutment. The lower reaches of Dead Canyon Creek (including the project site) are seasonal and general exhibit substantial braiding in coarse sediments. However, the railroad crossing created a pinch-point that concentrated flow and generated local scour that created an uncharacteristic pool for the reach (Fig. 16). The pool was an attractive nuisance for downstream migrants (*O. mykiss*), some of which would delay their transit, get trapped as flows receded, and eventually perish in the pool. In addition to being a contributor to fish mortality, the embankment was eroding (Fig. 16) and some parties had concern about water quality.

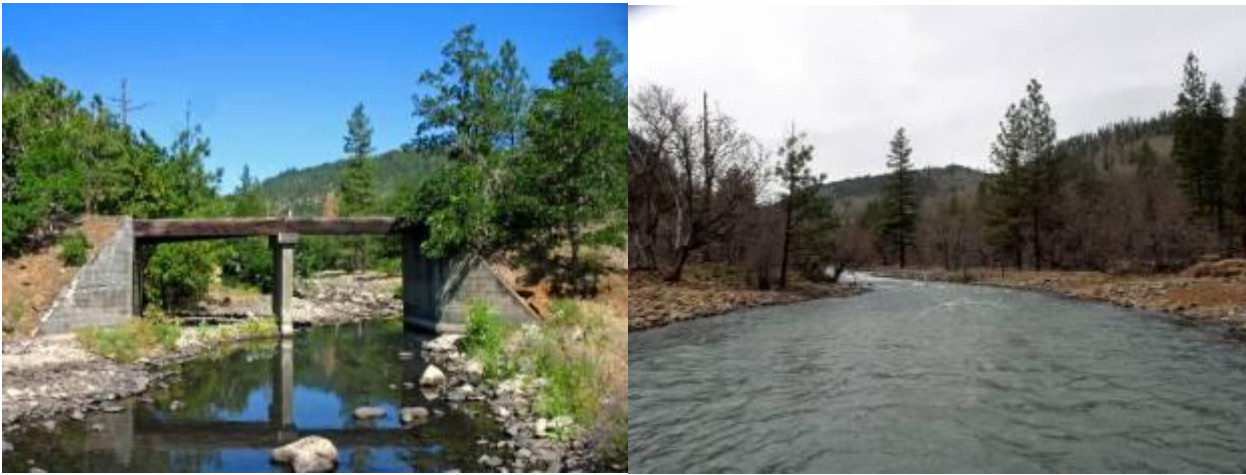
Figure 17. Upstream view of railroad crossing before (left) and after (right) treatment.

Treatment occurred during the summer of 2009 and involved removal of trestle, abutments, and cross-valley embankment (Fig. 17). Embankment materials were graded into the adjacent borrow ditches with the surplus end-hauled and graded into cut-slopes along the valley wall. The channel was graded to better match the stream profile (Fig. 18) and eliminate false-attraction of the pool. Additionally, 2800 lineal feet of embankment along the south margin of Dead Canyon was re-sloped and rehabilitated back to where it meets the modern Haul Road alignment. CLT staff provided lead on planning, permitting, and funding administration while KWEP staff provided design and field construction oversight. Construction funding was provided by a Washington Salmon Recovery Funding Board grant.

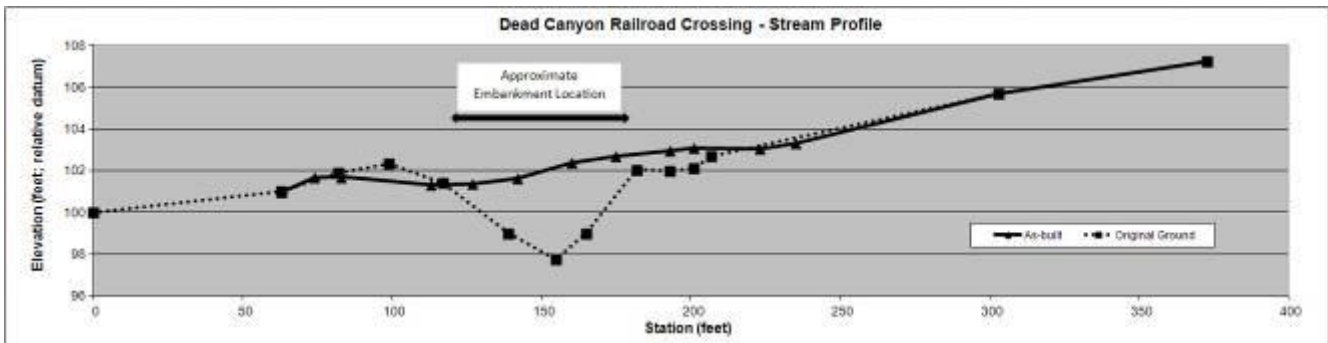
Figure 18. Profile of Dead Canyon Creek through railroad crossing before and after treatment.

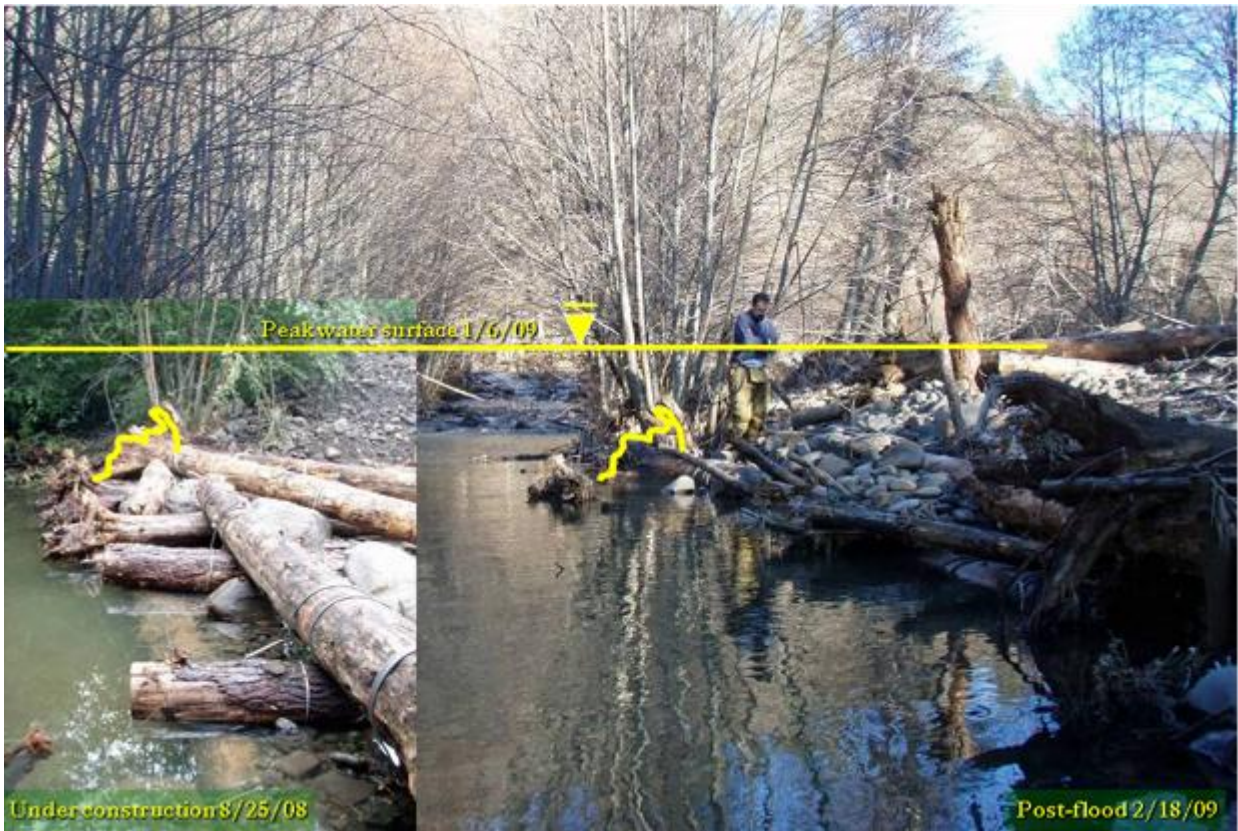
Figure 19. Element 4 during construction (inset) and post-flood.

Element	Residual Pool Depth (ft)			
	Pre-Construction	As-Built	March 2009	August 2009
1	0.2	No data	No data	2.0
2	Not constructed			
3	0.4	2.6	2.3	2.3
4	1.3	3.8	2.6	3.3
5	0.5	3.9	3.3	3.4
6	0.6	4.5	3.5	3.6

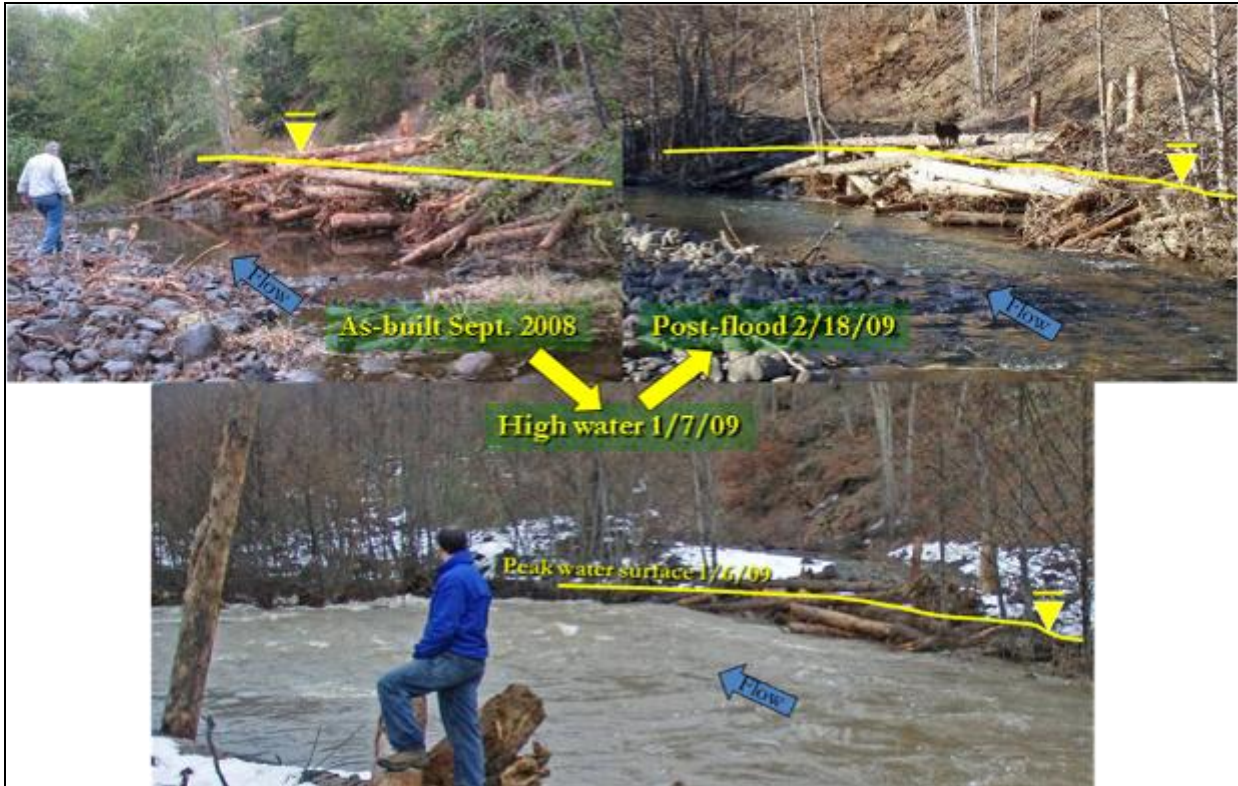
Figure 20. Element 5 as-built (top, left), during flood (bottom), and post-flood (top, right).

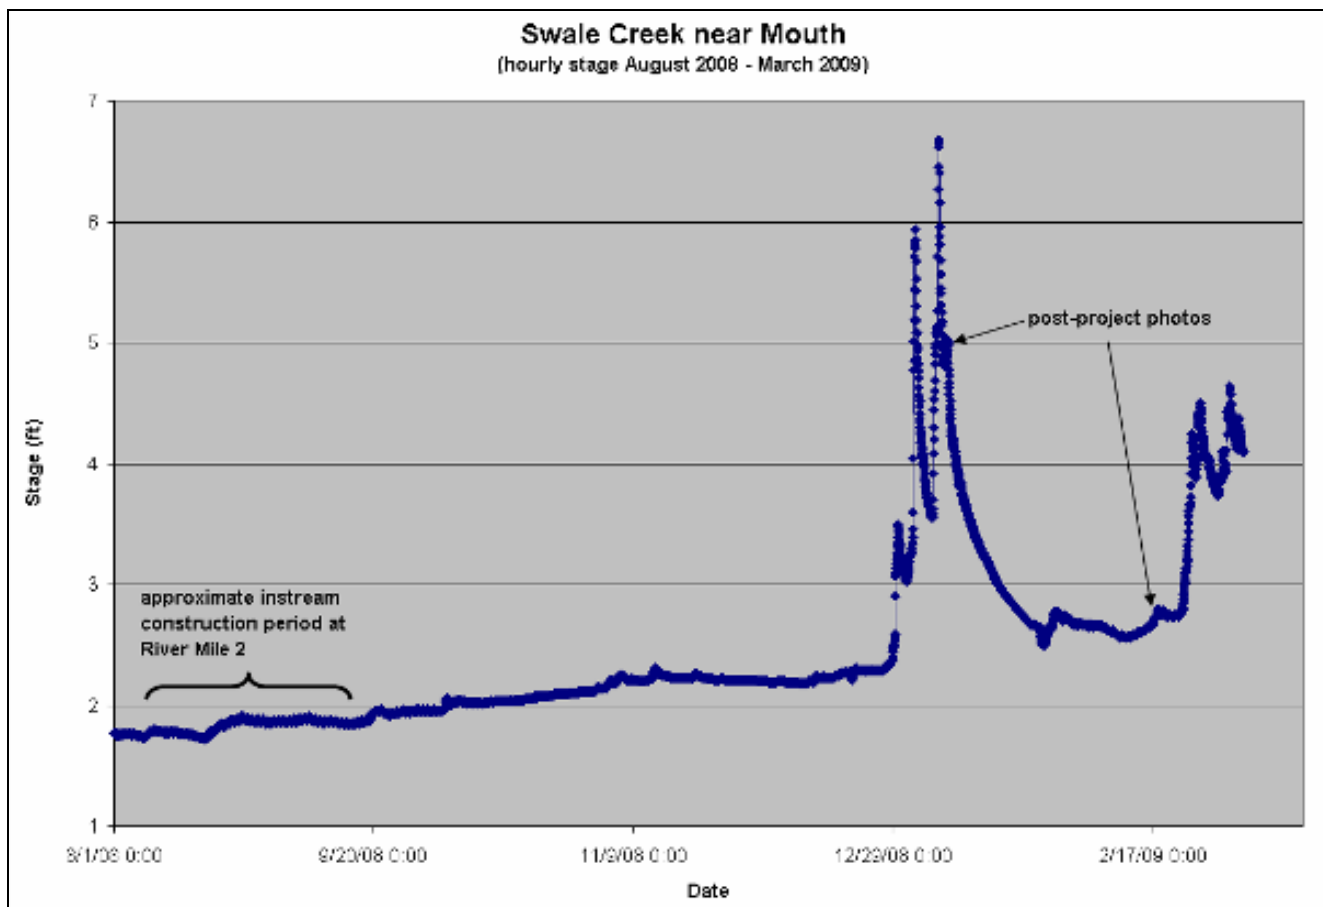
Figure 21. Hydrograph from the YNFP gage on Swale Creek near mouth.

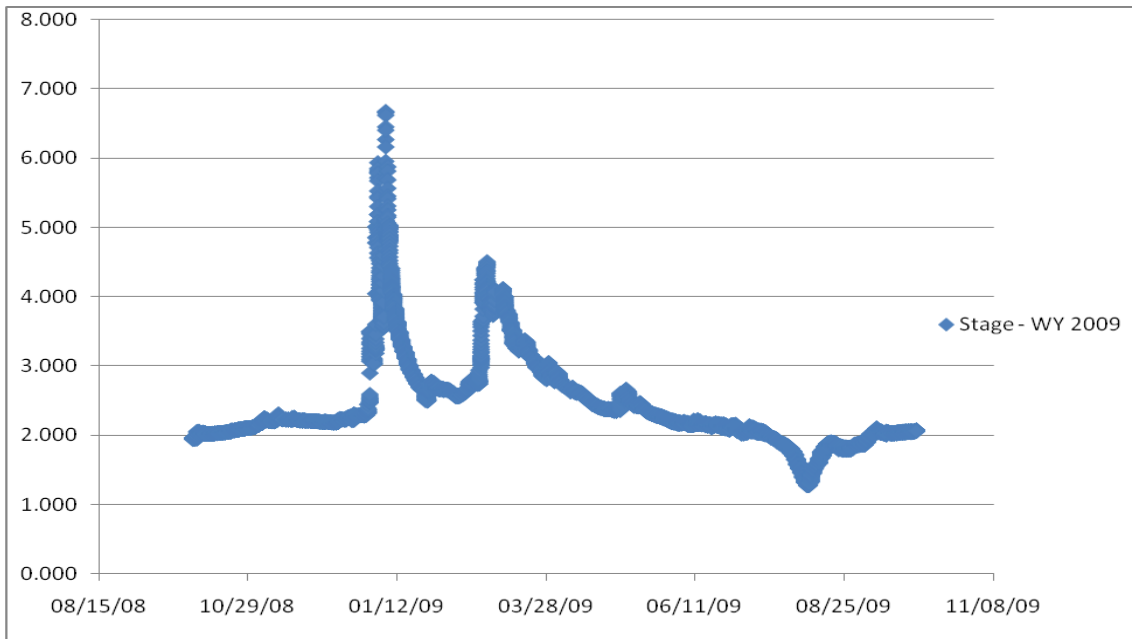
Figure 22. Stage at the Swale Creek Mouth site for Water Year 2009 (10/1/2008 – 9/31/2009).
