# Recovery of Dewatered Upland Habitat Following Dam Removal

**Martin Lafrenz**  
**Department of Geography**  
**Portland State University**

# The Sandy River at Mount Hood, Oregon

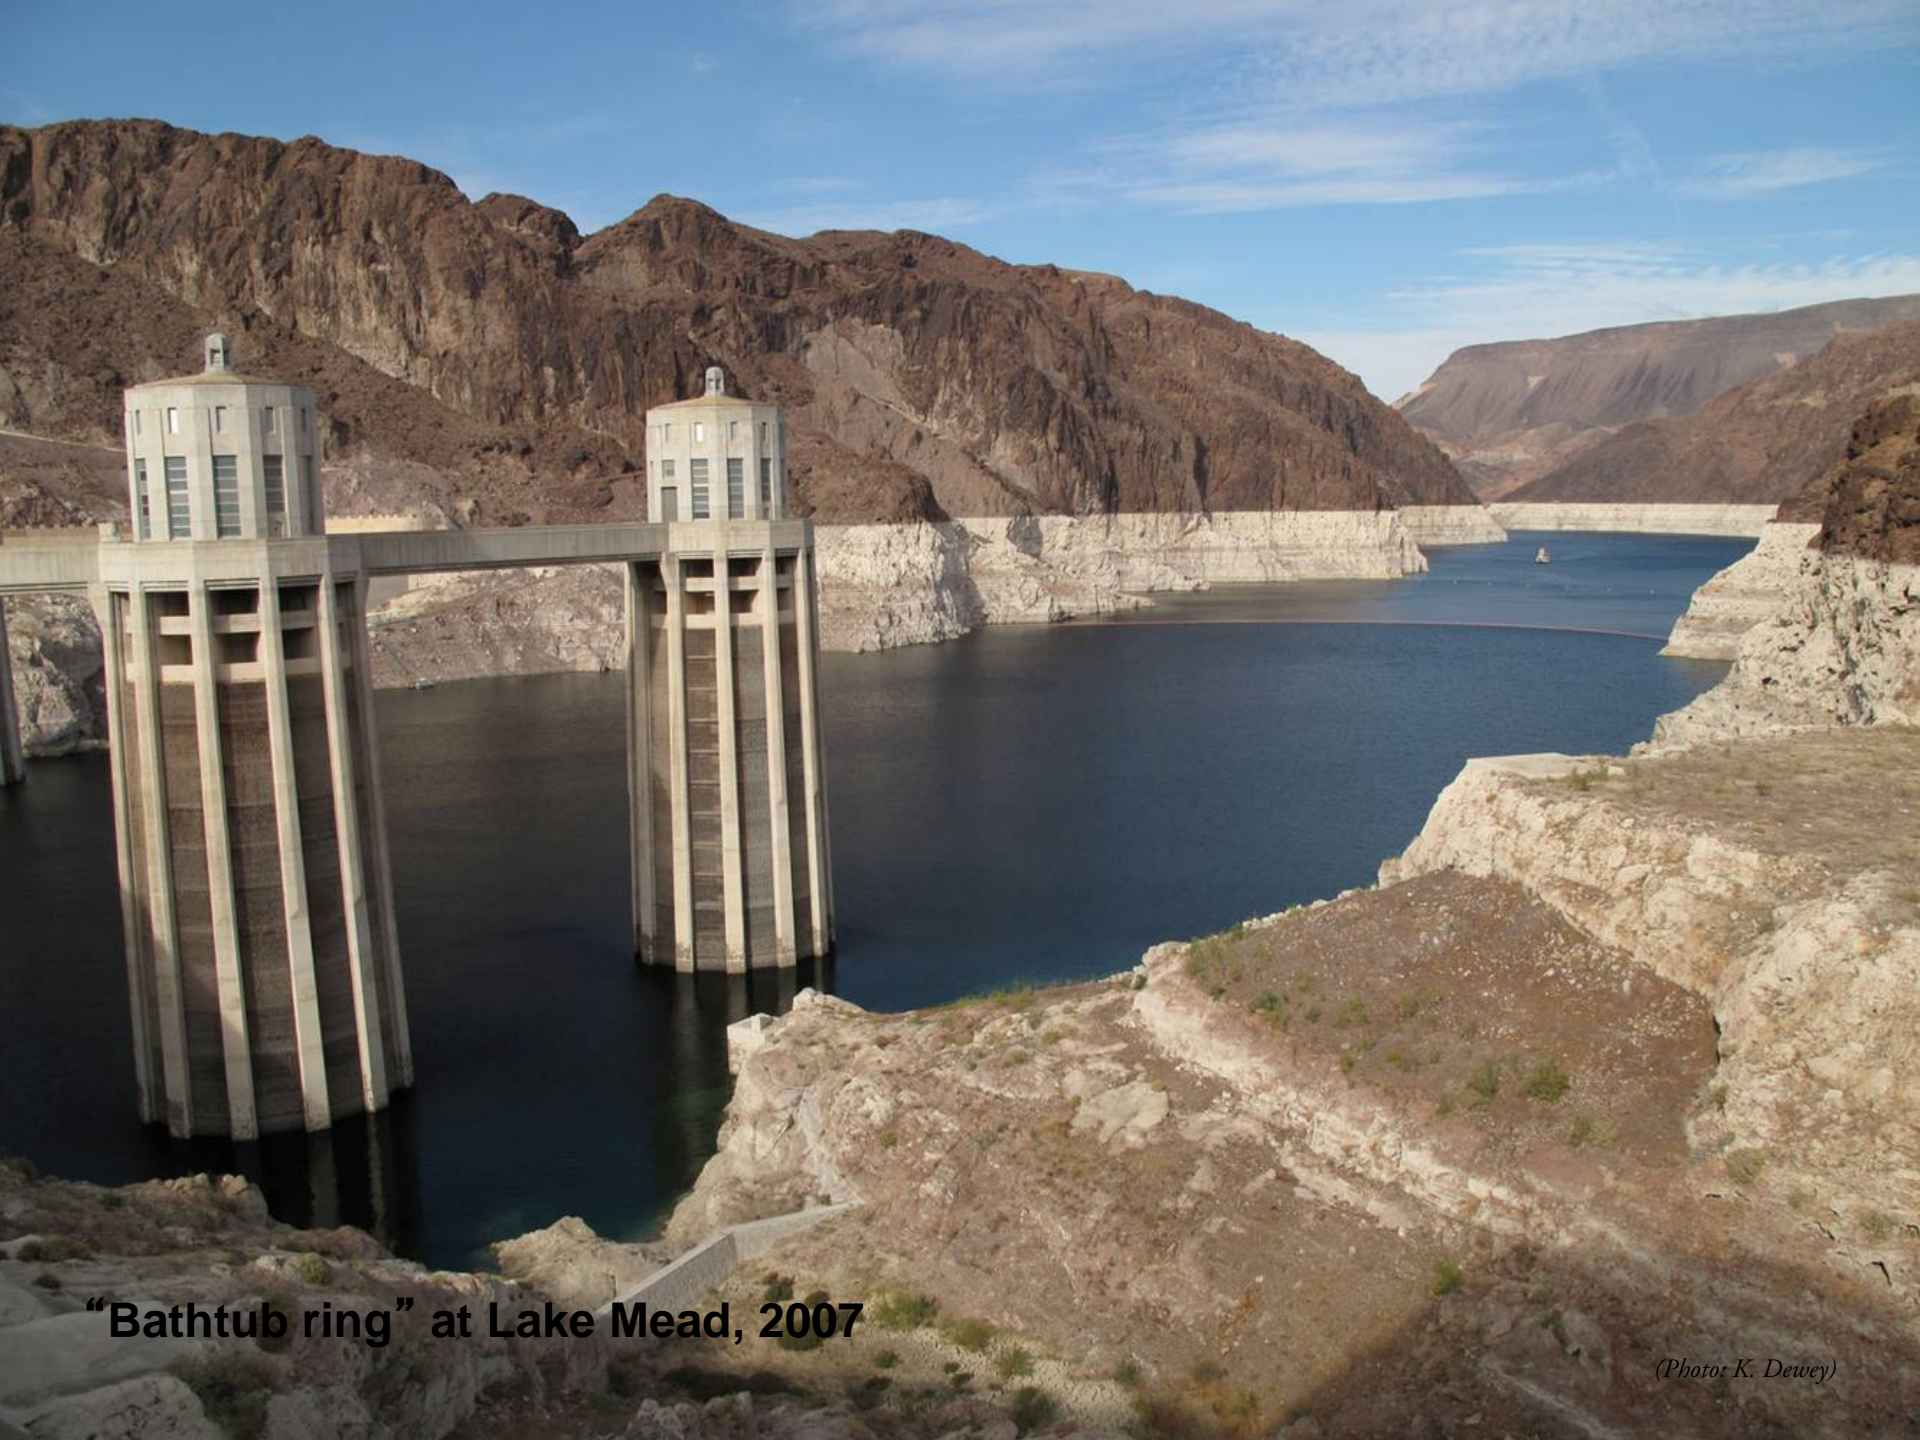
**“Bathtub ring” at Lake Mead, 2007**

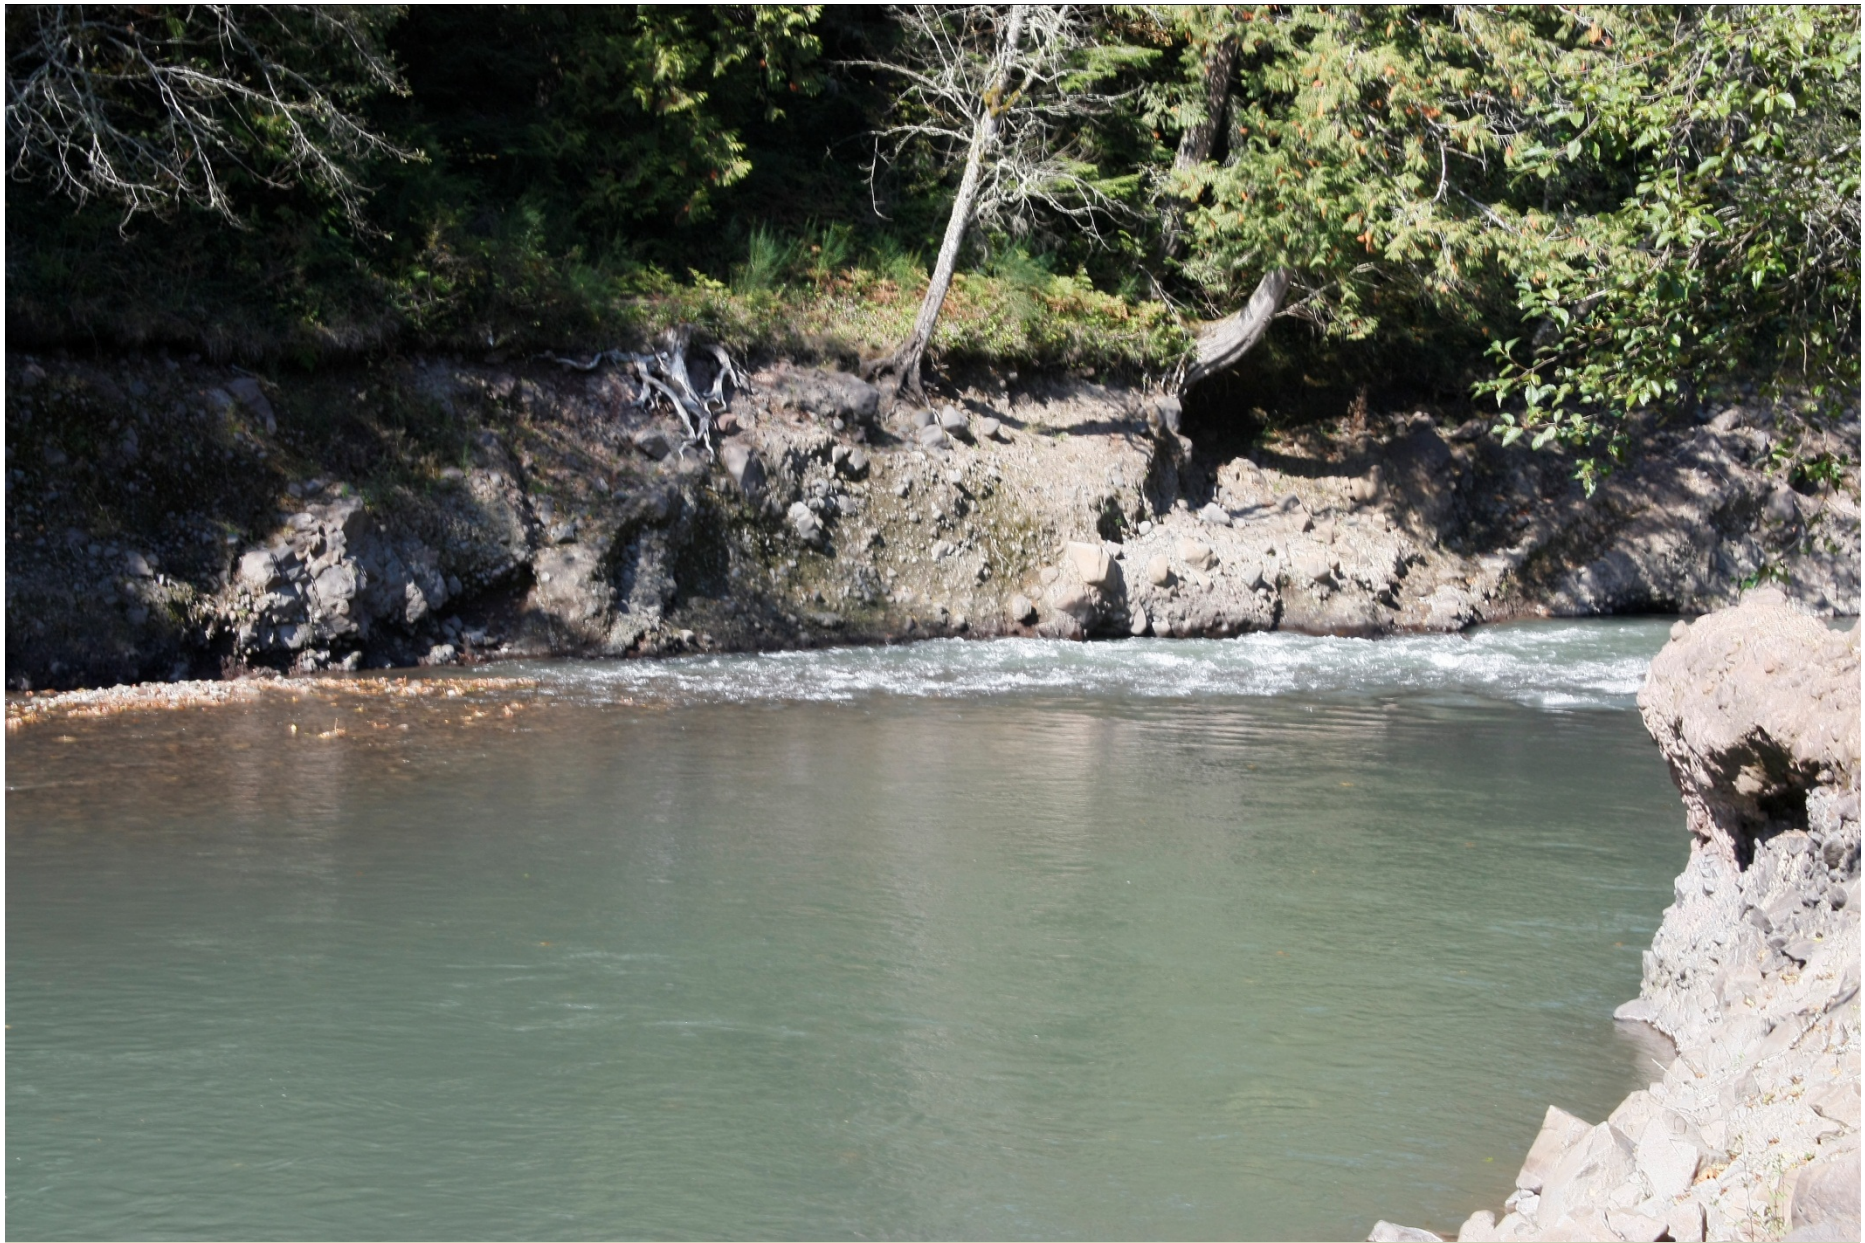
**“Bathtub ring” at Sandy River, 2011**

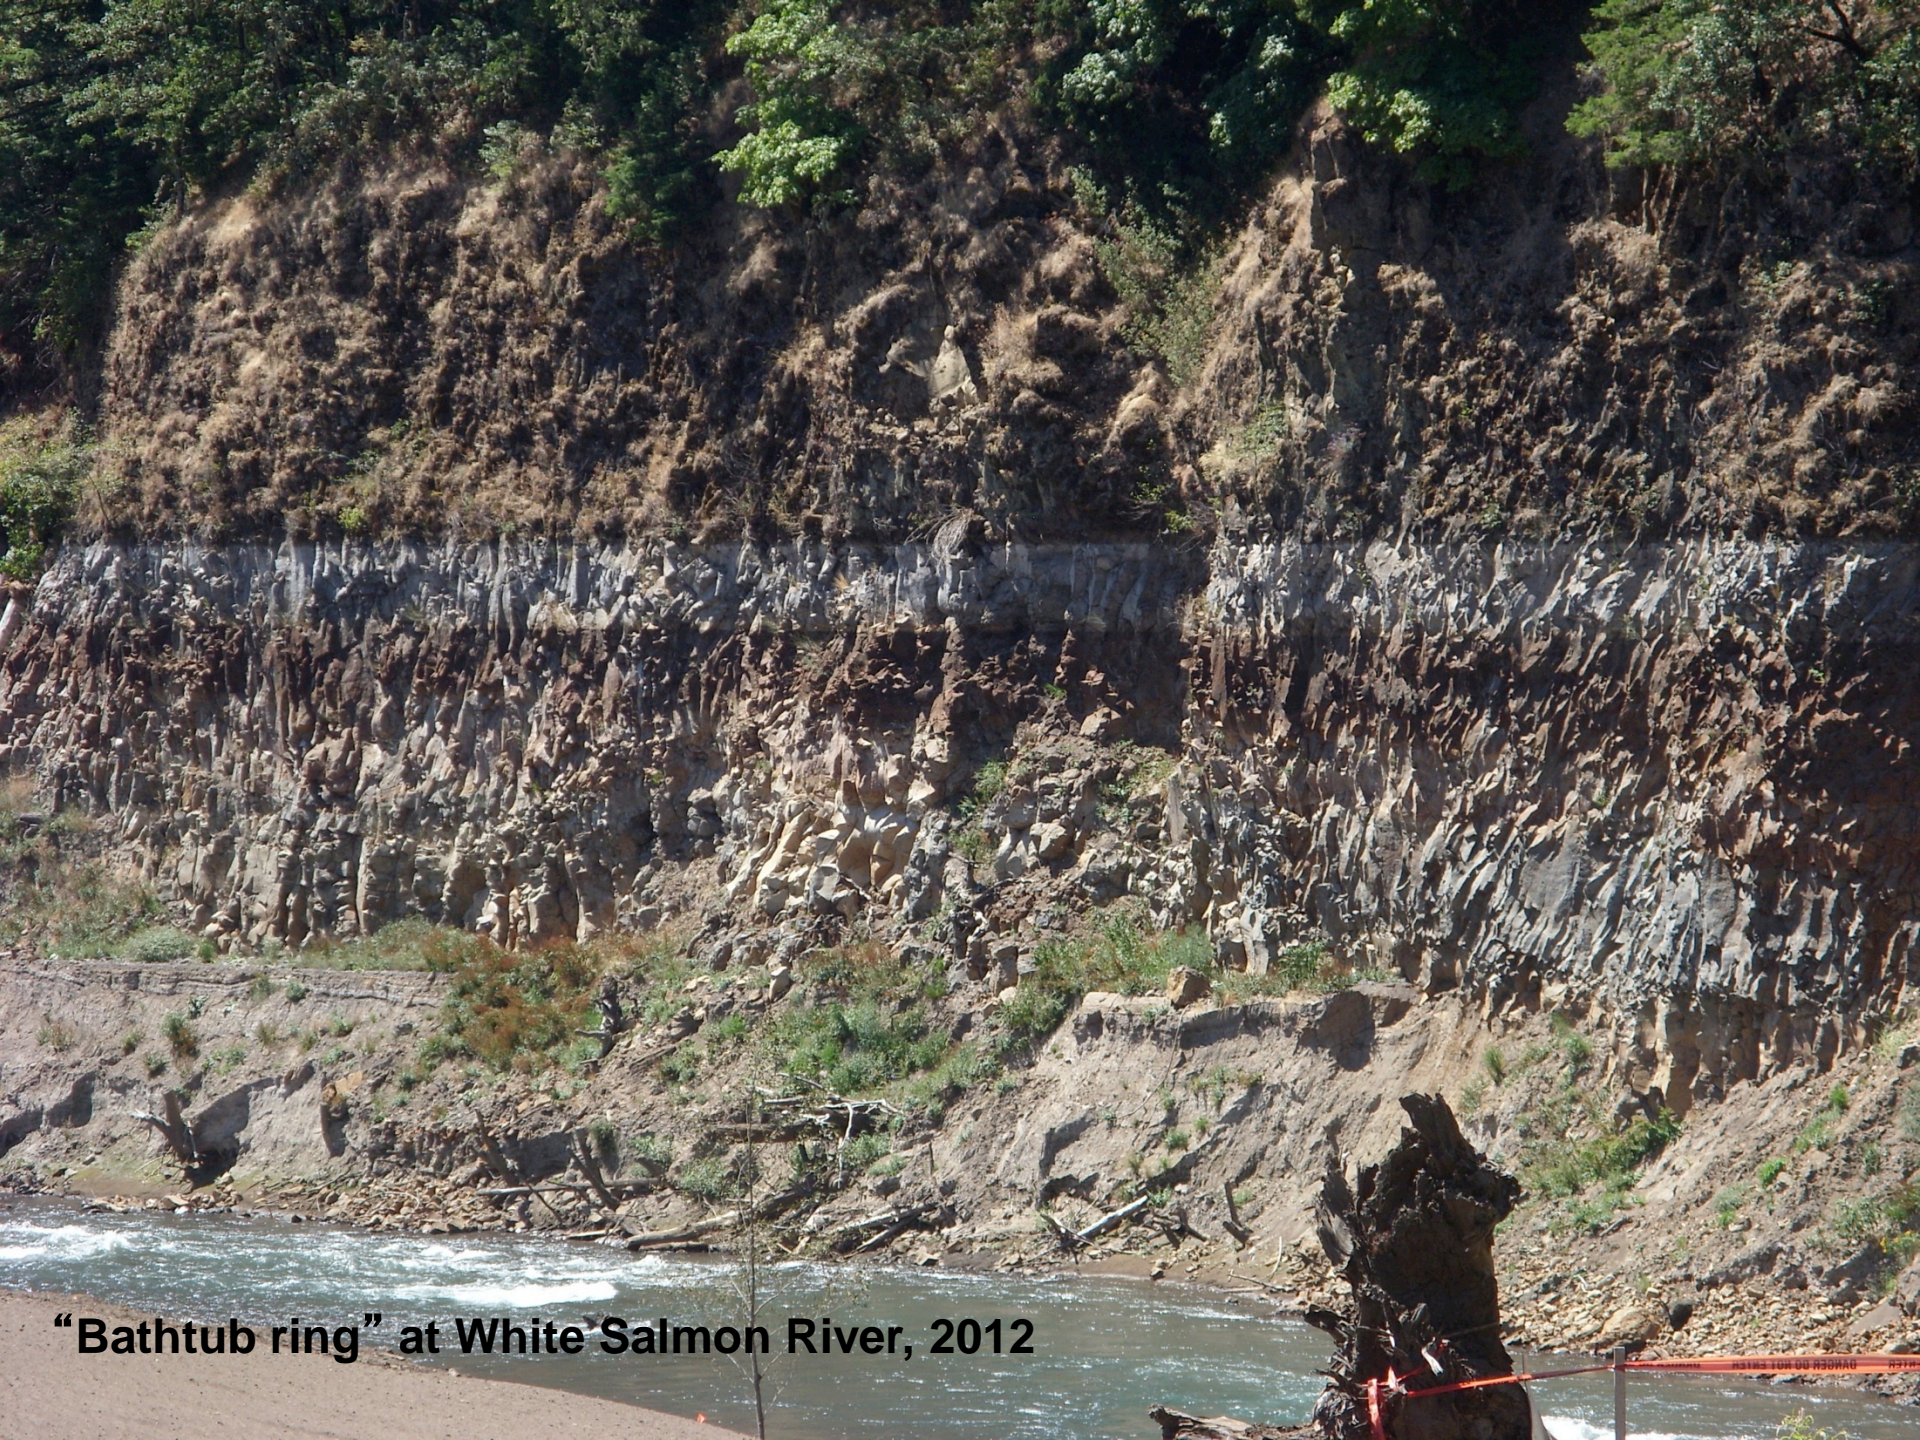
**“Bathtub ring” at White Salmon River, 2012**

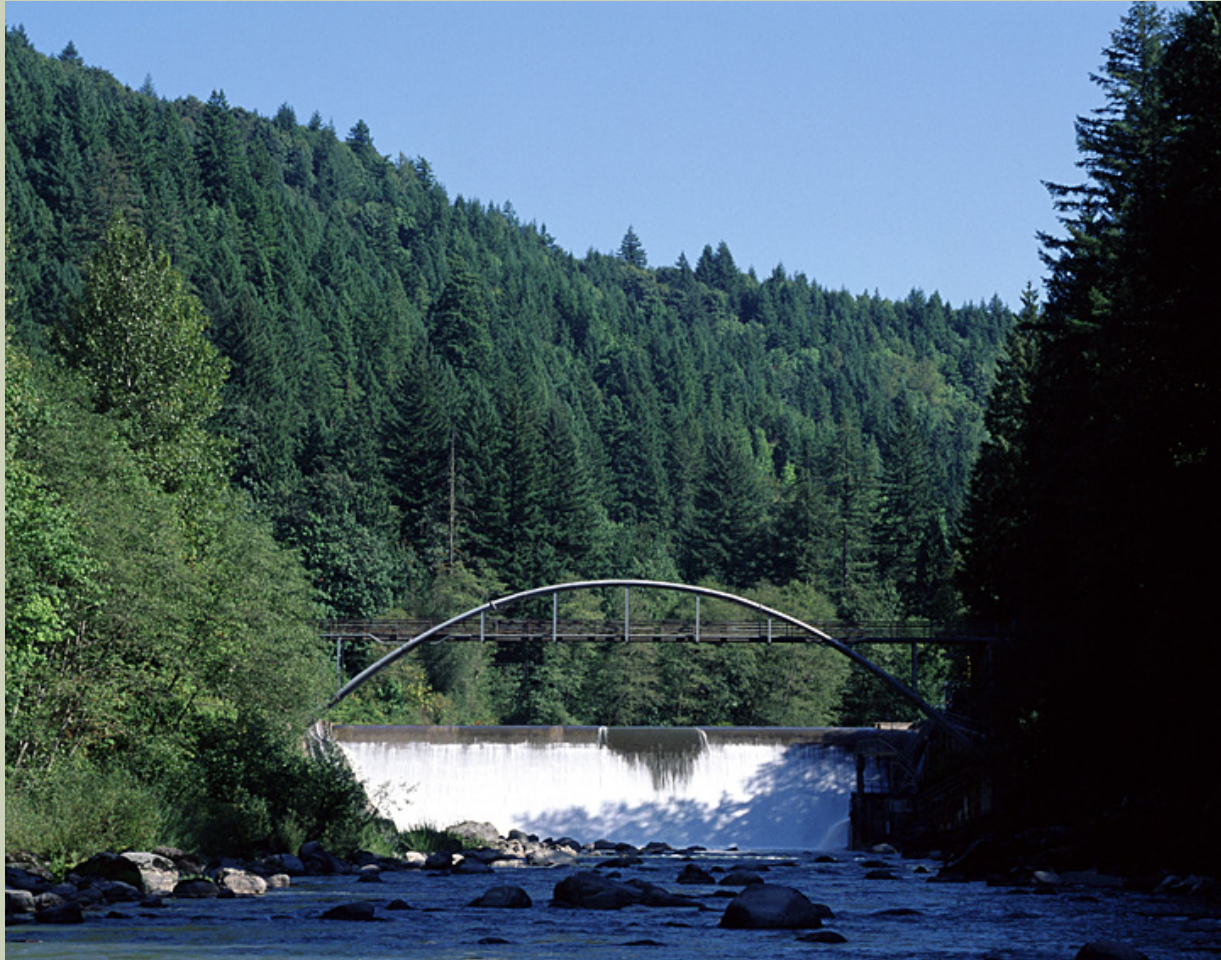
# MARMOT DAM

1908-2007; 14.3 m, concrete

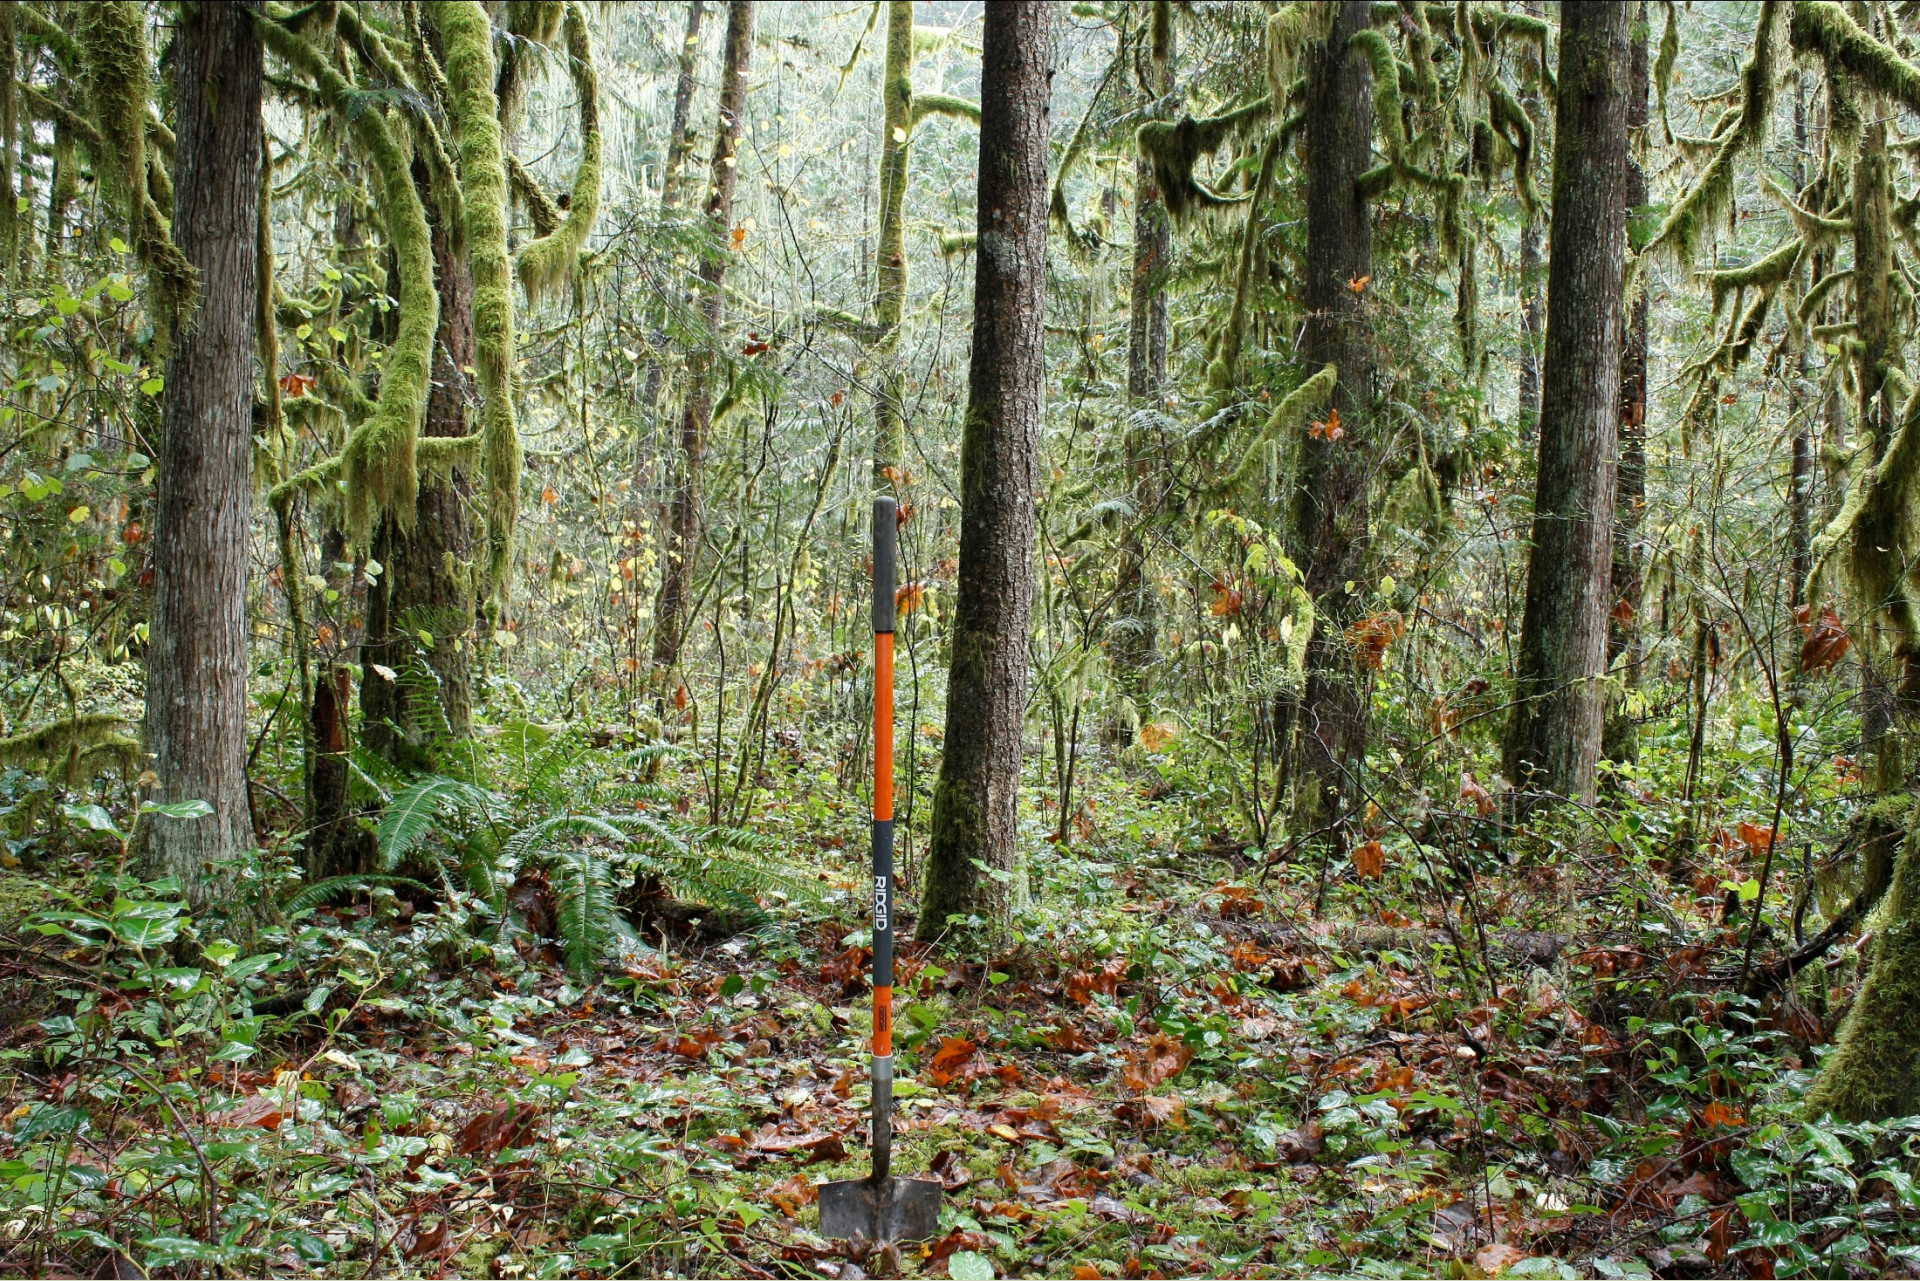
Downstream sample locations

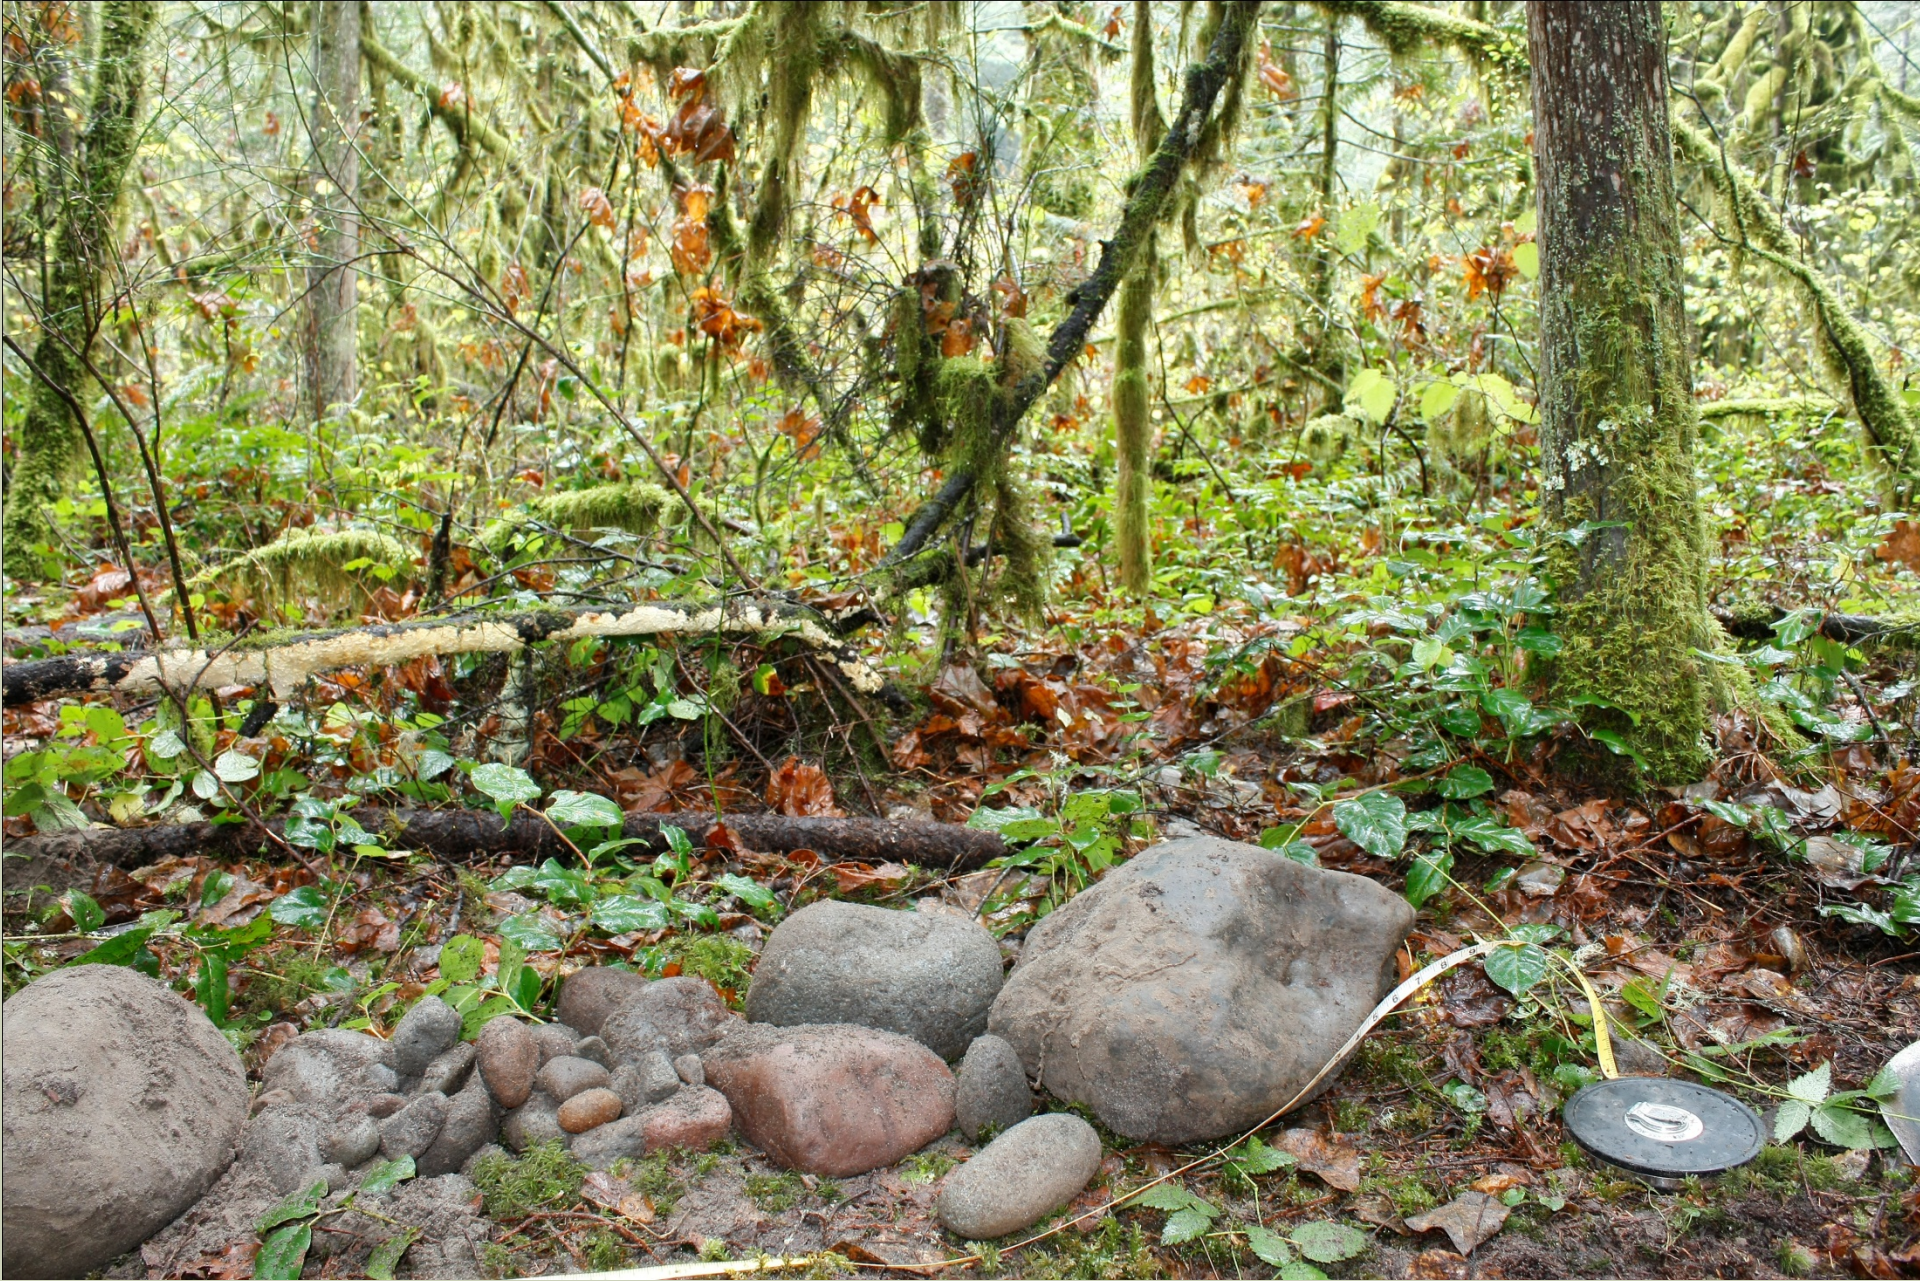
**Cobbles from DS-2, sizes over 200mm across the b-axis**

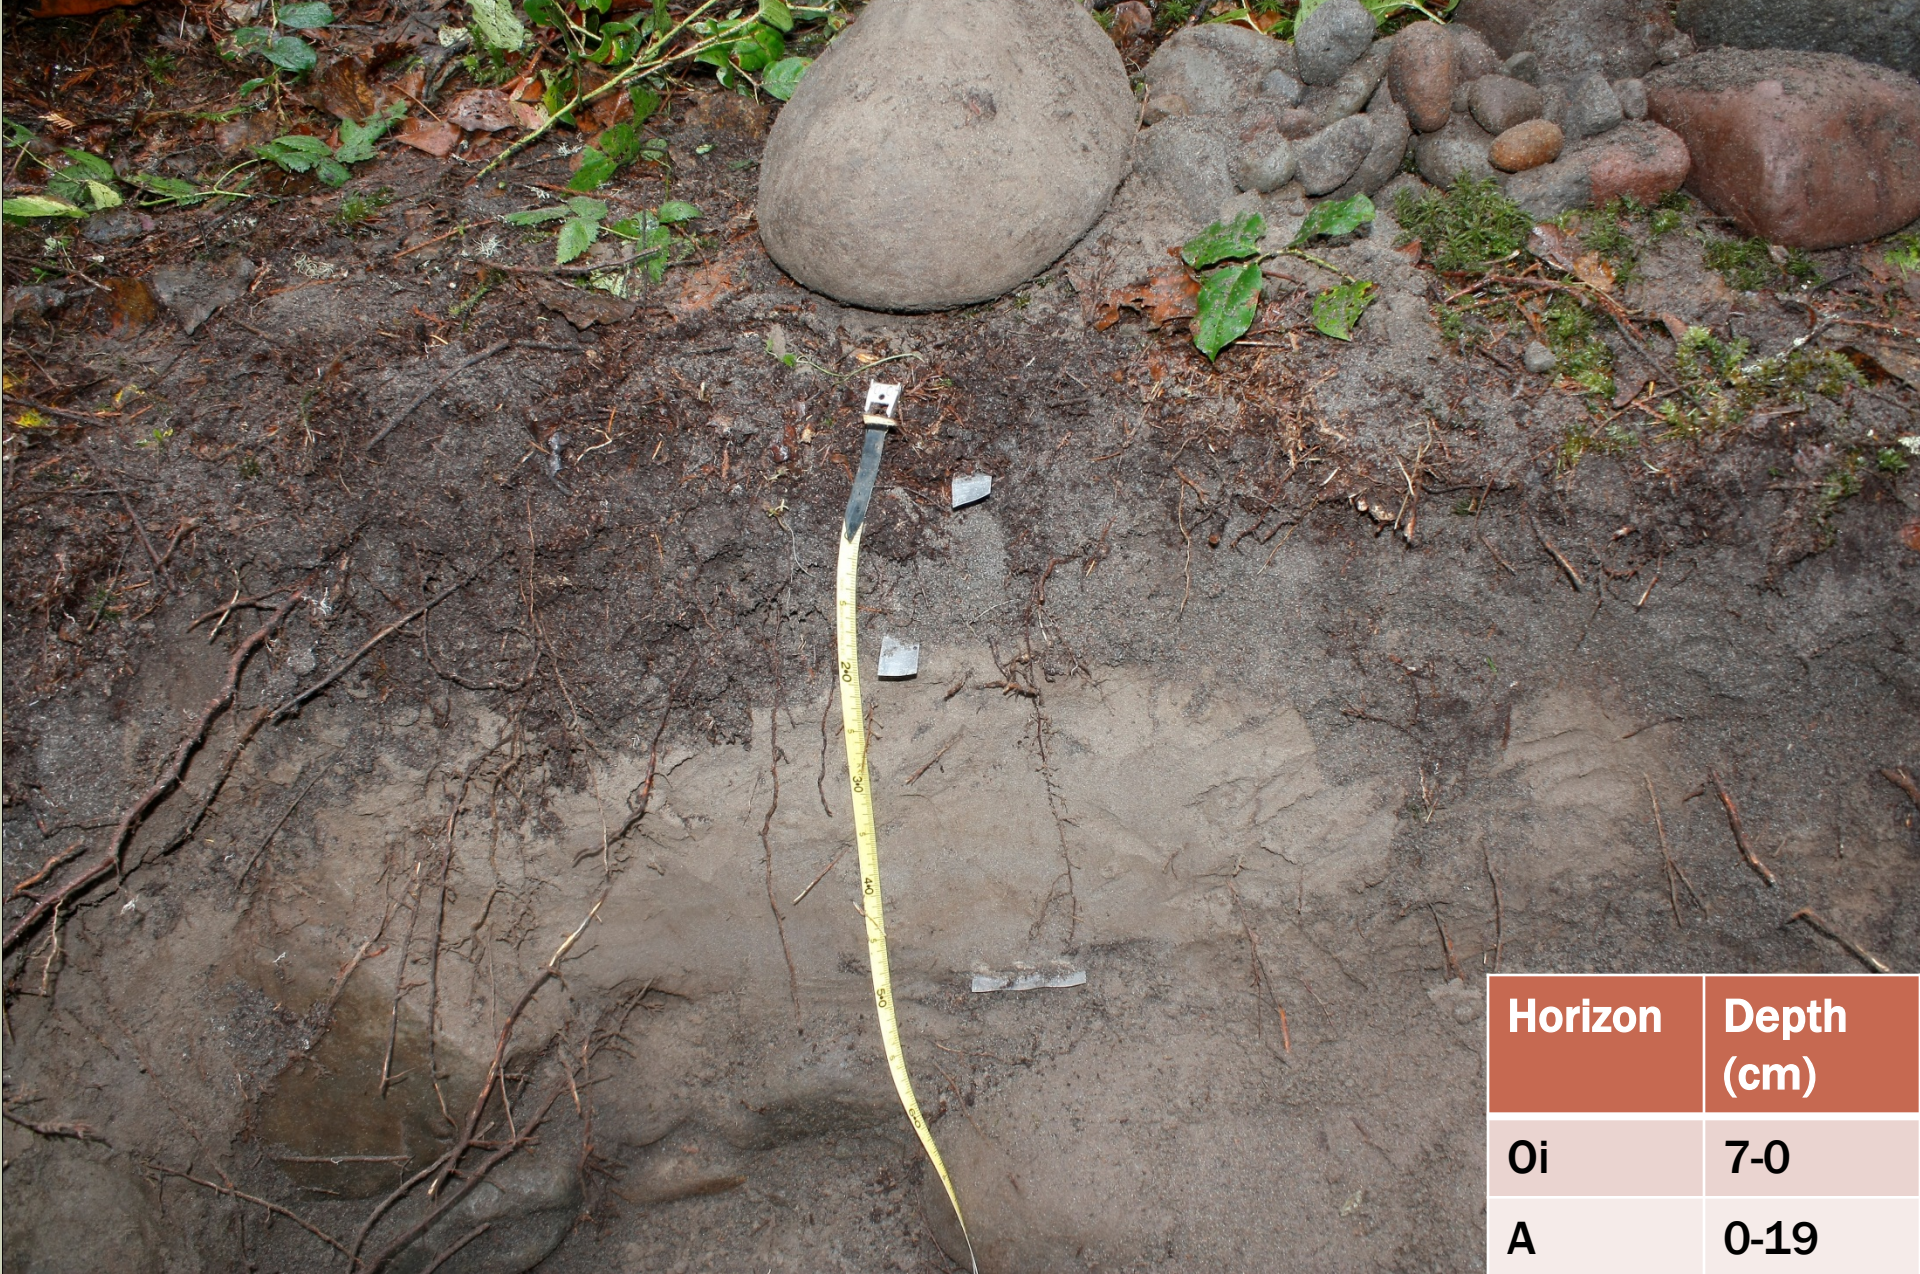
**DS-2 - Downstream terrace**

| <b>Horizon</b> | <b>Depth (cm)</b> |
| <b>Oi</b> | <b>7-0</b> |
| <b>A</b> | <b>0-19</b> |
| <b>Bw</b> | <b>19-51</b> |
| <b>Cu</b> | <b>51-90+</b> |

| Upstream | Depth (cm) | Color | Texture | Sand | Silt | Clay | Field Moisture | OM % | <i>n</i> value |
|---|---|---|---|---|---|---|---|---|---|
| A | 0-19 | 10 YR 3/2 | Coarse Sand | 97% | 1% | 2% | 8% | 1.0 | -2.5 |
| Bw | 19-51 | 7.5YR 5/2 | Fine Sand | 91% | 8% | 1% | 19% | 1.0 | -0.2 |
| Cu | 51-90+ | 10YR 5/1 | Coarse Sand | 98% | 1% | 1% | 9% | 0.9 | -3.1 |

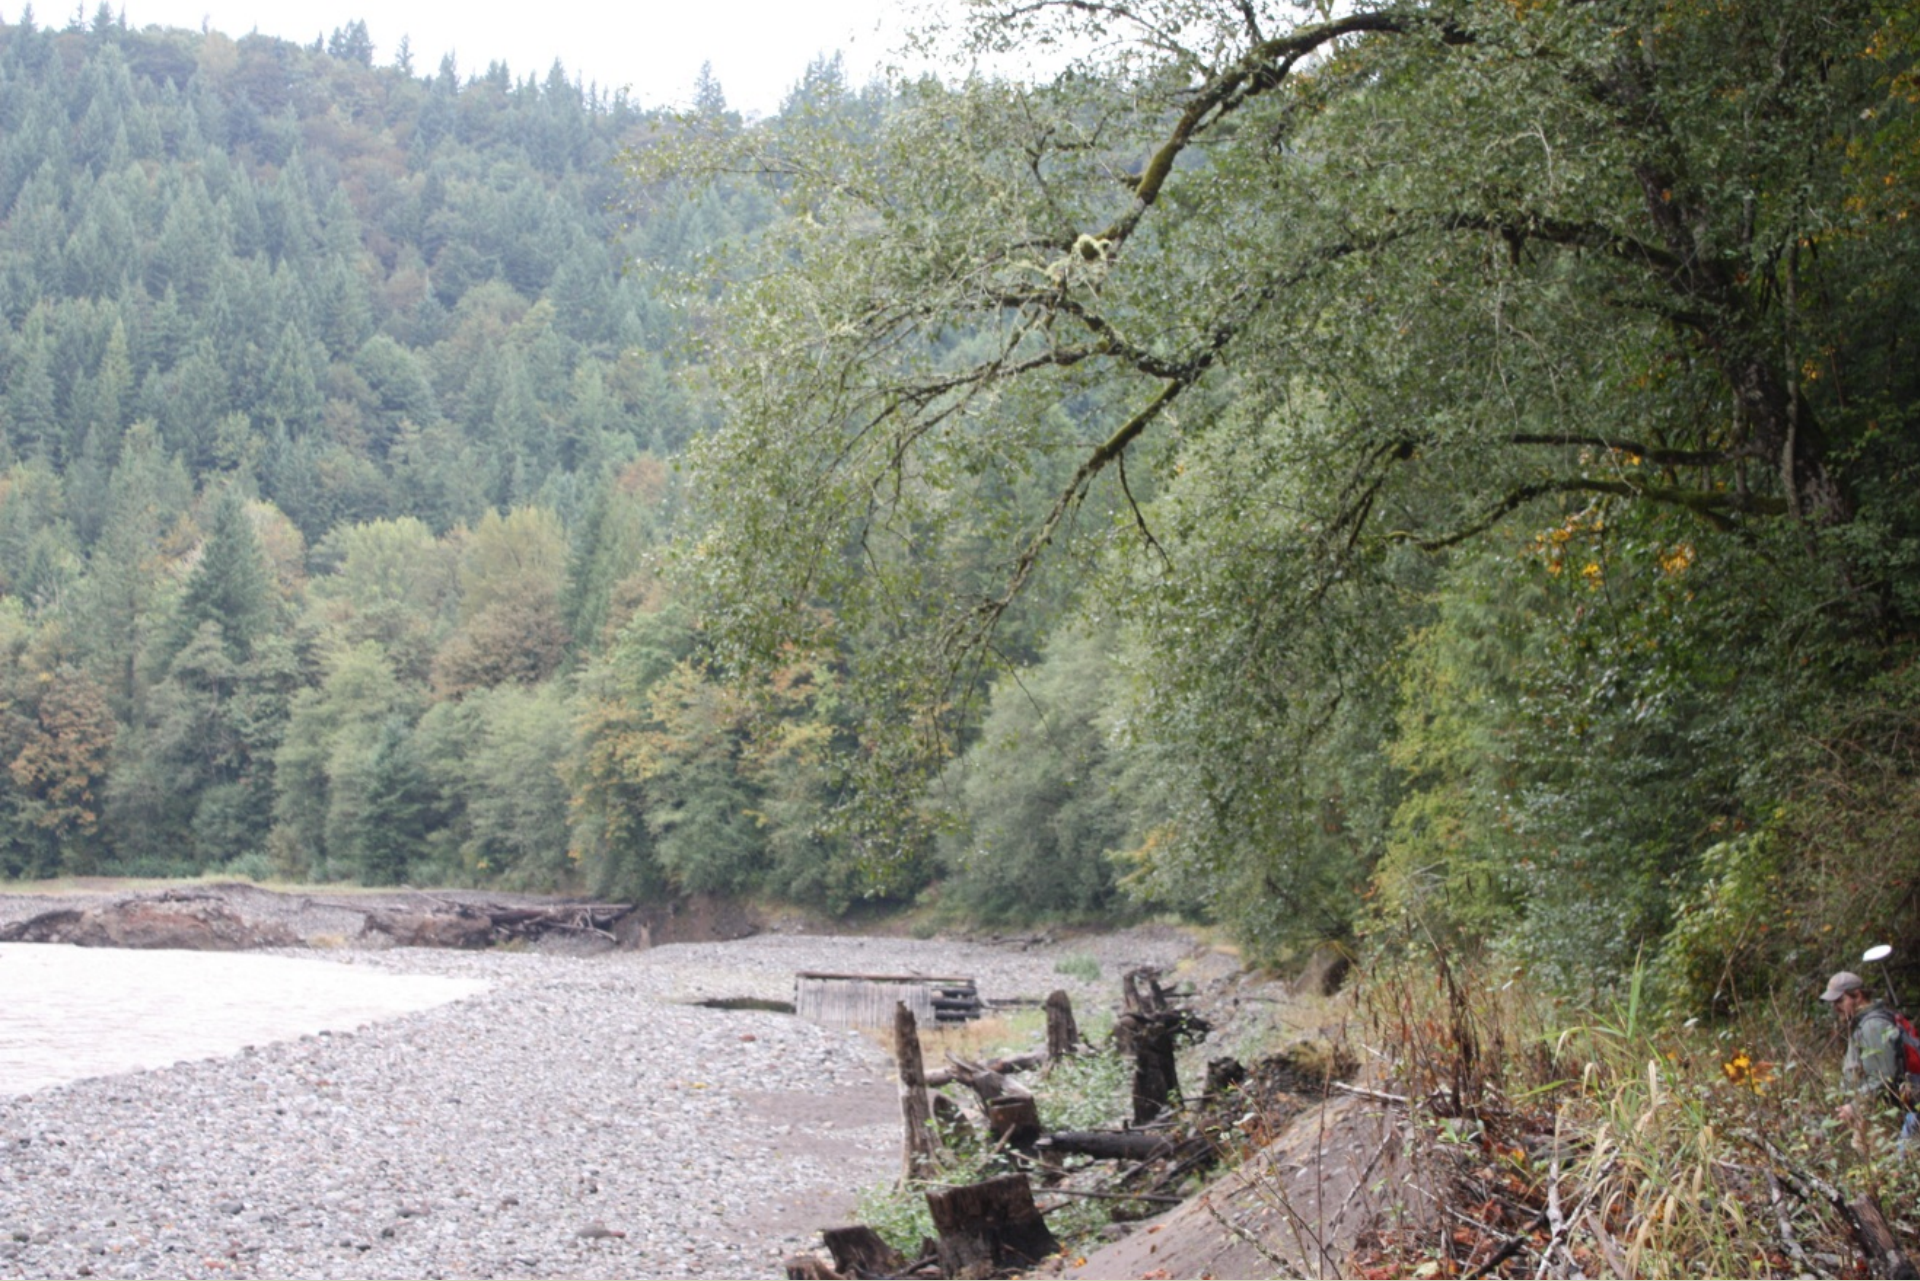
Site of upstream sample locations

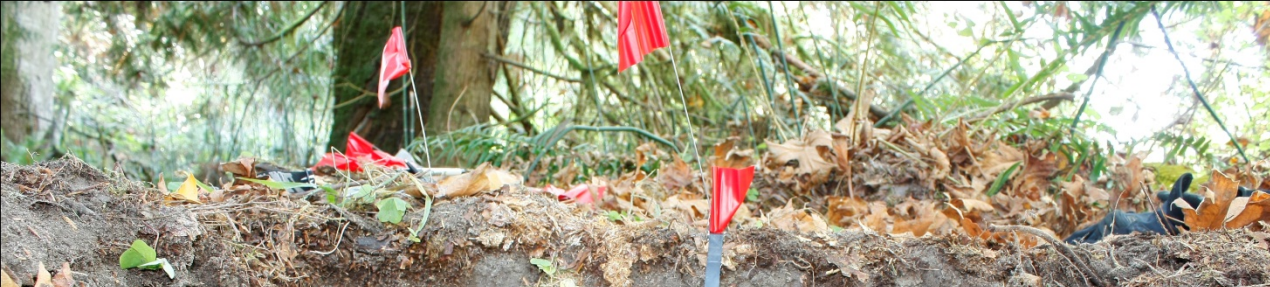
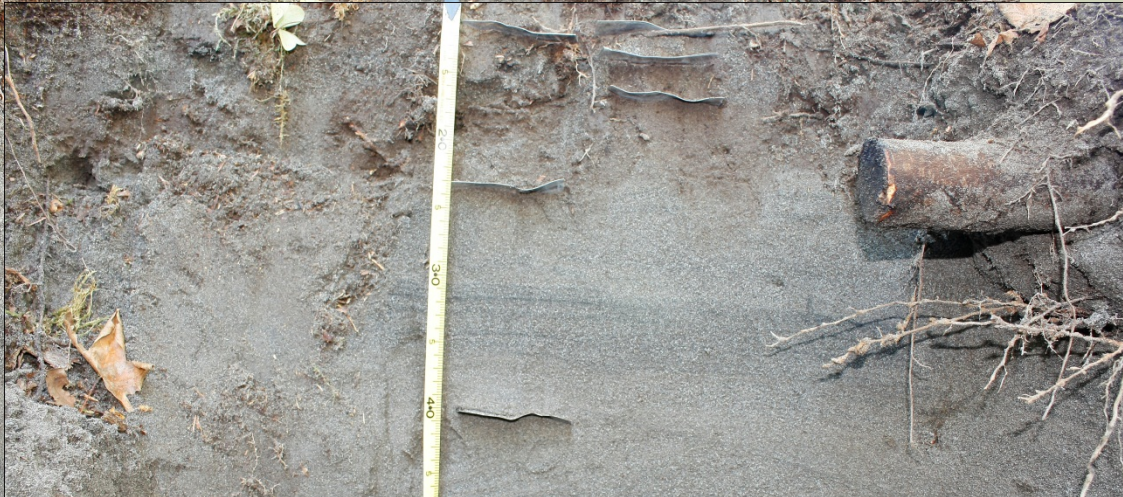
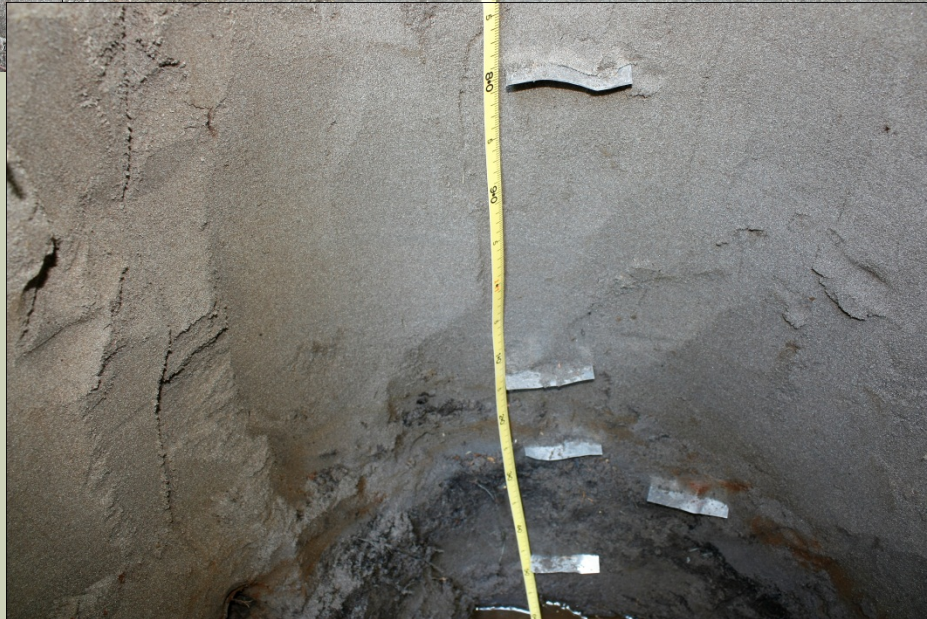
# US-1

| Horizon | Depth (cm) |
| A1 | 0-11 |
| A2 | 11-16 |
| Cu1 | 16-23 |
| Cu2 | 23-114 |
| Ab | 114-126 |
| Bwb | 126-134 |
| Cgb | 134-165+ |

Upstream accumulated sediment over “preupland” soil

| Upstream | Depth (cm) | Color | Texture | Sand | Silt | Clay | Field Moisture | OM % | <i>n</i> value |
|---|---|---|---|---|---|---|---|---|---|
| A1 | 0-11 | 10YR 6/3 | Sand | 85% | 10% | 5% | 15% | 1.6 | -0.4 |
| A2 | 11-16 | 10YR 5/3 | Loamy Sand | 88% | 8% | 4% | 17% | 2.3 | -0.2 |
| Cu1 | 16-23 | 2.5Y 5/2 | Fine Sand | 94% | 1% | 5% | 6% | 1.1 | -1.6 |
| Cu2 | 23-114 | 2.5Y 5/1 | Fine Sand | 97% | 1% | 2% | 9% | 0.7 | -2.8 |
| Ab | 114-126 | 10YR 4/1 | Fine Sand | 97% | 2% | 1% | 27% | 0.8 | 2.1 |
| Bwb | 126-134 | 10YR 5/2 | Fine Sand | 95% | 4% | 1% | 24% | 0.7 | 1.4 |
| Cgb | 134-165+ | 2.5Y 5/1 | Fine Sand | 93% | 7% | 0% | 24% | 0.9 | 1.4 |

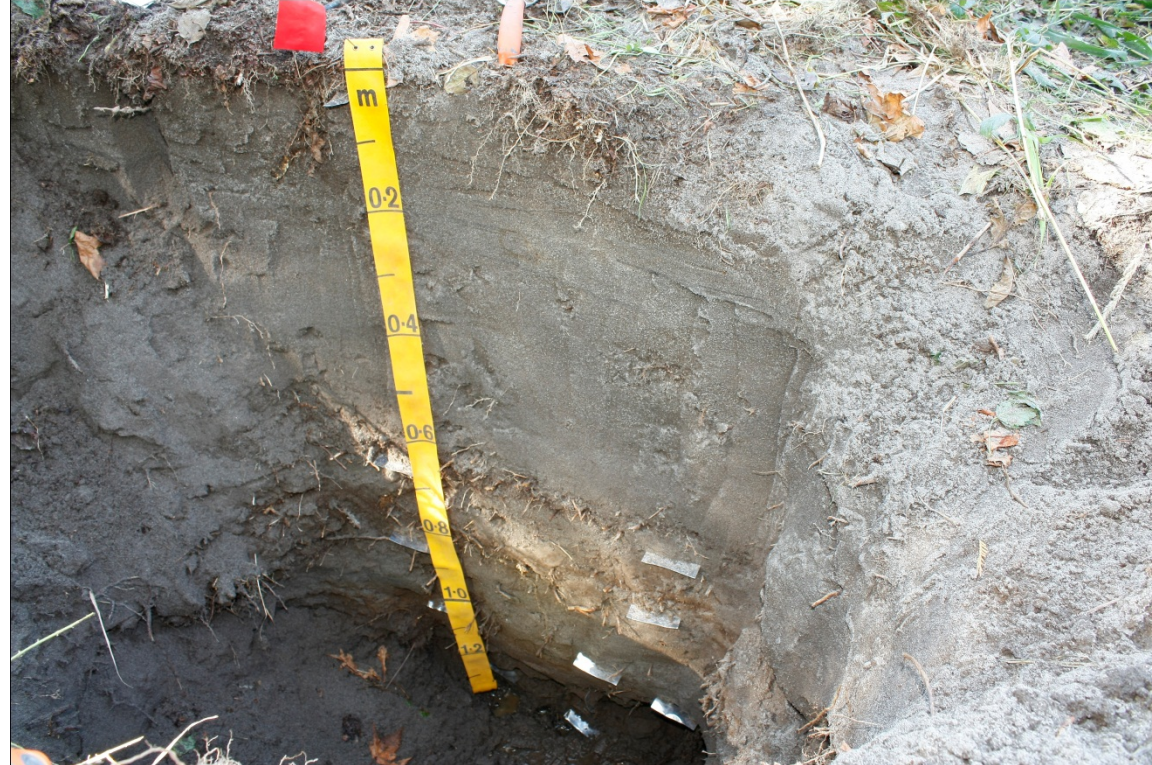
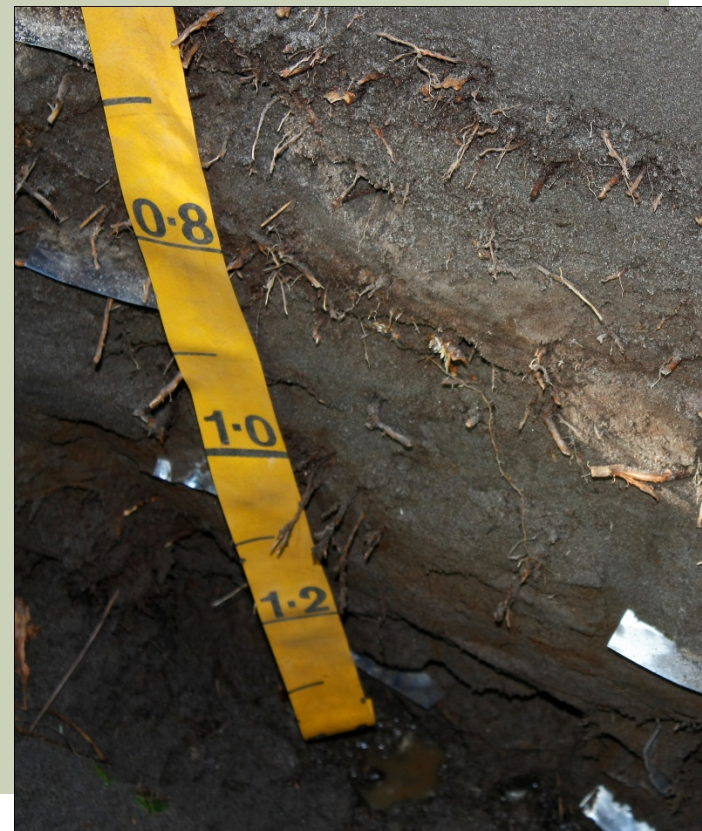
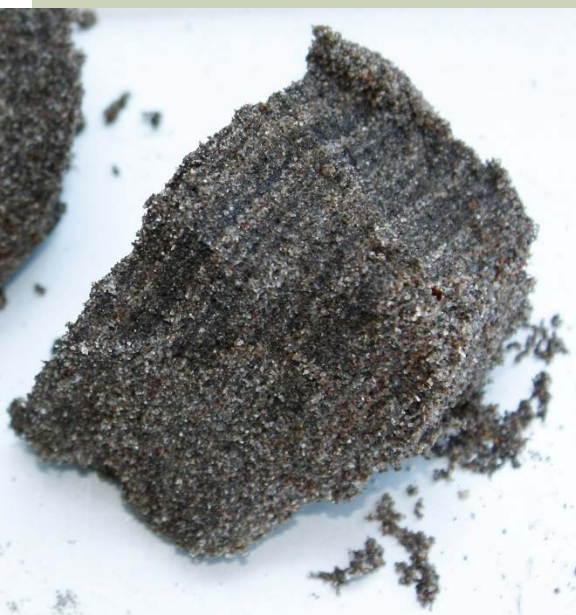
# US-2

| Horizon | Depth (cm) |
| A | 0-2 |
| Cu1 | 2-65 |
| Cu2 | 65-106 |
| Ab | 106-118 |
| Bwb | 118-139 |
| Water | |
