# Recovery of Dewatered Upland Habitat Following Dam Removal

**Martin Lafrenz**  
**Department of Geography**  
**Portland State University**

# The Sandy River at Mount Hood, Oregon

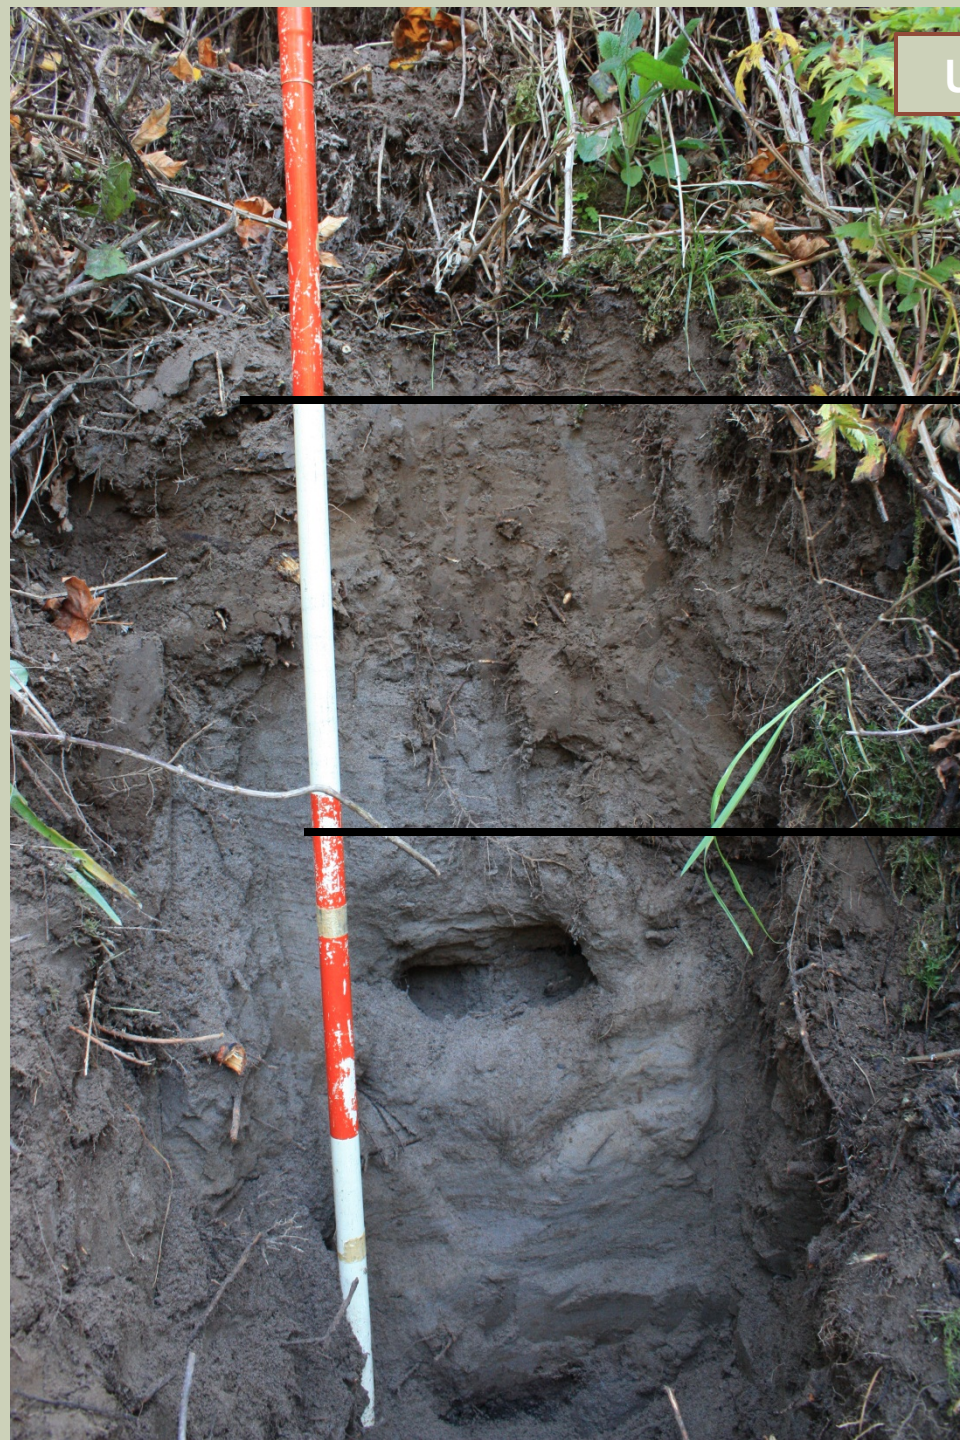
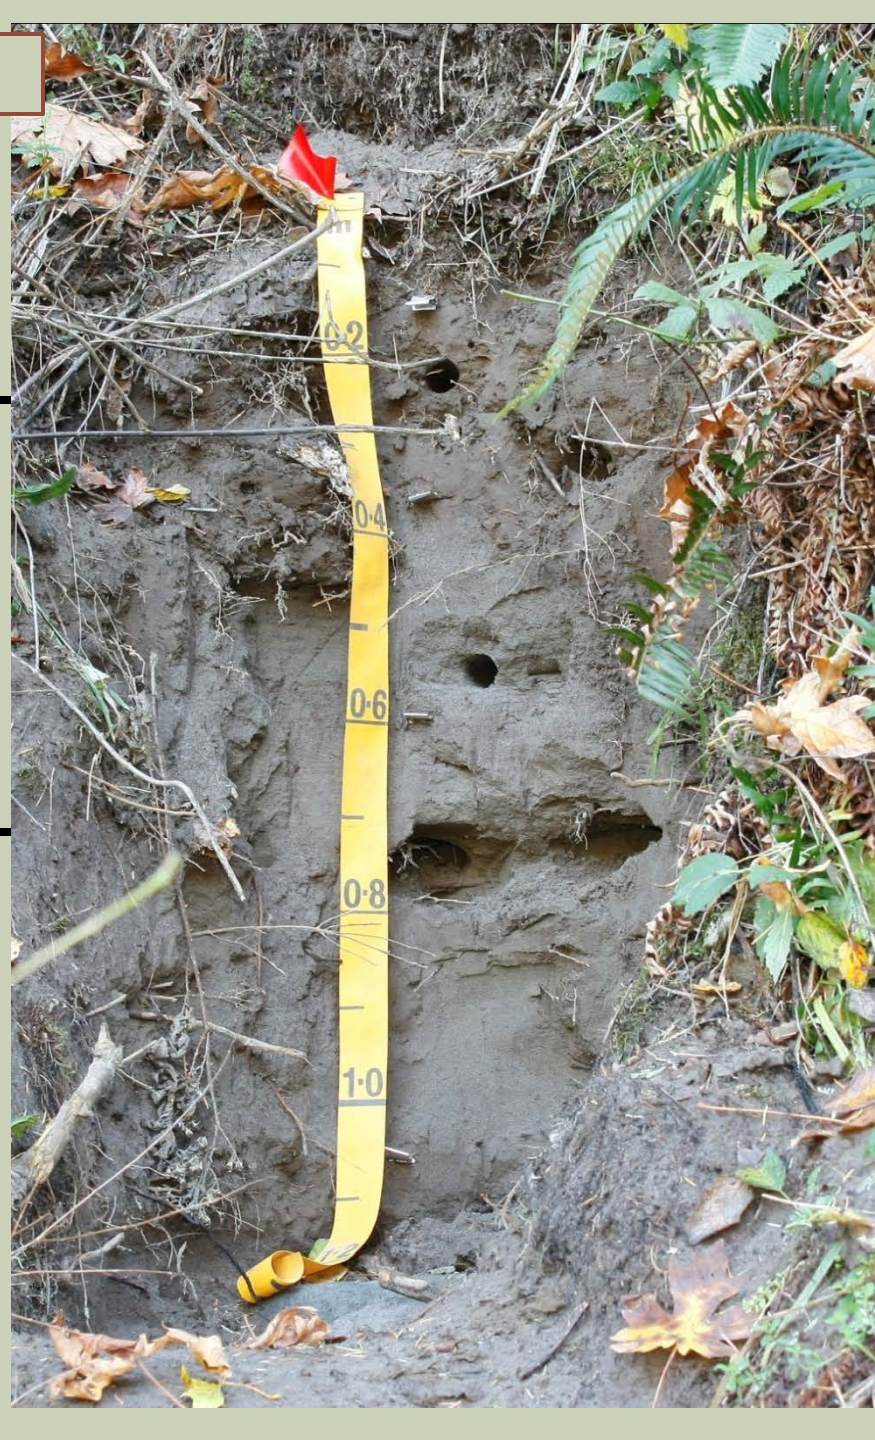
US-3

A  
0  
-  
1  
1

Bw  
1  
1  
-  
2  
6

Cg  
2  
6  
-  
1  
0  
5

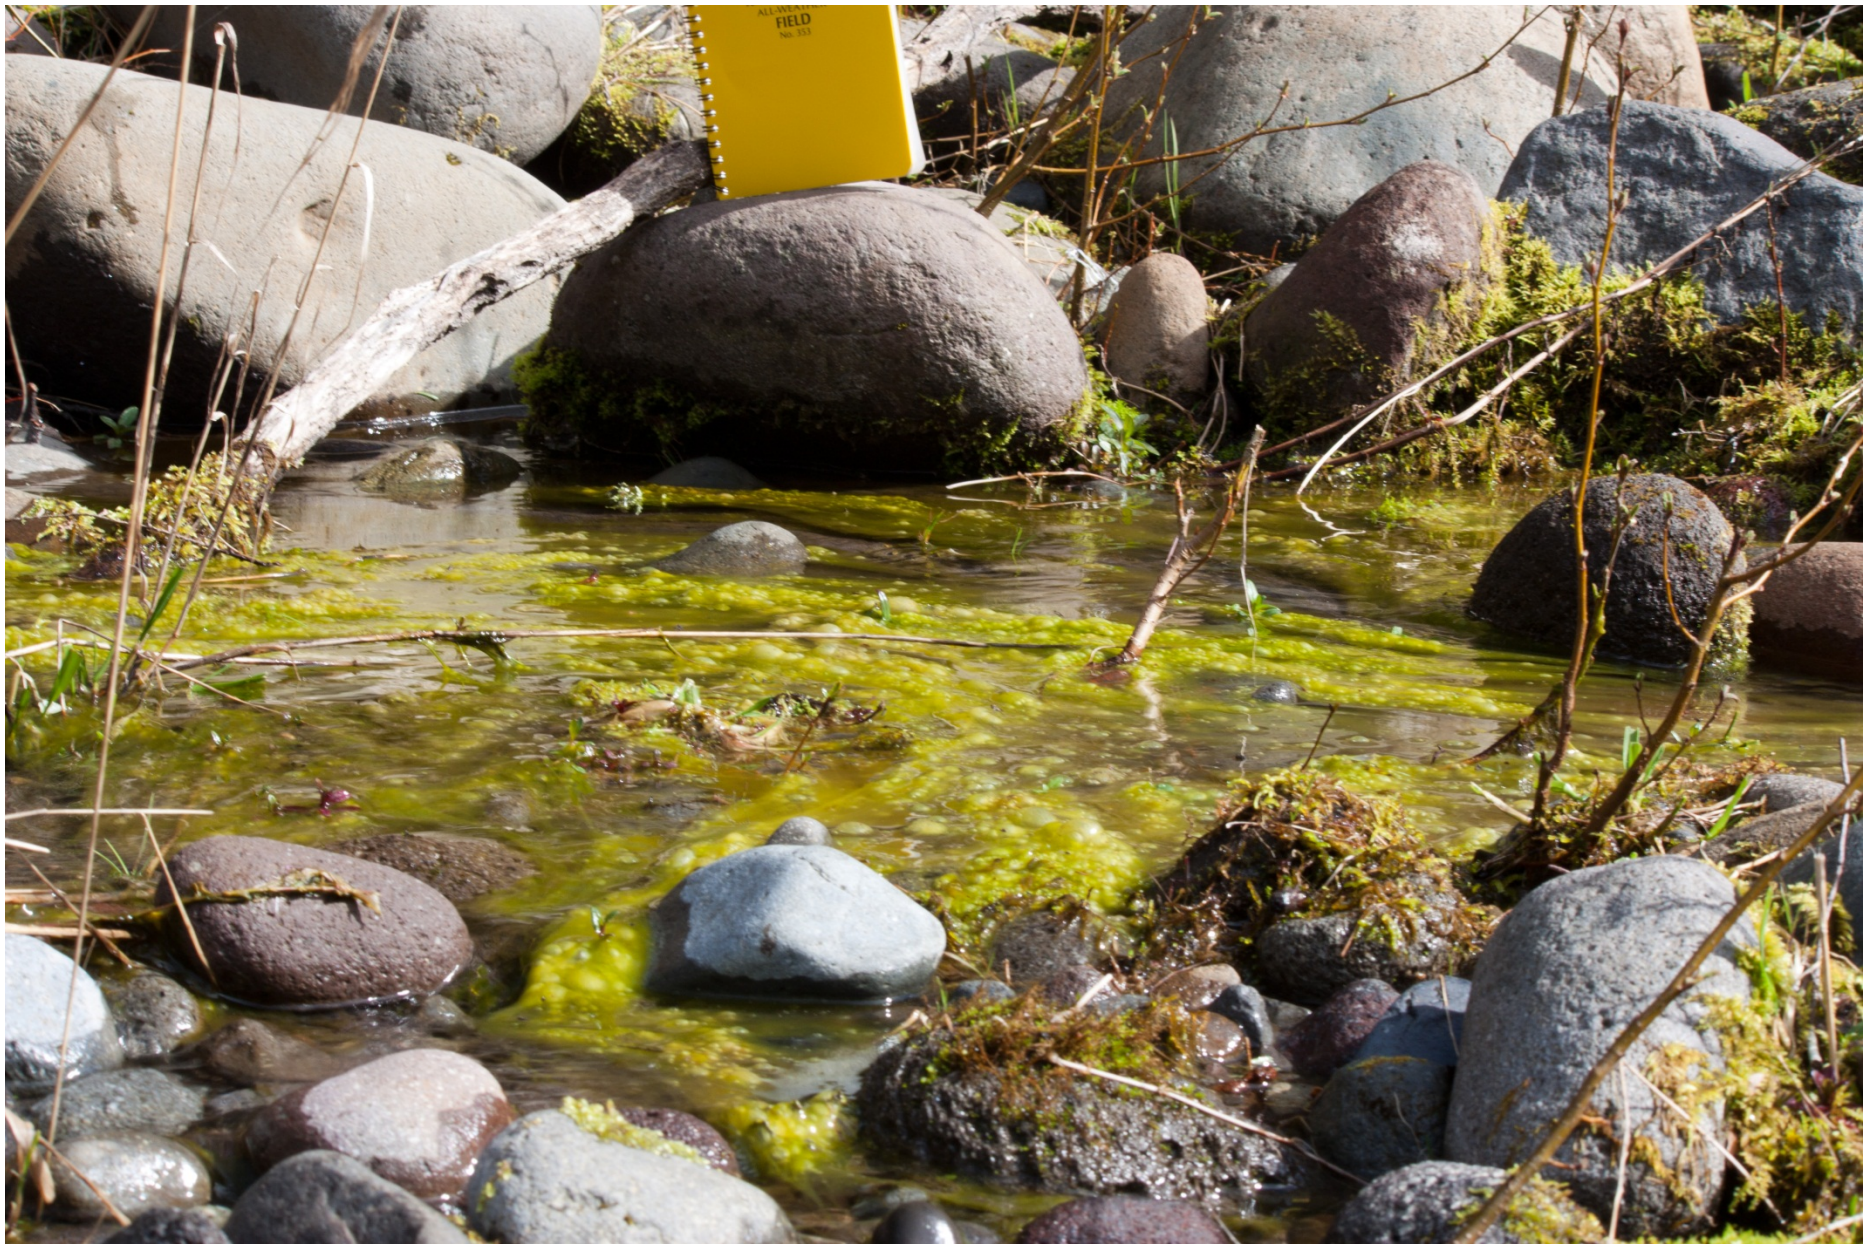
**“Bloom” from nitrates released by dewatered soil**

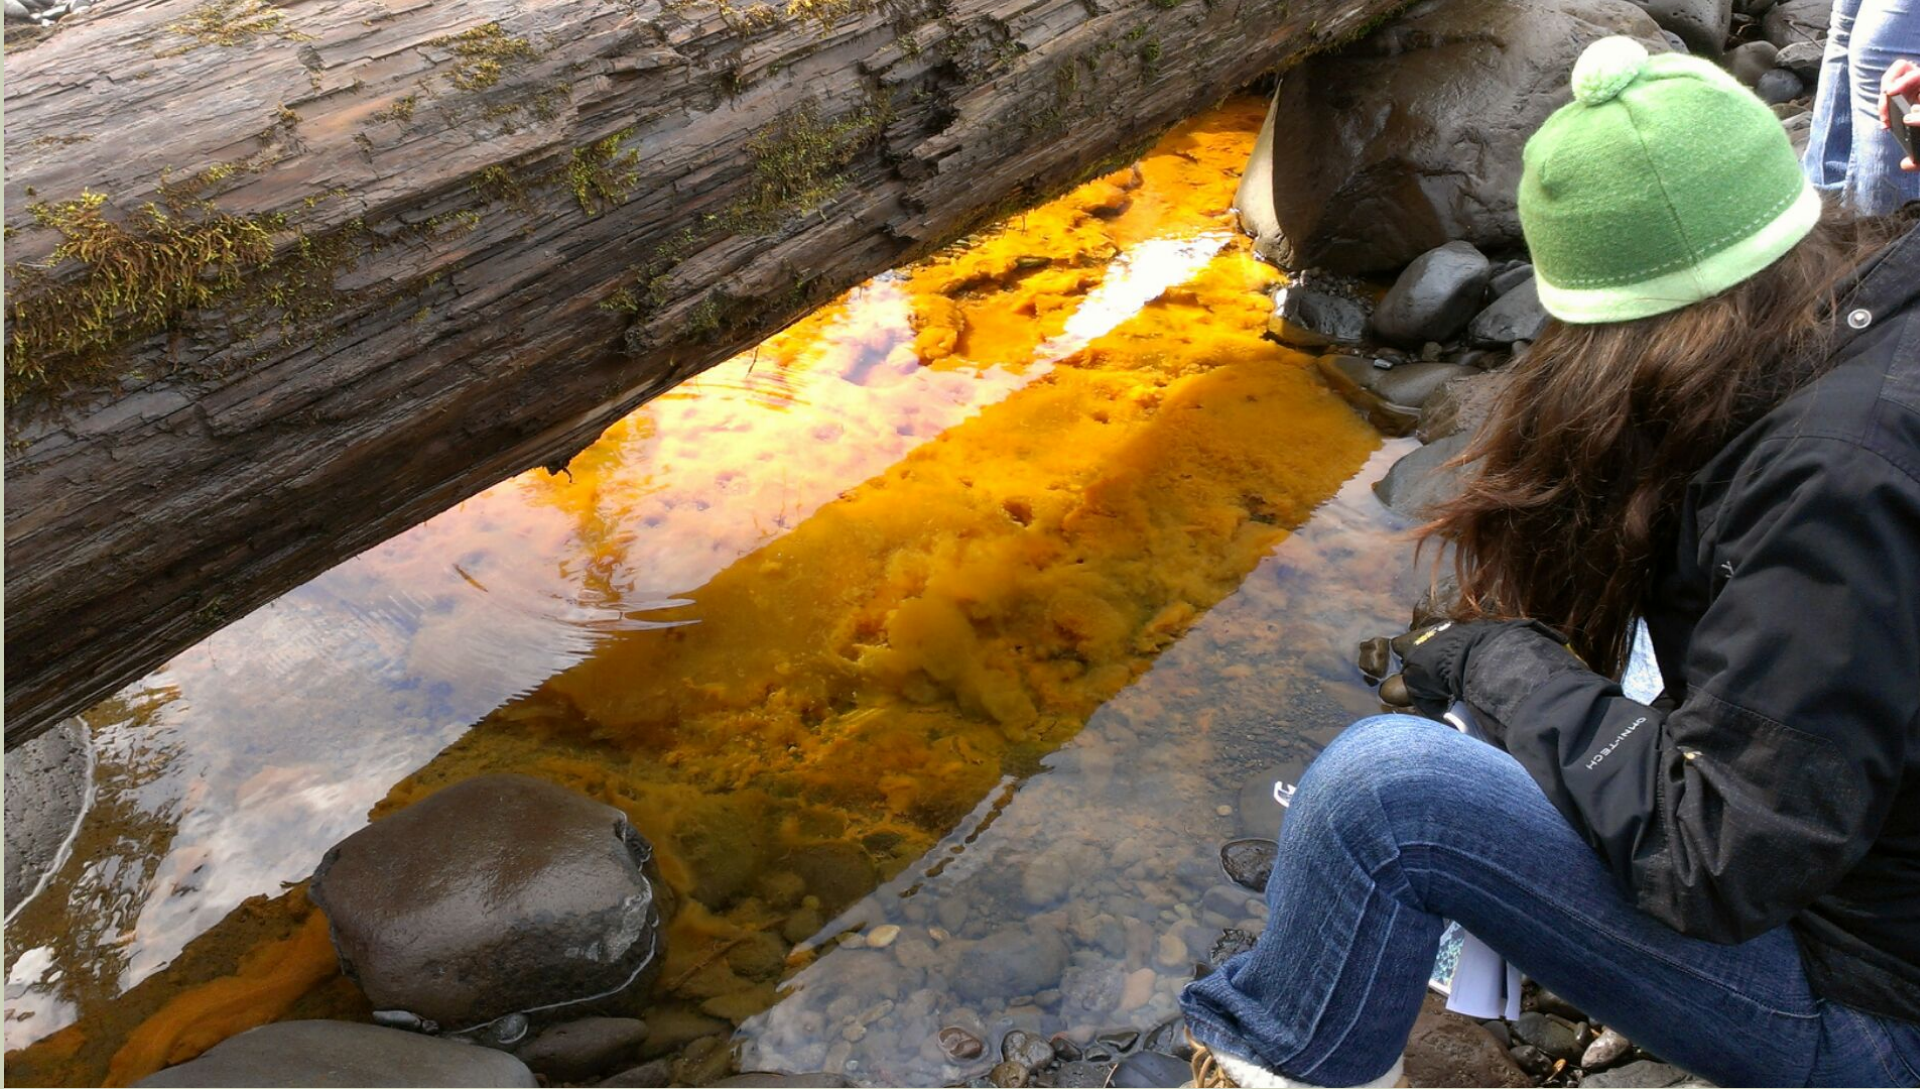
**Bacteria feeding on reduced, soluble (ferrous) iron released by dewatered soil behind the former Hemlock Dam on Trout Creek.**

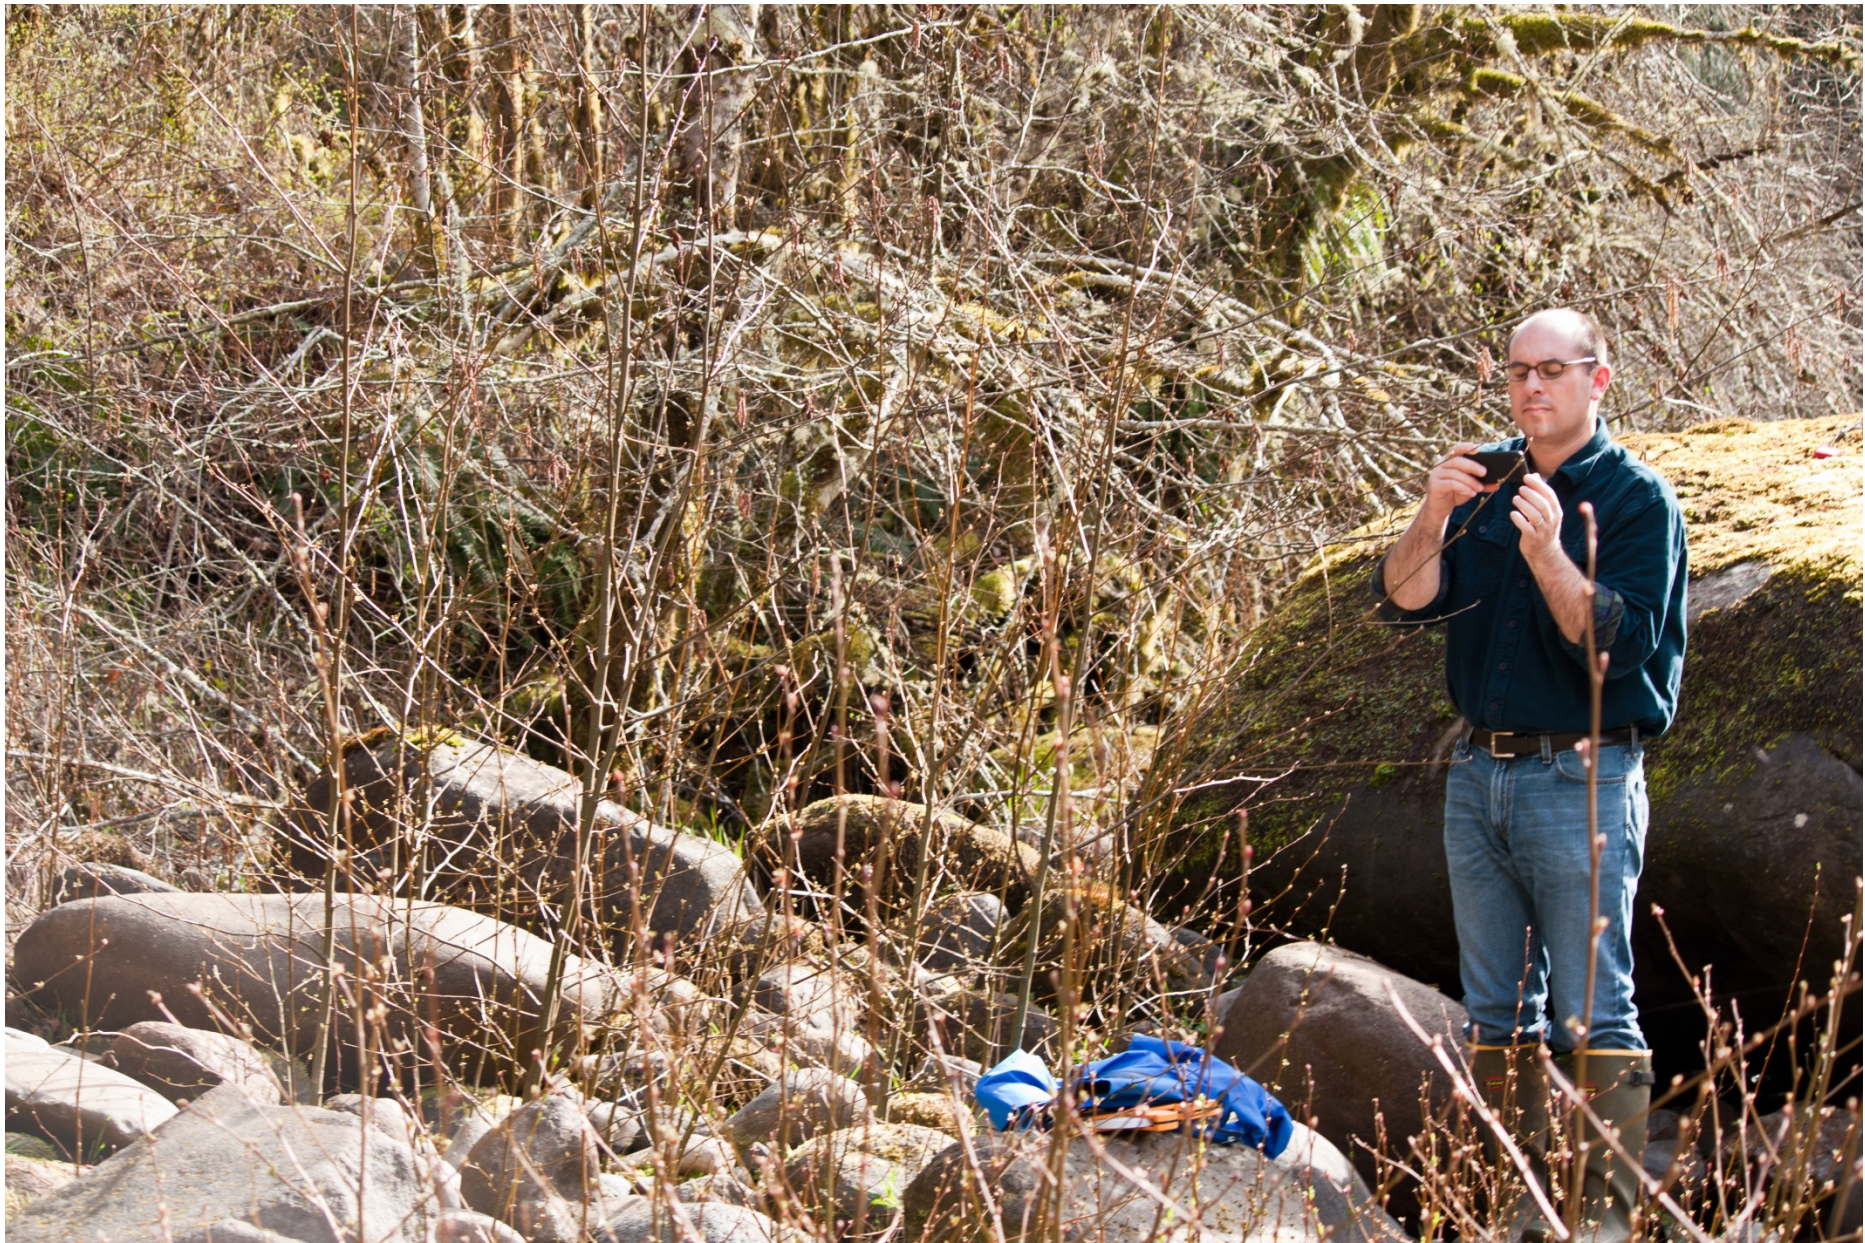
**Primary succession of red alder despite high nitrate levels**

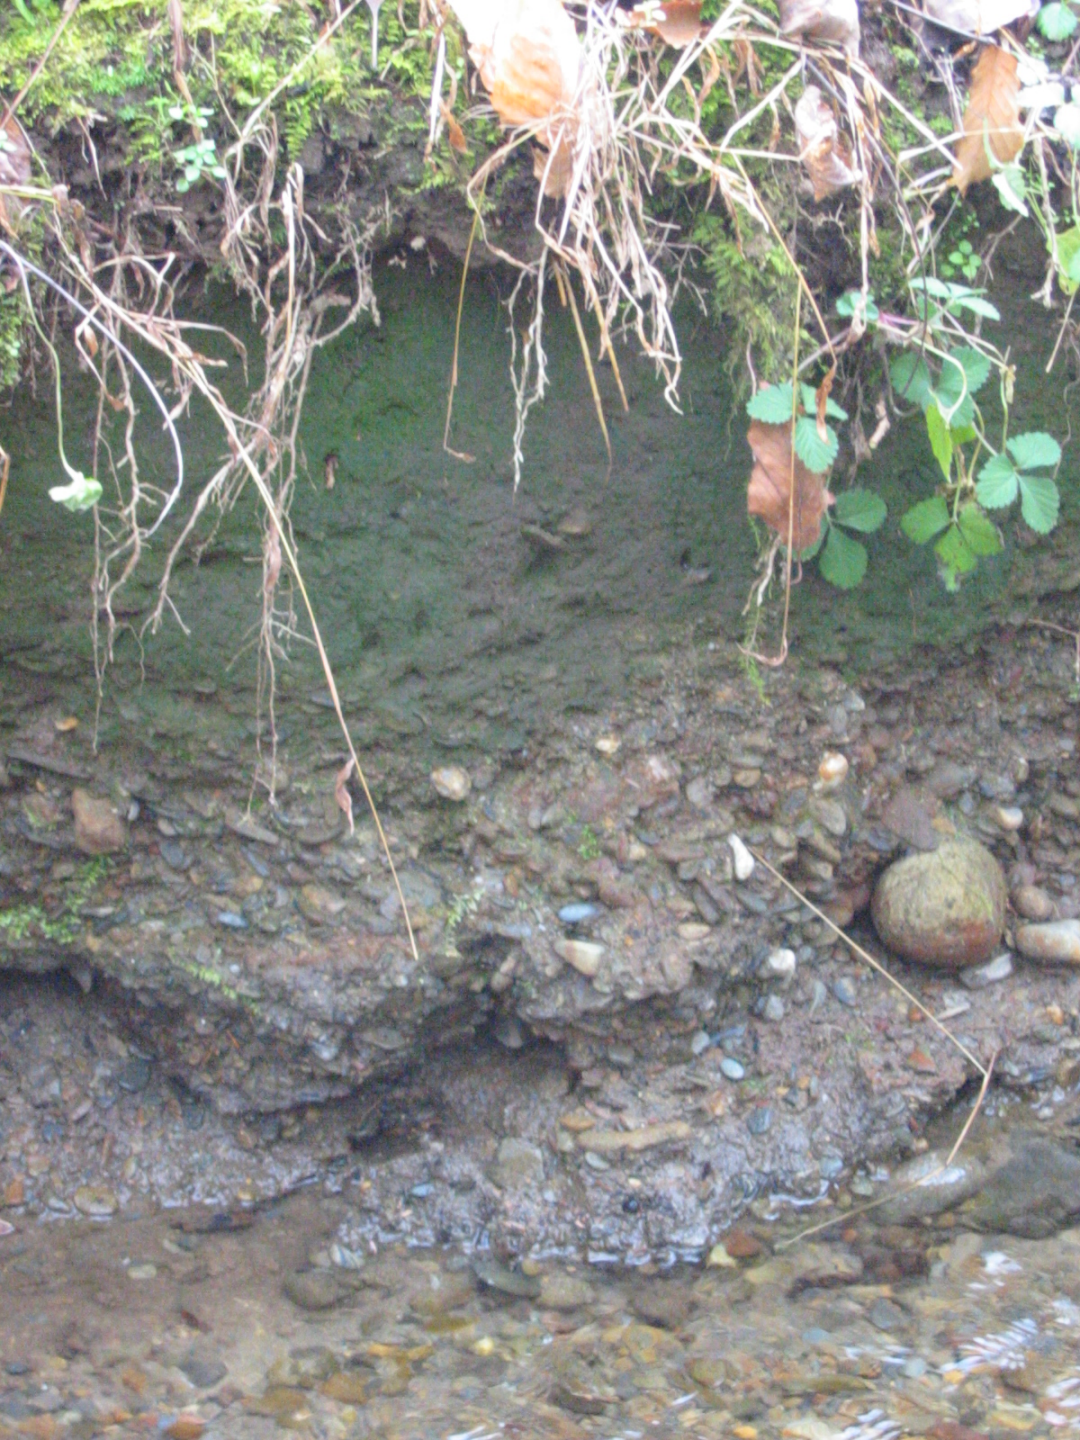
Post-logging bank surface →

Current floodplain →

Pre-logging bank surface →
