YAKIMA BASIN SIDE CHANNELS

FY 2014 ANNUAL REPORT

PROJECT #1997-051-00

Yakama Nation

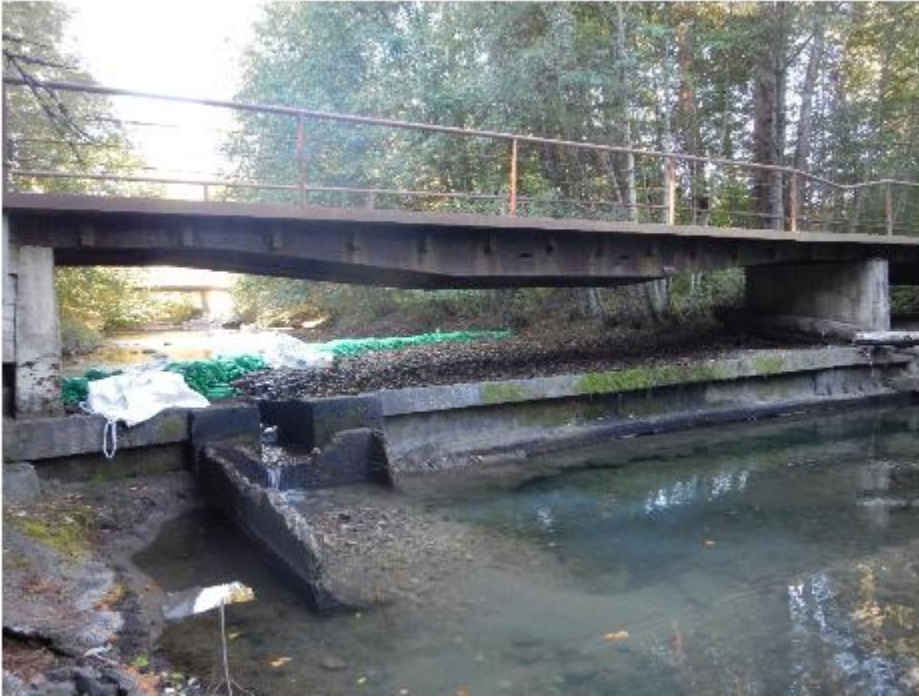
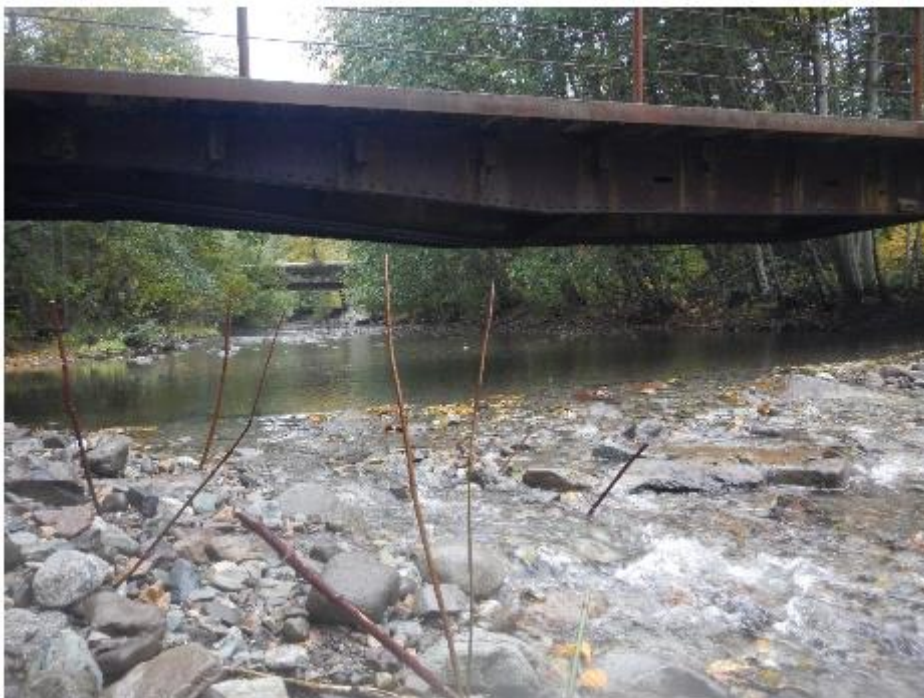
Figure 1. Before and after construction

Passage was improved by constructing a roughened channel to allow unrestricted upstream and downstream passage for native fish species. The roughened channel included large boulders and other rocks and gravel that altered the stream bed elevation, reconnecting two sections of the river separated by a vertical drop. The materials used to create the roughened channel bed and banks included angular rock that ranged from 24 to 48 inches in size. Small gravel and sand was sprayed into the voids between large boulders with a fire hose to pack materials into the cracks in order to keep Big Creek flowing over the new materials instead of becoming subsurface through the roughened channel reach.

The project was completed in October 2014. This work successfully restored passage at this site for all native fish species and all life-stage in both upstream and downstream directions opening up 20 miles of upstream habitat.

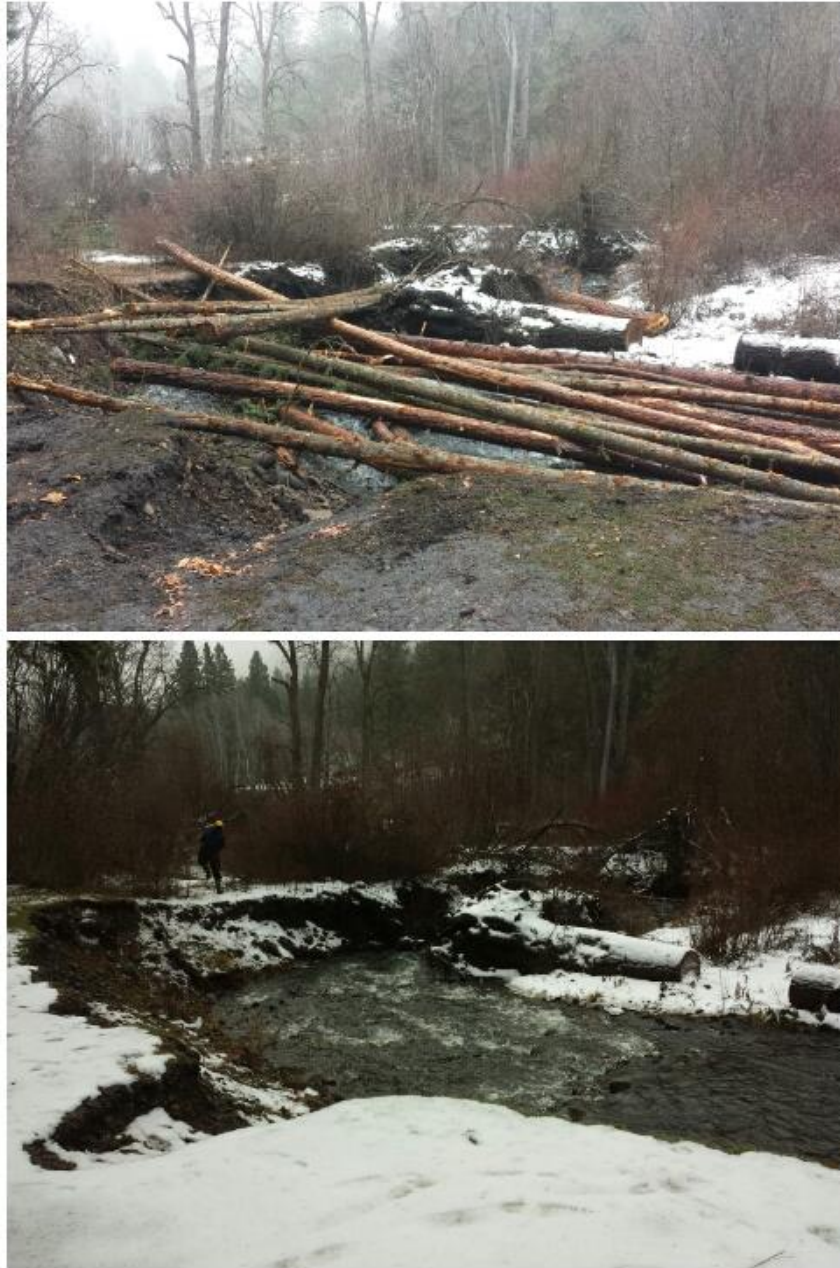
Figure 2. Before and after construction

This project was successful in placing 300 logs into the channel/floodplain of Oak Creek utilizing AmeriCorps hand crews thinning stream adjacent overstocked uplands. Wood was placed using grip hoists and tractor skid winches. All trees were harvested onsite, but outside the 130 foot riparian zone. Work was undertaken from 11/01/2014 through 02/01/2015. All work was completed over frozen ground. Work was halted for approximately 2 weeks during rain and some minor surface thawing.

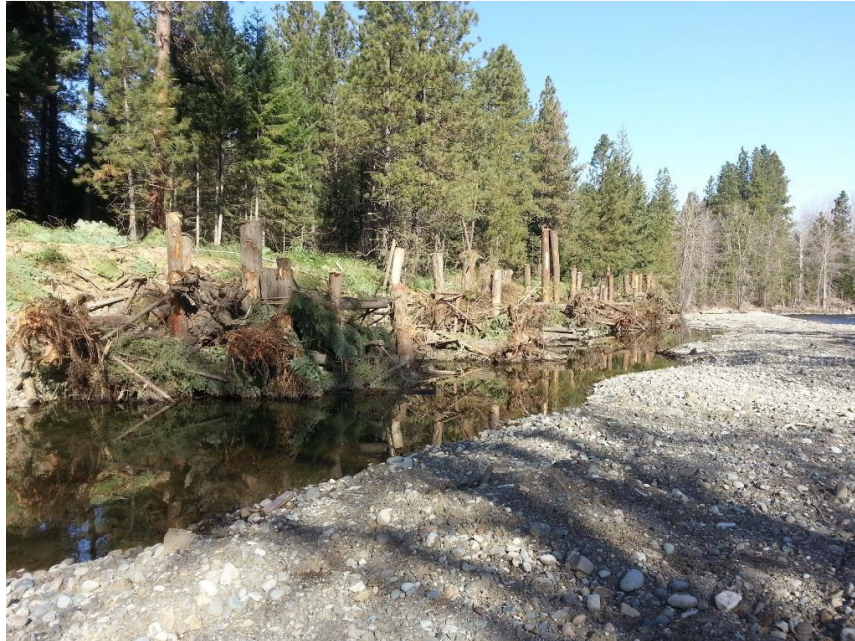
Figure 3. Type 1 structures

Wood structures were constructed on river banks and gravel during low flows, after cessation of irrigation delivery in the fall. Three types of structures have been designed; Type 1 structures will be along the banks with vertical posts providing stability to interwoven logs. Type 2 structures will be built on existing gravel bars during low flow; also using posts for stability and Type 3 structures will be post stabilized large snags. Each structure type has been carefully selected to provide habitat and to be stable at the 100-year flow event. These structures are expected to capture naturally recruited large wood over time and therefore may reduce large wood accumulations downstream on the South Cle Elum Bridge.

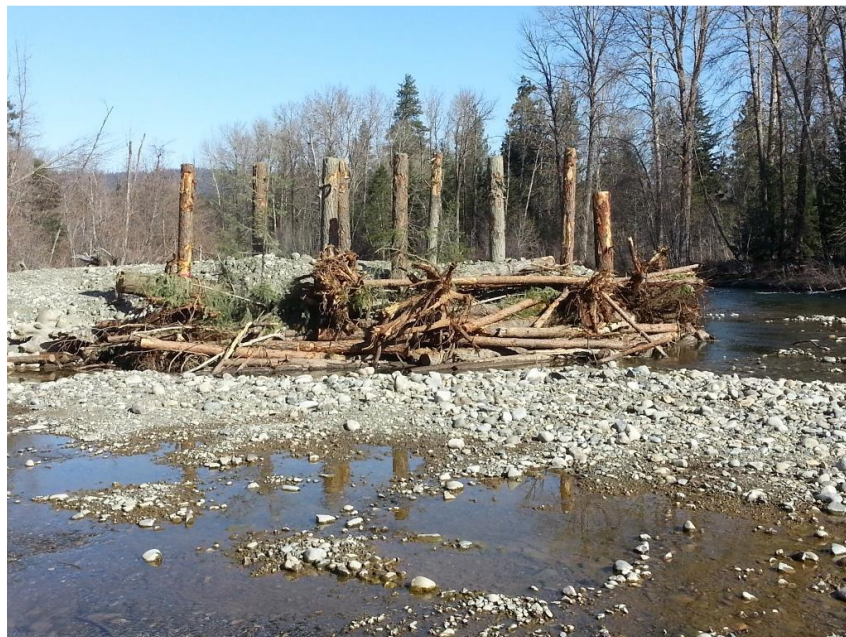
Figure 4. Type 2 structures

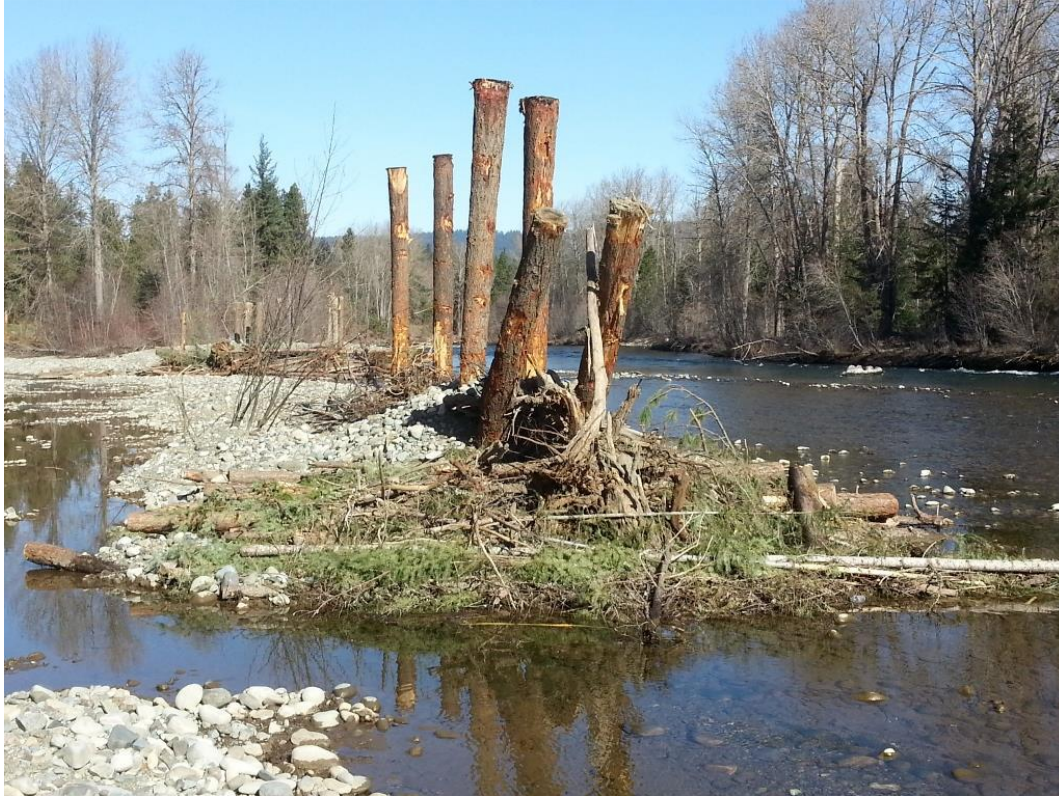
Figure 5. Type 3 structures

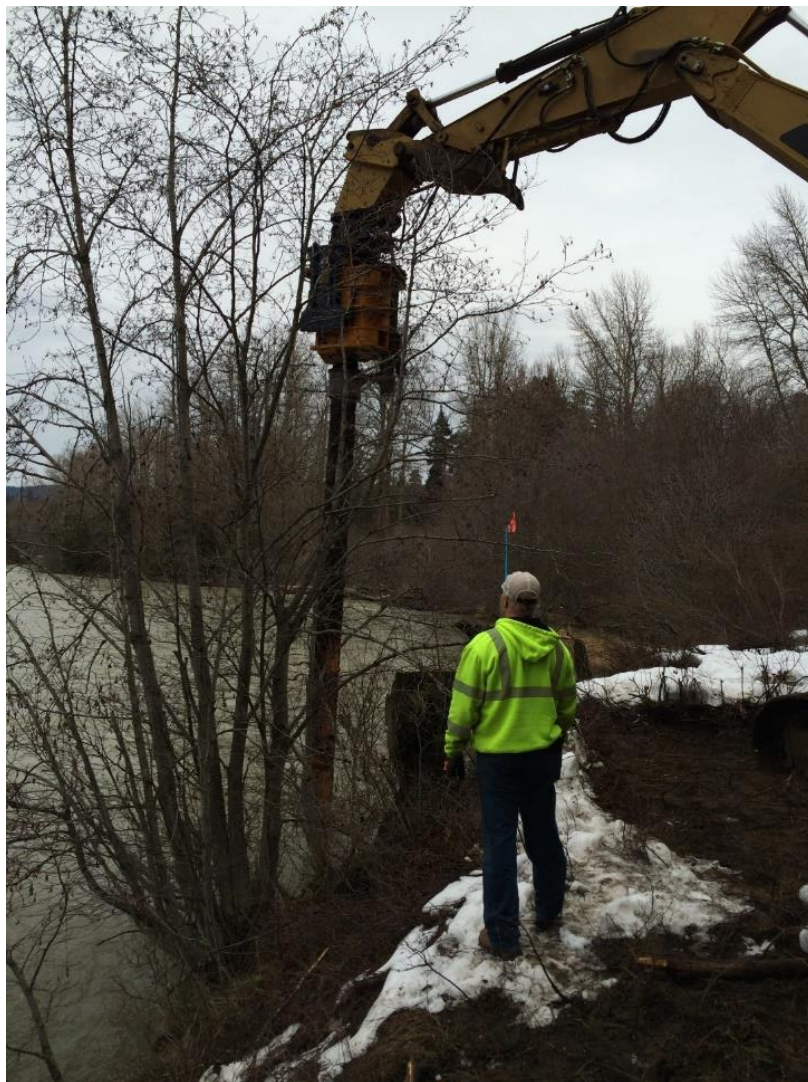
Figure 6 Habitat conditions during pile driving activities with a Movax. Note: flows were elevated and water was naturally turbid at the beginning of the project construction activities

Figure 6 is an example of the pile driving activities that occurred. A Movax was used to get the 14 inch piles to the specified 12' embeddedness. A clay layer, approximately 7' in depth was encountered approximately 2' below the river bed which caused pile driving progress to initially go extremely slow. To improve efficiency, piles were sharpened on the tip, and steel tips were fastened to the piles (figure 7). This improved driving speed slightly but not enough. Next, an 18' H-pile was modified to pre-drive a bore to depth prior to driving the wooden piles with the steel tips (figures 8 and 9). This proved very successful in improving pile driving efficiency. The pile driving activities produced very little turbidity. Turbidity was visually monitored throughout all in water work activities.

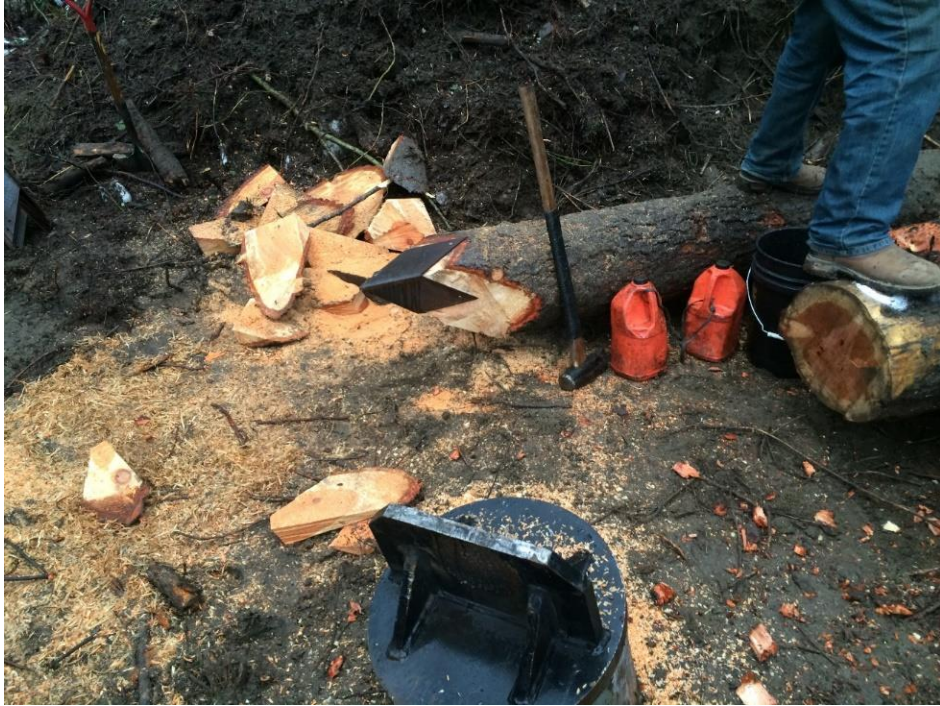
Figure 7 Sharpened vertical pile with steel tip fastened.

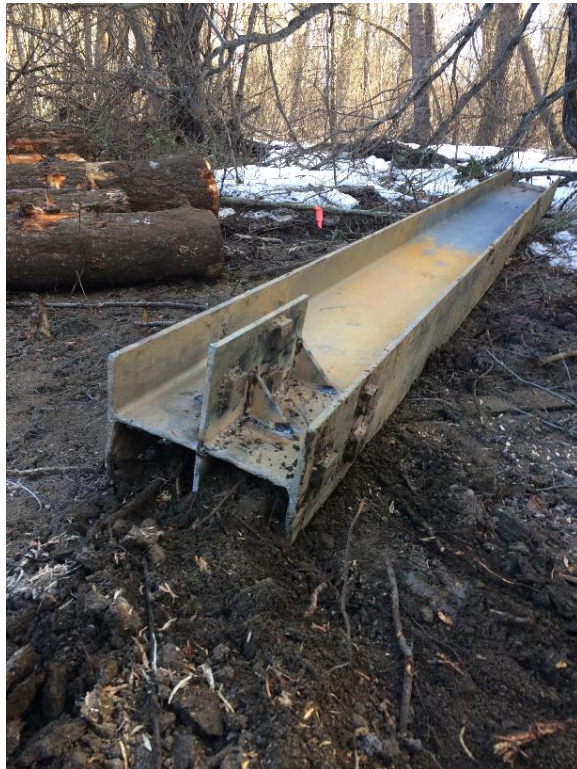
Figure 8 Modified H-Pile used to produce a bore for wooden pile driving

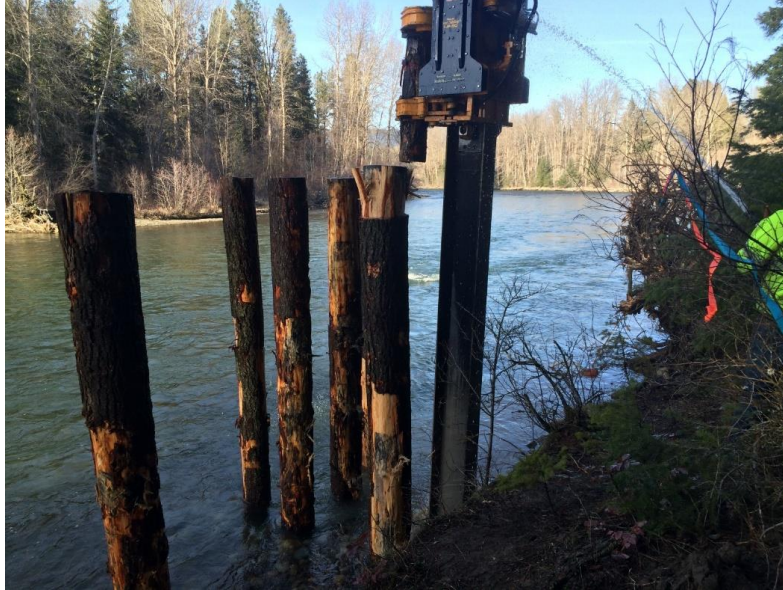
Figure 9 Habitat conditions during pile driving activities. An H-pile was used which essentially pre-drilled the bore to speed efficiency of pile driving and ensure all piles were driven to depth.

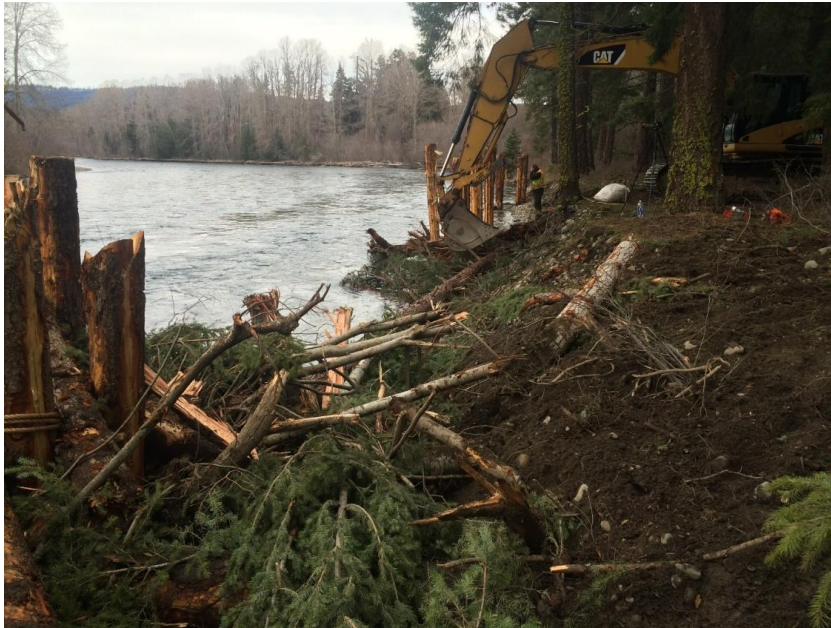
Figure 10 Habitat conditions during Type 1 log jam construction

Ultimately, 10 Type one engineered log jams (ELJ) were constructed over 0.25 miles with very little turbidity on the right bank of the main stem Yakima River. The site was vegetated with native plant species and erosion control measures are in place. Lessons learned from this project are:

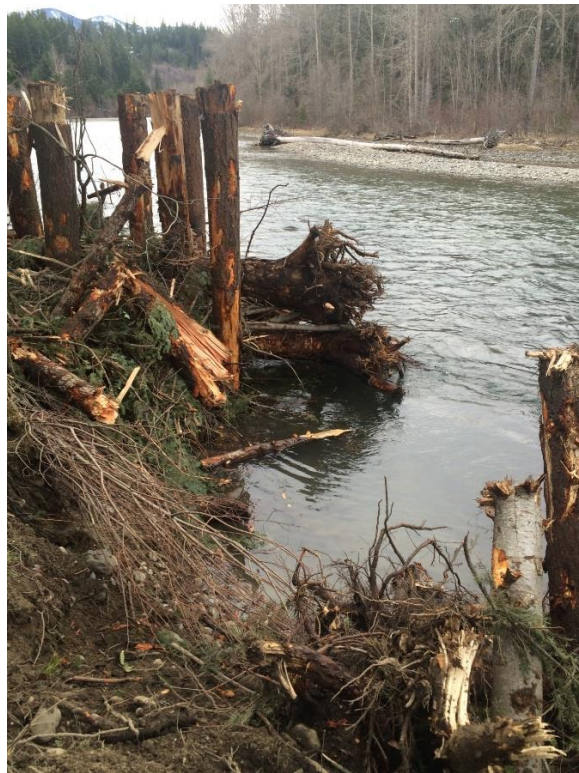
Figure 11 Completed Type 1 engineered log jam. Care was taken to ensure the structures did not produce a “straining” effect to improve boater safety.

An engineer was on call during the construction activities, and Yakama Nation fish biologists monitored project construction during all project phases. Special care was taken during project layout to ensure the structures would not capture the main river thalweg and ensure the appropriate site distance needed to achieve boater safety measures. Additionally, as depicted in figure 8, upstream voids in the structures were packed with slash and racking materials to ensure a suitable backwater eddy was produced and reduce the chances of a strainer developing which could put boaters at risk.

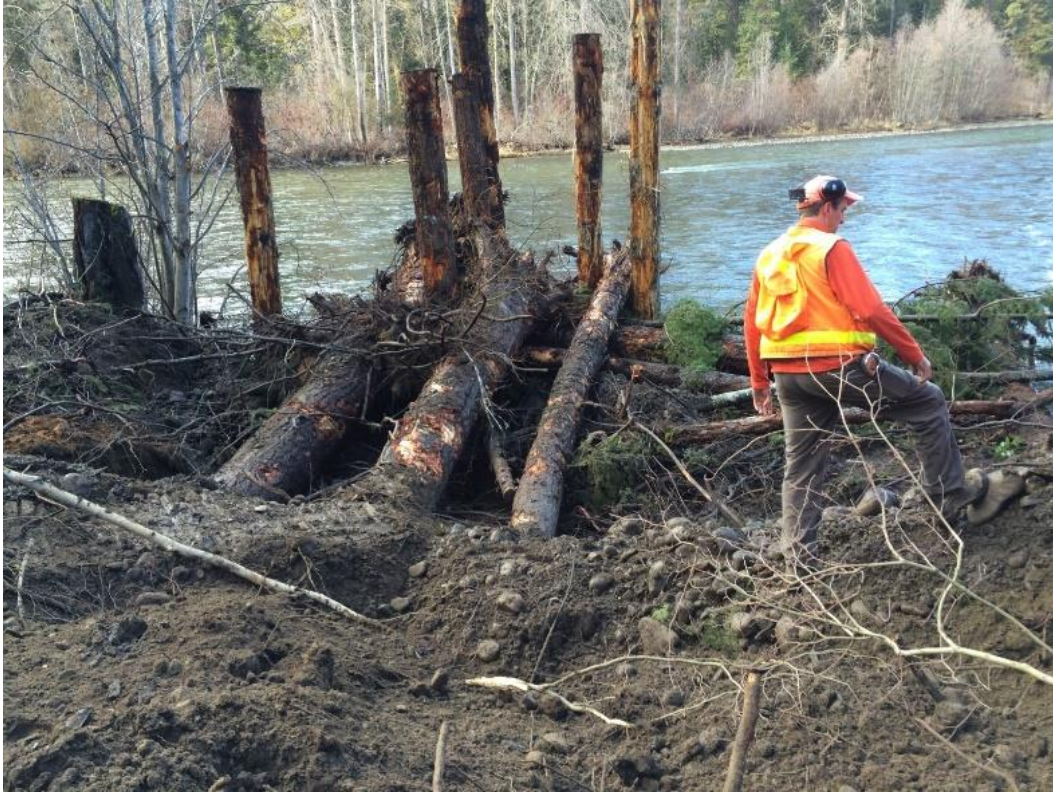
Figure 12 Furthest downstream engineered log jam near completion. This site proved challenging in that the total specified piles were not able to be driven to specified depth. A new design was engineered to mitigate the lack of piles which included increased bank excavation, installation of whole, small diameter trees in the back water downstream of this image. Two ELJ's worth of materials were installed at this one location. The end result more than doubled juvenile salmonid rearing and forage habitat.

The furthest downstream structure design was modified by engineers to compensate for a lack of vertical piles. Bedrock was encountered that prevented piles to drive to the specified depth. The final product was a log jam that had double the amount of materials as the other jams and the core of the jam will be able to handle the river forces despite the absence of the originally specified number of piles.

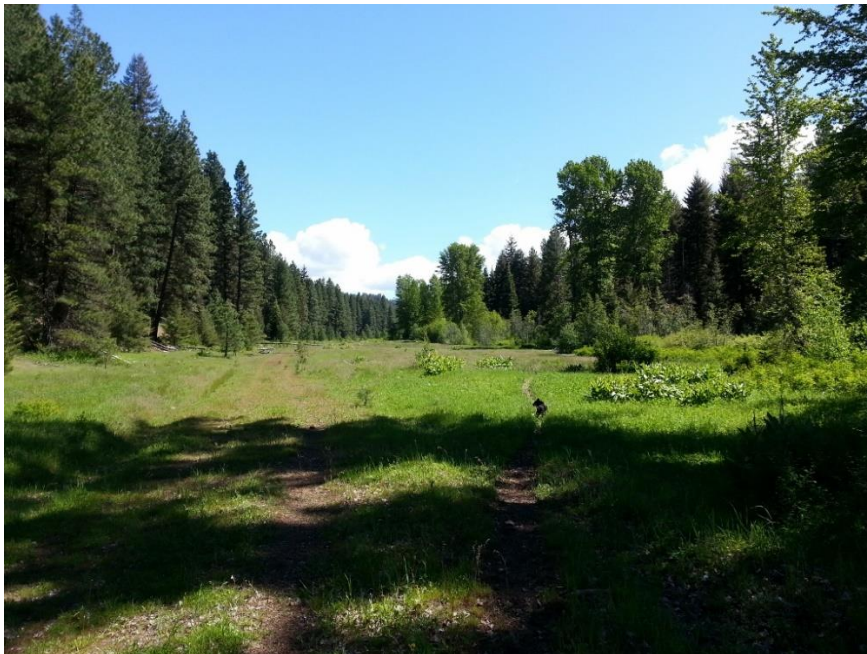
Figure 13 Indian Creek Floodplain before restoration project. Note lack of woody material.

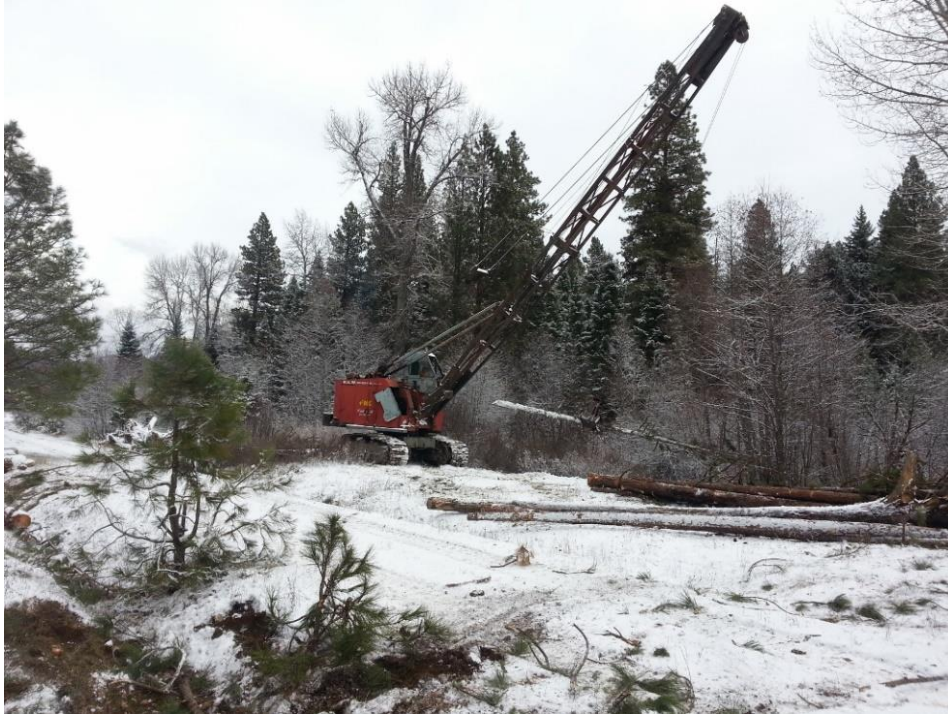
Figure 14 Indian Creek Floodplain during restoration.

Designing this project occurred over a period of five years, from initial discussions to implementation. The state-owned project area is managed by Washington Department of Natural Resources as school trust lands. Implementation took five weeks and was completed in early December, 2015. A total of 900 pieces of large woody material was placed on 1.3 stream miles in the channel and on the floodplain. About 250 of these pieces included rootwads, all pieces were between 15 and 60 feet in length. In addition approximately 40 cubic yards of timber harvest slash (tree branches) was placed in the stream channel and in existing artificial ditches to retard surface flow during wet conditions. No clearing of existing woody vegetation occurred. Sediment delivery to surface water was controlled by limiting operation to dry or frozen ground, with the exception of one short period when rainfall created soft soils. Equipment operation ceased during that time period. Straw mulch and locally-gathered forest duff was placed on disturbed ground to control runoff, and surfacing with crushed rock was done on approach roads that were sloping toward the stream course.

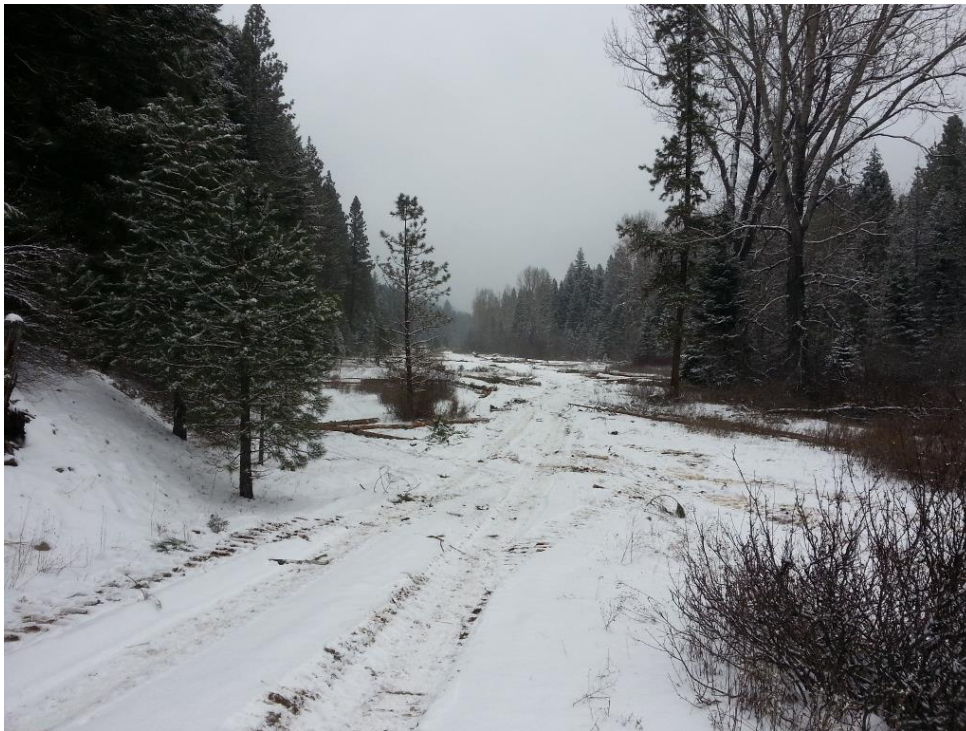
Figure 15 Indian Creek Floodplain after restoration project. Note woody material on the floodplain.
