Klickitat Watershed Enhancement Project (KWEP)

Yakima/Klickitat Fisheries Project (YKFP)

Report for January 1, 2017 - December 31, 2017

BPA Project # 1997-056-00

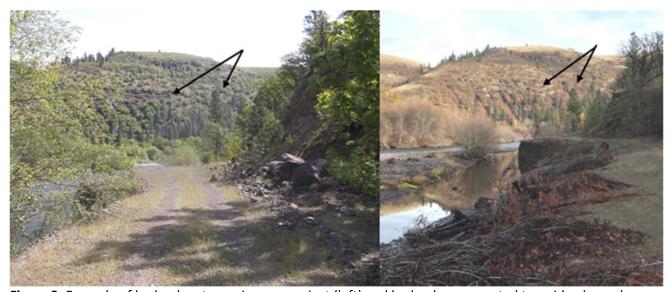
Figure 3. Example of bedrock outcropping pre-project (left) and bedrock reconnected to a side-channel of the Klickitat River (right).

Construction activities completed in 2017 (Figures 3 and 4):

- Removal of approx. 2,400 linear feet of floodplain embankment to restore lost overbank flow connectivity and habitat access to floodplain and side channels
- Reconnection of 4 acres of contiguous floodplain
- Partial embankment removal to restore river access to pool-forming features (bedrock outcroppings)
- Removal of rip-rap and pullback of 5,641 linear feet of embankment encroaching on the active channel to:
 - Increase bank deformability
 - Restore conditions suitable for establishment of bank cover and longterm woody-debris recruitment
 - Restore recruitment pathway for colluvial materials
- Removal of 12 culverts and restoration of natural drainage, 11 cross drains, 1 non-fish bearing tributary

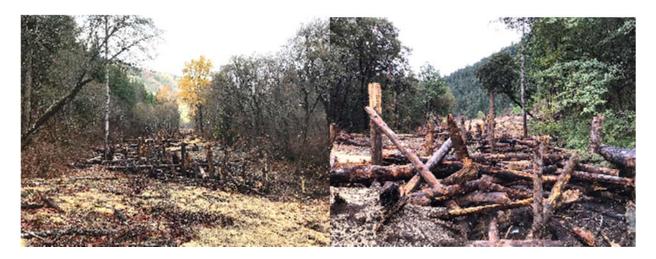
Figure 4. Floodplain roughness elements installed in former roadway corridor to reduce avulsion risk.

Planning - KWEP and CLT staff conducted several field visits to refine treatments and geographic scope of Phase 6 (Fig. 2). KWEP and CLT staff determined stationing for road segments delineated during the geomorphic assessment (Conley and Lindley 2012) and performed layout prior to soliciting bids for Phase 6. Phase 6 of the Haul Road received funding during the 2015 SRFB grant round. The SRFB funding received was significantly less than the total project costs to complete the nearly 3-mile-long project scope. A cost-share agreement between the Yakama Nation and Columbia Land Trust (CLT) facilitated financial BPA contributions to Phase 6 construction activities. BPA funding focused on road segments where removal of the road embankment reconnected floodplain. SRFB funding focused on road segments immediately adjacent to the mainstem Klickitat River where treatment types were full and partial fill removal (Fig. 4).

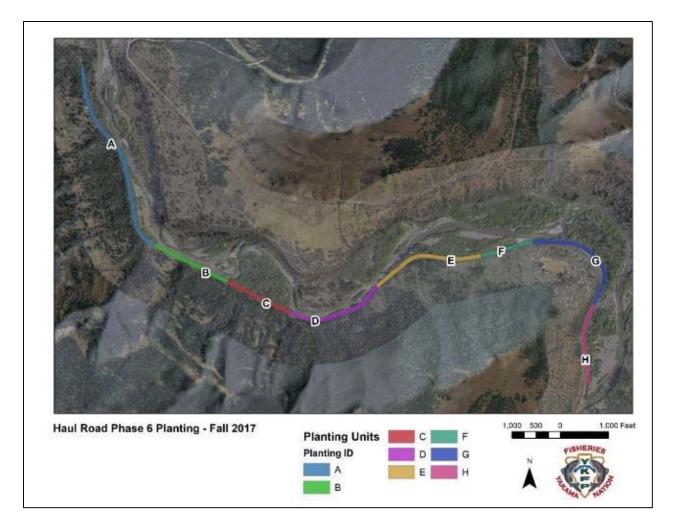
Figure 5. Haul Road Phase 6 Revegetation Planting Units.

Revegetation: In November of 2017, Washington Department of Ecology Conservation Crews (WCC) replanted the project site with native vegetation (Fig. 5 and 6). Three crews planted approximately 5600 plants in five work weeks. Potted native shrub and tree stock grown at the Klickitat Field Office or purchased from Humble Roots Nursery accounted for the majority of plant materials installed this fall. Bareroot conifer seedlings were purchased from Lava Nursery in Parkdale, OR and livestake cuttings of easily rooted black cottonwood were purchased from the Washington Association of Conservation Districts' Plant Materials Center in Bow, WA. Planting units are based on groupings of similar types of road removal treatments and site conditions (A-H, see Table 1). Planting prescriptions match site conditions (floodplain, upland, LWD jam installation, etc) to maximize plant regrowth on disturbed soils to reduce erosion, provide riparian shade, and provide leaf material for consumption by invertebrates.

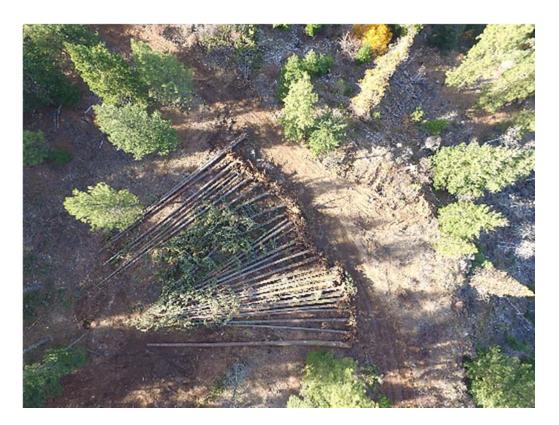
Figure 8. Aerial view of landing layout and access road, logs staged individually.

Based upon review of aerial photos and topography, several suitable stands in vicinity of the eastern canyon rim appeared to be suitable given their location and the apparent size distribution of trees. Staff evaluated road access and qualitatively assessed stand conditions through site visits. Followed by a simple timber survey of the most promising stand in T7N R 14E S30, BIA staff from the Glenwood Ranger Station marked 500 trees at nine landing locations along the canyon rim of White and Brush Creeks in the fall of 2016. In summer 2017 Tiin-Ma Logging Inc. of White Swan, WA was selected via a competitive bidding process to conduct harvesting and staging activities. For logistical reasons one of the harvest units was not entered, thus Tiin-Ma harvested 477 trees, 75% of which had intact rootwads. Tiin-Ma also graded and prepped a critical access road. To facilitate quick and efficient rigging of the logs during helicopter operations, logs were arranged at the landings in individual rows with one end of the log propped off the ground. Logs with rootwads were braced off the ground by their roots, while logs without rootwads were placed on a "bunk" log to prop one end off the ground (Fig. 8).

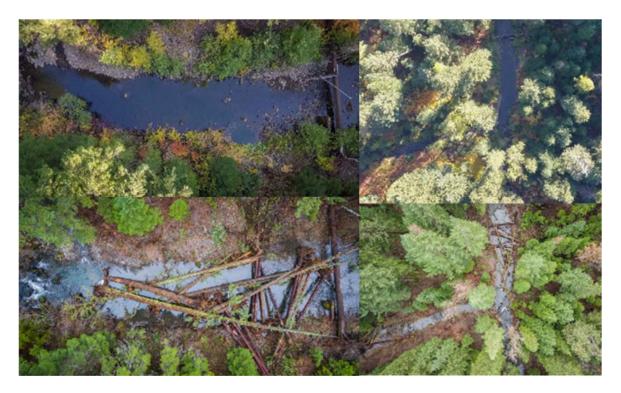
Figure 9. Pre- and post-project photos of the Brush Creek and White Creek confluence pool.

specific location and orientation of logs placed. One team would work with the helicopter crew to complete 1-2 sites, and then the helicopter would move to the second team to treat 1-2 sites. This leap-frogging method allowed for an efficient use of the helicopter that avoided any down time. The number of logs at a particular site ranged from 5-40 logs (Figures 9 and 10). Site locations are shown in 11 and 12.

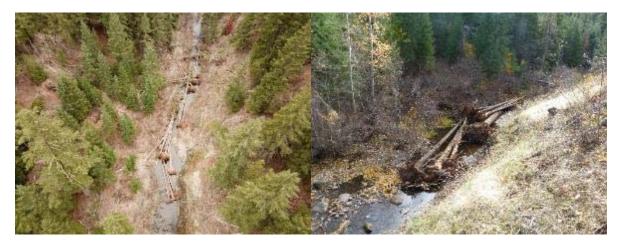
Figure 10. Typical examples of cluster log placements.

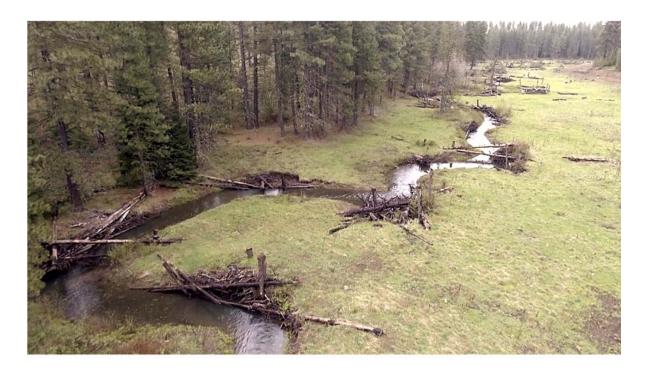
Figure 14. Tepee Creek Phase 2 site conditions as observed during June 2017 monitoring visit.

All photos taken as part of photo-monitoring are saved digitally, filed electronically in subdirectories by their respective project name and stored on the KWEP server. Figures 3 and 4 show examples of photographic comparisons of pre- and post-project monitoring in the first section of this report, entitled the "Tributary Habitat Restoration and Protection". An aerial photo (Figure 14) from a recent visit at Tepee Creek Phase 2 documents 2017 conditions.

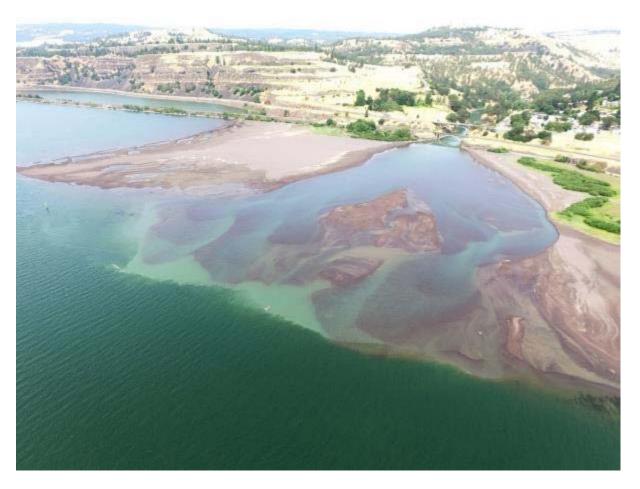
Figure 19. Aerial view of Klickitat River Delta under low Bonneville Pool conditions as observed on August 22, 2017.

During the 2017 reporting period, the sensor array installed in August of 2009 operated continuously. Data collection monitored via a File Transfer Protocol (FTP) site provides KWEP staff with remote access from the Klickitat Field Office. KWEP staff occasionally observed discrepancies, errors, data gaps, or non-reporting that dictated site visits for troubleshooting purposes. Additional site visits enable the collection of staff gage observations during a range of water elevations to establish stage reference points. These reference points are used to quality-control data collected by deployed sensors. The configuration of landforms at the confluence changed significantly during 2017 (Fig. 19).

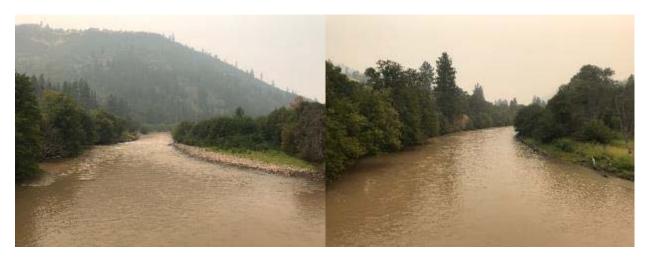
Figure 20. Naturally occurring late summer turbidity event on the Klickitat River, September 11, 2017, as observed from Horseshoe Bend Rd Bridge, Wahkiacus, WA (looking downstream on the left, looking upstream on the right). Air visibility conditions were a result of the Eagle Creek Fire in the Columbia Gorge.

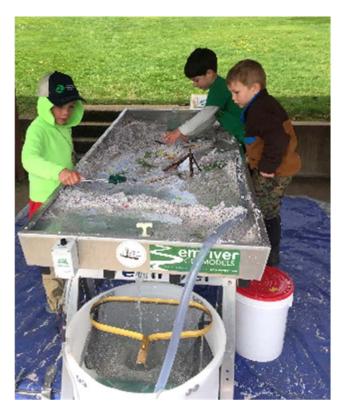
Figure 21. Stream table demonstration at Underwood Conservation District Tree Festival.

The Em2 Stream Demonstration Table purchased in 2016 assisted visualization of basic principles of river behavior, channel morphology, and sediment transport processes. The stream table was set up at local elementary schools, environmental education oriented festivals (Fig. 21), and Water Jam. These outreach events facilitated interactions with hundreds of students and adults providing a means for discussing watershed processes and concepts.
