Translocation of Adult Pacific Lamprey within the Yakima Subbasin, 2016-2017 Broodstock

Project No. 2008-470-00

Report covers work performed from: October, 2016 – November, 2017

**Confederated Tribes and Bands of the Yakama Nation
Yakama Nation Fisheries Resource Management Program, Pacific Lamprey Project
P. O. Box 151, Toppenish, Washington 98948, USA**

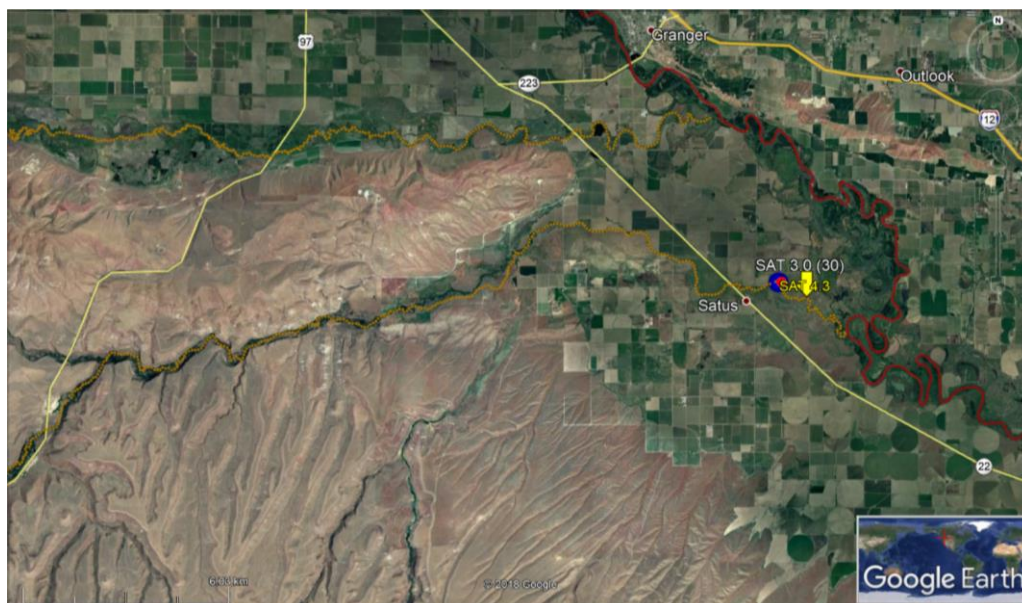
Figure 2. Aerial map of Pacific Lamprey translocation release site (yellow arrow) in Satus Creek (bottom orange line). "SAT" stands for Satus, the number next to the stream abbreviation is the river km, and the number in parenthesis is the total number of lamprey released. Also shown with the large blue circle is the PIT tag array location [one in lower Satus (river km 4.3)], and the red circle is the location of a screw trap. Yakima River is the red line.

In Satus Creek, there were two release events: 1) 15 lamprey were released at river km 3.0 on March 24, 2017, and 2) 15 lamprey were released at the same site on March 30, 2017 (Fig. 2). Water temperature were 7.0 and 7.6°C, respectively, during the two releases. For early spring release, we target our releases to take place when the rivers/streams reach 7-12°C.

The primary goal was two-fold: 1) to continue to increase the population abundance of Pacific Lamprey in Satus Creek and 2) to assess upstream movement through the lower PIT array at river km 4.3 (SAT).

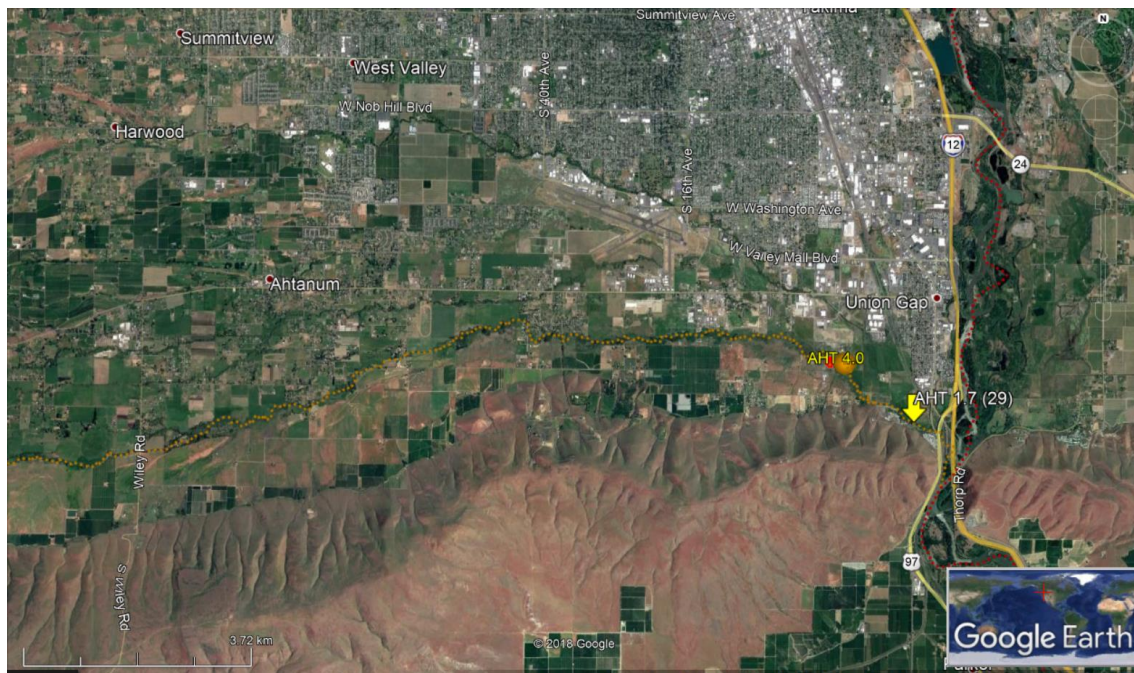
Figure 4. Aerial map of Pacific Lamprey translocation release site (yellow arrow) in Ahtanum Creek (orange dots / line). “AHT” stands for Ahtanum, the number next to the stream abbreviation is the river km, and the number in parenthesis is the total number of lamprey released. Also shown with the large orange circle is the PIT tag array location [one in lower Ahtanum (river km 4.0)], and the red circle is the location of a screw trap for juvenile monitoring. Yakima River is the red line.

In Ahtanum Creek, there was one release event: 29 lamprey were released at river km 1.7 on March 29, 2017 (Fig. 4). Water temperature was 7.1 during the release. For early spring release, we target our releases to take place when the rivers/streams reach 7-12°C.

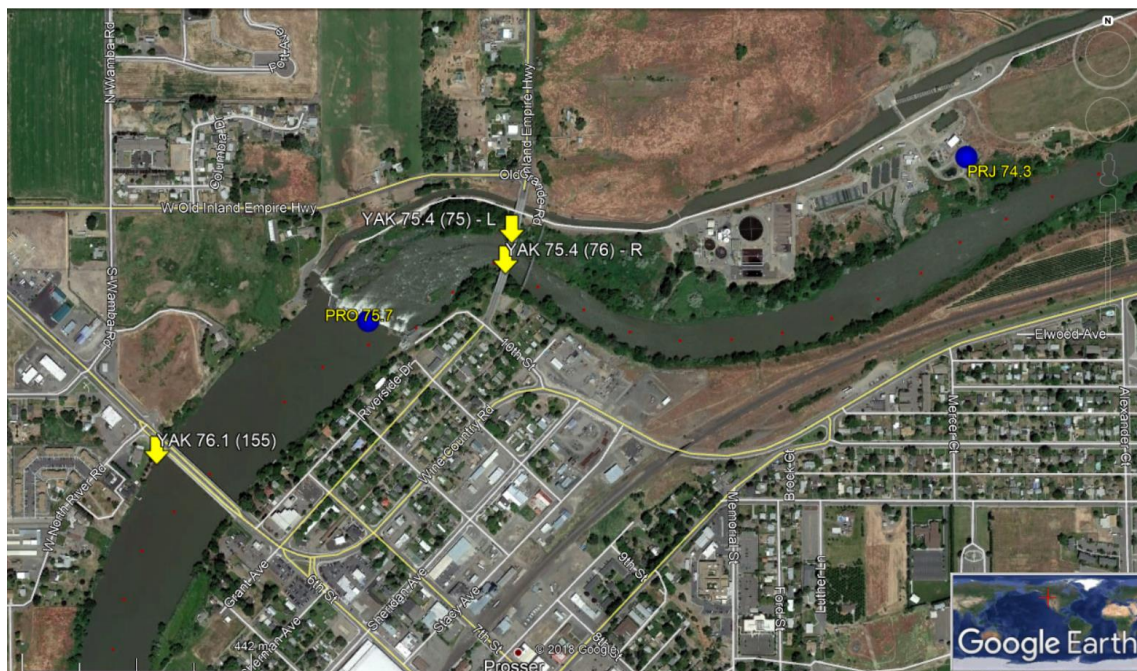
Figure 5. Aerial map of Pacific Lamprey translocation release sites (yellow arrows) in the Lower Yakima River. “YAK” stands for Yakima, the number next to the stream abbreviation is the river km, and the number in parenthesis is the total number of lamprey released. Also shown with the blue circles are the PIT tag array locations, including the location of Chandler Juvenile Monitoring Facility (PIT arrays are located on each of the three fish ladders at the dam). The red dots indicate 0.1 km segments of the Yakima River.

In the Lower Yakima River, there were three release sites: 1) 75 lamprey were released at river km 75.4 downstream of Prosser Dam (left bank looking downstream) on April 27, May 4, and May 11, 2017 (25 lamprey each); 2) 76 lamprey were released at river km 75.4 downstream of Prosser Dam (right bank looking downstream) on April 27, May 4, and May 11, 2017 (25 lamprey each for first two releases, and 26 lamprey for last release); and 3) 150 lamprey were released at river km 76.1 upstream of Prosser Dam on April 8 and 27, May 2, 5, 9, 11, and 12, 2017) (Fig. 5).

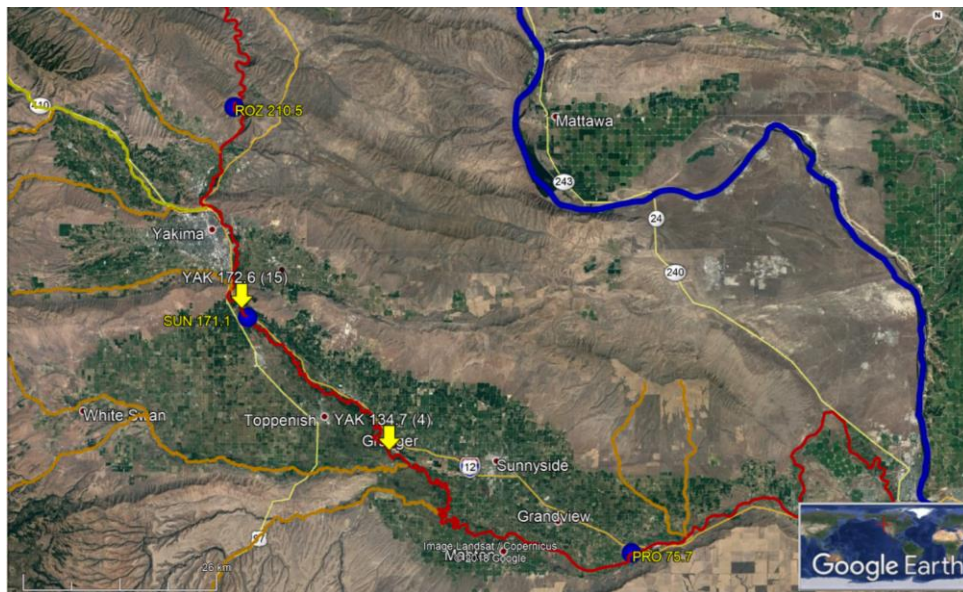
Figure 6. Aerial map of Pacific Lamprey translocation release sites (yellow arrows) in the upper part of the Lower Yakima River. “YAK” stands for Yakima, the number next to the stream abbreviation is the river km, and the number in parenthesis is the total number of lamprey released. Shown with the blue circles are the PIT tag array locations. Yakima River is the red line.

There were two additional release sites in the mid and upper portion of the Lower Yakima River: 1) four lamprey were released at river km 134.7 on May 18, 2017; and 2) 15 lamprey were released at river km 172.6 on April 27, 2017 (Fig. 6). Lamprey released at river km 172.6 were untagged (too ripe to PIT tag).

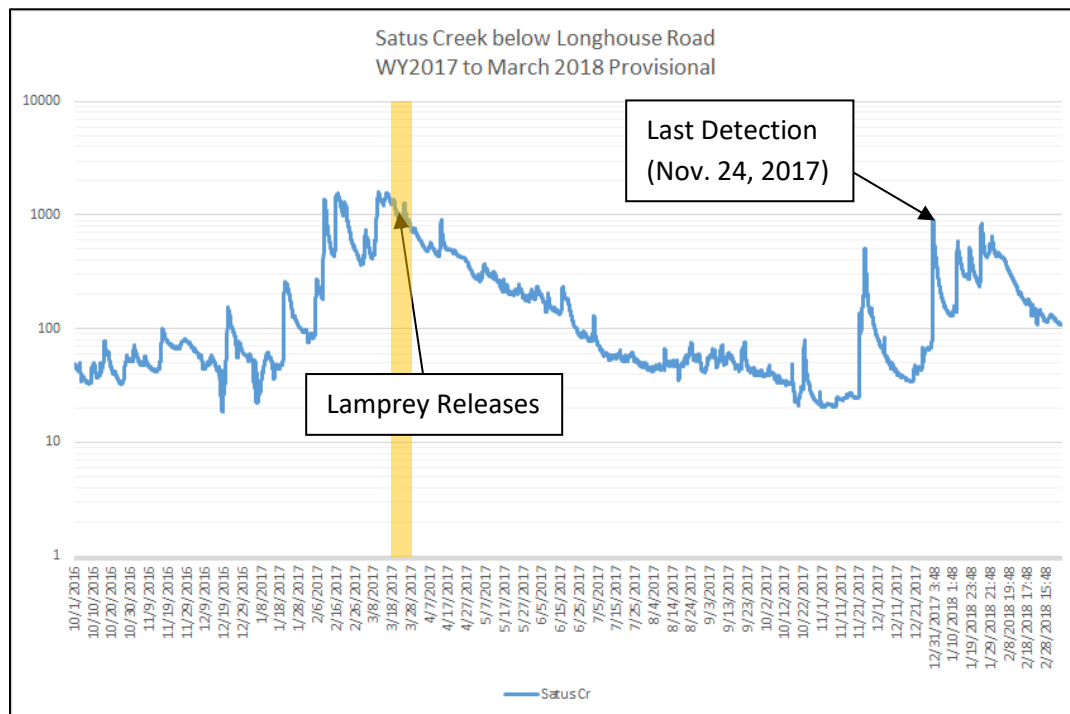
Figure 8. Discharge (cubic feet per second) data of Satus Creek in Satus, WA, below Satus Longhouse Road (river km 5.1) between October 1, 2016, and February 28, 2018 (Yakama Nation Water Resources Program), and associated lamprey releases and detection information.

Based on data provided by the flow monitoring stations within Satus Creek (river km 4.3), Toppenish Creek (river km 72.9), Ahtanum Creek (river km 1.0), and Yakima River (river km 177.7), the release events occurred primarily during the peak and tail end of the snow melt peak flow (Fig. 8, 9, 10, and 11). Discharge ranged between 6,000-17,000 cfs within the Yakima River, 100-350 cfs in Upper Toppenish Creek, 450 cfs in Lower Ahtanum, and 1,000 cfs in Satus Creek during the adult release period. The tail end of the detection was on July 15, 2017, which corresponds to the tail end of the rapid decline in water flow in all of these streams/ rivers, and the very last detection was on November 24, 2017 (Satus Creek), which corresponds to a high discharge point (potential movement of lamprey during the high flow event).

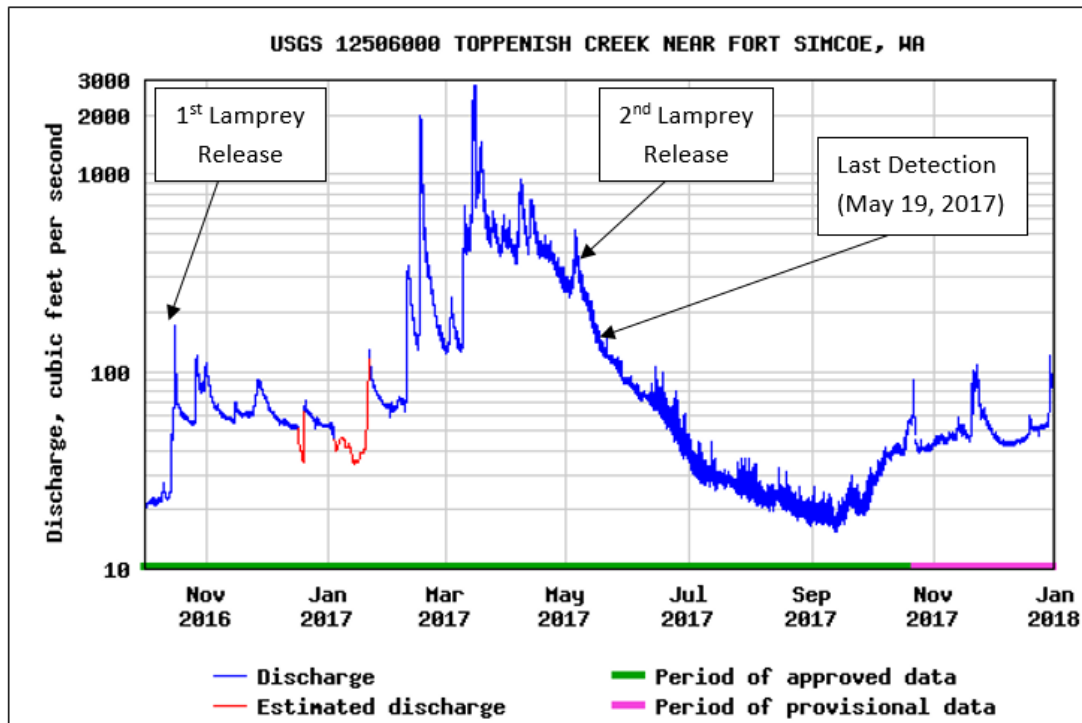
Figure 9. Discharge (cubic feet per second) data of Toppenish Creek near Fort Simcoe, WA (river km 72.9) between October 1, 2016, and December 31, 2017 (US Geological Survey National Water Information System: Web Interface), and associated lamprey release and detection information.

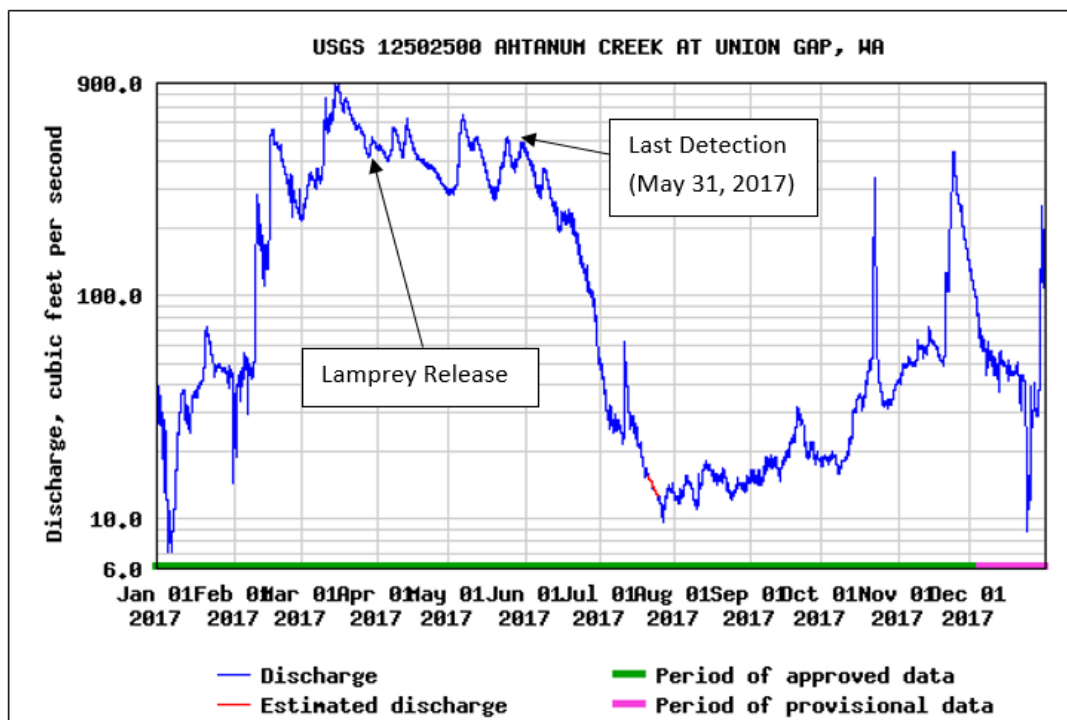
Figure 10. Discharge (cubic feet per second) data of the Ahtanum Creek at Union Gap, WA (river km 1.0) between January 1, 2017, and December 31, 2017 (US Geological Survey National Water Information System: Web Interface), and associated lamprey release and detection information.

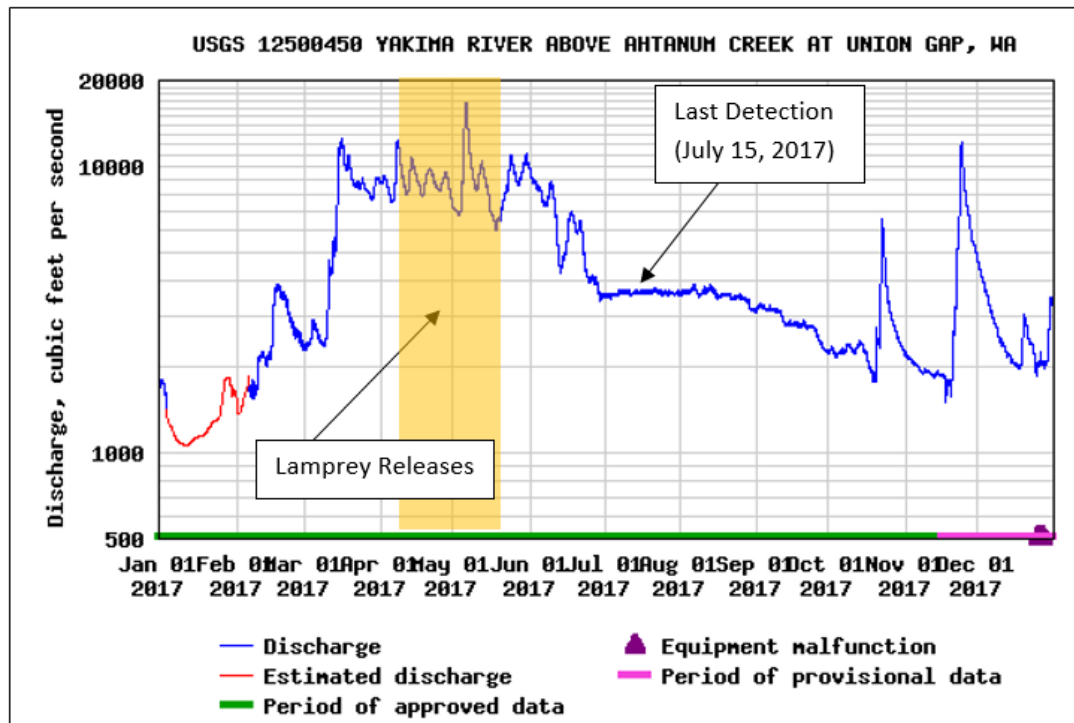
Figure 11. Discharge (cubic feet per second) data of the Yakima River at Union Gap, WA (river km 177.7) between January 1, 2017, and December 31, 2017 (US Geological Survey National Water Information System: Web Interface), and associated lamprey release and detection information.

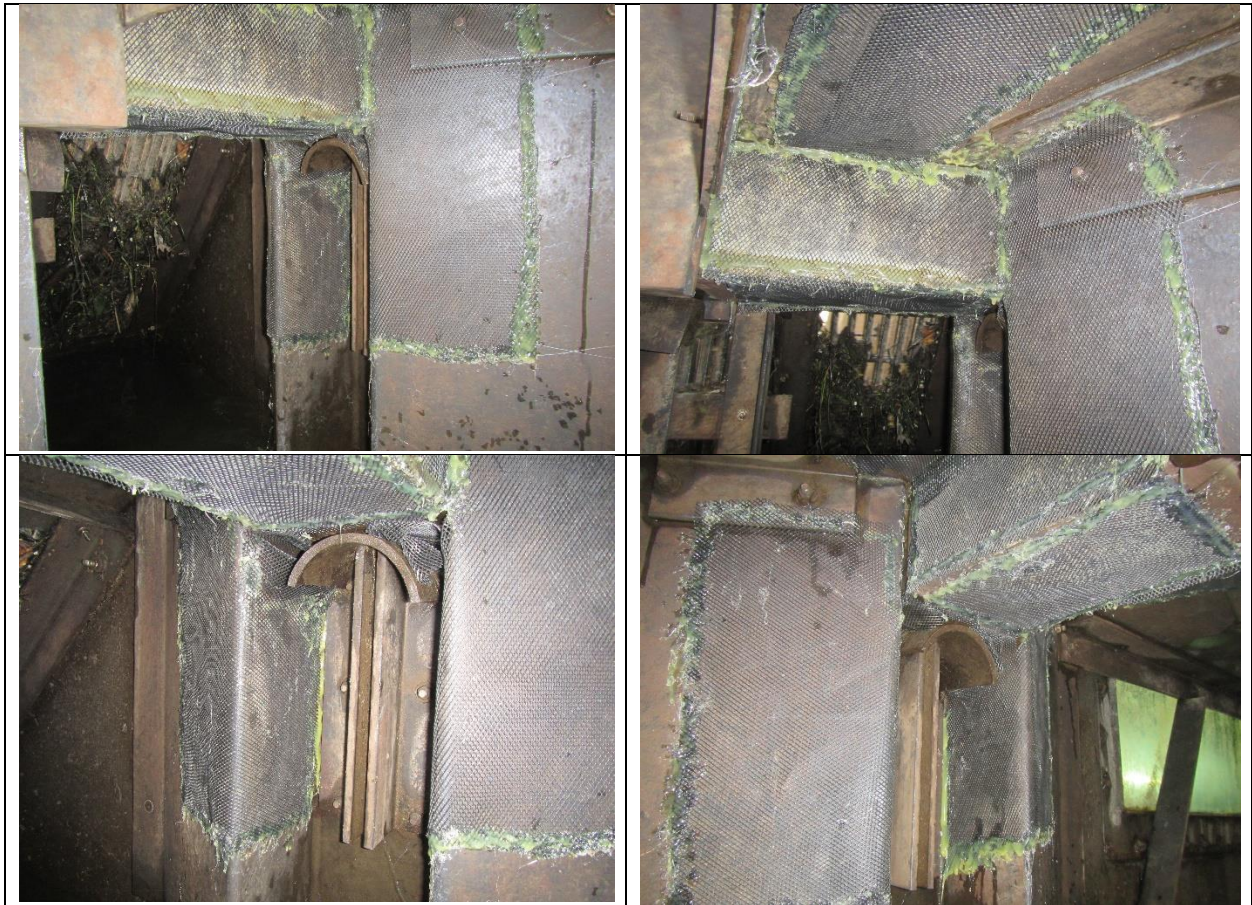
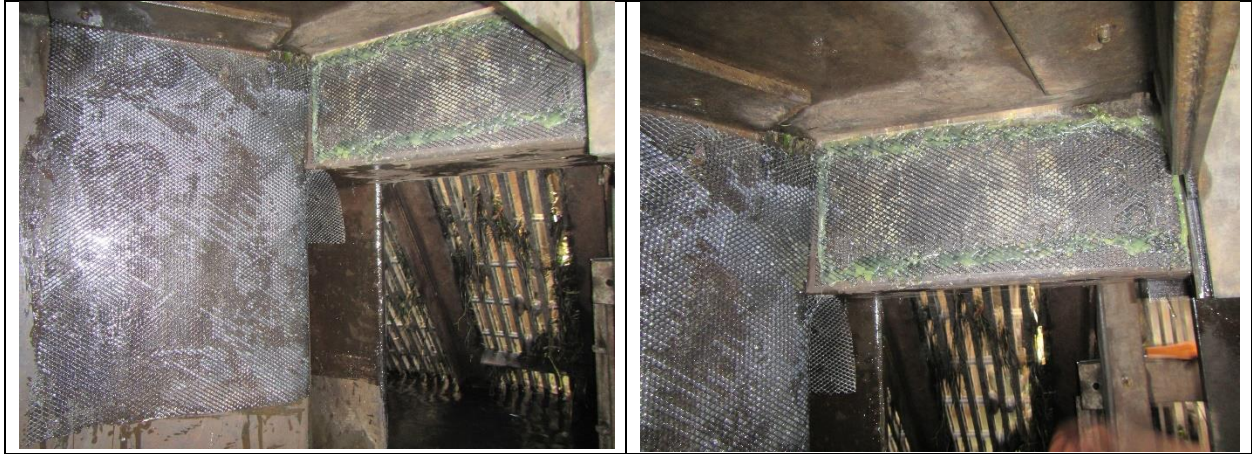
- At Roza Dam, there were four individual lamprey that were detected more than 25,000 times (75% were 9 mm PIT tags and 25% were 12 mm PIT tags). The highest number of detections from an individual lamprey from PRO was 64,032 (approximately 44 min of holding; 12 mm PIT tag).
- A solution was implemented on June 21, 2017 at Prosser Dam – vexar sheeting (3/8” mesh) was attached to the PIT array metal containers that were on the back side of the fish counting station at all three fish ladders. No holding in front of the PIT arrays were detected at Prosser Dam since this solution was implemented, and vexar sheeting was confirmed to be holding up during the assessment several months after the placement. See photos below.

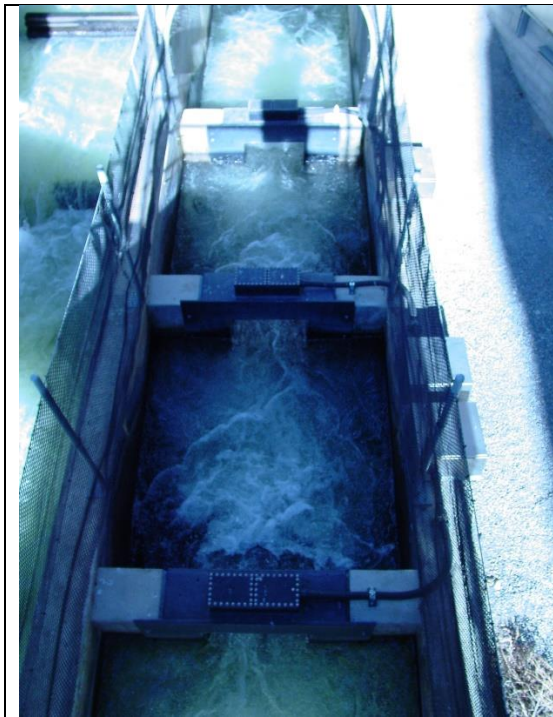
Roza Dam fish ladder weir PIT arrays (3 total).

<p>PSMFC - Rosa Dam PIT Tag Antenna Concept Drawing</p> <p>Concrete to be added for antenna installation. Required additional reinforcement not shown.</p> <p>Concrete to be added for antenna installation. Required additional reinforcement not shown.</p> <p>Concrete to be removed for antenna installation.</p> <p>Existing weir wall.</p> <p>12.00</p> <p>41.00</p> <p>20.50</p> <p>8.50 - 2 pics</p> <p>"Detail A"</p> <p>Top of new weir wall concrete to be 3" below sides of ladder.</p> <p>3.00</p> <p>NOTES: All dimensions in inches. Concrete to be removed in areas indicated. Concrete to be added in areas indicated. Antenna will be bolted to the weir wall through the flange.</p> <p>6/25/2007 - Page 1 of 2</p>	<p>Design drawing of the Roza Dam fish ladder weir PIT arrays.</p>
<p>Fill the 13/16" gap with 45" x 16" x 3/4" PVC board underneath on both sides</p> <p>12" PVC Pipe (half moon) sealed to PVC board using marine epoxy & stainless screws (*no direct attachment to array)</p> <p>Also, use epoxy b/w two boards and concrete wall</p> <p>stainless steel bolts</p> <p>8.00</p> <p>12.625 PVC</p>	<p>Conceptual drawing of one potential solution (a combination of half-moon PVCs and PVC boards to prevent lamprey from holding within the detection zone but also helping lamprey gain their continuous attachment surface needed to pass through the high velocity area).</p>

<p>8.00</p> <p>8.00</p> <p>6.00</p> <p>15.00</p> <p>24.00</p> <p>12.625 PVC</p> <p>Lamprey Holding Areas (Downstream Side)</p>	<p>Conceptual drawing of the PIT tag detection zone at the array (large red circle) and the proposed new half-moon PVCs (orange areas). Suspected lamprey holding occurs on the downstream side (as well as potentially on the upstream side).</p>

- Unlike the Prosser Dam holding issue, which occurred on the back side of the PIT arrays, the Roza Dam holding occurs within the fish ladder weir. Prevention of holding in the fish ladder weir will likely negatively impact lamprey passage (unless an alternate passage route is provided). As a result, solutions at Roza Dam is best if it could accommodate passage needs of lamprey as well as the prevention of PIT tag interference. A few solutions will be implemented during the dewatering period in 2017-2019. Shown below are some potential solutions being discussed.

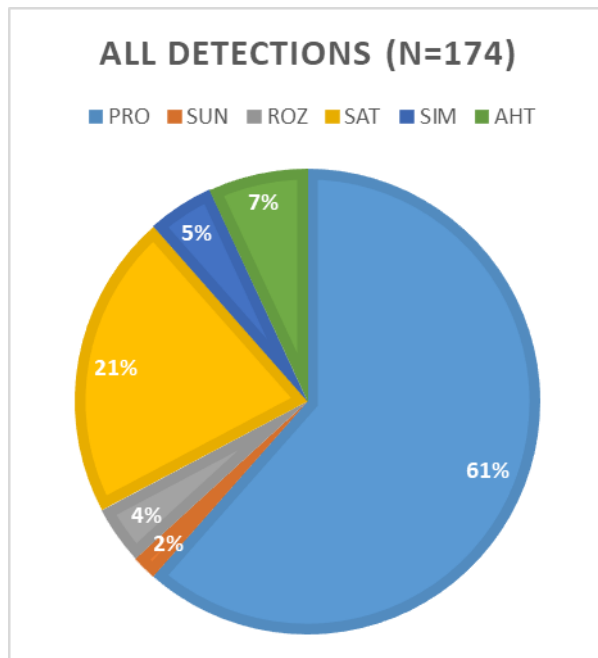
Figure 14. A pie chart summarizing all the site detections (N=169) from the 133 lamprey that were detected at least once from the 2017 spring translocation release in the Yakima Subbasin (none were detected from the 2016 fall release).

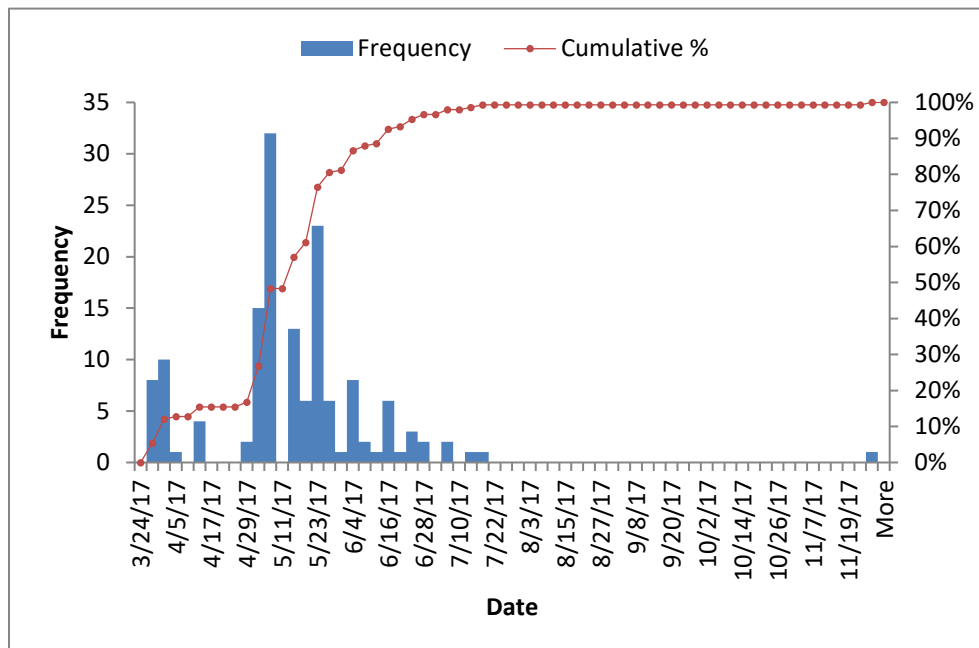
Figure 15. Frequency of movement displayed by Pacific Lamprey from the 2017 Spring release in the Yakima Subbasin based on PIT tag detection data.
