Teaway Community Forest

Teanaway Community Forest

Teanaway Accomplishments

June 2019 update:

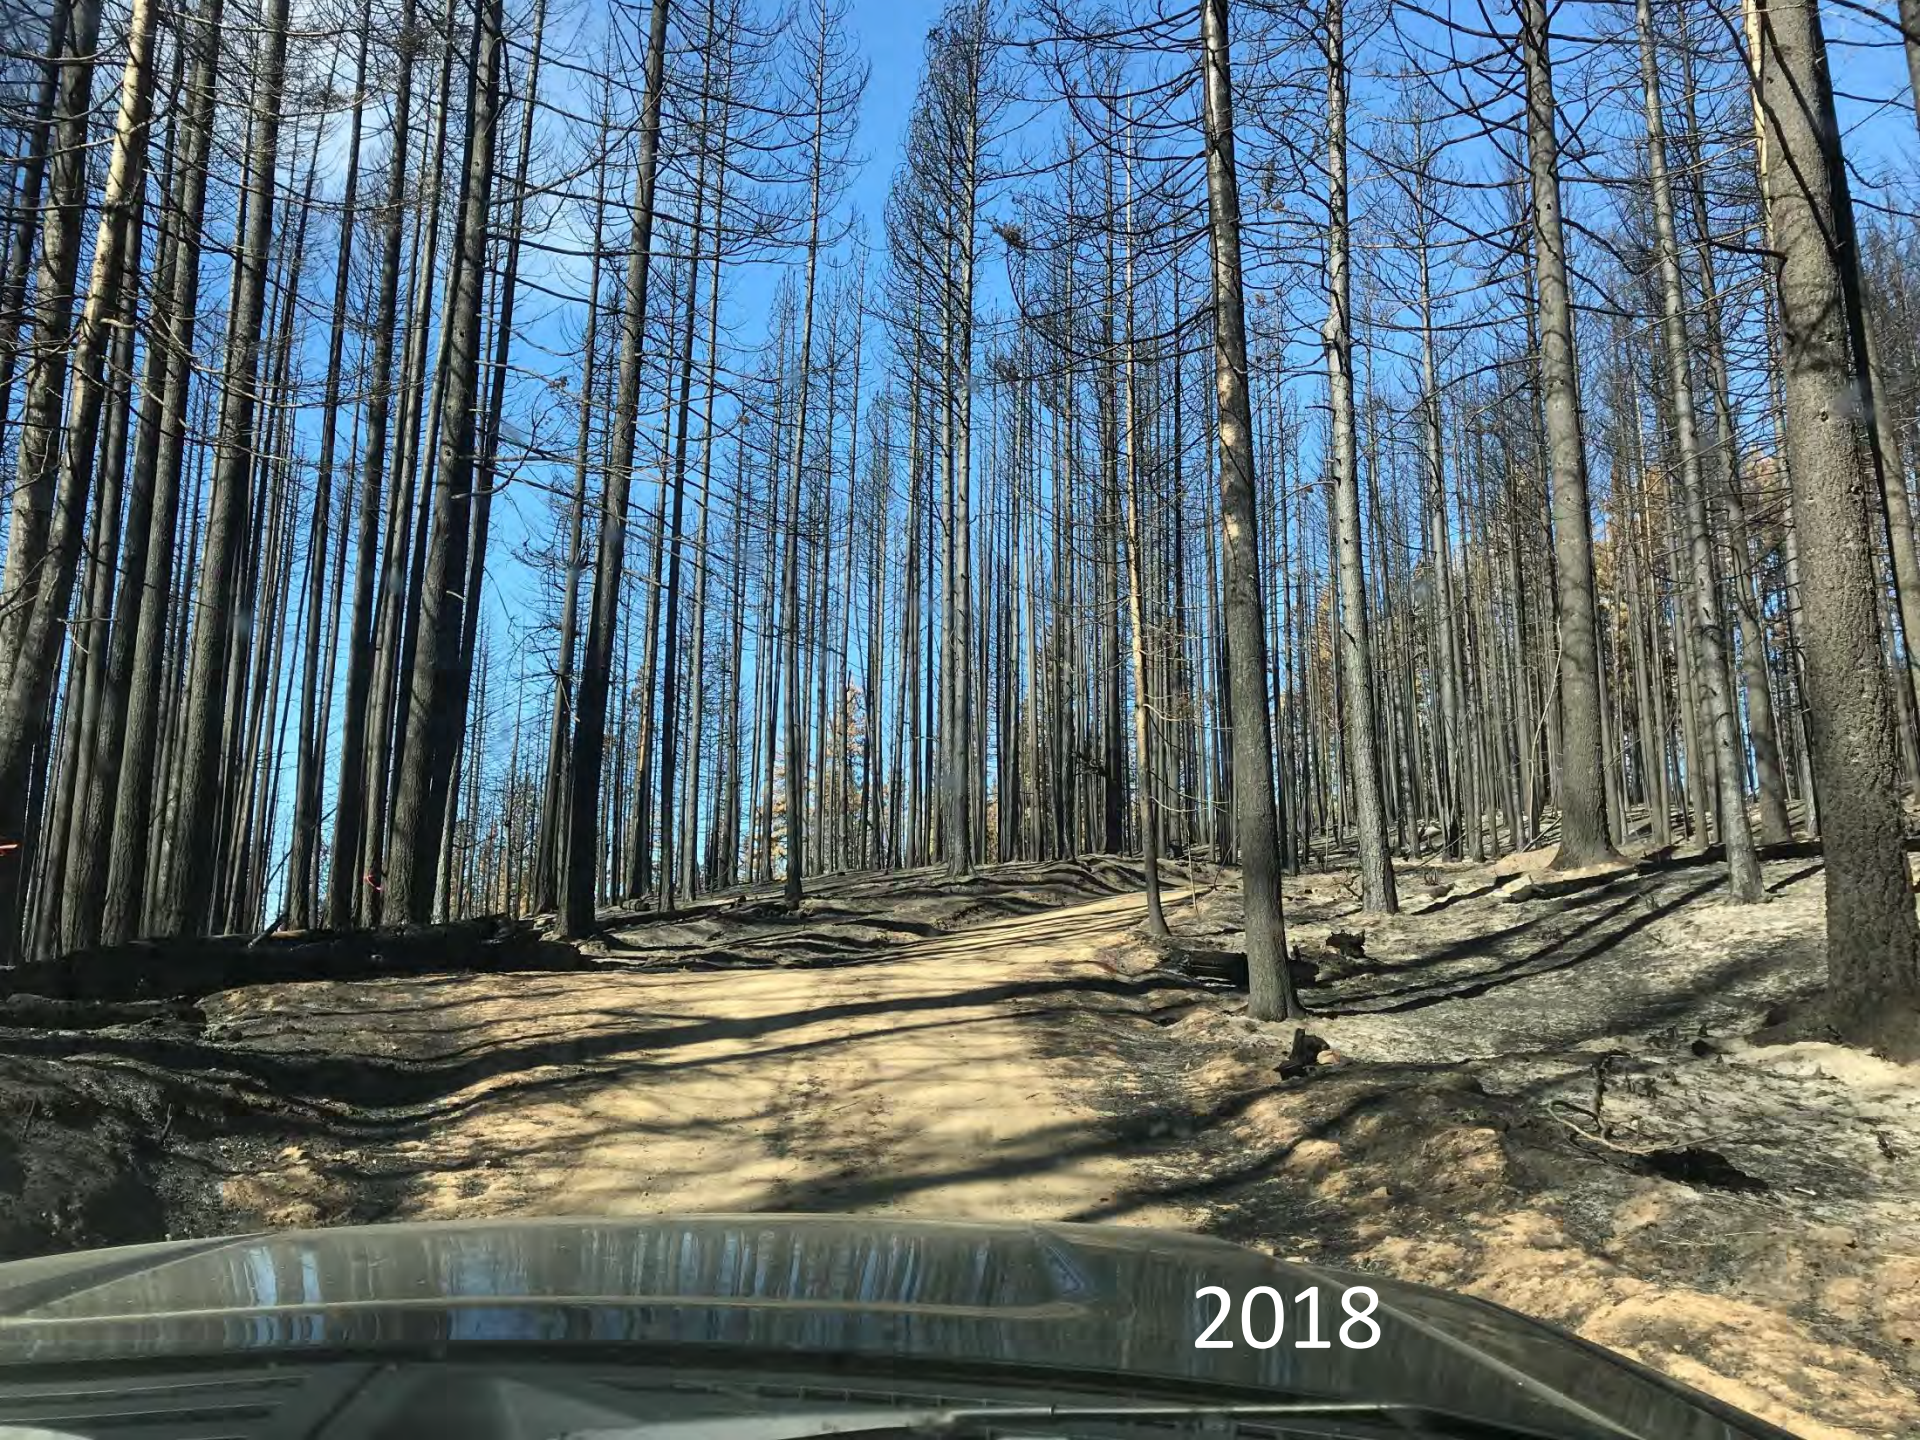
Burn Severity Map

Jolly Mountain Fire 2017

Total Burn 57.5 sq. miles
TCF Burn ~14.5 sq. mi.

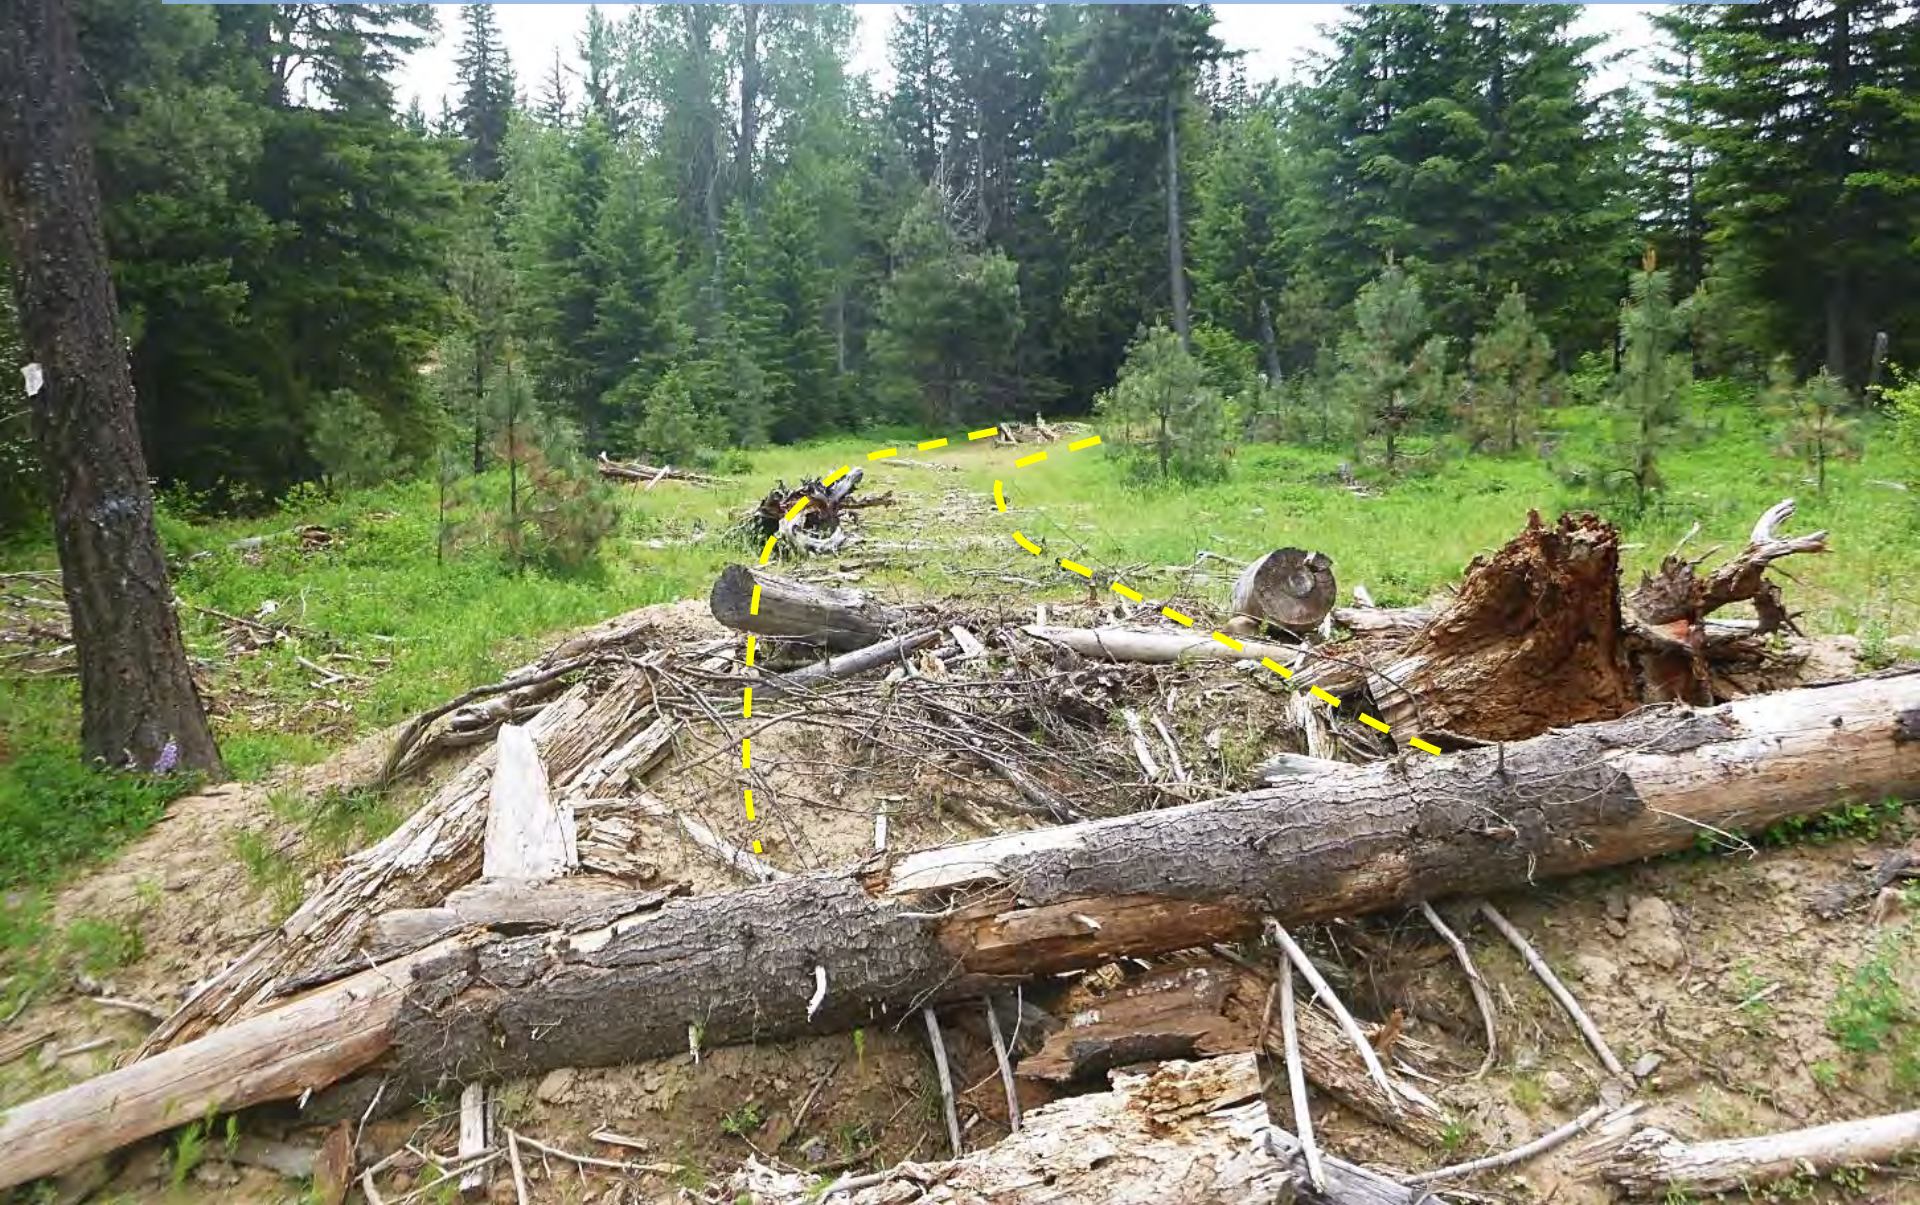
Road Abandonment:

11.7 miles abandoned; 85 miles maintained

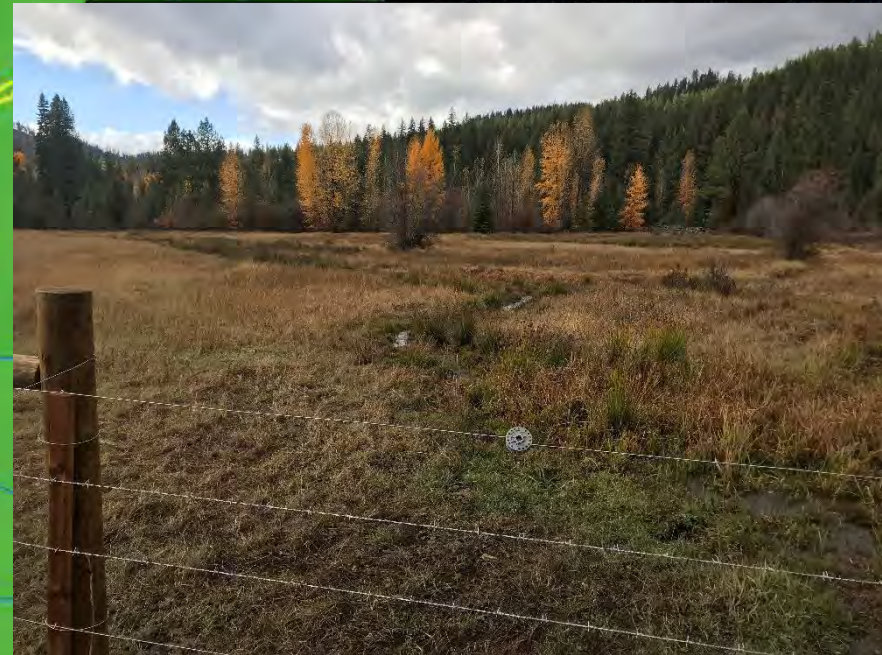
- Fencing – 7 miles
- 3-5 miles planned

Note: all phases of fencing shown

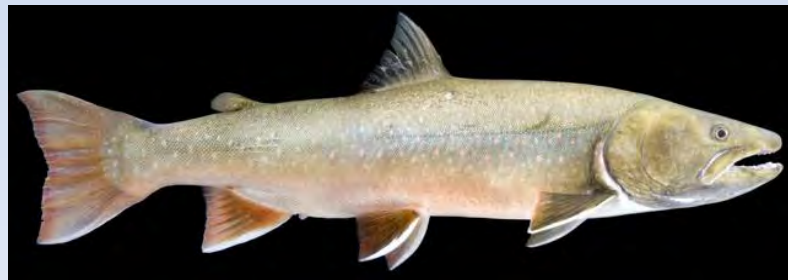
Teaway Bull Trout

Night Snorkel BT Observations (EIT)

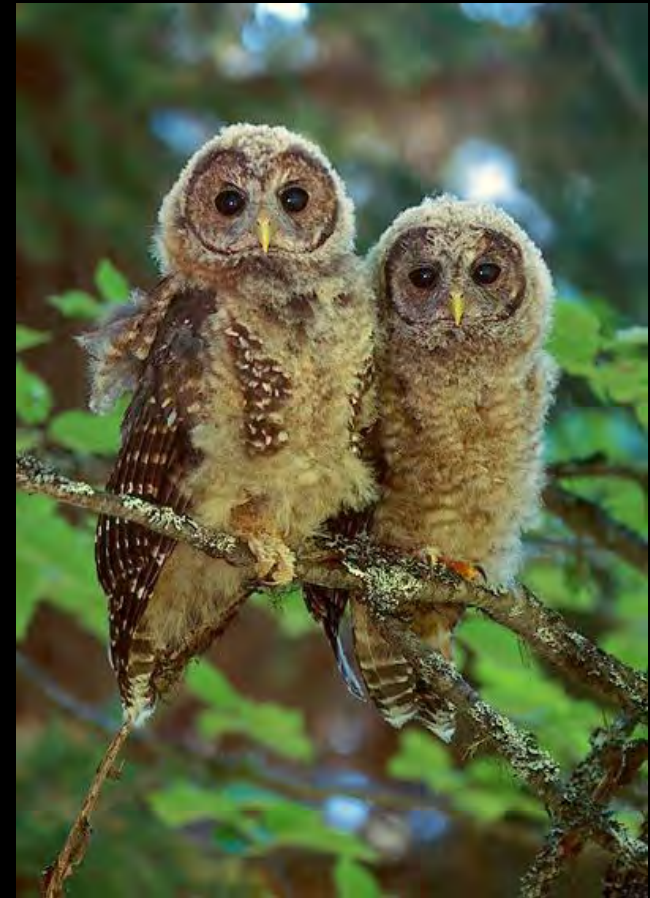
Spotted Owl highest-site-status & telemetry 1989-2018

- = Reproductive
- = Pair
- = Single

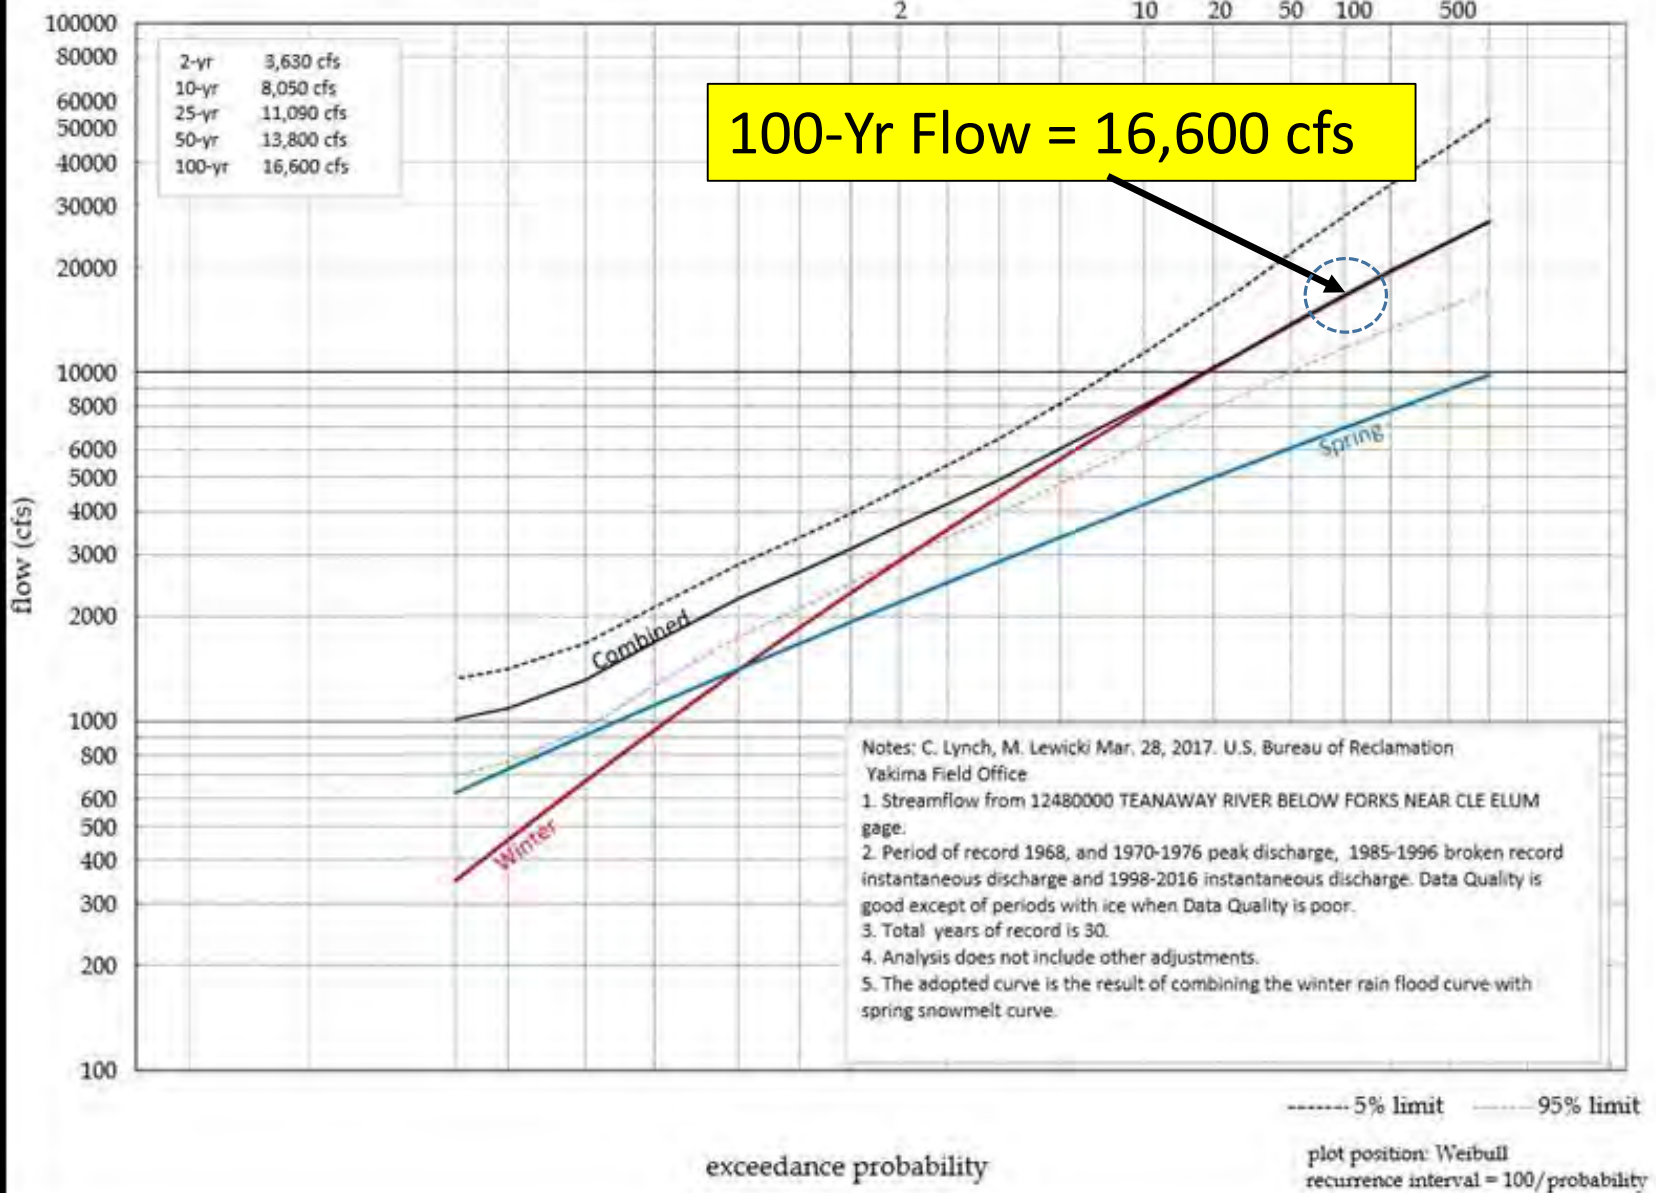
HYDROLOGY USBOR Gauge Analysis

USGS 12480000 TEANAWAY RIVER BELOW FORKS NEAR CLE ELUM, WA
