Bull Trout transport and monitoring in the Rimrock Recreation Area

Jason Romine¹, Rob Randall¹, Pat Monk², Jennifer Von Bargen³, and Jeff Thomas^{1,*}

¹USFWS – MCFWCO -- Yakima Sub-office ²Bureau of Reclamation – Yakima Field Office ³USFWS – Abernathy Fish Technology Center ^{*}USFWS – Retired

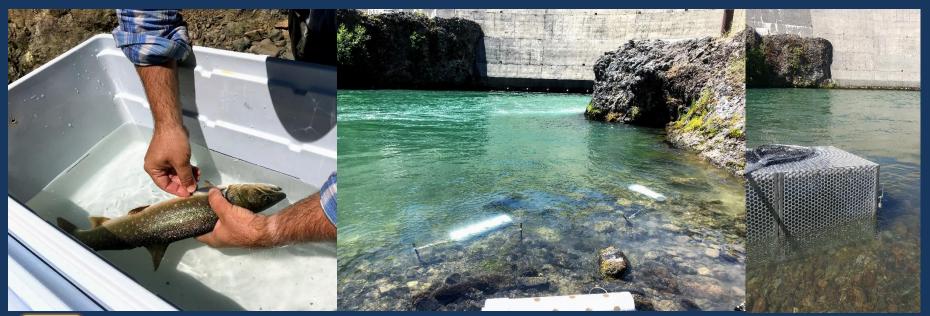
Fish Transport

- Work up
 - Measure, tag (HDX), fin clip
 - Recovery tubes (monitored)
 - Place fish back in holding pen
