YAKIMA BASIN SIDE CHANNELS

FY 2018 ANNUAL REPORT

SEPTEMBER 1, 2017 – FEBRUARY 28, 2018

PROJECT #1997-051-00

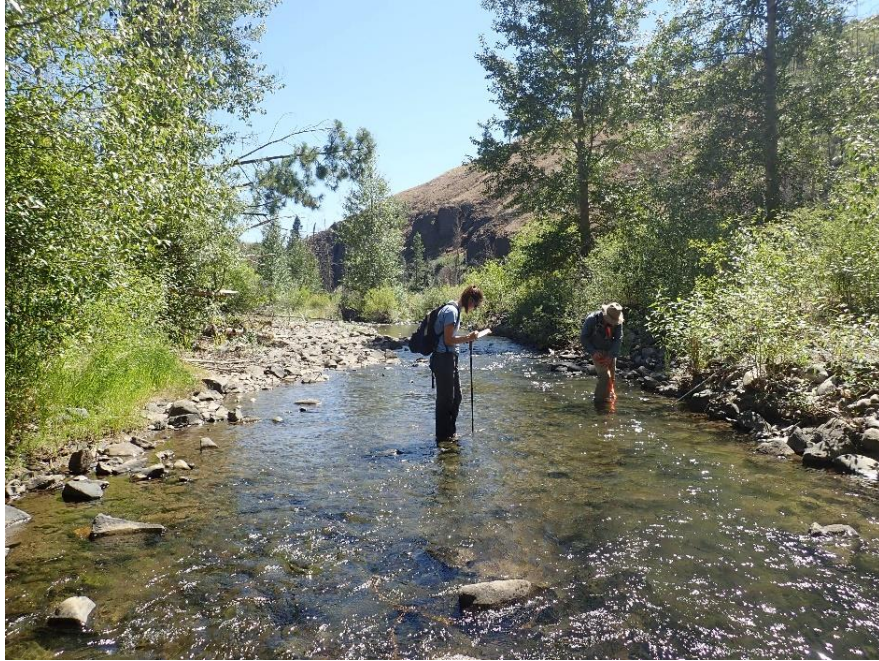
Figure 3. Photo of Swauk Creek showing an oversimplified channel with low instream habitat complexity that was characteristic of the project reach.

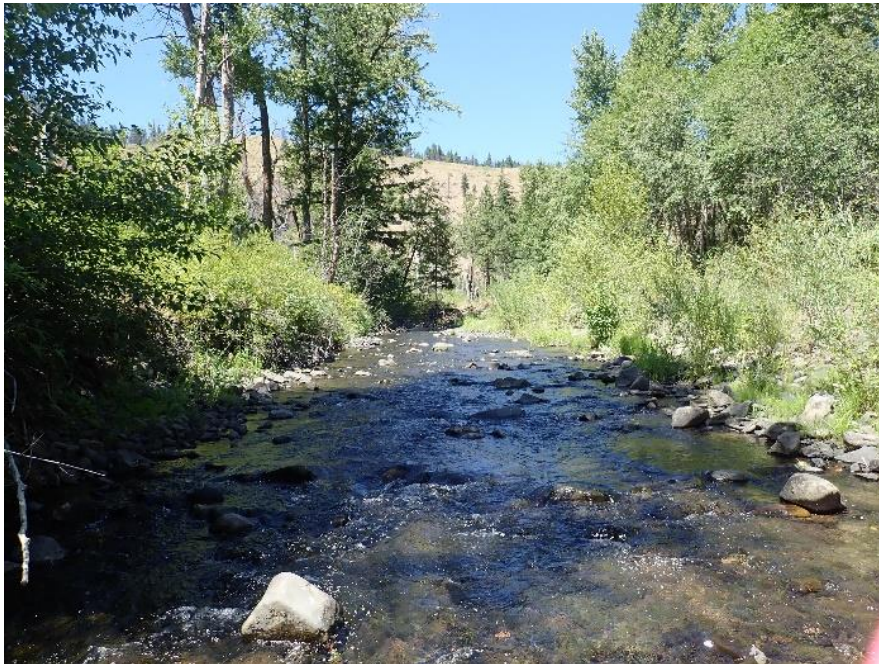
Figure 4. Photo of Swauk Creek showing an oversimplified channel with low instream habitat complexity that was characteristic of the project reach.

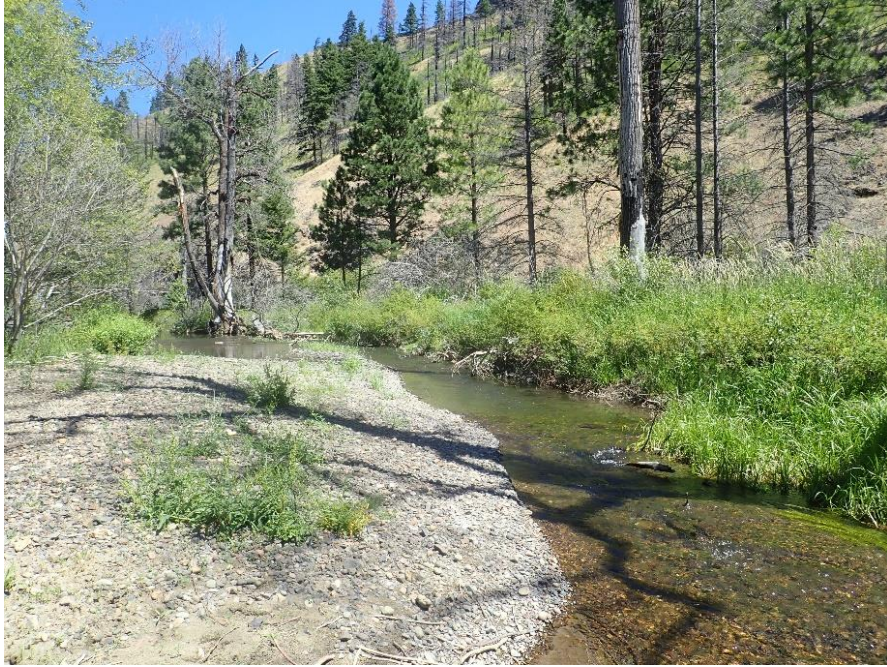
Figure 5. Photo of project reach demonstrating lack of cover for fish.

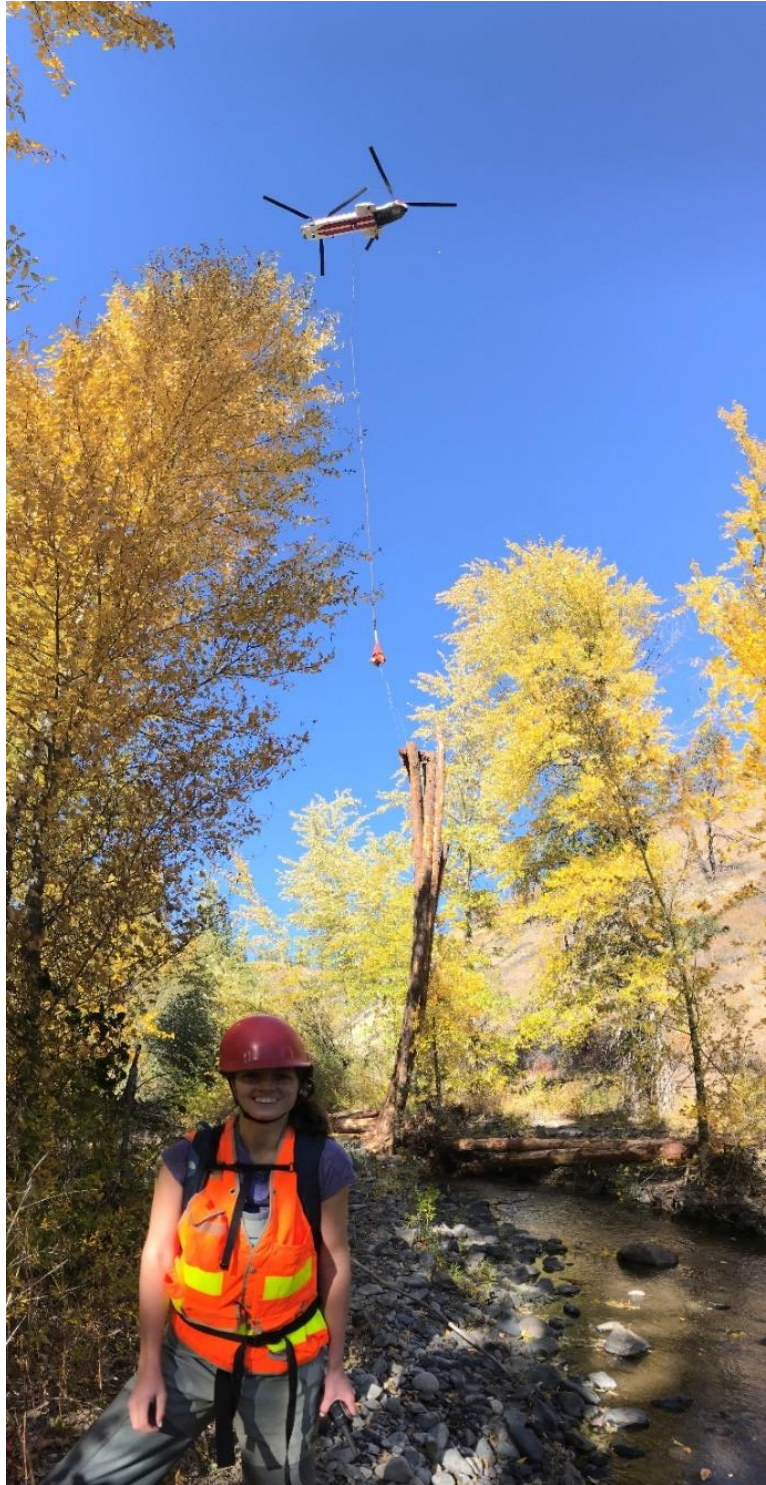
Figure 5. Photo of the 107-Vertol helicopter placing wood instream during project implementation.

Wood was placed in lower Swauk Creek and the adjacent floodplain during daylight conditions on October 13, 2018 using a 107-Vertol helicopter. A total of 552 logs were

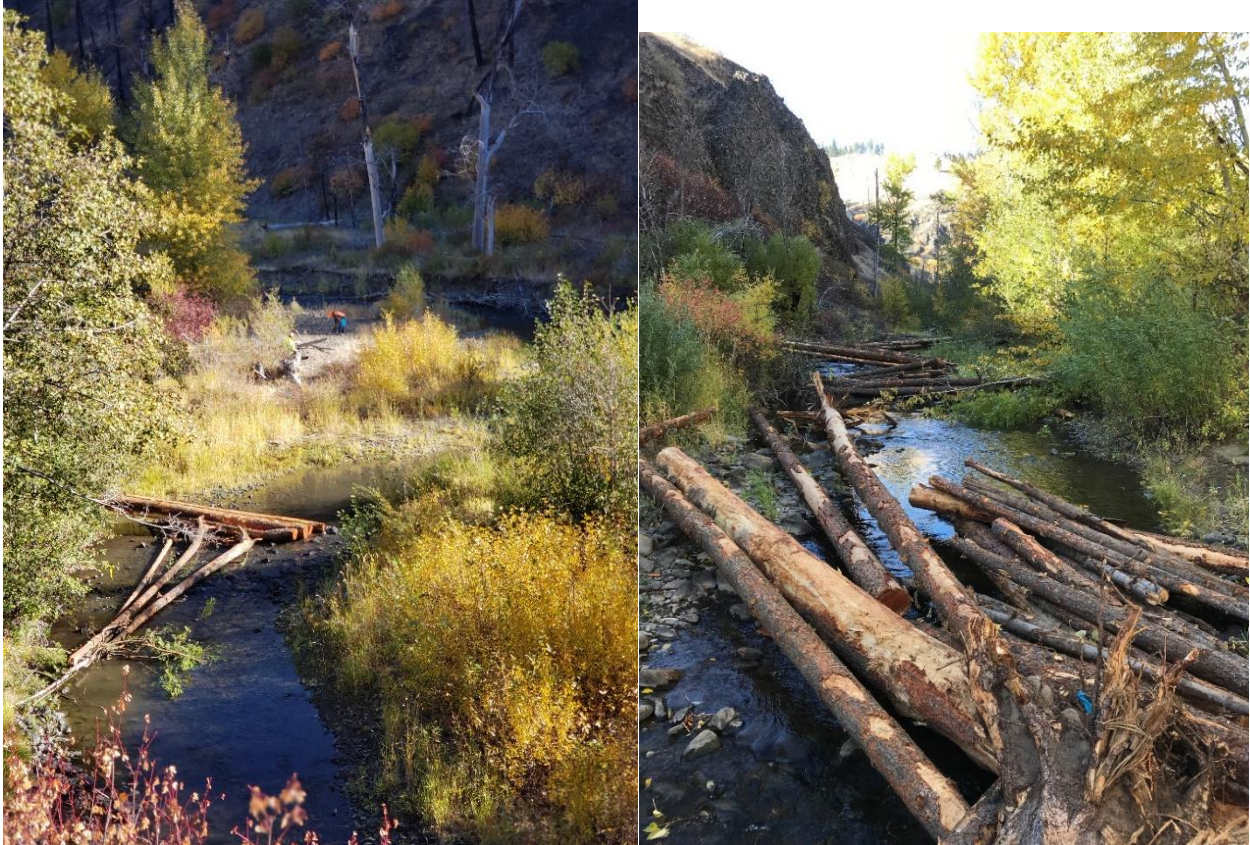
Figures 6 & 7. Photos of wood placement post implementation.

placed unanchored into the active channel and floodplain following concepts outlined in WDFW's Stream Habitat Restoration Guidelines (2012) for Wood Replenishment. Wood was placed in areas where it is likely to improve instream habitat, reestablish natural floodplain connectivity, attenuate downstream peak flows and enhance base flows.

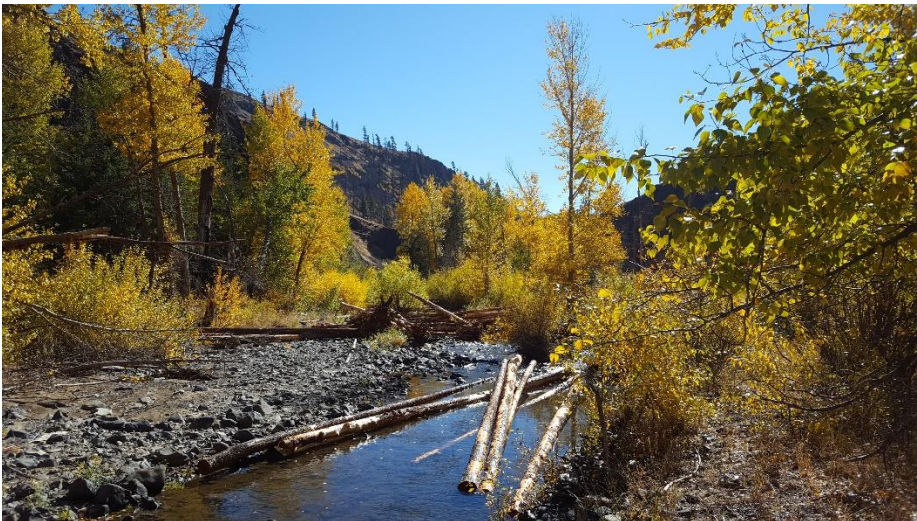
Figure 8. Photo of wood placement post implementation.

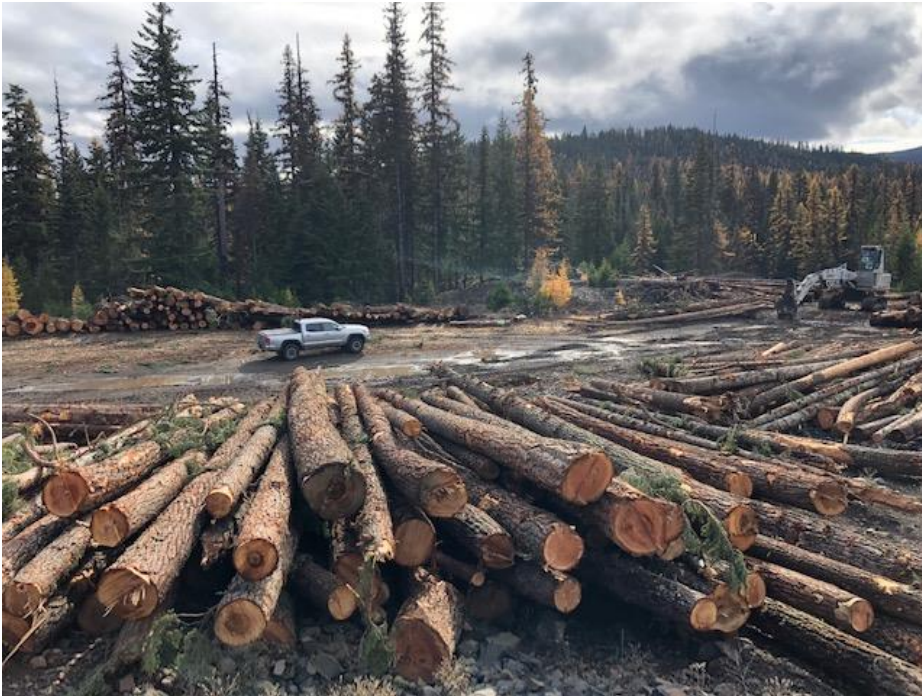
Figure 3. Photo of wood staged for project implementation.

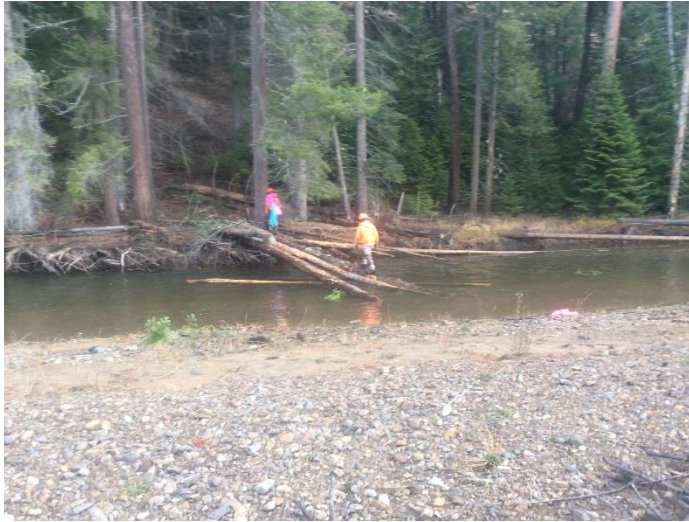
Figure 5. Photo of wood placement post implementation.

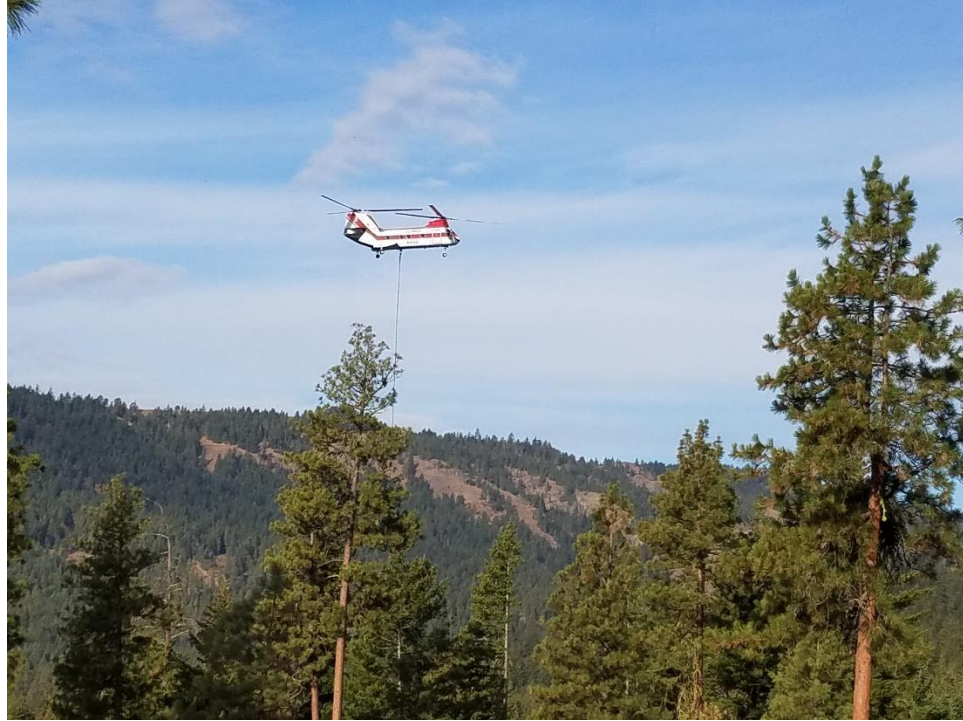
Figure 1. Helicopter flying wood into North Fork Manastash

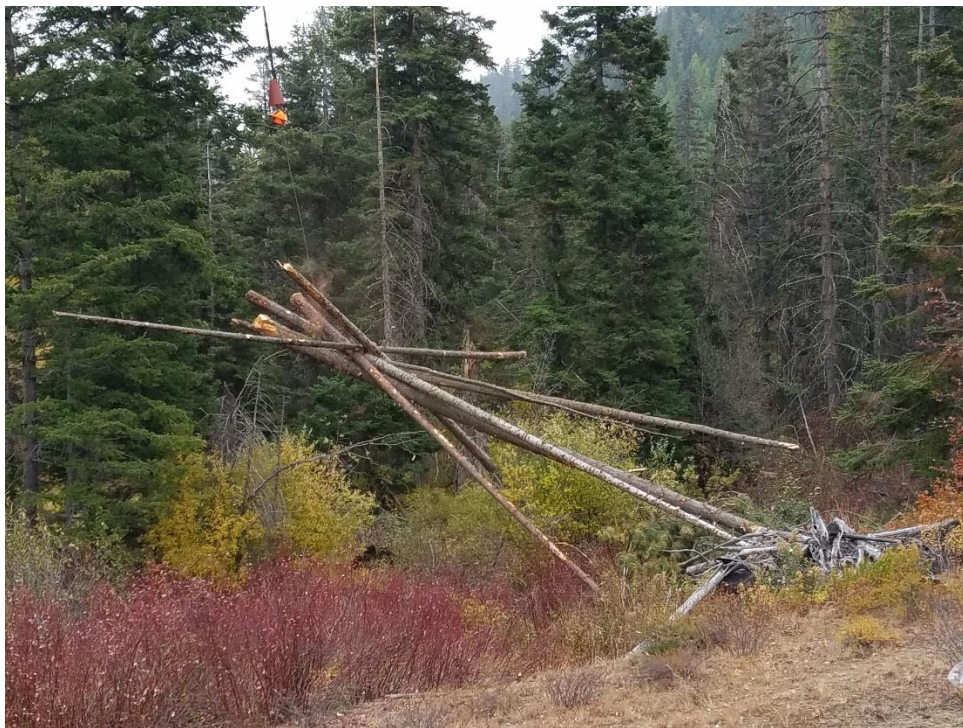
Figure 2. Helicopter placing wood in North Fork Manastash

YKFP habitat biologists, in partnership with Mid-Columbia Fisheries Enhancement Group, successfully directed the placement of 2,000 logs with and without rootwads instream and on the adjacent floodplain in NF Manastash Creek October of 2018. The amount of wood needed for the 7.5-mi helicopter reach was underestimated and approx. 2 miles between RM 5 and RM 7 within T18N, R16E, S26, S35 and T17N, R16E, S2 were not treated. This section of stream contains high priority broad disconnected floodplains with dry meadow vegetation. Placement of wood will aggrade the channel, reconnect it to its floodplain and return it to historic condition. YKFP is proposing a second phase of helicopter wood replenishment during August 2019 to add 500 pieces of large wood to the identified locations within the blue polygon.

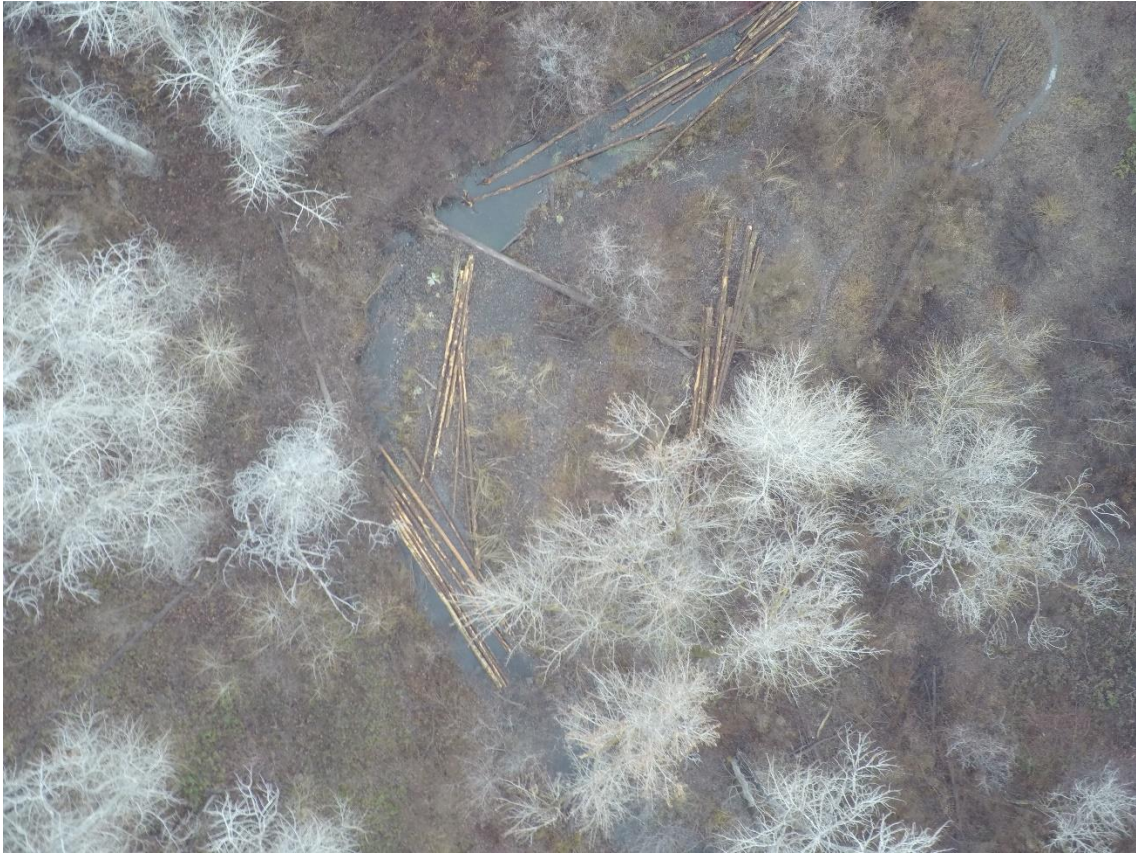
Figure 1. Drone imagery of Umtanum Creek post implementation

Umtanum Creek runs for ten miles through the Wenas Wildlife Area owned and managed by Washington Department of Fish and Wildlife before emptying into the Yakima River. Steep basaltic cliffs rise on both sides of the stream corridor. The narrow riparian forest zone adjacent to Umtanum Creek is comprised of ponderosa pine, Douglas fir, black cottonwood, aspen and willows. Beaver are active in this drainage. Instream wood is limited within the stream reach with no access. This project used wood sourced from the LT Murray Wildlife Area as part of a WWRP funded forest health thinning project to improve instream habitat. Large wood was hauled to nearby staging areas and placed in Umtanum Creek via helicopter. This project will improve habitat complexity in 4.5 miles of stream for Middle Columbia River Steelhead, Spring Chinook and Coho by adding 1,000 pieces of course woody material with and without rootwads attached, including small diameter trees and slash, to the stream channel and adjacent floodplain.

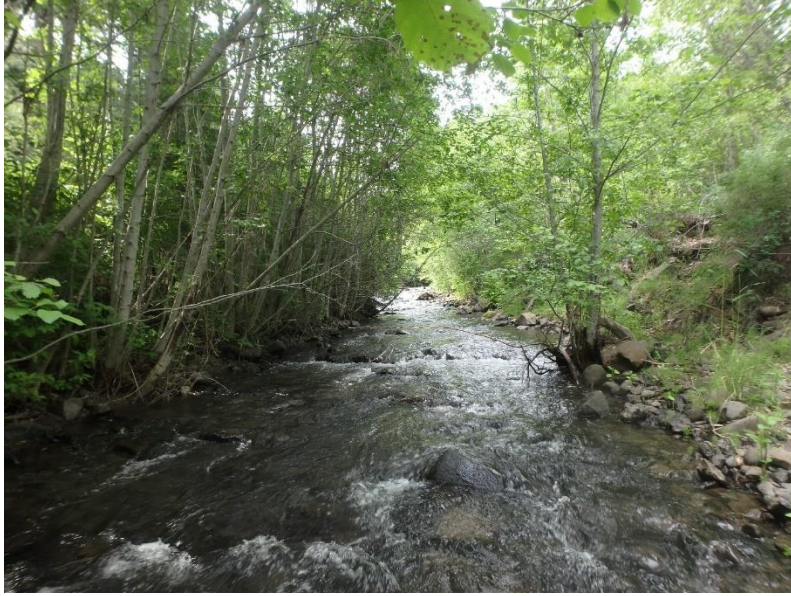
Figure 2. Photo of Little Rattlesnake Creek showing oversimplified, straightened channel, lacking in instream habitat complexity. This is characteristic of what was found throughout the project reach pre-implementation.

As a result of past road network development in the floodplain of Little Rattlesnake Creek, the channel had become oversimplified, straightened, and incised in some areas. As a result, the need for wood replenishment was identified by Yakama Nation YKFP staff during the road decommissioning project. Wood replenishment in the adjacent 5 miles of stream was previously included under BPA contract #56662 REL 61 WE Q 29 but had been canceled due to permitting not being completed prior to road decommissioning.

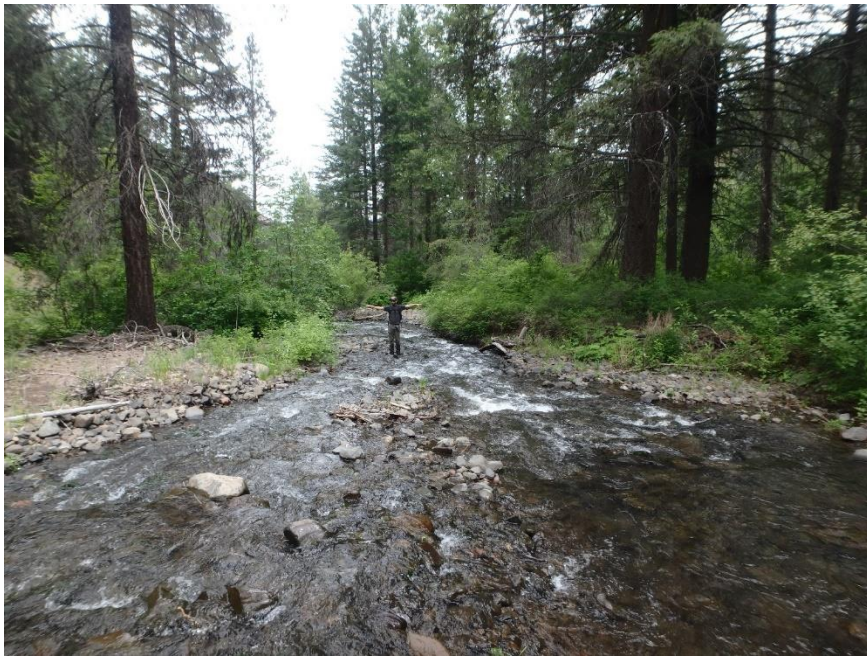
Figure 3. Photo of Little Rattlesnake Creek showing channel lacking in instream habitat complexity and cover.

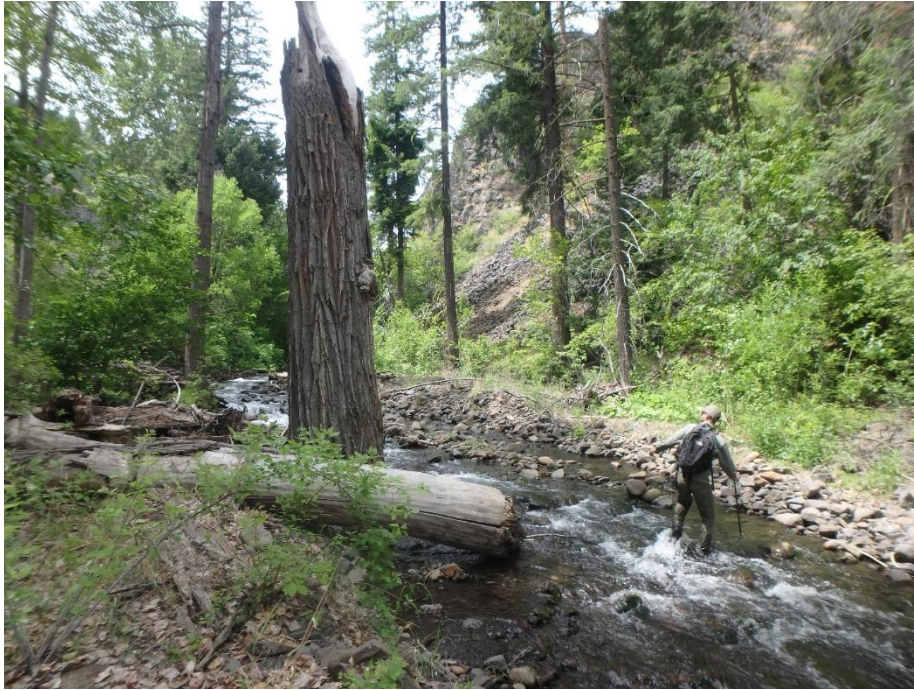
Figure 4. Photo of Little Rattlesnake Creek showing channel lacking in complexity.

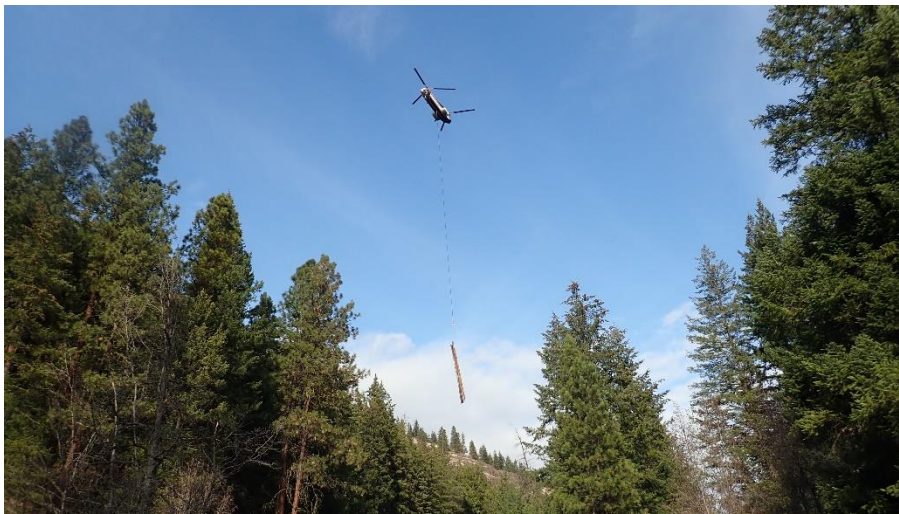
Figure 5. Photo of helicopter during implementation flying logs into Little Rattlesnake Creek.

In 2018, Mid-Columbia Fisheries Enhancement Group partnered with YKFP staff to place wood in the lower 5 miles of Little Rattlesnake Creek. Mid-Columbia Fisheries Enhancement Group still had some remaining funds from the SRFB grant to decommission the FS1501, which in addition to BPA funds, covered the 2018 wood replenishment work. This included placement of 496 logs into Little Rattlesnake Creek on November 9th and 10th, 2018 with the 107-Vertol Helicopter.

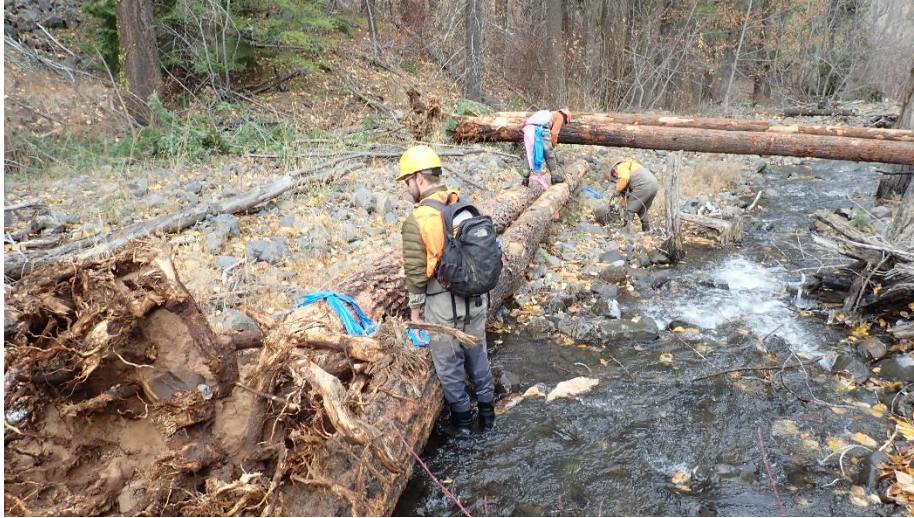
Figure 6. Photo of biologists directing placement of wood in Little Rattlesnake Creek during implementation.

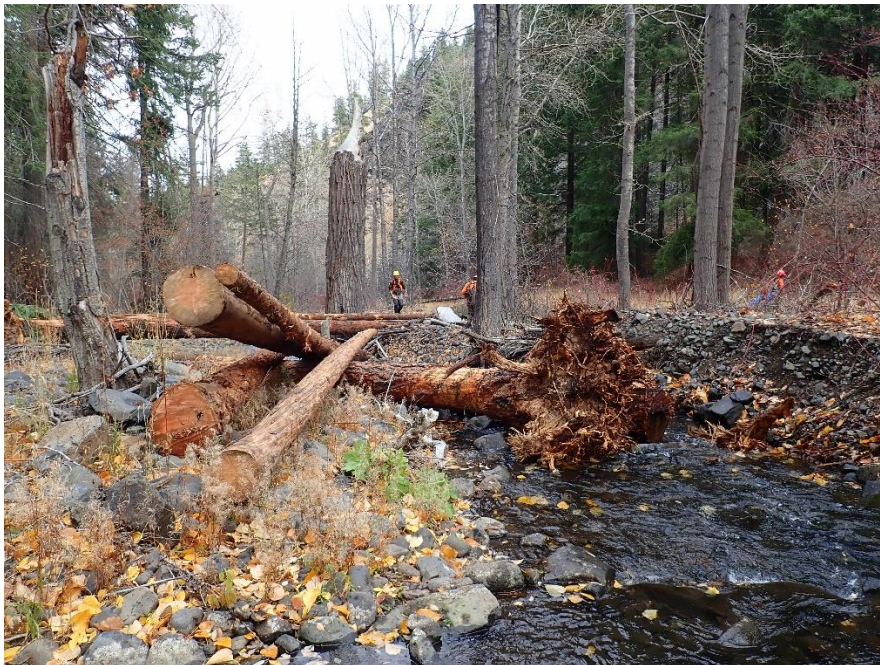
Figure 7. Photo of wood placement in Little Rattlesnake Creek.

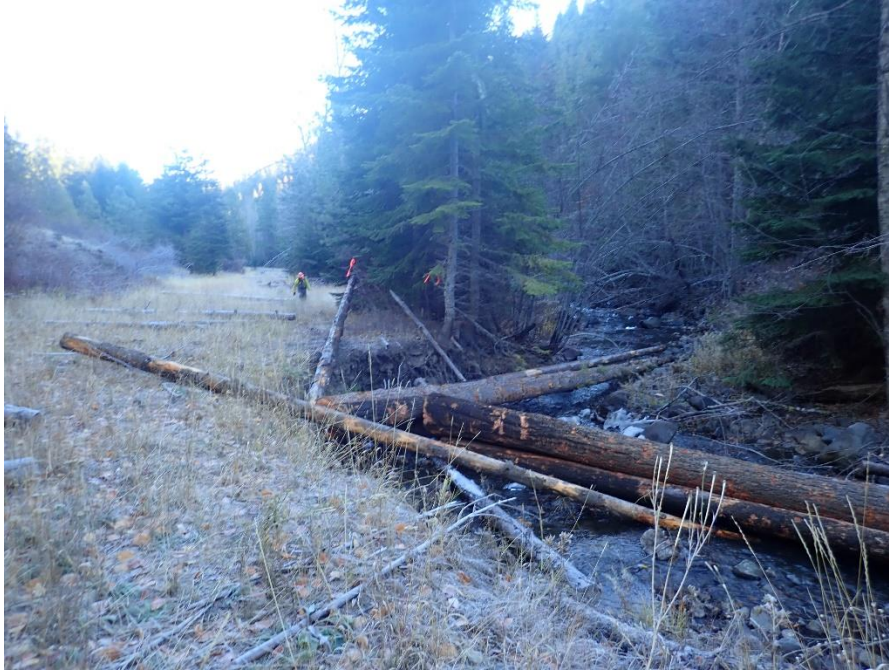
Figure 8. Photo of wood placement in Little Rattlesnake Creek.
