Klickitat Watershed Enhancement Project (KWEP)

Yakima/Klickitat Fisheries Project (YKFP)

Report for January 1, 2018 - December 31, 2018

BPA Project # 1997-056-00

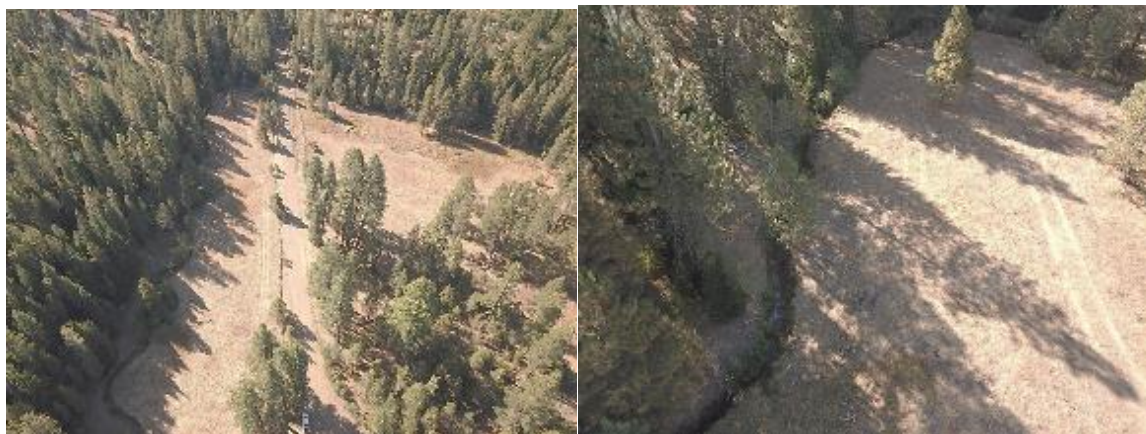
Figure 2. Pre-project conditions as observed in early-September, stream flow limited to isolated standing pools.

Currently, most of the incised reaches in the White Creek watershed (including the project reach) dry up from July through October. Anecdotal accounts from the 1960s suggest that at least some of these reaches were historically perennial. Many of the same reaches, which show signs of bed armoring, are also characterized by a simplified morphology with low pool frequencies, rectangular, canal-like cross sections, and an absence of large woody debris (LWD). Impacts from grazing (in the form of altered riparian vegetation, bank erosion, and channel incision) are evident in several meadow reaches within the watershed. Anecdotal evidence, along with watershed size, elevation, and precipitation, suggest that more reaches historically had perennial flow.

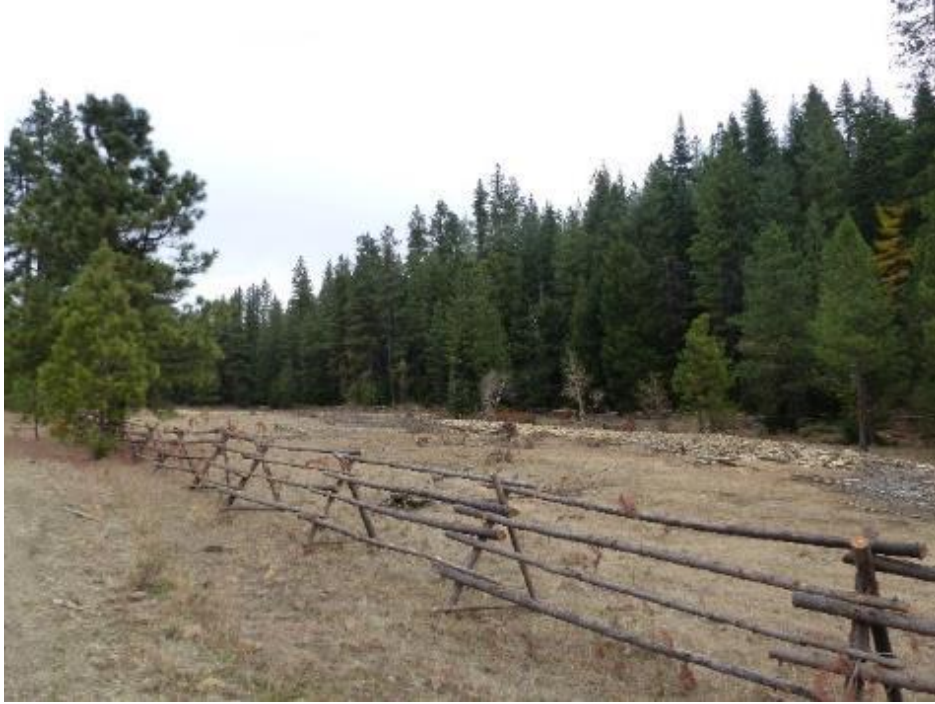
Figure 4. Cattle exclusion fence around perimeter of Tepee Creek Phase 3 Project.

As availability permitted, a four-person Yakama Nation crew constructed the fence around three sides of the project (Figure 4), leaving the downstream section and gates along the road open to facilitate construction activities. Completion of the fence occurred in October 2018 when work requiring heavy machinery access had terminated.

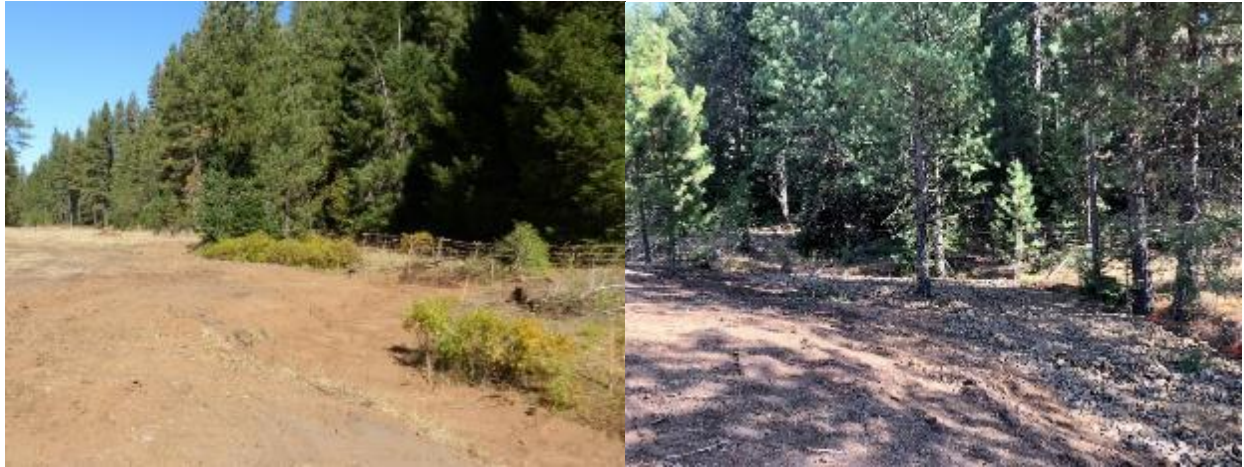
Figure 5. Channel conditions following placement of common borrow fill (left) and type 2 rock (right).

TMS Native Companies LLC of Toppenish, WA was selected via a competitive bidding process in June 2018 to produce, truck, and haul native fill soils and specified rock products to the project site. The reach was intermittent by mid-September with isolated pools. Prior to ground disturbing activities beginning the reach was isolated from migrating fish by placing sets of block nets at the upstream and downstream project extents. YN personnel from the Klickitat Monitoring and Evaluation Project conducted a fish salvage effort using standard electro-fishing methods. Work commenced on September 24, 2018 and proceeded in the downstream direction with native fill material placed first. Native fill and rock were hauled from two Yakama Nation source locations within the Reservation. The native soil and Type 2 rock came from a borrow pit less than a mile from the project site, while the Type 1 rock source was a pit 4 miles away. Following the native fill, type 1 rock (smaller of the two rock sizes) went in, and lastly the type 2 grade control rock was placed at the downstream terminus of the project (Figure 5). Final work elements entailed installing topsoil from station 1700 to 2000, refine channel grading to ensure design grade was met, and raking the work areas with the excavator bucket to decompact meadow soils (Figure 6 and Figure 7) and prep the site for riparian plantings. Heavy machinery work ended in early October with revegetation occurring throughout the month of October, and early November. YN personnel assisted TMS Native crew members with applying native seed mix and weed-free straw on all disturbed soils, and planted 150 containerized plants. Additional planting will occur in spring 2019.

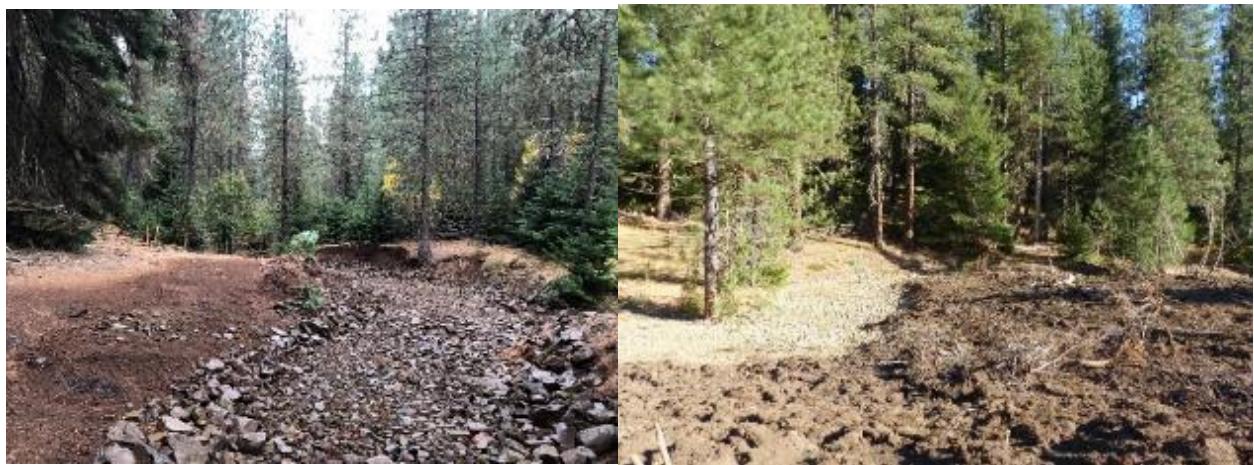
Figure 6. Channel conditions after Type 2 rock fill (left) and post de-compaction (right).

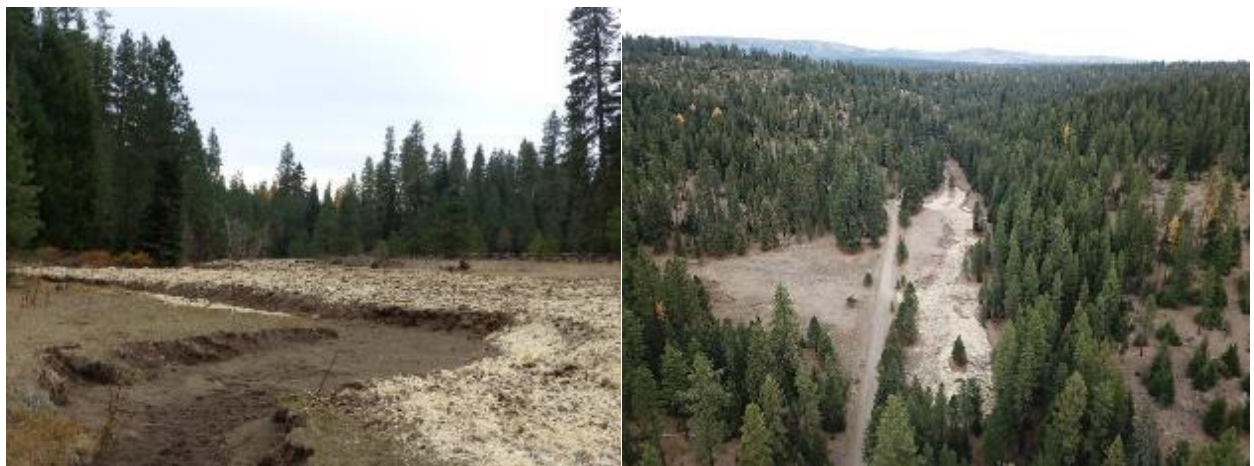
Figure 7. Topsoil placement upstream of station 1700 and aerial view of meadow post-construction.

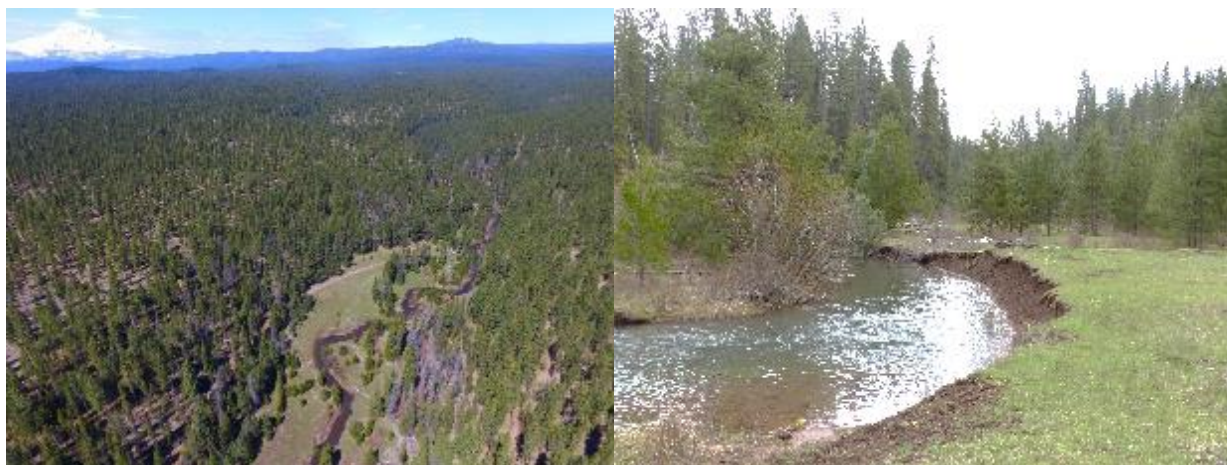
Figure 8. Pre-project photos of the overall project reach (left) and lateral channel migration occurring.

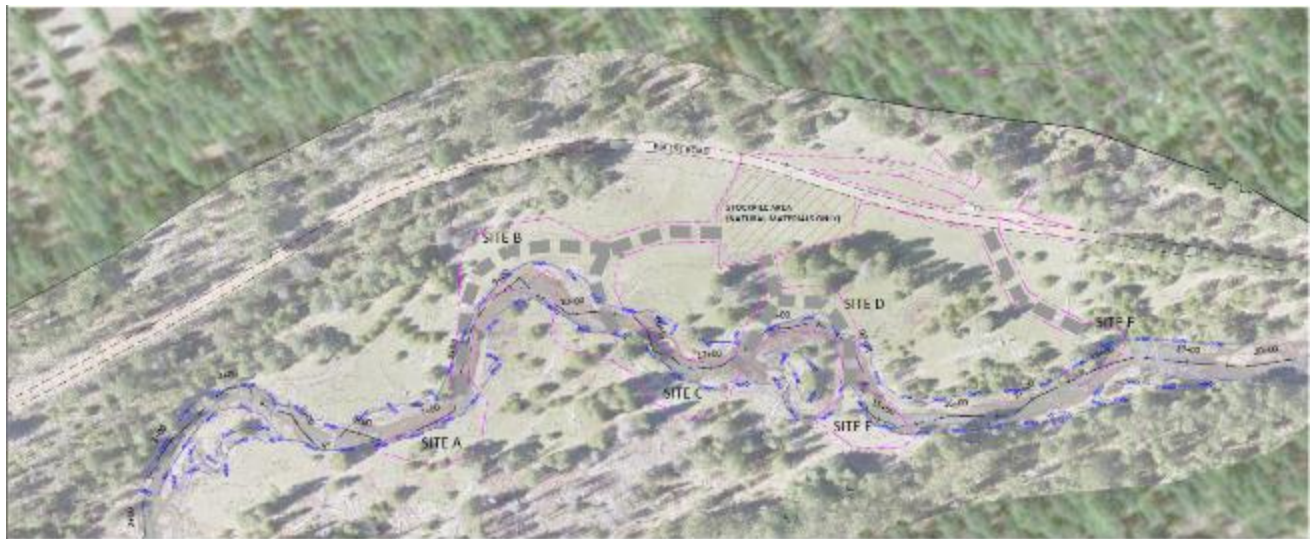
Figure 10. Aerial view of existing conditions and site access.

To enhance habitat further, existing pool areas will be excavated in areas associated with bank and valley-bottom excavation sites. Large wood will be placed to provide cover habitat over existing enhanced pools and within lowered segments of valley bottom to provide resiliency and roughness until wetland vegetation can become fully established (Figures 10, 11 and 12).

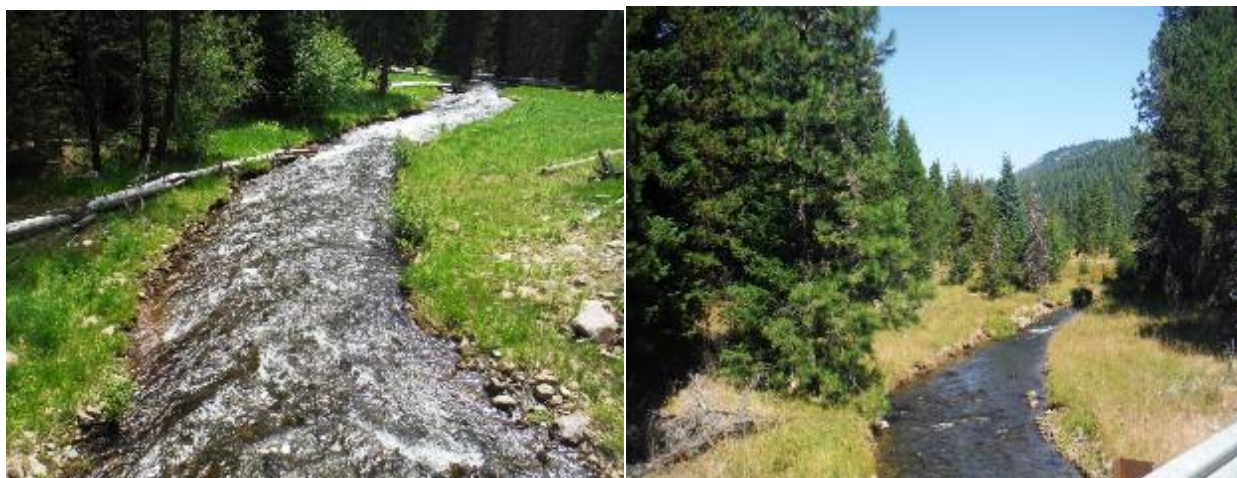
Figure 13. Upper Klickitat Phase 3 site conditions as observed May (left photo looking downstream) and August (right photo looking upstream) during 2018 monitoring visits.

All photos taken as part of photo-monitoring are saved digitally, filed electronically in subdirectories by their respective project name and stored on the KWEP server. Figure 2 and Figures 5-7 show examples of comparisons of pre- and post-project photo monitoring in the first section of this report, entitled the “Tributary Habitat Restoration and Protection”. Photos (Figure 13) from a recent visit at Upper Klickitat Phase 3 document 2018 conditions.

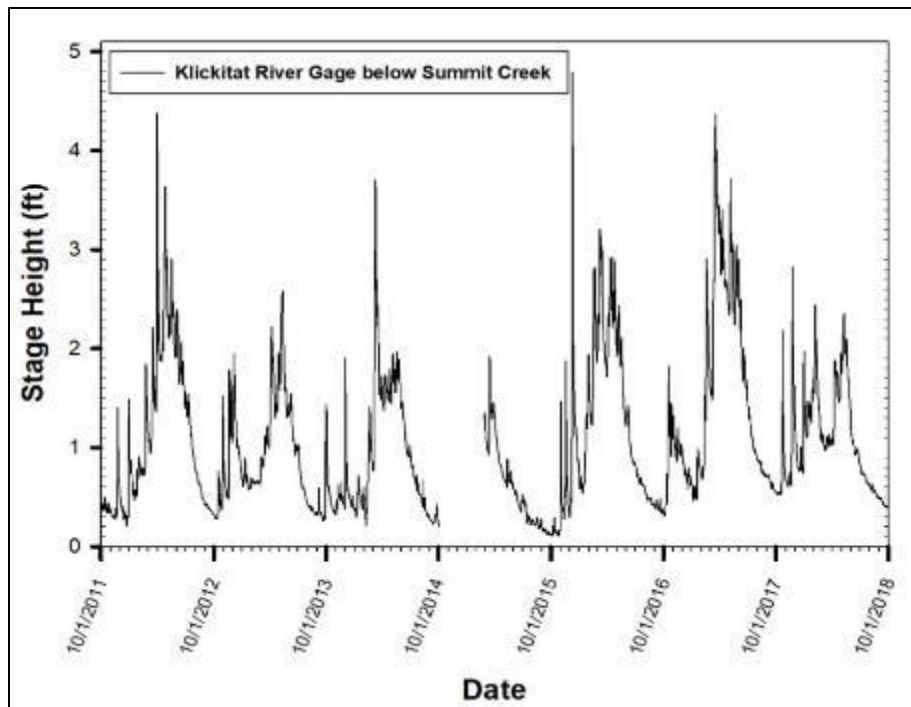
Figure 16. Klickitat River stage at the gaging site downstream of the mouth of Summit Creek for water years 2012 through 2018.

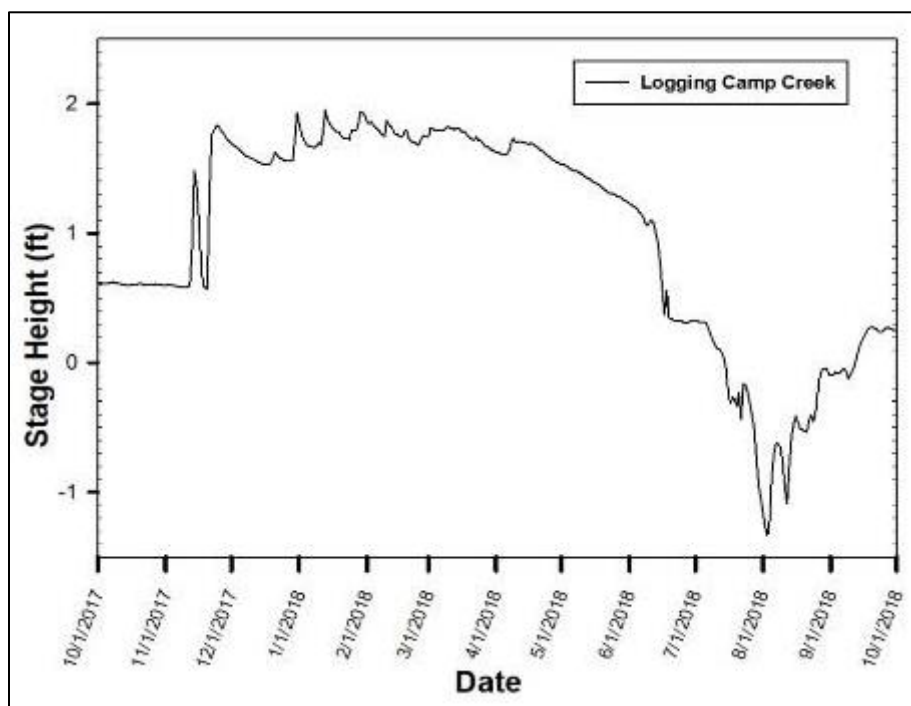
Figure 17. Logging Camp Creek stage at the gaging site near the confluence with the Klickitat River for water year 2018.

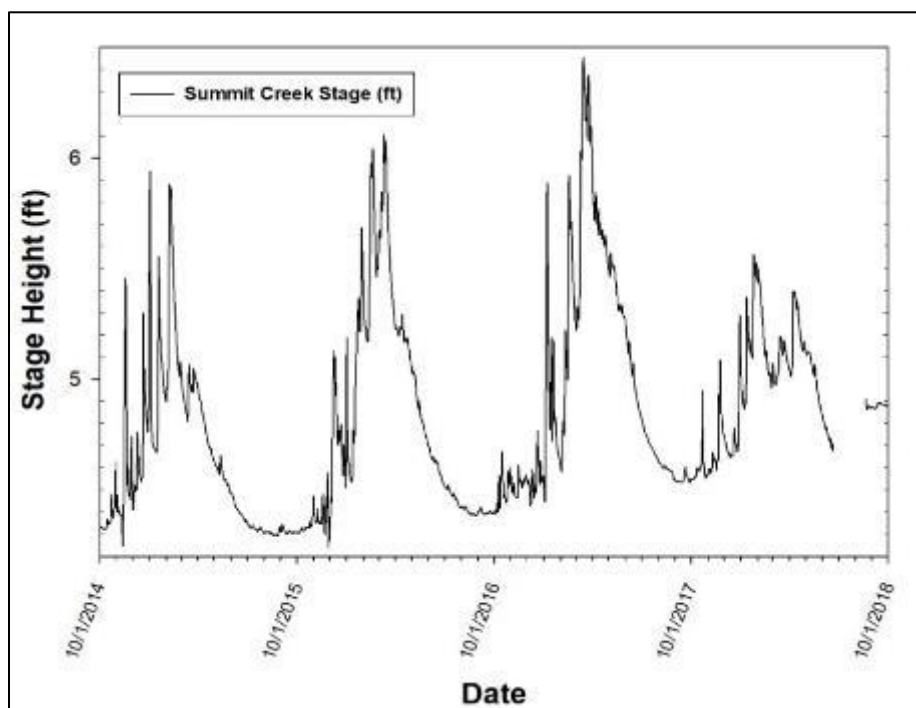
Figure 19. Summit Creek stage at the gaging site near the confluence with the Klickitat River for water years 2015 through 2018.

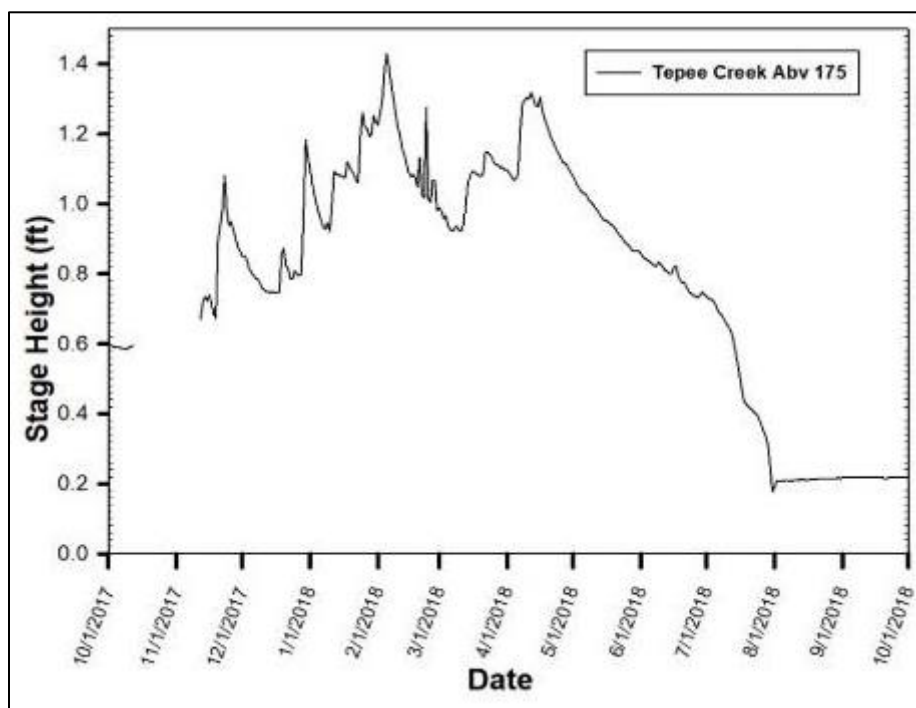
Figure 21. Tepee Creek stage at the gaging site above the 175 Road for water year 2018.

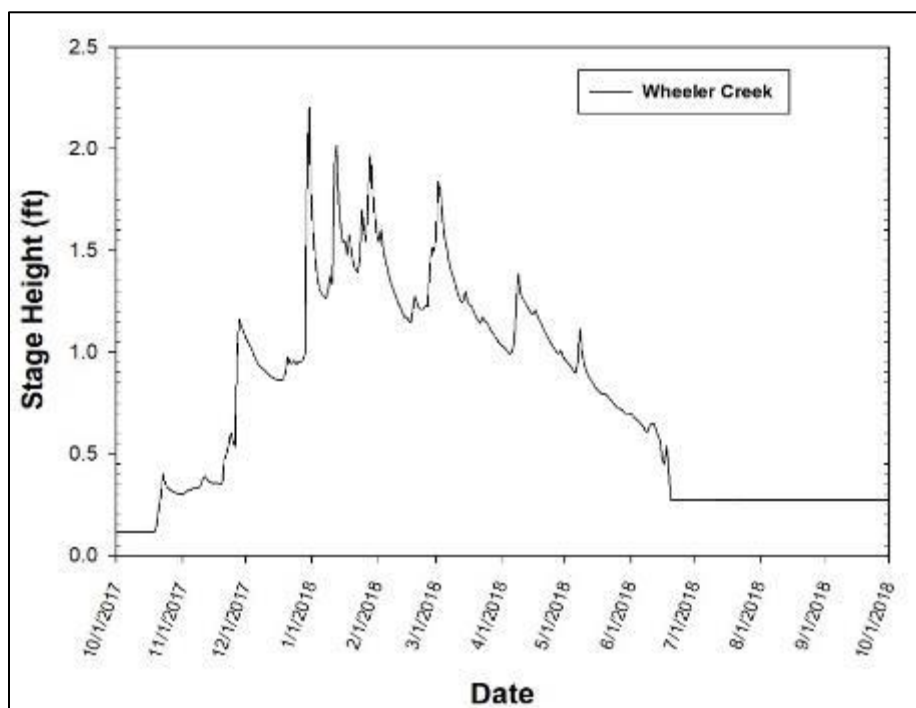
Figure 23. Wheeler Creek stage at the gaging site near the confluence with the Klickitat River for water year 2018.

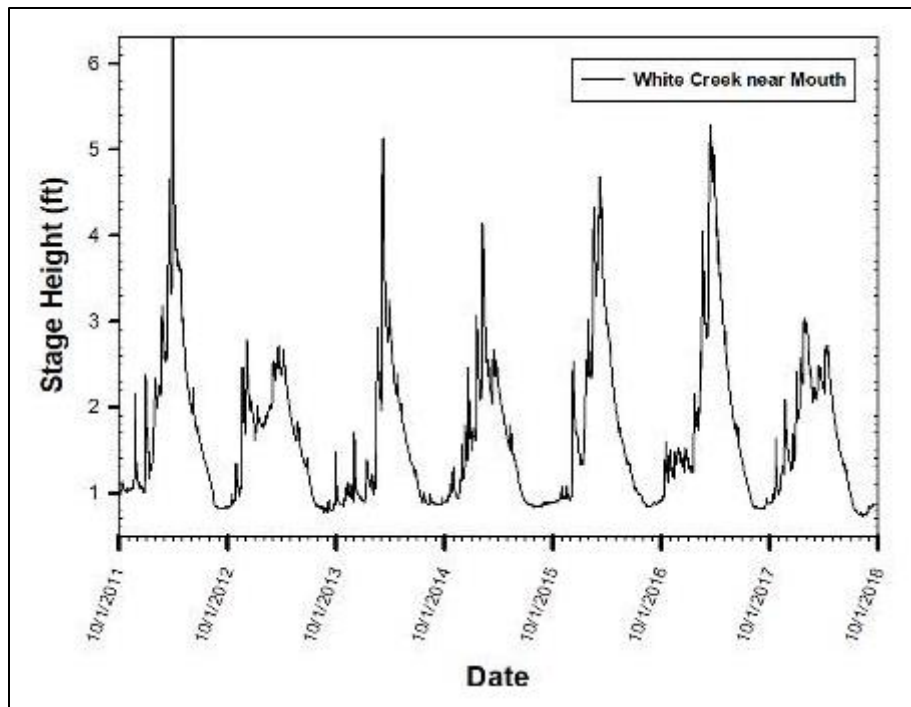
Figure 24. White Creek stage at the gaging site near the confluence with the Klickitat River for water years 2012 through 2018.

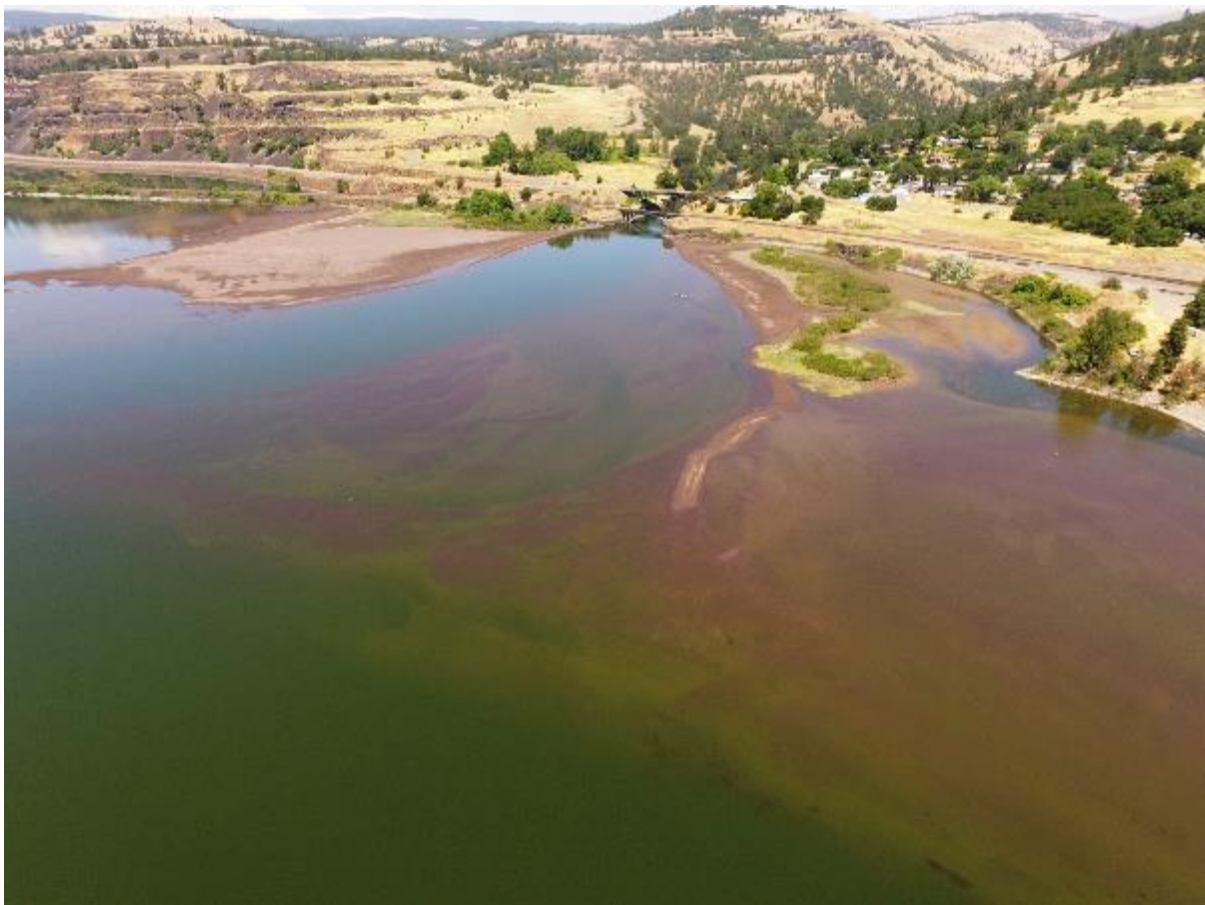
Figure 28. Aerial view of Klickitat River Delta under low Bonneville Pool conditions as observed on June 19, 2018.

During the 2018 reporting period, the sensor array installed in August of 2009 operated intermittently due to a failed sensor that occurred in the spring under high-flow conditions that prohibited safe access. Data collection monitored via a File Transfer Protocol (FTP) site provides KWEP staff with remote access from the Klickitat Field Office. KWEP staff occasionally observed discrepancies, errors, data gaps, or non-reporting that dictated site visits for troubleshooting purposes. Additional site visits enable the collection of staff gage observations during a range of water elevations to establish stage reference points. These reference points are used to quality-control data collected by deployed sensors. The configuration of landforms at the confluence changes constantly because of high flows and depositional patterns (Figure 28).

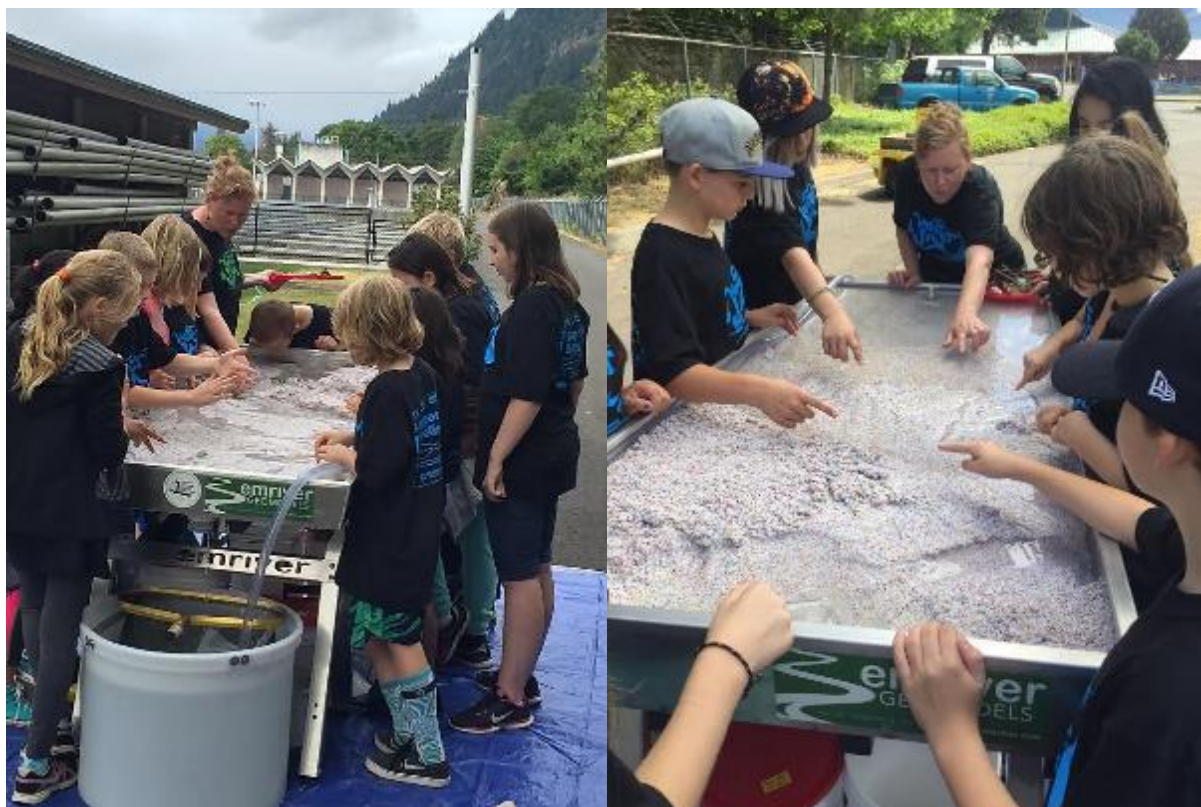
Figure 29. Stream table demonstration at Water Jam, the culminating event of the “Salmon in the Classroom” Program.

The Em2 Stream Demonstration Table purchased in 2016 assisted with visualization of basic principles of river behavior, channel morphology, and sediment transport processes. The stream table is central to the demonstration and educational content of curriculum presented to students from area schools. These outreach events facilitated interaction with approximately six hundred students and tens of adults via the Pathfinder Outdoor School, Camp Cowabunga and Water Jam (Figure 19). Curriculum focuses on watershed processes and their influence on aquatic fisheries habitat.
