**Yakama Nation**

**Upper Columbia Habitat Restoration Project**

**ANNUAL REPORT**

REPORT COVERS WORK FROM JANUARY 1<sup>ST</sup>, 2018 THROUGH DECEMBER 31<sup>ST</sup>, 2018

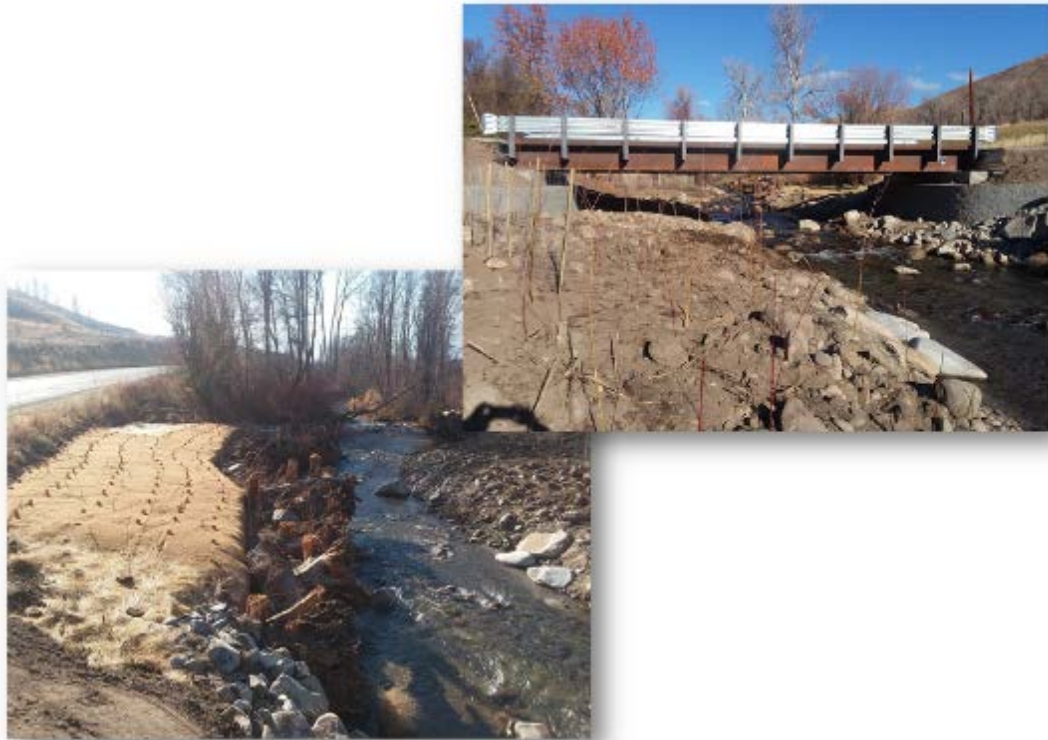
Replacement of an undersized 40 foot span bridge with a 55 foot span bridge that allowed removal of 700 cubic yards of artificial floodplain fill.

Excavation of a new 2 year inundation floodplain bench on the right bank of the creek.

Intensive native vegetation restoration to restore shading and future wood recruitment into Beaver Creek.

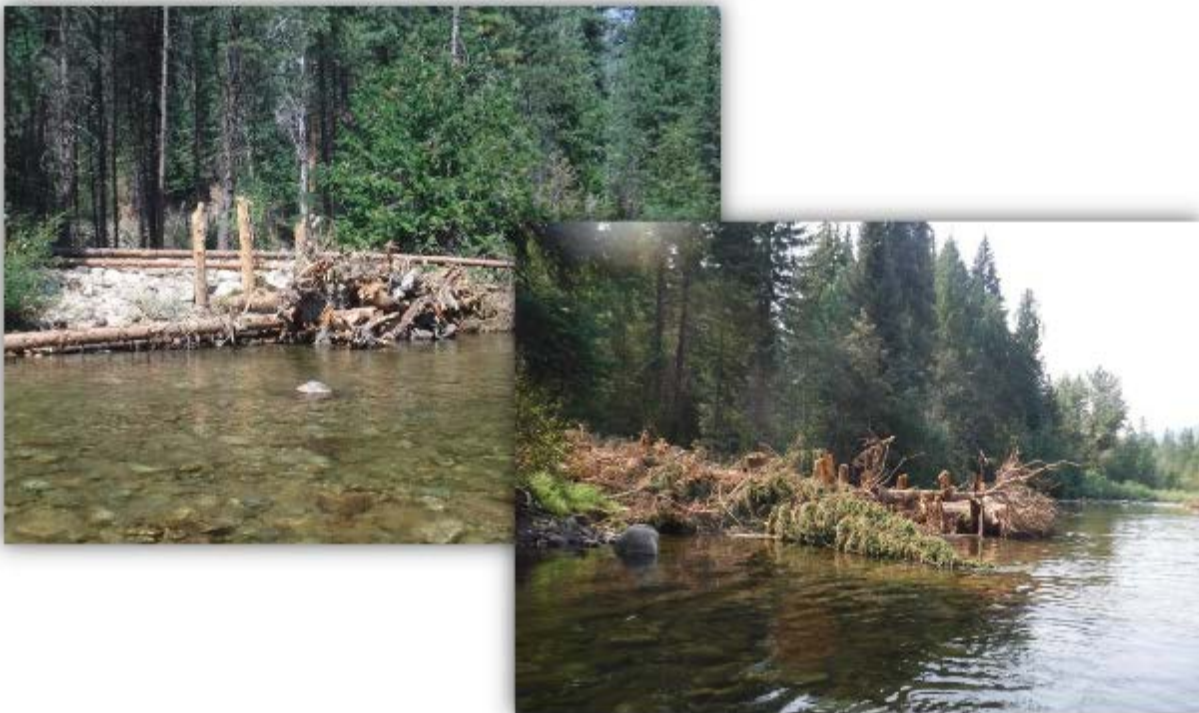
Two main channel large wood structures installed to promote lateral channel migration, natural wood recruitment, and increased floodplain inundation.

Two whole trees placed in an existing side channel to provide increased cover habitat.

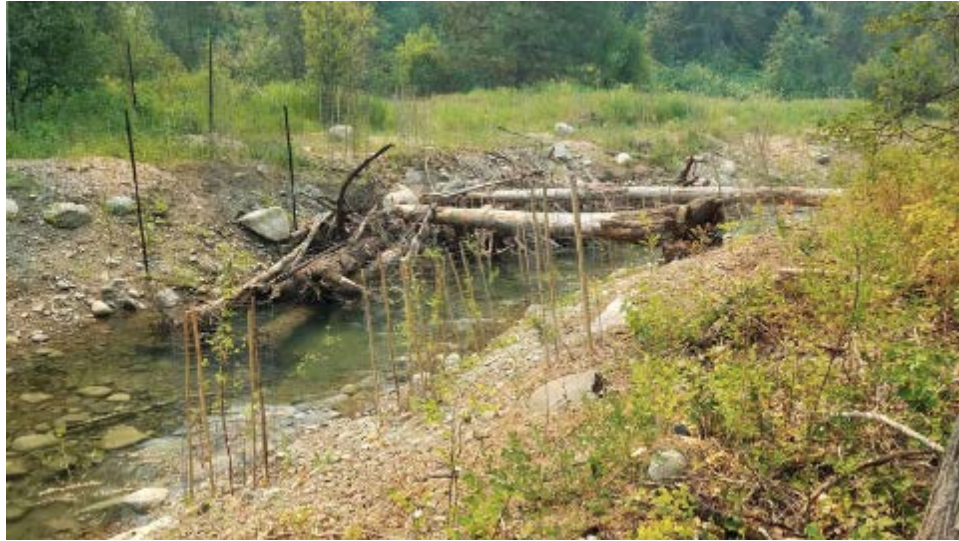
Two main channel margin large wood structures were installed to create bank margin complexity and promote scour pools in the bed of the Twisp River.

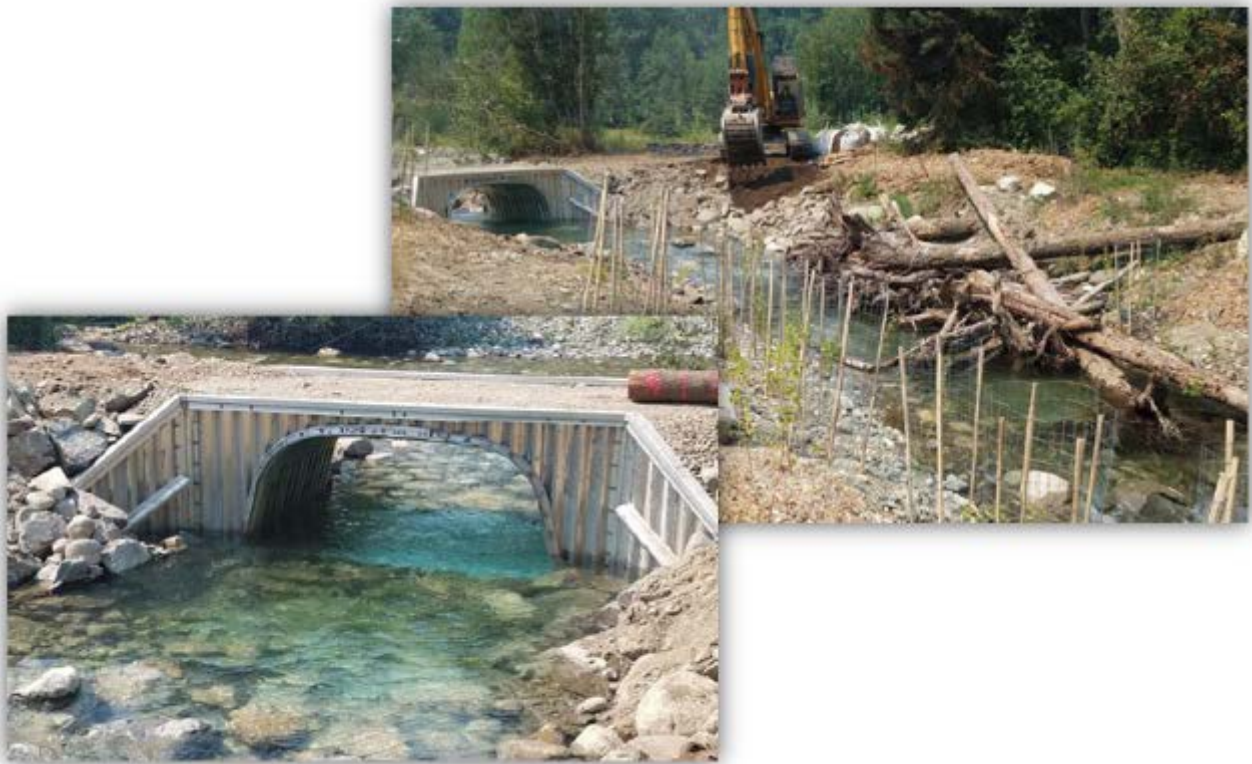
Five hundred feet of perennial flow through side channel was created.

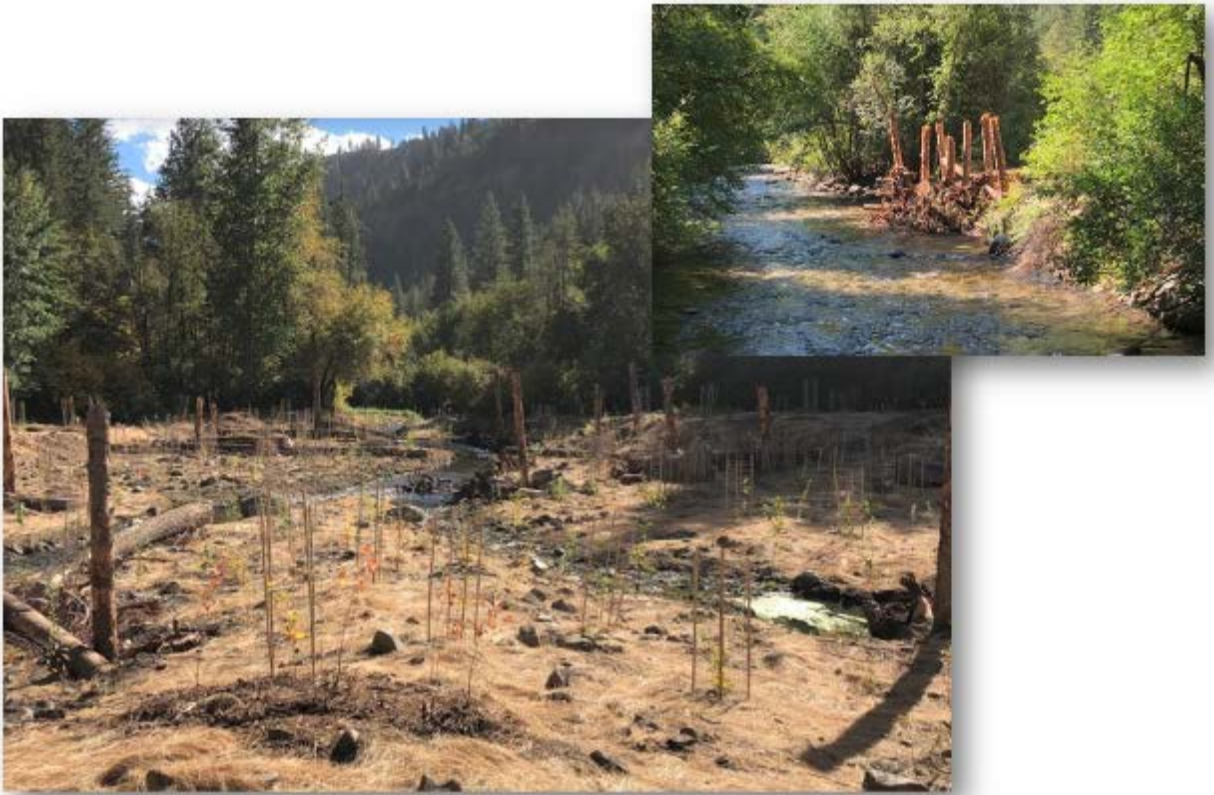
One groundwater fed side channel within the alluvial fan of Tillicum Creek.

Reconstruction of 2.25 acres of alluvial fan floodplain with extensive native plant restoration.

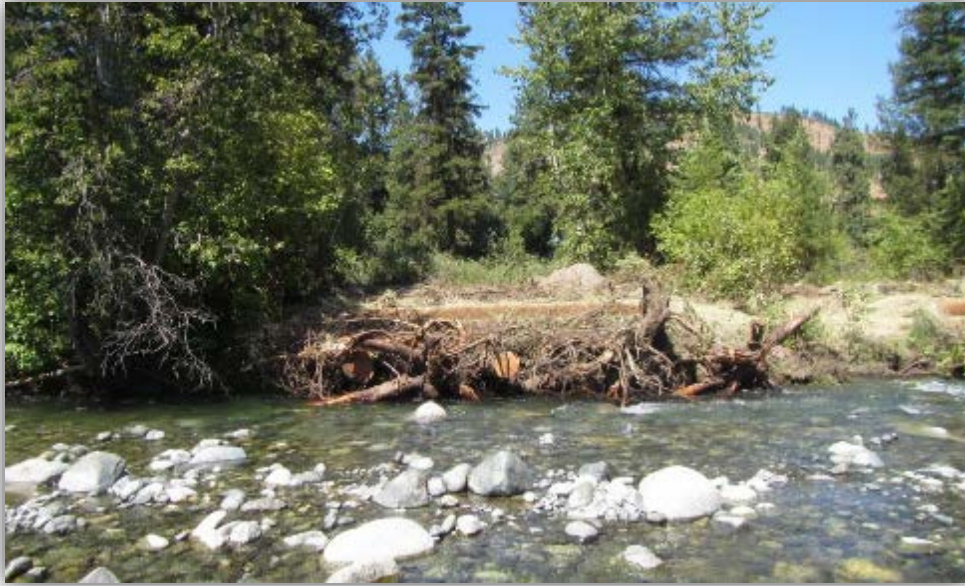
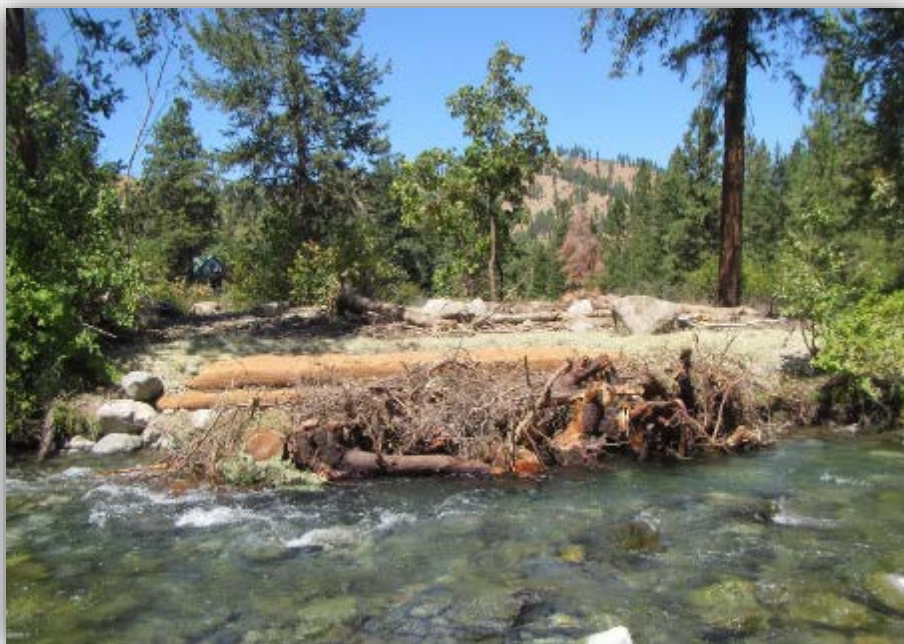
Five partially buried bank log structures were installed for cover habitat and to promote retention of scour pools in the bed of the Peshastin Creek.
