Rebuilding the Little Naches River: locally-sourced wood, balanced cut/fill and drone-assisted monitoring

Little Naches River

Intuitive innovation:
 Programmatic
 Environmental Compliance
 allows for balanced cut/fill

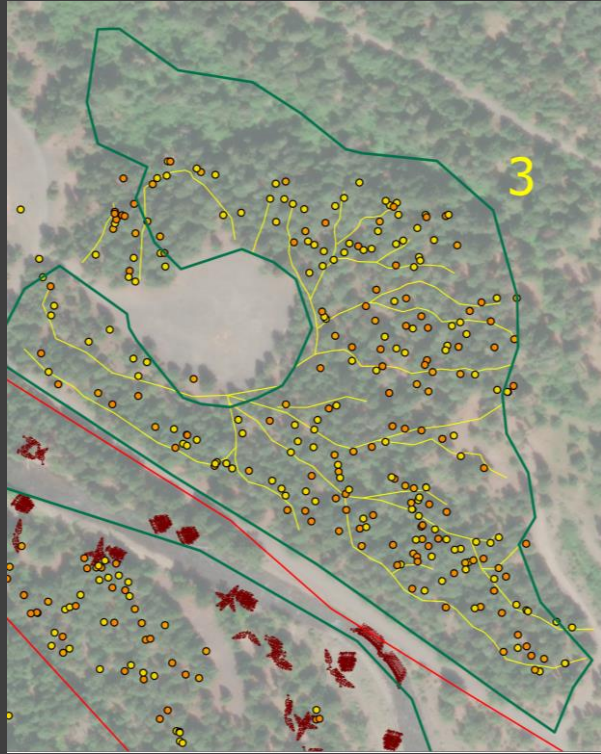
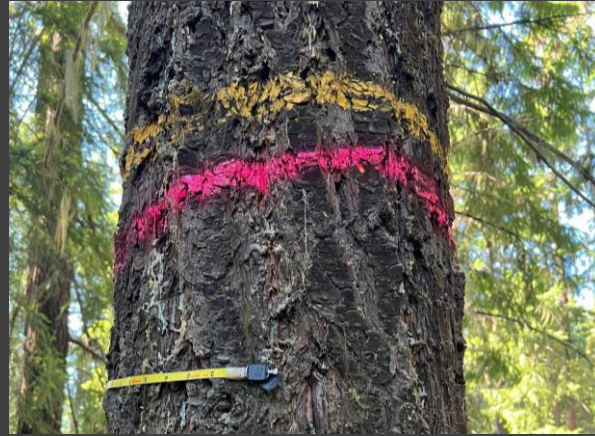
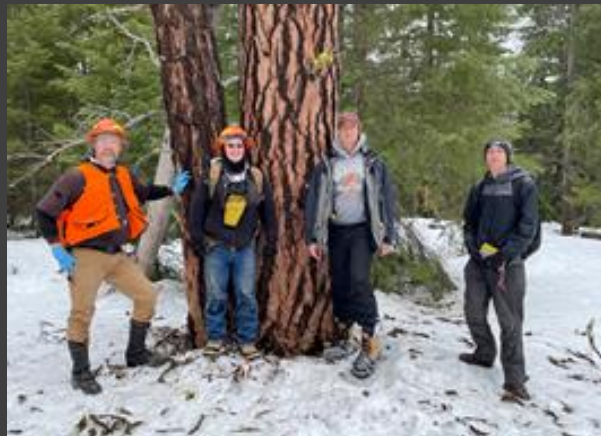
On Site Tree Harvest:

- Collaboration with partners: silviculturist, forester and biologist
- Tree acquisition, a project of its own
- Ongoing access to available wood throughout construction
- Close access, improved efficiencies
- Mapping aided both contractor and project managers
- Tree marking for quick identification: tipping and staging

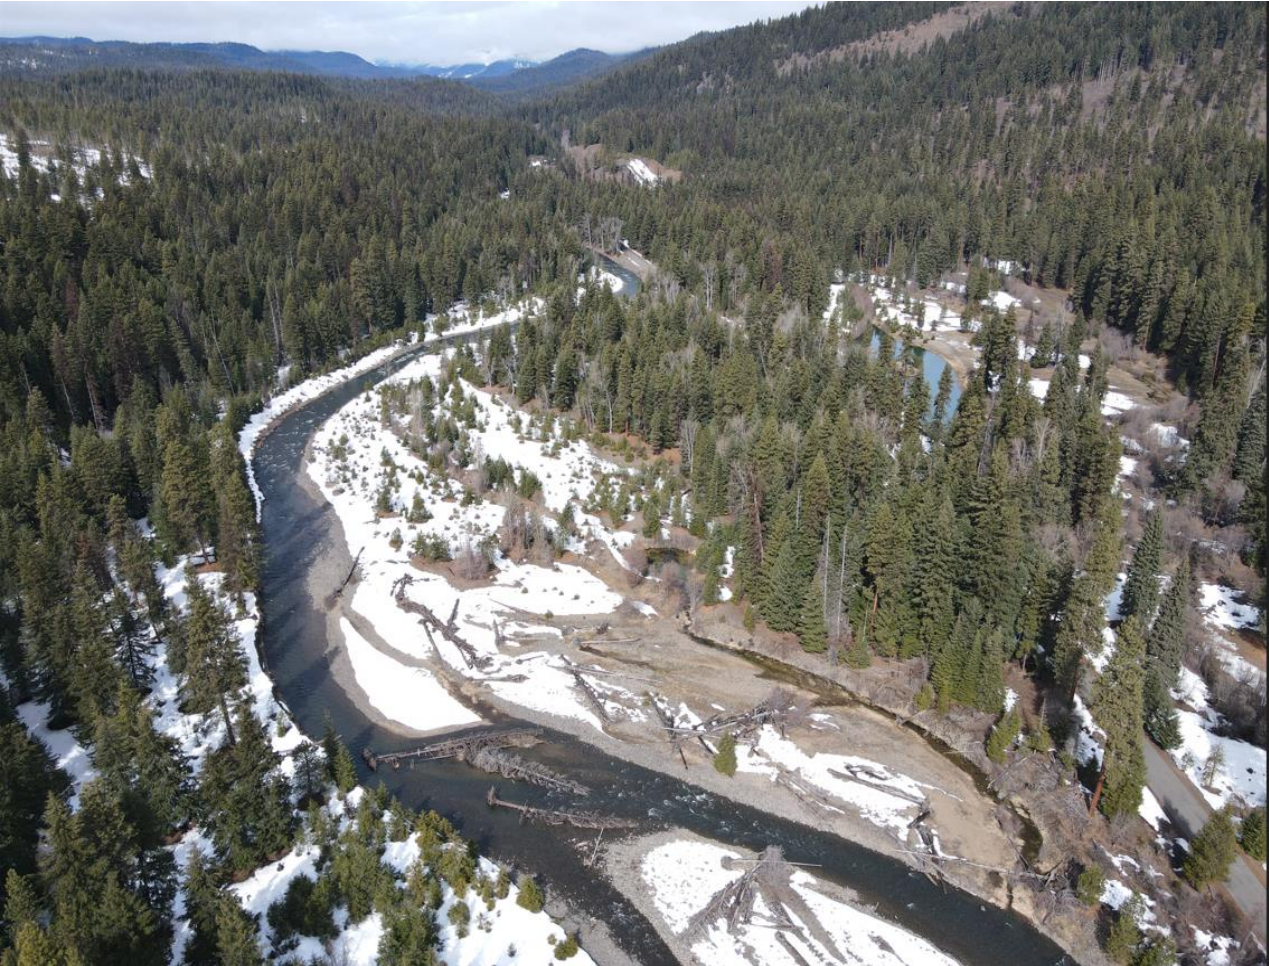
March 22, 2022

Pre-Project
~260 cfs

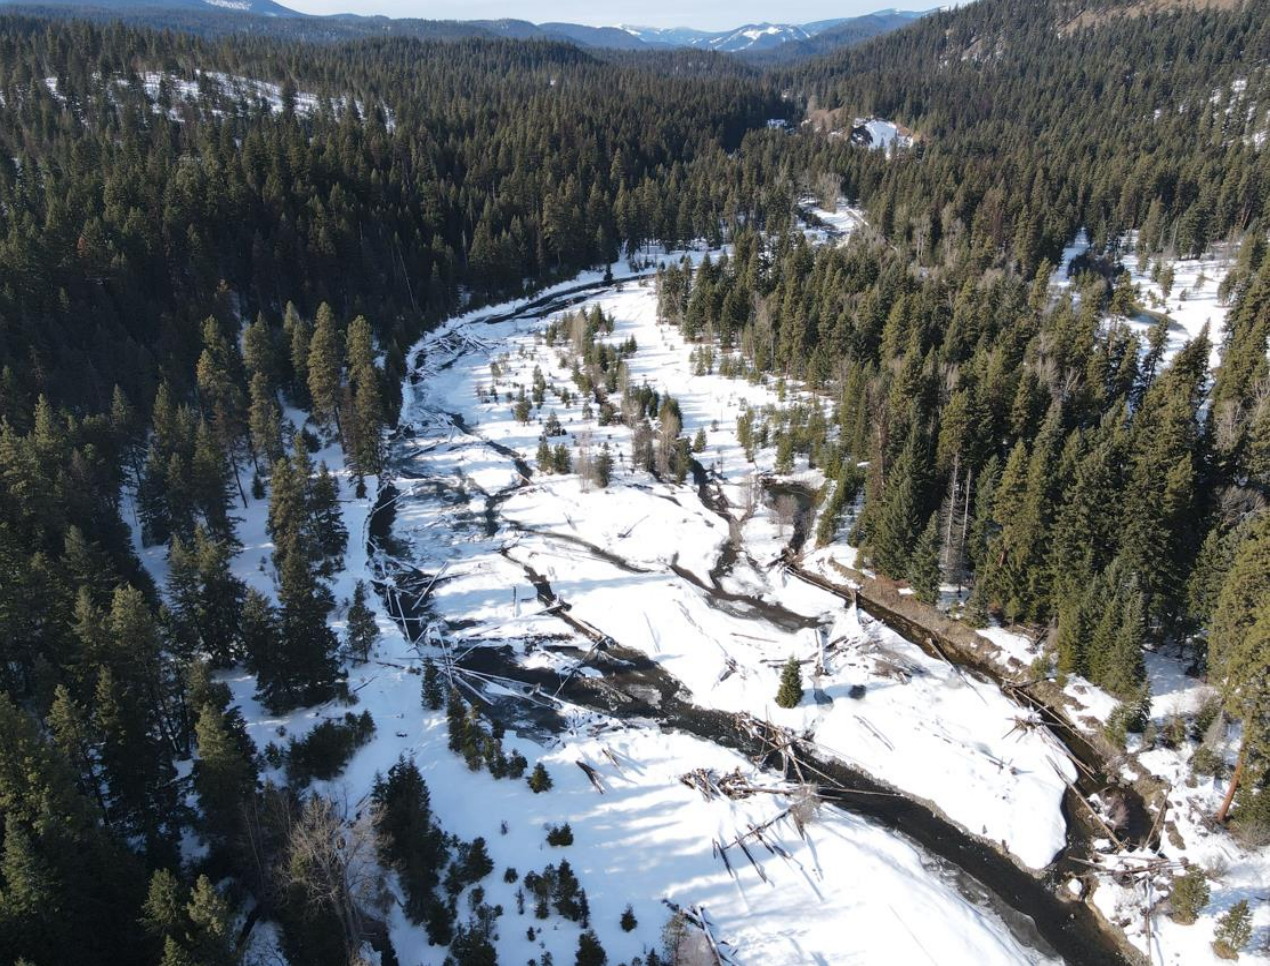
February 2, 2023

Post Project
~162 cfs

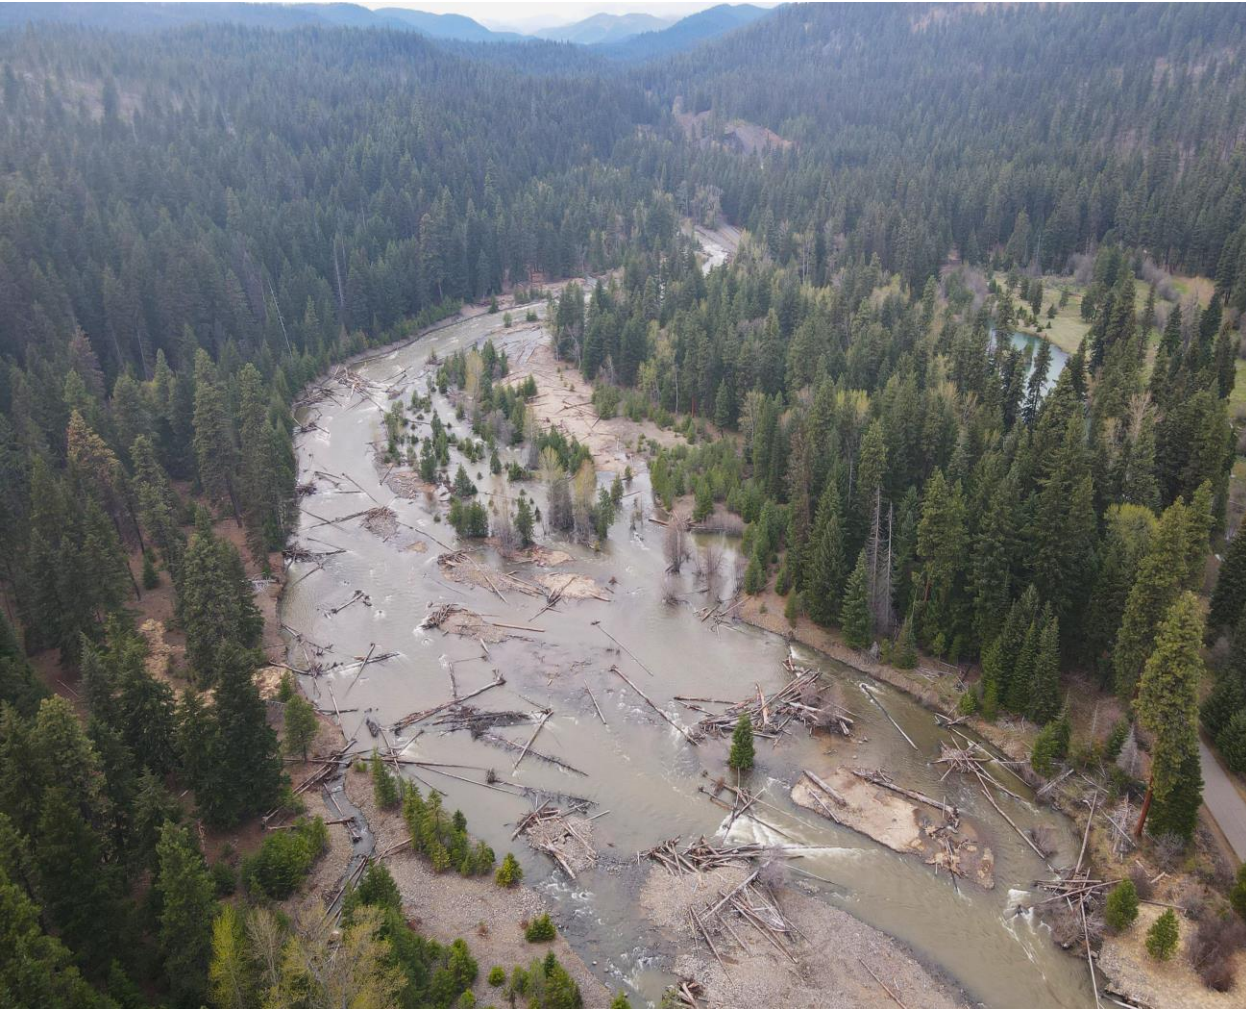
May 5, 2023

**5-year flow event
~1987 cfs**

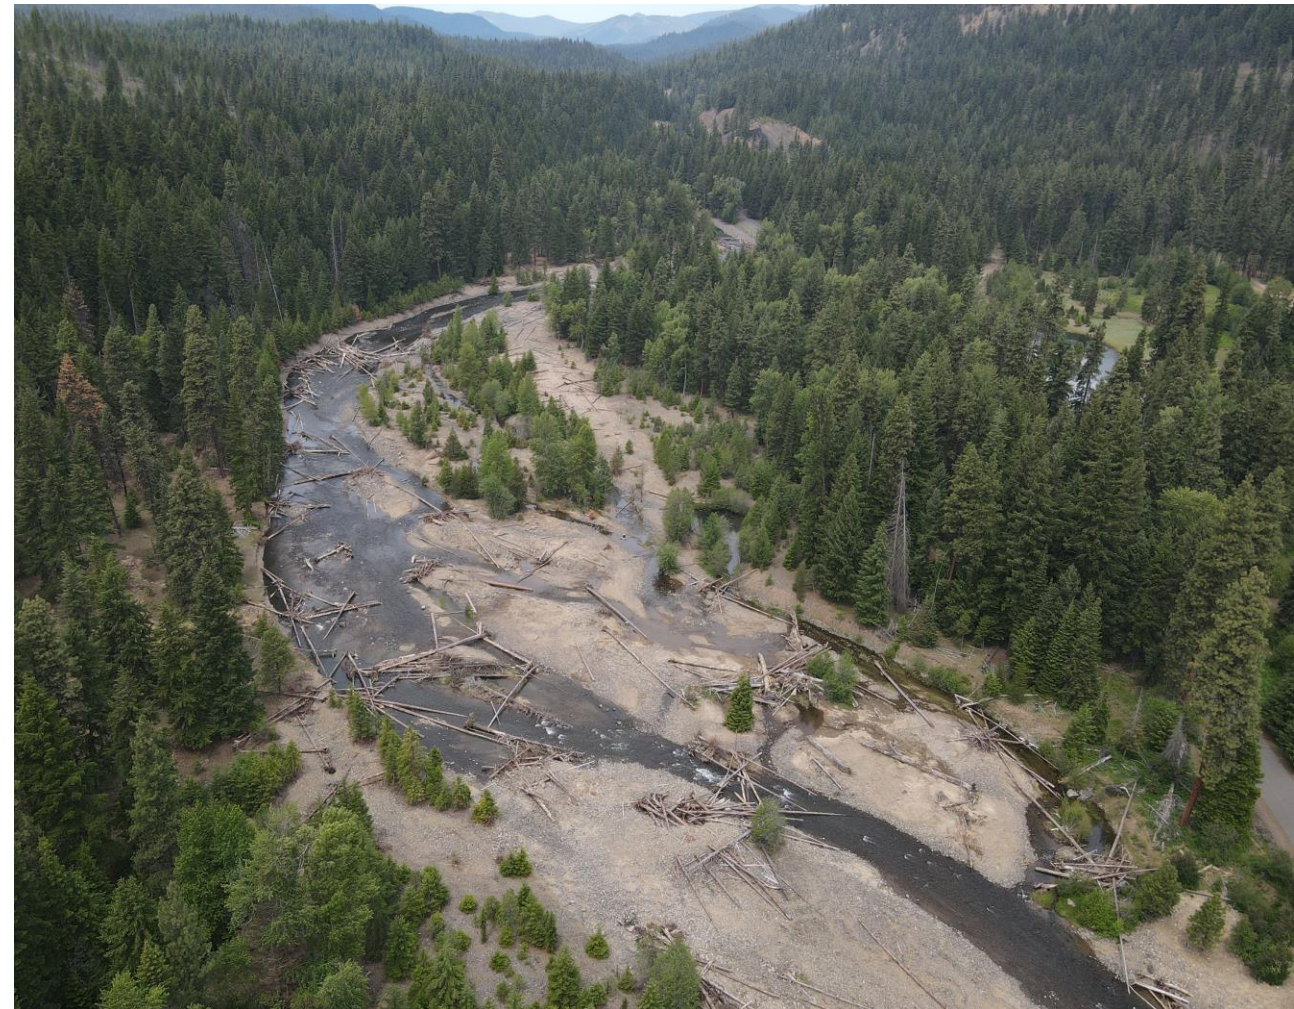
June 7, 2023

**Current Status
~ 158 cfs**

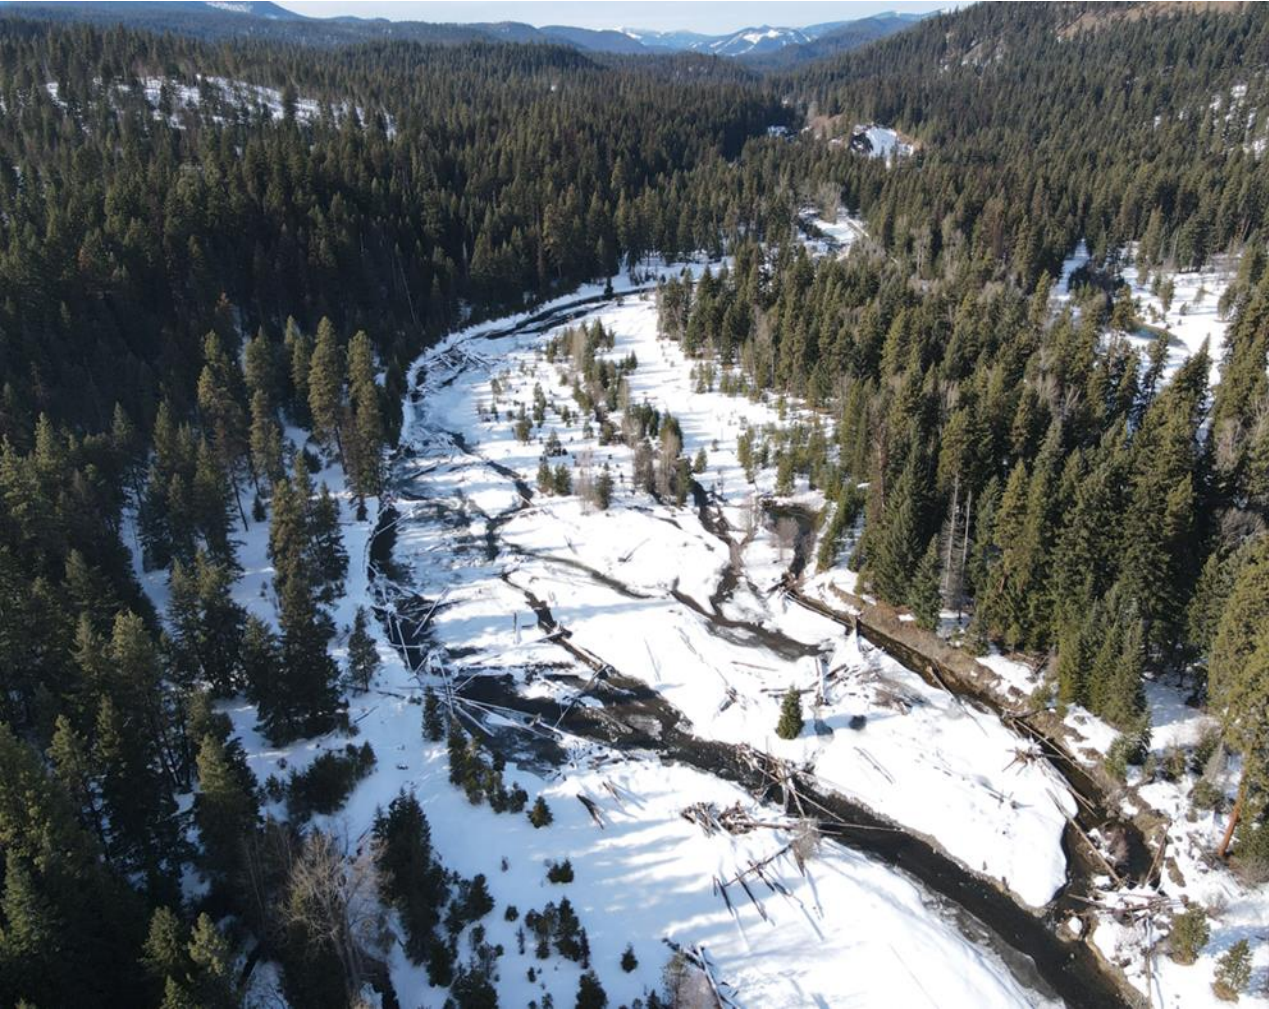
Feb 2, 2023

Winter 2023
~162 cfs

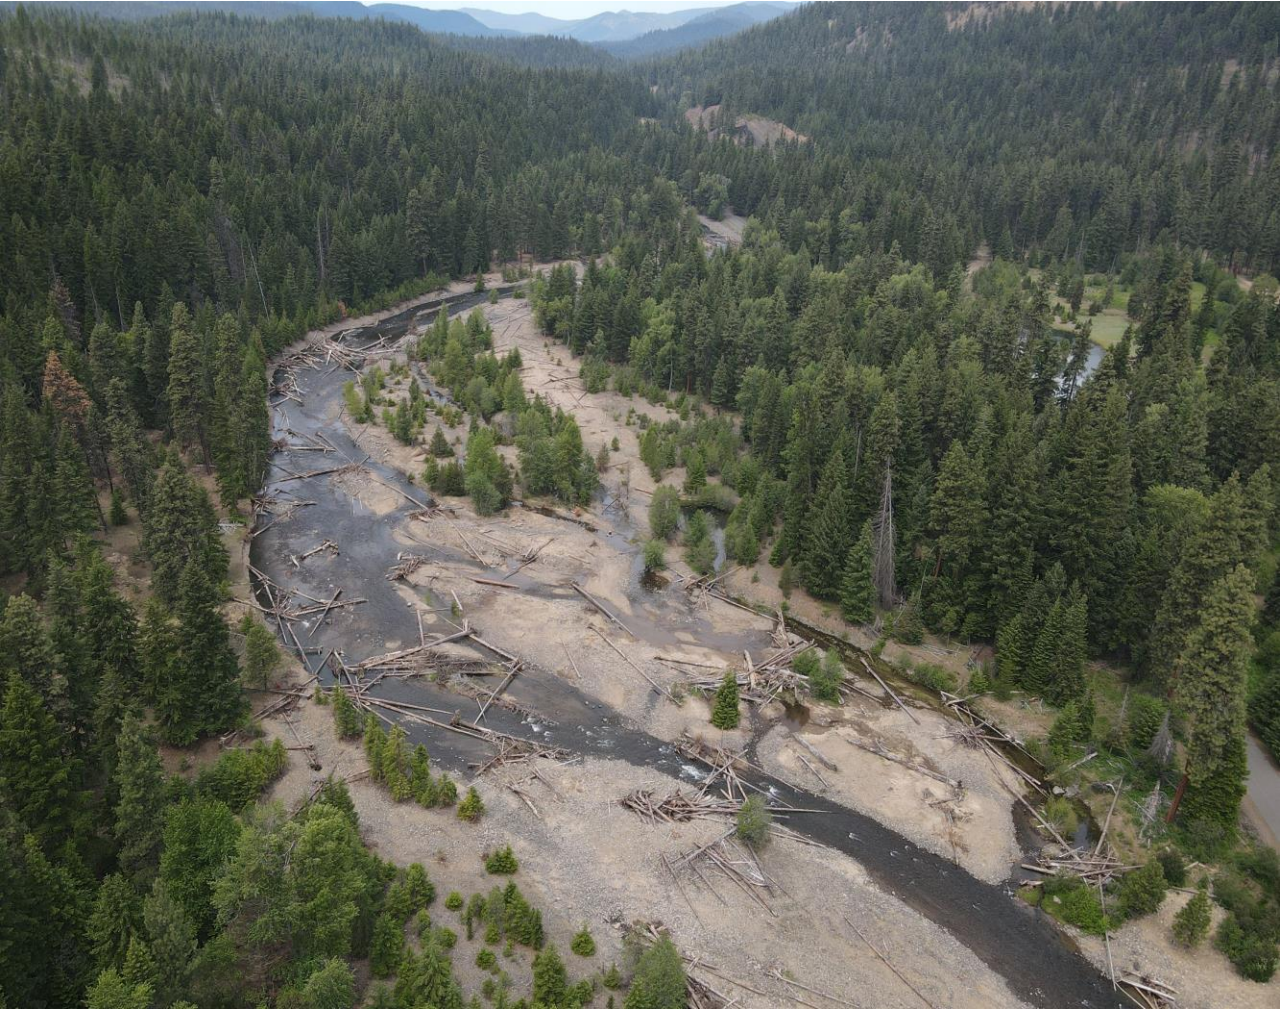
June 7, 2023

Current Status
~ 158 cfs

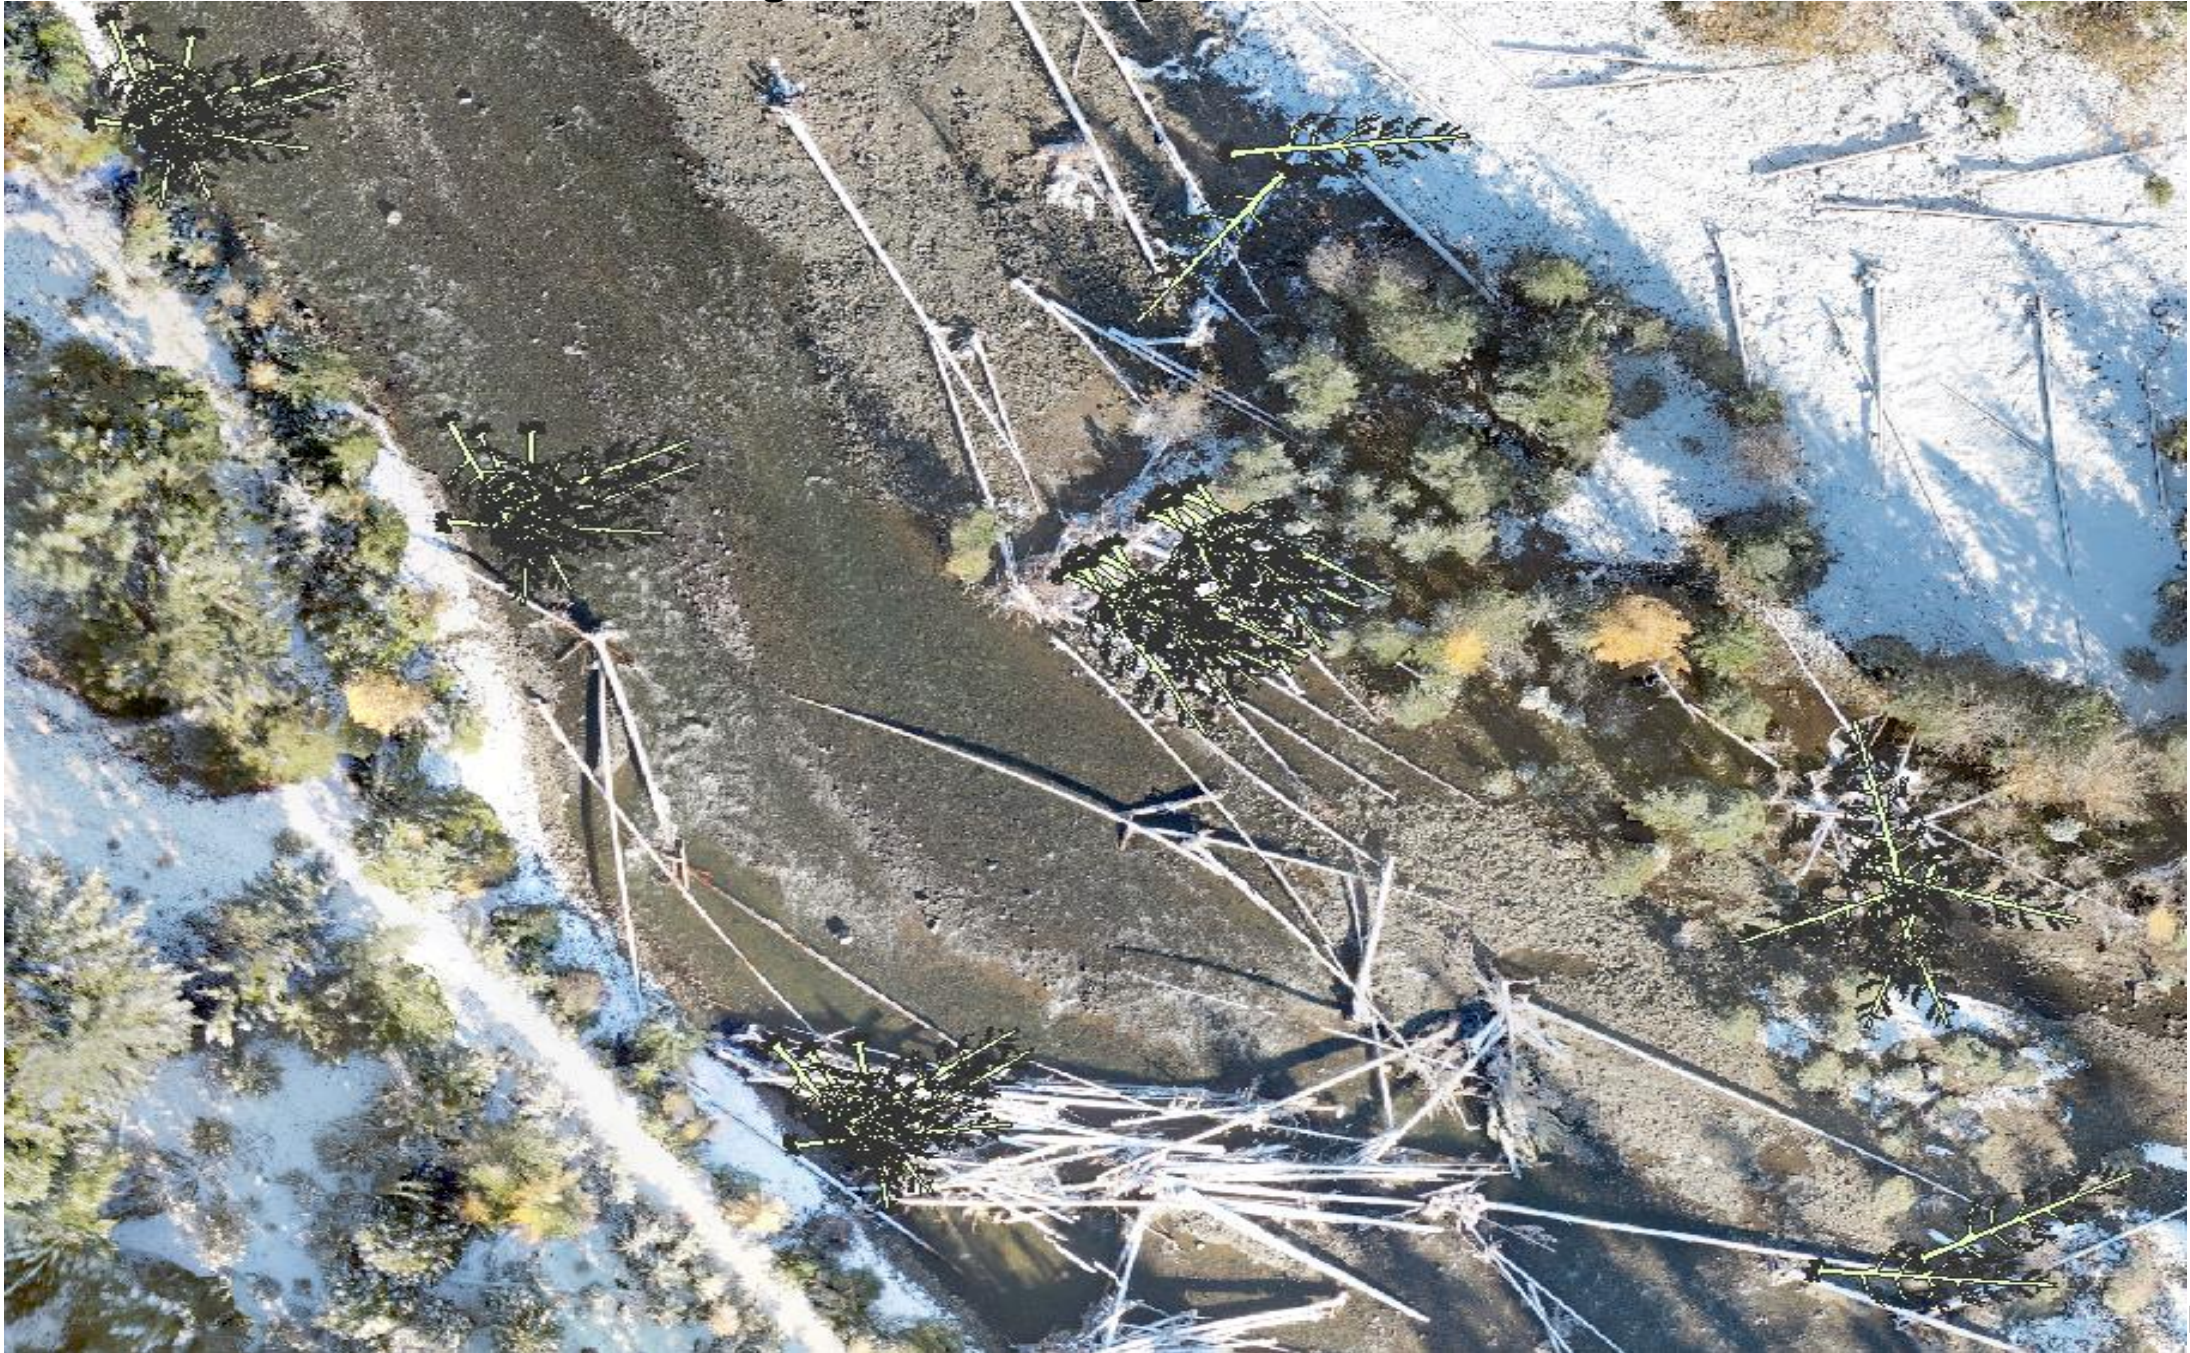
February 2, 2023

Log Jam Monitoring

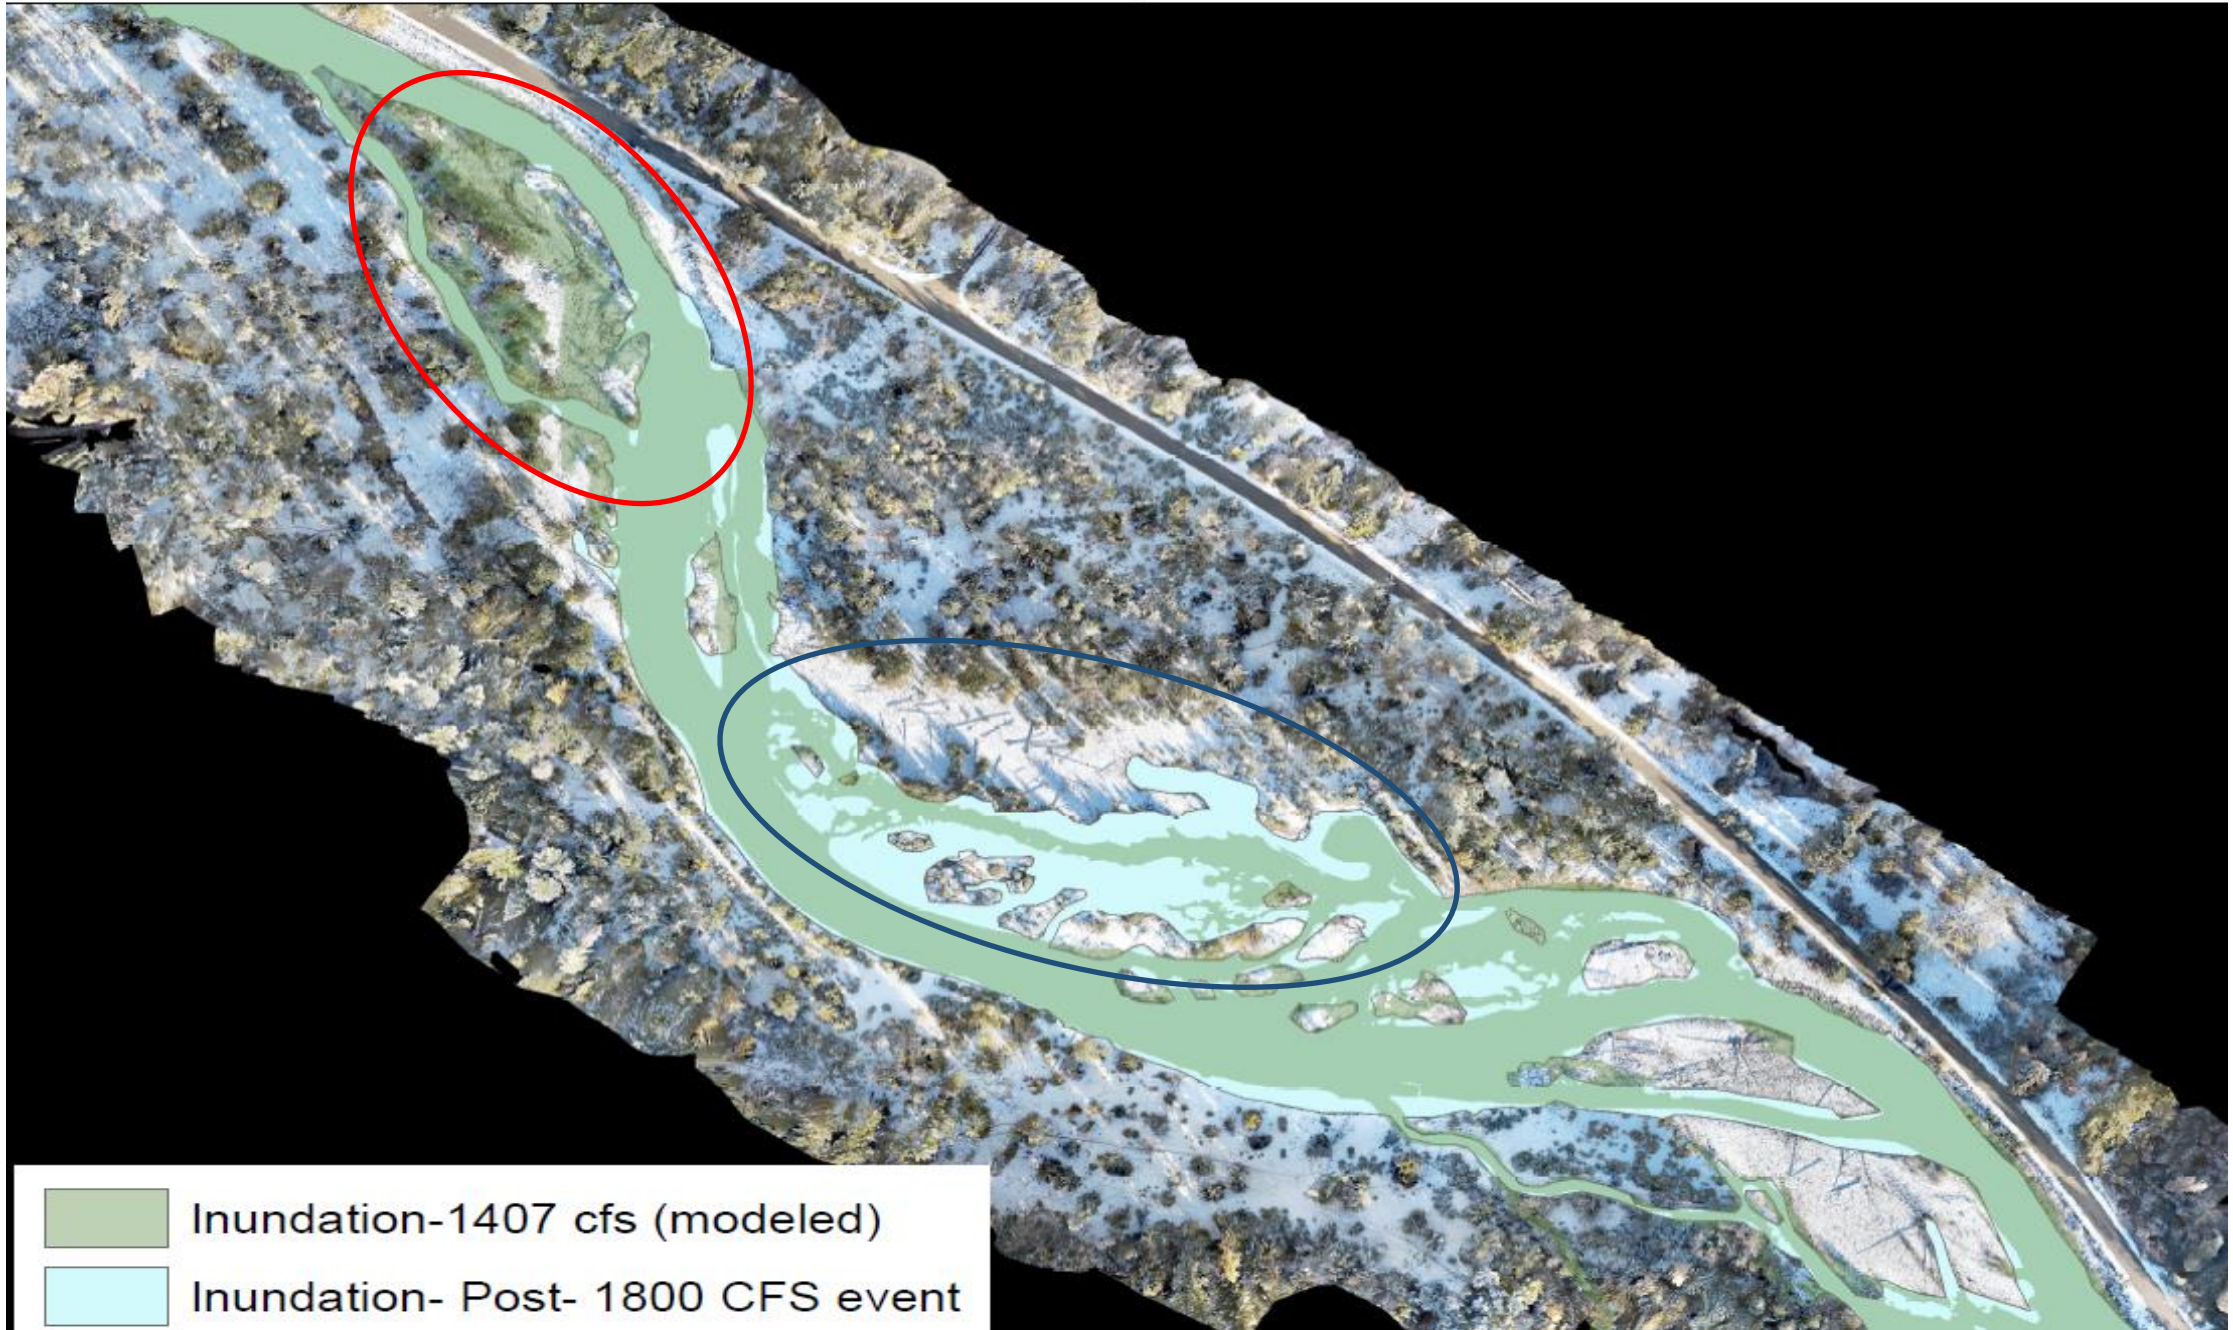
2-year Event Model Comparison

Inundation-1407 cfs (modeled)

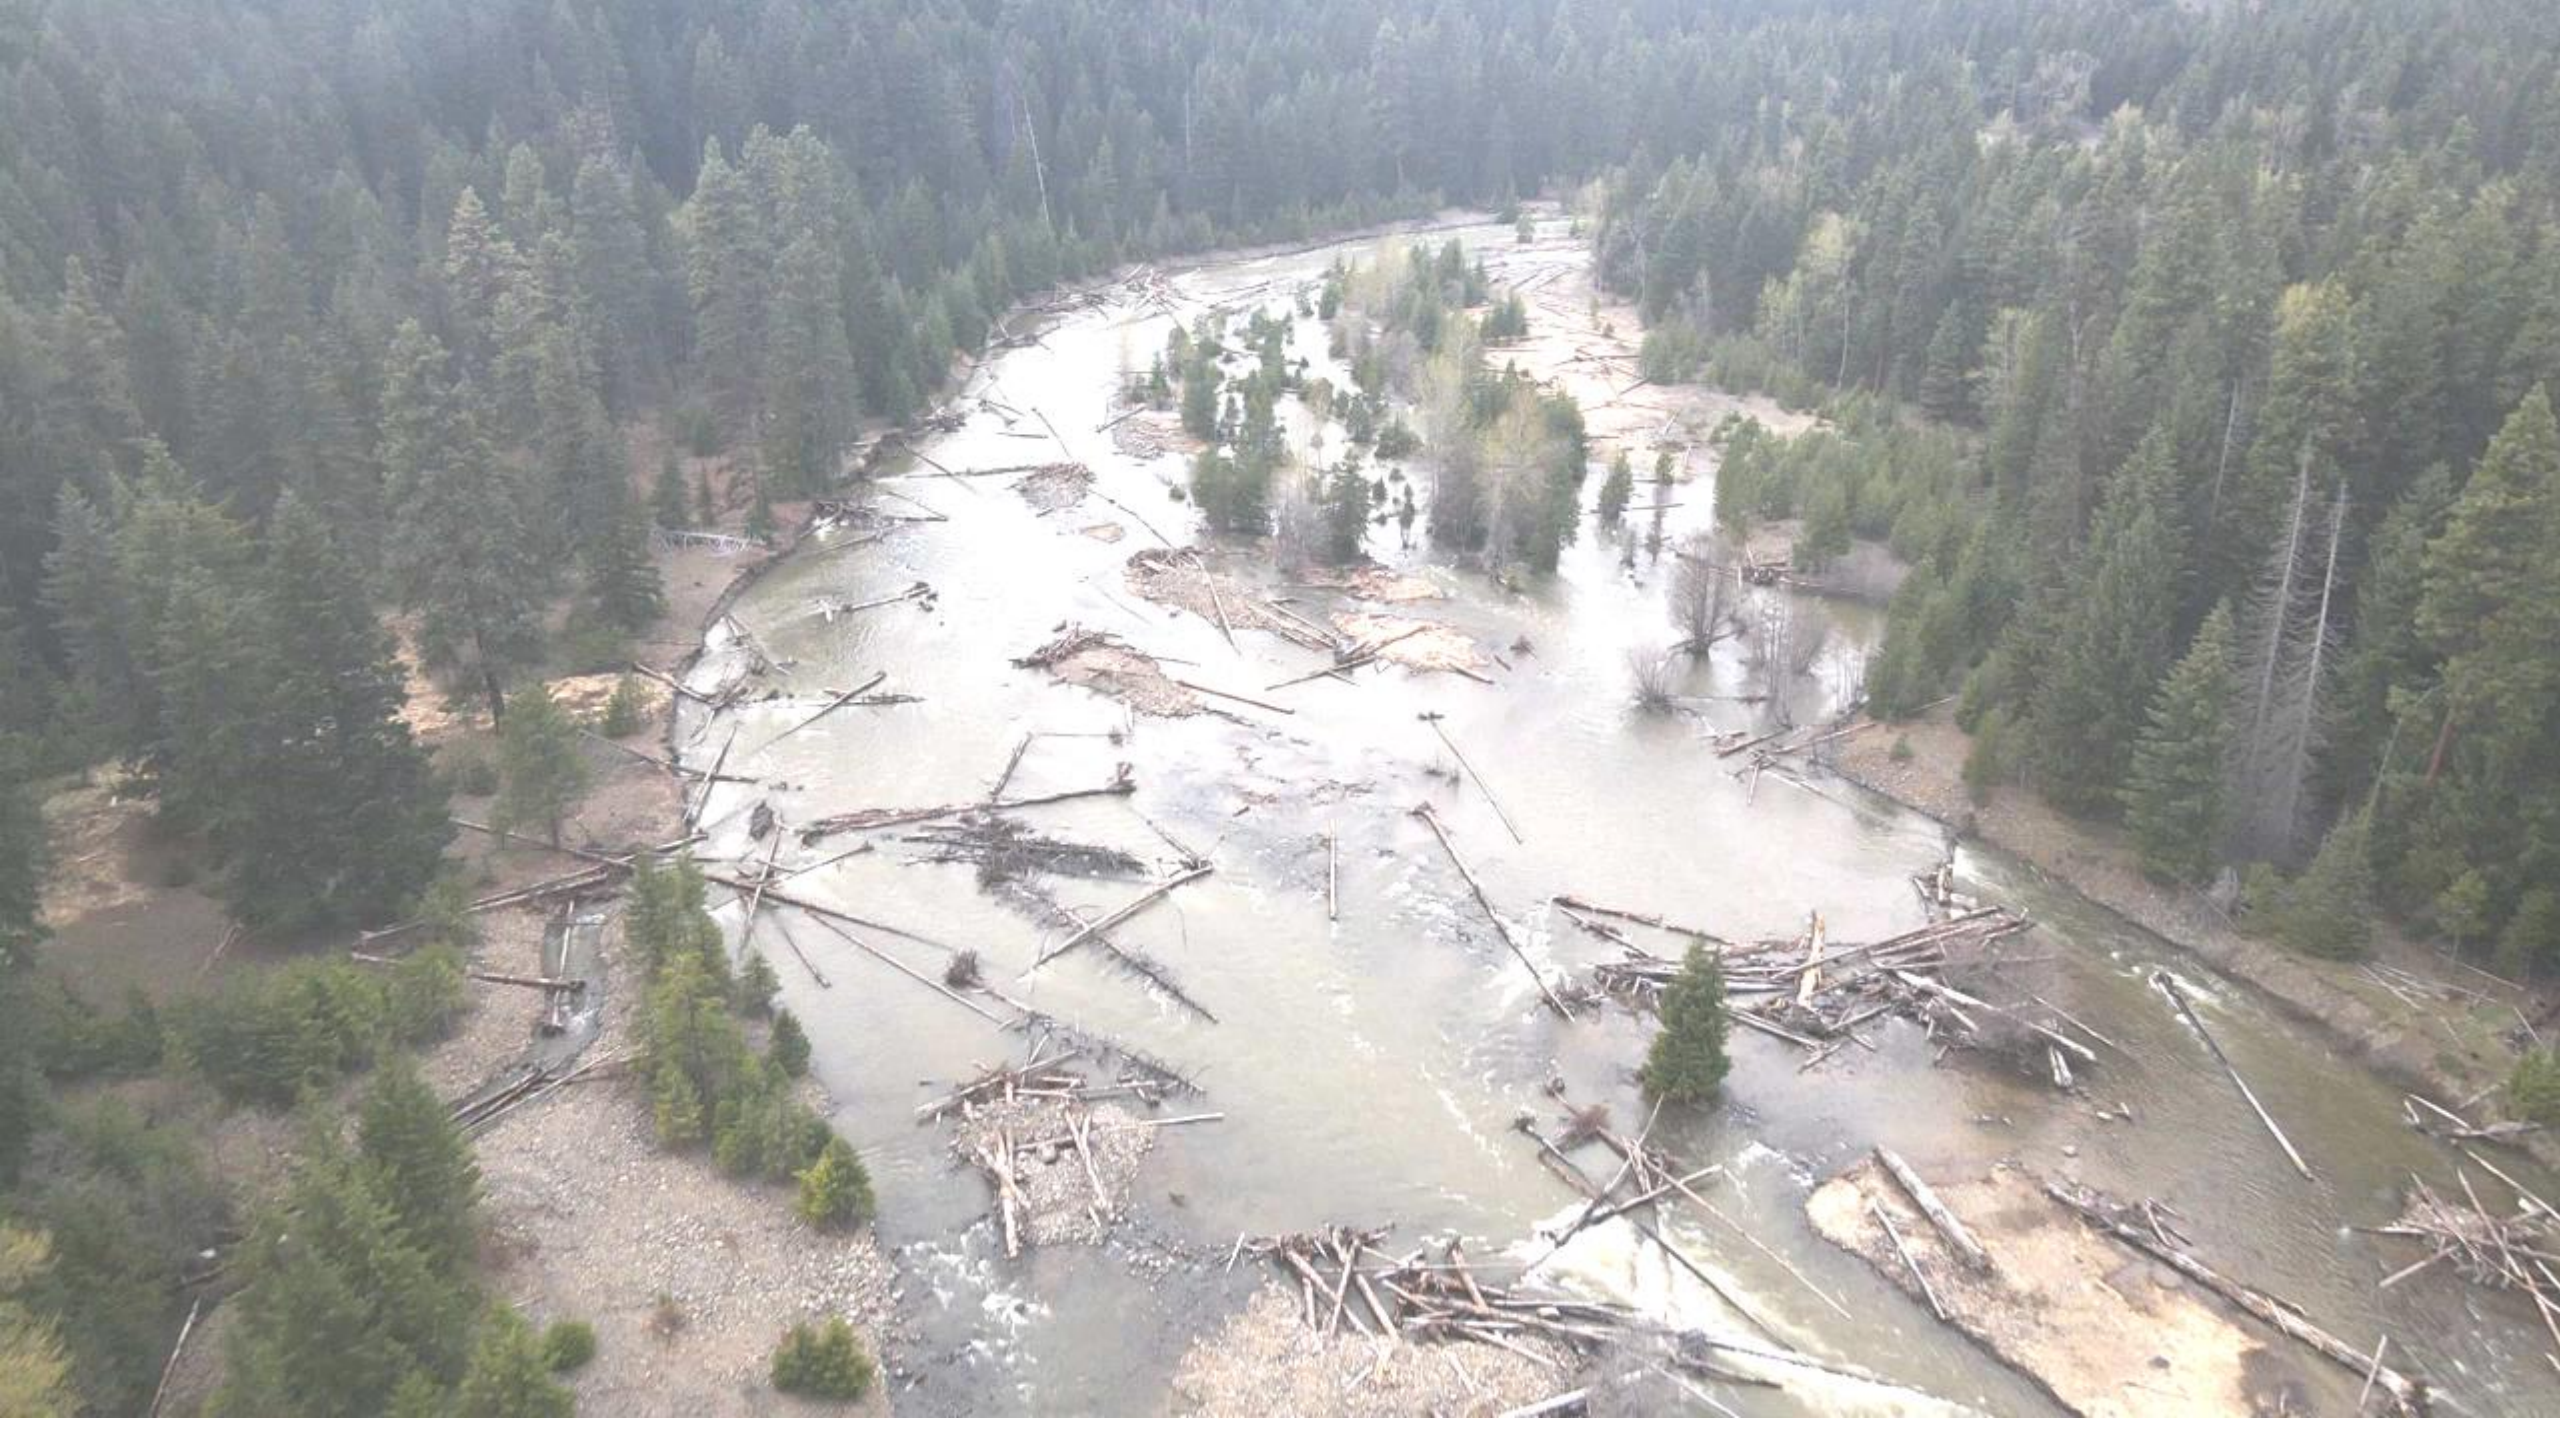
Inundation- Post- 1800 CFS event

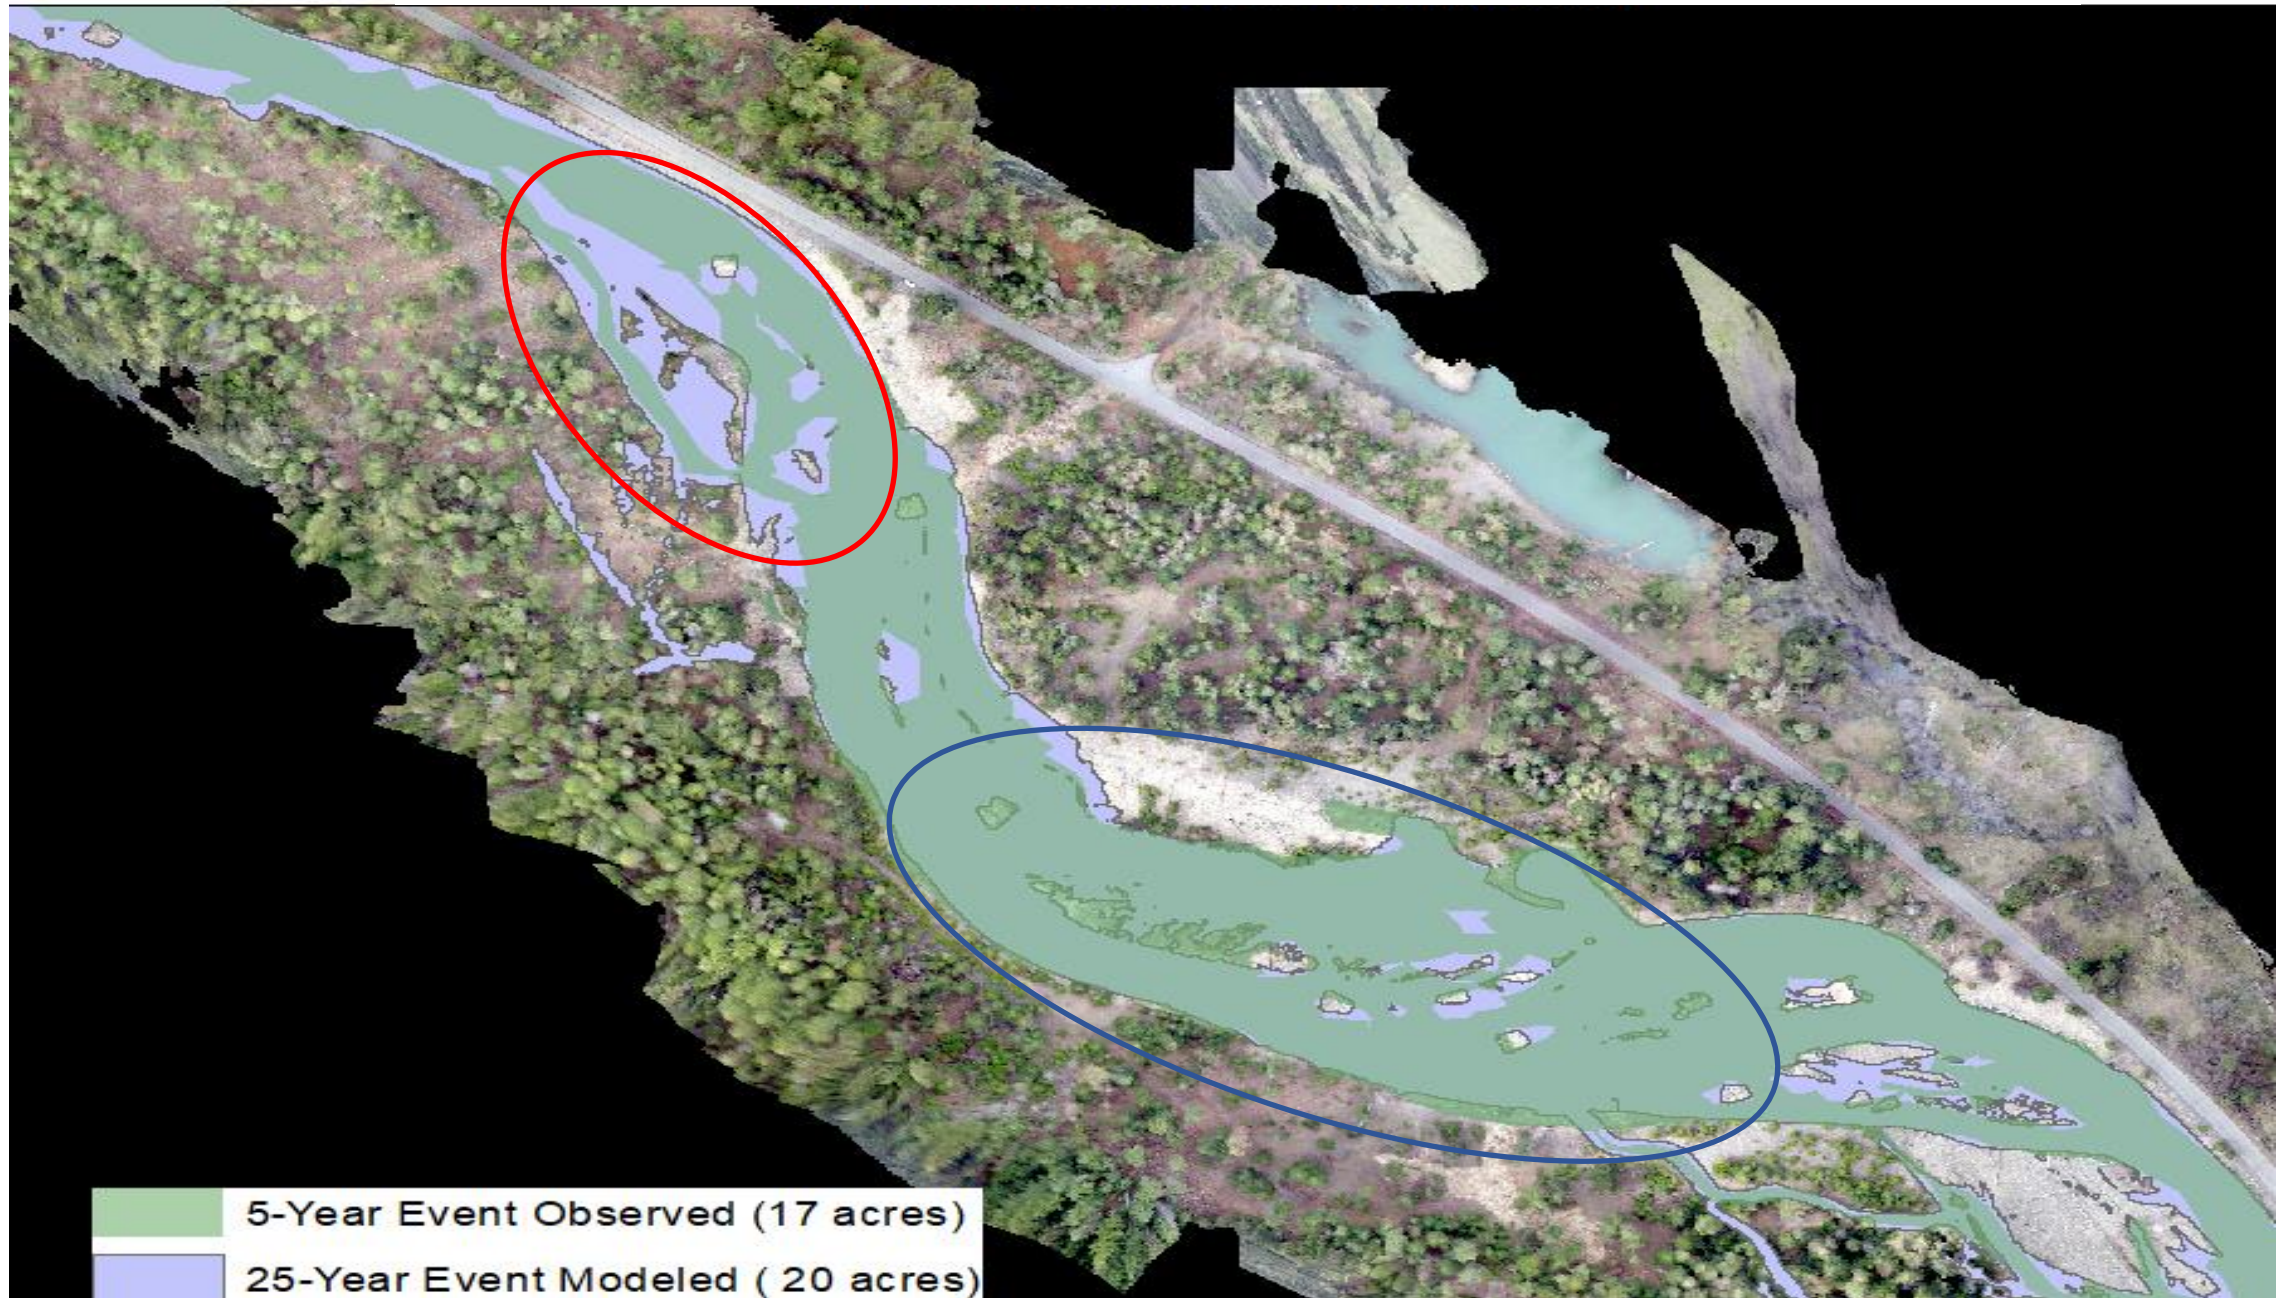
5-Year Observed versus 25-year Modeled (pre-project)
