Rebuilding the Little Naches River: locally-sourced wood, balanced cut/fill and drone-assisted monitoring

Little Naches River

Intuitive innovation:
 Programmatic
 Environmental Compliance
 allows for balanced cut/fill

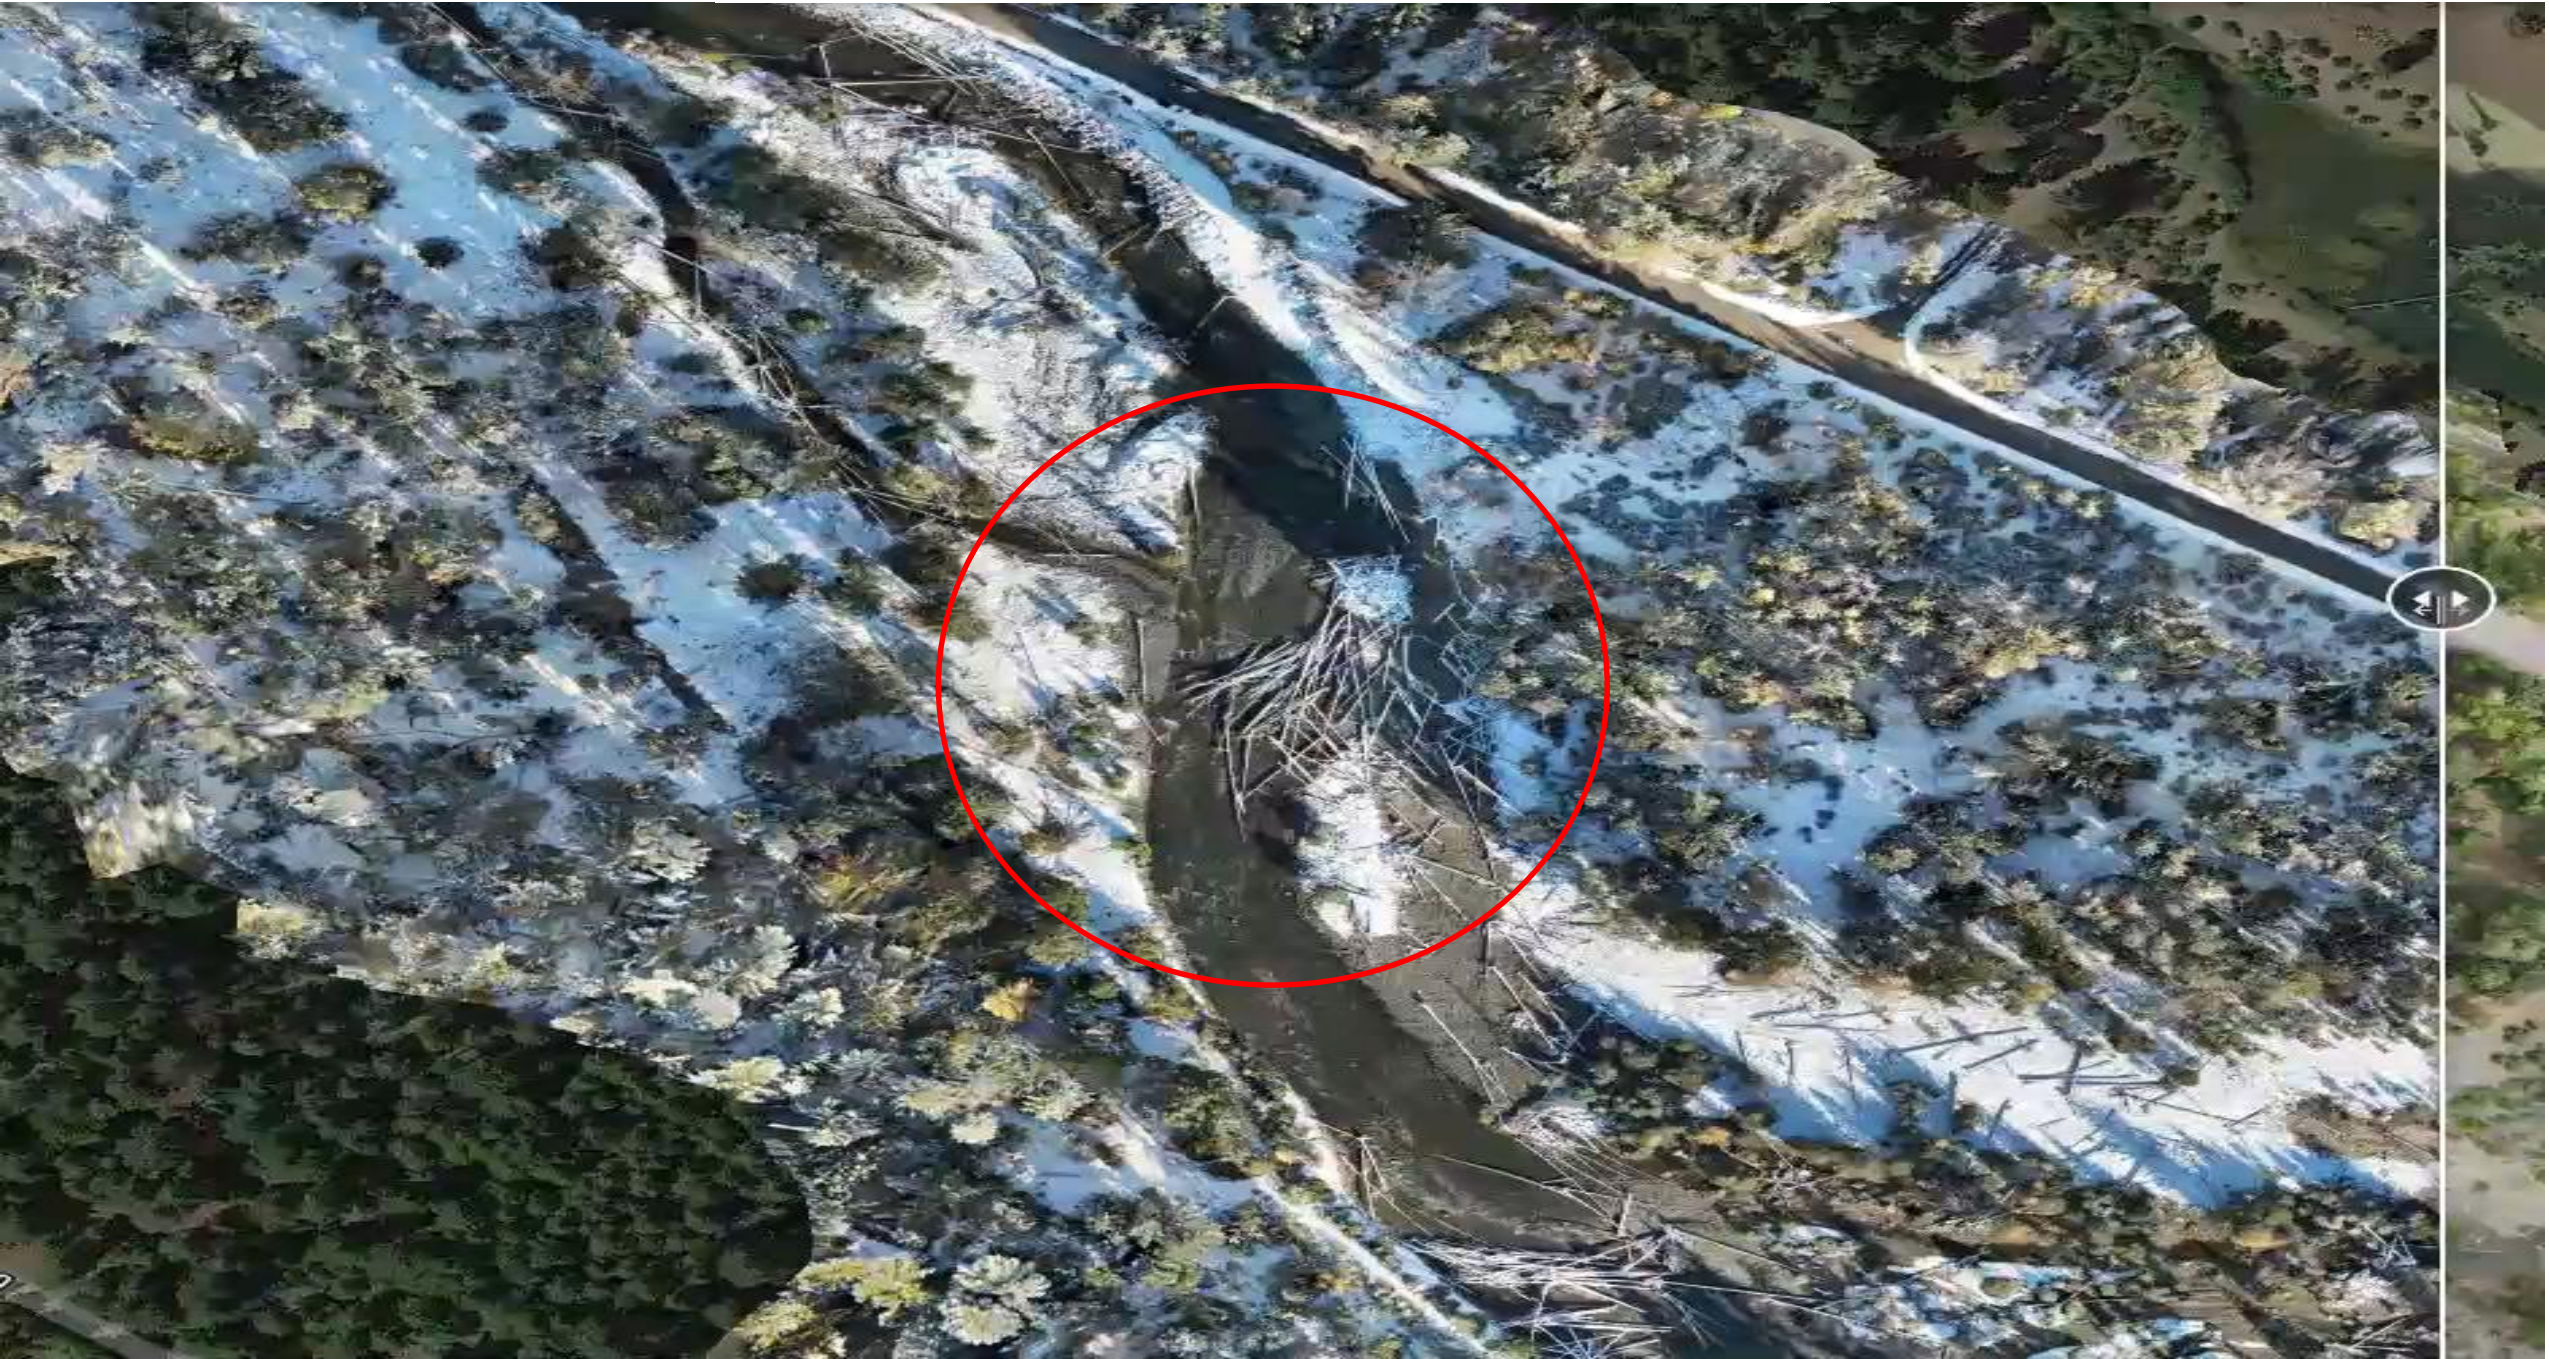
2- year/5-year Minimal Wood Movement

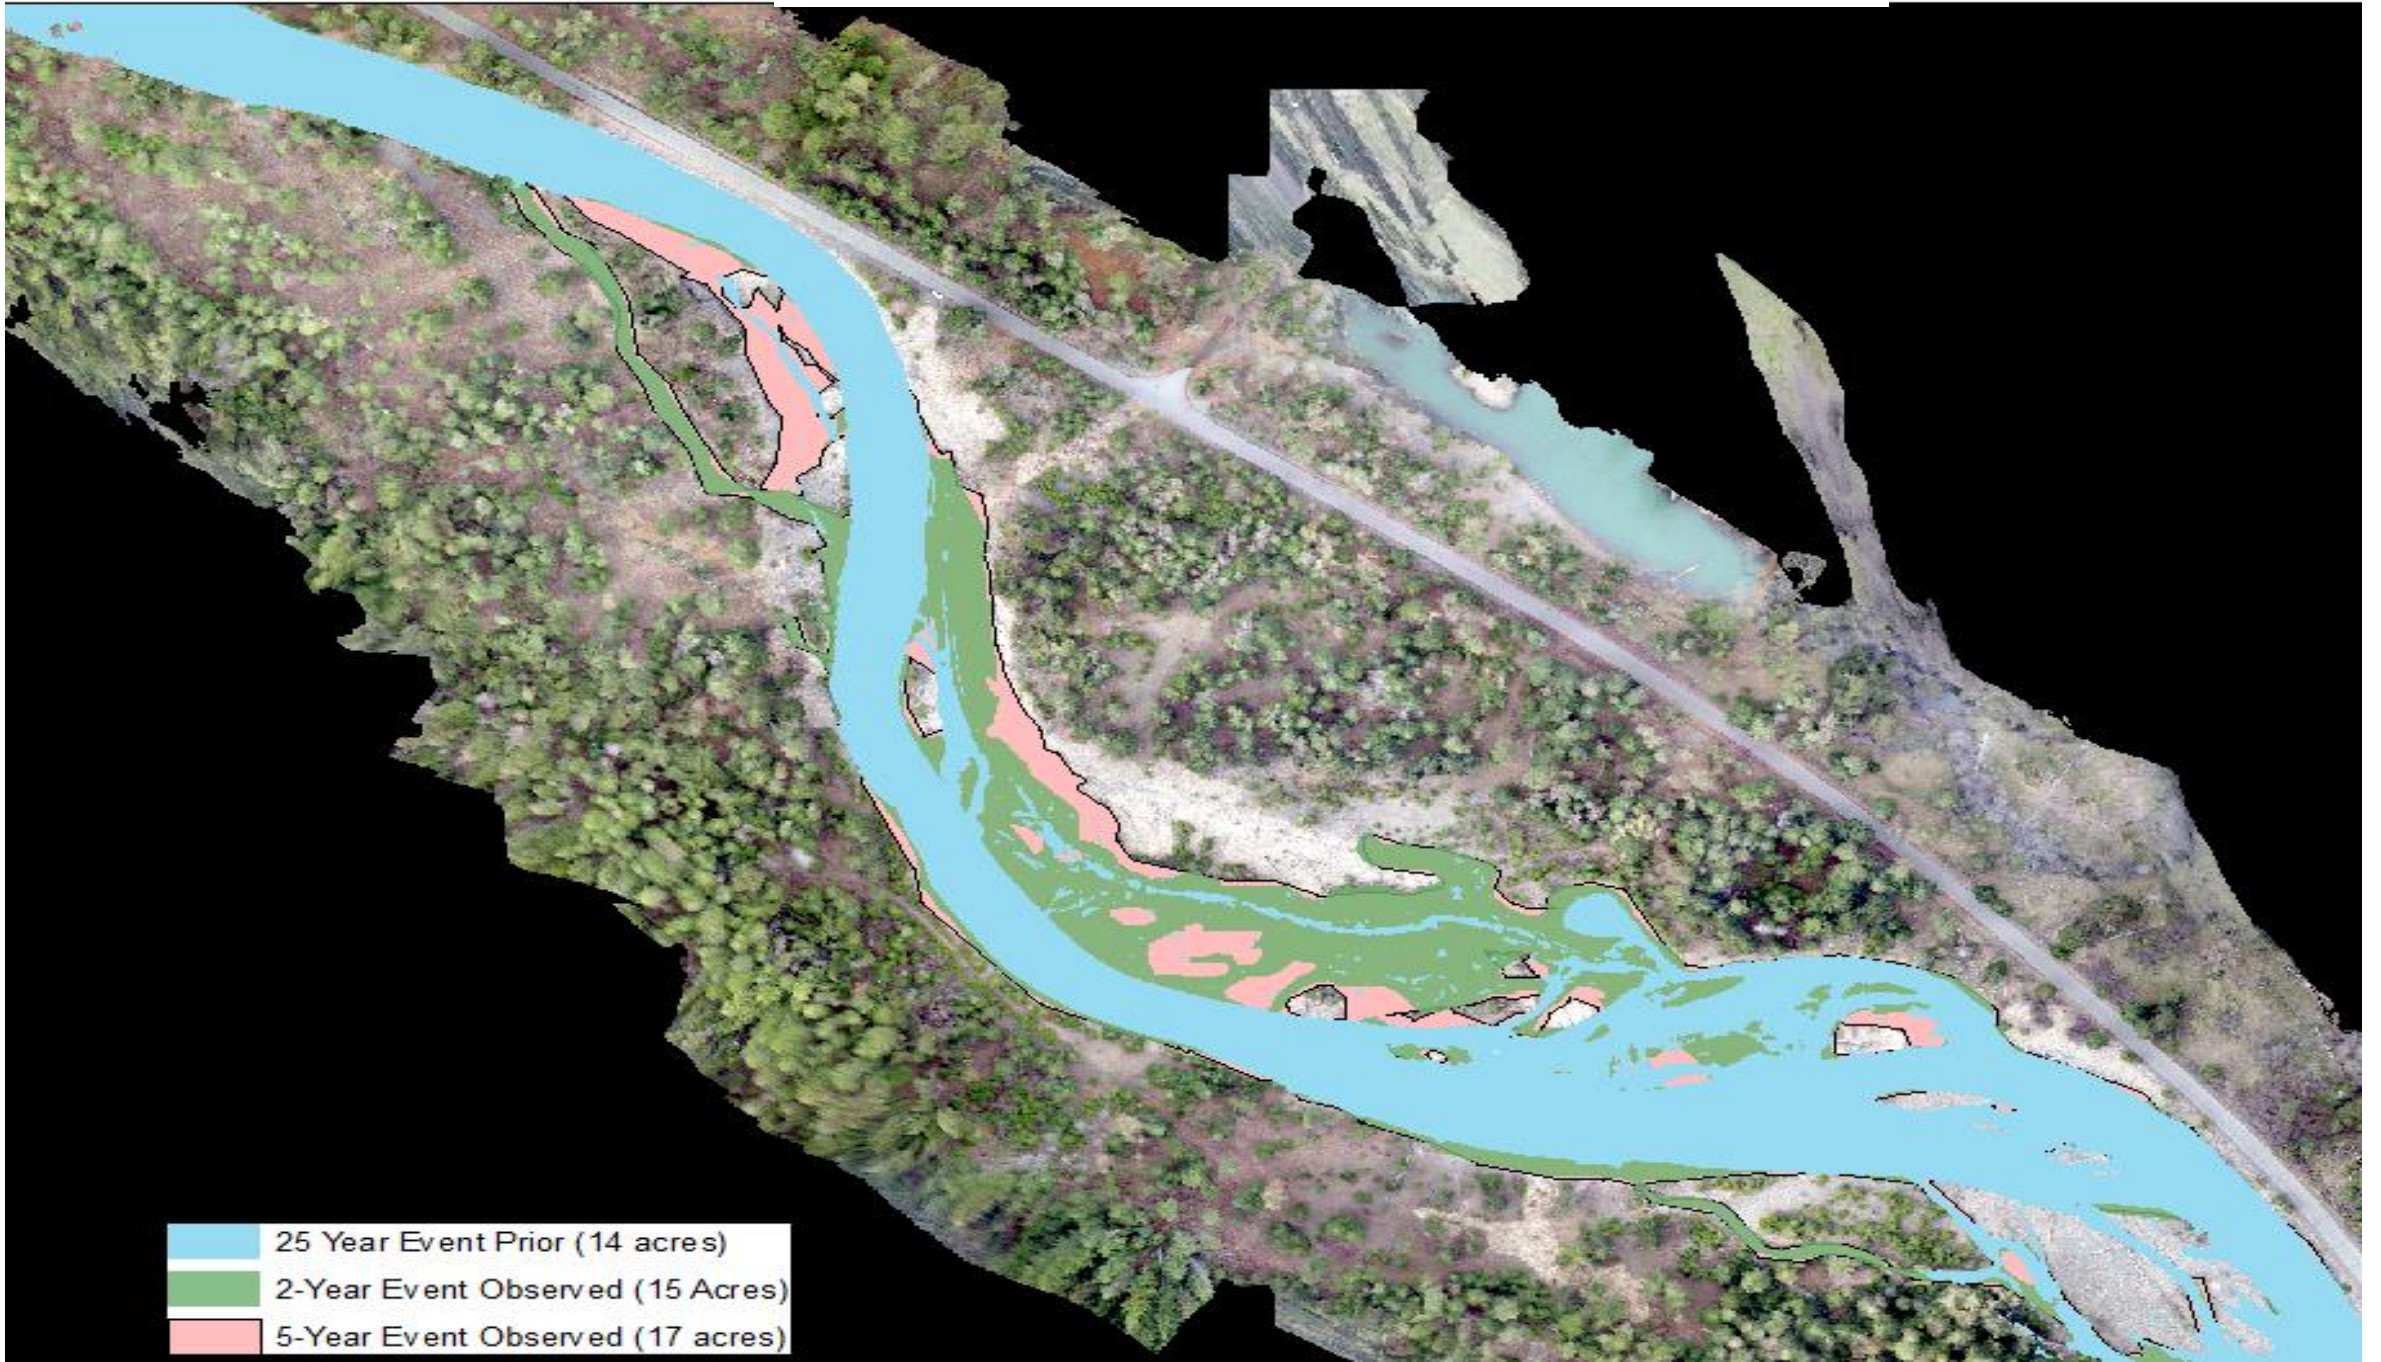
Flood Events Pre-Post Project

25 Year Event Prior (14 acres)
2-Year Event Observed (15 Acres)
5-Year Event Observed (17 acres)

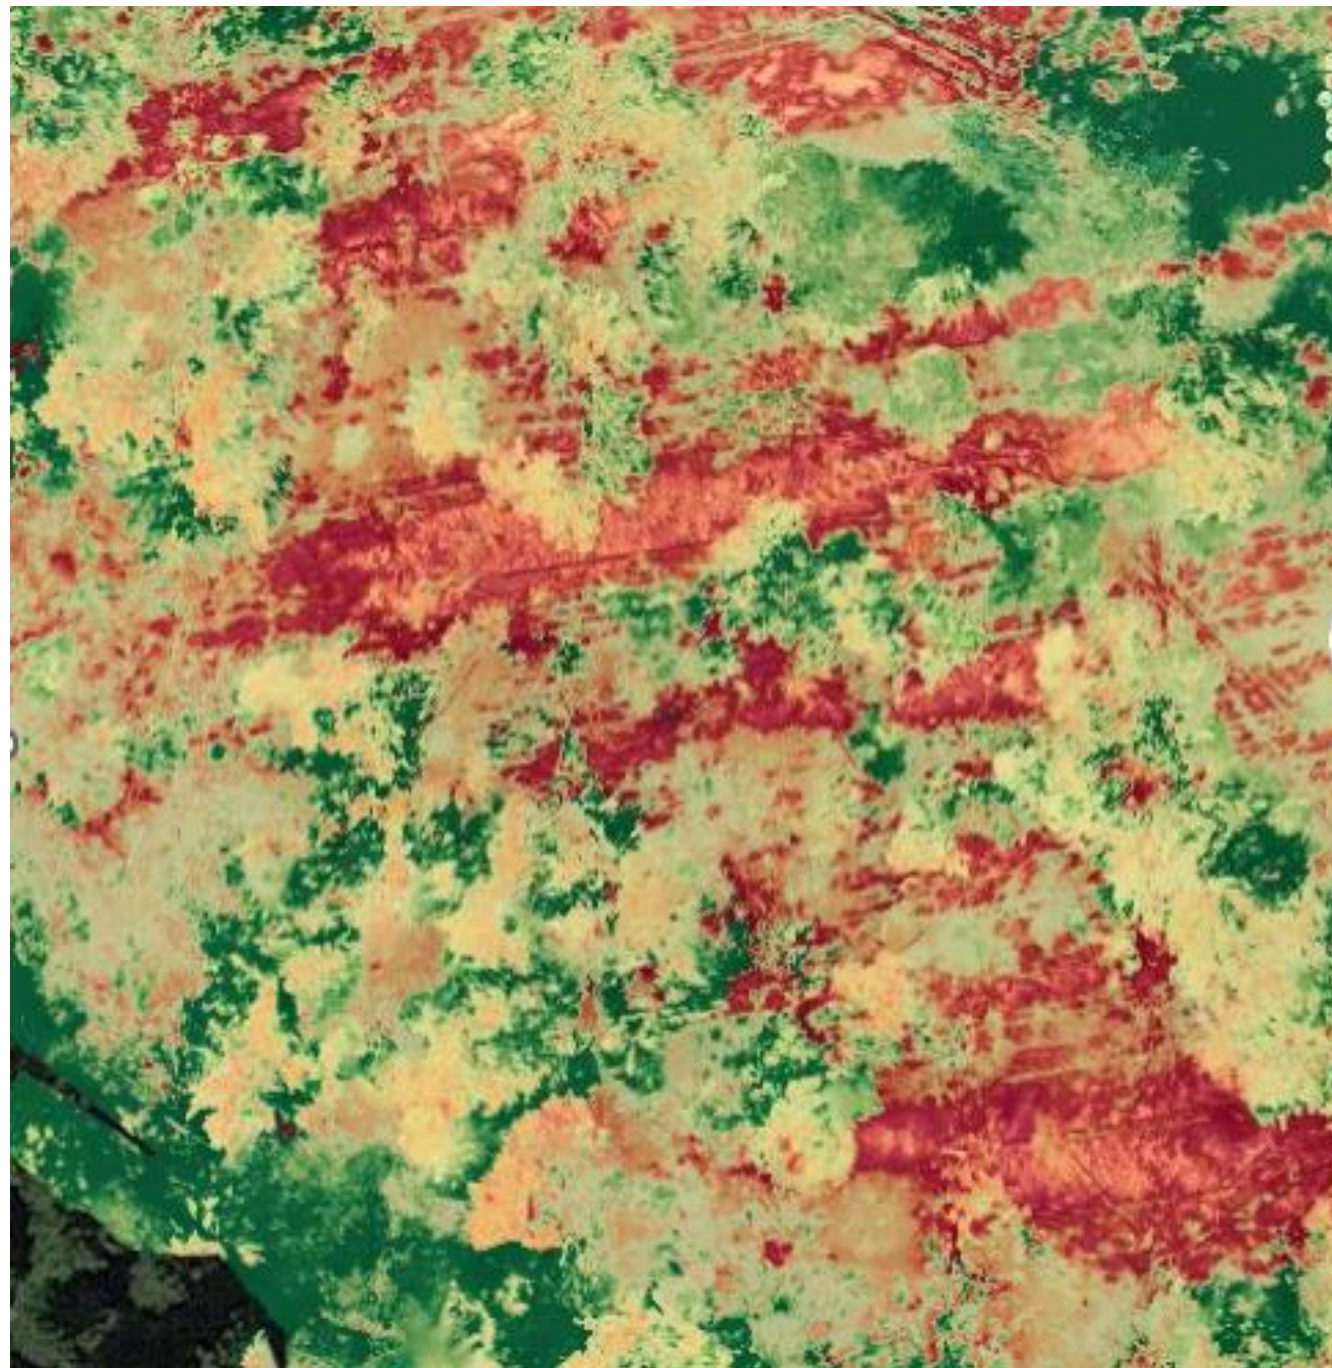
Meeting Harvest Prescription

- Quickly assess canopy density
- Programs can digitize canopy
- Can add clarity and consistency in canopy density set by NEPA, EA decisions

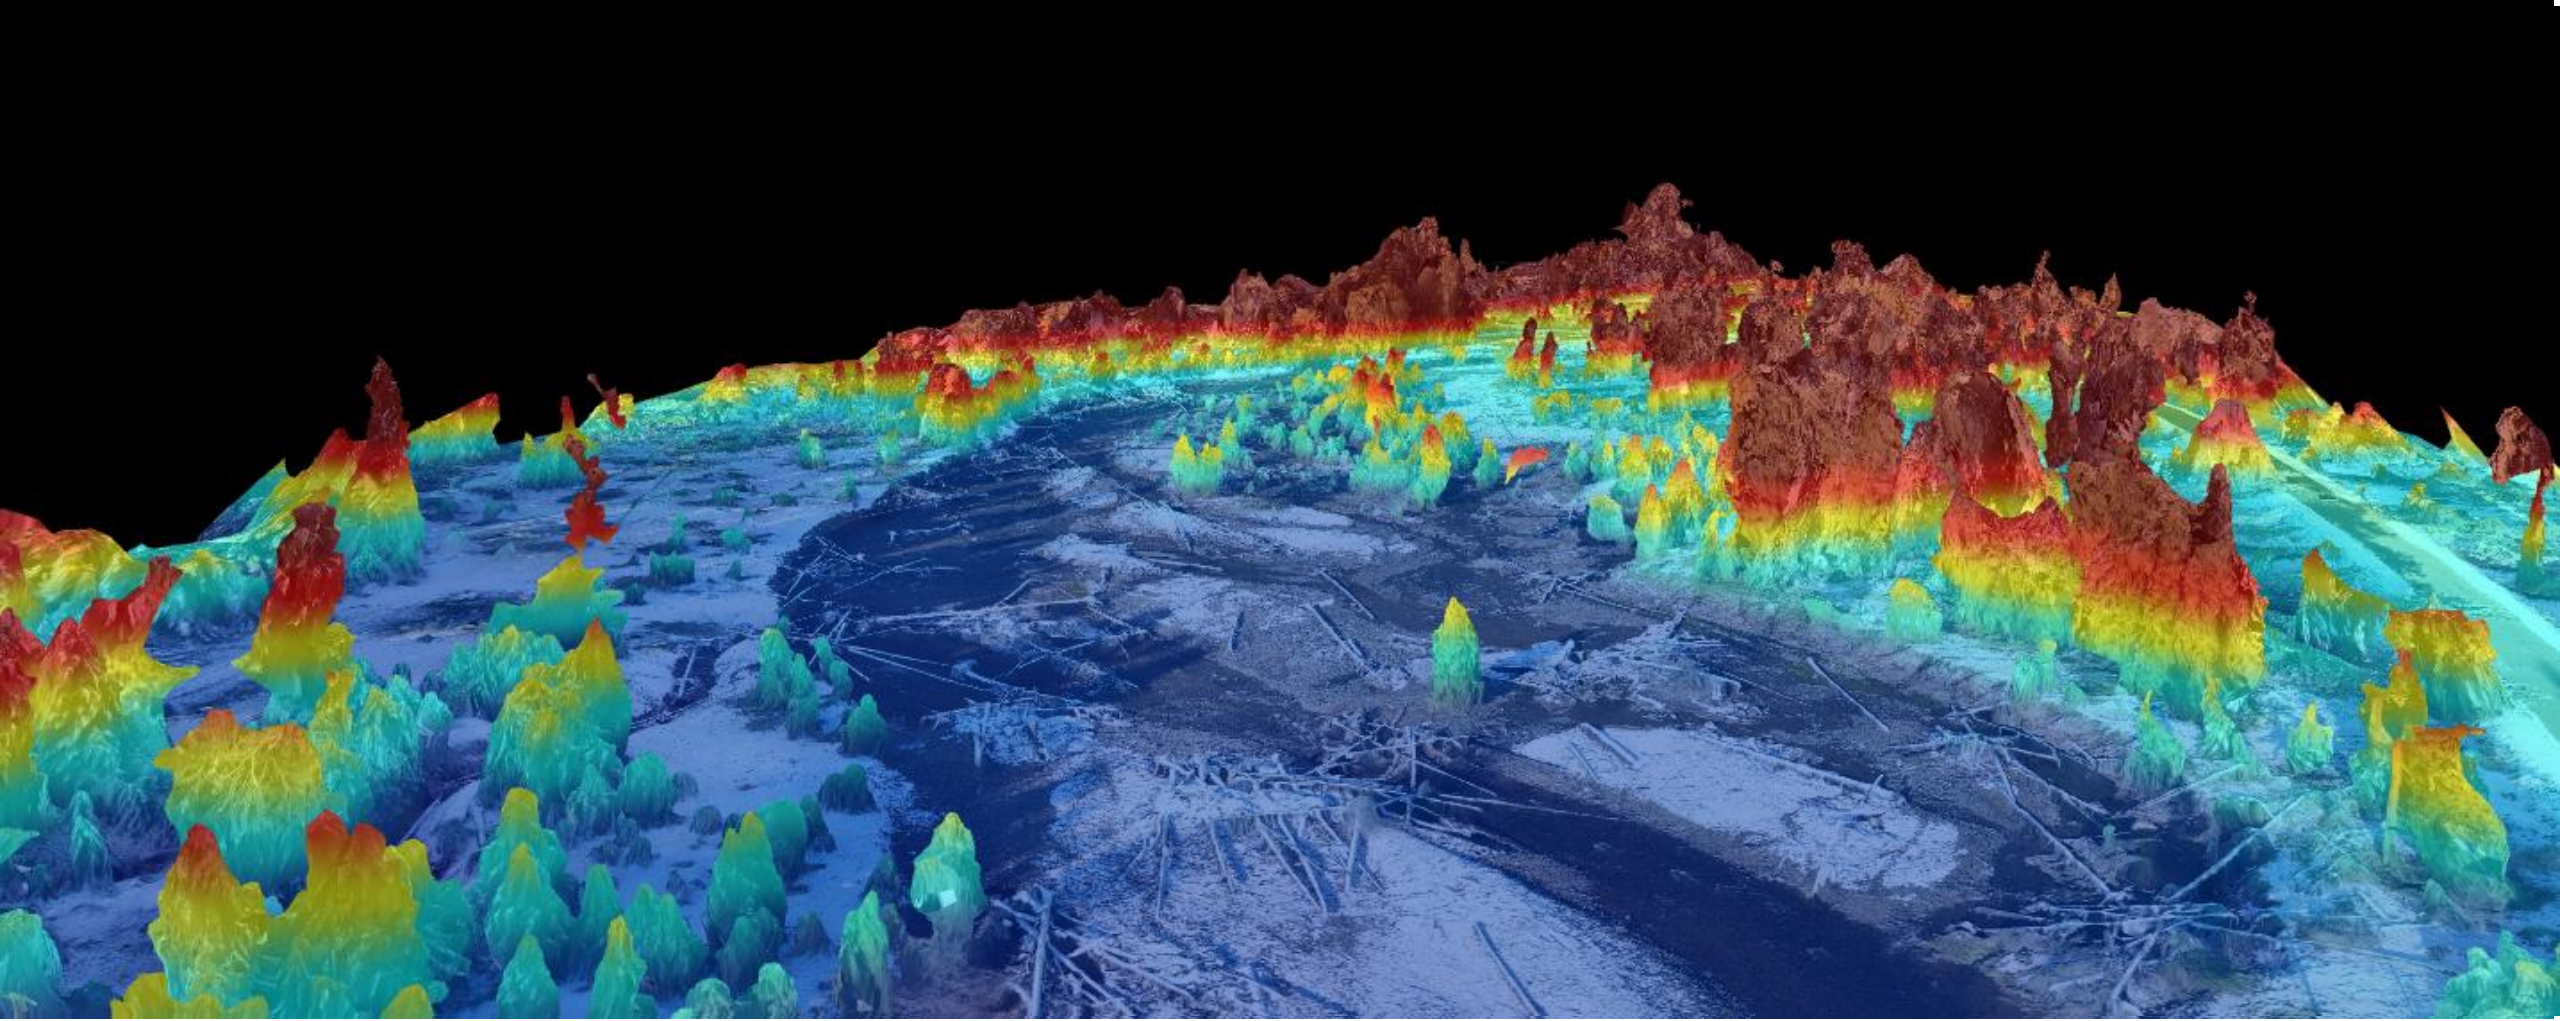
Vegetation Monitoring

- Trees over 50 greater than 50 feet over lowest elevation
- Create Proxy stream shade layers

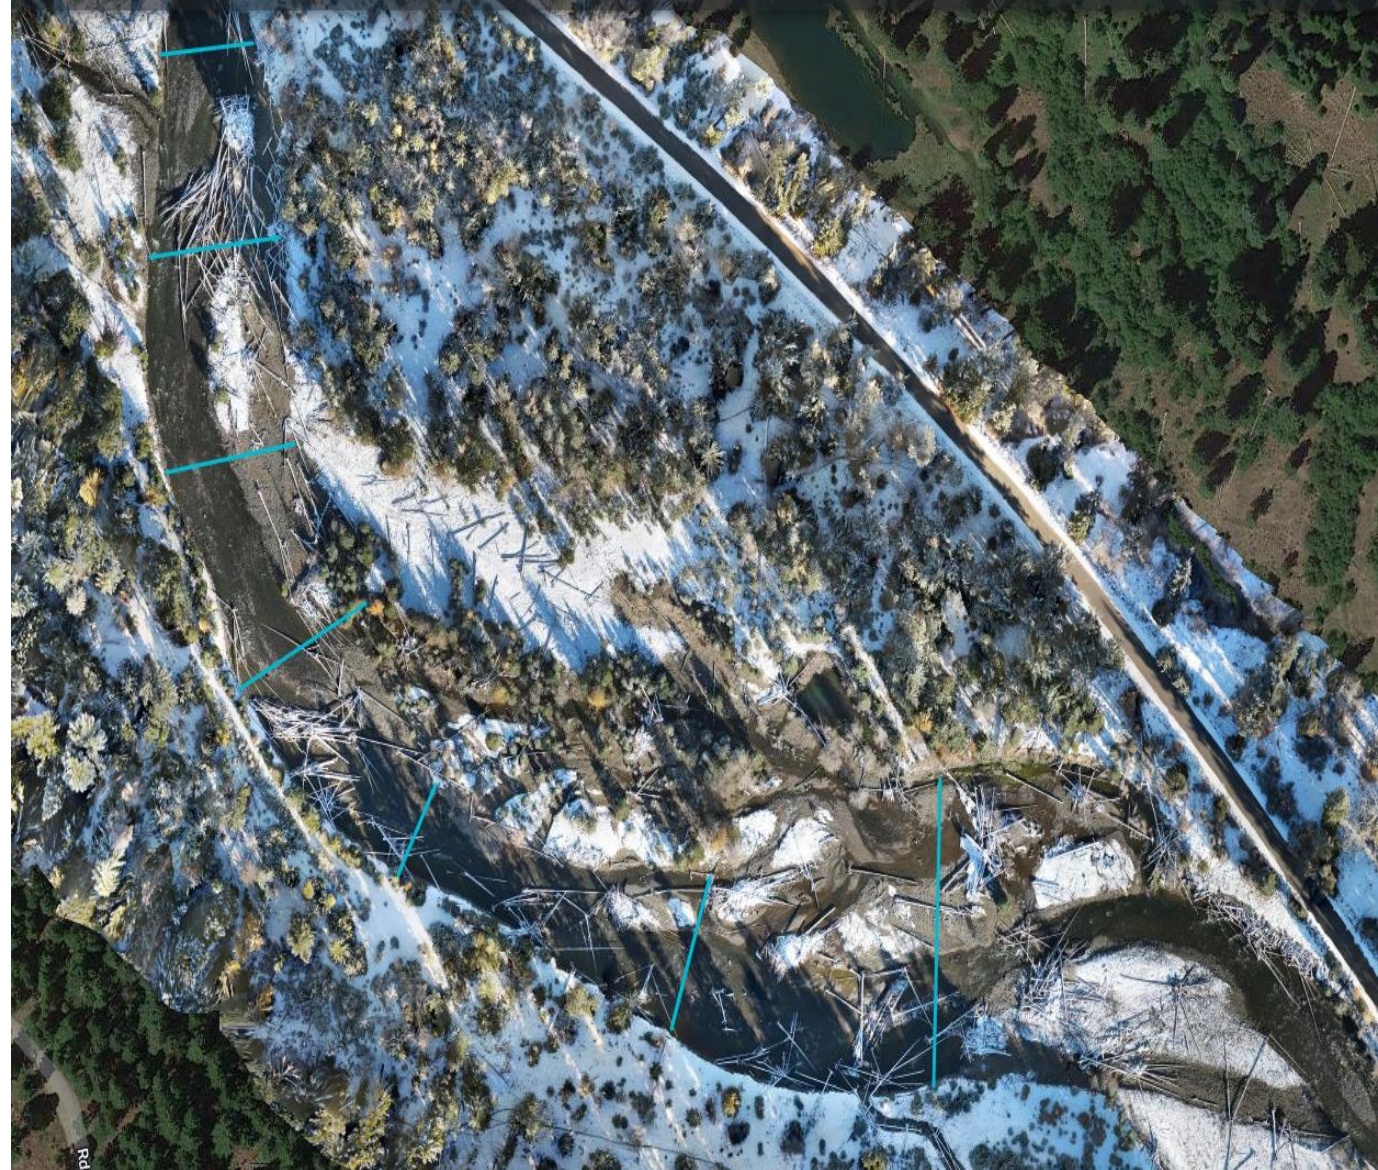
2-year flow widths

(gathered from flow path fall flow event)

- 162.28 wetted flow widths
- 79 feet pre-project conditions

Can monitor flow widths at seasonal intervals and rapidly target high flow events
