Satus Creek Watershed Restoration

**Annual Report
2003 - 2004**

Satus Creek Watershed Restoration Project
Project No. 199603501

ANNUAL REPORT
Project Fiscal Year 2004

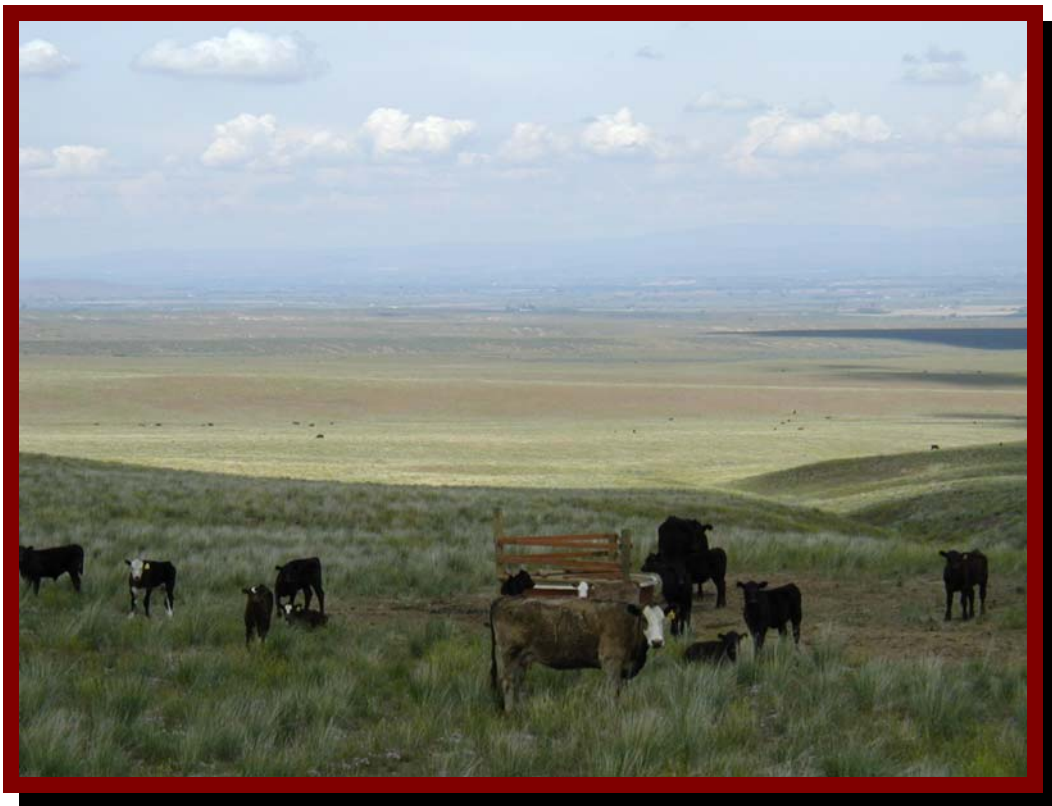
Figure 1. Well distributed grazing in managed pasture – Mule Dry Creek watershed.

We hired a new range rider in March of 2004. He has done an excellent job of keeping cattle out of the stream and mountain wetlands. He communicates with range permittees, who willingly work with him to remove cattle found outside their designated Range unit. He also patrols the area to assure that grazing management objectives (mainly exclusion from designated areas) are being met (Figure 1). The range rider also uses a GPS to record downed fence lines that need to be repaired.

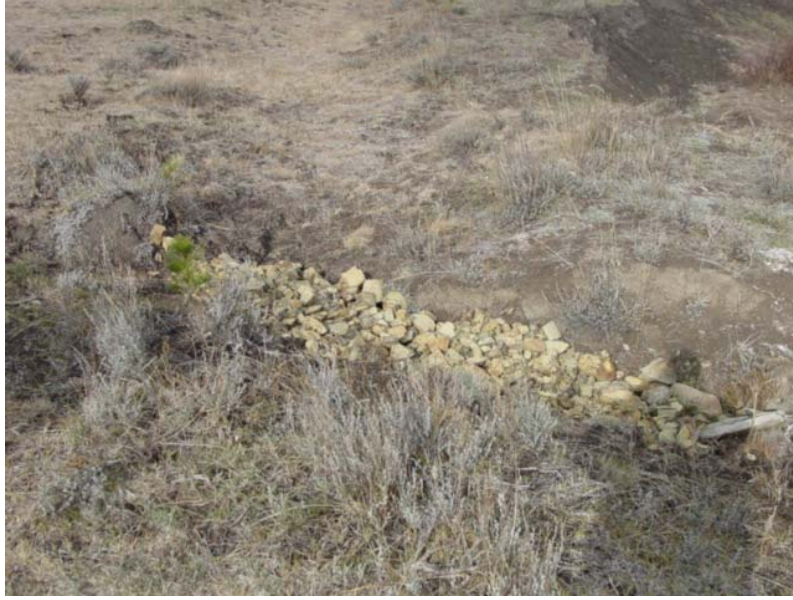
Figure 2. Headcut in cattle trail stabilized with rock structure.

Project staff have built rock structures in the upper portion of Dry Creek called Starvation Flats. This area is heavily impacted by wild horse and cattle trails. Project staff placed a number of rock structures to stabilize headcuts to prevent further incision to the creek (See Figure 2). The task was successful but needs to be expanded into the downstream portion of Starvation Flats. Plans are being developed to utilize larger rock structures in the creek to be more effective in building the channel draining Starvation Flats back up to its original level in communication with the floodplain (See Figure 3.) Construction would take place in 2006.

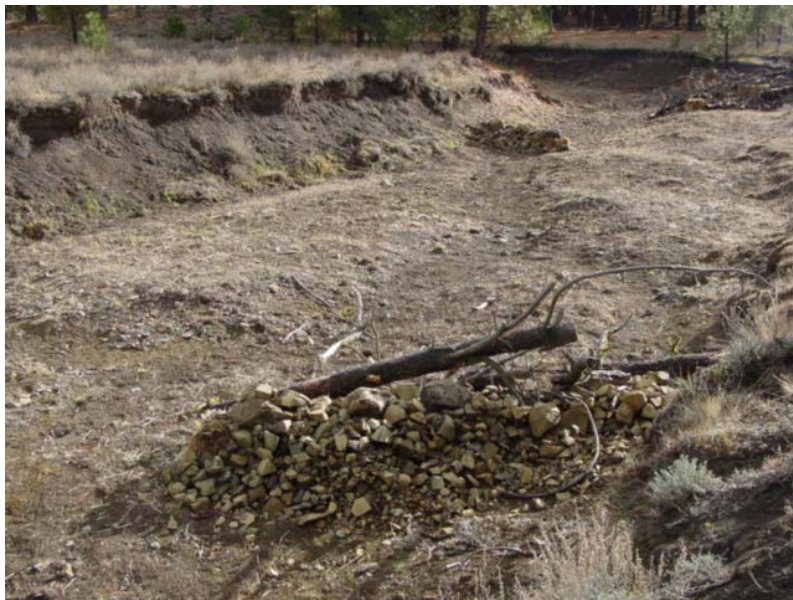
Figure 3. Small rock check structure.

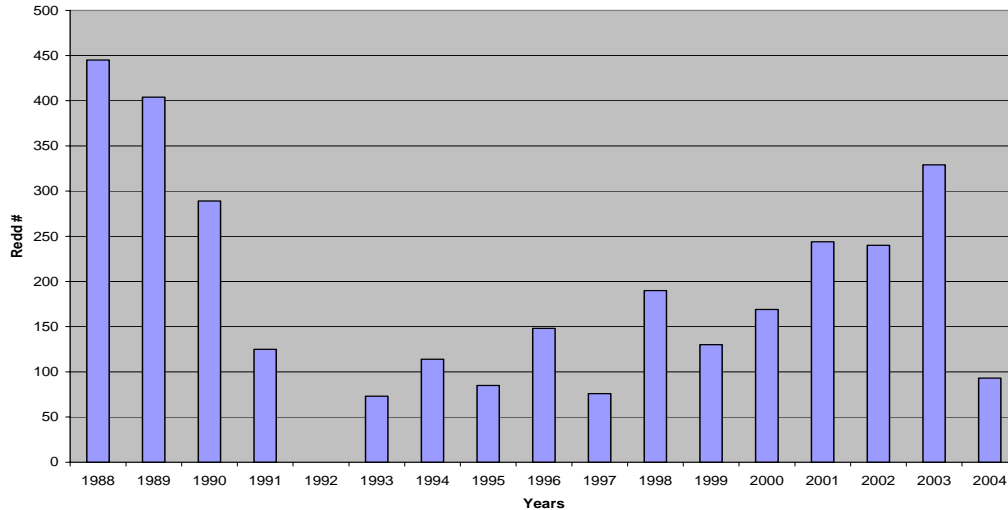
which water conditions were excellent for surveying. However the total redd count for 2004 was only 93. This is lower than most recent years, as shown in Chart 1. There are no obvious reasons for this single-year decrease, but it illustrates the need to focus steelhead recovery efforts on multiple watersheds, as the YN has been doing. Staff have recorded all redd locations with a GPS unit, for entry into a GIS database.

Spawning ground survey results for Satus Creek and its tributaries.

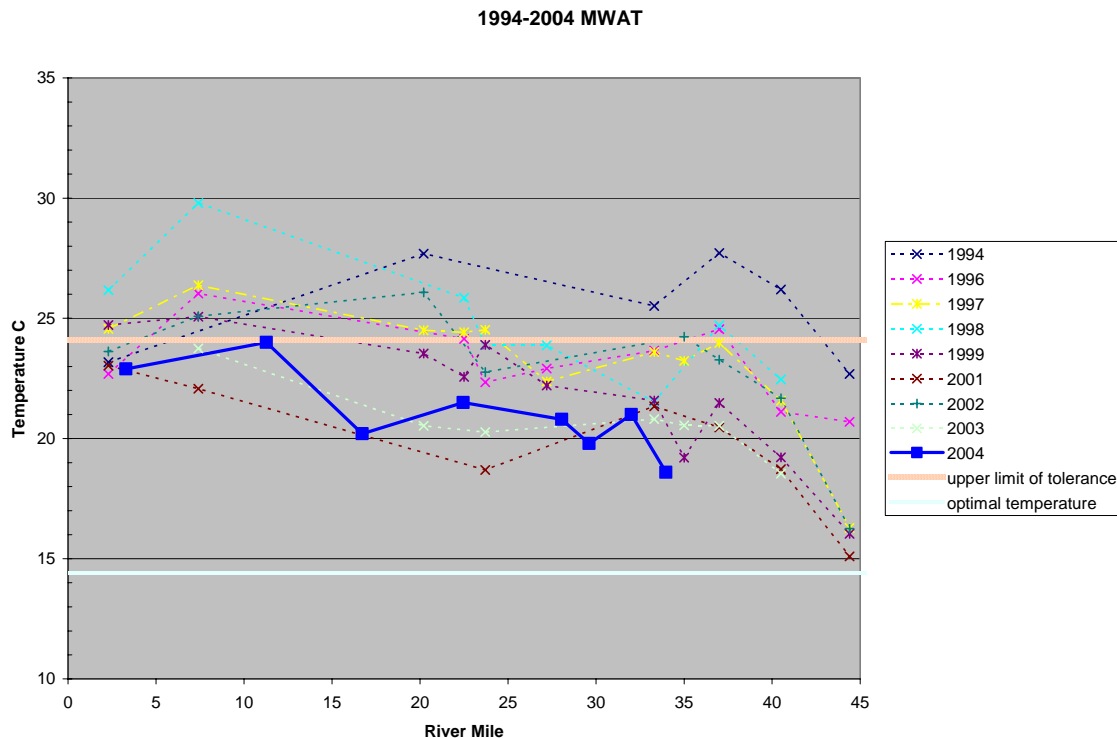
Figure 4. Satus Creek Temperature history from 1994 to 2004.

Temperature data is based on a 7-day maximum average. At all monitoring locations, summer temperature stayed slightly lower than the upper limit of tolerance.

The Satus project has continuously monitored temperature in the stream. Despite a dry summer, Satus Creek has shown some improvements in temperature throughout the years (See Figure 4.).

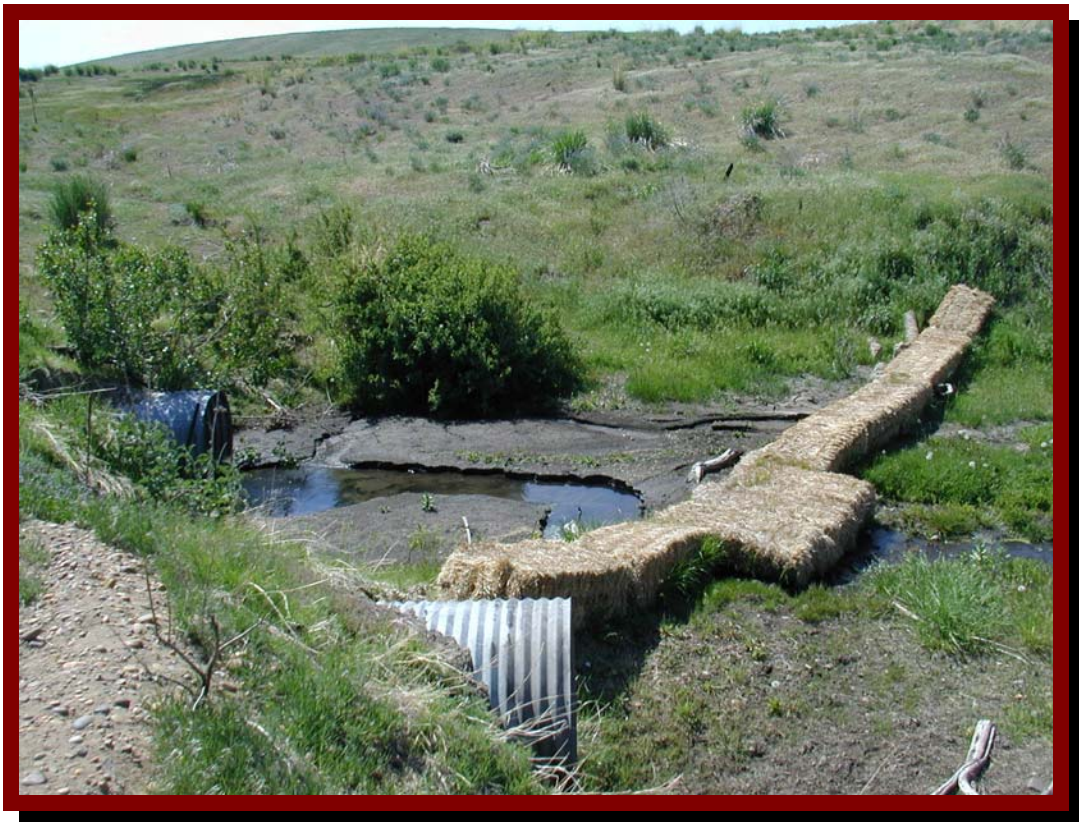
Figure 8. Sediment captured behind a bale structure on headwaters of Mule Creek.

Numerous photo points were developed in the course of installing sediment retention structures (Figure 8). Over the past winter we found that erosion pins are too susceptible to ice, debris, etc., to reliably measure sediment deposition. If time is available we will begin surveying sediment accumulation this summer.
