Satus Creek Watershed Restoration Project

Annual Report 2004 - 2005

DOE/BP-00019982-1

ANNUAL REPORT
Project Fiscal Year 2005

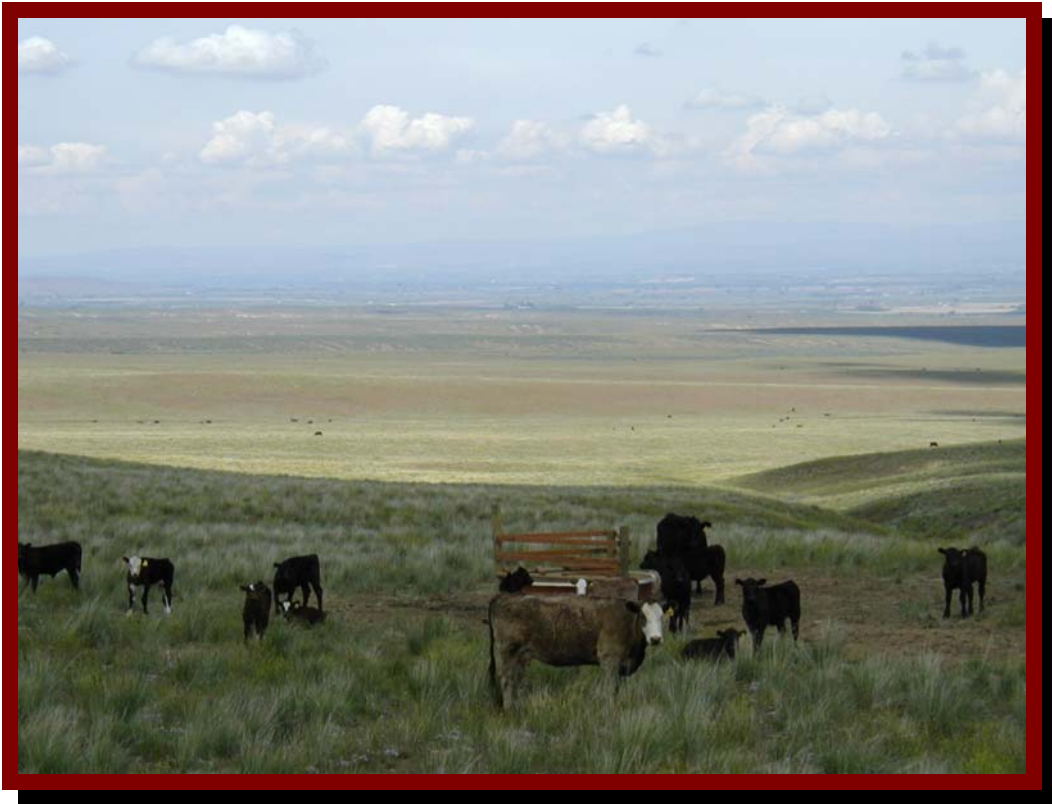
the range rider assures that grazing management objectives (exclusion from designated areas) are being met (Figure 1). The Range Rider also GPS's downed fence lines that need to be repaired.

Figure 1. Well-distributed grazing in managed pasture within Mule-Dry Creek sub-watershed.

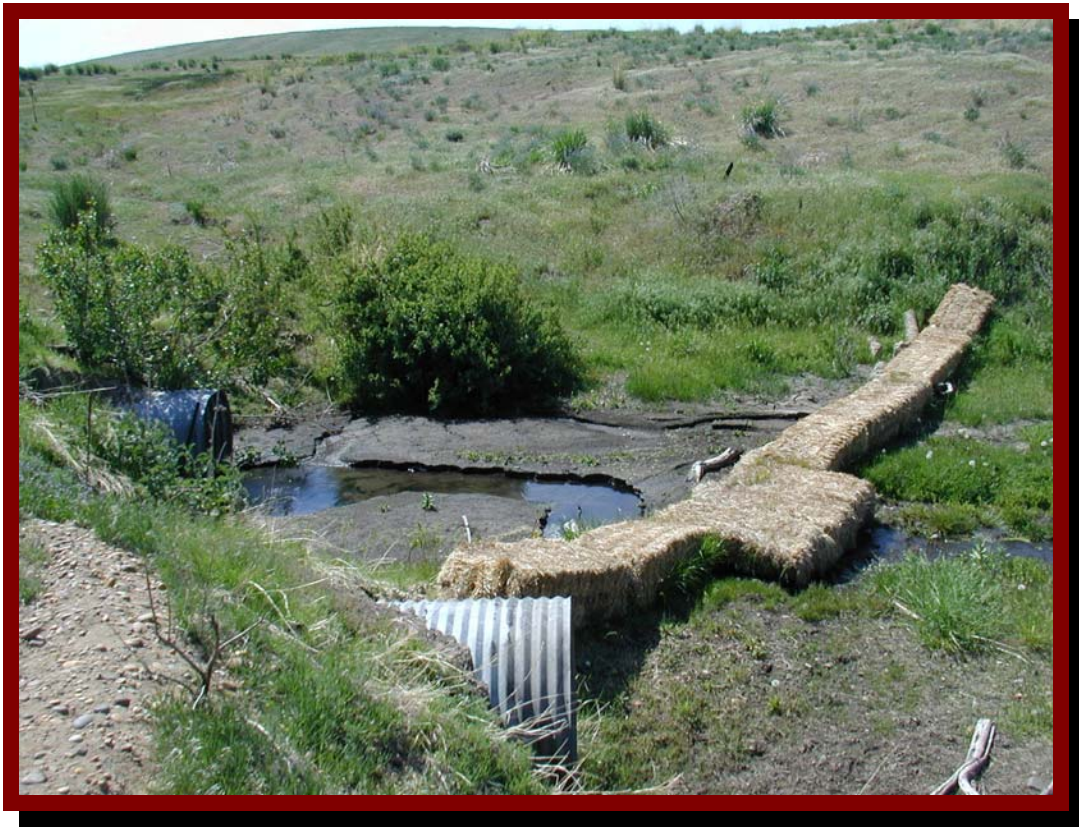
Numerous photo points were developed in the course of installing sediment retention structures (Figure 5). Project staff believe hand-placed rock structures are more effective sediment traps than straw bales. In the 2006 year the project plans to use only rock for sediment traps. The bale structures are effective in the short term, but the long-term stability of rocks more than compensates for greater installation difficulty, even if hand placement is the only option.

Figure 5. Sediment captured behind a bale structure on headwaters of Mule Creek.
