# FY2016 ANNUAL REPORT

YAKAMA RESERVATION WATERSHEDS PROJECT

*BPA Project #1996-035-01-Contract #56662 REL 99*

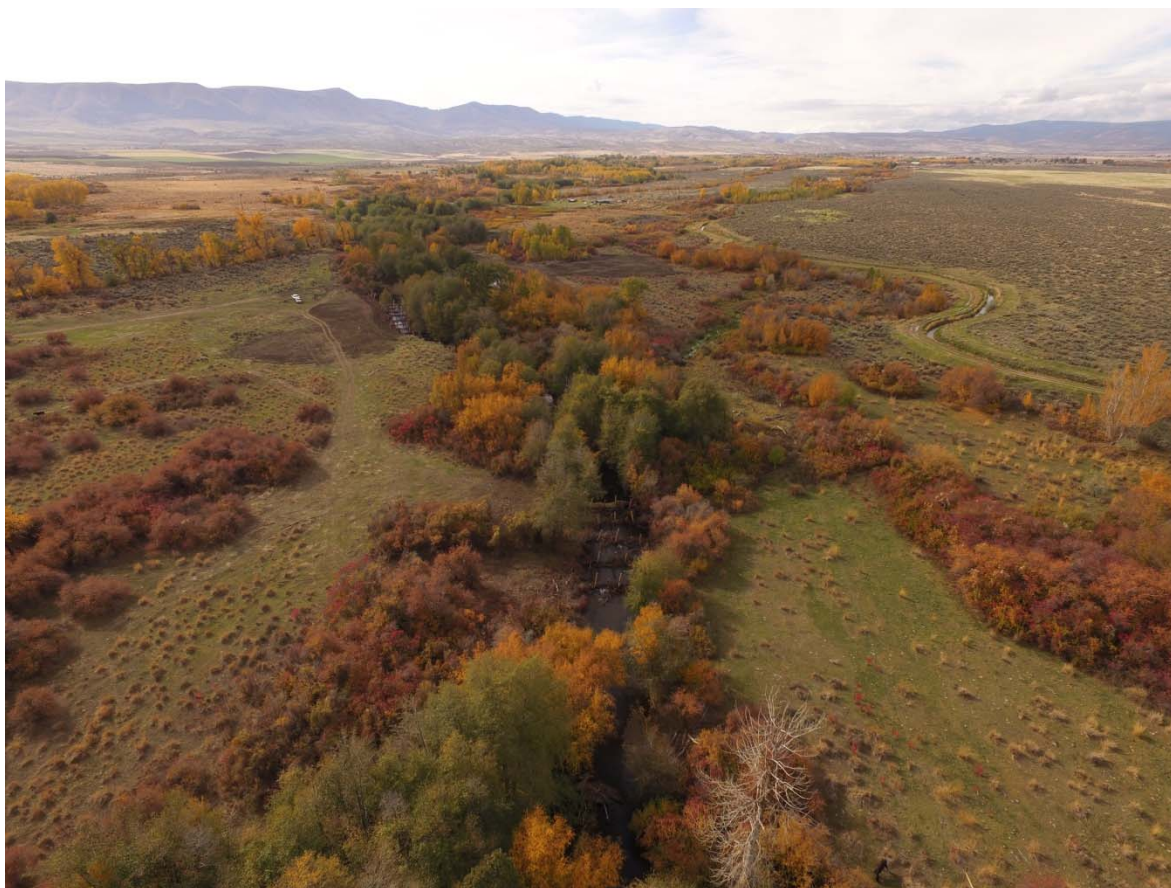
Toppenish Creek restoration project completed September 2016. Photo taken via drone courtesy of the North Yakima Conservation District.

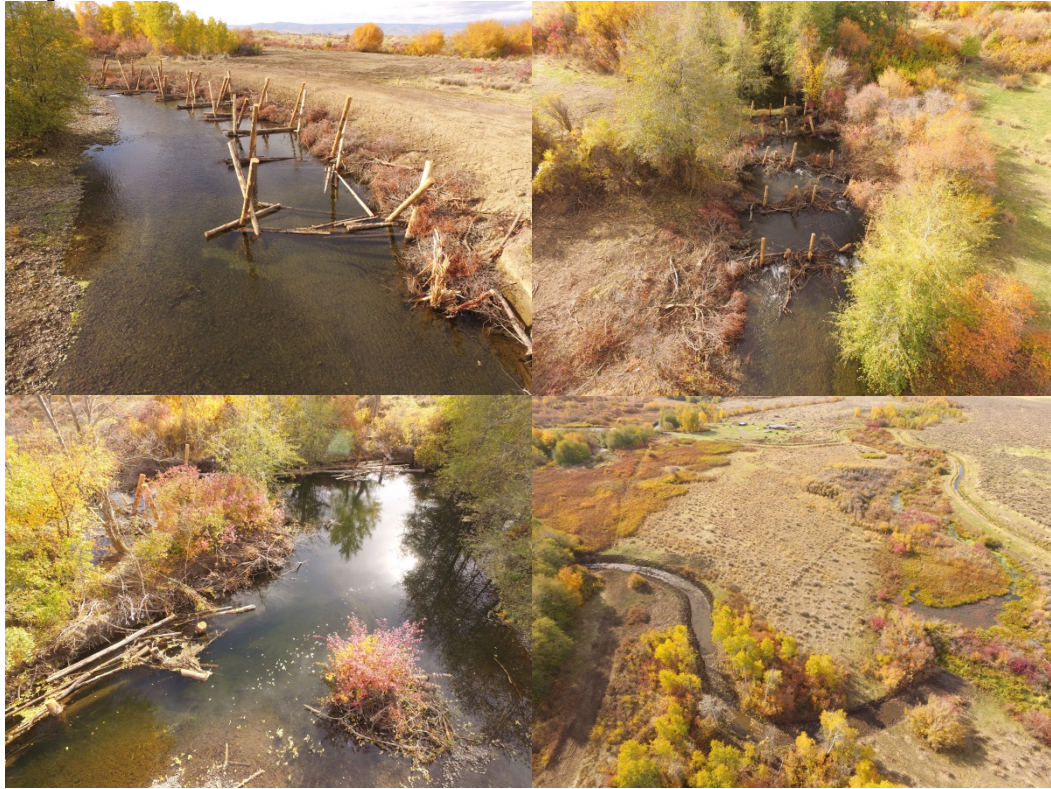
*Figure 1. Image depicts restoration work post implementation along Toppenish Creek near river mile 37 (8/8/16-9/2/16). Habitat structures pictured in images above were designed by Natural Systems Design (NSD).*

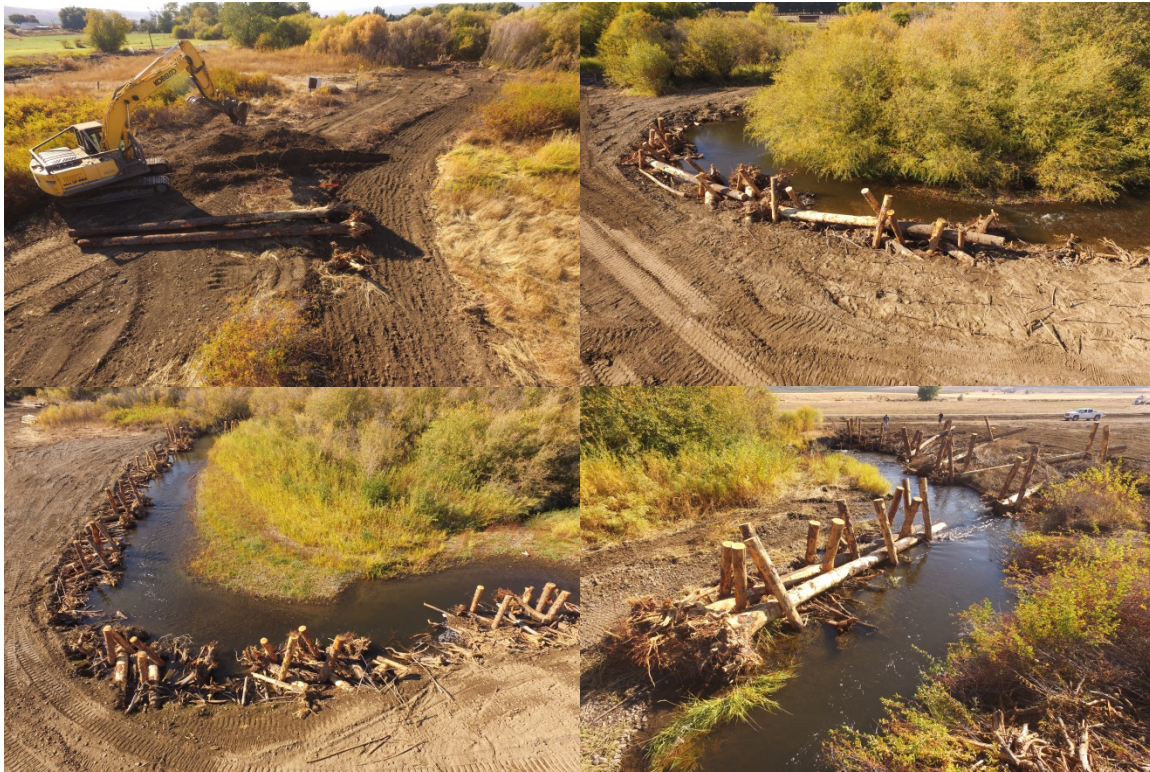
*Figure 2. Images depict restoration work during and after implementation (9/6/16-10/14/16). Structures were designed by Natural Systems Design (NSD).*

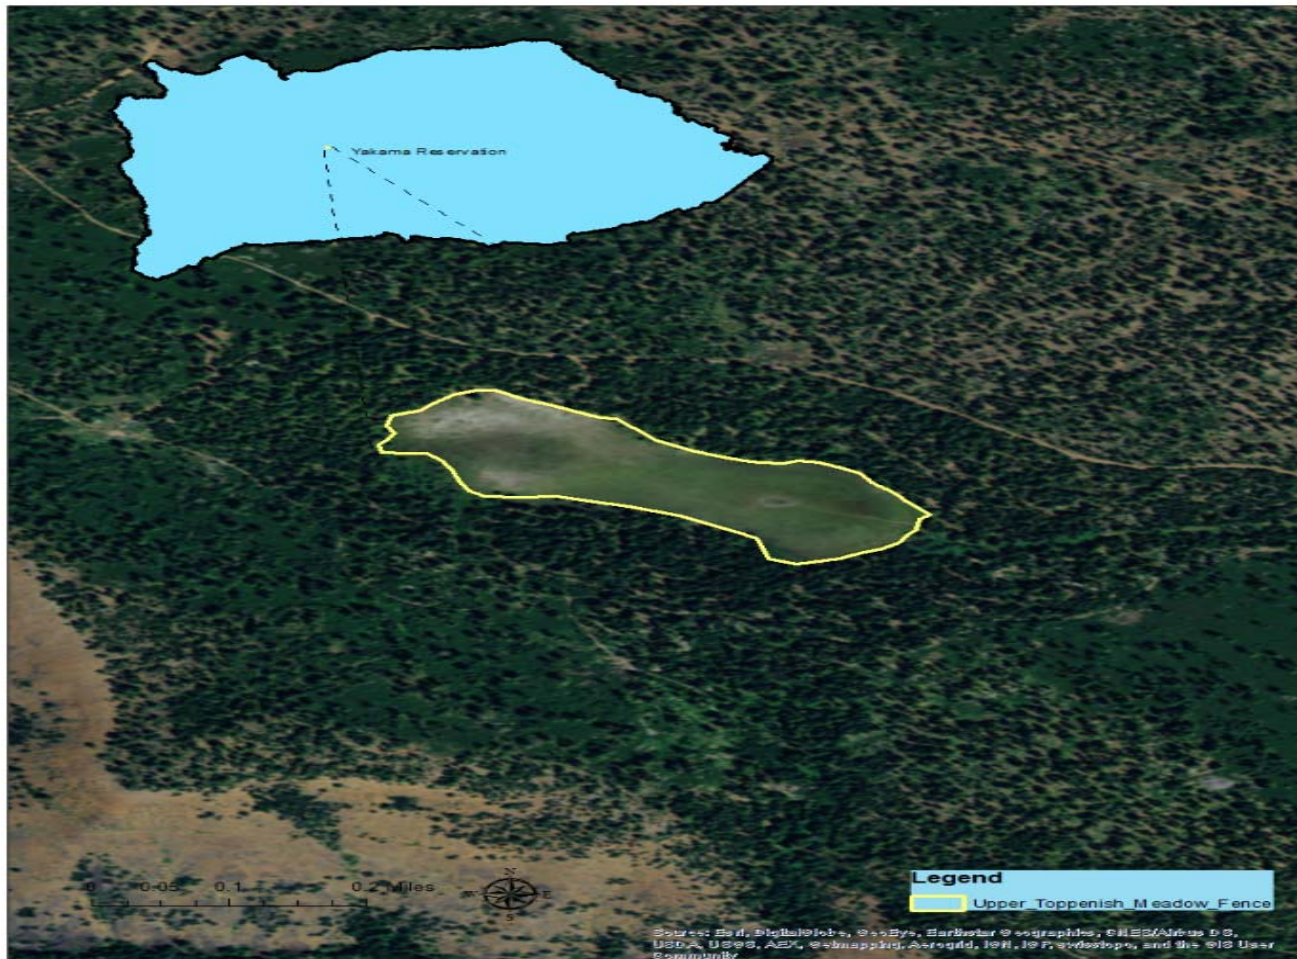
*Figure 3. Map depicts where the meadow fencing was conducted in the Upper Toppenish Creek watershed. The buck and pole style fence protects meadow resources while reducing negative impacts to livestock and wildlife.*

The Upper Toppenish Meadow Buck and Pole Fence was completed during the summer of 2016. The fence protects valuable meadow resources and minimizes livestock degradation to stream resources.

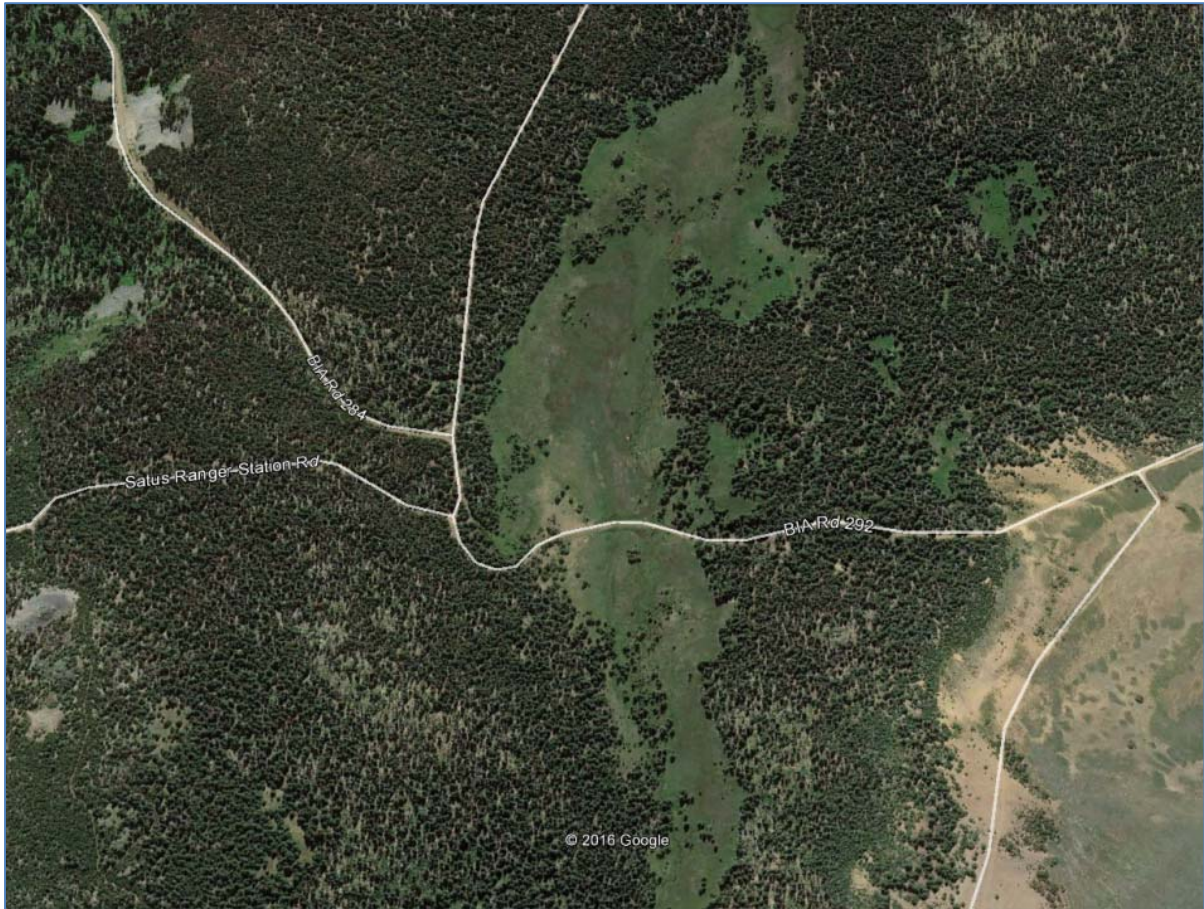
*Figure 4. Image depicts meadow and approximate area that fence was constructed during the summer of 2016. Final assessments and fence work will continue into the 2017 field season.*

The Lakebeds fence was started during the summer of 2016. It is a combination of buck and pole and 4-strand barbed wire. The fence will protect valuable cultural, meadow, and stream resources. The fence was only partially constructed during the summer of 2016. The project was larger than initially anticipated. An attempt to complete the fencing project will be made in 2017.

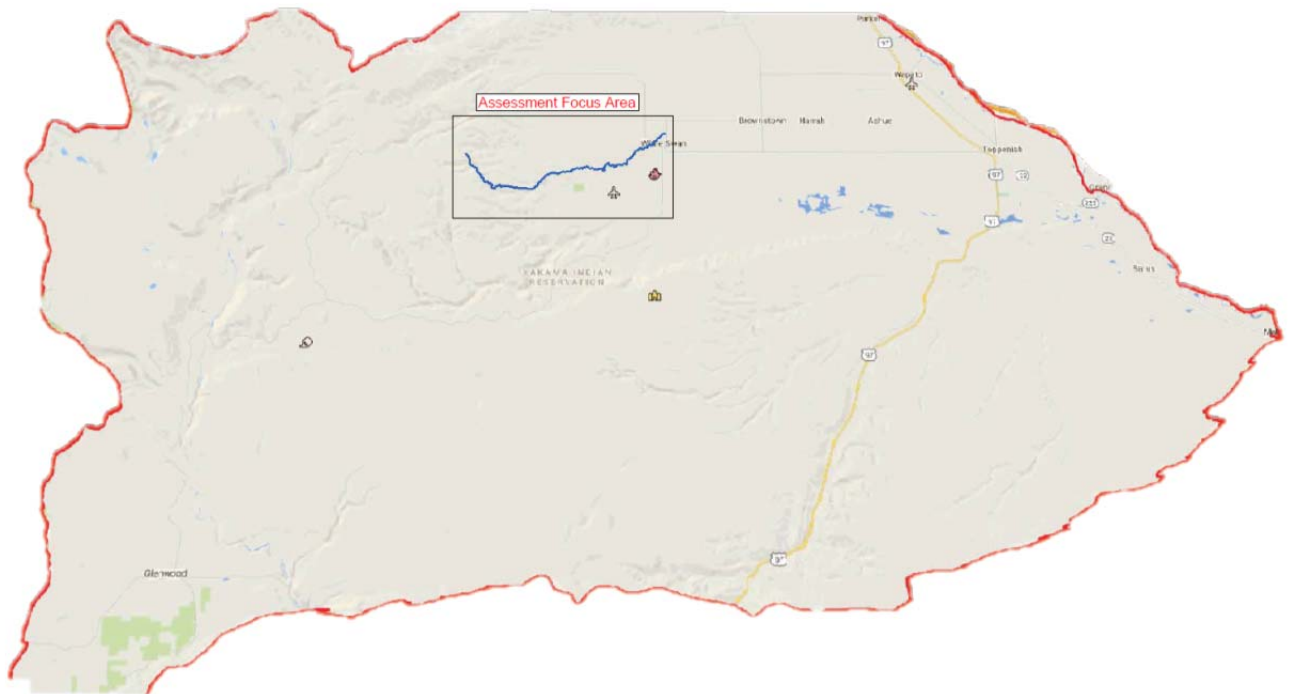
*Figure 6. Map depicts area where the Simcoe Creek reach assessment was conducted. Habitat conditions and potential project identification were assessed during the survey of Simcoe Creek 11/21/16-12/2/16.*
