Lower Wenatchee River Reach Assessment

LOWER WENATCHEE RIVER REACH ASSESSMENT

YAKAMA NATION FISHERIES
401 Fort Road
Toppenish, WA 98948

May 2016

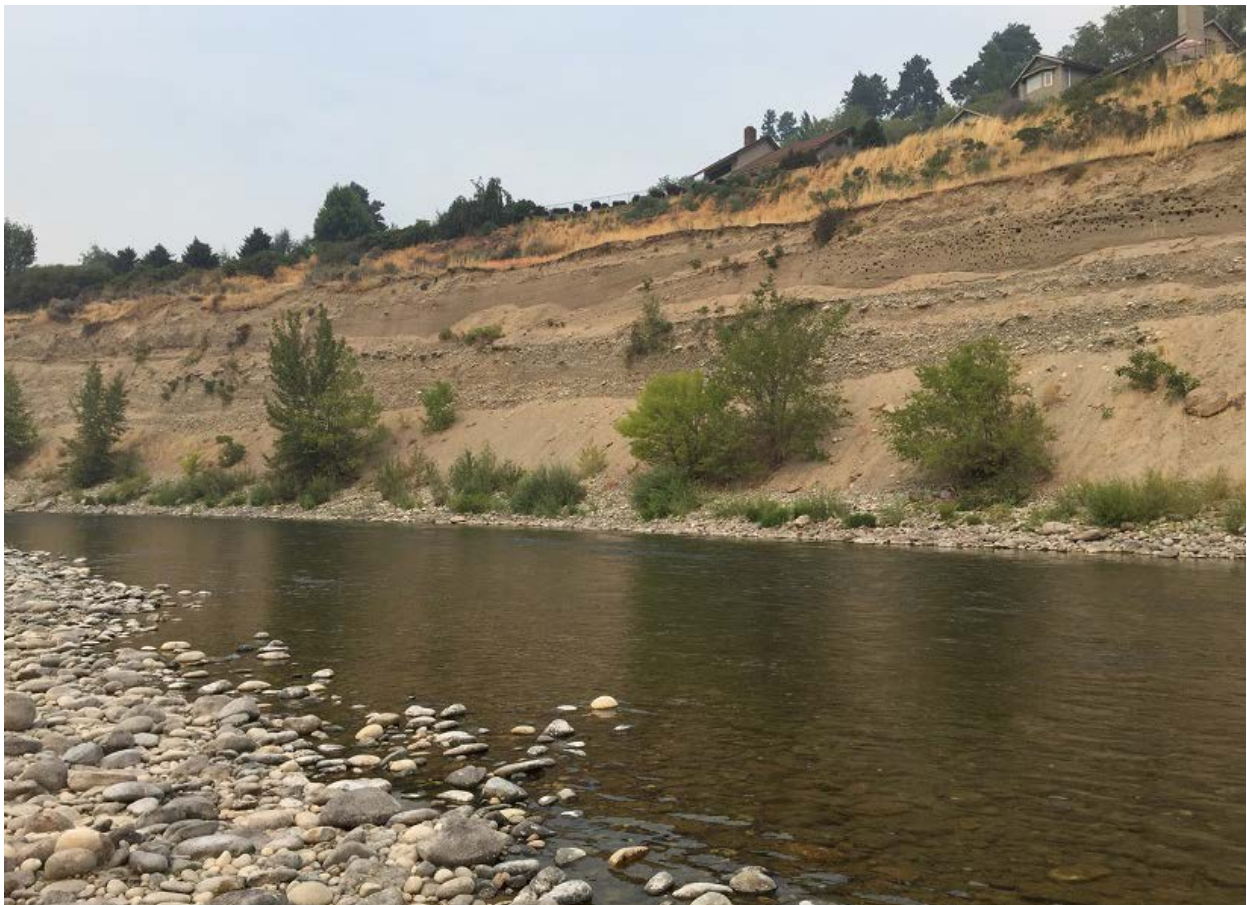
Figure 2-3. Photograph of Exposed Glacial Terrace in Reach 2 near RM 1.7

The resulting landscape of the lower Wenatchee valley is a mosaic of glacial moraines and terraces, steep-sided valley hillslopes, bedrock outcrops, and stepped alluvial floodplains. The photograph in Figure 2-3 shows an exposed glacial terrace in Reach 2 near RM 1.7. Figures 2-4a and 2-4b contain geologic mapping of the lower Wenatchee River valley including bedrock geology and depositional features (Tabor et al. 1982; Tabor et al. 1987).

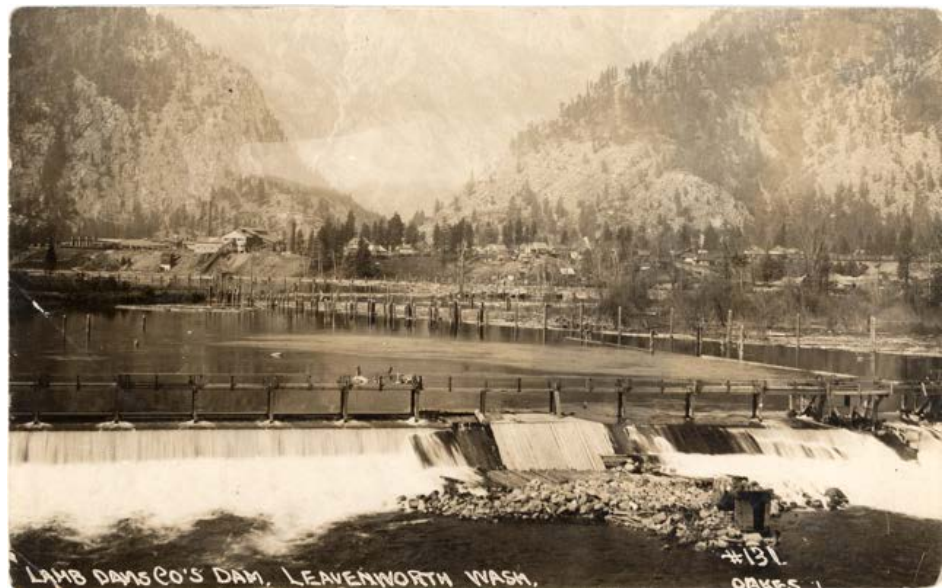
Figure 2-8. Lamb-Davis Lumber Company – Mill Pond Dam (Source: Upper Valley Museum at Leavenworth).

The main timber industry feature along the Lower Wenatchee River was the mill in Leavenworth. In 1903, the Lamb-Davis Lumber Company was incorporated, located on the banks of the river at the southern edge of town (Kinney-Holck and Upper Valley Museum 2011). The historic photograph in Figure 2-7 shows workers standing in front of the mill. The harvest for the mill took place upriver near Lake Wenatchee, and then logs were floated down to the mill for processing, often by splash damming. The historic photograph in Figure 2-8 shows the mill pond dam.

present-day Enchantment Park in Leavenworth, WA). The mill pond dam no longer exists, though remnants such as log pilings and a boulder line are visible in the river. Prior to construction of this dam, Native American fishing grounds were near the mouth of Tumwater Canyon; after its construction they had to fish below the structure (Mullen 1992).

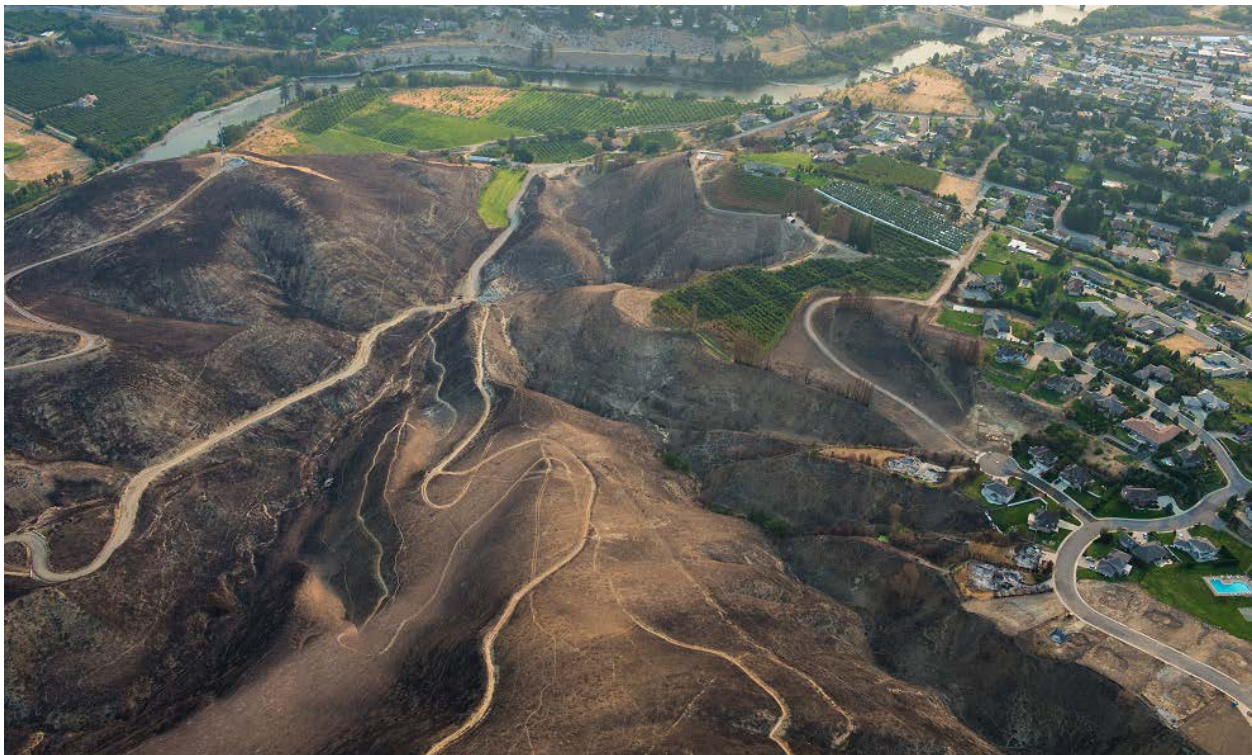
Figure 2-9. Oblique Aerial Photograph of Recent (2015) Fire Damage in the Foothills near Wenatchee (source: Shane Wilder of Icicle TV, flight provided by Lighthawk and the UCSRB)

In 2015 fire season started earlier than usual, in late June, with the Sleepy Hollow Fire west of the city of Wenatchee. The wildfire burned 2,950 acres, destroying 29 homes and several commercial buildings (InciWeb 2015). The oblique aerial photograph in Figure 2-9 shows fire damage from the Sleepy Hollow Fire.

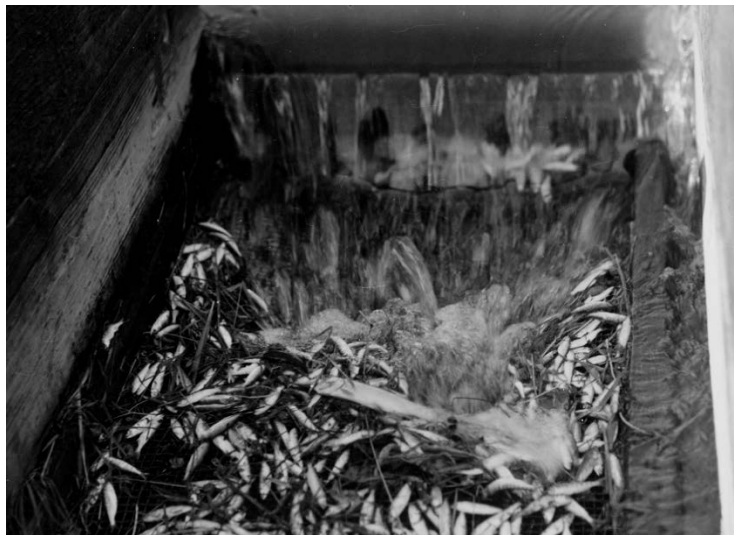
Figure 2-12. Photograph of Dead Chinook Fingerlings in an Unscreened Diversion Box at the End of the Rock Island Branch of Dryden Canal – 1940 (source: Oregon State University Libraries Special Collections & Archives Research Center)

Starting in 1891, the lower Wenatchee River has been diverted for irrigation. Early diversions were unscreened for many decades, which was a considerable limiting factor for salmonids. The photograph in Figure 2-12 shows dead Chinook fingerlings in an unscreened diversion box on Rock Island Branch of Dryden Canal in 1940.

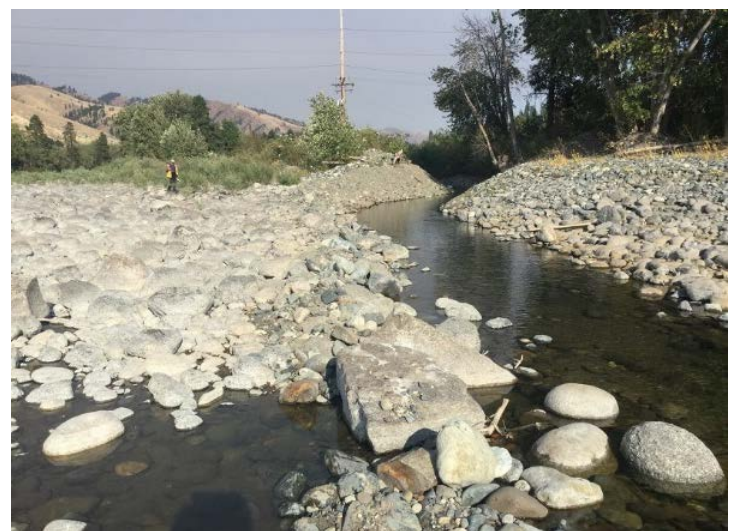
Figure 2-13. Example of an Irrigation Diversion near RM 13.7

The photograph in Figure 2-13 shows an irrigation diversion in Reach 6. Although not shown in the photograph, the diversion is screened.

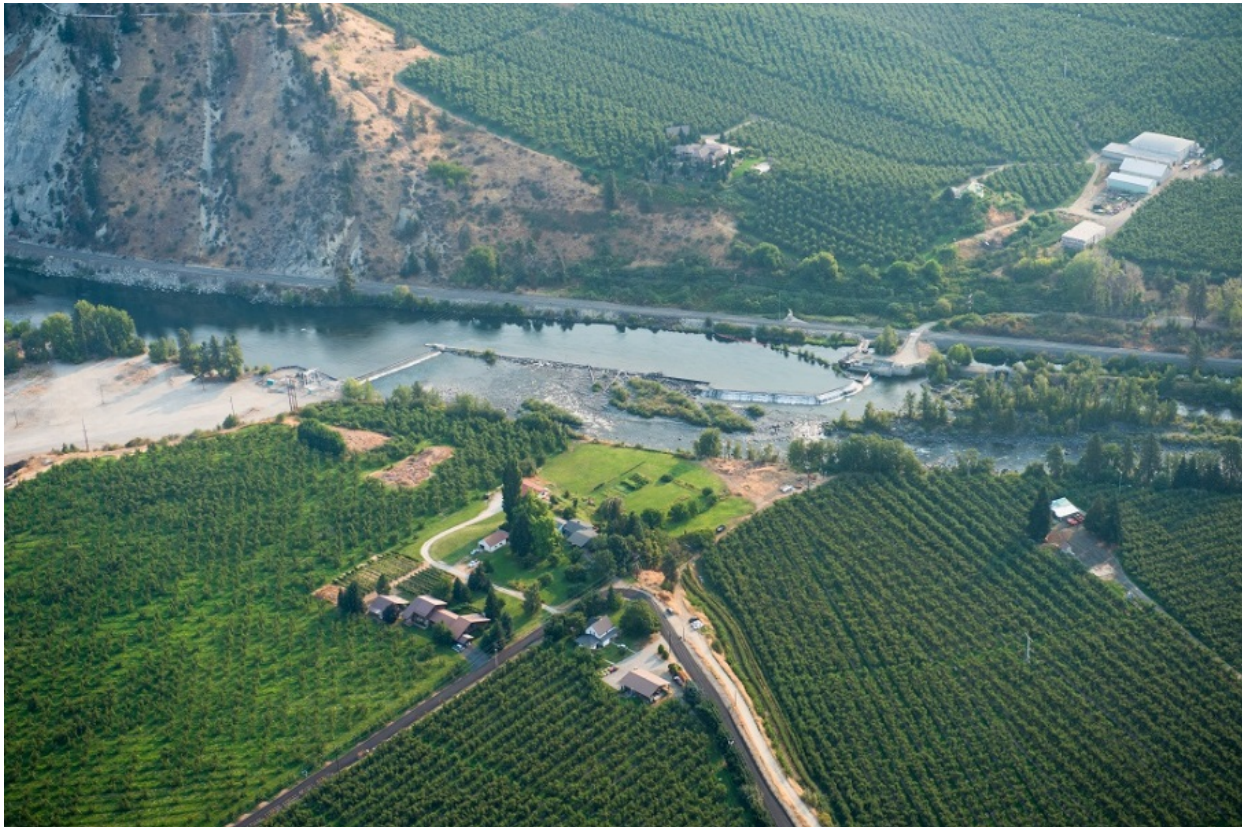
Figure 2-14. Oblique Aerial Photograph of the Dryden Diversion Dam (source: .Shane Wilder of Icicle TV, flight provided by Lighthawk and the UCSRB)

The U.S. Fish and Wildlife Service (USFWS) documented as early as 1942 that salmon runs decreased rapidly after the dam was built in Leavenworth for the mill and the Tumwater Dam (Mullen 1992). The Dryden Diversion Dam, shown in Figure 2-14, has two functioning fish passage and trapping facilities (right and left bank) for broodstock collection with fish screens improved in 2001 (Andonaegui 2001).

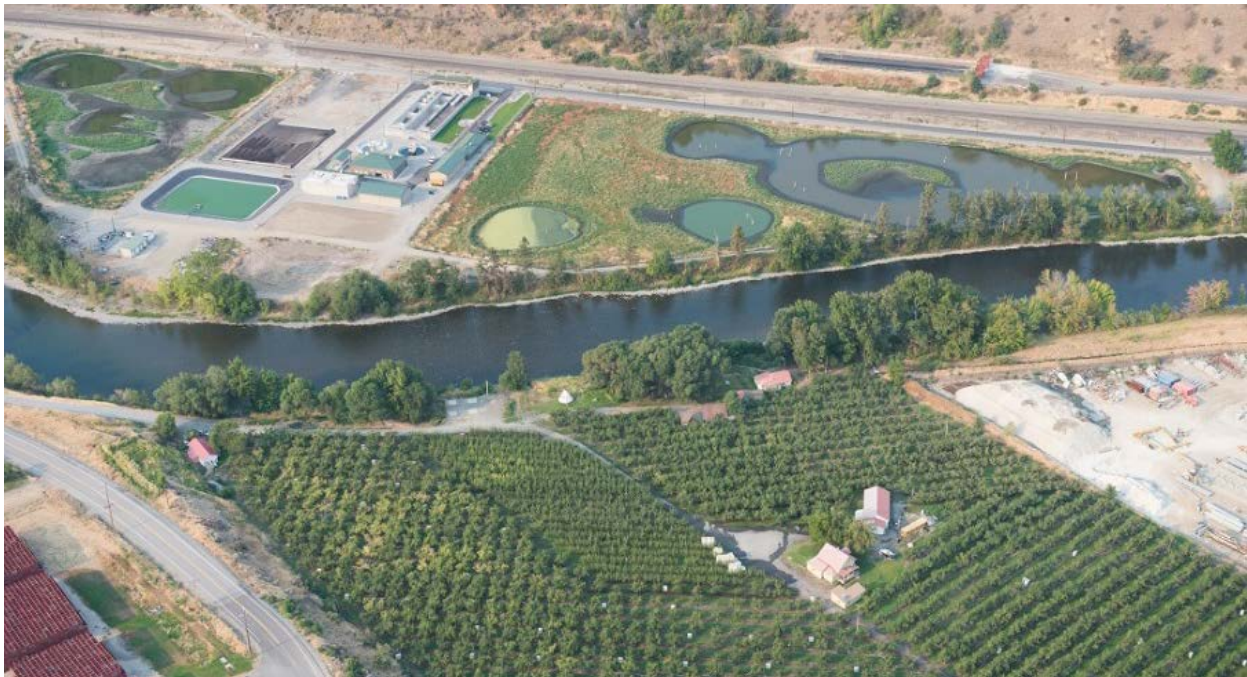
Figure 2-15. Oblique Aerial Photograph of the Sewage Treatment Facility near Cashmere (source: Shane Wilder of Icicle TV, flight provided by Lighthawk and the UCSRB)

Two wastewater treatment facilities in Peshastin and Cashmere are considered point sources of phosphorus into the lower Wenatchee River (Ecology 2009). The oblique aerial photograph in Figure 2-15 shows the Sewage Treatment Facility near Cashmere. These facilities directly discharge treated water and may be able to implement improved treatment systems to reduce phosphorous. Non-point sources of pollution to the lower Wenatchee River area may include landfills, on-site septic systems on the floodplain, trash dumps in Dryden and Cashmere, the Dryden community septic drain field, agricultural runoff, and a number of other potentially leaking waste/sewer systems (Ecology 2009).

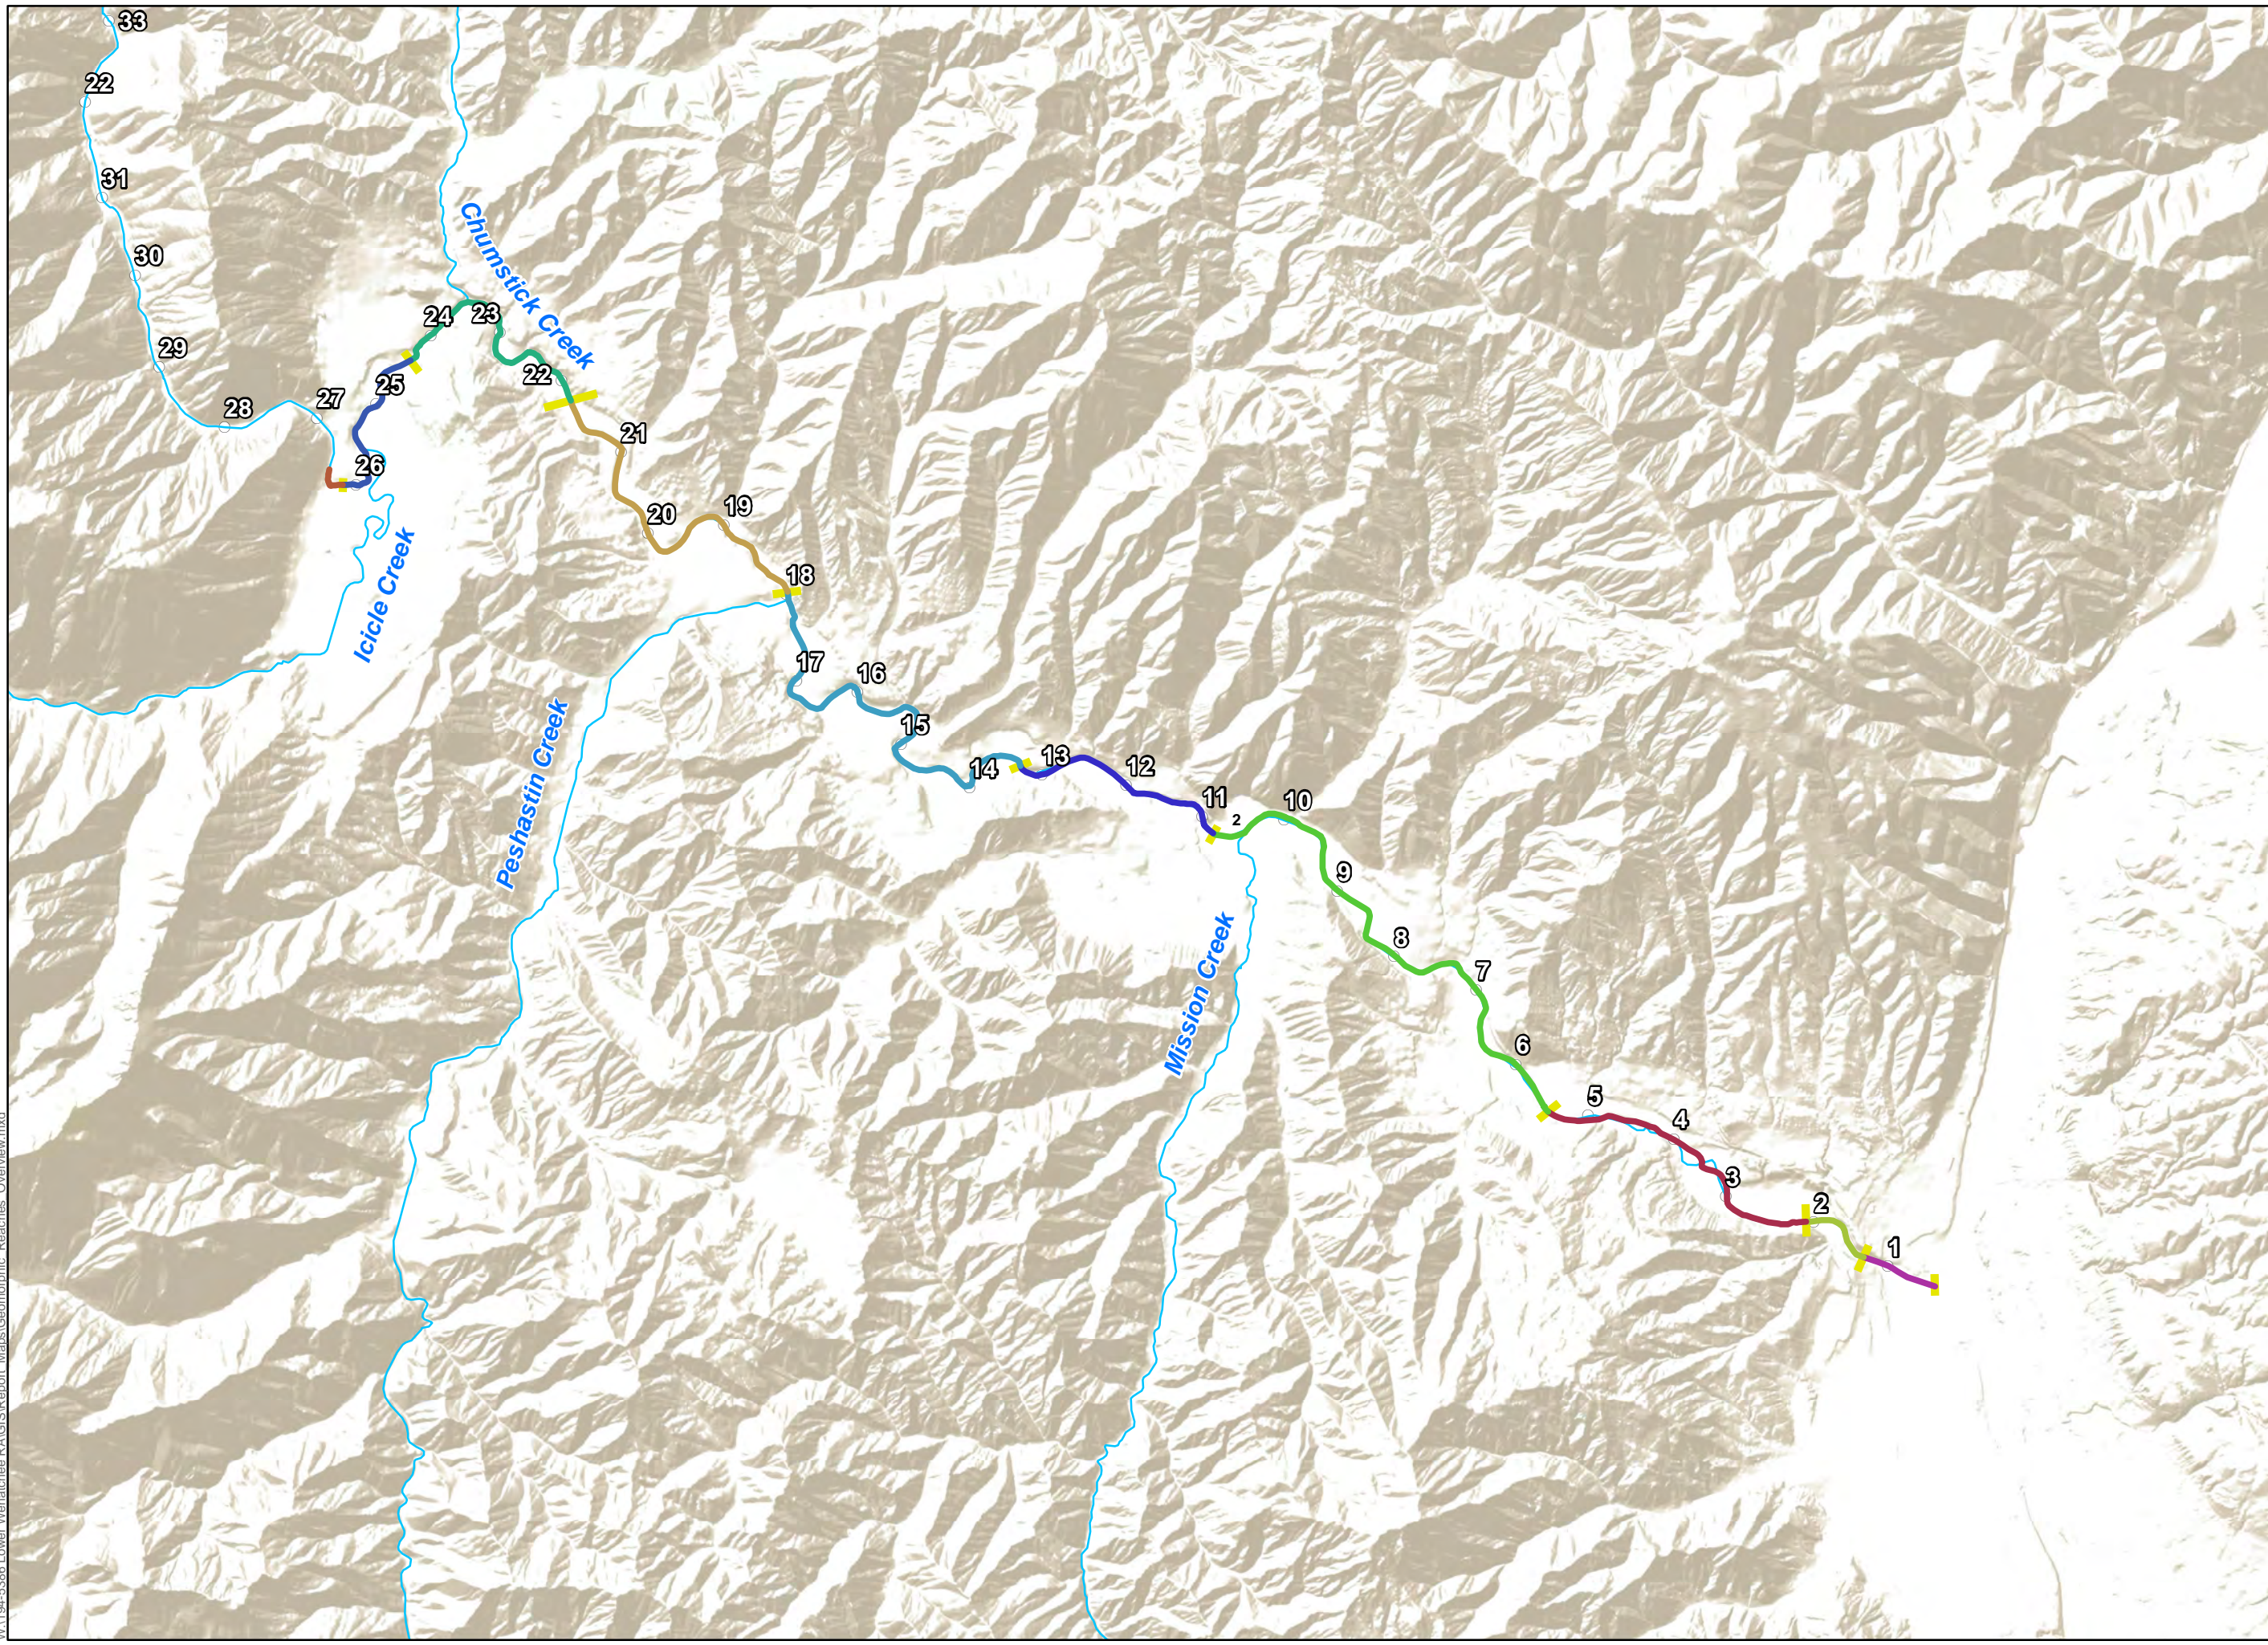
Lower Wenatchee River Reach Assessment Geomorphic Reaches Overview

- USGS River Mile
- Reach 1
- Reach 2
- Reach 3
- Reach 4
- Reach 5
- Reach 6
- Reach 7
- Reach 8
- Reach 9
- Reach 10
- River/Stream
- Geomorphic Reach Break

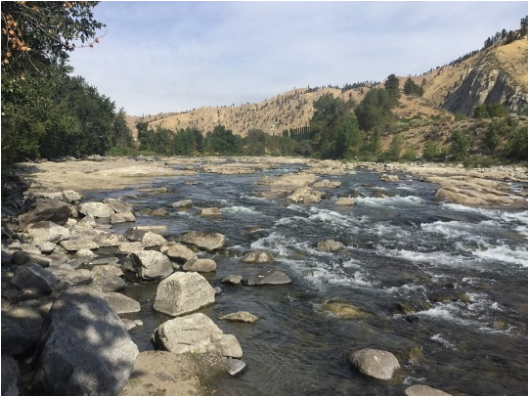
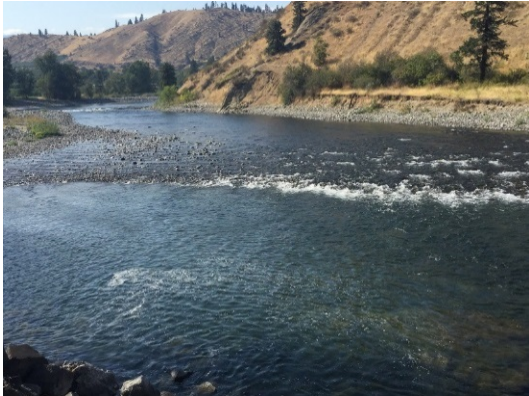
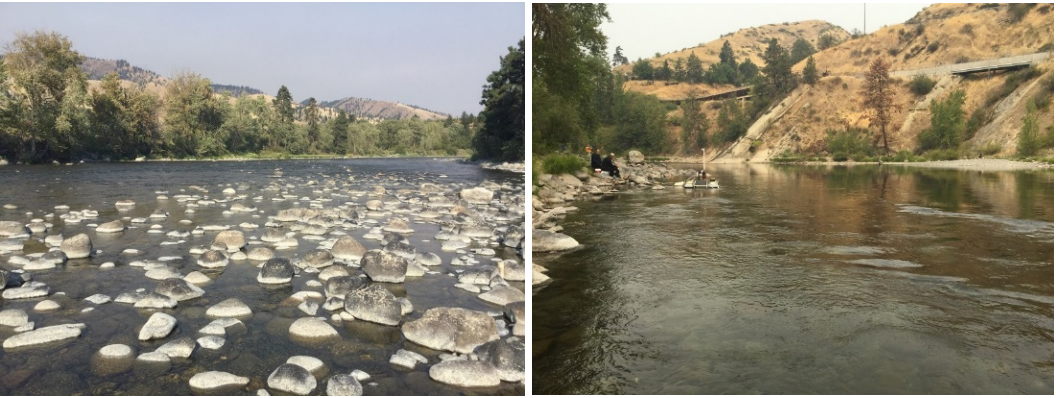
Table 4-7. Geomorphic Reach 6 Location and Existing Characteristics

Reach Characteristics		Location Map and Photos
River Miles	13.25 to 18.0

Valley Setting	Broad, stepped terrace	
Confining features	BNSF Railway, roads and highways, valley hillslopes, bedrock, and high terraces, Dryden Diversion Dam, residential and urban development	
Channel Morphology	Irregular sinuous pattern, occasional islands, point, mid-channel, and lateral bars	
Migration Process	None ^{1/}	
Rosgen Type	F3	
Gradient	0.52%	
Sinuosity	1.65	
Bankfull Width (ft)	235	
Floodplain Width (ft)	566	
Bank Condition	Armored (10%), eroding (0%)	
Floodplain Disconnected	62%	
Sediment	Sand (10%), gravel (10%), cobble (45%), boulder (25%), bedrock (10%)	
LWD (pieces/mile)	1.4	
Channel Units	Pool (21%), Glide (17%), Riffle (59%), Rapid (2%)	
Off Channel Habitat (percent of total)	0%	
REI Score	17 (fair)

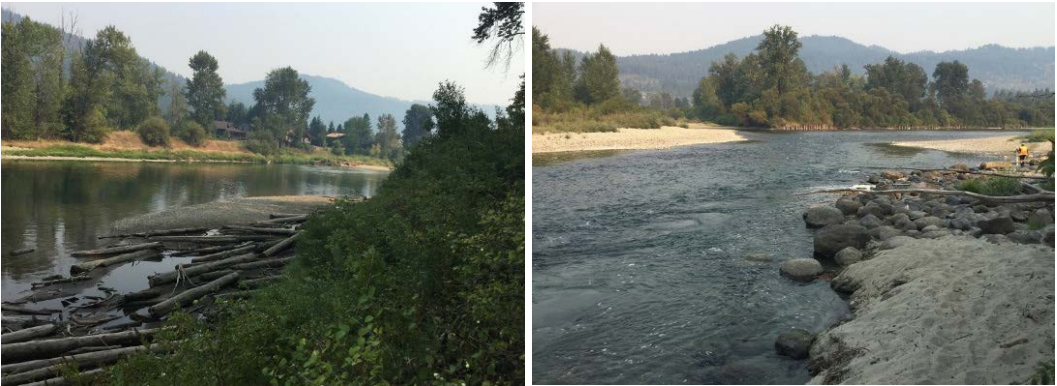
Table 4-10. Geomorphic Reach 9 Location and Existing Characteristics

Reach Characteristics		Location Map and Photos
River Miles	24.35 to 26.15	
Valley Setting	Very broad, low stepped terrace	
Confining features	Low terraces, residential and commercial development	
Channel Morphology	Irregular sinuous pattern, frequent irregular islands, point and lateral bars	
Migration Process	Irregular lateral	
Rosgen Type	C4	
Gradient	0.15%	
Sinuosity	1.28	
Bankfull Width (ft)	344	
Floodplain Width (ft)	1,566	
Bank Condition	Armored (1%), eroding (0%)	
Floodplain Disconnected	13%	
Sediment	Sand (23%), gravel (33%), cobble (39%), boulder (6%), bedrock (0%)	
LWD (pieces/mile)	5.4	
Channel Units	Pool (10%), Glide (74%), Riffle (16%), Rapid (0%)	
Off Channel Habitat (percent of total)	45%	
REI Score	23 (good)

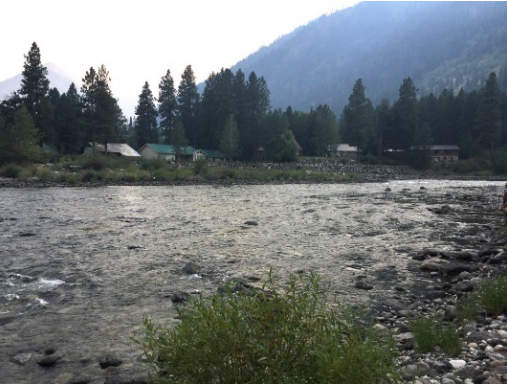
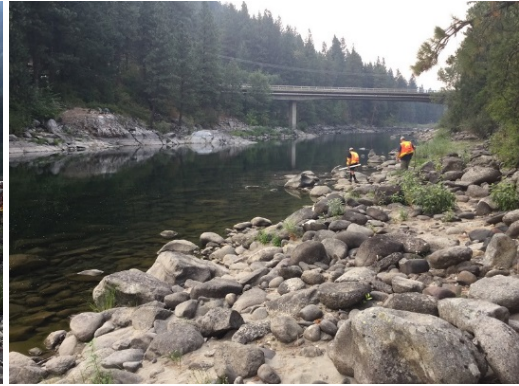
Table 4-11. Geomorphic Reach 10 Location and Existing Characteristics

Reach Characteristics		Location Map and Photos
River Miles	26.15 to 26.40

Valley Setting	Narrow, right bank valley hillslope	
Confining features	Valley hillslope, roads, and residential bank protection	
Channel Morphology	Sinuuous planform, no islands, point and lateral bars	
Migration Process	Irregular lateral	
Rosgen Type	F2	
Gradient	0.18%	
Sinuosity	1.44	
Bankfull Width (ft)	196	
Floodplain Width (ft)	217	
Bank Condition	Armored (16%), eroding (0%)	
Floodplain Disconnected	7%	
Sediment	Sand (15%), gravel (13%), cobble (35%), boulder (38%), bedrock (0%)	
LWD (pieces/mile)	3.3	
Channel Units	Pool (63%), Glide (0%), Riffle (37%), Rapid (0%)	
Off Channel Habitat (percent of total)	0%	
REI Score	23 (good)

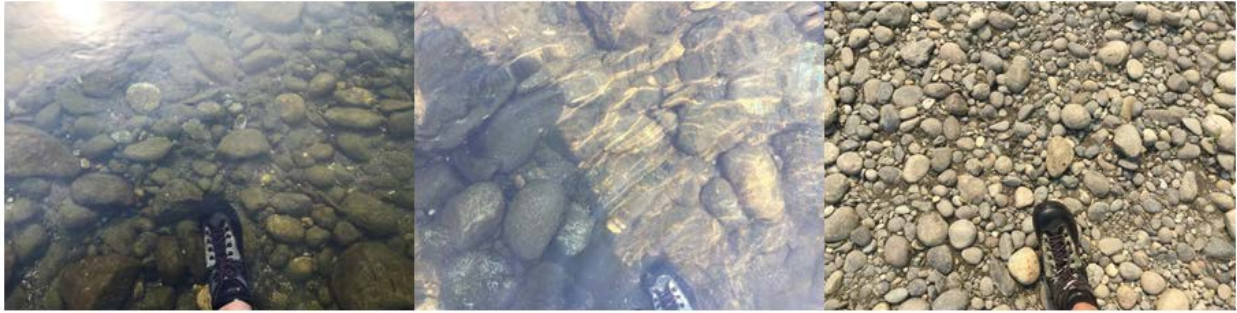
Figure 4-10. Photos of Typical Channel Substrate Conditions at 3 Locations Including RM 2.0 in Reach 2 (left), RM 19.1 in Reach 7 (middle), and RM 24.6 in Reach 9

In general, the lower Wenatchee River is cobble-dominated with the exception of Reach 1, where bed sediments transition rapidly from cobble- to sand-dominated, and Reach 9, which transitions from cobble- to gravel-dominated, both in the downstream direction. From Reach 8 downstream, there is a gradual trend of decreasing size in the cobble-dominated substrate. The three field photographs in Figure 4-10 show typical bed sediments in Reach 2, Reach 7, and the downstream end of Reach 9.

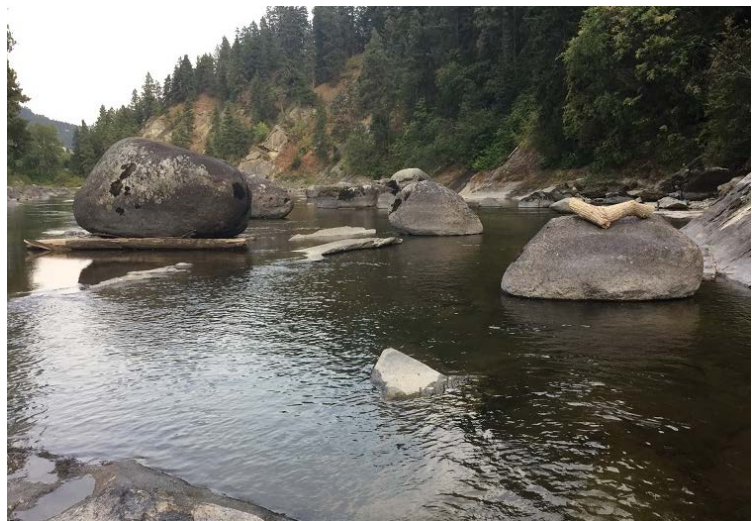
Figure 4-11. Boulders and Bedrock near RM 22.7 in Reach 8

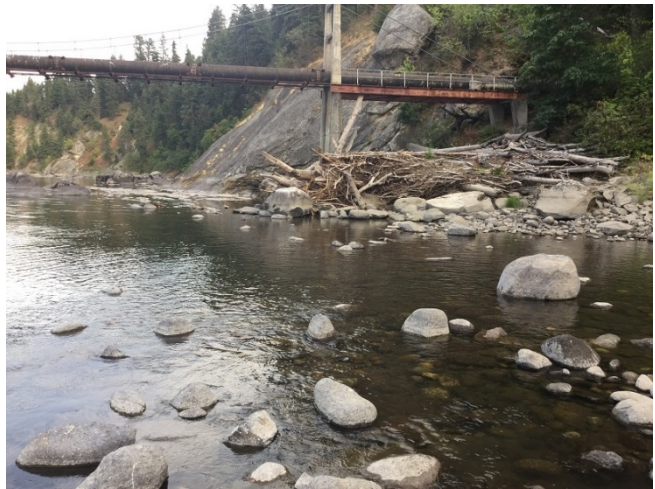
Figure 4-13. Photograph of Rare Log Jam Racked on a Crossing Abutment in Reach 8, near RM 22.8

Over 95 percent of the LWD inventoried was in the medium size class. Typically, individual pieces of LWD were found intermittently along the bankfull channel margins occasionally in small groups but not in jam configurations. One exception to this was the log jam shown in Figure 4-13 within Reach 8 that was racked on a crossing abutment in a narrow, bedrock controlled part of the river.

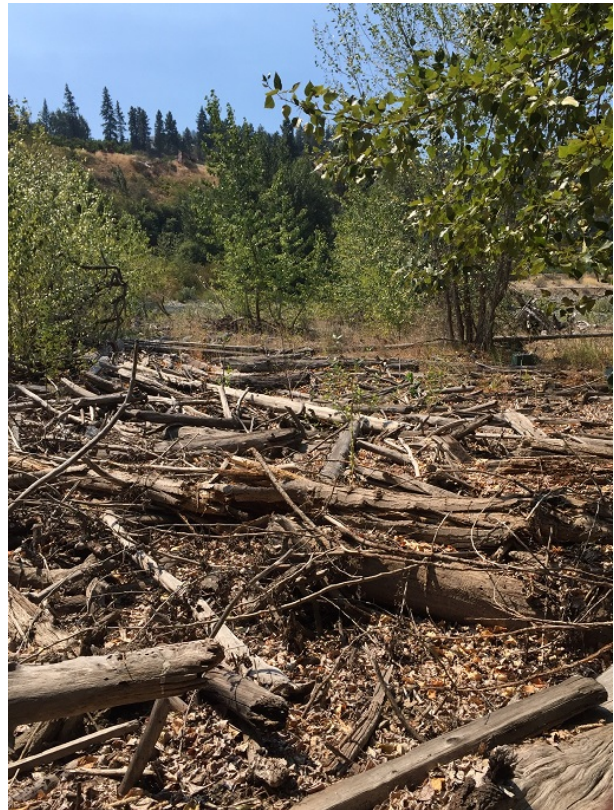
Figure 4-14. Photograph of Floodplain Jam at a Side Channel Inlet in Reach 5 at RM 12.0

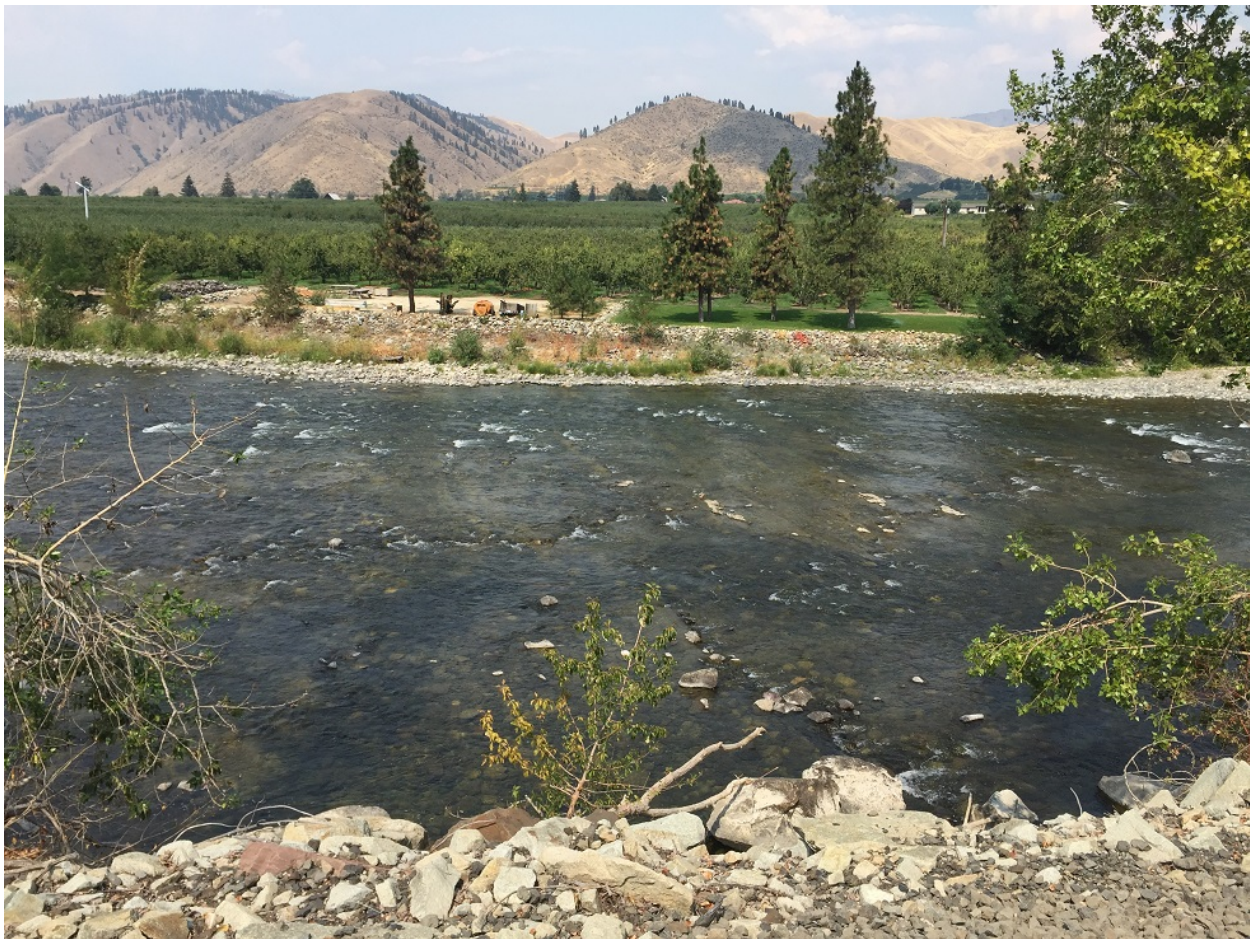
Figure 4-17. Example of an Existing Orchard in the Riparian Area near RM 7.7 in Reach 4

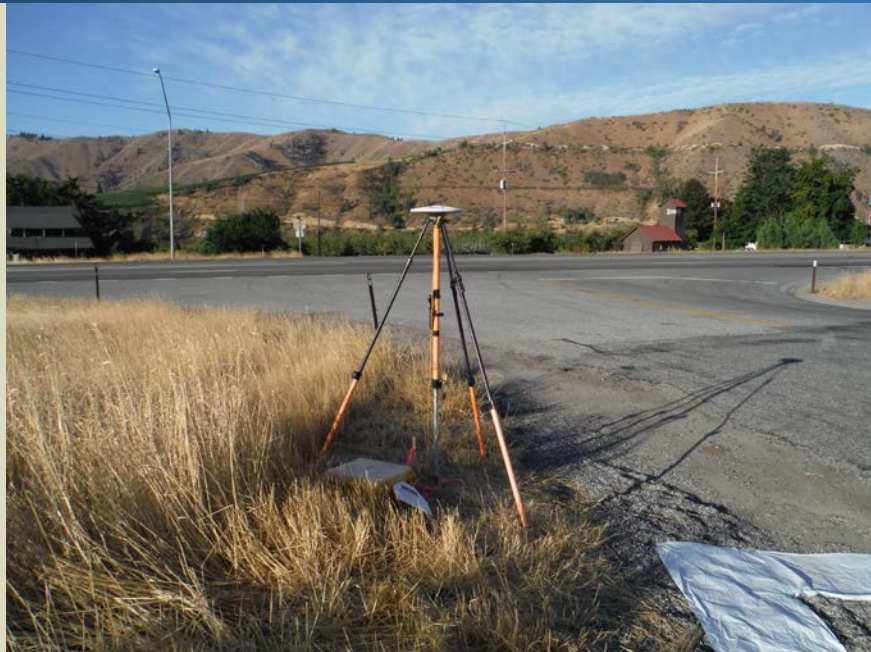
QSI's ground acquisition equipment set up over monument LOW_WEN_02 in the Lower Wenatchee River LiDAR study area.

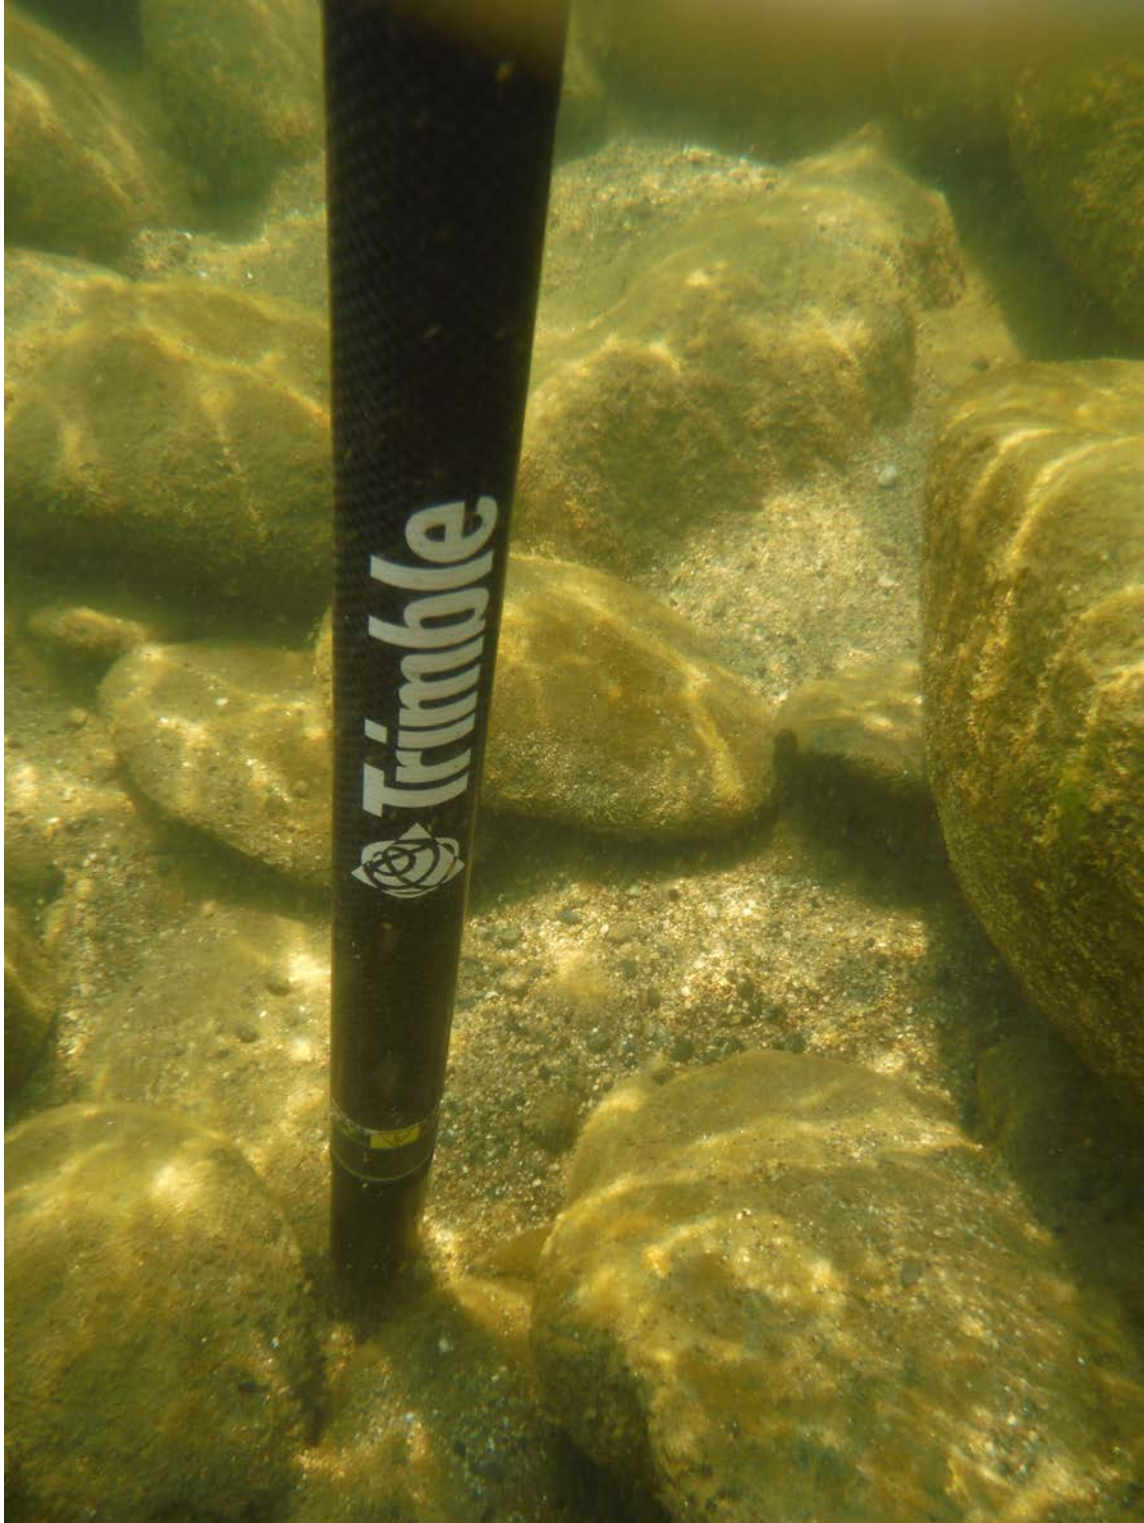
This photo taken by QSI acquisition staff displays water clarity conditions in the Lower Wenatchee River near the town of Monitor, WA.

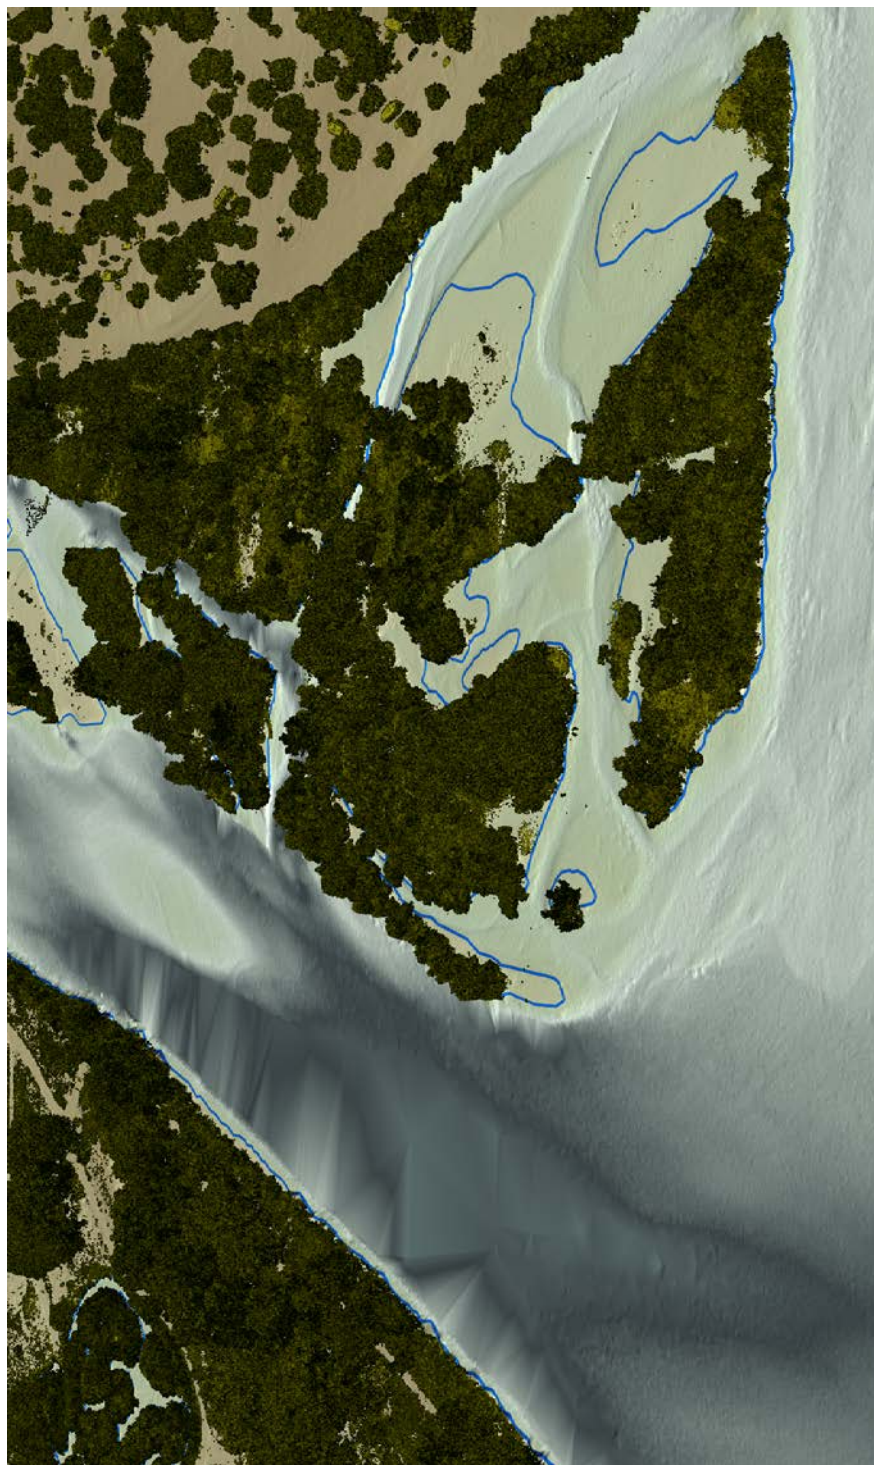
Figure 22: View looking west over Wenatchee River Confluence State Park. The image is created from the gridded, topobathy bare earth model overlaid with the vegetation point cloud and water breaklines.

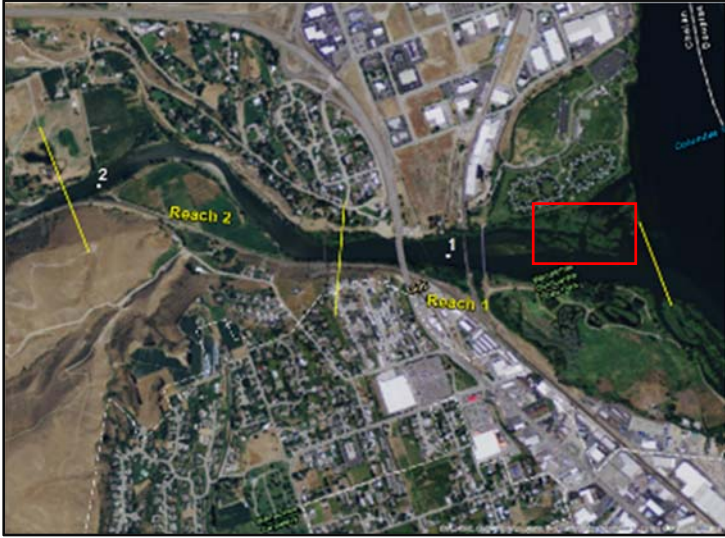
RM 0.8 Left Bank	Install Habitat Structures	1 – Land Protection 20 – LWD Placements	Existing distributary channels lack complex instream habitat and cover. Install large wood habitat structures in distributary channels to create habitat complexity and cover; protect property to maintain existing connectivity. Access to channels for large wood placement may be problematic.	28

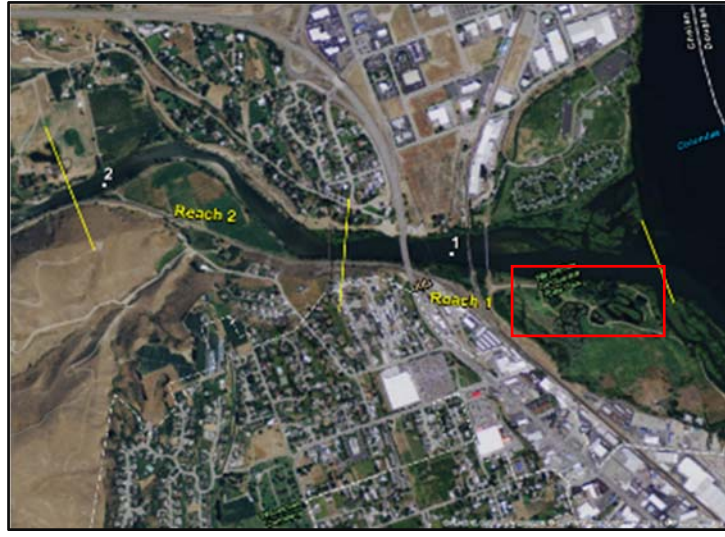
RM 0.8 Right Bank	Floodplain Habitat Reconnection	1 – Land Protection 14 – Beaver Re-introduction 16 – Bank Shaping and Stabilization 17 – Remove Bank Armoring 18 – Bank Bioengineering 20 – LWD Placement 24 – Floodplain Restoration 25 – Floodplain Benching 28 – Secondary Channel 31 – Alcove	Existing distributary channels are disconnected from mainstem, floodplain is perched. Evidence of past restoration efforts, but did not reconnect to mainstem. Reconnection of historic distributary channels and disconnected floodplain, with added large wood structures will provide added instream habitat. Modification of existing trails and install water crossing structure.	11

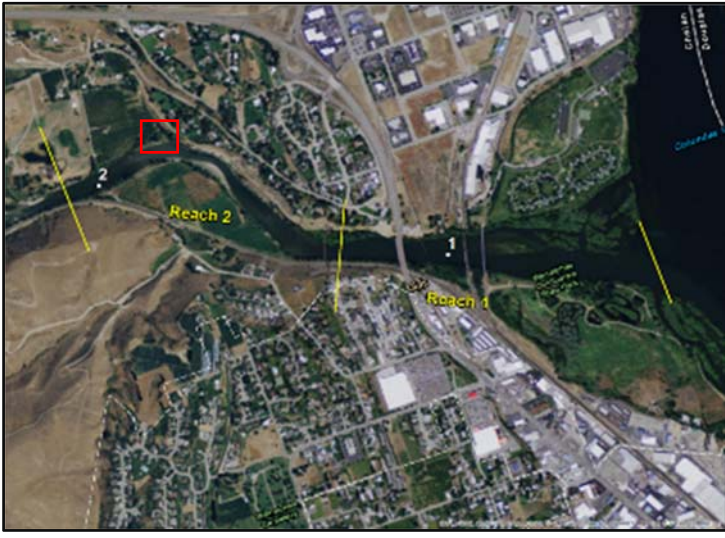
RM 1.9 Left Bank	Floodplain Habitat Reconnection	1 – Protection 12 – Riparian Buffering 20 – LWD Placements 31 - Alcove	There is a small existing alcove located on the outside bend, providing limited habitat. Floodplain upstream can be graded to increase the size of the existing backwater alcove. Install large wood habitat structures to create habitat complexity and cover; plant native vegetation.	23

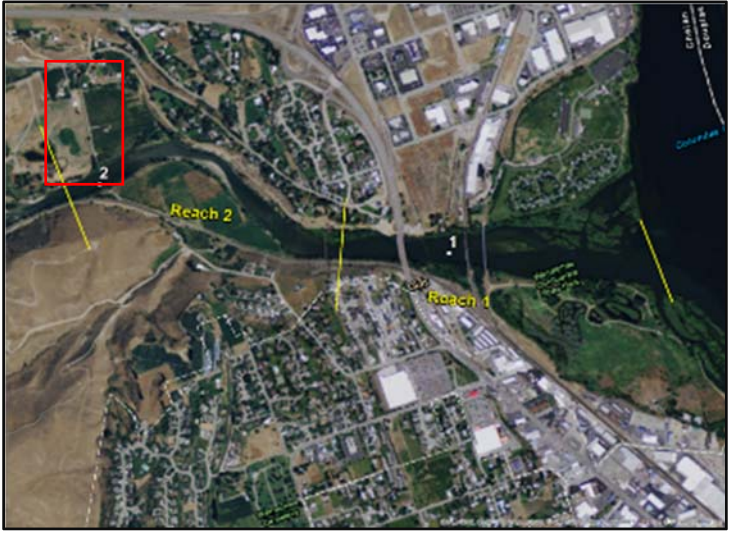
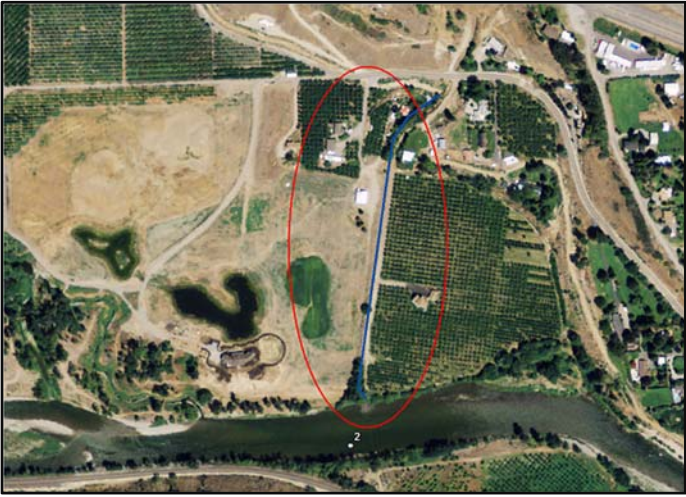
RM 2.0 Left Bank	Tributary Restoration	<ul style="list-style-type: none"> 1 – Protection 12 – Riparian Buffer Strip 15 – Riparian Fencing 20 – LWD Placement 24 – Floodplain Restoration 34 – Pool Construction 35 – Riffle Construction 37 – Channel reconstruction 	Existing irrigation ditch (Highline Ditch return) currently functions as a cold water return source. Confluence is connected at summer low flows, so channel is perennially accessible. Realignment of this channel, with construction of pools and large wood structures will significantly increase rearing capacity along with shading via native vegetation planting.	9

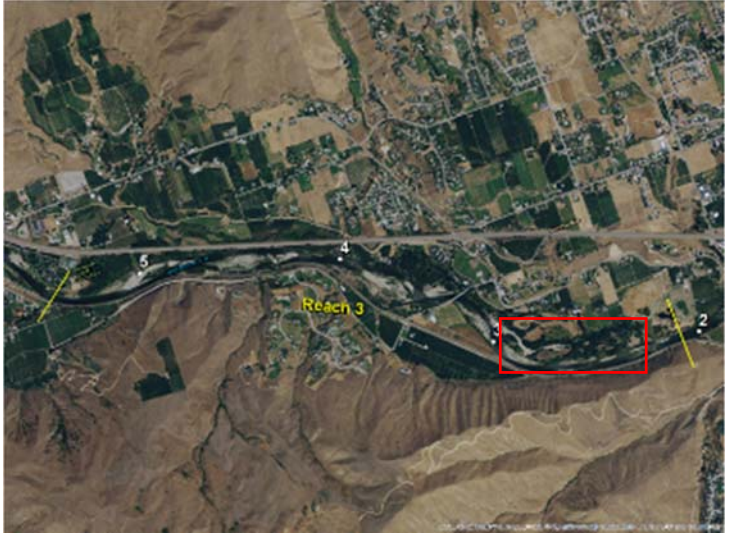
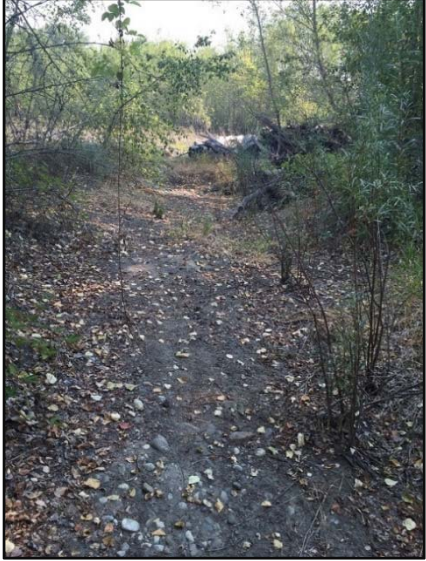
RM 2.2 to 3.0 Left Bank	Floodplain Habitat Reconnection	<ul style="list-style-type: none"> 1 – Protection 12 – Riparian Buffer 18 – Bank Bioengineering 20 – LWD Placements 24 – Floodplain Restoration 26 – Thermal Refugia 27 – Perennial Side Channel 28 – Secondary Channel 32 – Hyporheic Off-Channel 36 – Meander Re-connect 	Existing side channels with existing cover and decent instream habitat are cut off from main channel. Evidence of past restoration efforts at downstream end of floodplain. Excavation of inlet and ELJ to control inlet flows. Reconnecting side channels and installing large wood structures will increase available rearing habitat. Purchase for future protection.	1
