Lower Wenatchee River Reach Assessment

LOWER WENATCHEE RIVER REACH ASSESSMENT

YAKAMA NATION FISHERIES
401 Fort Road
Toppenish, WA 98948

May 2016

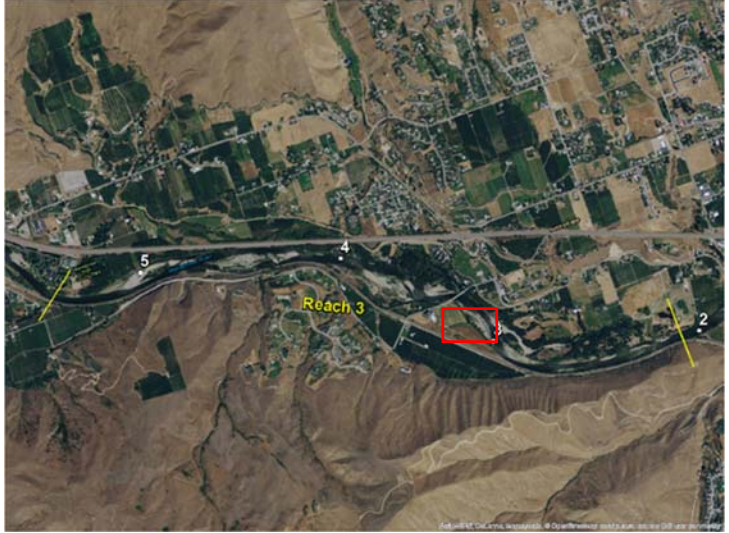
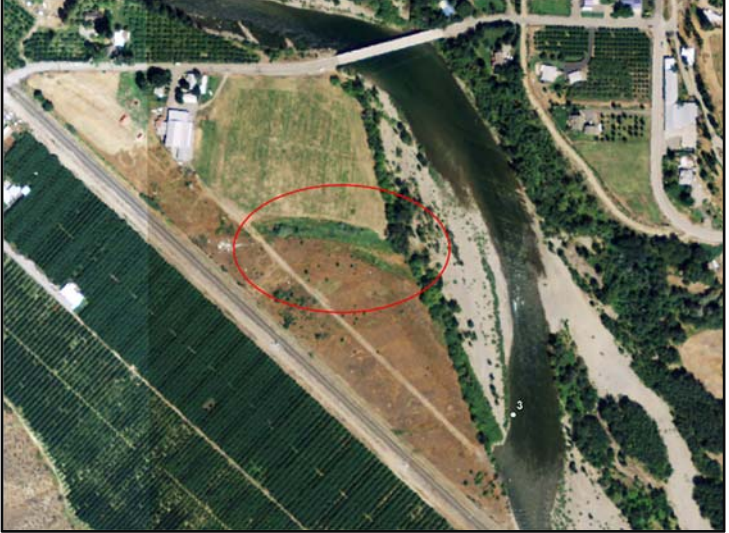
RM 3.0 Right Bank	Floodplain Habitat Reconnection	<ul style="list-style-type: none"> 1 – Land Protection 12 – Riparian Buffer 20 – LWD Placements 24 – Floodplain Restoration 31 – Alcove 	Proposed backwater alcove area is currently accessed at the 2-yr flood event. Would require minimal excavation to activate perennially. Would require excavation or large wood placement upstream to encourage perennial flows to utilize the low floodplain topography. Plant native vegetation.	19

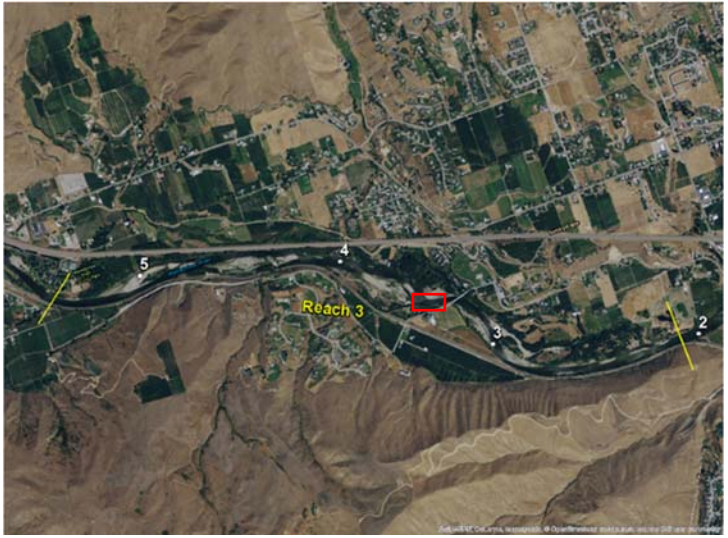
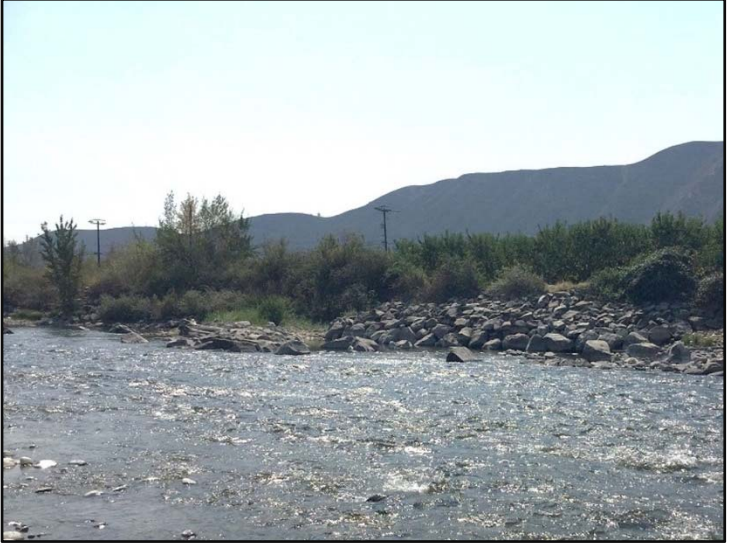
RM 3.3 Right Bank	Enhance Existing Bank Protection	18 – Bank Bioengineering 20 – LWD placement	Existing groins provide bank stability, but only minimal habitat benefit to river. Additions of large wood and ELJ would create local habitat complexity and cover. Large wood additions provide opportunity to create local scour pools.	30

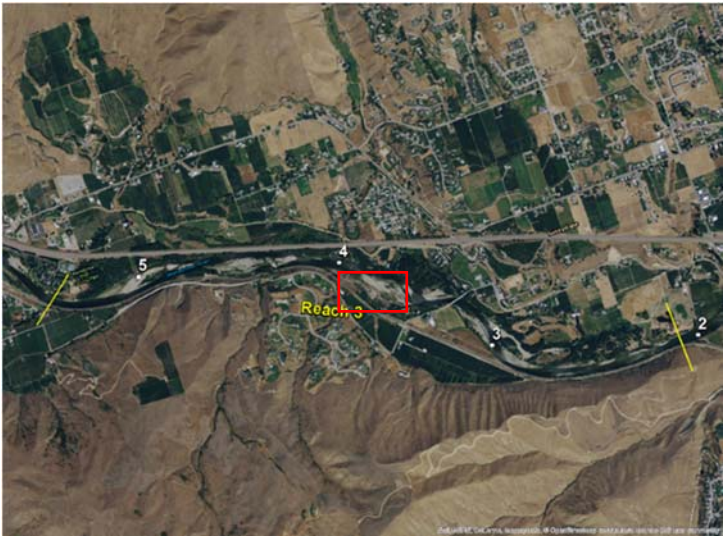
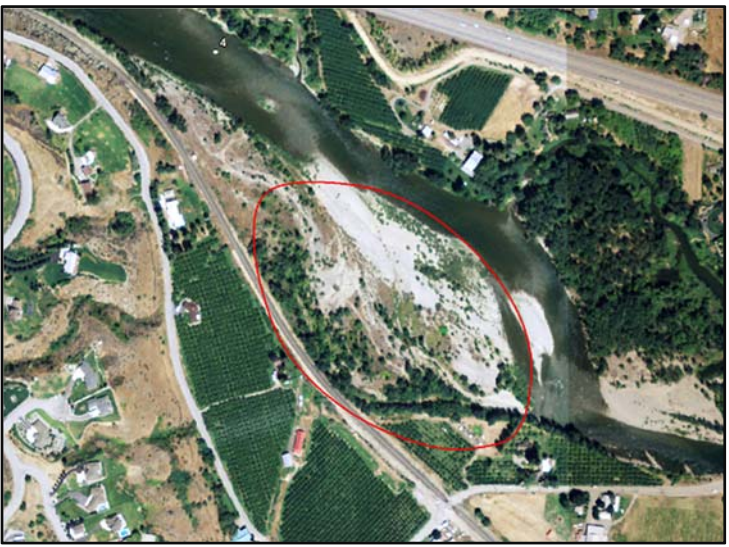
RM 3.8 Right Bank	Floodplain Habitat Reconnection	1 – Land Protection 12 – Riparian Buffer 20 – LWD Placement 24 – Floodplain Restoration 27 – Perennial Side Channel 28 – Secondary Channel 31 – Alcove	Downstream section of existing side channel has very good habitat complexity and cover, while upstream section is lacking. No defined inlet to side channel, will require large amount of excavation to initiate side channel, ELJ to control inlet flows and large wood for habitat complexity and cover. Plant native vegetation. Upstream section is in close proximity to railroad.	14

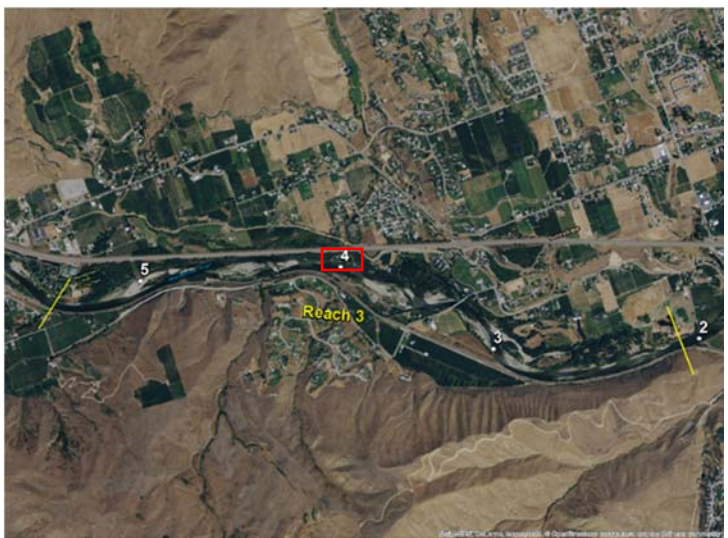
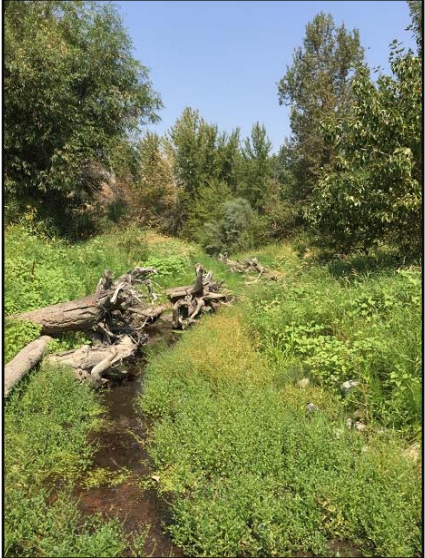
RM 4.0 Left Bank (CMZ 6)	Floodplain Habitat Reconnection (Modify Existing Restoration Site)	1 – Land Protection 20 – LWD Placements 25 – Floodplain Excavation 27 – Perennial Side Channel	Existing side channel has decent habitat and cover, but is not accessed perennially. Large sediment loads are deposited at inlet of side channel. Excavate to initiate side channel with realignment of inlet could improve function of side channel sediment flushing flows and increase temporal use.	24

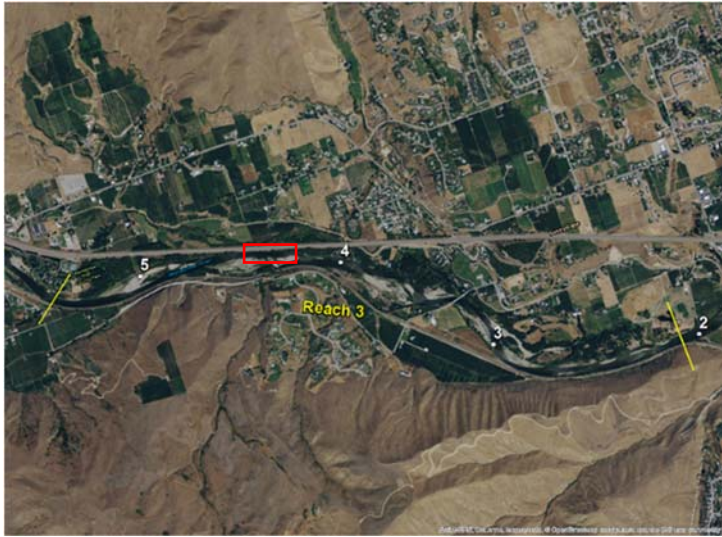
RM 4.5 Left Bank	Enhance Existing Bank Protection	<ul style="list-style-type: none"> 18 – Bank Bioengineering 19 – Boulder Placements 20 – LWD Placements 	Existing groins provide some bank protection but minimal habitat benefit to river. Additions of large wood would create local habitat complexity and cover. Large wood additions provide opportunity to create local scour pools.	31

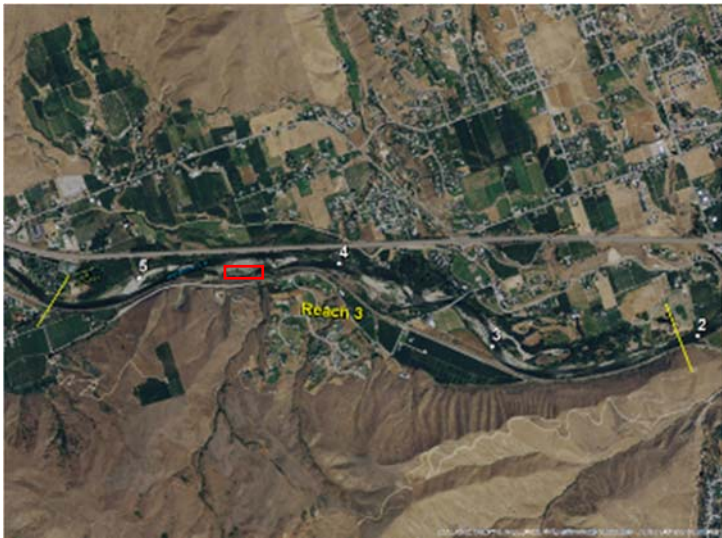
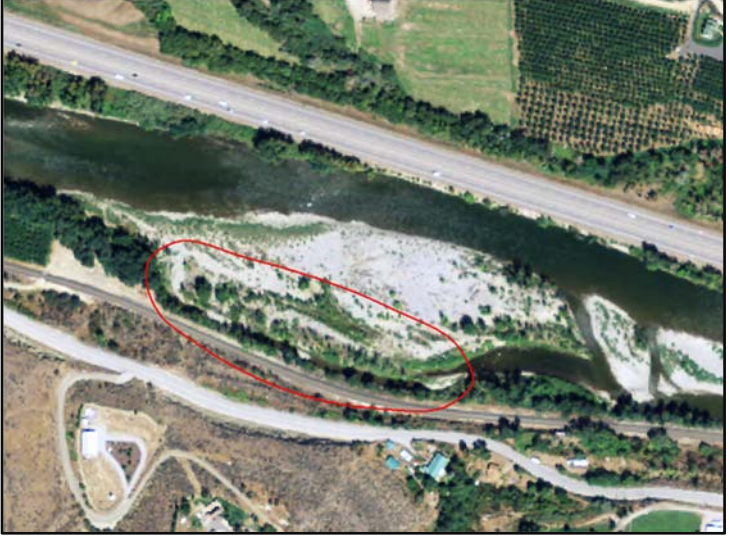
RM 4.8 Right Bank	Floodplain Habitat Reconnection	<ul style="list-style-type: none"> 1 – Land Protection 12 – Riparian Buffer 20 – LWD Placements 24 – Floodplain Restoration 28 – Secondary Channel 31 – Alcove 	Existing backwater alcove is functioning properly. Expand this alcove to provide increased backwater and low floodplain habitat. Alcove is fed by hyporheic flows, no need to excavate inlet to channel. Install large wood habitat structures to create habitat complexity and cover; plant native vegetation	16

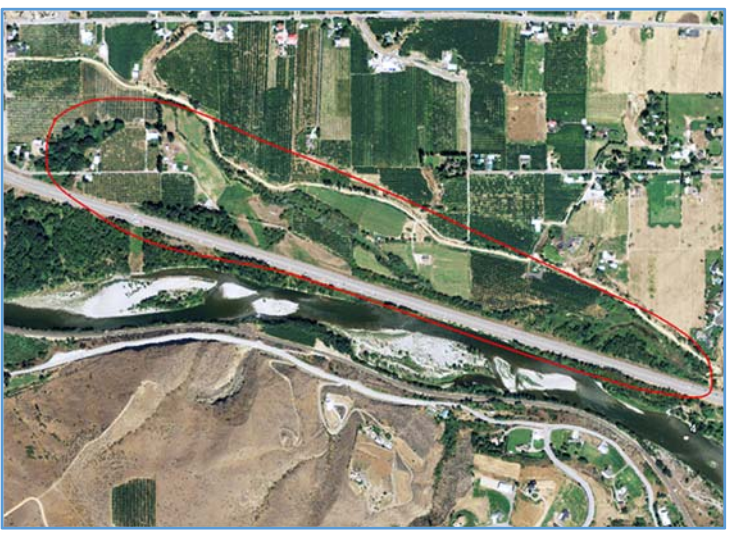
RM 4.0 to 5.2 Left Bank	Floodplain Habitat Reconnection	<ul style="list-style-type: none"> 1 – Land Protection 6 – Road Grading 12 – Riparian Buffer 20 – LWD Placement 23 – Relocate Floodplain Infrastructure 24 – Floodplain Restoration 27 – Perennial Side Channel 28 – Secondary Channel 32 – Hyporheic Off-Channel 36 – Meander Re-connect 39 – Barrier removal 	Large portion of floodplain cut off by U.S. Highway 2. Reconnection of this section would greatly increase habitat availability. Evaluate several alternatives for reconnection or groundwater infiltration projects. Bridges or realignment of the highway may be considered.	2

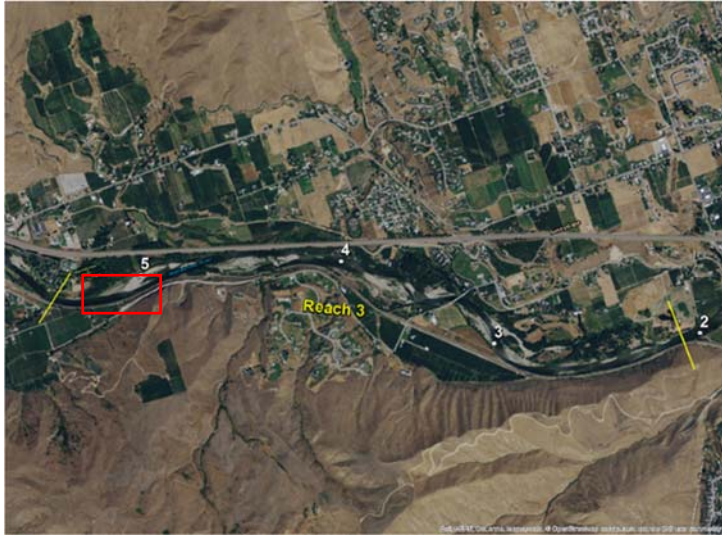
RM 5.0 to 5.3 Right Bank	Enhance Existing Bank Protection	1 – Land Protection 12 – Riparian Buffer 20 – LWD Placement 24 – Floodplain Restoration 26 – Thermal Refugia 27 – Perennial Side Channel 32 – Hyporheic Off-Channel (groundwater)	Existing groins provide some bank protection but minimal habitat benefit to river. Additions of large wood would create local habitat complexity and cover. ELJ additions provide opportunity to create local scour pools.	37

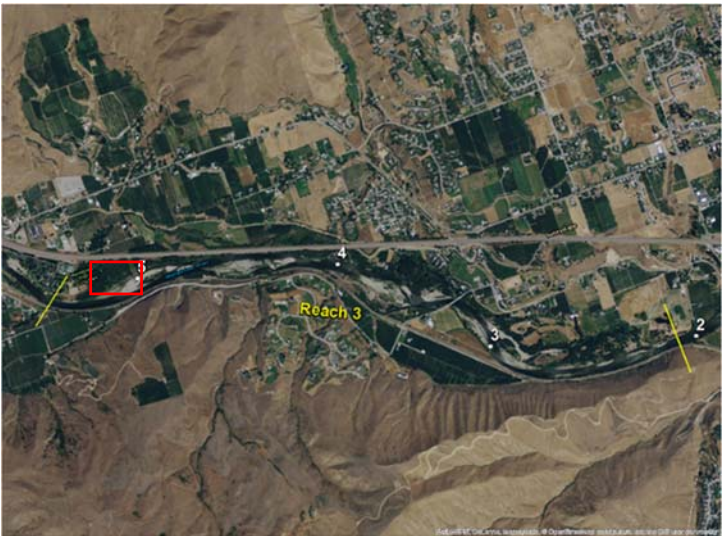
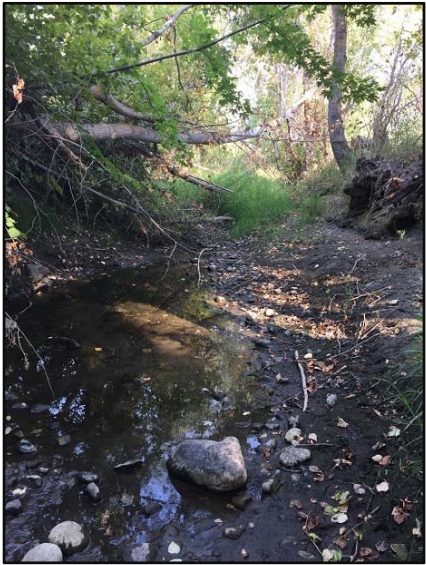
RM 5.2 Left Bank	Floodplain Habitat Reconnection	18 – Bank Bioengineering 19 – Boulder Placement	Existing side channel has good habitat complexity and cover but is cut off from main channel flows. High flood events may access channel, but existing habitat is not being used perennially. Excavation of an inlet for base flows to the side channel would increase surface flows and habitat complexity.	13

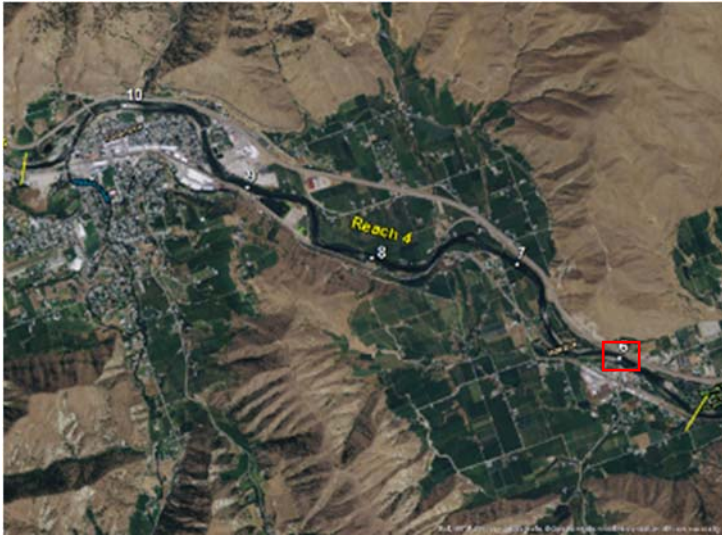
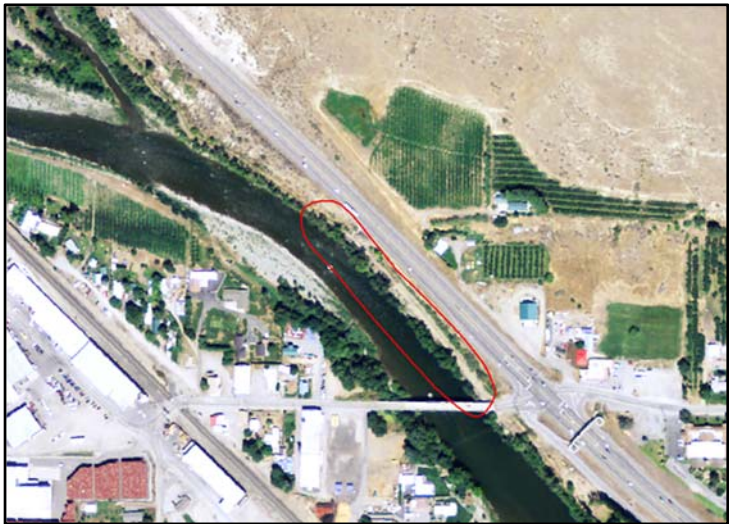
RM 6.0 Left Bank	Enhance Existing Bank Protection	18 – Bank Bioengineering 19 – Boulder Placement	Existing groins provide some bank protection but minimal habitat benefit to river. Additions of large wood would create local habitat complexity and cover. Large wood additions provide opportunity to create local scour pools.	38

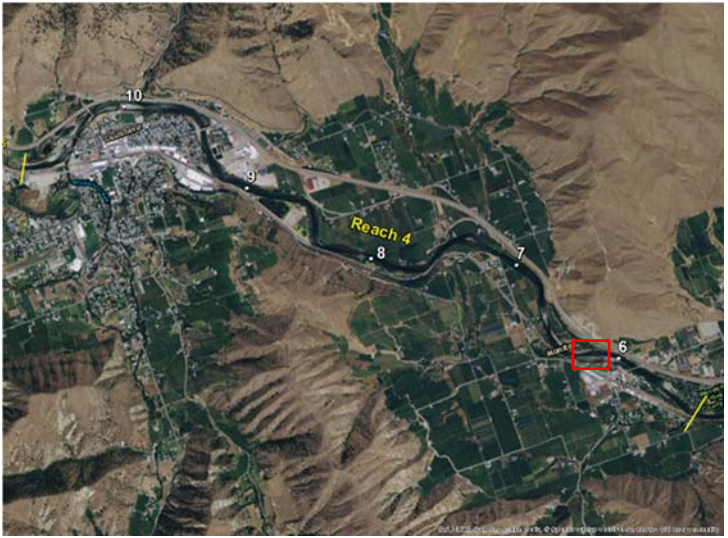
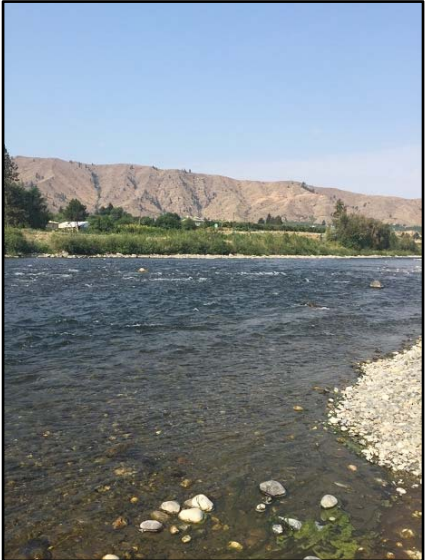
RM 6.2 Mid-channel	Install Habitat Structures	19 – Boulder Placement	This section of river is lacking instream habitat complexity. Addition of mid-channel boulder clusters would create local scour pools and increase the instream habitat complexity in areas where hydraulics characteristics are suitable.	33

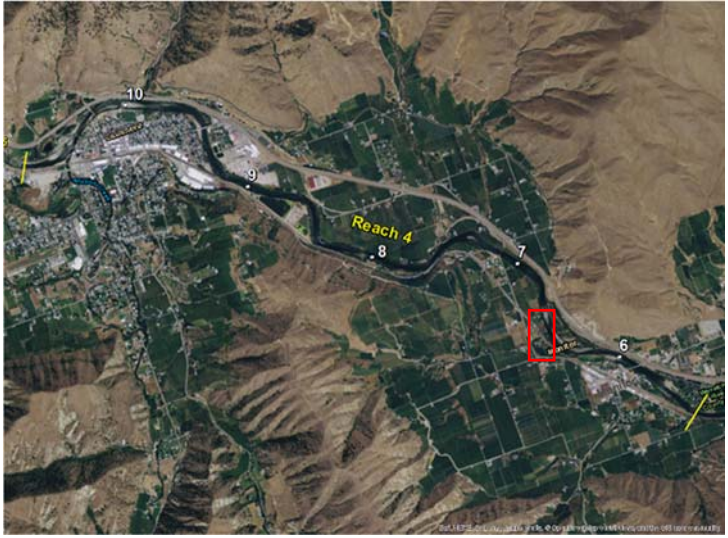
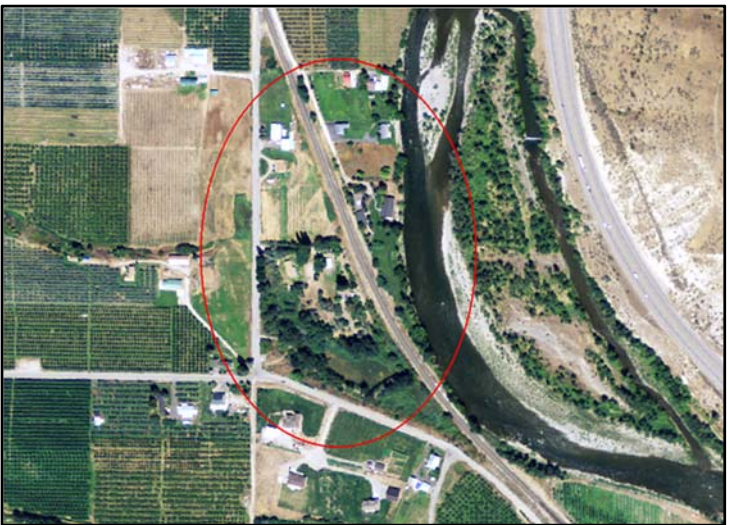
RM 6.5 Right Bank	Floodplain Habitat Reconnection	1 – Land Protection 12 – Riparian Buffer 20 – LWD Placement 24 – Floodplain Restoration 31 – Alcove 32 – Hyporheic Off-channel (groundwater)	Floodplain and off-channel habitat is currently cut off from the main river by the railroad. Low topography in the vicinity can be converted to groundwater galleries, or larger project to create backwater alcove. Evaluate potential for directing groundwater to off-channel areas. Purchase floodplain properties.	18

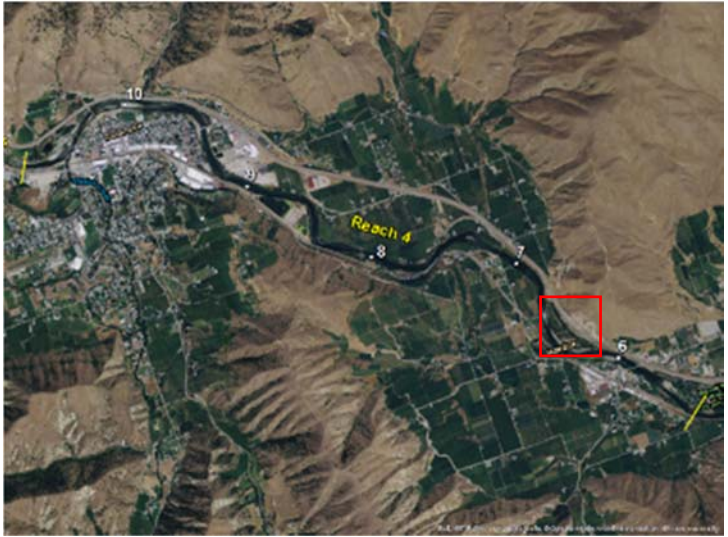
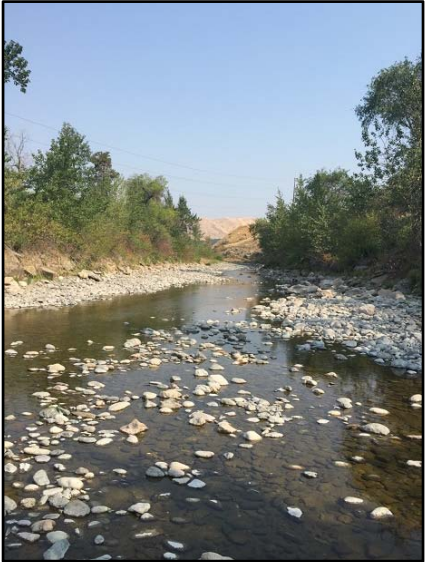
RM 6.5 Left Bank (Pioneer Side Channel)	Install Habitat Structures (Modify Existing Restoration Site)	1 – Land Protection 12 – Riparian Buffer 20 – LWD Placement 27 – Perennial Side Channel 34 – Pool Construction 35 – Riffle Construction	Existing side channel functions hydraulically but lacks complex habitat and cover. Possible alternate project is to reshape channel and create complex pool habitat that are not currently present in side channel.	7

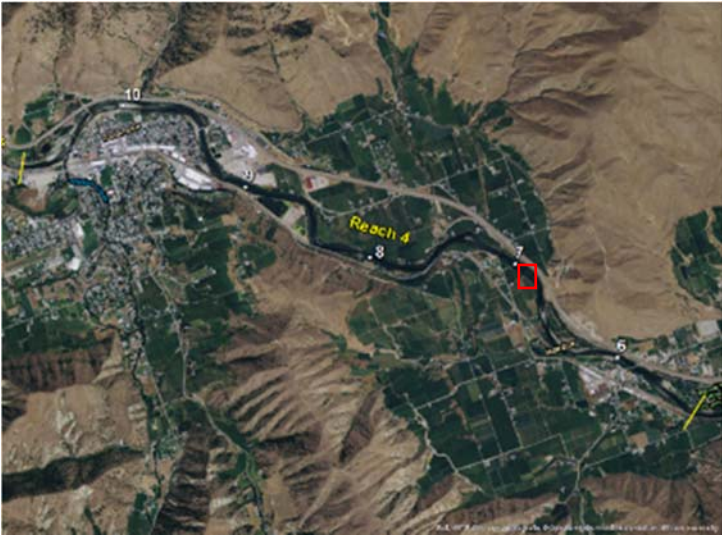
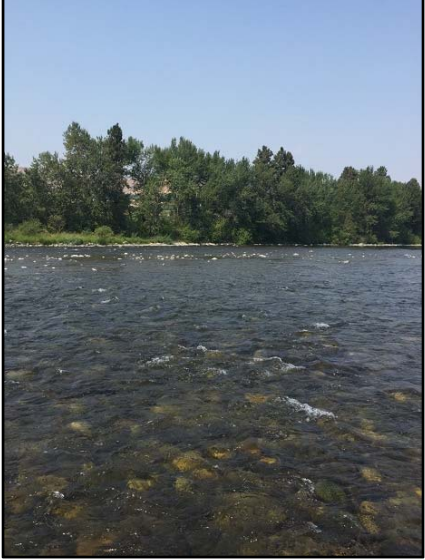
RM 6.9 Mid-channel	Install Habitat Structures	19 – Boulder Placements	This section of river is lacking instream habitat complexity. Addition of mid-channel boulder clusters would create local scour pools and increase the instream habitat complexity in areas where hydraulics characteristics are suitable.	34

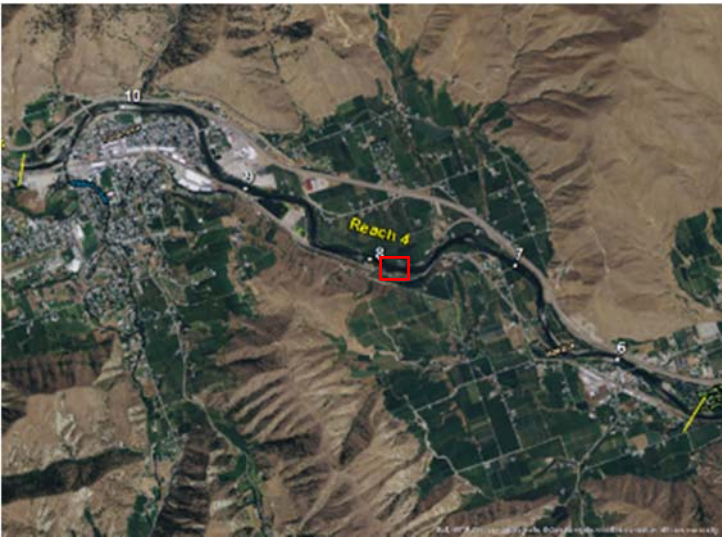
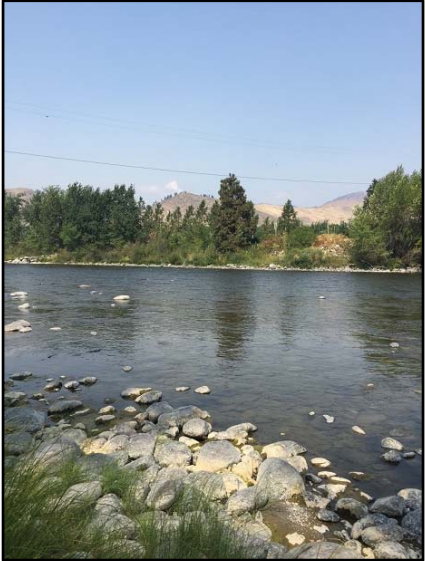
RM 7.9 Mid-channel	Install Habitat Structures	19 – Boulder Placements	This section of river is lacking instream habitat complexity. Addition of mid-channel boulder clusters would create local scour pools and increase the instream habitat complexity in areas where hydraulics characteristics are suitable.	35

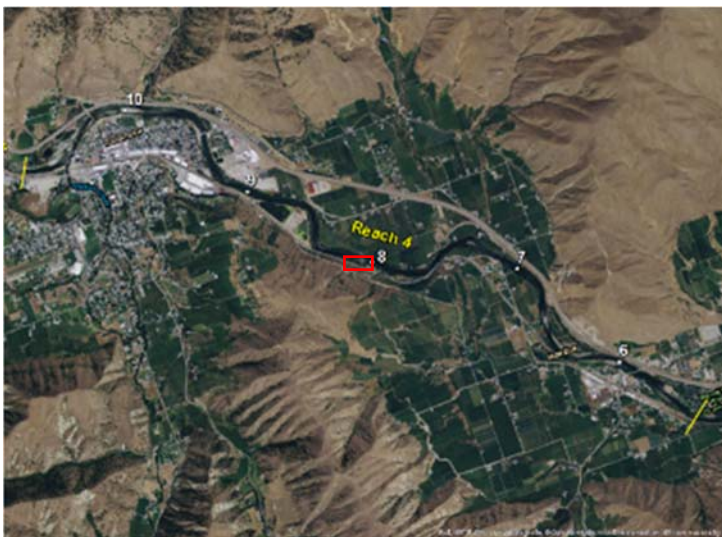
RM 8.1 Right Bank	Floodplain Habitat Reconnection	1 – Land Protection 12 – Riparian Buffer 20 – LWD Placement 23 – Relocate Floodplain Infrastructure 24 – Floodplain Restoration	Historic side channel has been altered by man-made construction. Purchase property in floodplain. Reconnection would require some excavation to remove fill and structures, and to recreate full extent of side channel. Existing side channel would provide added habitat and cover. Install ELJ for inlet flows and large wood to create habitat complexity and cover; plant native vegetation.	26

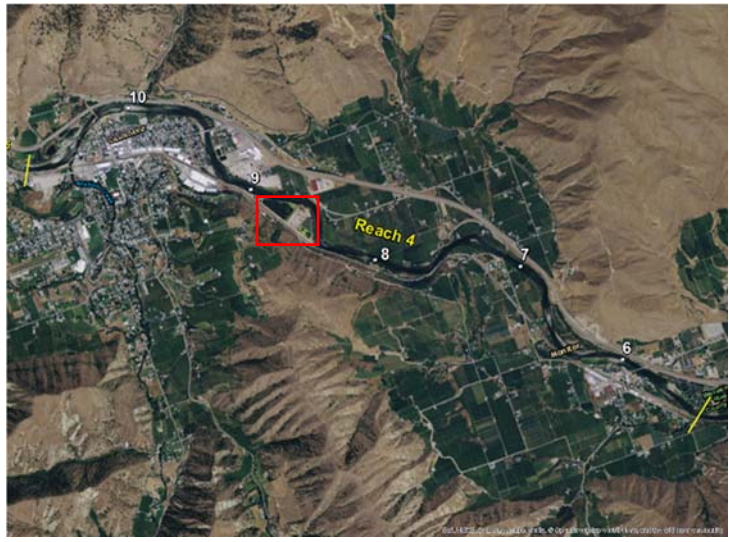
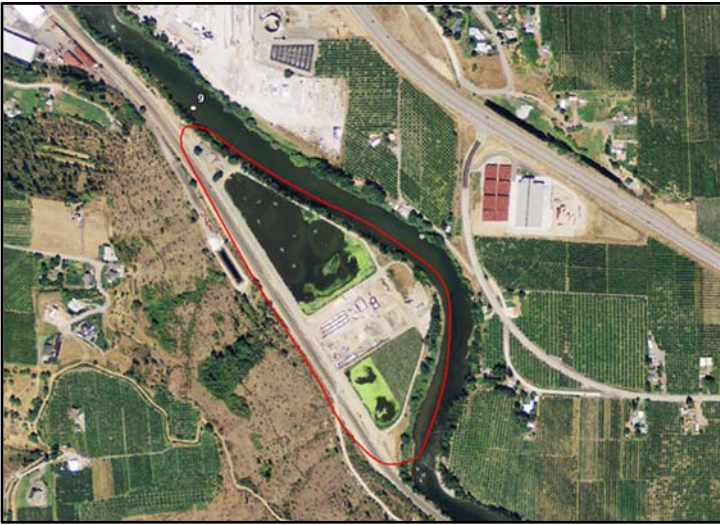
RM 8.6 Right Bank	Floodplain Habitat Reconnection	<ul style="list-style-type: none"> 1 – Land Protection 3 – Mitigate Point Source Impacts 12 – Riparian Buffer 20 – LWD Placement 23 – Relocate Floodplain Infrastructure 24 – Floodplain Restoration 27 – Perennial Side Channel 28 – Secondary Channel 31 – Alcove 37 – Channel Reconstruction 	Creating a large floodplain by relocating the treatment facility would provide much needed habitat complexity in a section of river that lacks both habitat and cover. Creation of the floodplain would require large amounts of excavation, large wood structures. Conduct soil and site remediation. Reconstruct floodplain habitats.	10

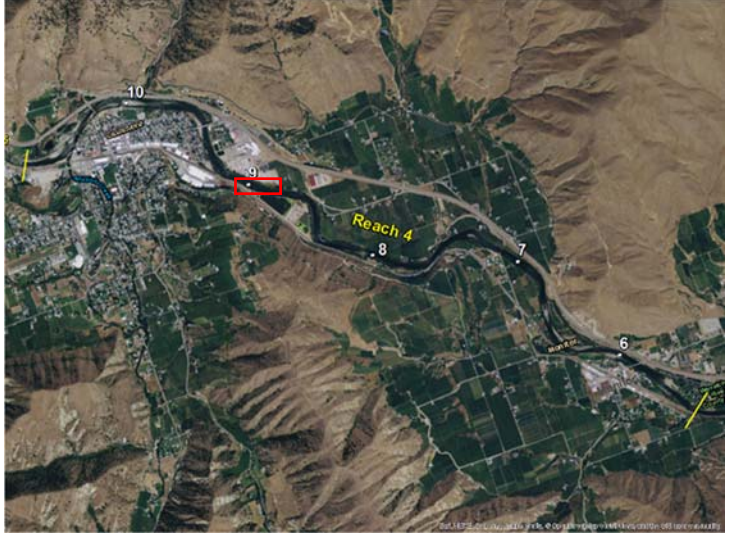
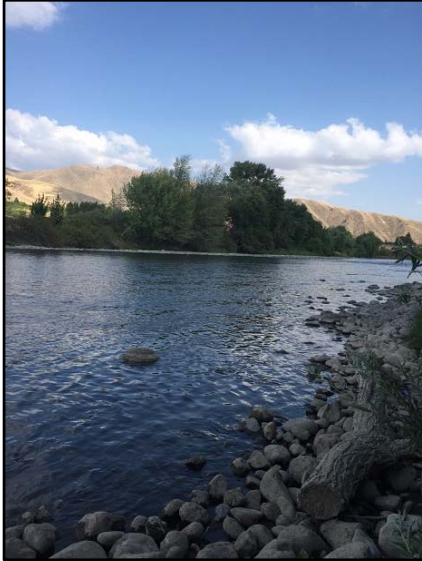
RM 9.0 Mid-channel	Install Habitat Structures	19 – Boulder Placements	This section of river is lacking instream habitat complexity. Addition of mid-channel boulder clusters would create local scour pools and increase the instream habitat complexity in areas where hydraulics characteristics are suitable.	36

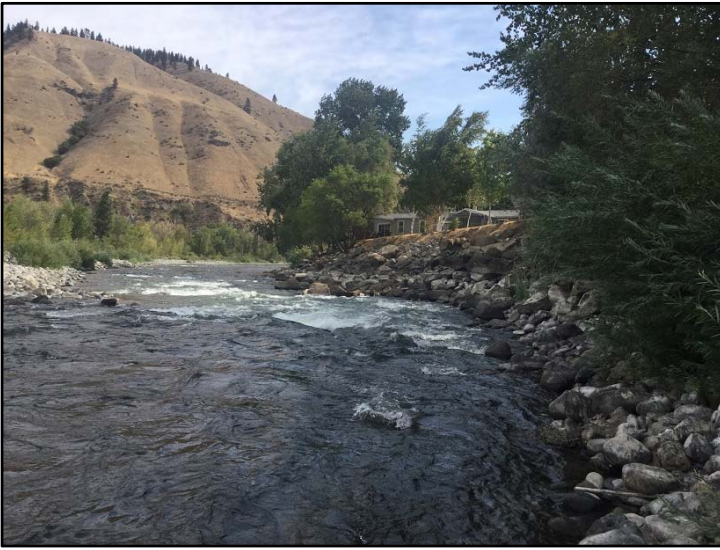
RM 9.2 to 10.7 Right Bank	Floodplain Habitat Reconnection	<ul style="list-style-type: none"> 1 – Land Protection 3 – Mitigate Point Source Impacts 12 – Riparian Buffer 20 – LWD Placement 22 – Levee Modification 23 – Relocate Floodplain Infrastructure 24 – Floodplain Restoration 27 – Perennial Side Channel 28 – Secondary Channel 31 – Alcove 37 – Channel Reconstruction 	Modification of the existing levee would give access to historic floodplain to reestablish historic meander pattern. This opportunity has many potential constraints and would require levee modifications, including the potential for a setback levee, and the relocation of homes and businesses.	4

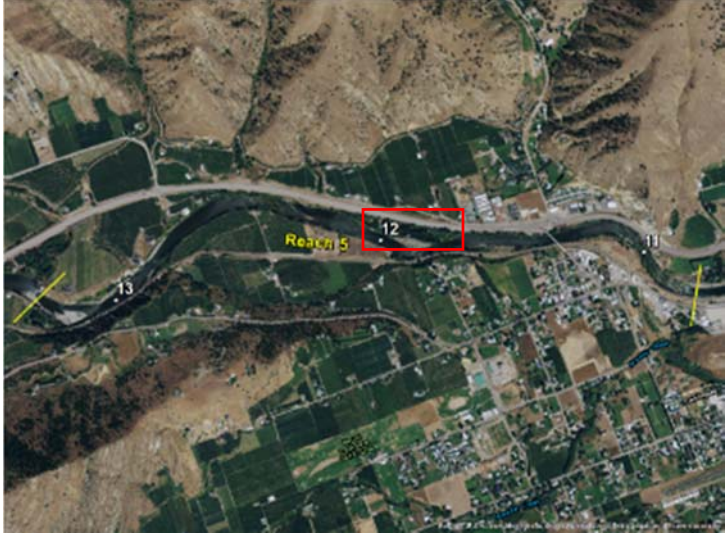
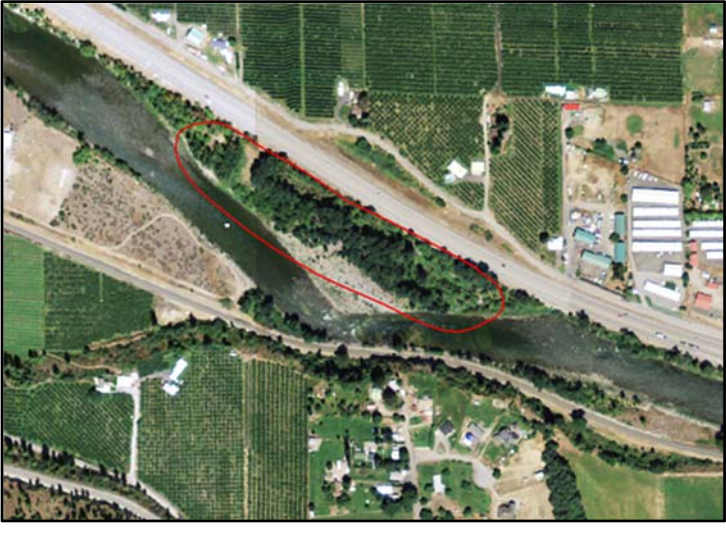
RM 12.0 Left Bank	Floodplain Habitat Reconnection	<ul style="list-style-type: none"> 1 – Land Protection 20 – LWD Placement 22 – Levee Modification 24 – Floodplain Restoration 27 – Perennial Side Channel 28 – Secondary Channel 32 – Hyporheic Off-channel (groundwater) 	Existing side channel has good habitat and cover, but is cut off from base flows. Lots of existing large wood in side channel. Excavate to initiate side channel for perennial flows, add large wood structures to enhance existing habitat. Would require excavation and removal of large log jam at inlet of side channel.	25

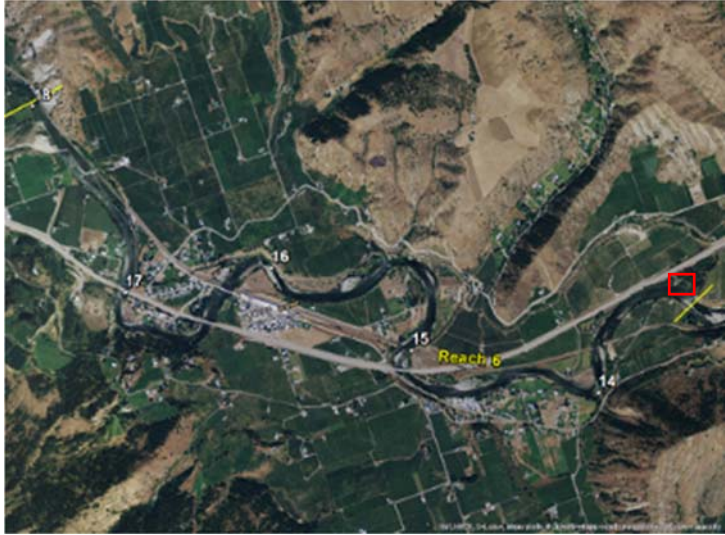
RM 13.3 Left Bank (CMZ 11)	Floodplain Habitat Reconnection (Modify Existing Restoration Site)	<ul style="list-style-type: none"> 1 – Land Protection 20 – LWD Placement 21 – Weir for Grade Control 27 – Perennial Side Channel 31 – Alcove 	Existing side channel functions but lacks complex habitat and cover. Possible alternate project is to reshape channel and create complex pool habitat that are not currently present in side channel. Install ELJ and grade control structure to control inlet flows.	22

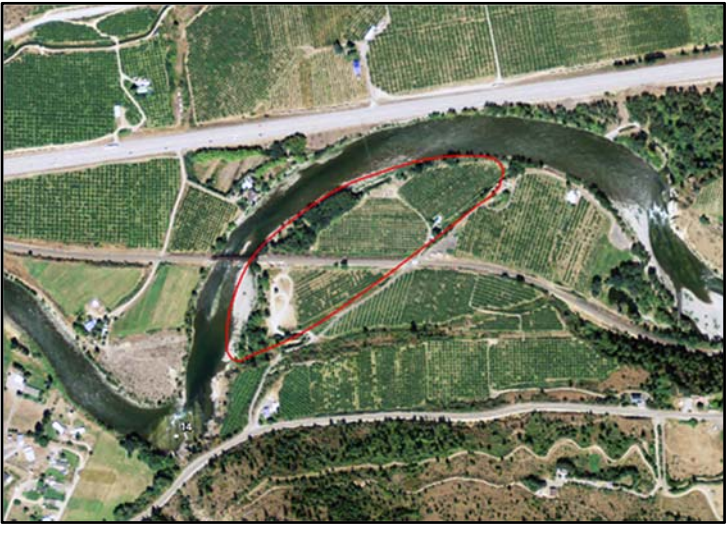
RM 13.8 Right Bank	Floodplain Habitat Reconnection	<ul style="list-style-type: none"> 1 – Land Protection 20 – LWD Placement 23 – Relocate Floodplain Infrastructure 24 – Floodplain Restoration 27 – Perennial Side Channel 28 – Secondary Channel 31 – Alcove 37 – Channel Reconstruction 	Floodplain is dissected by railroad. Complete reconnection would require construction of bridges for BNSF Railway. Large excavation to reconnect floodplain and off-channel habitats at lower flood events. Purchase floodplain properties.	3

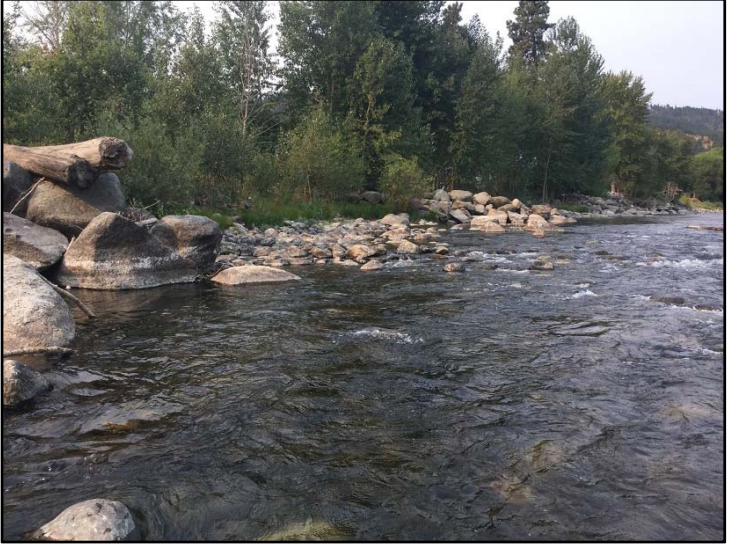
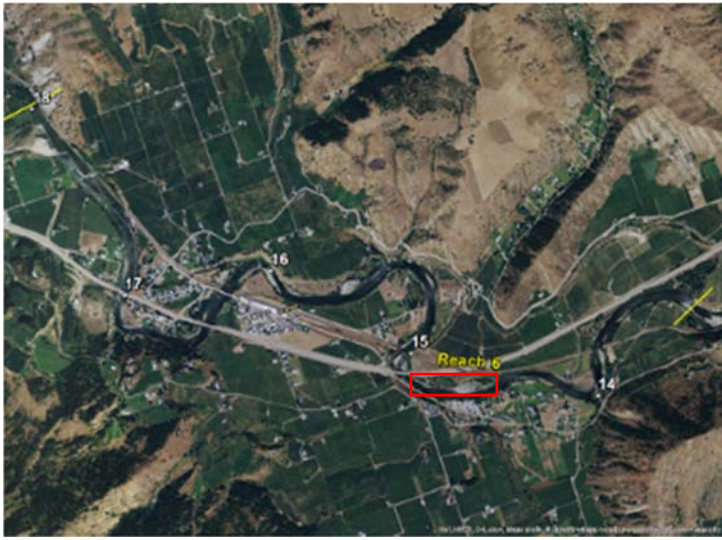
RM 14.4 Right Bank	Enhance Existing Bank Protection	20 – LWD Placements	Existing groins provide some bank protection but minimal habitat benefit to river. Additions of large wood would create local habitat complexity and cover. ELJ and large wood additions provide opportunity to create local scour pools.	32

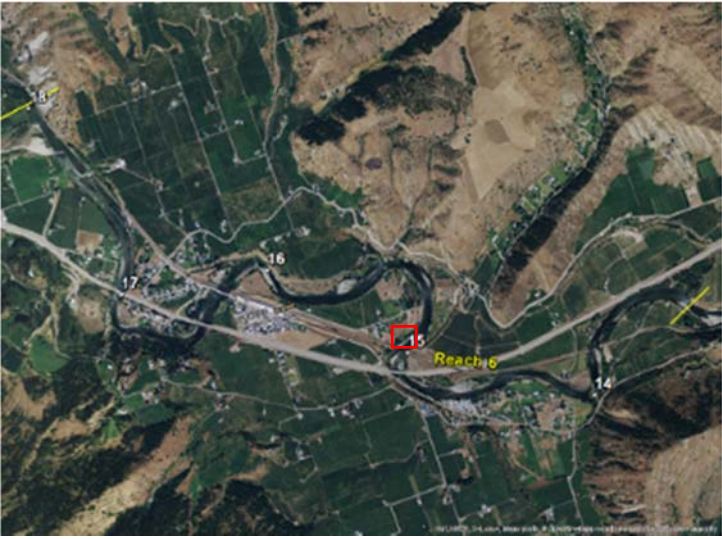
RM 14.6 Left Bank (CMZ 12 and 13)	Floodplain Habitat Reconnection (Modify Existing Restoration Site)	1 – Land Protection 20 – LWD Placement 21 – Grade Control Weirs 27 – Perennial Side Channel 30 – Wetland 31 – Alcove	Existing side channel has good habitat complexity and cover but is cut off from main channel flows. High flood events may access channel, but existing habitat is not being used perennially. Excavation of an inlet for base flows to the side channel would increase habitat complexity and provide sediment flushing flows. Increase hydraulic connectivity of CMZ 12 and 13.	17

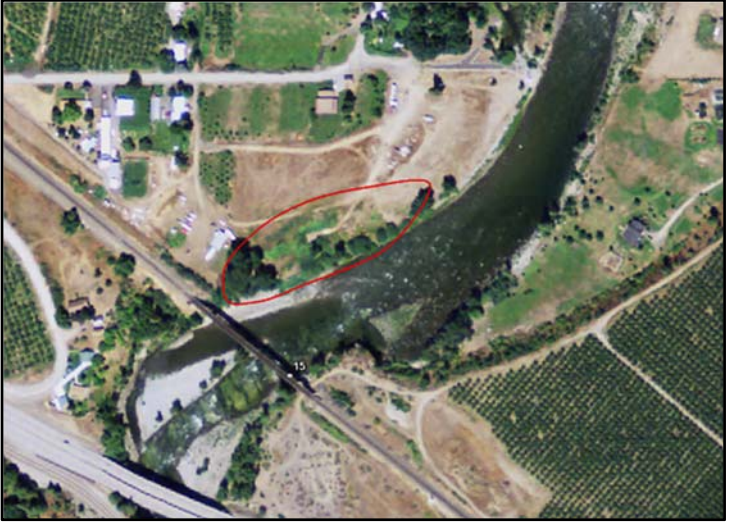
RM 15.0 Right Bank	Floodplain Habitat Reconnection	1 – Land Protection 12 – Riparian Buffer 20 – LWD Placement 26 – Thermal Refugia 27 – Perennial Side Channel 31 – Alcove 32 – Hyporheic Off-Channel (groundwater)	Utilizing existing groundwater spring location to create perennial backwater alcove would provide cold water recharge and rearing habitat. Install large wood structures to protect inlet of alcove and to create habitat complexity and cover. Plant native vegetation.	20

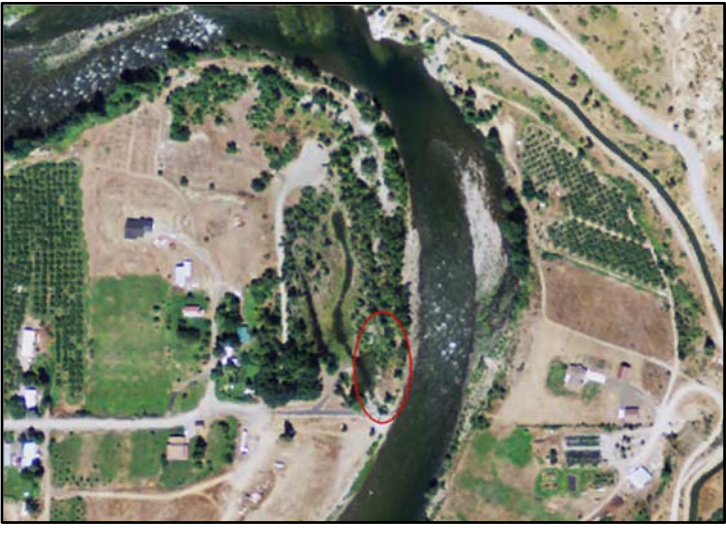
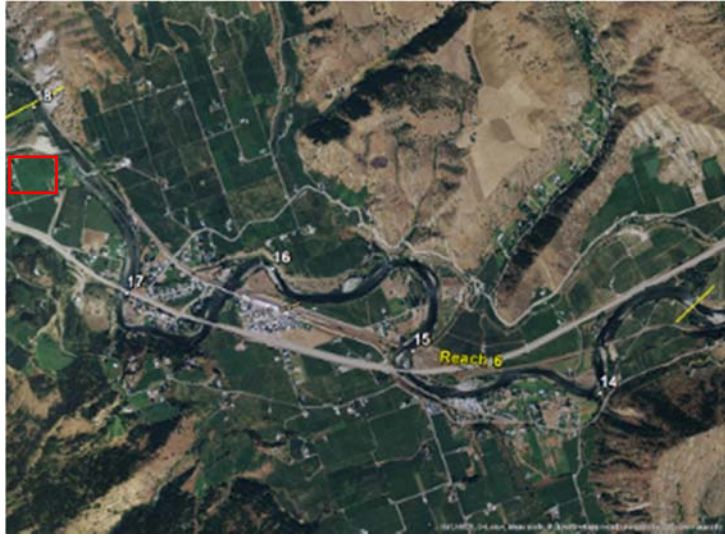
RM 15.3 Right Bank (Dryden Fish Enhancement Project)	Floodplain Habitat Reconnection (Modify Existing Restoration Site)	<ul style="list-style-type: none"> 1 – Land Protection 14 – Beaver Re-introduction 18 – Bank Bioengineering 20 – LWD Placement 22 – Levee Modification 24 – Floodplain Restoration 28 – Secondary Channel 38 – Structural Passage 	Existing pond upstream of confluence has good habitat and cover, but fish access is restricted by a levee and beaver dam. Partial removal of levee would provide perennial access to past restoration efforts.	15

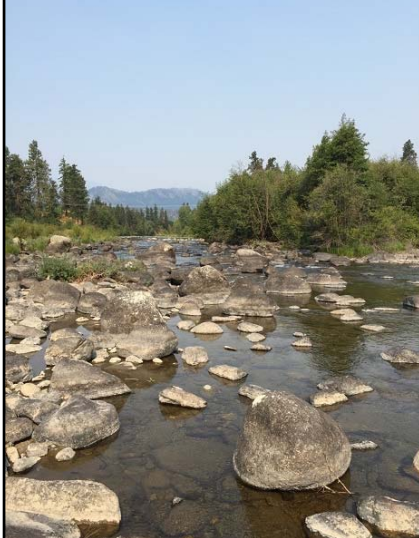
RM 18.4 Left Bank	Install Habitat Structures	<ul style="list-style-type: none"> 1 – Land Protection 20 – LWD Placement 	Existing side channels function properly, but lack complex habitat and cover. Installing large wood structures would increase habitat complexity and cover. Would require large wood structures, as side channel takes a large portion of storm flows.	29

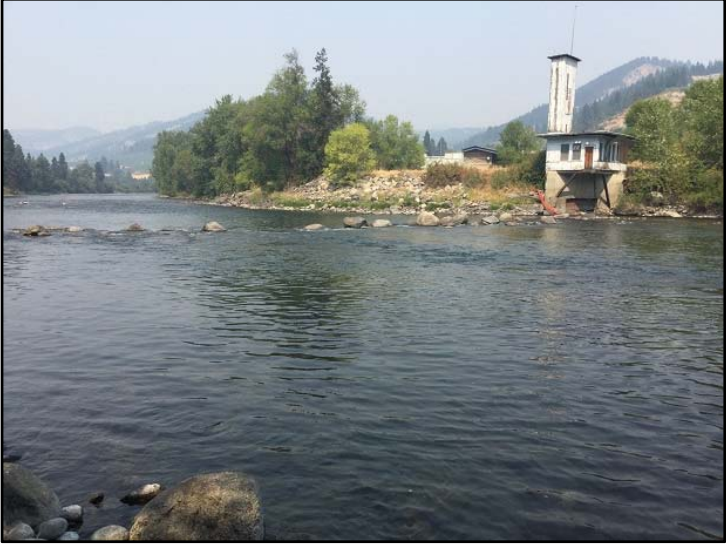
RM 20.5 Left Bank	Remove Instream Structures	23 – Relocate Floodplain Infrastructure	Left bank structure removal to enhance aesthetics of river in this area and increase uninterrupted flood capacity.	39

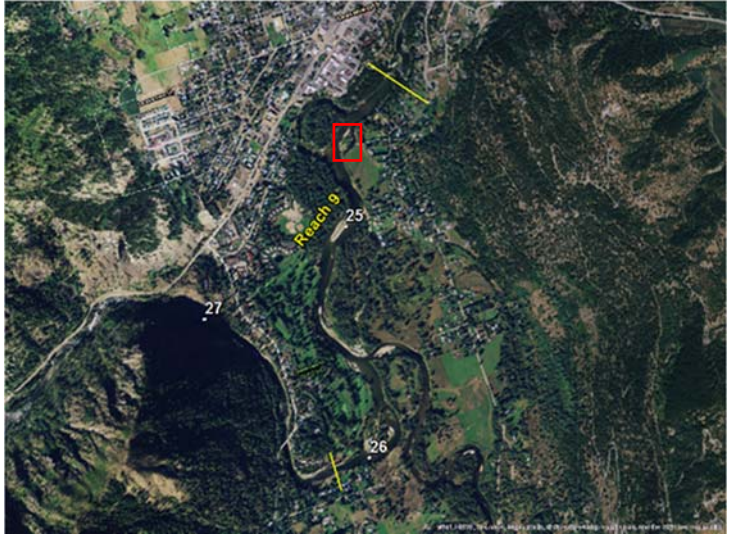
RM 24.4 Right Bank (CMZ 19A – Boat Launch)	Floodplain Habitat Reconnection (Modify Existing Restoration Site)	1 – Land Protection 20 – LWD Placement 24 – Floodplain Restoration 28 – Secondary Channel 31 – Alcove	Existing backwater alcove lacks complex habitat and cover. Install large wood structures to increase habitat and cover. Excavate outlet of channel to provide perennial access. Opportunity to excavate an inlet to alcove.	12

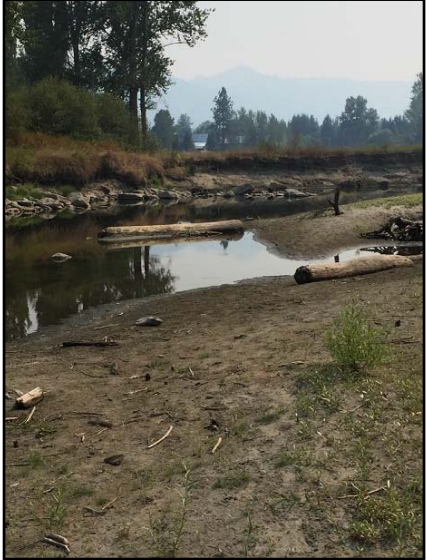
RM 24.5 Right Bank (CMZ 19)	Install Habitat Structures	1 – Land Protection 20 – LWD Placement	Existing side channels function properly, but lack complex habitat and cover. Installing large wood structures would increase habitat complexity and cover. Would require large wood structures, as side channel takes a large portion of storm flows. Infrastructure downstream should be considered when designing large wood structures. Plant native vegetation.	21

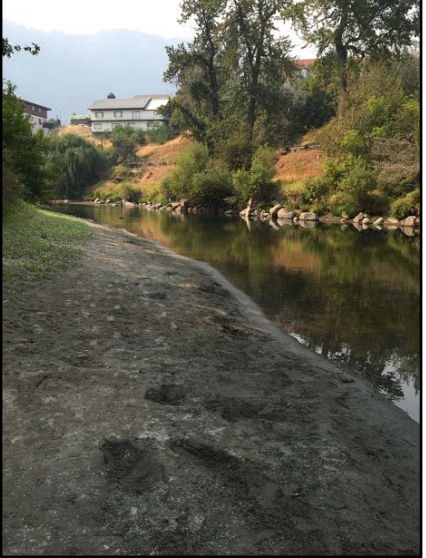
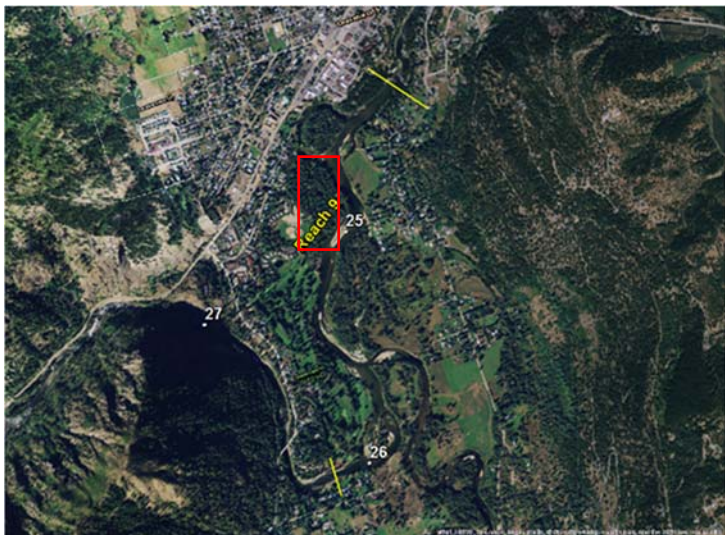
RM 24.5 Left Bank (Blackbird Island)	Install Habitat Structures	1 – Land Protection 20 – LWD Placement	There is evidence of large wood under streambed creating grade controls. Lack of complex instream habitat in side channel. Existing scour at bridges. Install large wood structures that consider recreational boater safety and to create scour pools, instream habitat and cover. Restore and protect existing bridge abutments. Opportunity to reshape channel to create complex habitat.	27

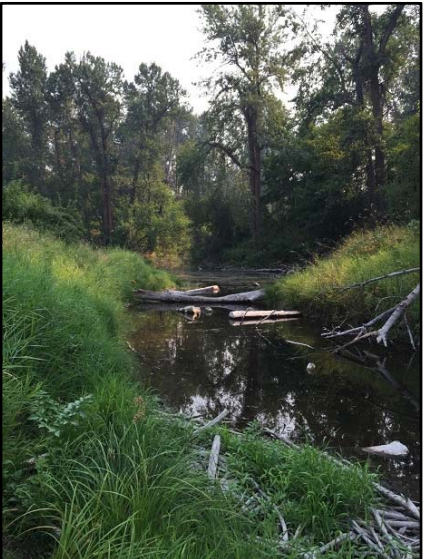
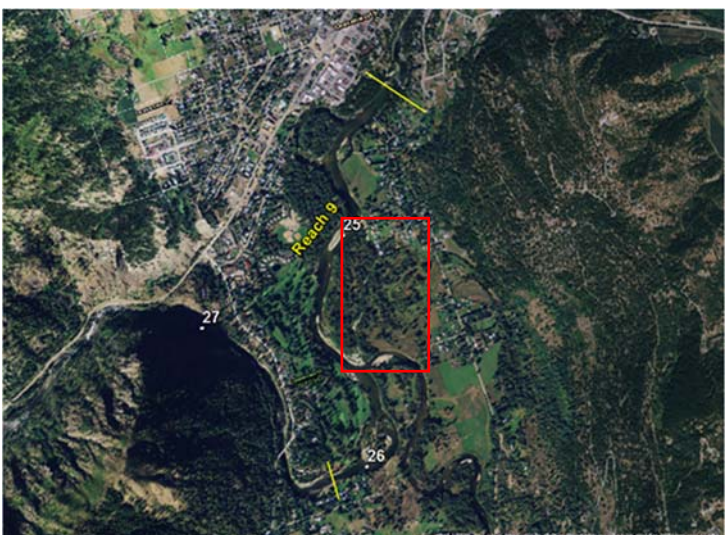
RM 24.7 Left Bank (ICTU Blackbird Island)	Floodplain Habitat Reconnection (Modify Existing Restoration Site)	1 – Land Protection 20 – LWD Placement 23 – Relocate Floodplain Infrastructure 24 – Floodplain Restoration 27 – Perennial Side Channel 39 – Barrier Removal	Outlet to channel is blocked by apparent beaver activity. Excavate to widen the existing outlet channel to preserve the woody debris and cover while providing perennial fish access to channel. Evaluate alternates to excavate an upstream inlet to create surface flow connectivity.	8

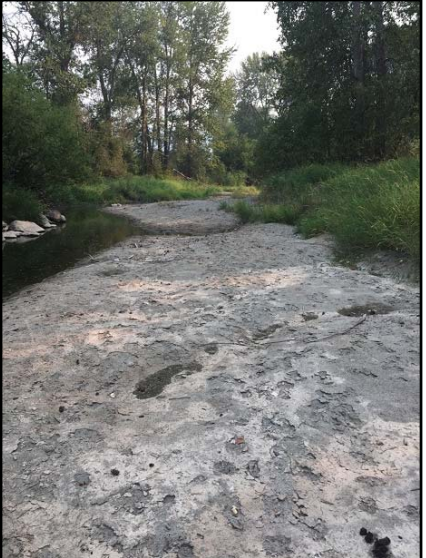
RM 25.0 to 25.6 Right Bank (CMZ 20)	Floodplain Habitat Reconnection (Modify Existing Restoration Site)	1 – Land Protection 12 – Riparian Buffer 20 – LWD Placement 27 – Perennial Side Channel 28 – Secondary Channel 32 – Hyporheic Off-Channel (groundwater)	Existing side channels have good habitat and cover, but entire channel is clogged with fine sediment. Excavate inlet of side channels to provide perennial flows in side channels, install large wood structures to increase habitat complexity and cover, and create local scour pools. Opportunity to redirect Iccle Creek into side channels.	5
