Fluvial Reconnaissance of Rock Creek and Selected Tributaries with Implications for Anadromous Salmonid Habitat Management

Rock Creek, Klickitat County, WA

Will Conley, Hydrologist/Geomorphologist
Yakama Nation Fisheries Program
Klickitat Field Office
Wahkiacus, WA

Project Number: 2007-156-00
56662 REL 112

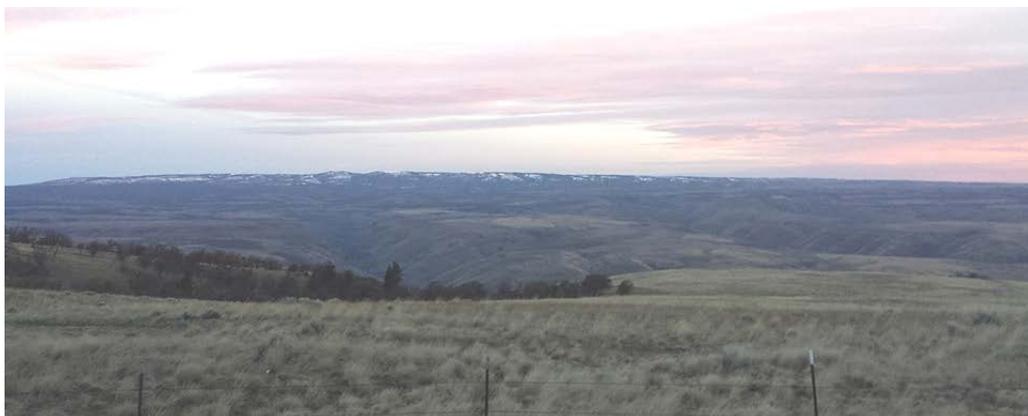
Figure 4. Looking north across grass and shrublands (foreground) toward forested headwaters in the Horse Heaven Hills (horizon). Canyons dissect landscape between foreground and headwaters.

Quartz, Squaw, and Box Canyon creeks and the mainstem of Rock Creek originate along the crest of the Horse Heaven Hills where coniferous forests are abundant (Figure 4). Badger, White, and Harrison creeks drain primarily shrub-steppe dominated plateaus. Luna Gulch drains plateau as well as a portion of the steeper, north side of the Goodnoe Hills and is predominantly vegetated by grasses and shrubs (Figure 5). Aspect (2004) reports statistics based on 1992 LANDSAT data indicating shrublands (46.9%), forested uplands (25.8%), and grasslands (16.2%) comprise most land cover types for the Rock Creek watershed.

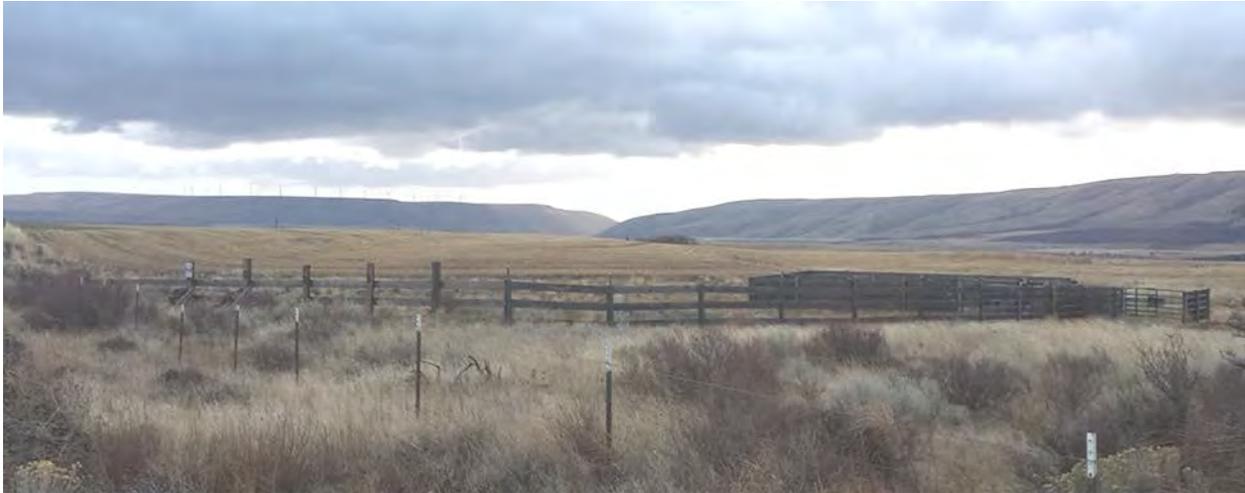
Figure 5. Looking south across agricultural lands on plateau draining into Luna Gulch. Goodnoe Hills on horizon.

Review of NED elevation data (USGS 2013) indicates all named streams cut canyons that vary from 400-700 feet deep at their respective mouths (Figure 6). The Rock Creek canyon reaches its greatest depth of approximately 1,700 feet where it transects the main axis of the Goodnoe Hills (horizon line gap in Figure 5) before resuming an approximate 600 foot depth as it enters the Columbia River (Figure 7).

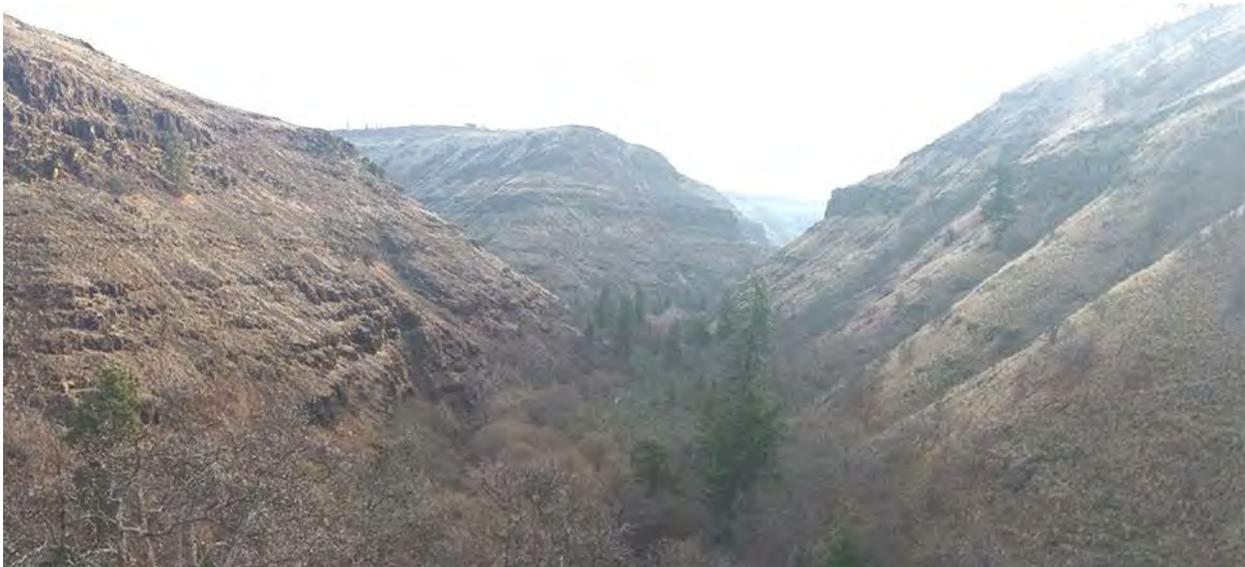
Figure 6. Typical confined canyon (Rock Creek in vicinity of Quartz Creek confluence; ~VM 17).

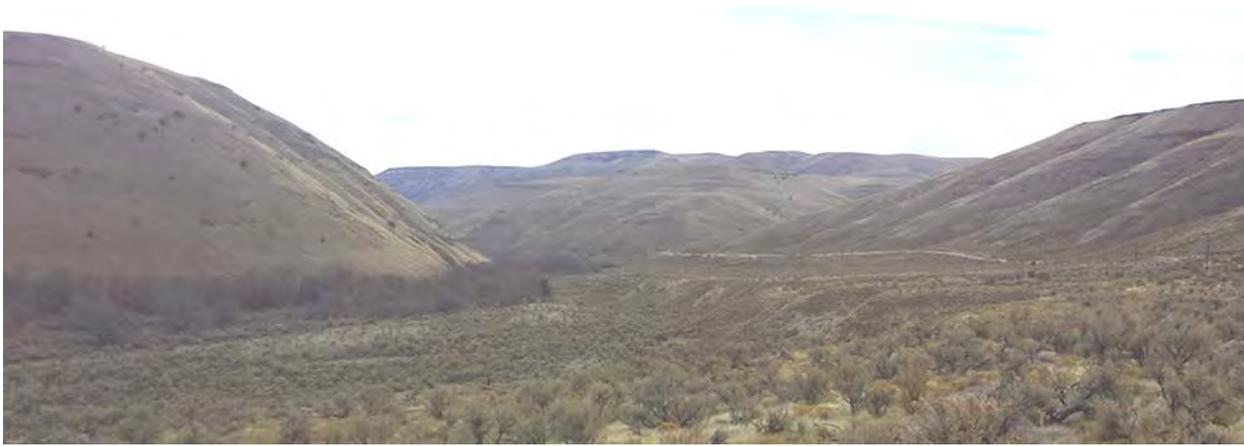
Figure 7. Less-confined canyon with loess terraces (Rock Creek canyon ~VM 3).

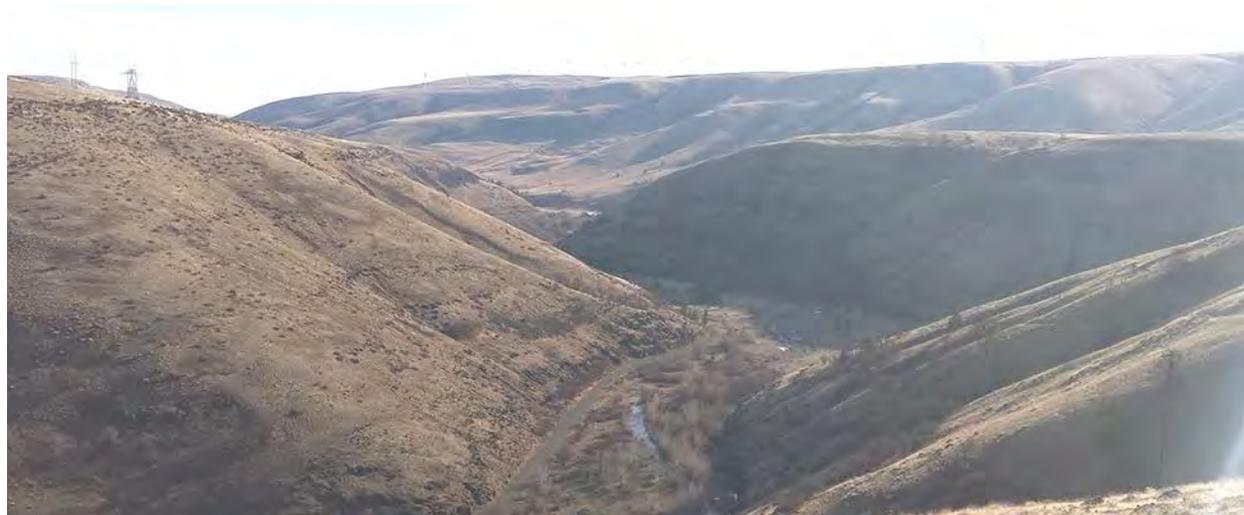
Figure 8. Typical moderately-confined canyon (Rock Creek in vicinity of Luna Creek confluence; ~VM 11).

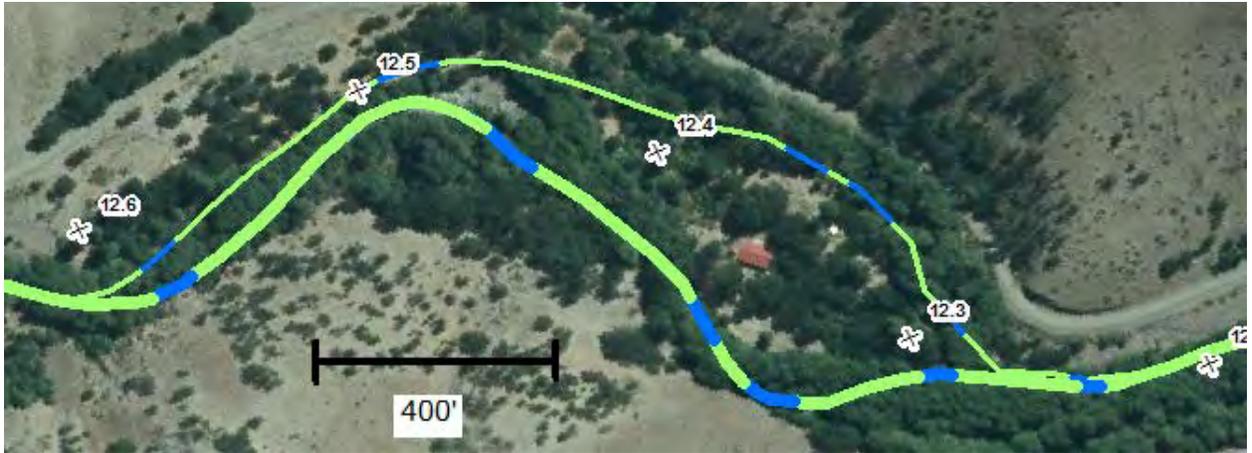
Figure 17. Valley segment where low-flow habitat units based on pre-LiDAR shapefile geometry (thin lines) and LiDAR-derived stream geometry (thick lines) diverge.

As noted in Methods, delineating channels in Rock Creek based solely on 2D imagery can be challenging. Initial (pre-LiDAR) efforts to map the 2012 low-flow data (CRITFC 2013 and 2014) appeared generally acceptable at 1:24,000 or coarser. However, pre-LiDAR geometry diverges by several hundred feet in some valley segments from 1:1,200 stream geometry, particularly in areas of dense riparian tree cover (Figure 17). Aside from creating lateral inconsistencies, differing channel alignments combined with accumulated field discrepancies cause habitat unit position changes along the profile in some reaches (Figure 18). In combination, these precision complications create a practical problem when trying to evaluate unit persistence through time and/or establishing a spatial reference for revisitation. (e.g. for assessment, design, or treatment). Thus, the LiDAR-derived stream delineation provides a reliable and consistent alignment surveyed in 2012 and observed during this study.

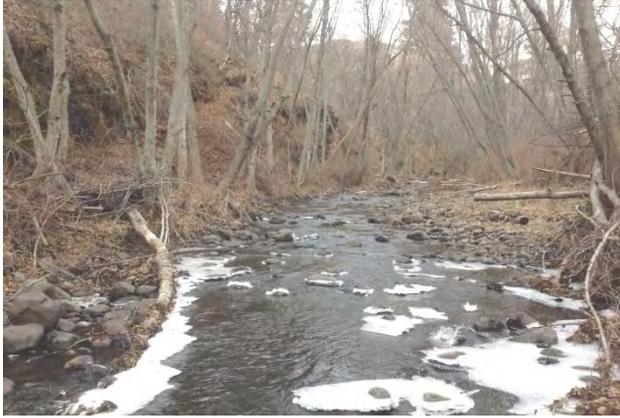
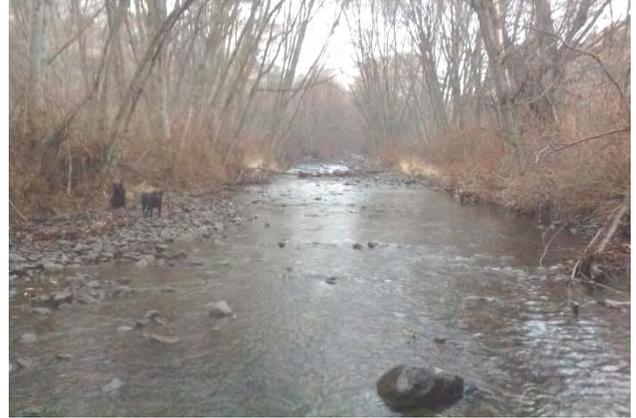
Figure 19. Simple, shallow plane-bed habitat conditions predominate throughout much of Rock Creek.

Field surveys found and abundance of long, linear, simple instream features in Rock Creek. Plane-bed conditions are prevalent and there is a general lack of pool structure (Figure 19). Long, shallow glides become increasingly common downstream of Bickleton Highway, often many hundreds of feet long.

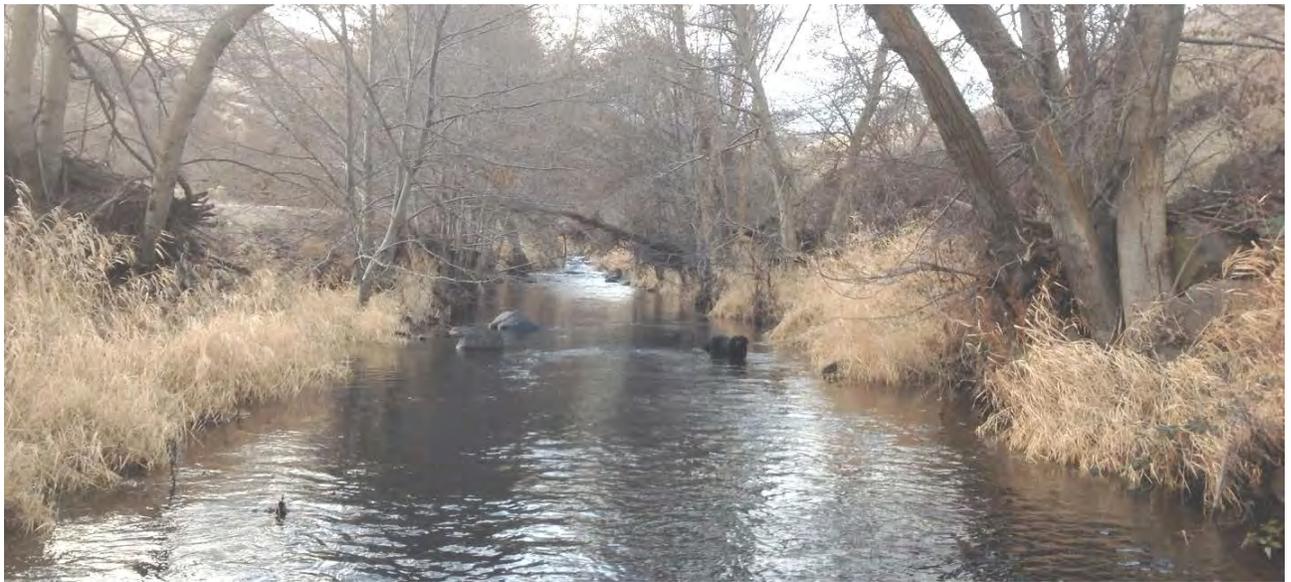
Figure 20. Long, shallow glides are common in entrenched reaches with occasionally have deeper pockets associated with alder roots.

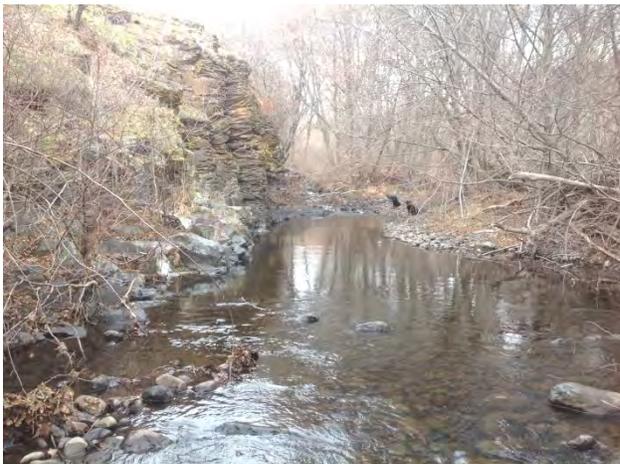
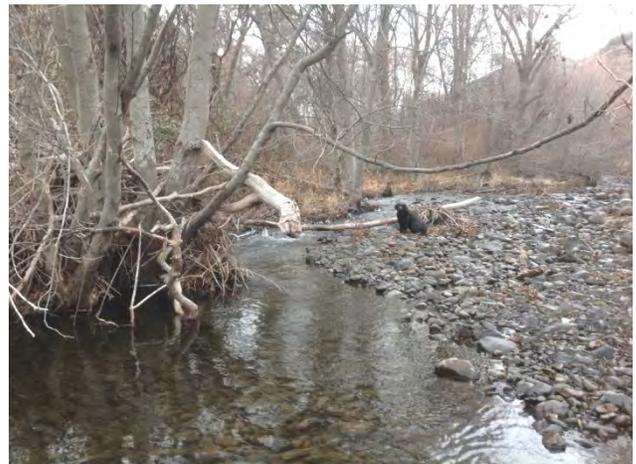
Figure 21. Higher-quality salmonid habitat is uncommon and tends to be forced, typically by bedrock (left) and riparian trees (right).

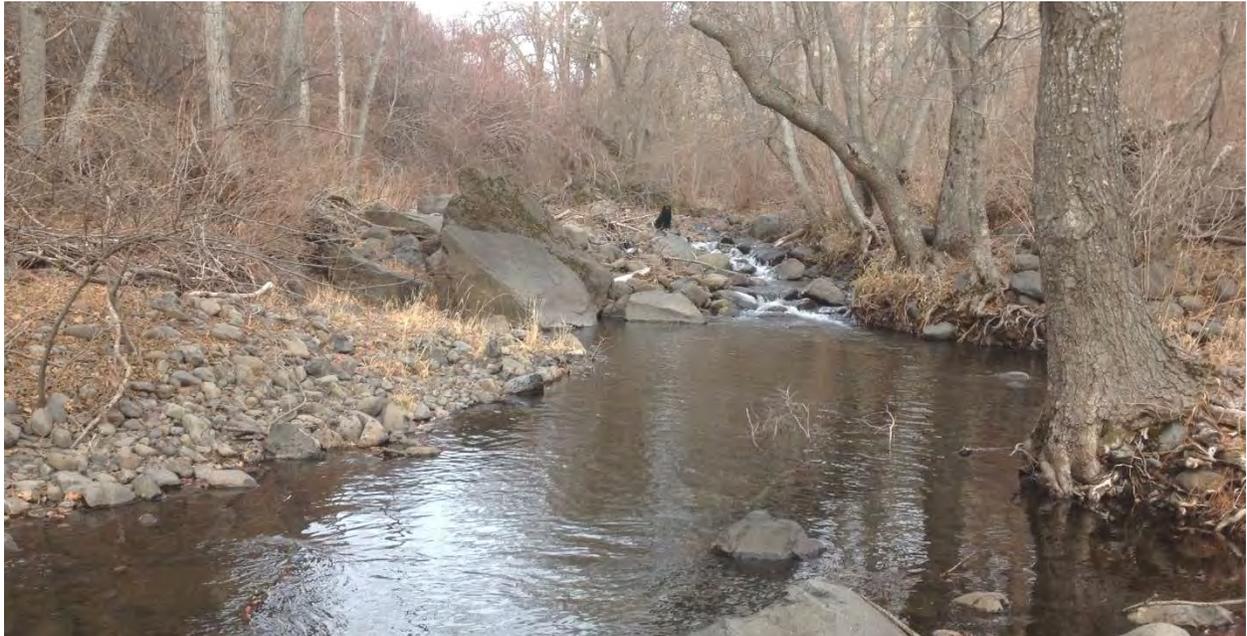
Figure 22. Forcing by colluvial particle clusters is less common, but can produce channel-scale pool units in combination with mature trees that increase bank resistance as well as create refugia during high flows.

Large (>3 feet in diameter) colluvial particles are reasonably common, particularly upstream of VM 10.5, but rarely produce more than small pocket habitat and, in many cases, produce little bed deformation, usually only a few tenths of a foot, if any at all. In other words, pocket-pools often associated with large clasts as a result of scour appeared to be generally absent more than they were present. Clusters of large colluvial particles are infrequent, but were observed to generate channel-scale pool units in several instances (Figure 22).

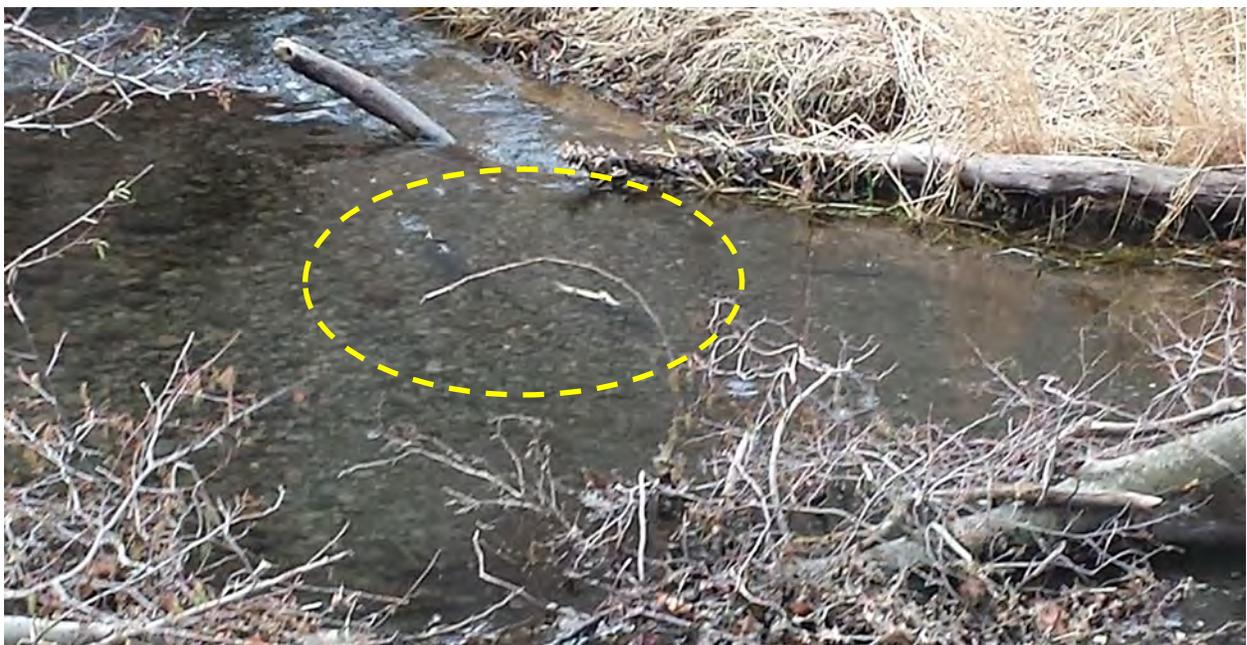
Figure 23. Pair of coho salmon spawning in the highest quality habitat observed; associated with bedrock-forcing, VM 6.9 to 7.5.

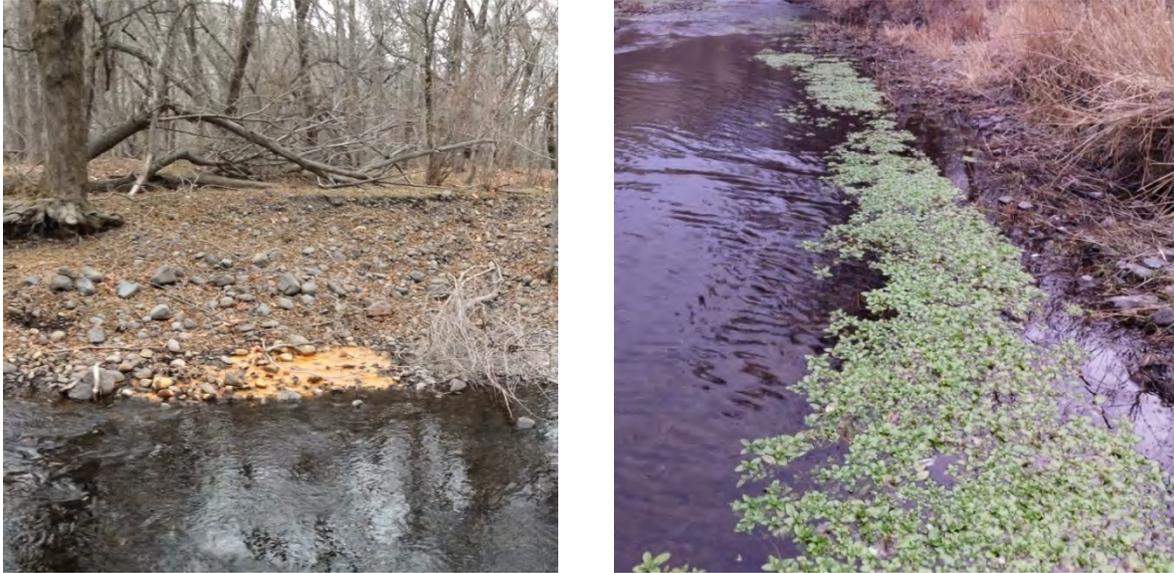
Figure 24. Indicators of groundwater expression; rusty seepage (left) and emergent aquatic vegetation (right).

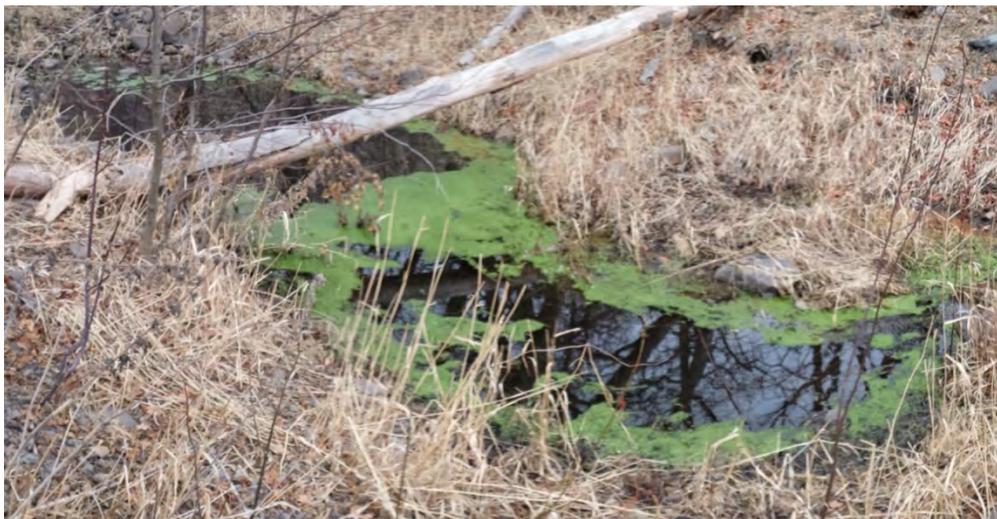
Figure 25. Secondary habitat feature that functions as off- and side-channel habitat depending on flow.

Winter side channel habitat is not uncommon, but habitat quality varies. Multiple chutes typically dissect diagonal bars and are active at different flows. Scour in areas where multiple high-flow chutes converge occasionally generate features that function as off-channel habitat during spring, summer, and some winter flows (Figure 25).

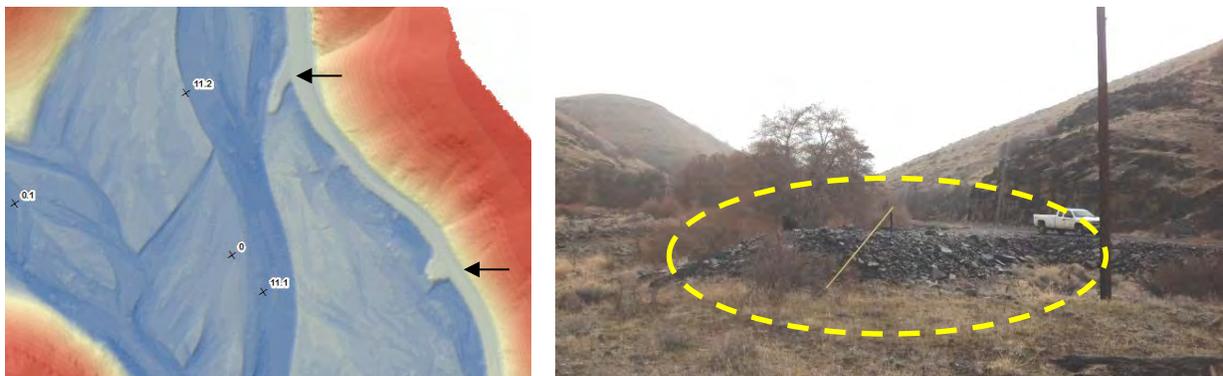
Figure 28. Rock barbs to protect road and utility pole.

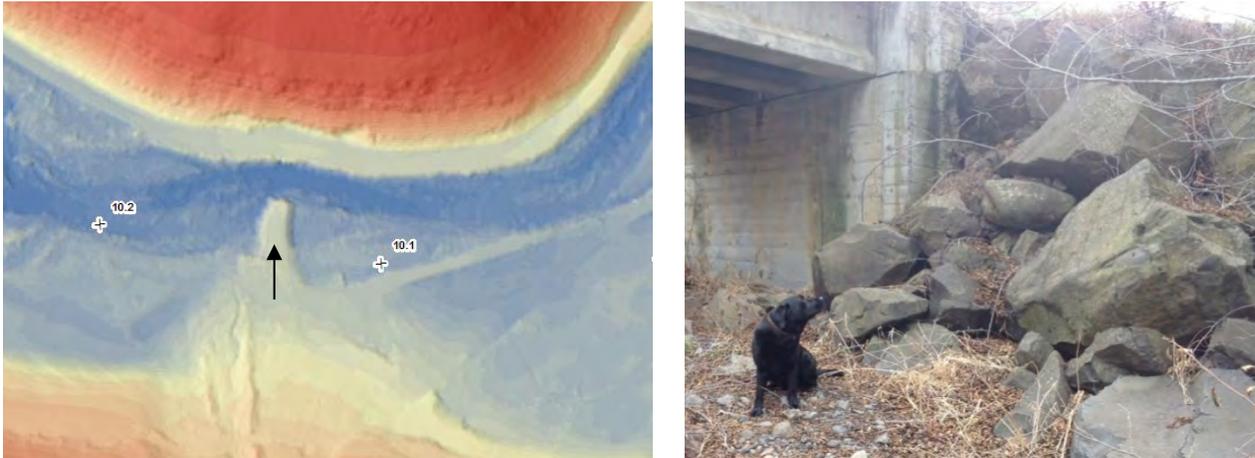
Figure 29. Undersized bridge at Imrie Road (~VM 10.1) is missing the right-upstream wingwall. Riprap repair likely indicate historic flood damage.

Valley-spanning embankments occur in a limited number of locations, but have the greatest hydraulic effects. Most notable are the road embankments at Imrie Road (Figure 29) and Old Highway 8. Both are hydraulically under-sized and backwater some flood flows. The local decrease in water surface slope (as a proxy for the energy line) upstream of the crossings contributes to deposition of bed materials, resulting in multi-thread channel patterns with flanking behavior immediately upstream (Figure 30). Signs of scour and fill and historic damage were observed at both locations. The bridge's upstream right wingwall is missing and apparently torn from the right abutment at Imrie Road and has been repaired with large riprap (Figure 29). The right abutment footing at the Highway 8 bridge was visible in the bottom of the pool. Both

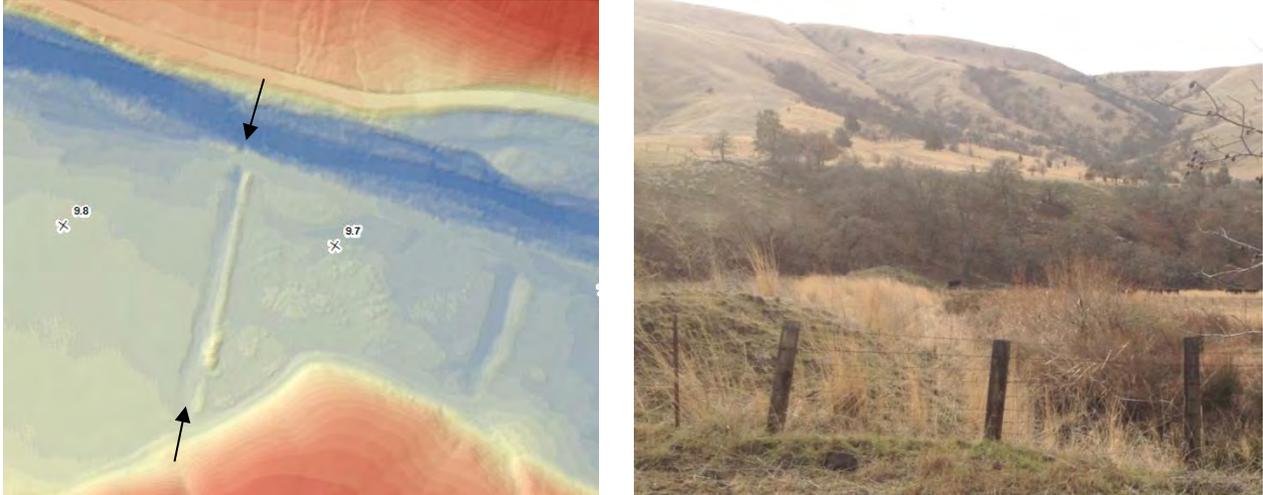
Figure 31. Drain with low, cross-valley levee vicinity (~VM 9.7).

Drains constitute the fourth common type of hydromodification and usually have companion cross-valley (but not valley-spanning) levees (Figure 31). Occurrence of drains was observed in areas of richer valley-bottom soils associated with springs. These areas appear particularly productive for forage/hay production and/or pasturing livestock. The levees are likely by-products of drain excavation and some hydraulic effect can be expected during low-frequency events. The effect of the drain itself constitutes a more routine, hydrologic modification by drawing down the water table and reducing soil-water storage. While drains could conceivably contribute to late-summer and early-fall streamflows, it is also possible that they could reduce instream flows during the same period due to lost storage capacity. Their specific effect on streamflow is unknown and seasonal variation in spring discharge would need to be evaluated.

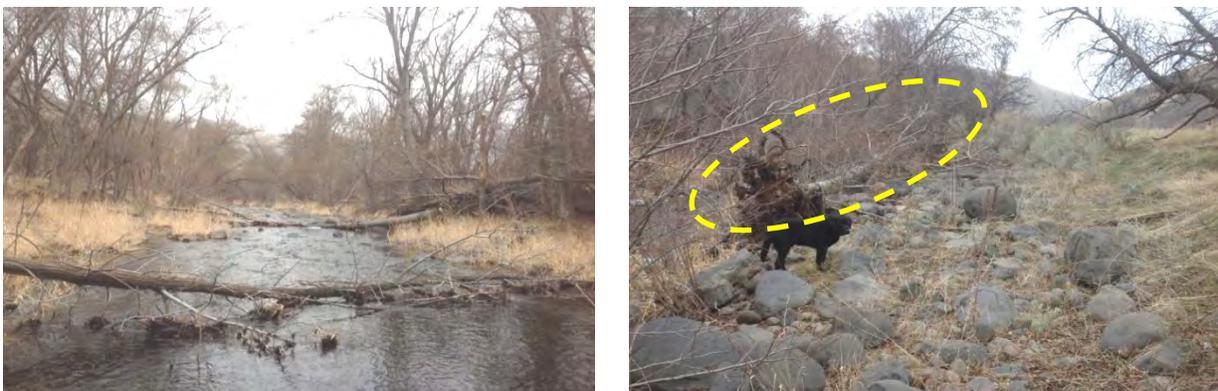
Figure 32. Small, single pieces of woody debris in the wetted (left) and active (right) channels are not uncommon, but rarely form persistent habitat.

Woody debris is abundant in Rock Creek, but is generally of small diameter and length and contributes little to habitat formation. In the reaches surveyed, alders provide the primary source of woody debris. Single pieces within the wetted and active channels are generally not in configurations expected to persist through a single water-year (Figure 32). Buried woody debris was notably absent in bank facies throughout the 14 mile field survey, except for two isolated locations in the lower six miles.

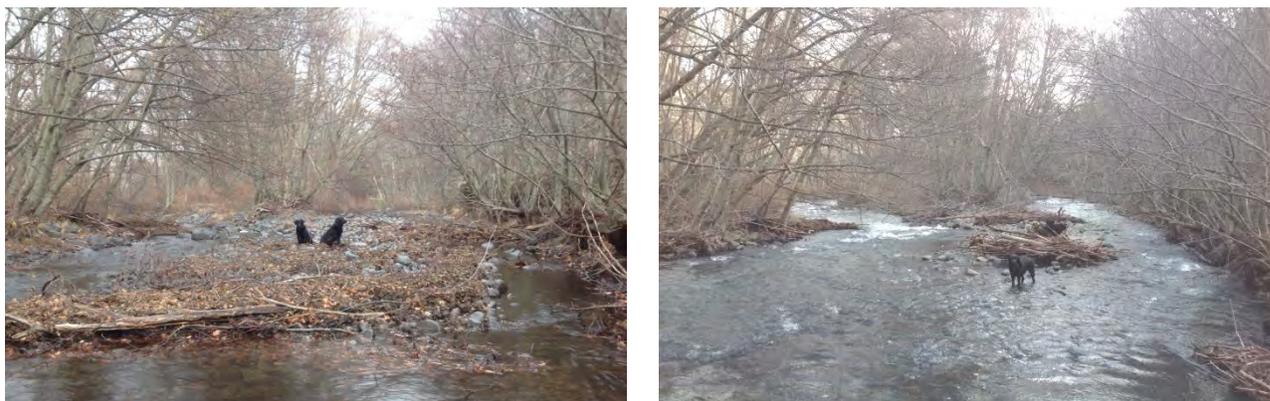
Figure 33. Same location on 1/7/14 during prolonged low-flow (left) and on 2/26/14 following small ($\ll Q1.01$) freshet. Note redistribution of mid-channel woody debris.

Wind and icing events tend to be the input mechanism for these smaller woody debris pieces (inclusive of small branches) which move during the first freshet (Figure 33). Though transient, these features were observed providing primary habitat collect leaf litter which increases water depth of some glides and pools up to 0.4 additional feet (Figure 34).

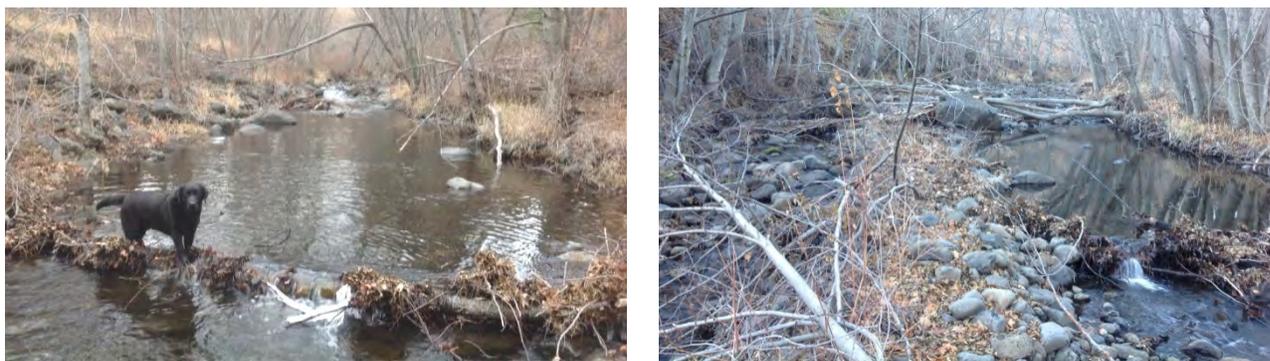
Figure 34. Transient pool habitat created by single LWD trapping hardwood leaf litter and increasing upstream water depth.

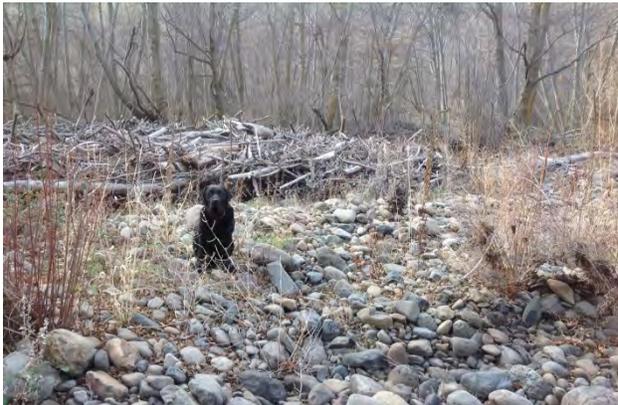
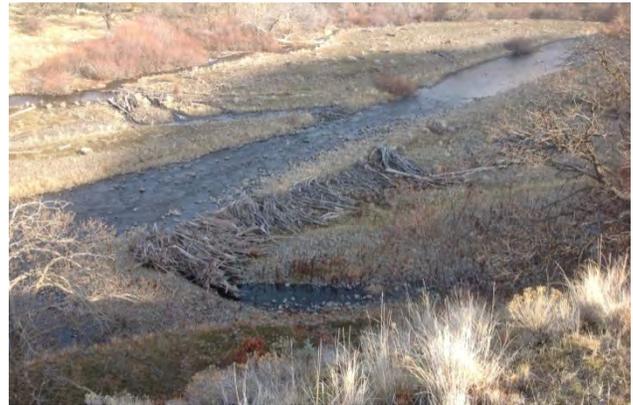
Figure 35. Examples of woody debris ‘rafts’; many exhibit signs of accretion (right) with younger material deposited by recent events near bar apex in flow separation zones.

- *rafts* – usually occur in overbank areas on the tops of bars (Figure 35) and floodplains (Figure 36) as well as down-valley extents of diagonal and transverse bars. Rafts form where flow becomes too shallow to maintain transport or by accretion into previous raft and may be dispersed and re-distributed by large events. In some instances, rafts may be reinforced by

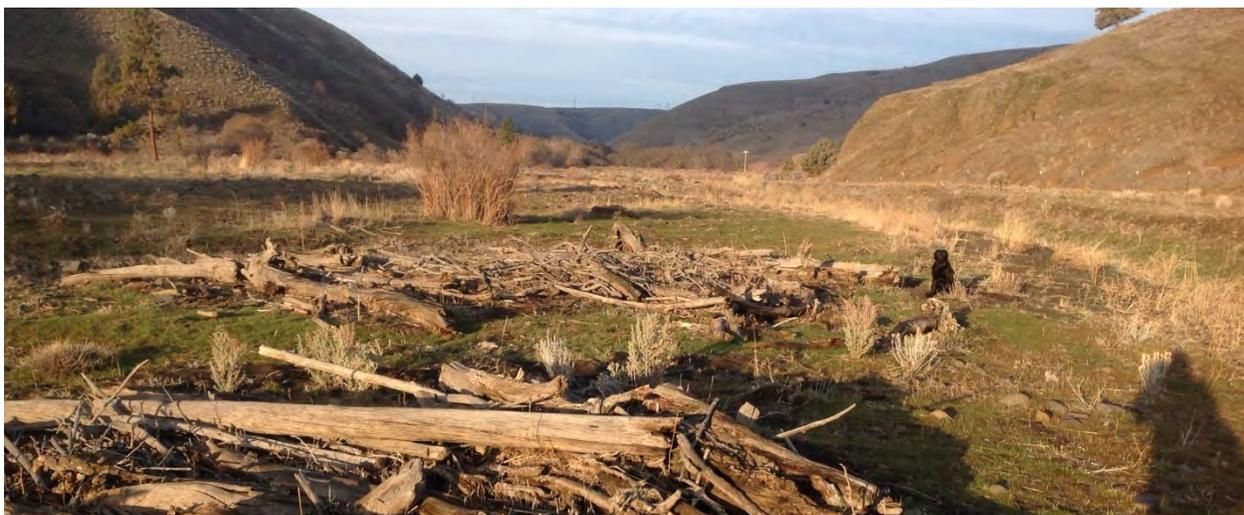
Figure 36. Floodplain woody debris ‘rafts’ deposited by the March 2012 peakflow event (Q3).

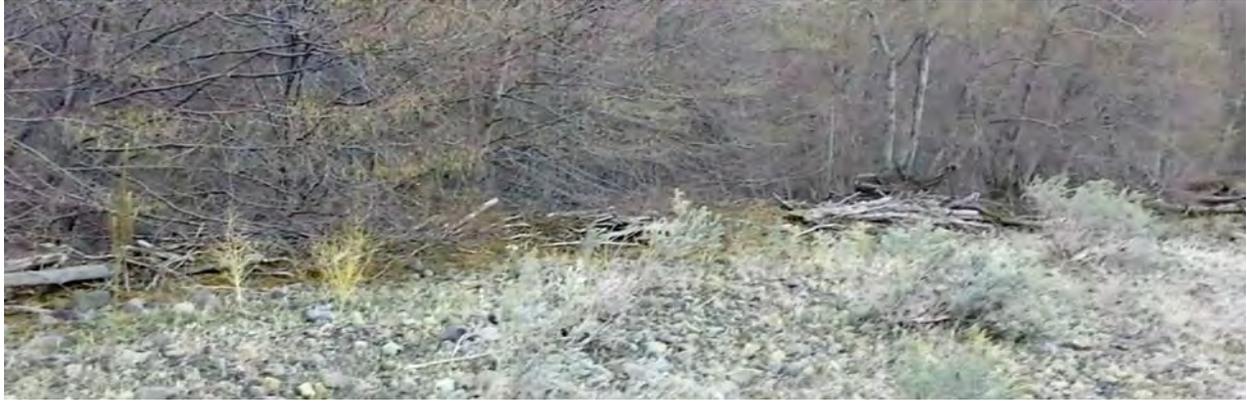
Figure 37. Woody debris "fences" occur in areas where perched floodplain flow re-enters a channel.

- *fences* – generally parallel the active channel. Occur in re-entrant areas where perched, overbank flow re-enters the primary or secondary channel and woody debris becomes racked into the off-channel side/face of riparian vegetation (Figure 37).

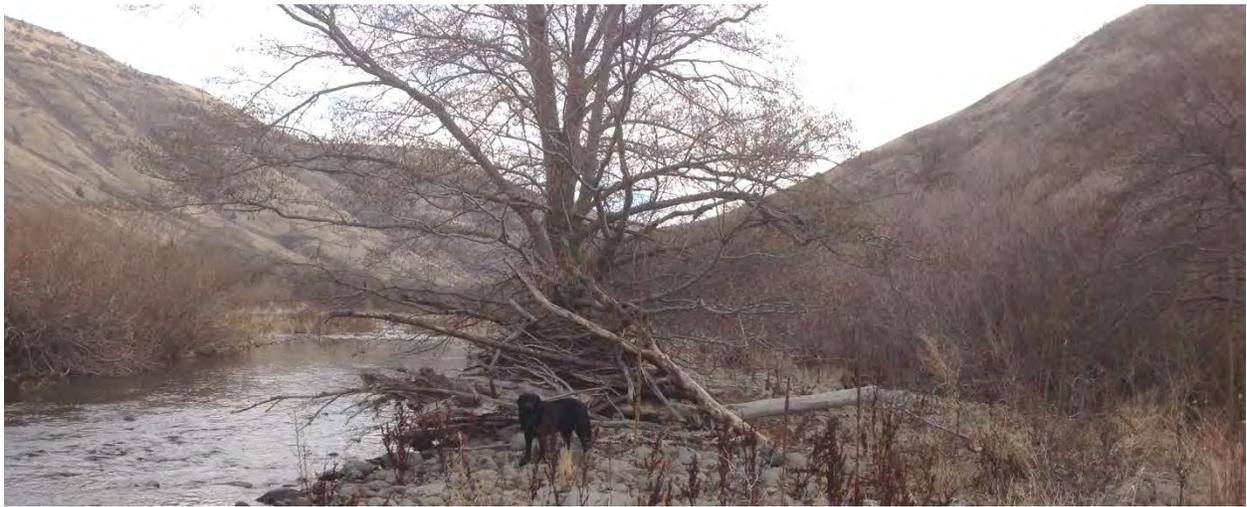
Figure 38. Example of alder growing within active channel and recruiting woody debris in "mini-apex" form during 2012 event (Q3).

- *mini-apex* – occur where smaller debris is racked into the upstream face of standing riparian vegetation and splits flow (Figure 38 and Figure 39), in-particular where mature alders occur within the active channel. Likely ephemeral; dispersed and re-formed at high-frequency floods (<Q10).

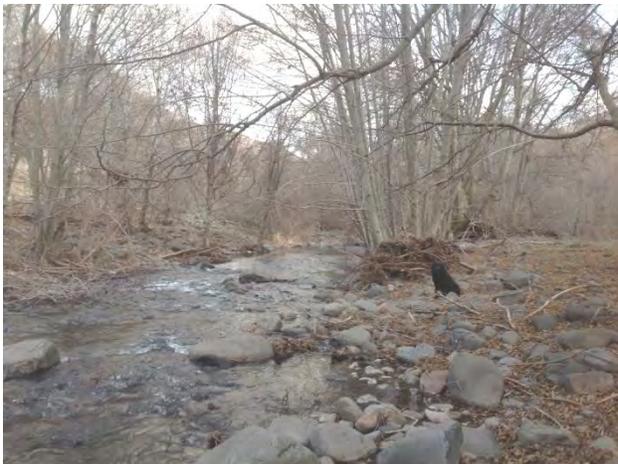
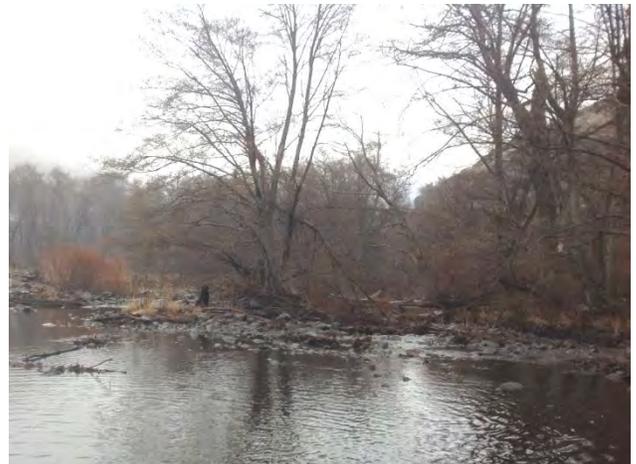
Figure 39. 'Mini-apex' forms of woody debris accumulation on edge of active channel with adjacent floodplain lacking roughness (left) and along margins of diagonal bar where flow splits into multiple chutes (right).

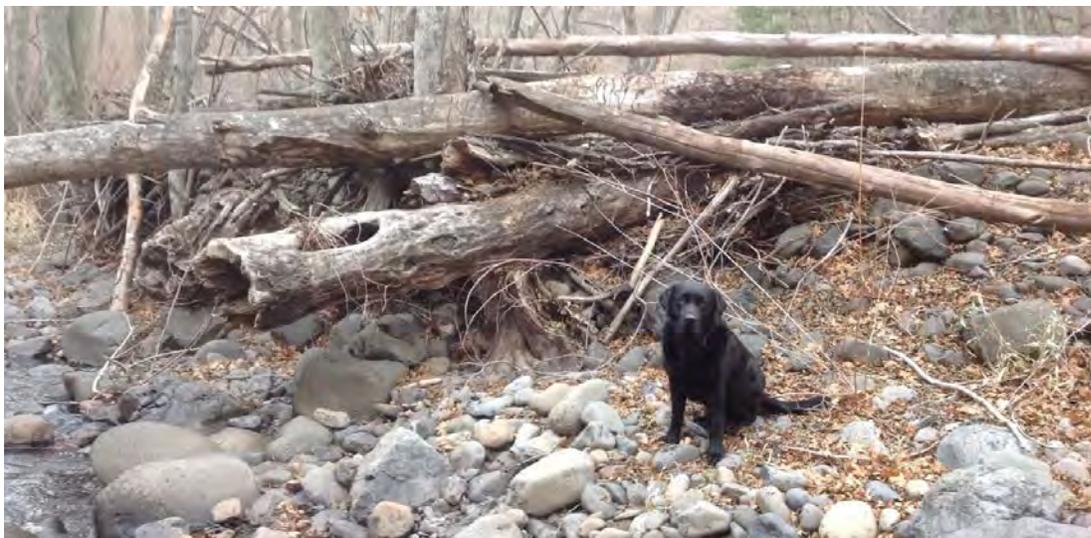
Figure 40. Woody debris ‘spur’ oriented perpendicular to channel with no flow path around the off-channel end.

- *spurs* – occur on channel margins and are oriented perpendicular to active channel, racked into upstream face of riparian vegetation with one end tied into topography so flow only occurs around one side or over the top (Figure 40 and Figure 41). May be over-topped during large (> Q5 or Q10) events. Spurs often have larger wood pieces (10-14 inch diameter) and appeared most likely to be habitat-forming (though infrequent).

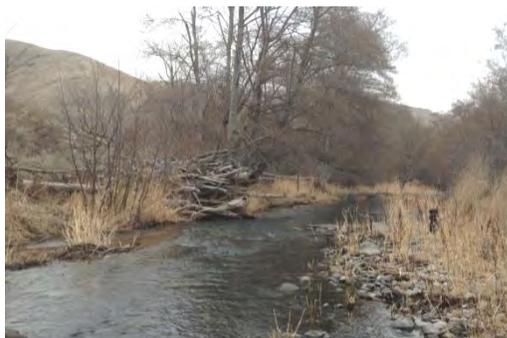
Figure 41. Example of woody debris spurs; racked into riparian trees, oriented perpendicular to channel, with one end butted into a higher topographic surface.

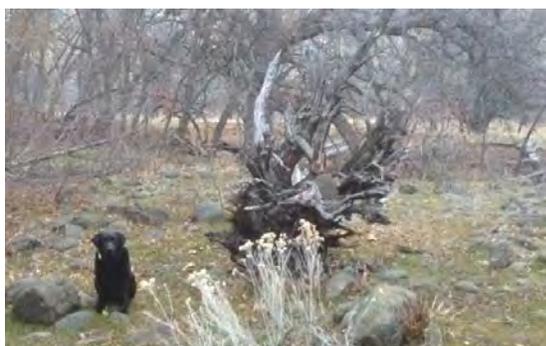
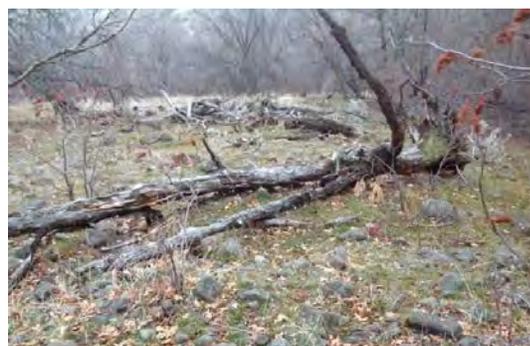
Figure 42. Example of a modest (16” diameter) walnut tree that was transported and deposited overbank by the 1996 (or earlier) peakflow event. Note degree of rootmass and portion of branching structure still intact.

Though, not as common as alder, flood-deposited black walnuts trees (*Juglans nigra*) are common on the highest active floodplain surfaces where they were deposited by the 1964, 1974, and/or 1996 peakflow events. Sounding of numerous specimens indicated found most of the older flood-deposited walnut trees to be surprisingly solid and able to bear their own weight, often with much of their primary branching structure still intact.

This stands in stark contrast to the native alders, which are quite brittle even when live and deteriorate quickly. As more walnut trees are recruited in the fluvial system over time, their increased resistance to weathering and fluvial transport (via greater specific gravity, persistent length, and form complexity) has potential to alter the nature of stream processes and habitat formation. The ecological implications of walnut trees are discussed further in the Vegetation Patterns section.

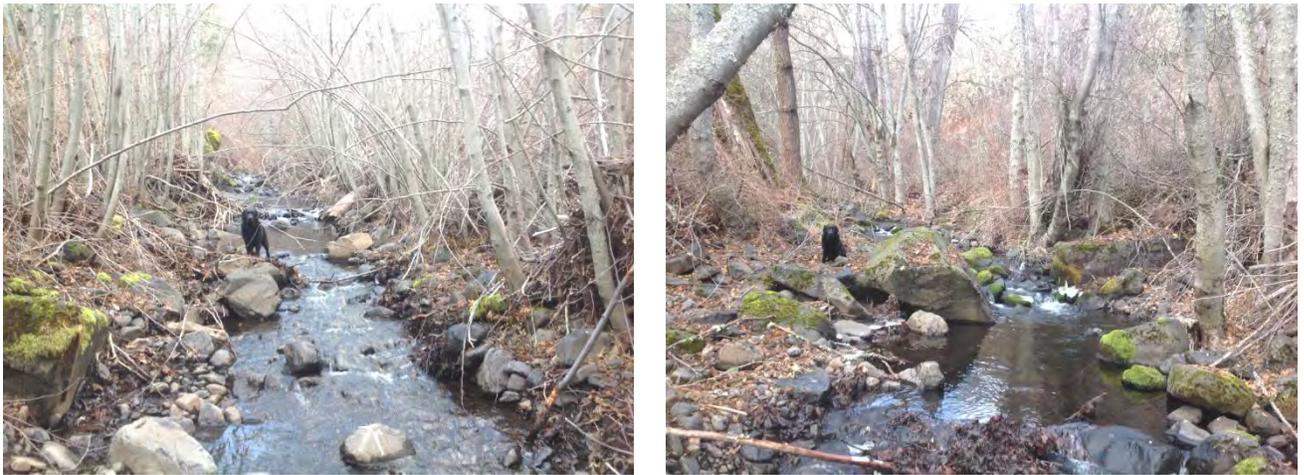
Figure 43. Rock Creek upstream of Quartz Creek confluence (~VM 16.9).

Coniferous LWD of sufficient size to individually generate a response in channel morphology or primary habitat was rarely observed during field surveys. This is likely due to availability of source material. Upstream of the Quartz Creek confluence both streams have topwidths of about 20-25' or less (Figure 43). Upstream of the confluence, both streams flow through confined, generally bedrock-controlled, higher gradient (> 0.05 average) canyons, each four to five miles long with multiple choke-points. The likelihood of upstream sources to contribute LWD of appreciable size to reaches downstream of the Rock-Quartz confluence is very low.

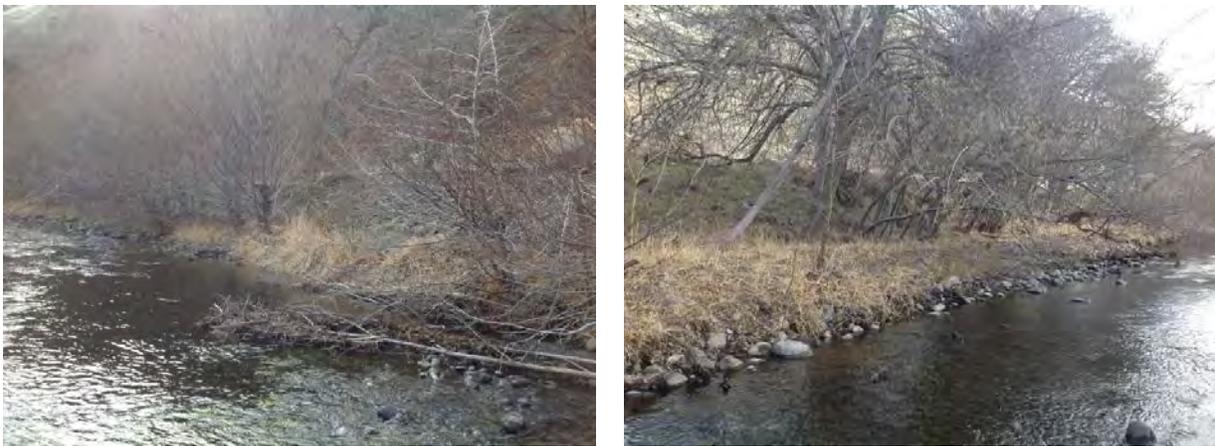
Figure 44. Alder cohorts on active channel margins.

Alder is the most common riparian tree along stream banks within the surveyed area. Using trunk diameter as a proxy for age, four to five cohorts were observed. The youngest cohort was typically less than 2 inches basal diameter. This group was old enough to have survived at least several winter peak flow and summer low-flow cycles and seemed to be consistently rooted in a narrow, linear band between 0.5 and 1.5 vertical feet above channel control. This narrow, linear pattern of colonization is reflected in the persistence of larger cohorts which, roughly, group into 4-8", 8-12" 12-16", and greater than 16" diameter at breast height (DBH), though there were local variations along the profile. It was not uncommon to have different cohorts on opposite banks in some hydraulic units. Alders greater than 16 and even 20 inches were not uncommon. It should be noted that at least two different species of alder are documented in the Rock Creek watershed which have different growth habits which may complicate interpretation for smaller-diameter (<~8-10" diameter) single-stem cohorts, particularly given field visits during dormancy.

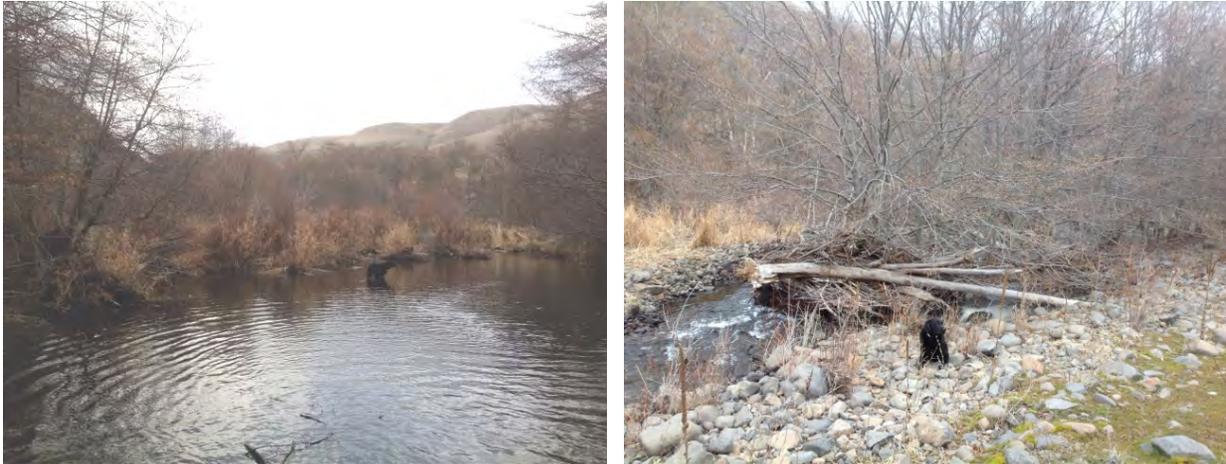
Figure 45. Mature in-channel coyote willow copse (left) and in-channel alders recruit woody debris (right).

Perennial vegetation within the active channel occurs throughout surveyed reaches (Figure 45). Alder bands were most widespread and often associated with compound active channels consisting of an inset wetted channel and a slightly higher ledge surface (Figure 46).

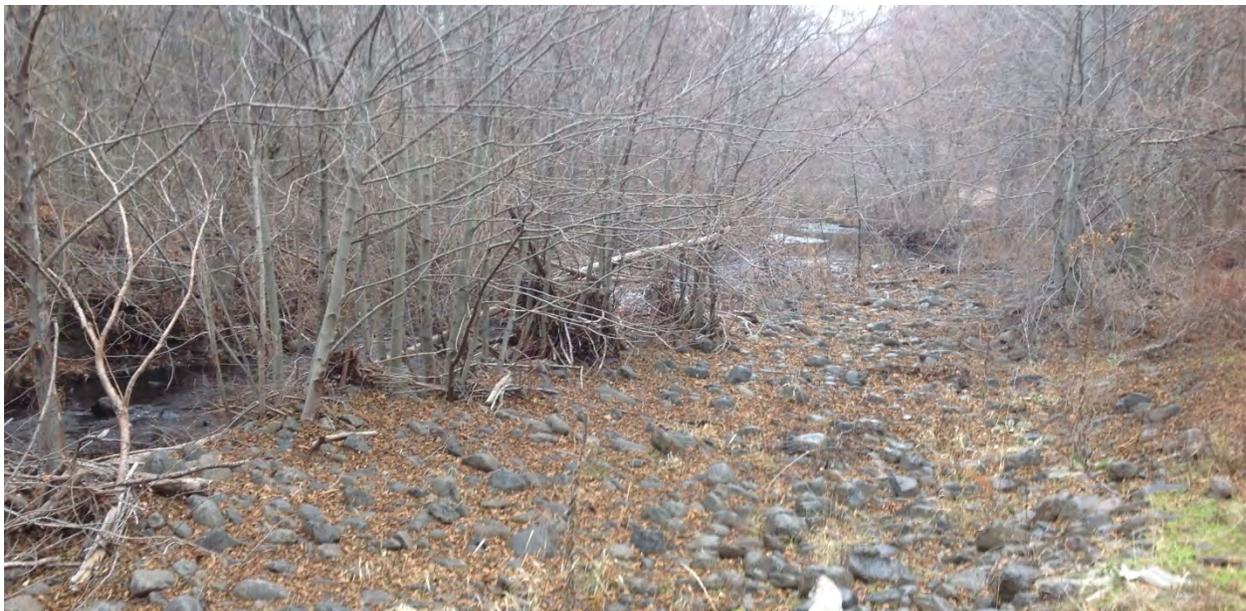
Figure 46. Young alder cohort persists in narrow band within compound active channel.

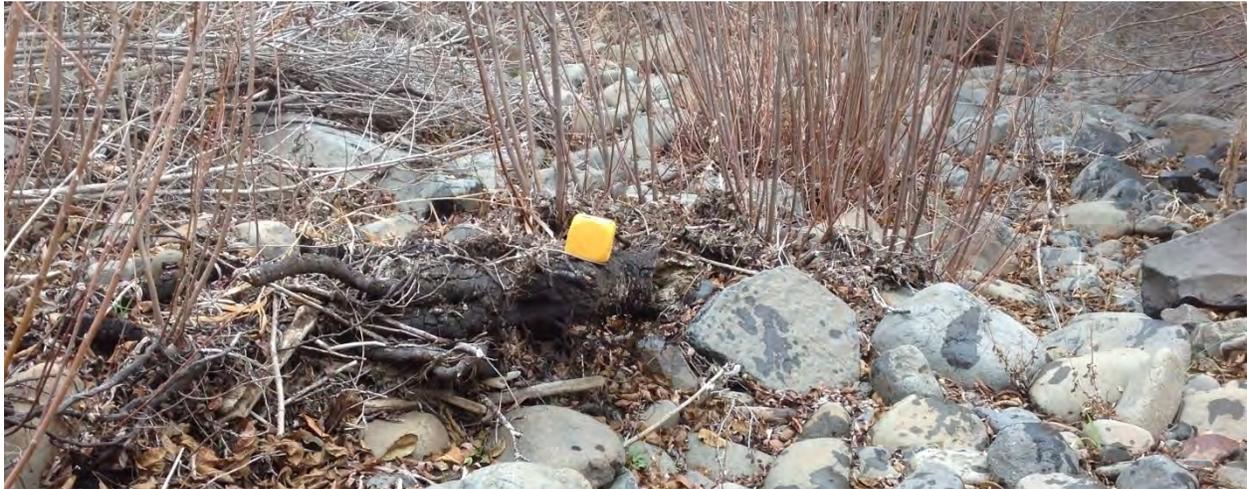
Figure 47. Older coyote willow root (>4" diameter) within active channel, re-sprouting with young, vigorous leaders.

Willow copses were also observed growing within the active channel, though these tended to occur in proximity to reaches or channel units where surface flow is seasonal. While leaders were often young, rootstocks indicated long-term (probably > 10 years) persistence (Figure 47). Though low-density in nature, woody hydrophytes were observed even in some of driest
