Fluvial Reconnaissance of Rock Creek and Selected Tributaries with Implications for Anadromous Salmonid Habitat Management

Rock Creek, Klickitat County, WA

Will Conley, Hydrologist/Geomorphologist
Yakama Nation Fisheries Program
Klickitat Field Office
Wahkiacus, WA

Project Number: 2007-156-00
56662 REL 112

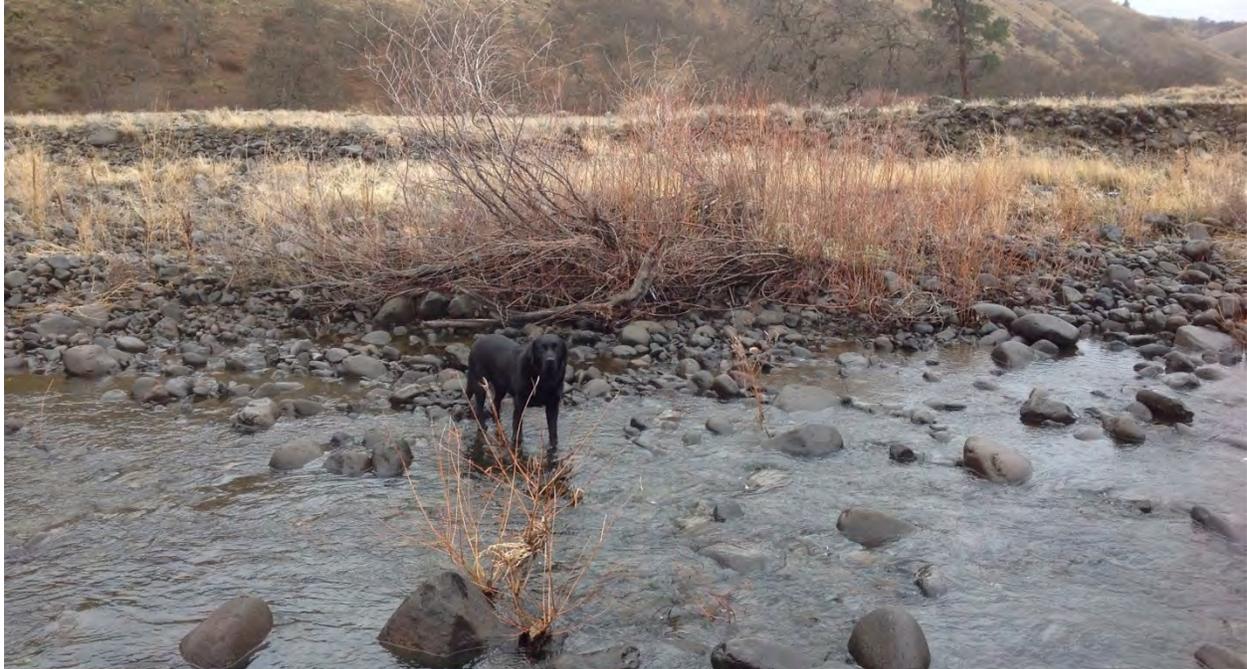
Figure 48. Mature coyote willow colony with incrementally younger suckering radiating upstream (to right).

summertime reaches such as in proximity of the Luna Creek confluence (Figure 48). Coyote willow (*Salix exigua*) was the most common species observed in such areas. The presence of a few well-established and vigorous individuals suggests establishment and early colonization as the limiting period, with successful recruitment classes potentially highly dependent on summer flow duration. Once mature coyote willow rootstocks are established, they seem to tolerate and resprout from routine disturbances (e.g. beaver browse and flood abrasion) quite well.

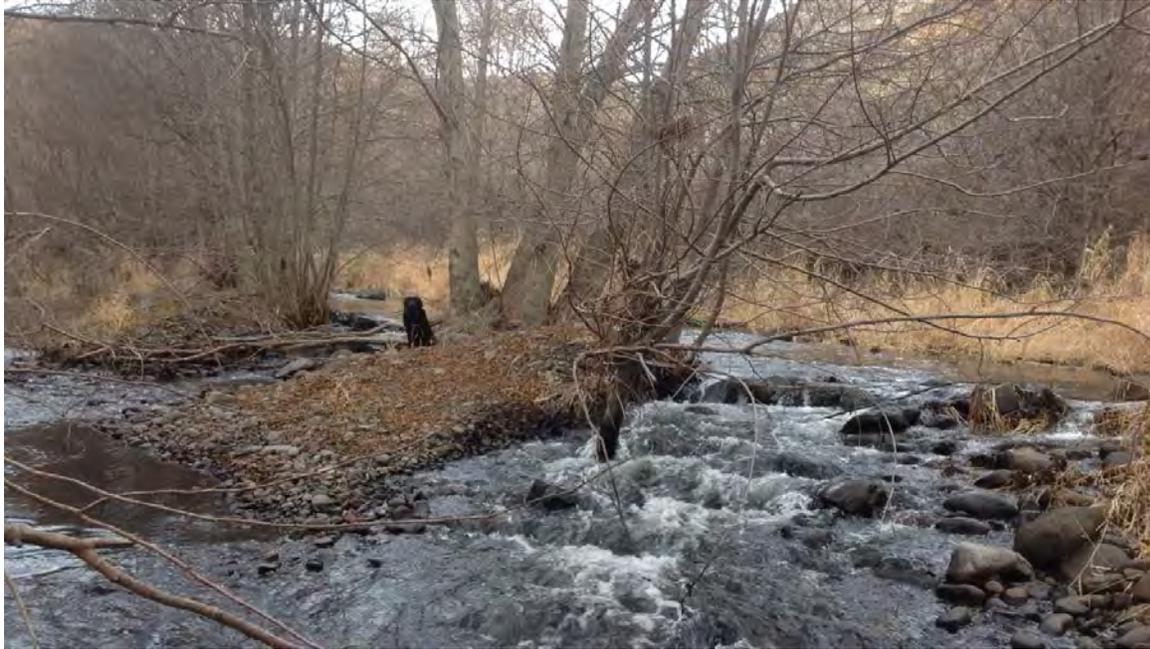
Figure 49. Older alders established under different channel conditions now occupy (and influence) chute dissection of diagonal bar. Lower channel (left) is a "seam" resulting from headward channel extension.

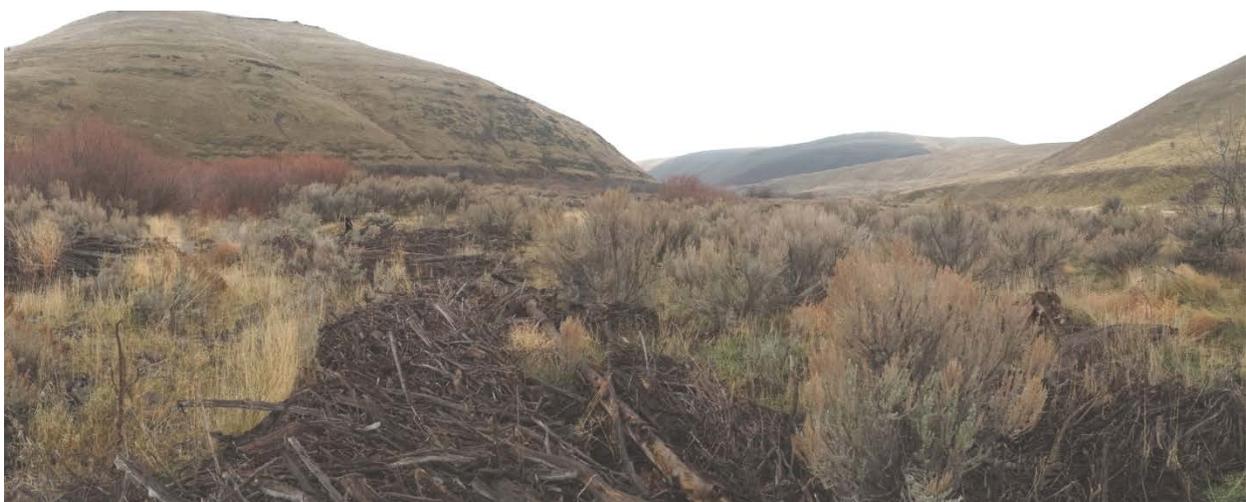
Figure 50. Woody debris deposited during 2012 event (Q3) amongst mature big sagebrush.

The position and juxtaposition of shrubs not typically considered as occupants of active floodplains was also intriguing. A variety of indicators left by the 2012 peak flow event (Q3) were observed throughout areas occupied by big sagebrush (Figure 50 and Figure 51) and rabbitbrush (*Chrysothamnus* spp, Figure 52) including woody debris and gravel sheets.

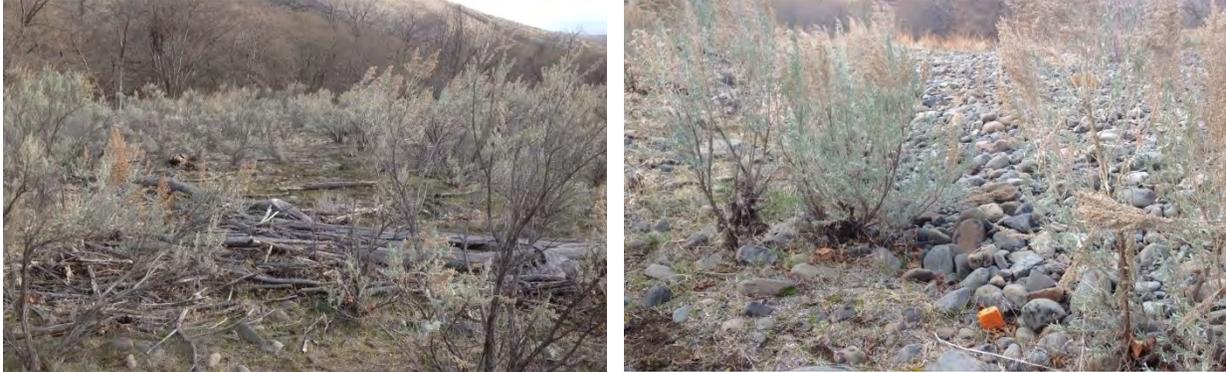
Figure 51. Woody debris (left) and gravel sheet (right) deposits associated with Q3 event adjacent to big sagebrush.

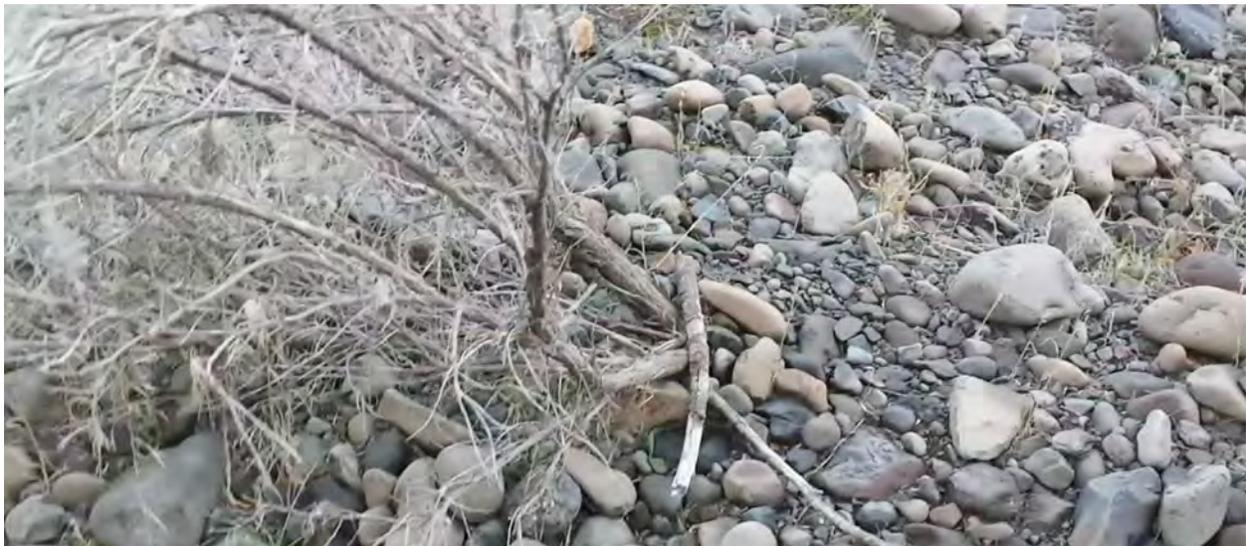
Figure 52. Mature rabbitbrush with downstream lean, woody debris, and gravel from the 2012 (Q3) event.

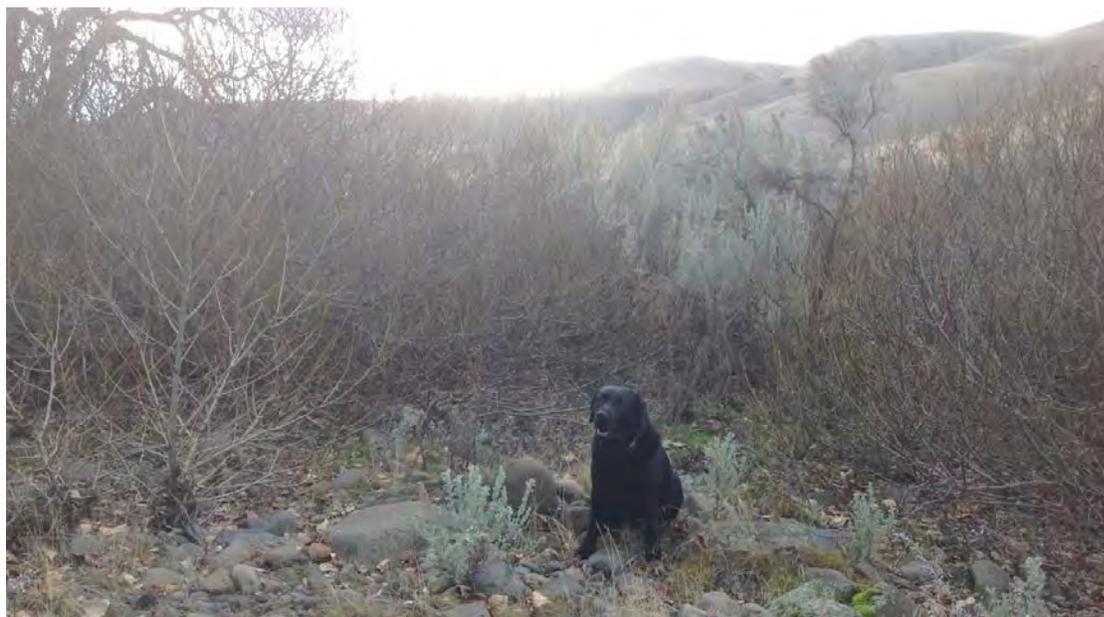
Figure 53. Black cottonwood, big sagebrush, and willow occupy and actively recruiting on same surface.

Figure 53 illustrates an example of a site where black cottonwood, big sagebrush, and an unidentified species of willow are all vigorous and actively recruiting new individuals or expanding colonies on the same floodplain surface. Establishment in these areas may be driven

by interannual hydroperiod variability. Wet years with extended streamflow recession likely favor cottonwood and willow establishment. Sagebrush may be favored by years with good winter moisture in the absence of major inundation events. Dry years may preclude establishment by any species. Persistence of species with a wide array of moisture tolerance in such areas is likely due to a water table with sufficiently short duration of near-surface saturation, but a September water table within accessible depth of the hydrophytes' roots.

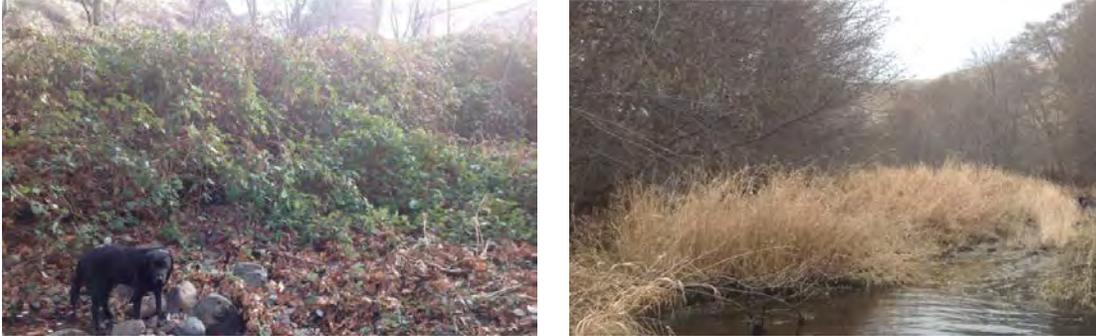
Figure 54. Invasive species such as Himalayan blackberry (left) and reed canary grass (right) become increasingly common downstream of VM 13.

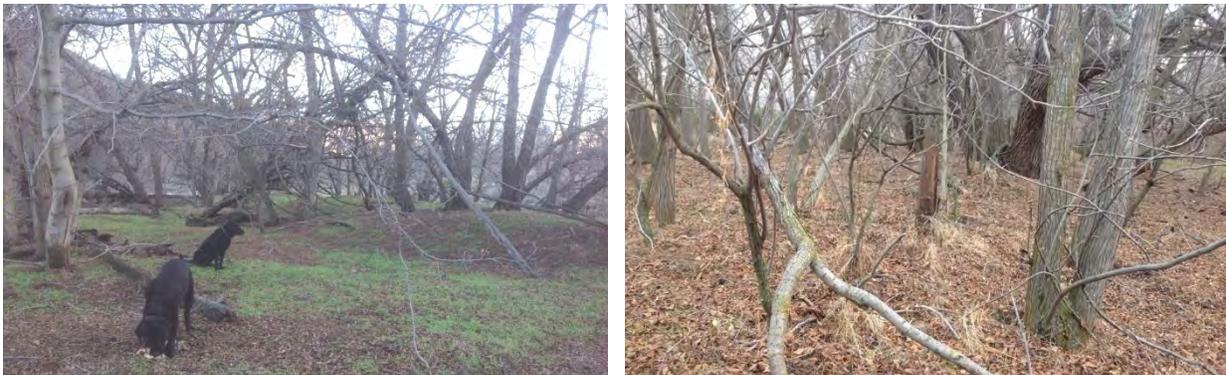
Figure 56. Walnut grove monocultures along Rock Creek floodplain in vicinity of VM4 (left) and VM 8 (right).

Expected benefits of increased shade and prospects for instream habitat formation by walnut trees have potential trade-offs. Black walnut is allelopathic; that is, it produces a toxin that inhibits or prevents growth of other plants in its proximity (USDA 2014). Walnut monocultures where native vegetation has been displaced were observed in several locations (Figure 56) and seem to be an increasing in distribution.

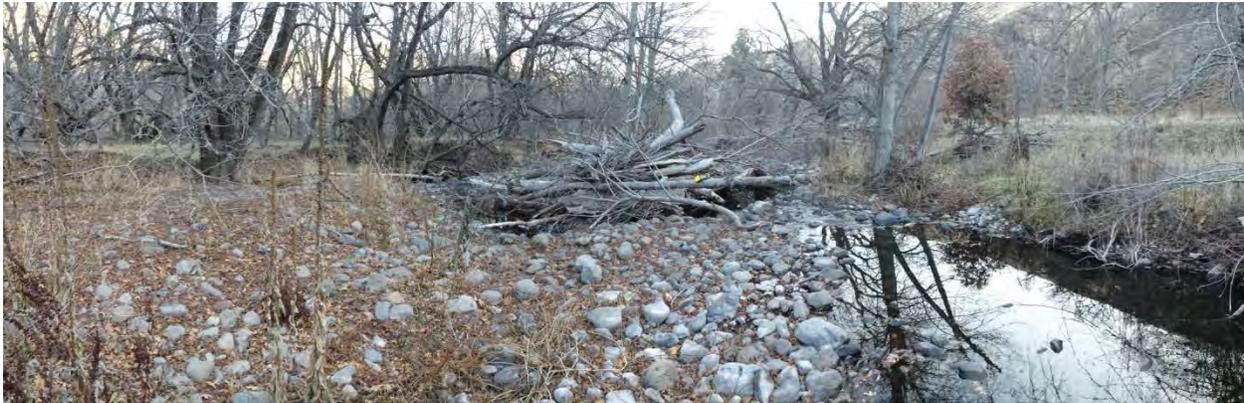
Figure 57. Apex jam contributing to upstream bar development on Squaw Creek.

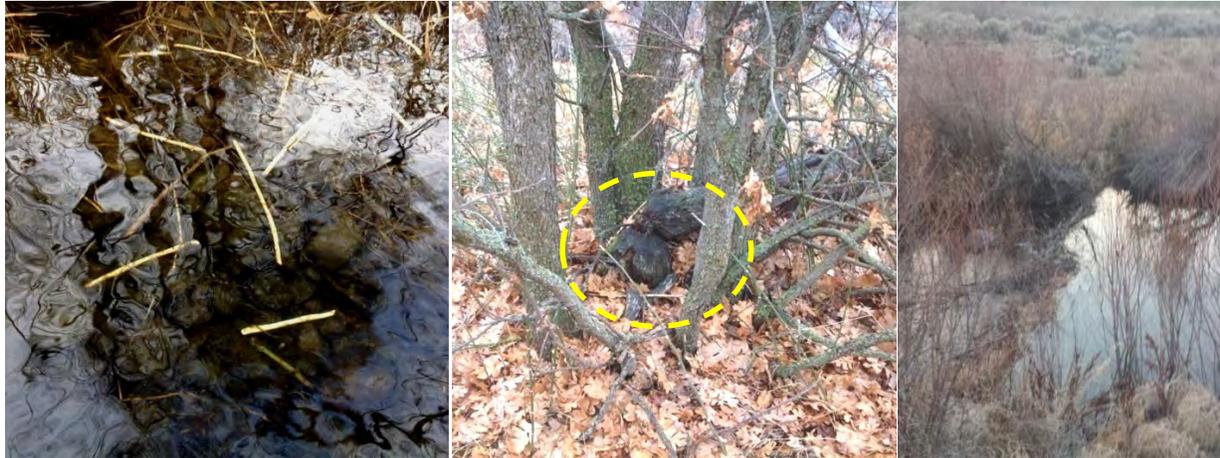
Figure 58. Freshly chewed sticks (left) and historic stumps (middle) were not uncommon during field surveys along Rock Creek. Channel-spanning beaver dams (right) were less frequent, but noted in several locations in the lower 10 miles.

Fifty-eight instances of beaver activity were noted while walking the lower 17 miles of Rock Creek (Figure 58). All but one observation were in reaches where stream gradient is less than 0.02 and downstream of VM 12.2, with most observations, including all fresh signs, downstream of Luna Creek. Age of signs ranged from days or weeks old to over a decade or more (Figure 58). Channel-spanning beaver dam construction was infrequent and generally composed of smaller materials (e.g. coyote willow) less likely to survive significant peakflow events. However, ballasting with cobble was observed and the general low-head character of dams (all of which had less than a 1.0 foot of water surface differential) likely increases their chances of persistence.

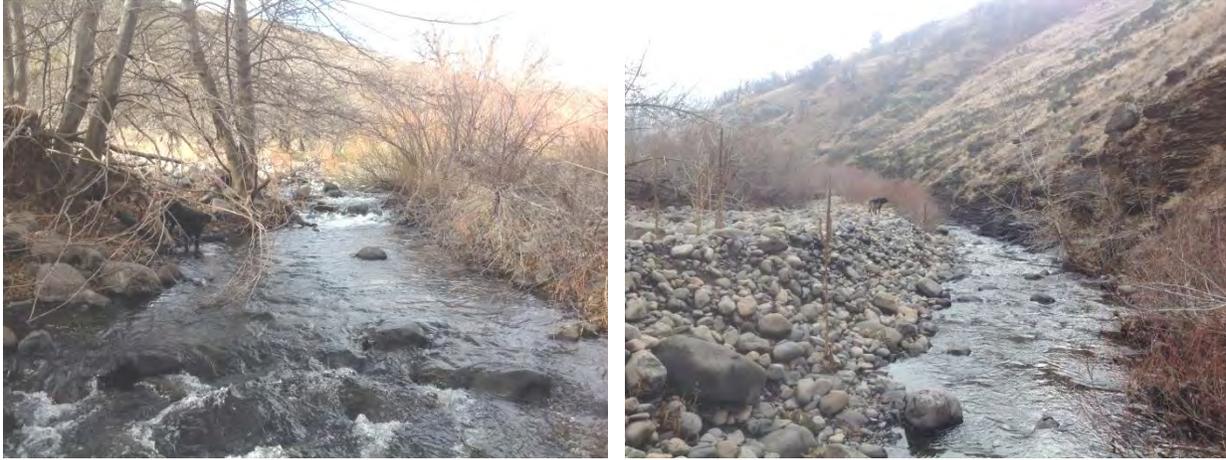
Figure 59. High-relief bedforms; post-dissection (left) with larger residual clasts and active-dissection (right).

- 2) *High-relief bedforms and channel controls* (Figure 59) occur mainly as diagonal and transverse bars composed of large-gravels to large-cobbles. Most are well-packed, except on the distal/downstream facies where steeper local gradients at higher-frequency peak discharges result in ongoing re-working. The chutes and seams that dissect these areas often have particles with greater relative relief and are less well-packed. These features are interpreted to be sediment slugs deposited by high-magnitude peakflow events (Q25 or greater) that were transported over the armor layer and dissected by subsequent flows following deposition. “Perched” water surfaces at relatively low flows likely indicate a greater subsurface fines component.

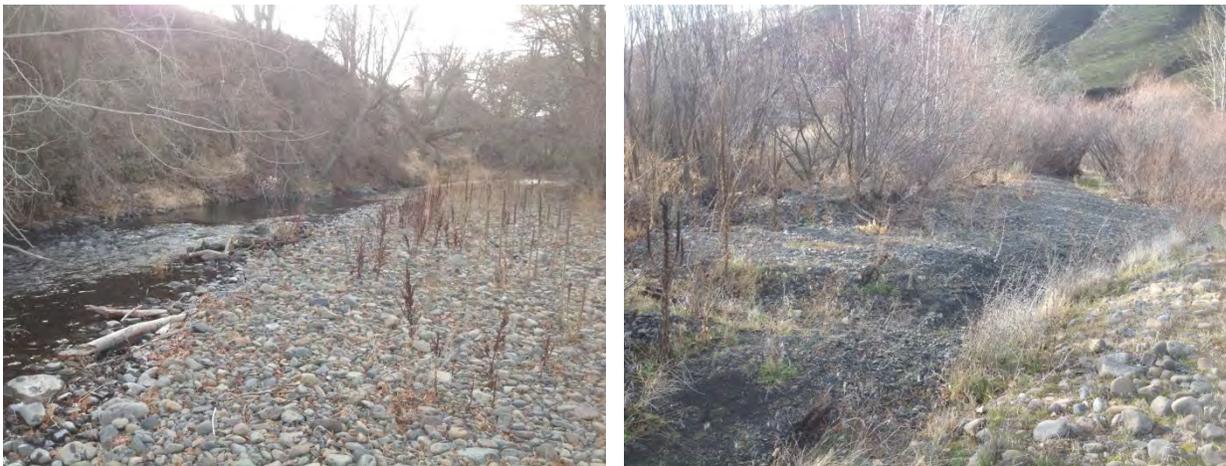
Figure 60. Low-relief features (low-gradient riffle and lateral bar; left) and channel fill (right).

- 3) *Low-relief bedforms* and channel controls (Figure 60) tend to be gravel-dominated, but many include cobbles. They are largely inset features (lateral bars, medial bars, and low-gradient riffles) within longer plane-bed features, may act as a hydraulic control at lower discharges, and are interspersed within high-relief bedforms. Particles associated with these features tend to be somewhat smaller, rounded, not particularly well-packed and likely associated with higher frequency sediment transport. Their deposition and formation may be associated with localized backwatering and ineffective flow areas within the active channel.

- 4) *Channel fills* (Figure 60) tend to be sandy gravels and occupy former channel alignments where active channel “switching” or modest flow into overbank channels has occurred. They are granular and unpacked. These are highly localized and infrequent. Until they are stabilized by vegetation, their erodibility facilitates reoccupation of old channel alignments during low-frequency peaks.

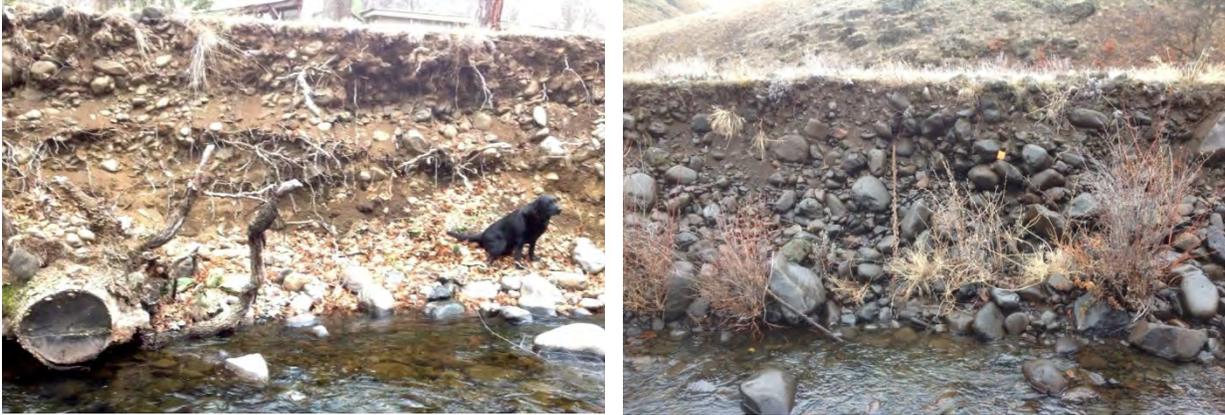
Figure 61. Bank facies reveal poorly sorted floodplain sediments.

- 5) *Floodplain sediments* are generally poorly- to moderately-sorted, often weakly clast-supported, and have a comparatively high component of fines ($<2\text{mm}$) with modest cohesive properties (mainly silts). Larger clasts tend to be sub-rounded to sub-angular cobbles and small boulders. Many of these deposits are in the process of being re-worked via stripping or lateral erosion by the active channel. Sorting apparent in bank facies suggests turbulent depositional conditions and is interpreted to be largely associated with large magnitude, low-frequency events. Characterization of some floodplain surfaces is locally complicated by sand or gravel sheets (recent deposition).

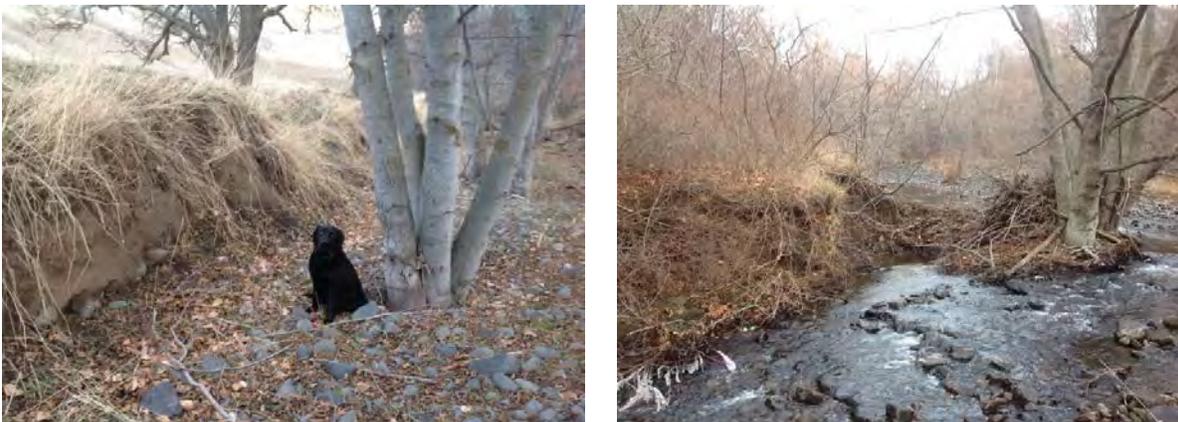
Figure 62. Eroding facies of fine-textured sediments.

- 6) The *relic fines* group (Figure 62 and Figure 63) consists of deposits of generally high silt content, displays cohesive properties, and generally thickly-bedded (3-8'). This group of sediments generally only appears in erosional banks and was not observed in areas of recent deposition or bank construction. This group of sediments appear to be more laterally extensive downstream of VM 10. A few localized occurrences in bank facies were observed between VM 10 and 13 with little surficial indication of horizontal extent, but they are generally uncommon. All observed instances occur below 1050' elevation which is within the maximum Missoula Flood stage modeled (~1,115') by Benito and O'Connor (2003) for the Columbia River at the mouth of Rock Creek. This could be geologic coincidence as the deposits were not often observed to have distinctive bedding or laminations and many bank facies appeared massive. However, they could be the result of upstream re-working of slackwater fines and subsequent redeposition. "Relic fines" units often occupy more central portions of the valley floor unlike units showing laminations which tend to occupy only valley margins, frequently as terraces. They appear to be representative of depositional environments that do not currently exist in Rock Creek, possibly secondary deposition due to downstream obstructions (e.g. beaver dams or tributary alluvial fans that temporarily dammed the valley). Hand-texturing suggests they may also have slightly higher clay content than terrace materials.

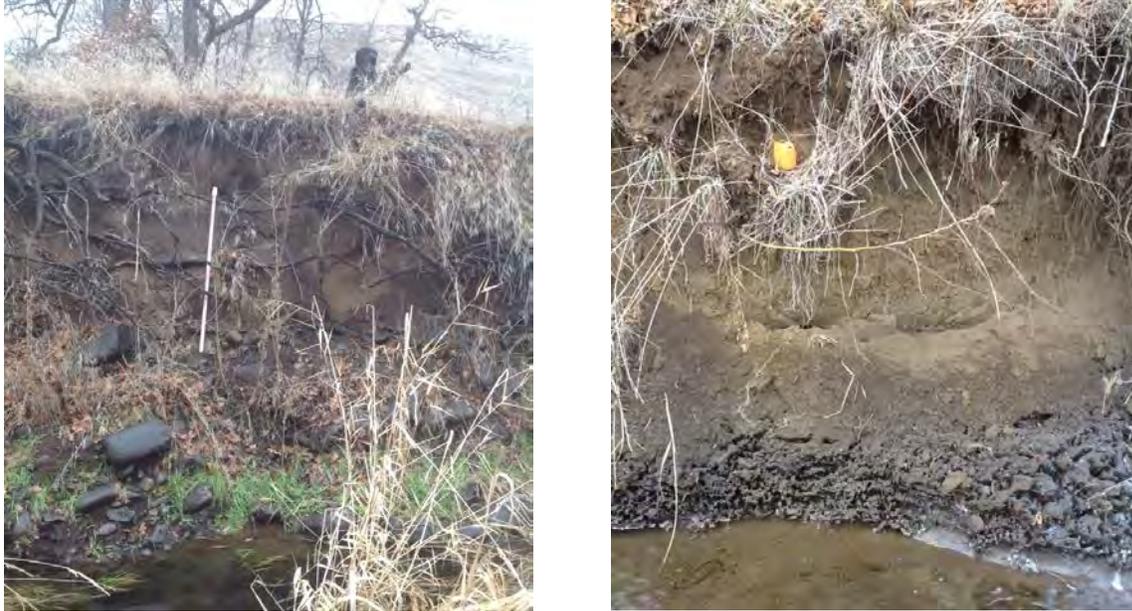
Figure 63. Thicker deposits of ‘relic fines’ in the valley floor.

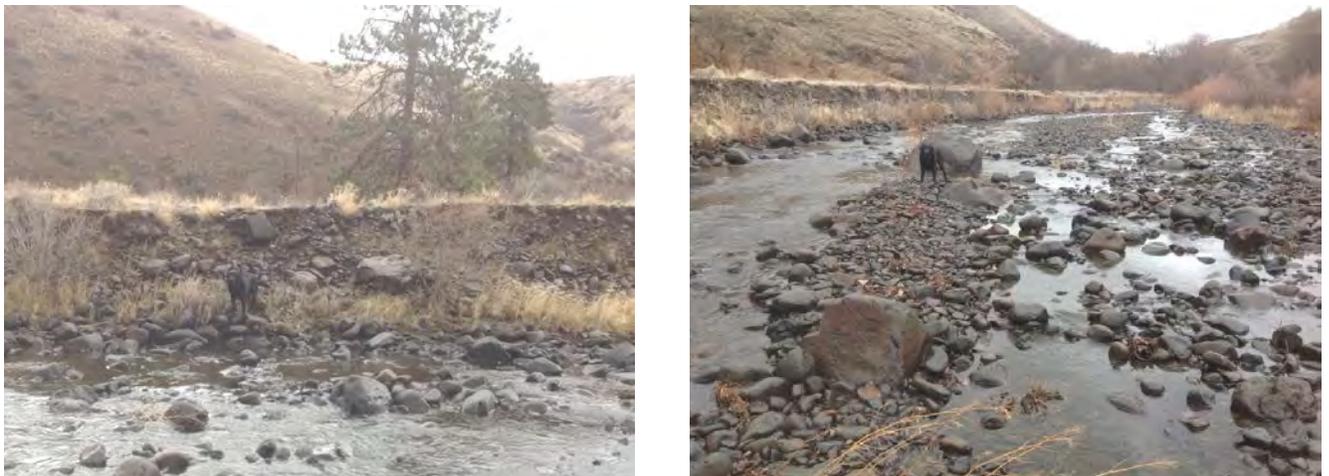
Figure 64. Poorly-sorted, unreinforced banks eroded (left) leaving larger clasts behind (right).

- ongoing dissection of high-relief bedforms - Bar dissection seems to occur during higher frequency peakflows $Q_{1.01}$ to Q_{10} when free-overflow of the riffle crests and steep local water surface gradients on the downstream faces prevail. “Hot Spots” in stream power graphics on maps in Appendix B are indicative of such gradients (Figure 59).
- lateral erosion of banks with lower resistance and consolidation – This occurs generally as a function of low density of woody riparian plants and is moderated by content of cohesive fines as well as self-armoring by cobbles and small boulders as the generally poorly sorted floodplain materials are reworked (Figure 64 and Figure 65).

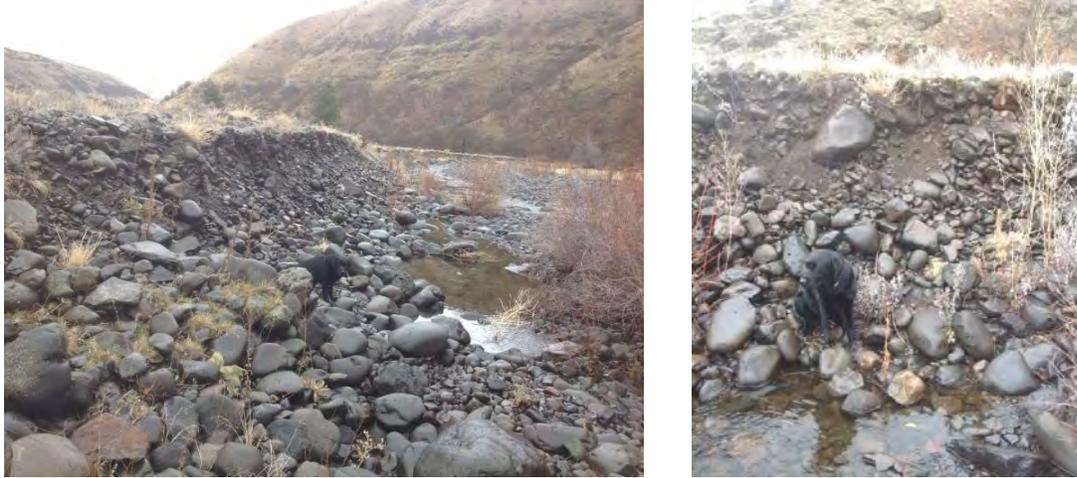
Figure 65. Self-armoring of bank toe as lateral erosion re-works poorly-sorted floodplain sediments.

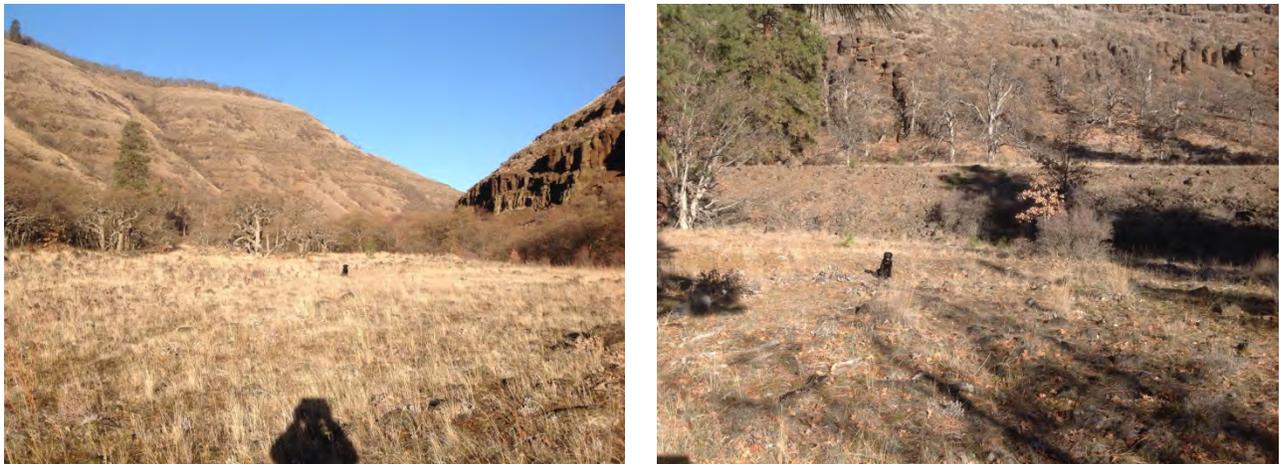
Figure 66. High terraces between Bickleton Hwy and Quartz Creek often intercept many colluvial particles as well alluvial sediments from smaller, unnamed tributaries.

Unnamed tributaries to Rock Creek between VM 14.1 and 17.0 appear largely decoupled in terms of sediment supply except during very low-frequency events. Where bed-sized materials were observed exiting these drainages, they were generally intercepted by floodplains and terraces (Figure 66). Some alluvial sediment continuity was observed for both named and unnamed tributaries at VM 12.0 and 14.0. However, throughout much of the lower mainstem of Rock Creek, fluvial sediments from most unnamed tributaries are intercepted by terraces or floodplains and provide generally few routine contributions to the active channel of Rock Creek.

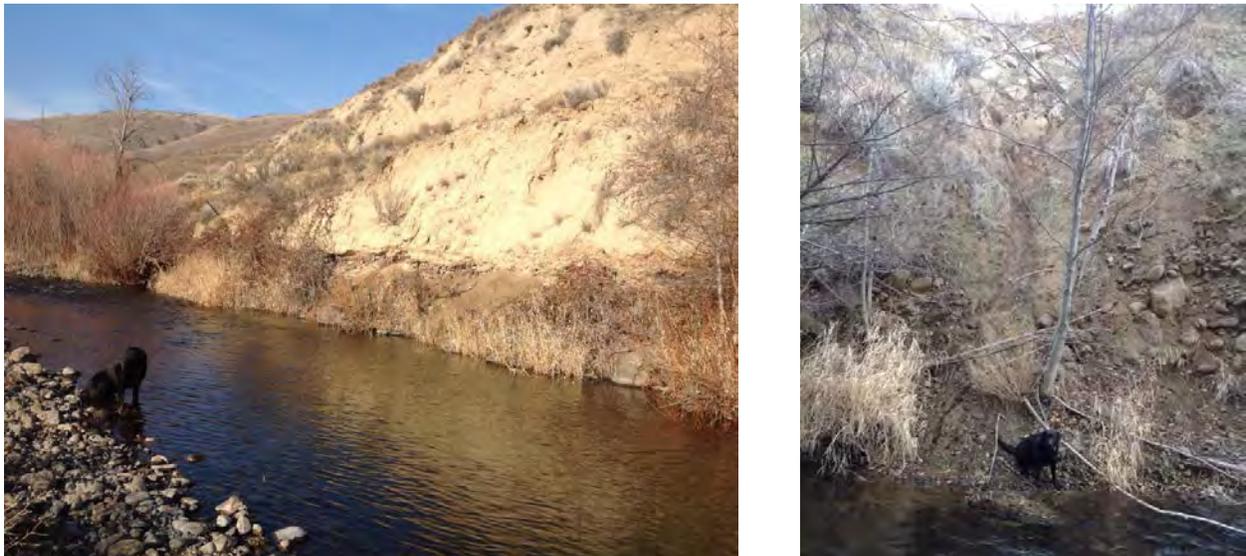
Figure 67. Fine sediment (loess) sources from direct channel contact (left) are infrequent. Concentrated road runoff (right) drains onto fines overlying alluvial fan deposits.

Sediment recruitment was noted from a variety of more consolidated materials (though at much slower rates), including terraces (Figure 67 and Figure 68), re-working of alluvial and debris flow fans (Figure 69), and cutting into indurated layers (Figure 70). The latter includes a location at ~VM 8.75 that was the only location noted where the bed was composed of and channel actively cutting into indurated sediments. Stripping of unconsolidated floodplain surface sediments (Figure 71) was also observed as a sediment source.

Some of the most noticeable landforms in lower Rock Creek are high terraces composed of pale silts along the valley margins (Figure 67). Though most apparent downstream of VM 5.5 in Rock Creek and VM 1.5 in Squaw Creek, similar features occur upstream but are subtler and diminish in relief. Some of the features appear on soil maps USDA (2013) as “loess”. Examinations of eroded facies at two locations upstream of Squaw Creek reveal thin bedding. Animal burrows are common in vertical faces as well as the upper surface and investigation of castings produces very few clasts, none of which were larger than about 30 mm in size. Terrace relief above the valley floor decreases in the up-valley direction and degree of dissection appears to increase. Thick silt deposits on valley margins were found as far upstream as the vicinity of the Luna Gulch confluence. Relatively little active toe erosion of these terraces was observed as they generally overly other clastic sediments (e.g. alluvial fans), or have self-armored from past erosion, or benches of toe ravel have been colonized and somewhat stabilized by woody hydrophytes. Peakflows exceeding the Q5 to Q10 seem necessary to engage these sediments.

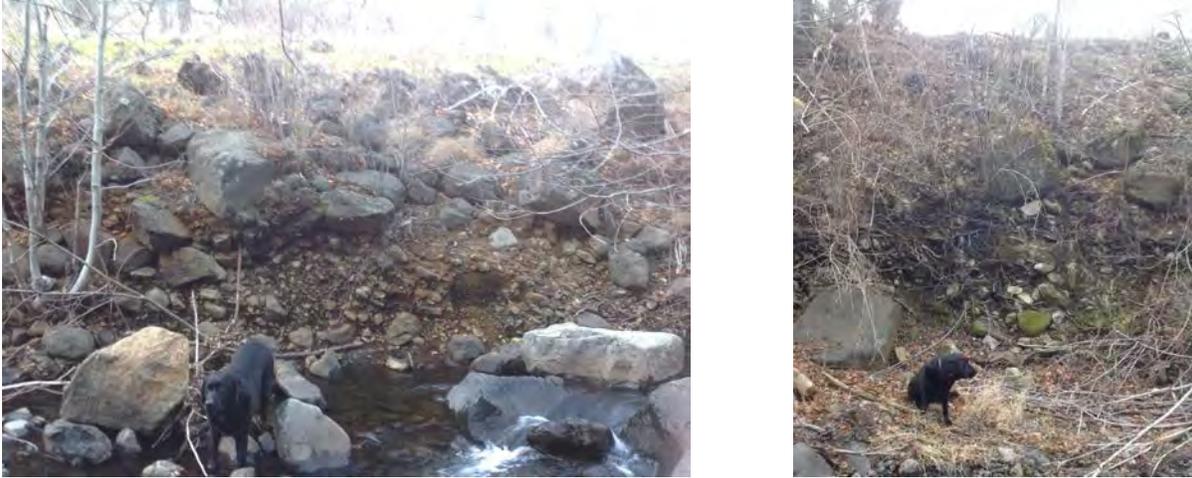
Figure 68. Re-working of poorly-sorted terraces with high cohesion. Terrace on left appears to have surficial armor layer from period of pre-incision re-working. Terrace on right is composed largely of matrix-supported materials (possibly from debris flow).

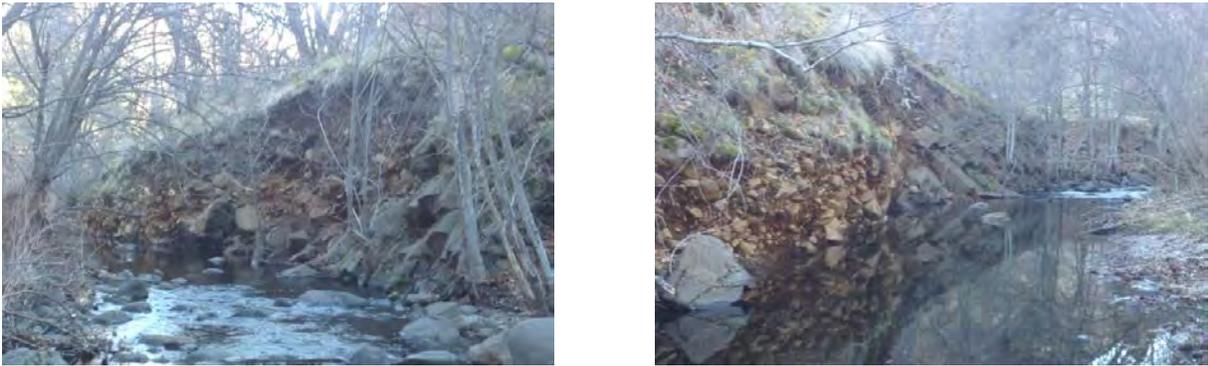
Figure 69. Re-working of historic alluvial and debris fan toes.

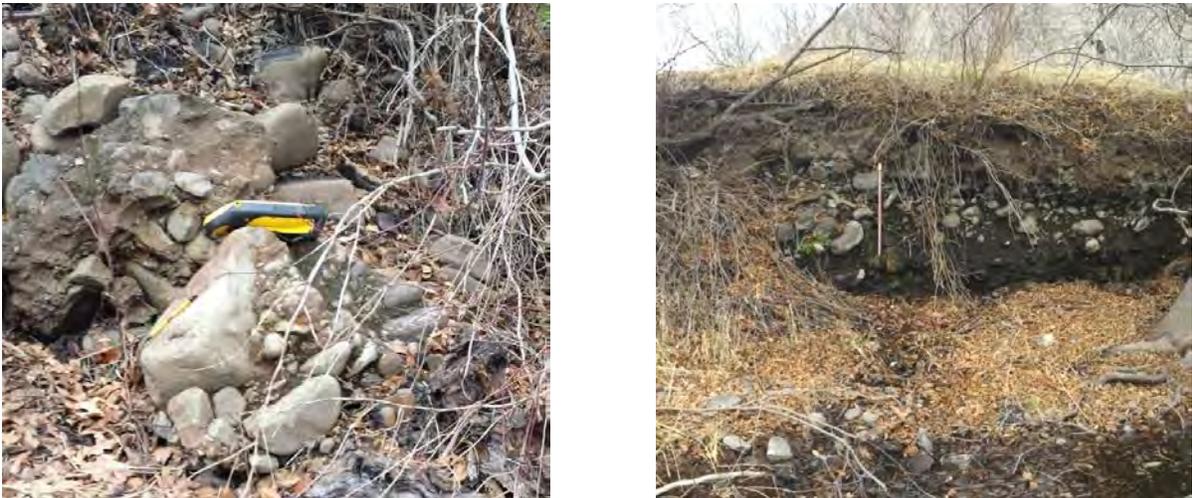
Figure 70. Exposures of indurated sediments were observed locally throughout the field-surveyed area., generally exhibiting greater erosion resistance and frequently associated with groundwater.

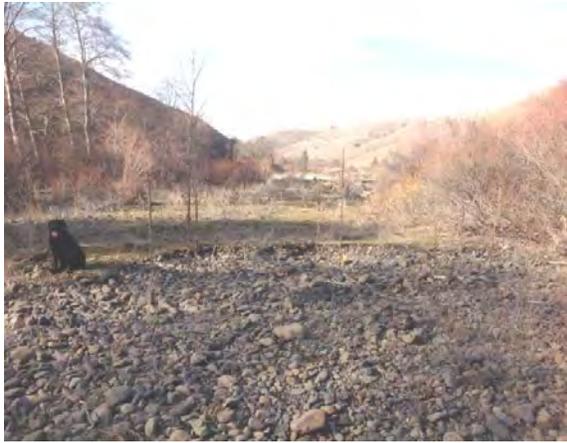
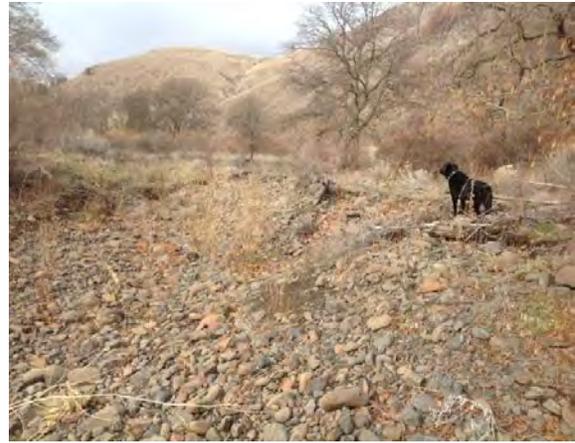
Figure 71. Floodplain stripping, most recently active during March 30, 2012 (~Q3).

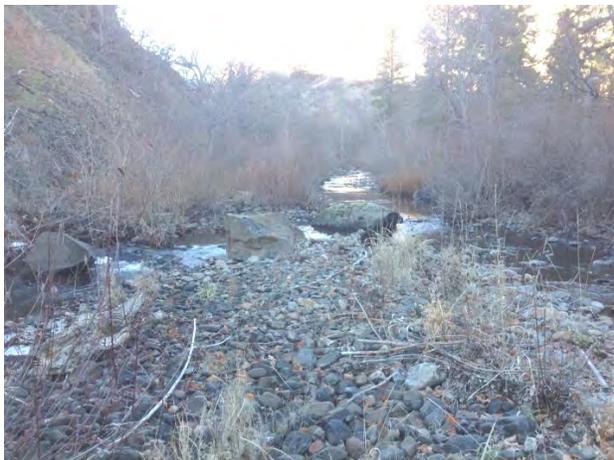
Figure 72. Active medial (left) and lateral (right) bars are infrequent upstream of ~VM 14 along Rock Creek.

Supply of bed-sized particles from the upper watershed (upper Rock and Quartz creeks) was not notably abundant during field surveys. Gravel and cobble bars within the active channel were infrequent (Figure 72).

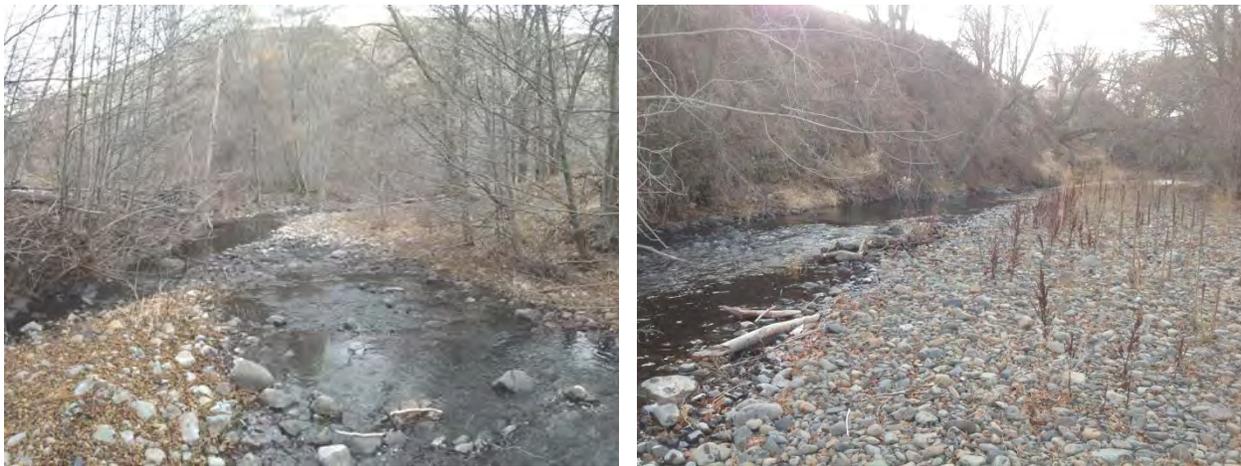
Figure 74. Low-relief bedforms: diagonal bar (left) and low-gradient riffle (right).

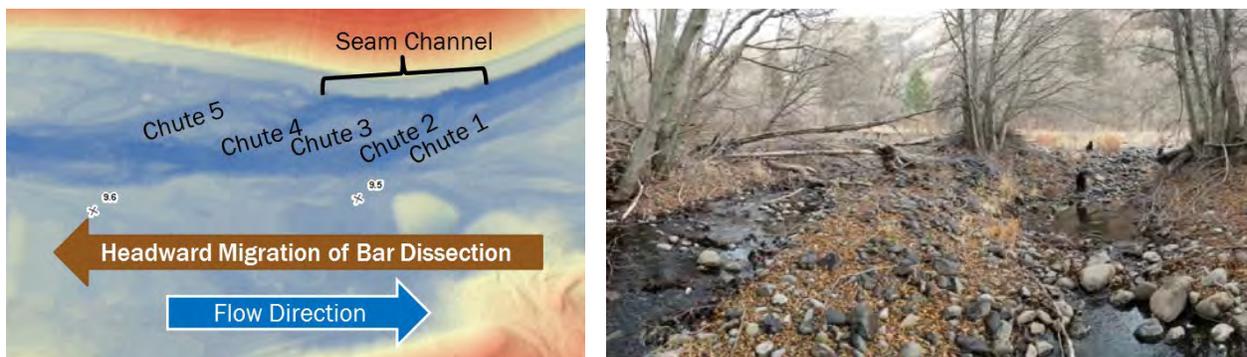
Figure 75. Schematic showing development of high-relief diagonal bar (left) and upstream view of chutes (right).

Figure 75 illustrates the mechanism by which dissection of high-relief diagonal bars in Rock Creek is likely occurring. Sediments deposited initially as a unit (e.g. “slug” or “wedge”) during a large, infrequent peakflow event are re-worked incrementally through time, driven by local gradient. Crossover flow concentrates into a “seam” channel which incises, usually along a resistant boundary. As the seam channel migrates headward, local gradients steepen, capture crossover flow, and eventually form channelized “chutes”. The youngest chutes are upstream (e.g. Chute 5) and the oldest are downstream (e.g. Chute 1) and become abandoned or require

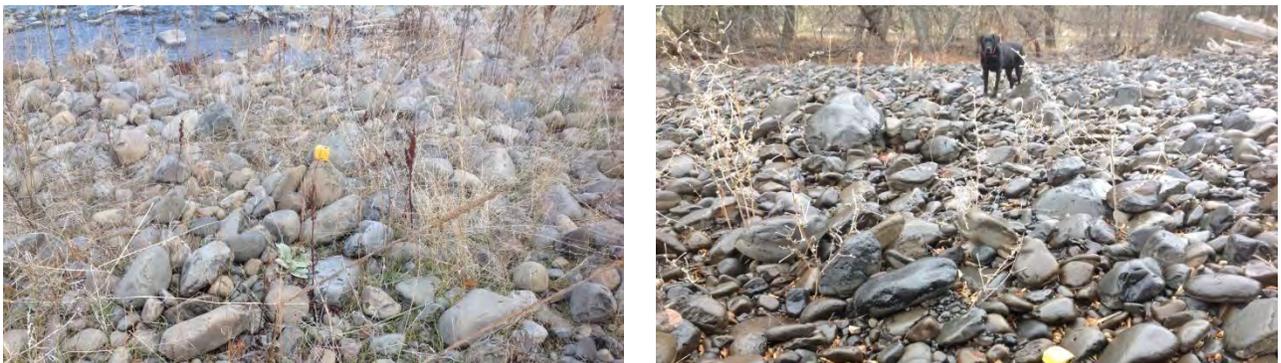
Figure 77. Clustering (left) and imbrication (right) of larger clasts is frequent along the mainstem of Rock Creek.

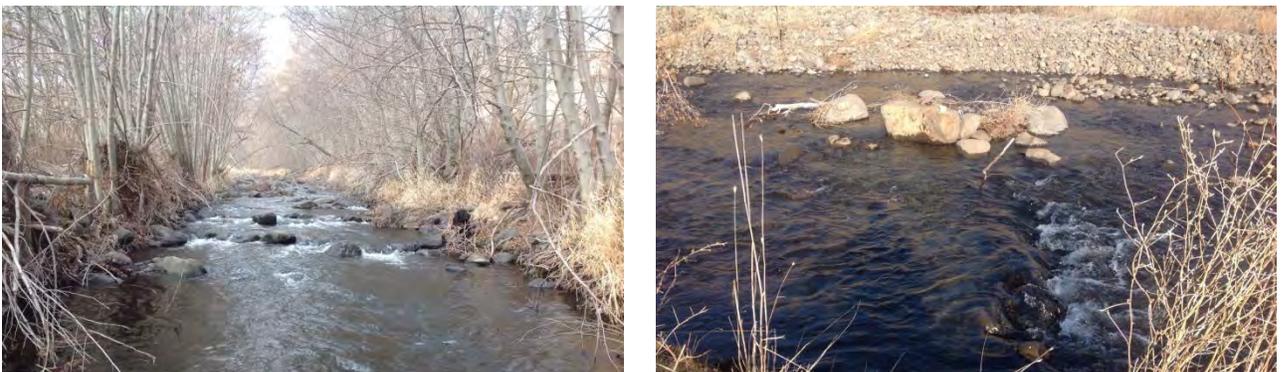
Figure 78. “Ribs” (left and right) are commonly observed in plane-bed and low-gradient riffles, sometimes associated with clusters (right).

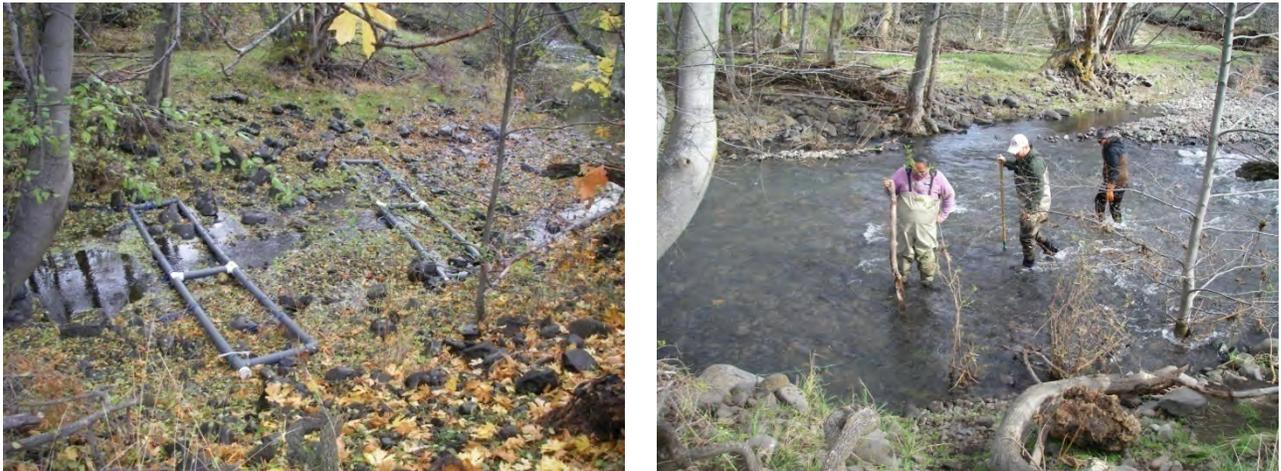
Figure 79. PIT-tag array near mouth of Squaw Cr before (left) and immediately after (right, buried) 2012 peak flow (~Q3). Photos courtesy of B. Allen, USGS.

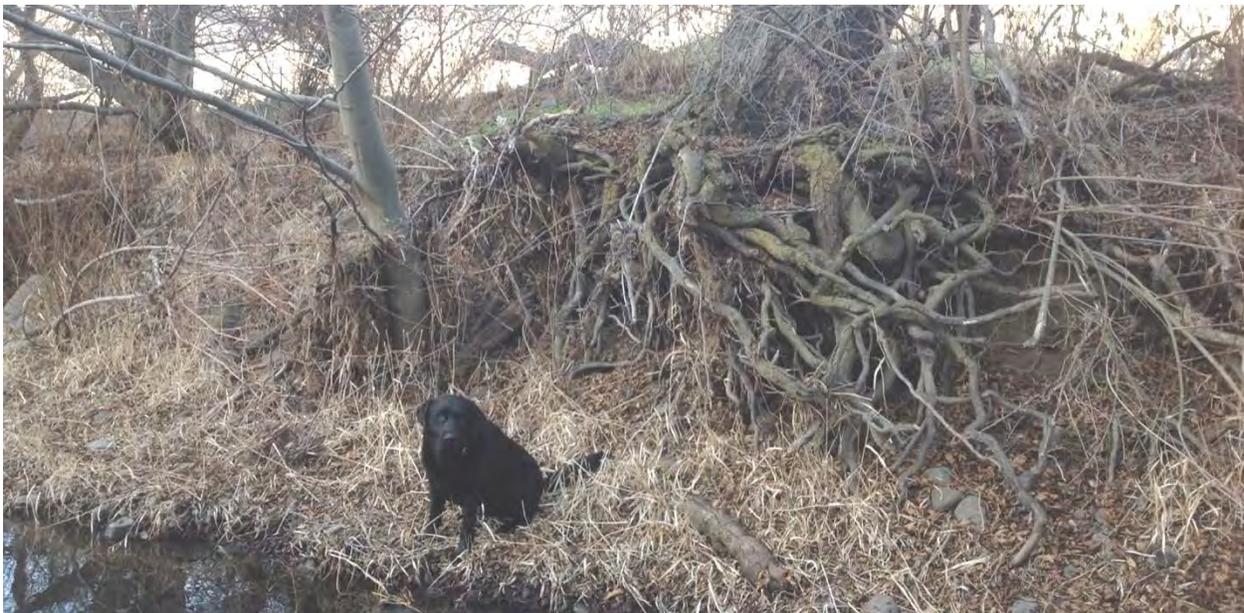
Figure 83. Alder rooted near top of bank indicates 5-6 feet of incision has occurred fairly recently (likely <50 years).

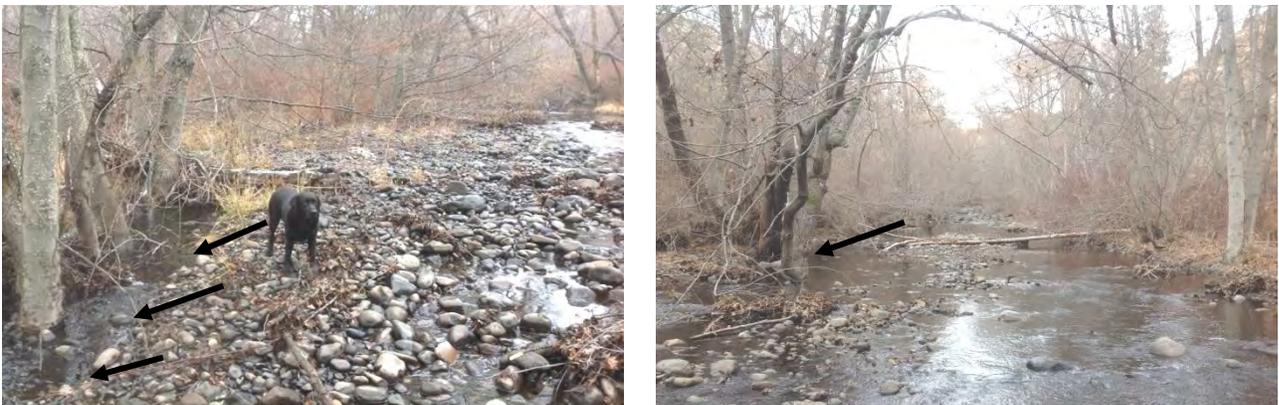
Figure 85. Emergent, live alders where bed has recently aggraded.

As discussed in the "Bed Organization" section, the combined duration of the system's post-disturbance reaction and relaxation times relative to the expected recurrence of such events, it seems likely that Rock Creek is in a near continuous state of adjustment. Indicators of local aggradation, primarily alders (either live or stumps), were noted in several locations (Figure 85 and Figure 86). In general, indicators of incision were more abundant and widespread. Though most were subtle and indicated less than a foot or two of incision (Figure 87), some indicate more significant vertical and/or horizontal channel movements (Figure 88).

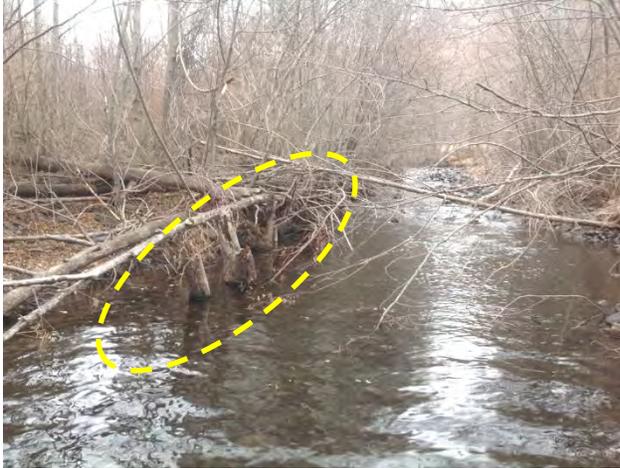
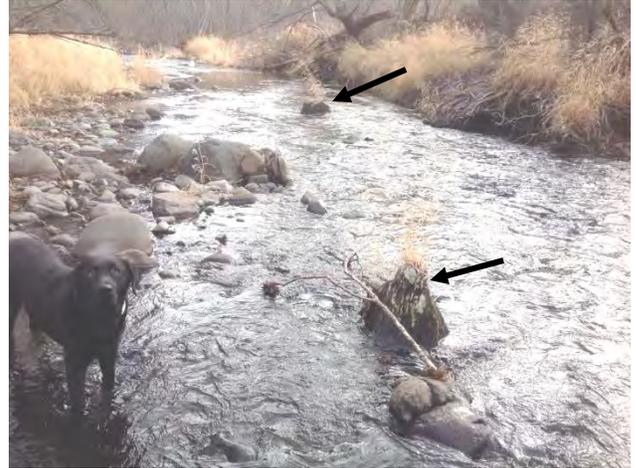
Figure 86. Emergent stumps in areas where bed has previously aggraded.

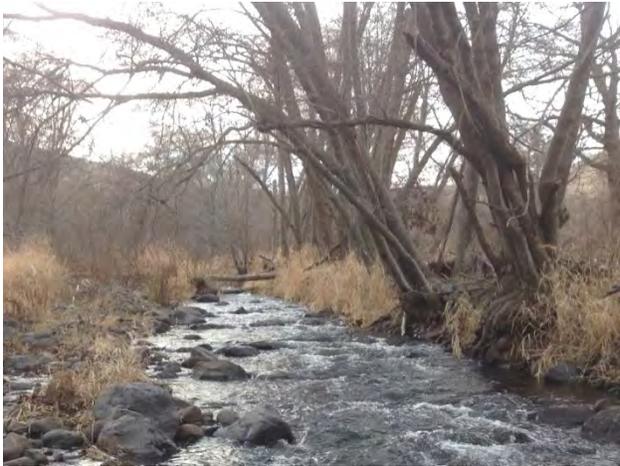
Figure 87. Alders suggest modest incision has occurred based on position of root crown relative to water surface and growth form of roots.
