Fluvial Reconnaissance of Rock Creek and Selected Tributaries with Implications for Anadromous Salmonid Habitat Management

Rock Creek, Klickitat County, WA

Will Conley, Hydrologist/Geomorphologist
Yakama Nation Fisheries Program
Klickitat Field Office
Wahkiacus, WA

Project Number: 2007-156-00
56662 REL 112

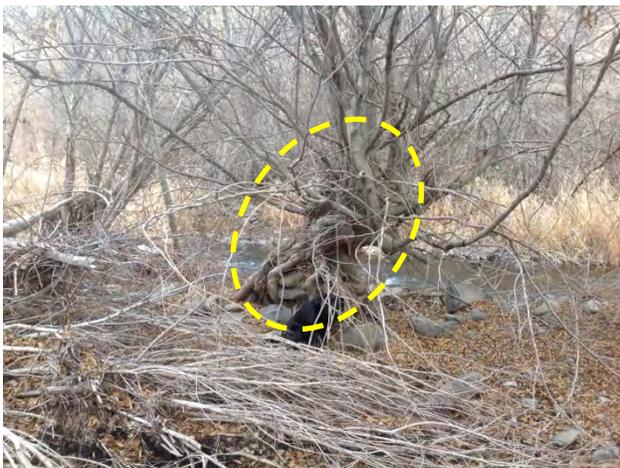
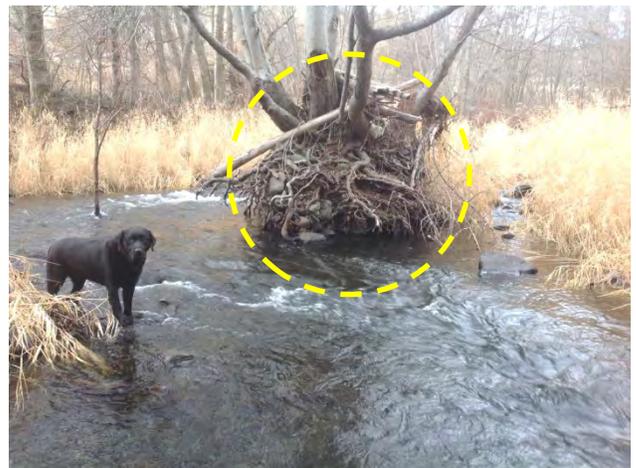
Figure 88. Pedestalling of mature alders where channel has incised and laterally migrated.

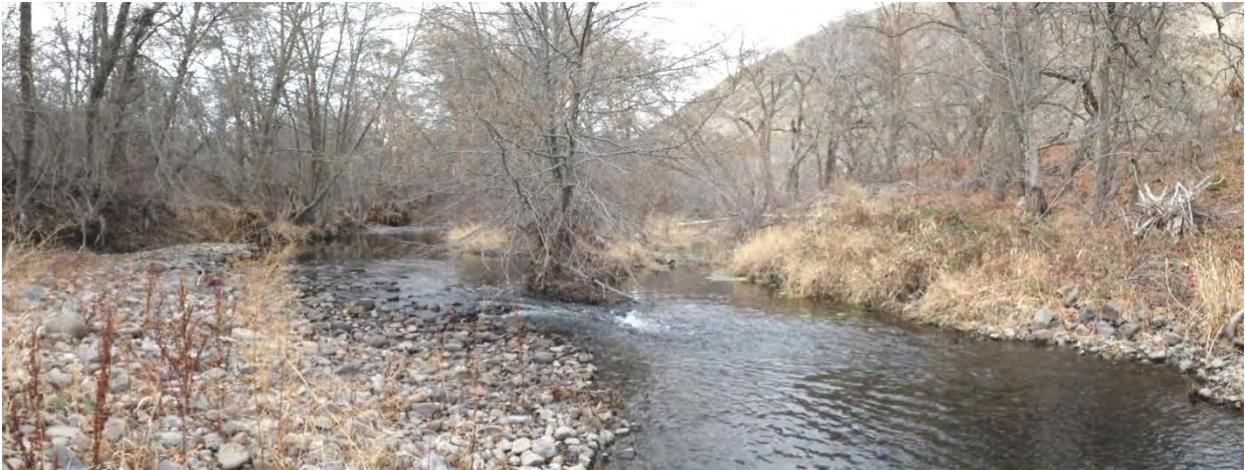
Figure 89. Looking upstream at mouth of mature diagonal bar "seam" channel (right).

The most common and widespread channel adjustment in the subbasin appears to be re-working/dissection of sediment slugs into (primarily) diagonal bars. The process, described and illustrated in Bed Organization specific to high relief bars, is observed on low-relief bars as well. In all cases, the “seam” channel (Figure 89) appears to be the driver as it incises in the upstream direction approximately parallel with the valley axis. Chutes form to connect the original channel (now perched) to the seam. Older/downstream chutes become less active (requiring greater discharge to activate) as new chutes form as the sequence progresses headward (Figure 90).

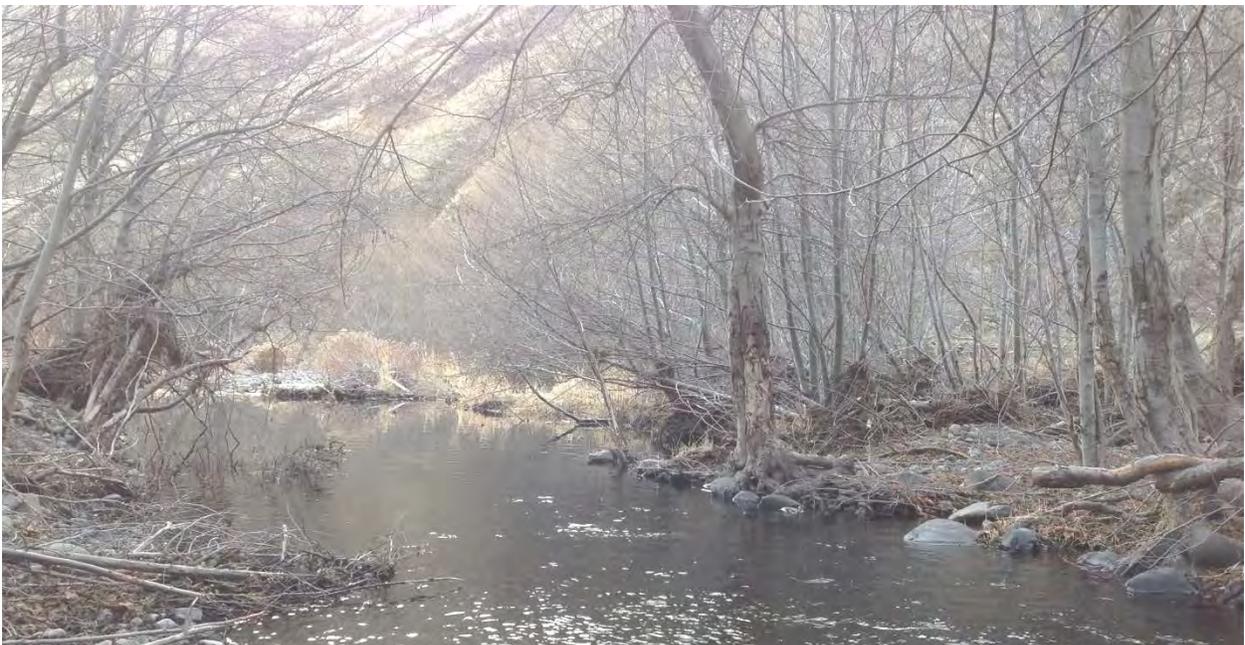
Figure 90. Downstream view at early stages of “seam” development at future head of diagonal bar.

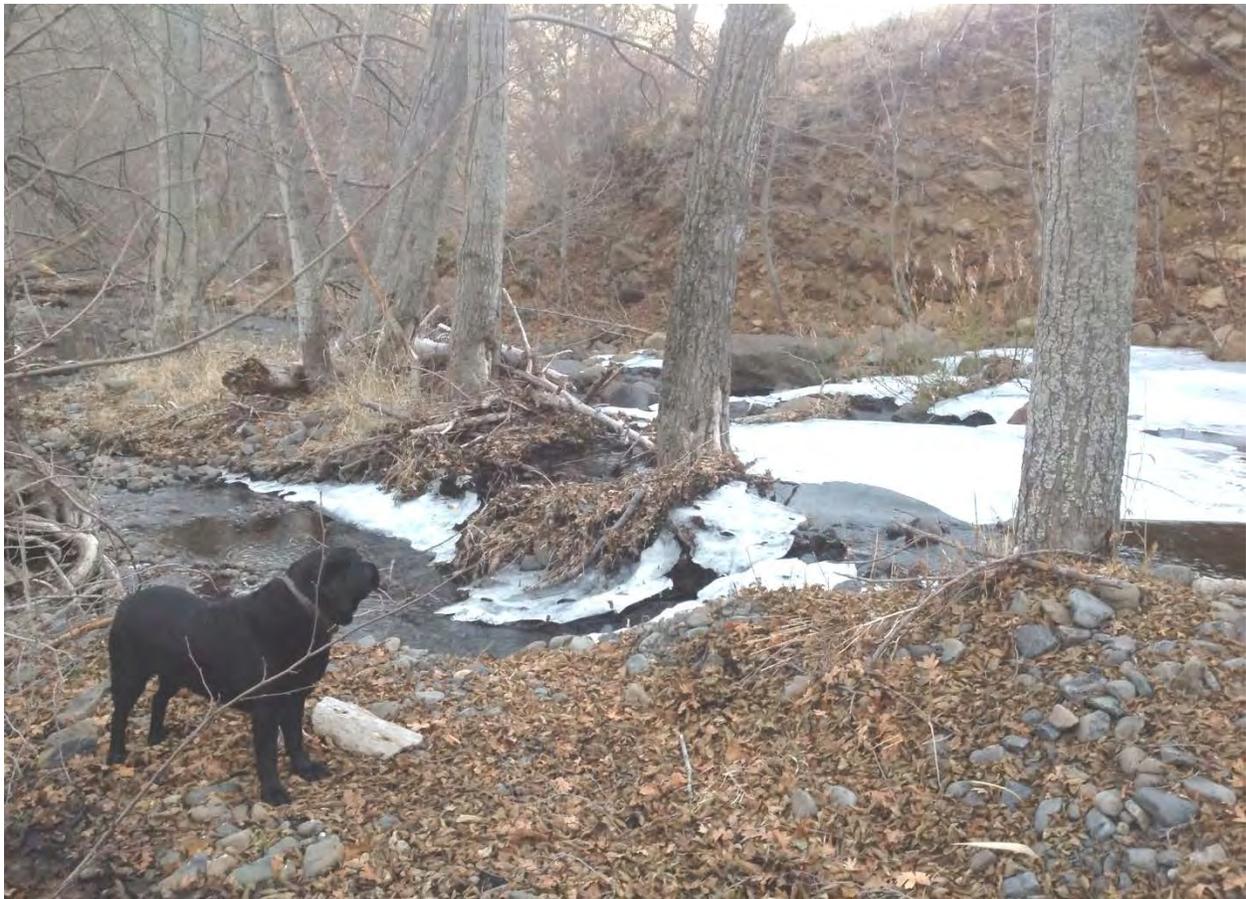
Figure 92. Cross-over flow through strip of alders converts floodplain (that may have previously been a channel) into active channel.

Gaps may be twenty or more feet wide and effectively alleys of lower hydraulic resistance that concentrate flow in narrow zones of the floodplain or old channel alignments (Figure 91). This can increase shear in a narrow zone and stimulate channel development (Figure 92). In time, the primary channel may “switch” back and forth between two or more alignments.

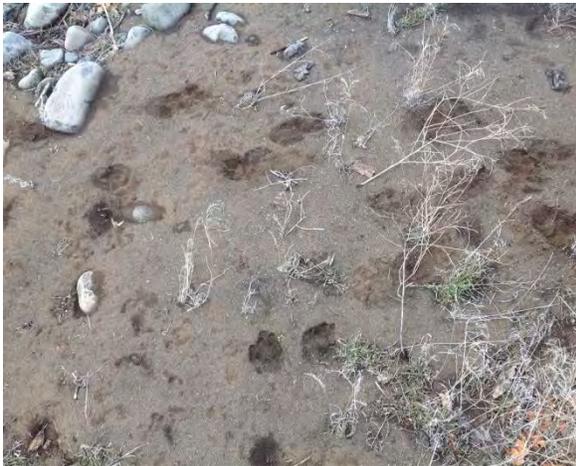
Figure 93. Recent sand deposits (left) on floodplain correlate with elevation of top of debris line (right, arrows) 4.5 to 5 vertical feet above channel controls; likely resulting from 3/30/2012 event.

Field observations between valley miles 3 and 17 of Rock Creek in December 2013 and January 2014 found field indicators of historic flood stages to be ubiquitous. Relatively fresh mineral and organic deposits along banks and floodplains occurred throughout the surveyed area (Figure 93 and Figure 94) consistently at 4.5 to 5.0 vertical feet above bed controls. A few localized exceptions were as low as 4.0 and high as 5.5 feet. This elevation was also correlated with the top of accumulations of woody debris racked into riparian vegetation. Channel-margin and floodplain sand deposits still mostly unvegetated but showing early colonization by grasses were correlated at similar relative elevations. Recent tree scars (Figure 95) on streamside trees is correlated with the same stage. Given that water-year (WY) 2013 and early WY2014 lacked significant peak events, finer organic debris, uncolonized / barely colonized sand deposits, and fresh tree scars were interpreted to result from the March 30, 2012 event (Q3).

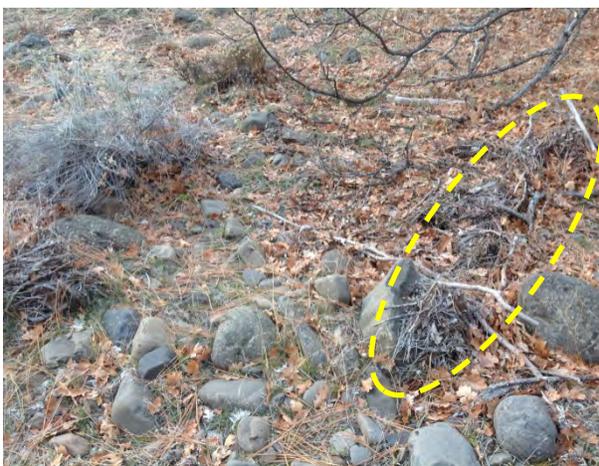
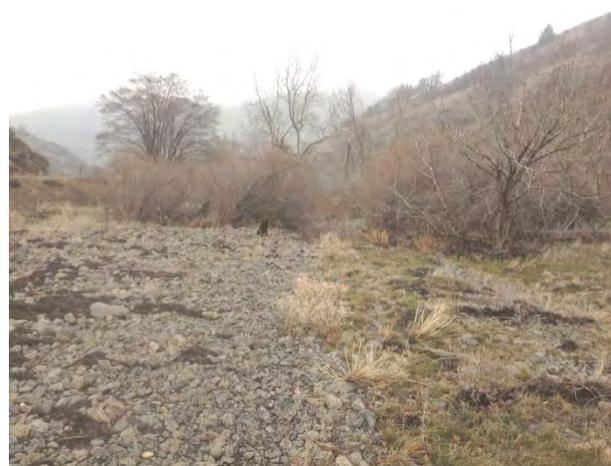
Figure 94. Floodplain depositional features indicating minimum high water surface and/or inundation: band of detritus (left, circled) and gravel sheet with detritus patches (right).

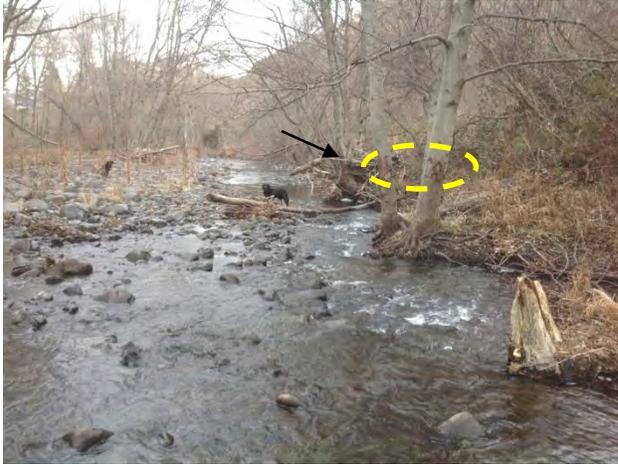
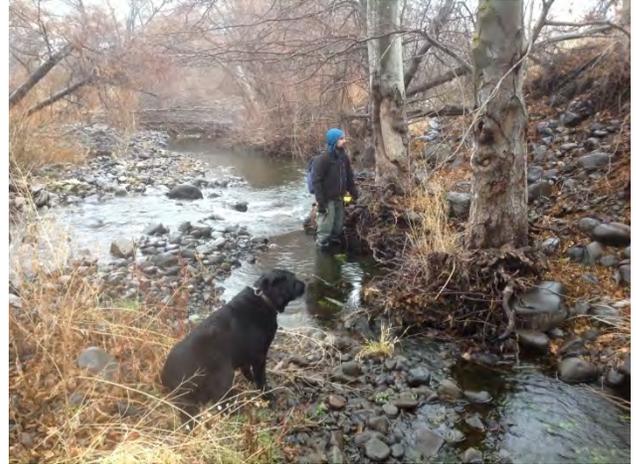
Figure 95. Scarring on the upstream faces of bank alders. Light scarring (left, circle) from 2012 event correlated with debris accumulation (left, arrow). Scarring from multiple events (right).

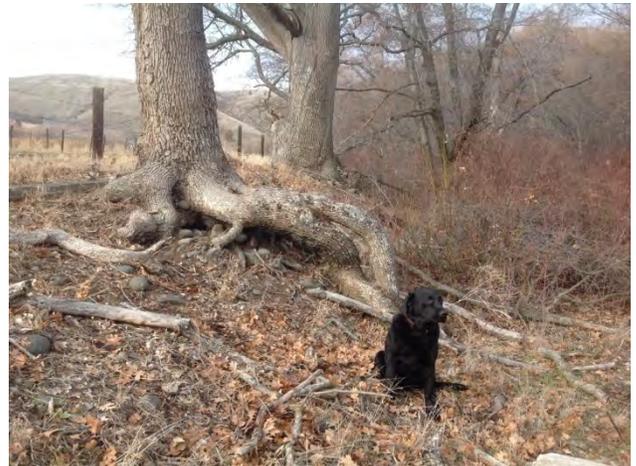
Figure 96. Scouring of oak trees rooted on the margin of high floodplain surfaces.

Robust indicators from past, higher magnitude peakflow events are widespread and include: scoured roots of non-riparian tree species (Figure 96 and Figure 97), scarring of tree trunks (Figure 98), fluvially transported debris (Figure 98, Figure 99, and Figure 100), altered growth forms (Figure 101), and translocated and/or partially buried human debris in alluvial deposits (Figure 102, Figure 103, Figure 104, and Figure 105).

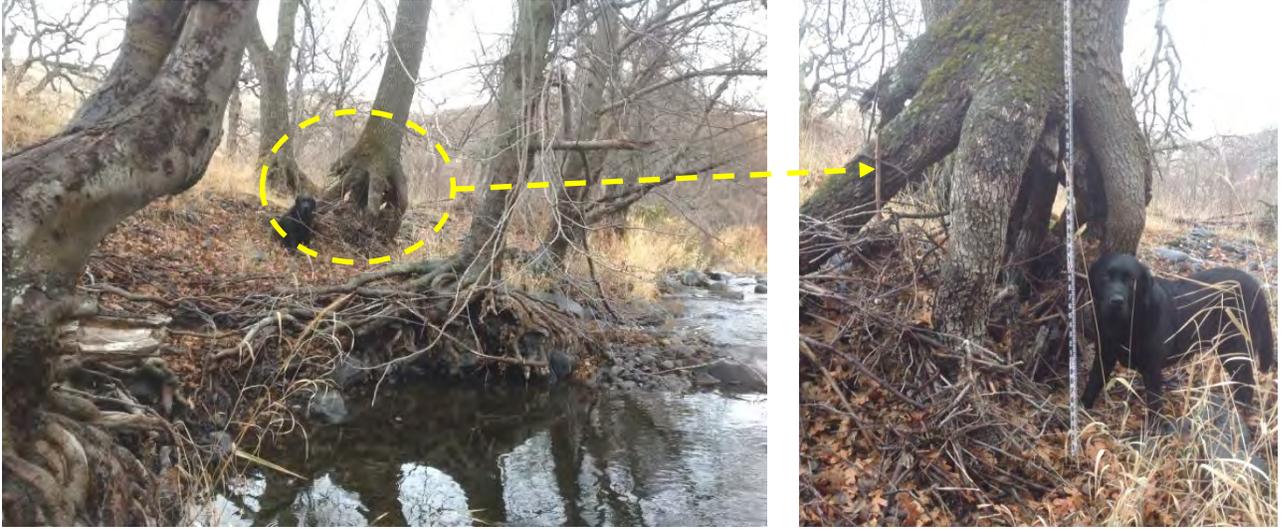
Figure 97. Buttressing and scour of oak tree roots along margin of high floodplain.

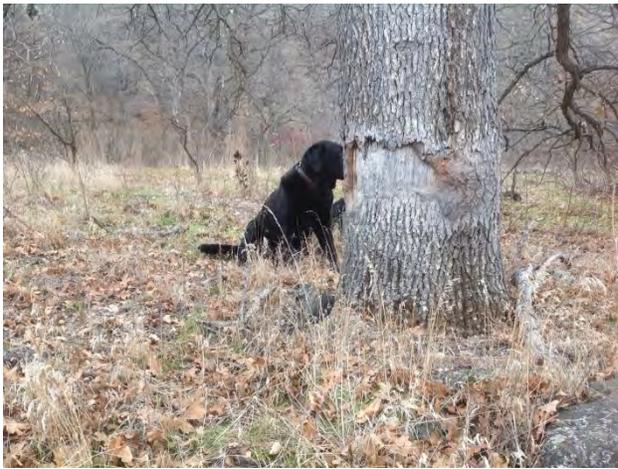
Figure 98. Modern high-stage indicators include scarring of upstream faces of trees. Rooted on high floodplain surfaces (left) and lower-lying areas with raked debris (right).

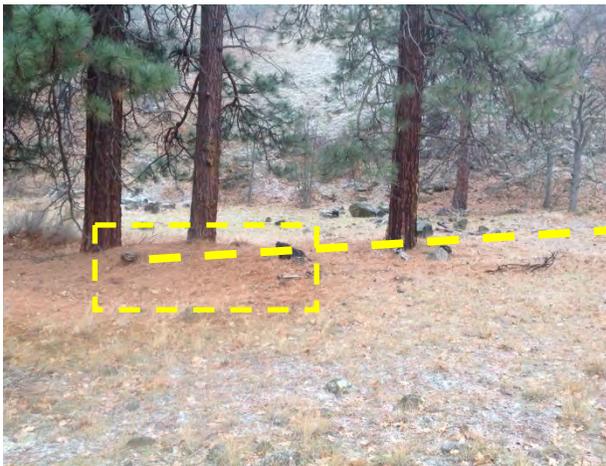
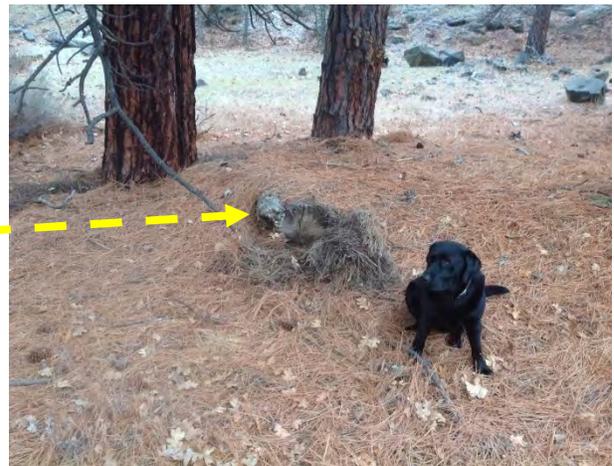
Figure 99. Woody debris 'raft' on high floodplain upstream of ponderosa pines, buried by years of needle-cast (left). Individual debris pieces visible with removal of needle cover (right).

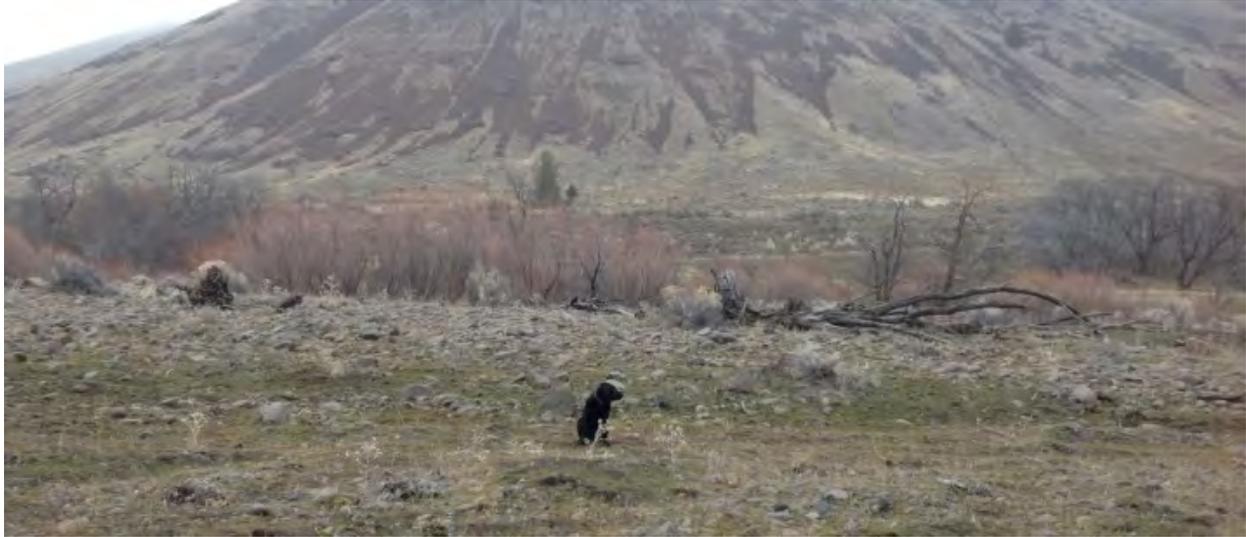
Figure 100. Fluvially transported and/or re-worked walnut trees on highest portion of floodplain (~VM 7.7).

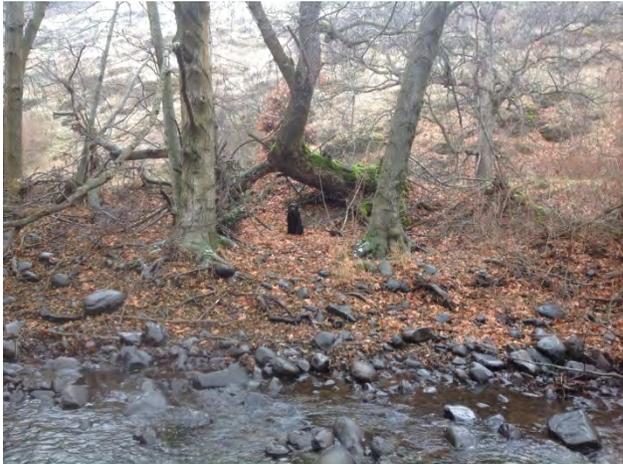
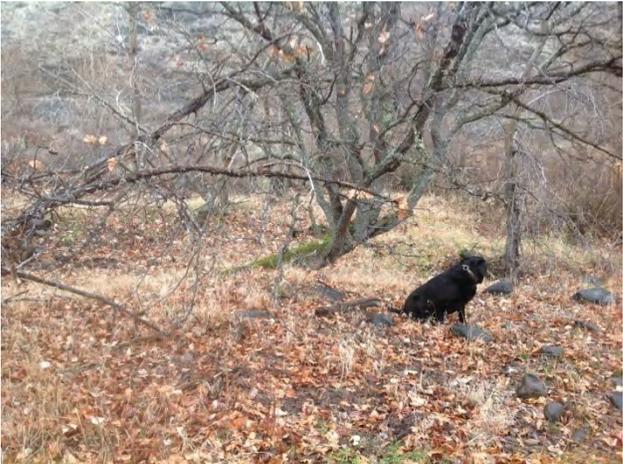
Figure 101. Riparian (left) and floodplain (right) trees with down-valley lean/sweep rooted on high floodplain surfaces.

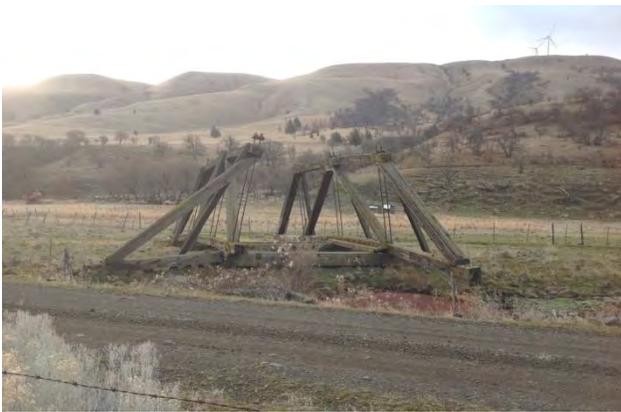
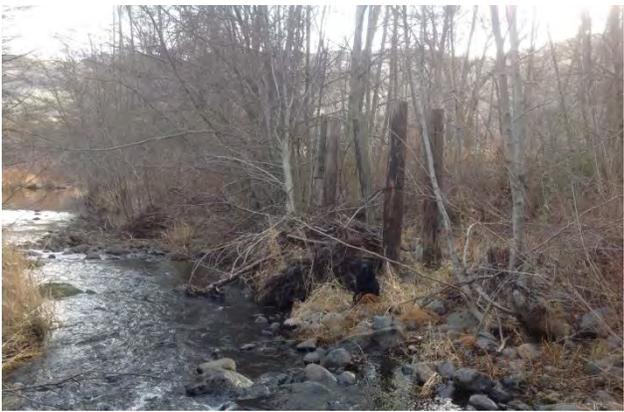
Figure 102. Bridge (left) that was washed off its piling foundation 1500 lineal feet upstream (right) and deposited by the 1964 flood on a high floodplain surface (~VM 10.1).

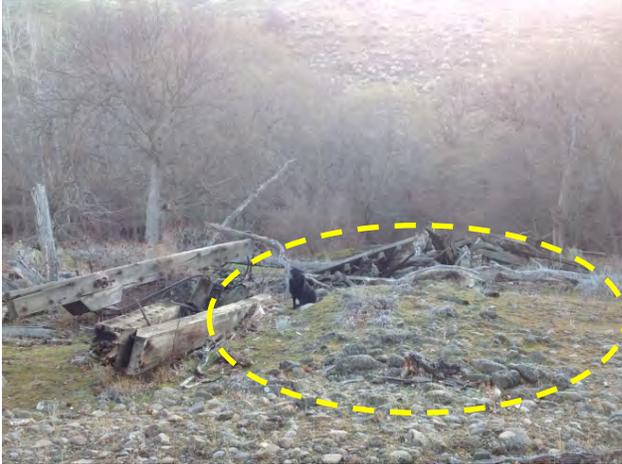
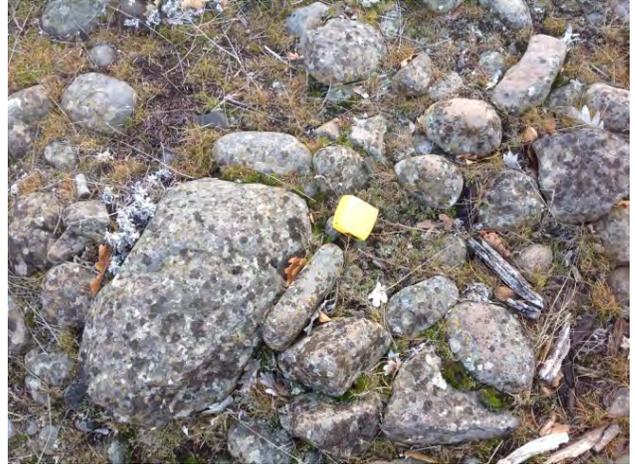
Figure 103. Remnants of bridge (left) washed-out and deposited by the 1964 flood on a high floodplain surface 1900 lineal feet down-valley (~VM 8.6). Note sediment wedge (circled) to right/upstream of bridge debris. Surface clasts wedge have dense lichen cover (right).

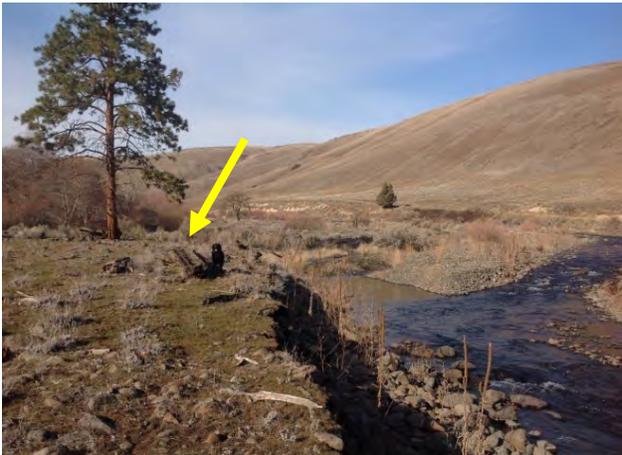
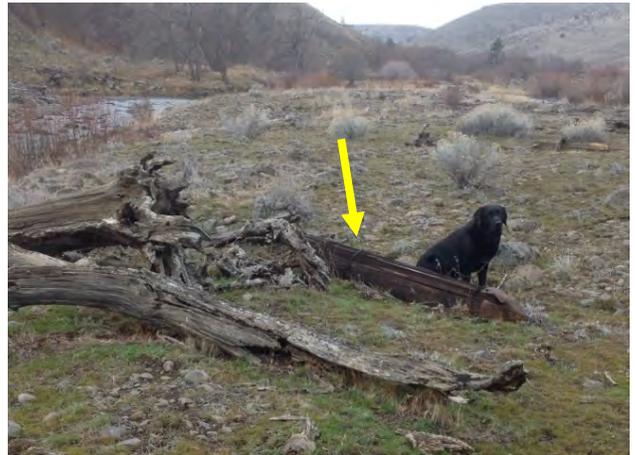
Figure 104. Bridge timber (left) and pile (right) deposited on high floodplain surfaces.

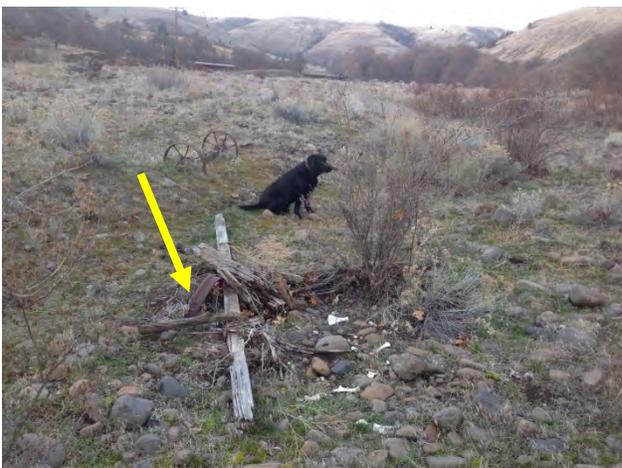
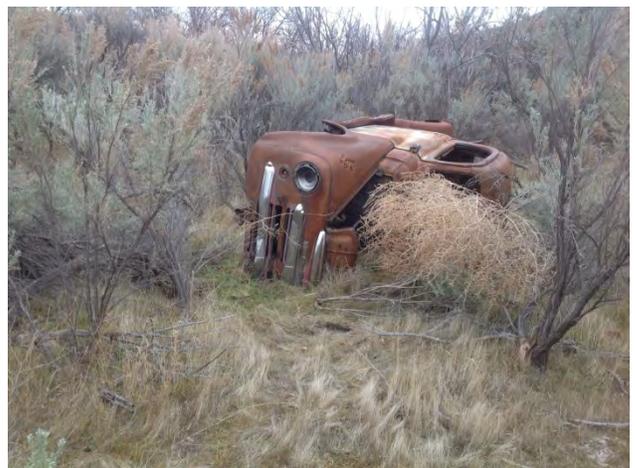
Figure 105. Wheel (left, at arrow) and old pickup truck (right) partly buried in alluvial sediments on high floodplain surfaces.

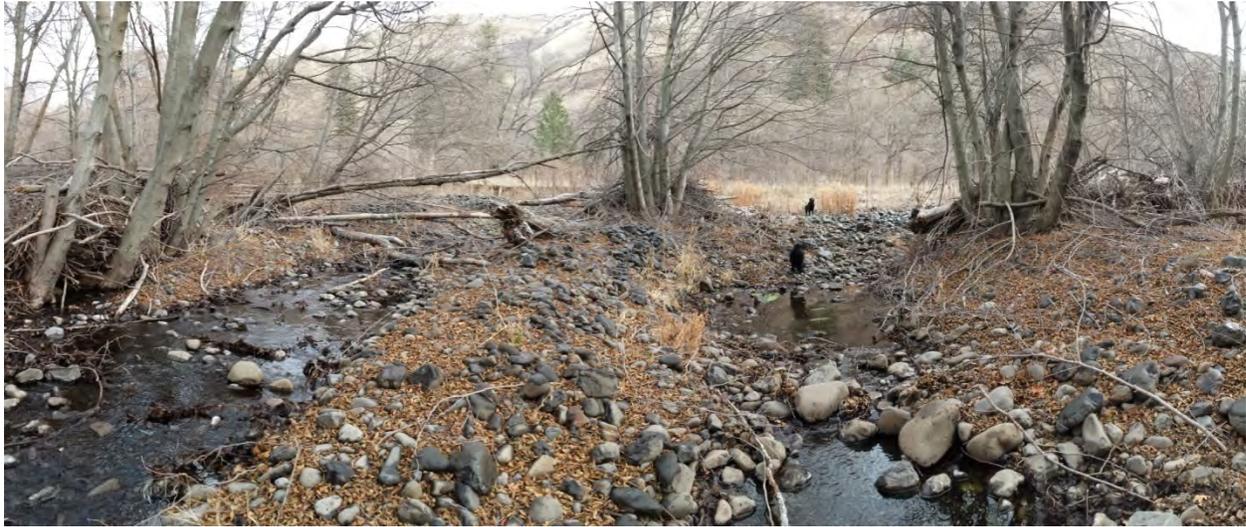
Figure 109. Upstream view of multiple chutes and perennial vegetation within active channel at crest of transverse bar.

Transverse and diagonal bars are a significant hydraulic influence throughout the lower 13 miles of Rock Creek with many having 4-8 vertical feet of profile relief. These features have multiple

chute channels and, frequently, perennial vegetation growing within the active channel (Figure 109).

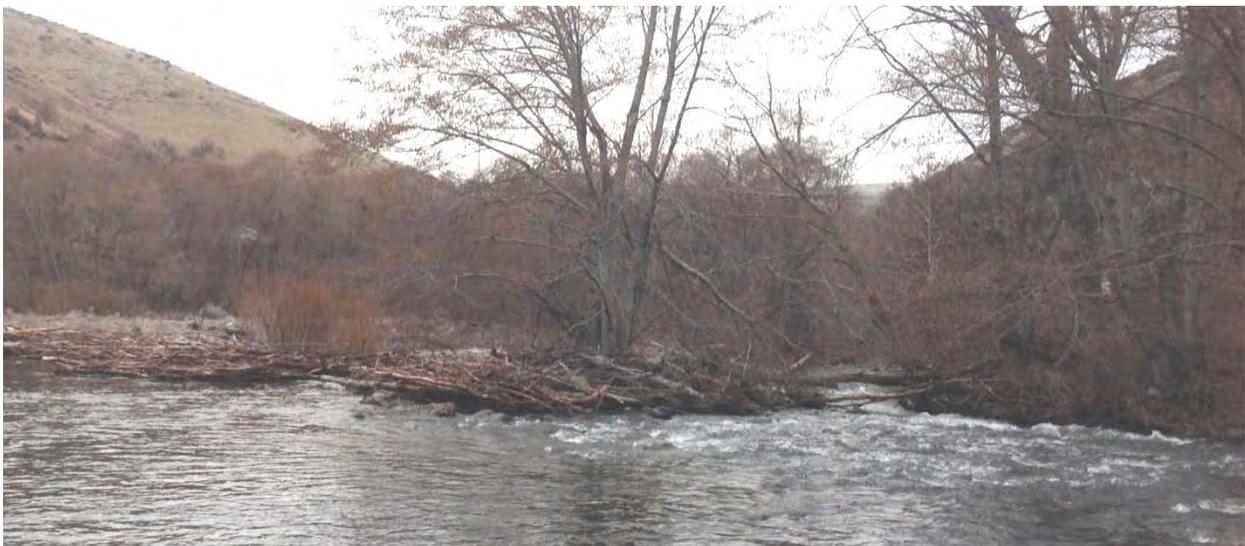
Figure 111. Downstream view of multiple chutes and perennial vegetation within active channel at crest of diagonal bar. Mid-stream trees recruited woody debris during recent freshet ($<Q_{1.01}$).

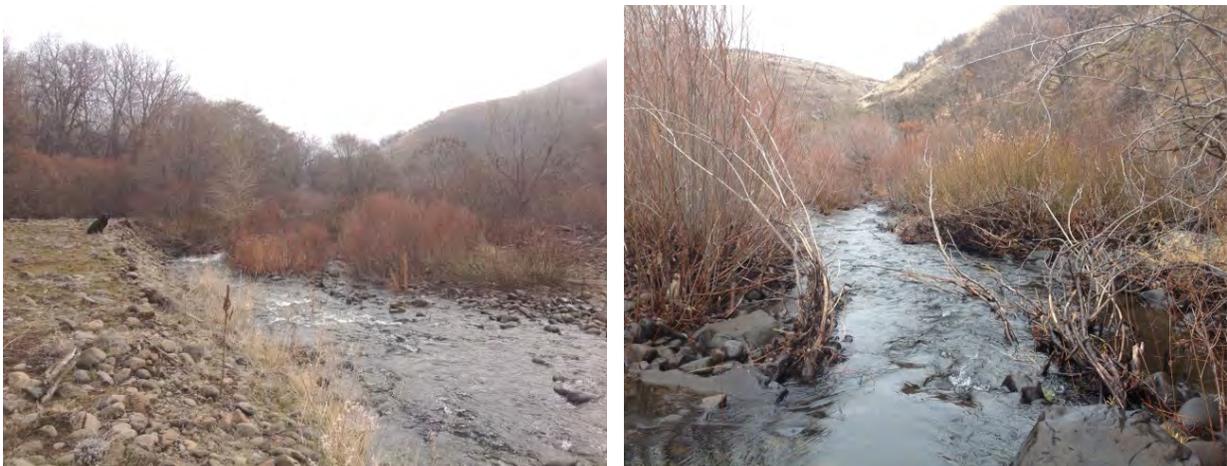
Figure 112. Examples of perennial vegetation growing within and crowding active channel.

In some reaches, this study observed woody vegetation encroaching aggressively and almost spanning the active channel (Figure 112). The hydraulic influence of woody vegetation rooted nearly continuously across the channel is particularly notable downstream of the Luna Gulch confluence (~VM 10.8-11.0), upstream and downstream of Imrie Road (~VM 9.8-10.3), upstream of the Squaw Creek confluence (~VM 7.8 – 8.0), and downstream of the Longhouse (~VM 3.2). The active channel in these areas is often dominated by shrubs and/or smaller alders (<4” basal diameter). Coyote willow is particularly robust and persistent in these reaches, often with basal diameters greater than 2 inches. Based on low-flow data (Allen et al. 2014), it seems many of these reaches dry seasonally, but must have somewhat shallow summer water tables.

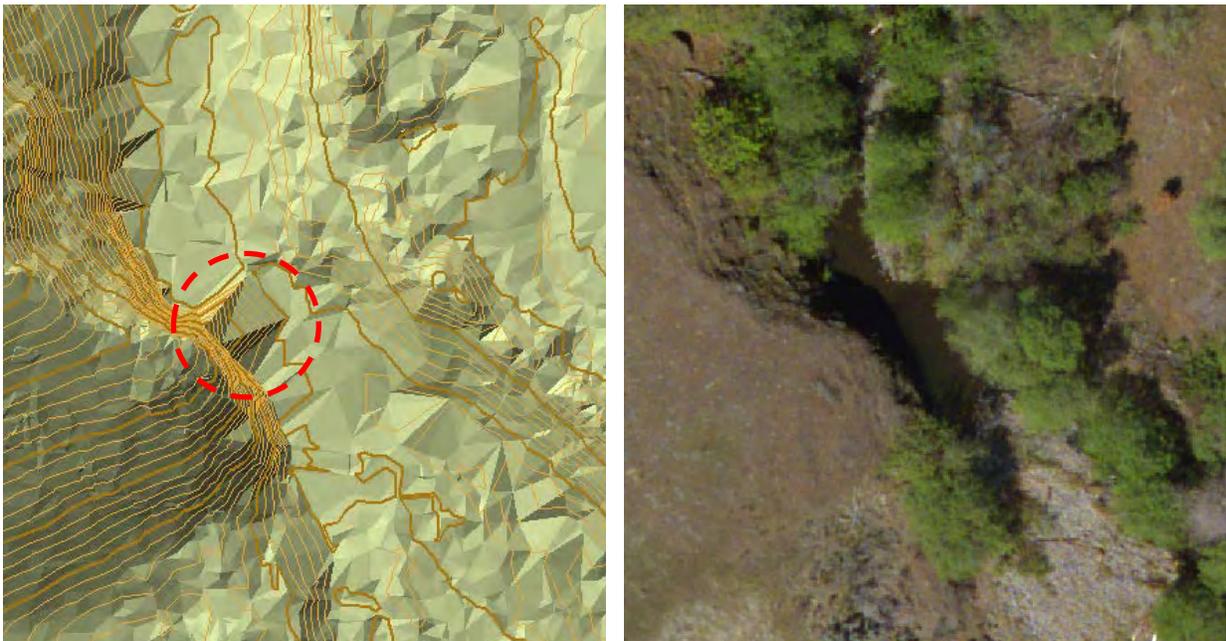
Figure D2. Example of an artificial projection into stream channel by terrain data artifact (left) , in this case extending 17' into a channel with 24' toe width. Aerial photograph of same site (right).

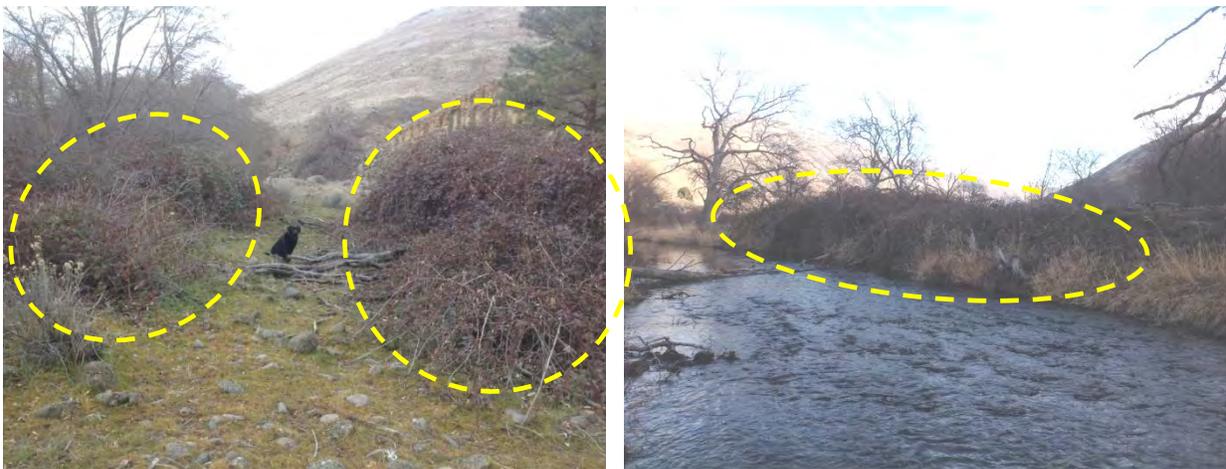
Figure D4. Examples of blackberry patches 5-7' above ground surface, which typically has a 1-3' vertical effect on the terrain model, often less when under tree canopy.
