Yakama Nation

Upper Columbia Habitat Restoration Project ANNUAL REPORT

REPORT COVERS WORK FROM JANUARY 1ST, 2017 THROUGH DECEMBER 31ST, 2017

REPORT CREATED FEBRUARY 26, 2018

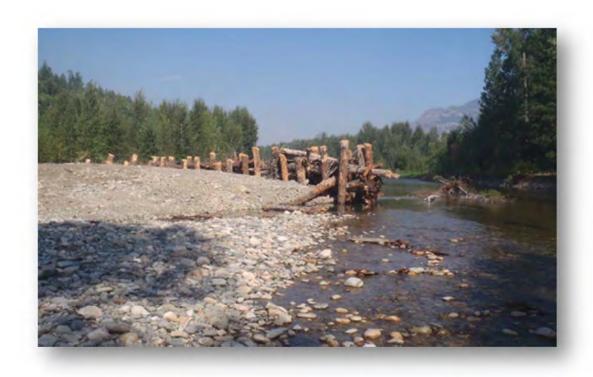
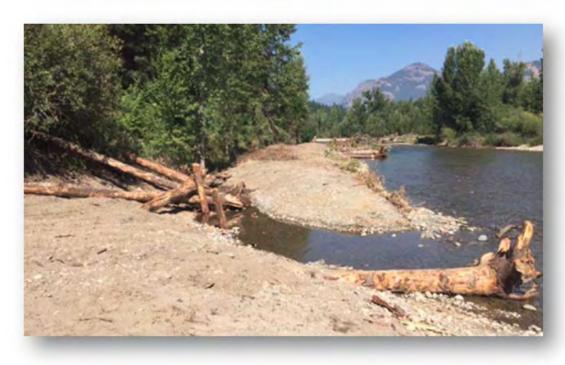
An old ditch within the floodplain was decommissioned by removing an abandoned concrete weir and filling a portion of the ditch.

Five acres of native plant restoration was placed to restore riparian vegetation conditions.

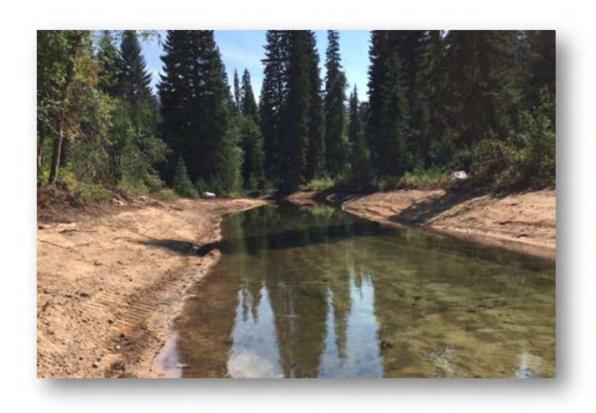
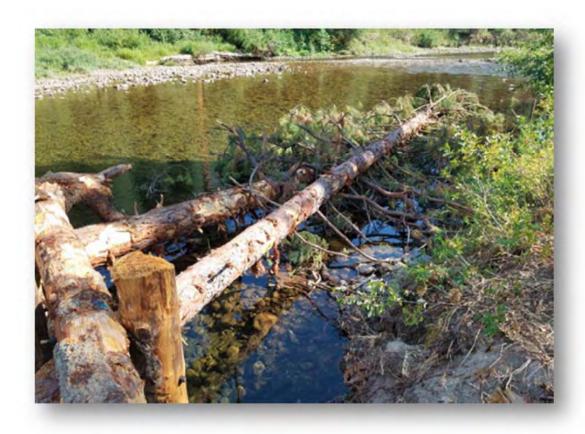
Three main channel large wood structures installed to promote lateral channel migration, natural wood recruitment, and increased floodplain inundation.

One 2,800 long side channel system was reconnected as a perennial flow through side channel with only 650 linear feet of excavation needed to connect the entire side channel with perennial flow.

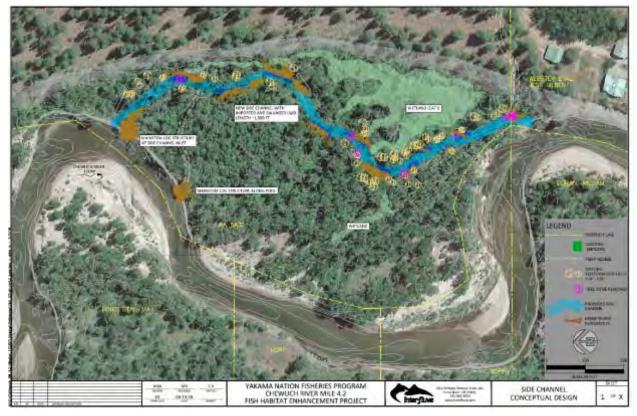
Chewuch Rivermile 4.6 Project (Engineering Only)

In 2017 we started collecting data and drafting restoration concepts for a section of WDFW owned floodplain at rivermile 4.6 in the Chewuch River. Project opportunities identified for this site in the 2010 Lower Chewuch Reach Assessment include floodplain connectivity, side channel enhancements, stream bank restoration, and large wood enhancements. Data collection for this site did not start until October 2017, so most of the design work will take place in 2018.

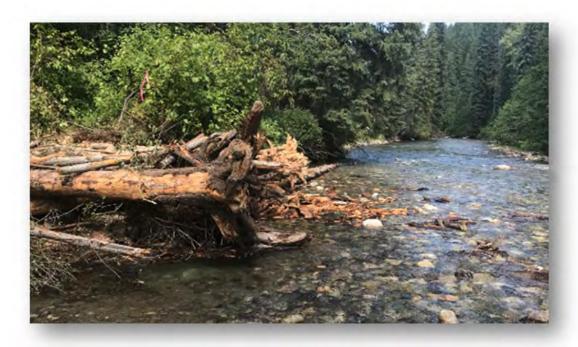
Five hundred feet of perennial groundwater fed alcove channel was created.

Two main channel margin large wood structures were installed to create bank margin complexity and promote scour pools in the bed of the Twisp River.

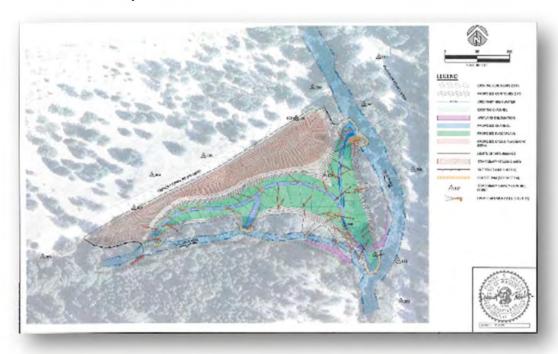
Tillicum Fan Project (Engineering Only)

The YN has been partnering with the USFS to reconnect both Tillicum Creek and the Mad River with the Tillicum Creek alluvial fan floodplain to improve fish habitat. The site is the location of an old homestead and currently used as a seasonal sheep grazing site. Tillicum Creek is highly incised and does not regularly come in contact with the floodplain. As recent as late summer/fall 2016, it has been used as a sheep grazing pasture and has some old plantings of alfalfa.

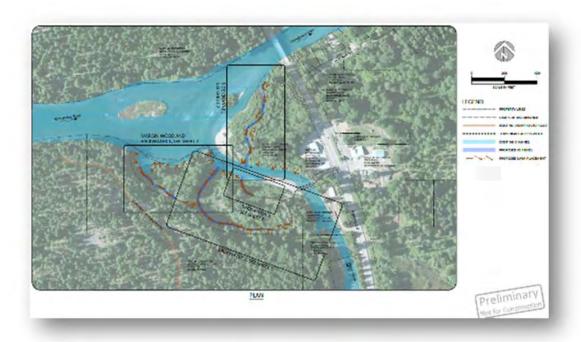
Nason Confluence Project (Engineering Only)

In 2015 we produced multiple detailed concepts for side channel restoration on USFS lands at the confluence of Nason Creek with the Wenatchee River where bridge construction, large wood removal, and human development impacts have decreased lateral channel migration and reduced side channel connectivity. In 2017 we continued development of conceptual alternatives working with USFS staff. We are seeking to restore hundreds of feet of groundwater fed alcove side channels with perennial flow. In 2017 we devised a groundwater study plan for the site with USFS staff to determine how side channel actions might interact with groundwater inputs. Groundwater monitoring and additional design work is now scheduled to occur in 2018.

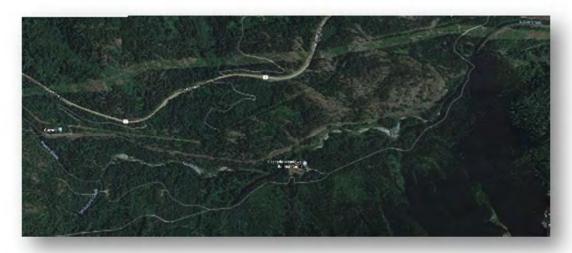
Upper Nason Creek Habitat Assessment

We are partnering with the USFS to conduct a comprehensive evaluation of stream habitat conditions in the highest section of Nason Creek where previous assessments have not occurred yet geomorphic conditions are promising for habitat restoration actions. The study area begins at the train bridge over White Pine Road (river mile 14.1) and extends up to White Pine Creek.

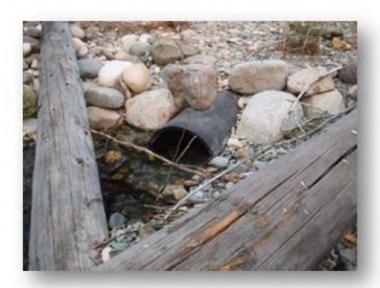
At the 1890s Side Channel along the Methow River near the town of Twisp, the high spring flows caused surface water from the Methow River to pass under the WSDOT Highway 20 bridge at the head end of the channel, bringing a large current of water down the historic channel alignment and into the constructed channel area starting at the pipe outlet location at station 41+00. The boulder carpet placed around the pipe outlet and around the head end of the constructed channel cut successfully held the post project grade and prevented a significant head cut from forming in the upper channel bed. However some smaller diameter gravels and silt did mobilize during the peak flow event, which deposited some gravel and small cobbles into the pipe outlet zone.

Performance of the infiltration gallery was not affected by the cobble/gravel deposits near the pipe outlet because the gallery invert is still well above the elevation of the deposited bed load. However it is recommended by the project engineer that the gravel/cobble mound be shoveled out by hand to recreate the post project plunge pool conditions and prevent additional sediment deposition from occurring at the pipe outlet.

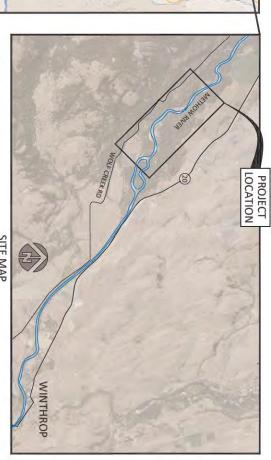
METHOW RIVER - BIG VALLEY SOUTH FISH HABITAT ENHANCEMENT PROJECT

ASBUILT PLANS WITH MONITORING PHOTO POINTS
