# Eagle Creek Fire

## *A Watershed Perspective*

Diane Hopster  
Hydrologist

Forest Service  
Columbia River Gorge NSA and East Zone, Mt. Hood National Forest

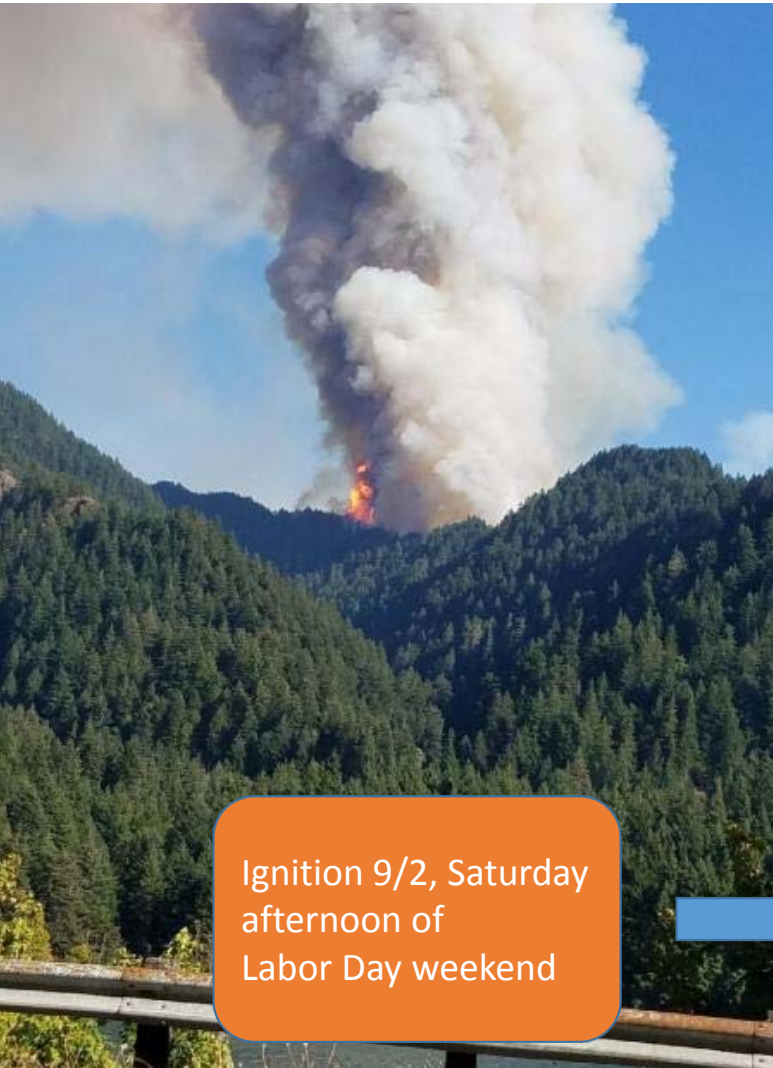
# Fire Behavior

Ignition 9/2, Saturday  
afternoon of  
Labor Day weekend

Fire made a 13 mile  
run during 16 hours  
over 9/4 & 9/5

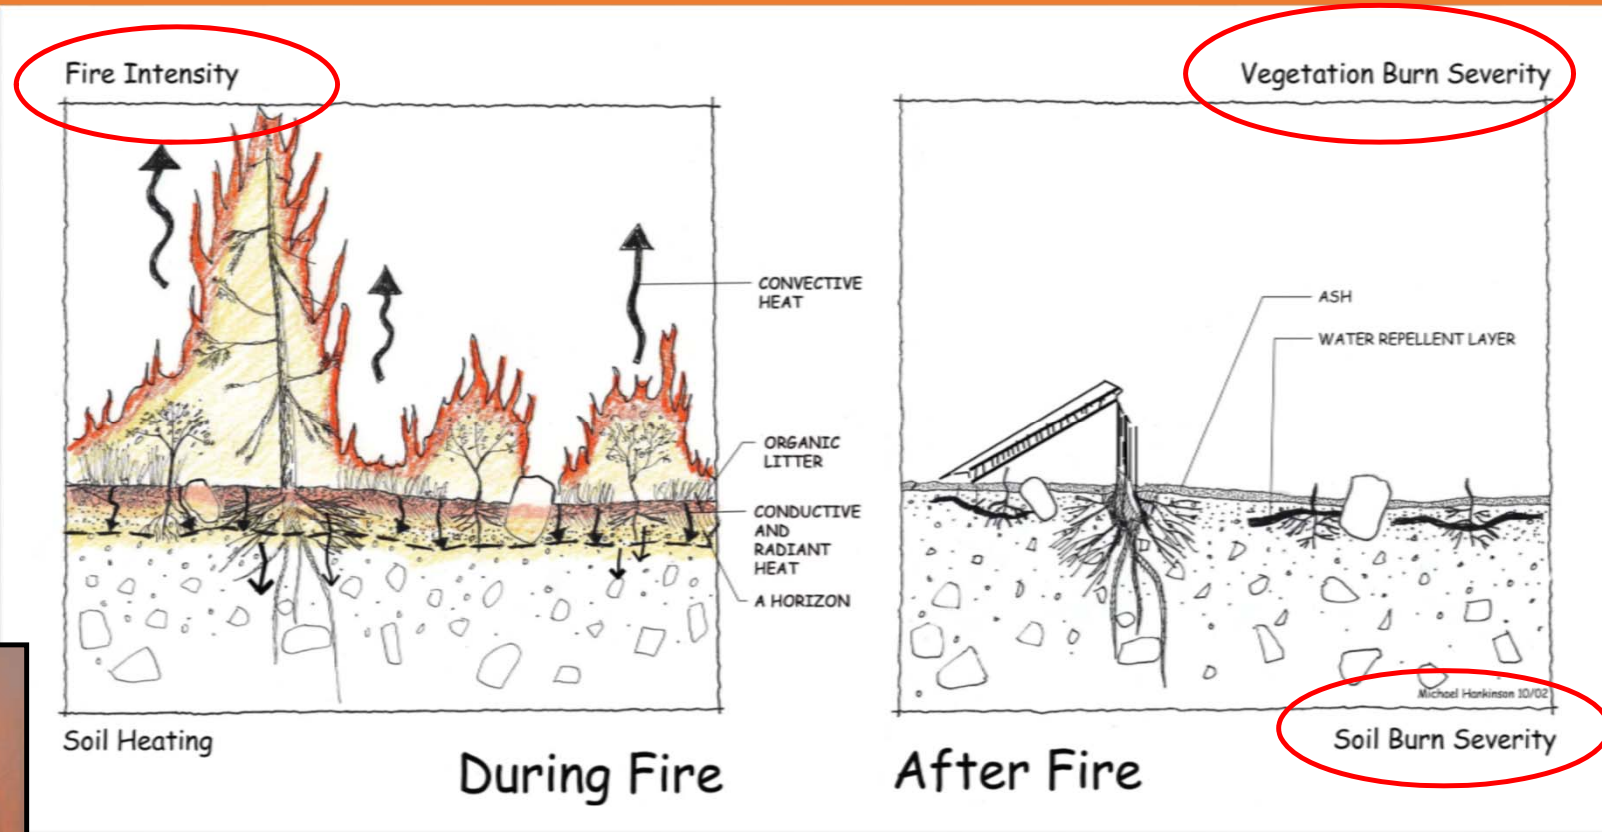
# Fire Intensity and Fire Severity

Fire intensity = energy or heat release during the consumption of organic matter.

Fire intensity does not always indicate fire effects on soils.

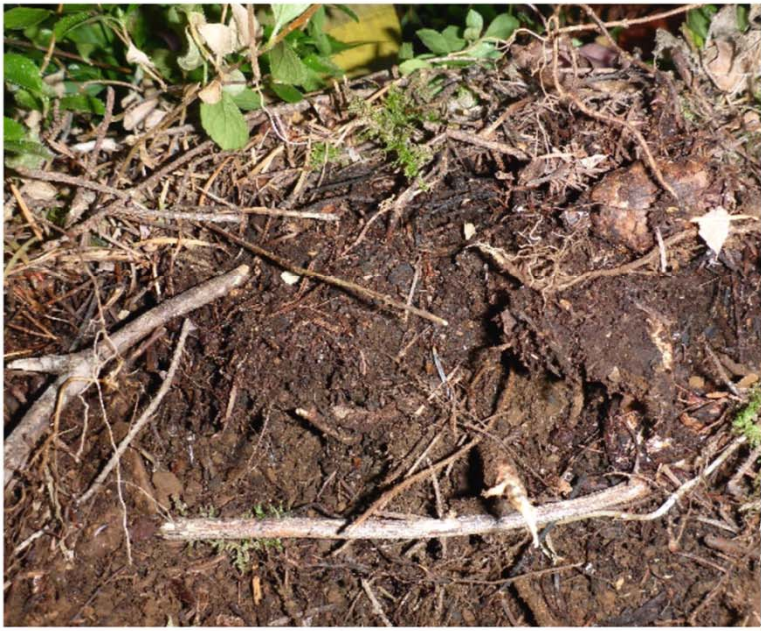
# Field Assessing Soil Burn Severity

**Unburned – High root density, 100% soil cover**

**High - Surface structure destroyed, soil cover completely consumed, roots consumed**

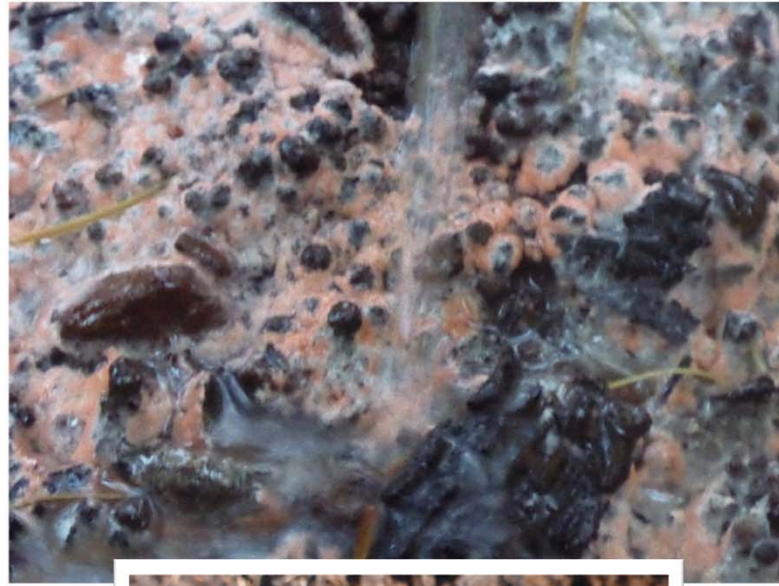
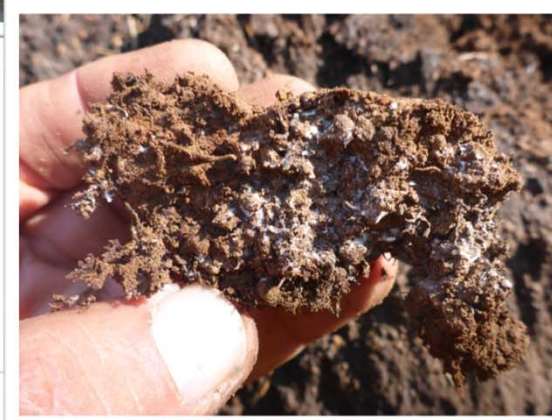
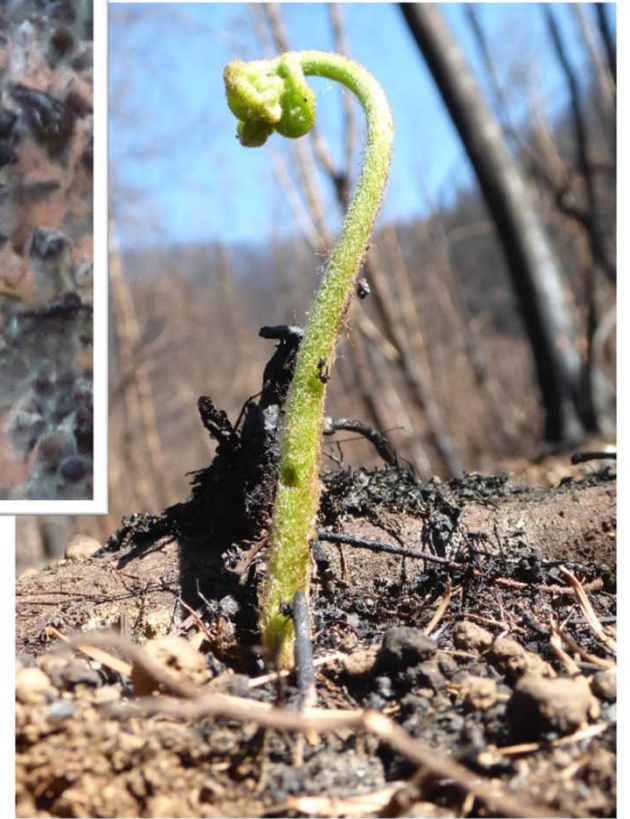
# Rapid Natural Recovery Observed!

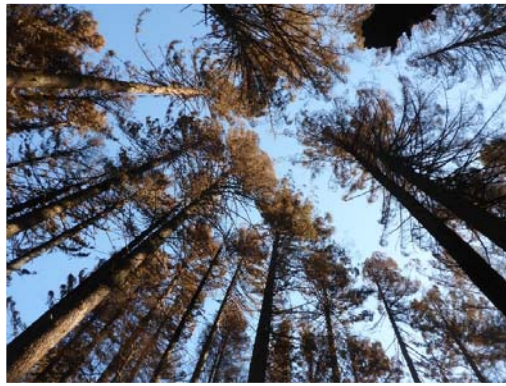
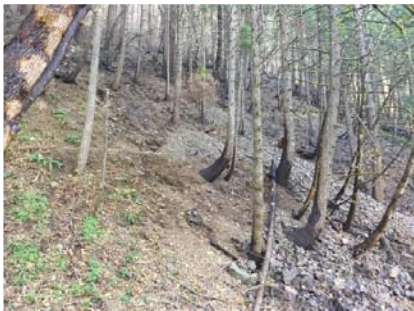
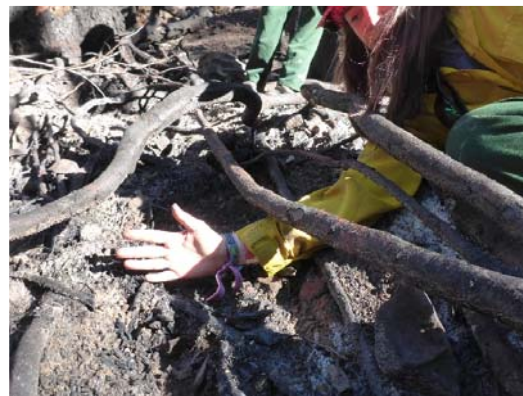
Eagle Creek

# Erosion

- Post-fire erosion factors:

- Climate
- Topography
- Surface Rock Armoring
- Litter fall
- Fire Severity

- 2 distinct soil types

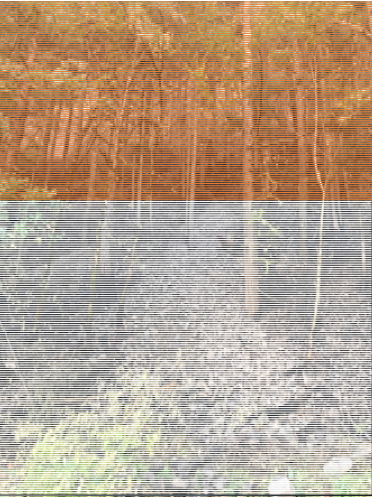
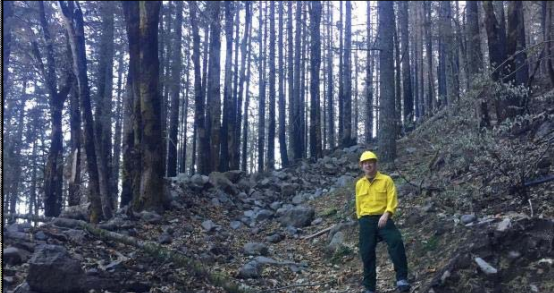
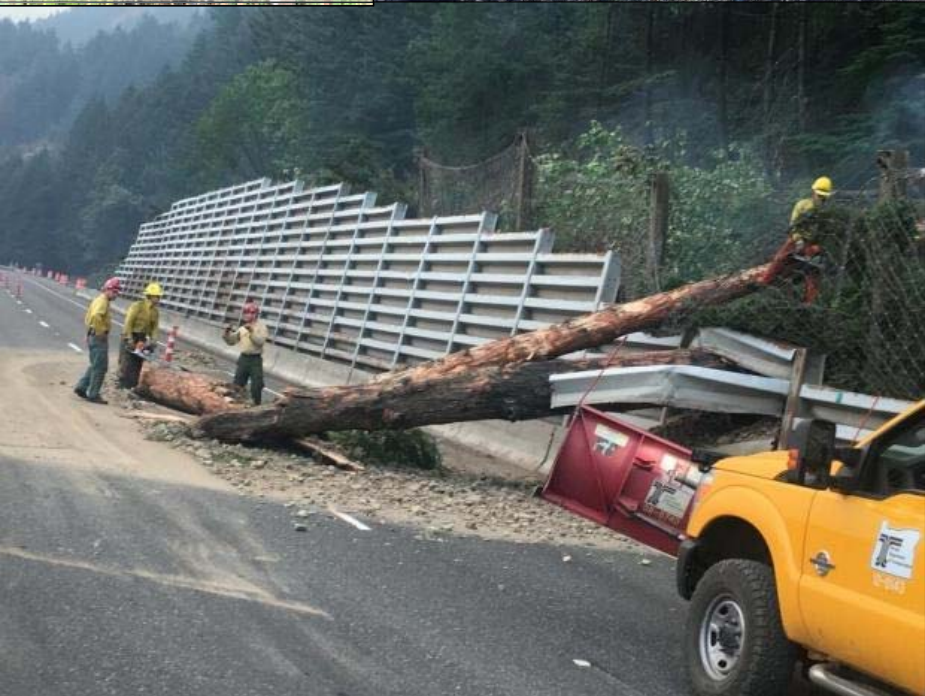
# Unique BAER Challenges

- BAER Team Safety Concerns from geologic instability & 'forested scree'
- High Profile Situation Politically and in Public View
- High visitation area with dispersed access points created closure enforcement concerns
  - 122 miles of trails in fire area
  - over 50 access points to closed fire area
  - 3-5 weekly Search & Rescue operations pre-fire
  - To date more nearly 4,000 'turnarounds', 600 verbal warnings, and 50 citations

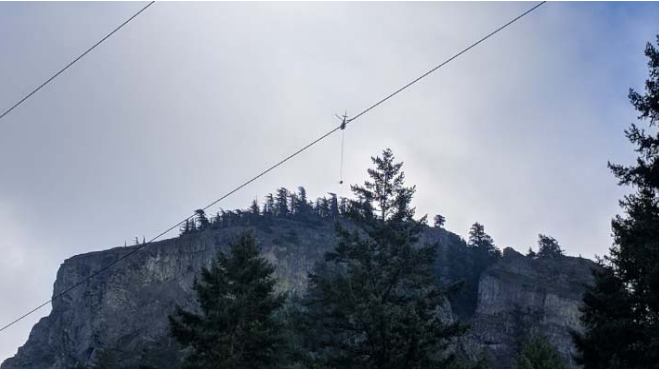
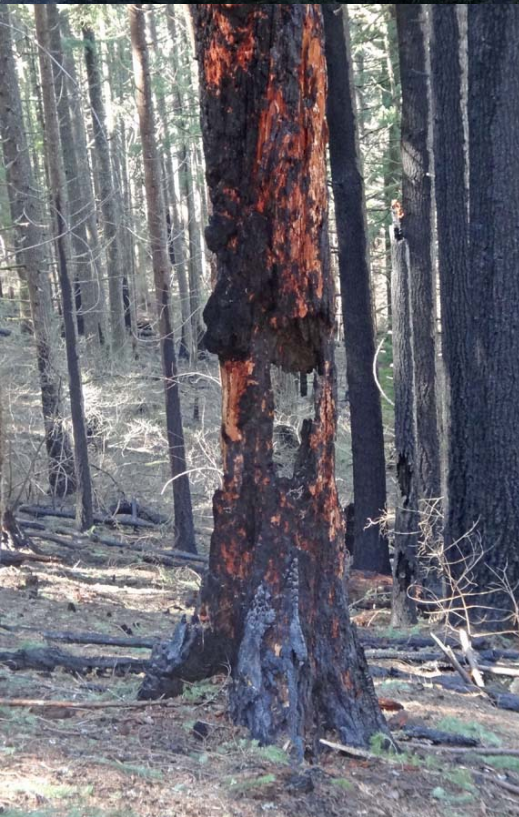
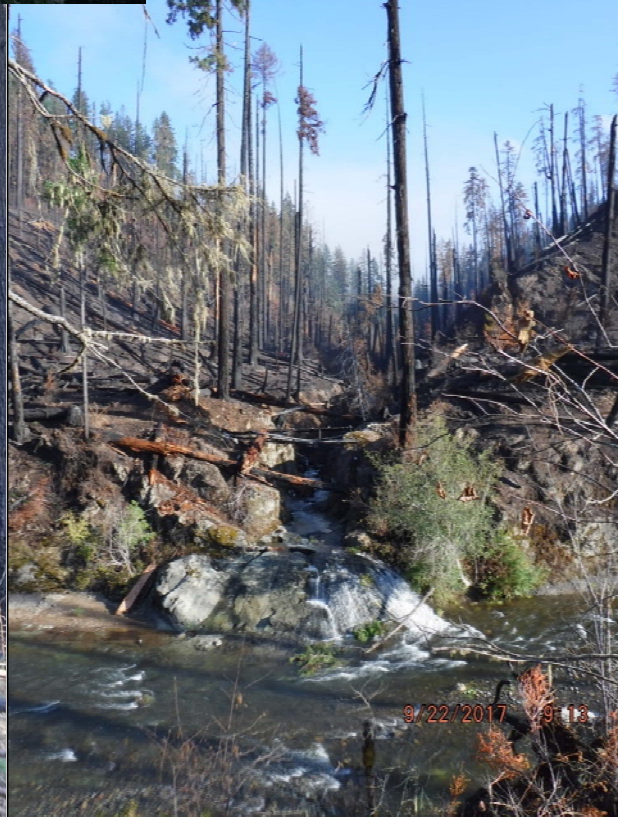
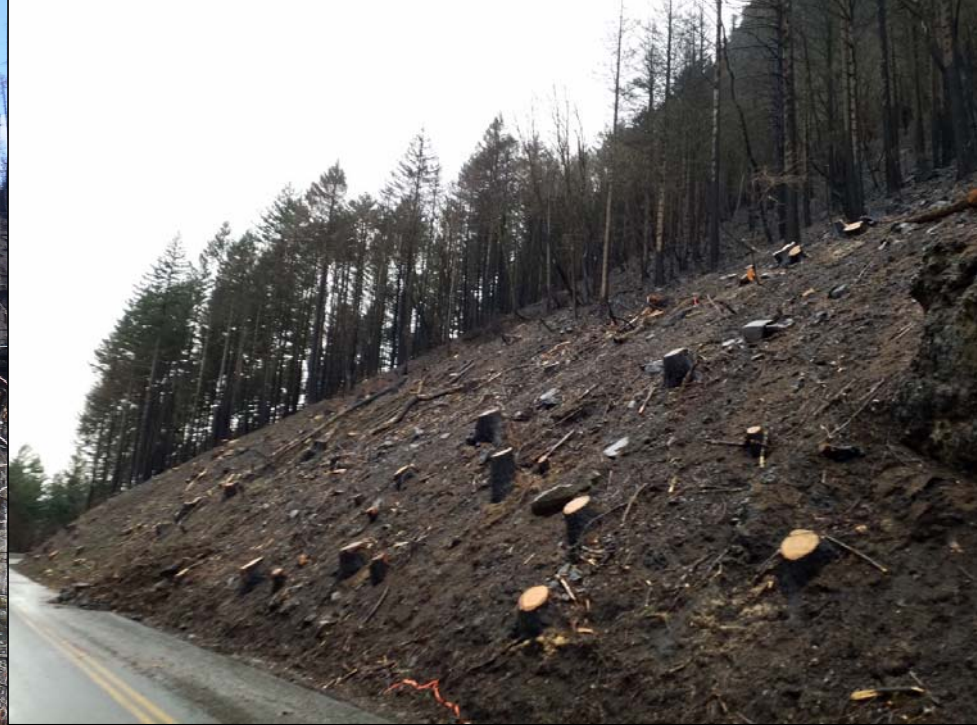
**Very high potential for threats to human life and safety from hazard trees on and off of NFS lands**

USFS, ODOT with limited BAER funding

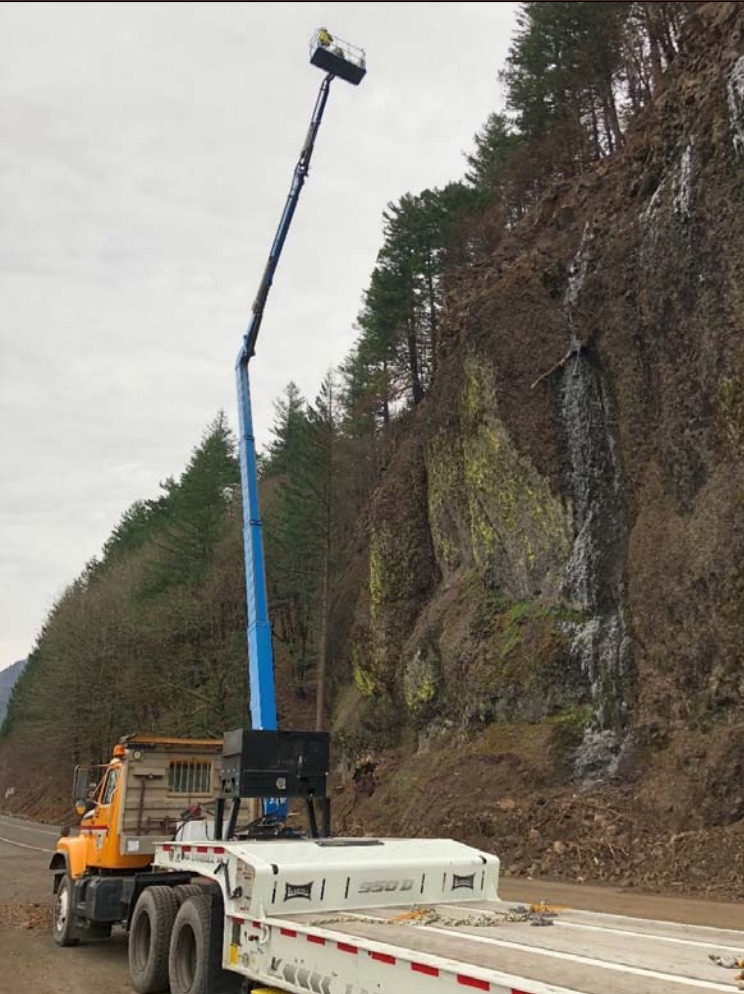
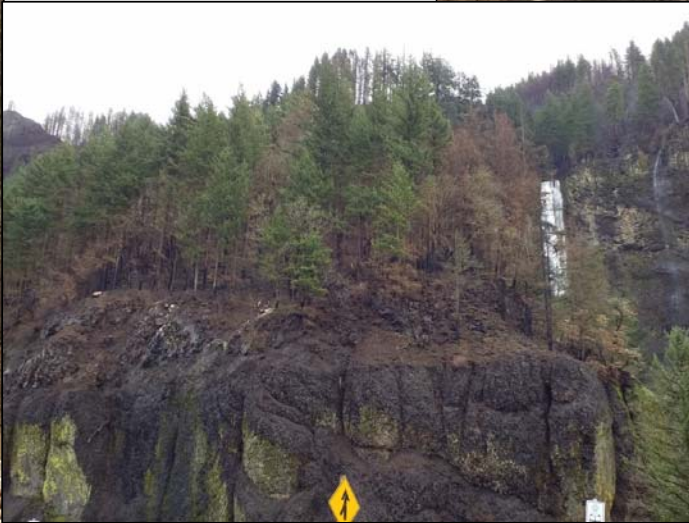
# Very high potential for threats to human life and safety from rock fall on and off of NFS lands

USFS, ODOT with limited BAER funding

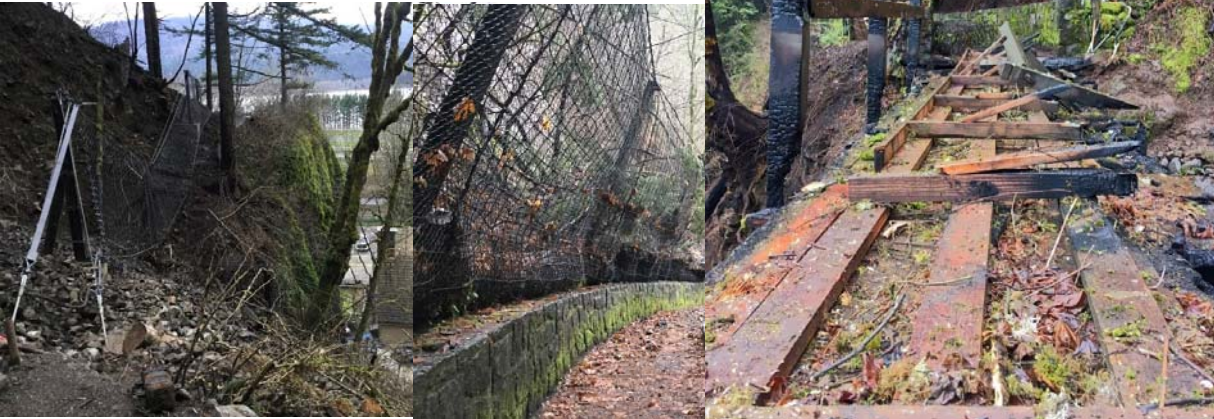
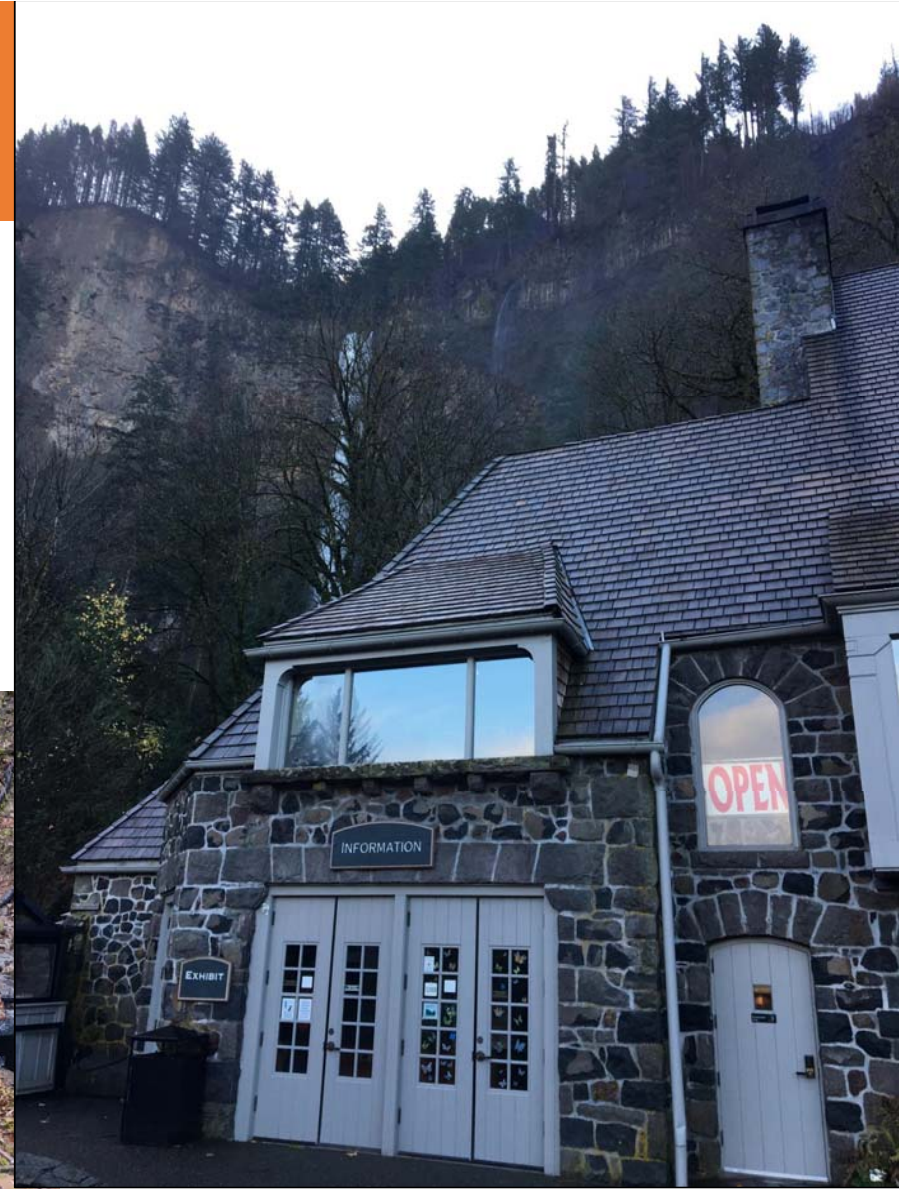
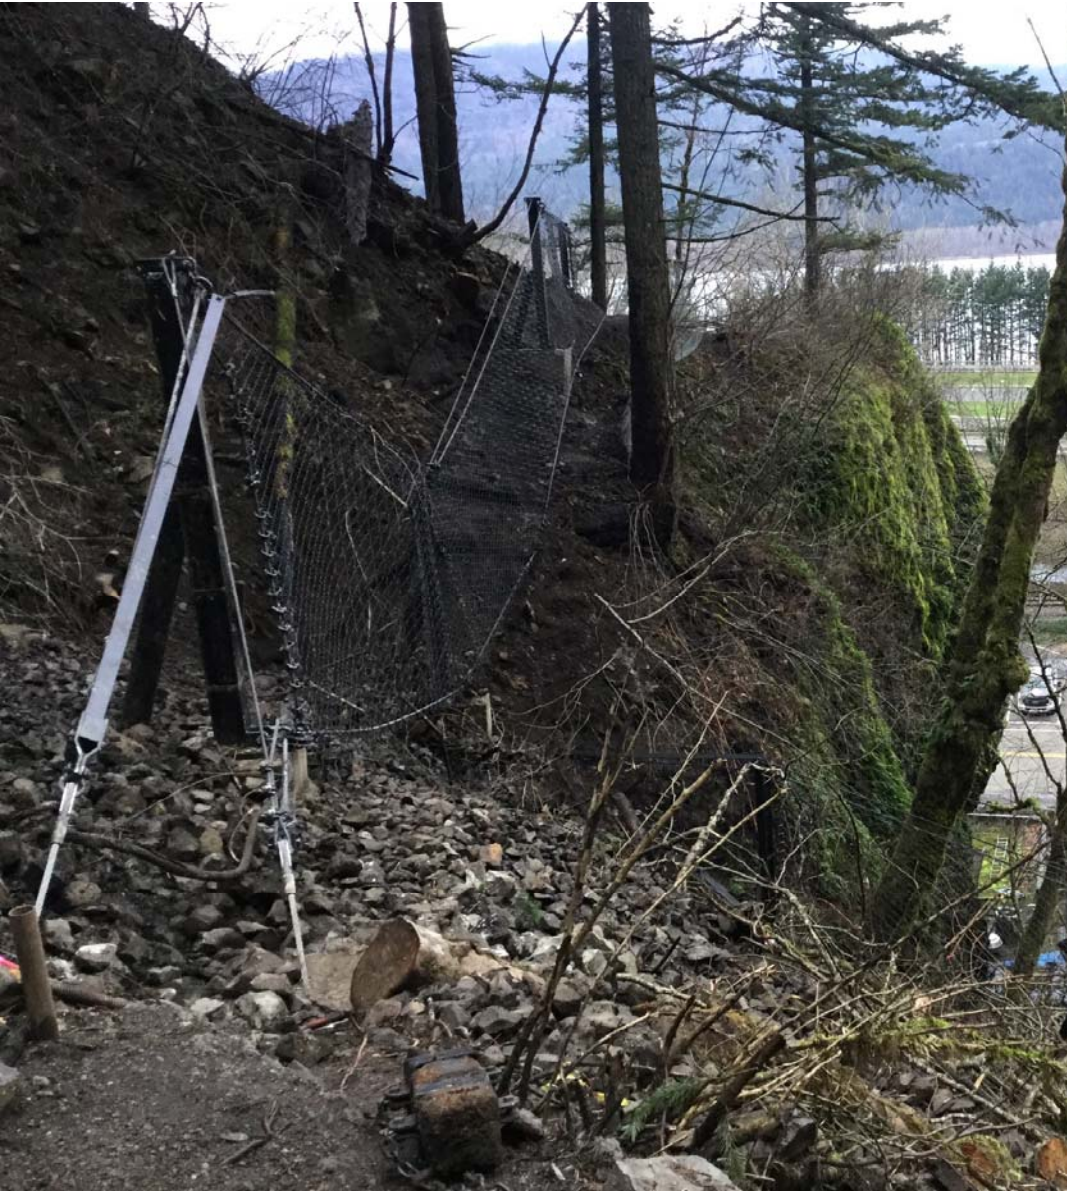
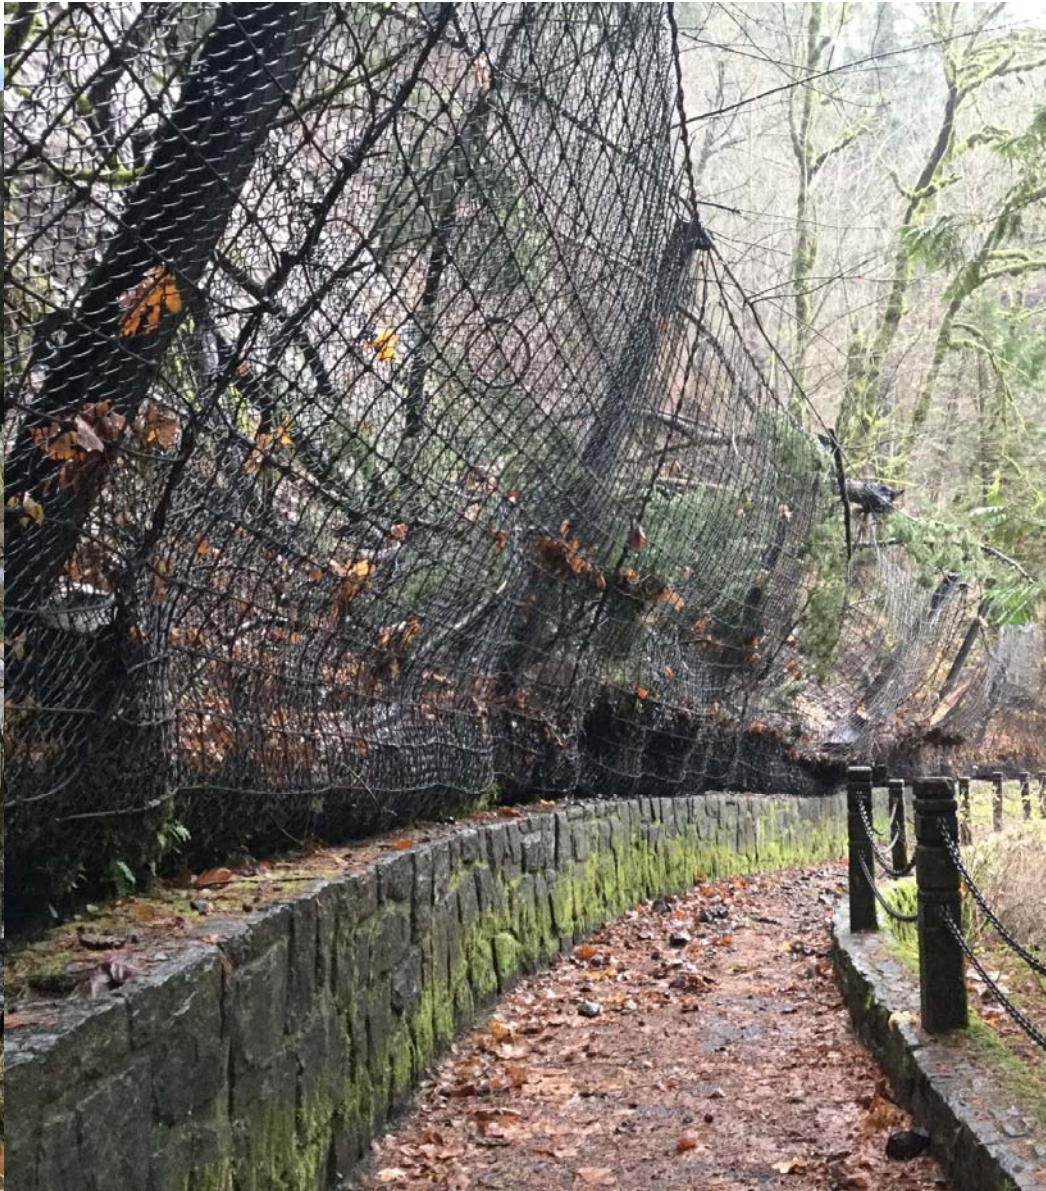
# Multnomah Falls

Multnomah Lodge is part of National Historic Landmark designation for Columbia River Gorge (Reopened 11/29/2017)

- Fire and prevention damage repair
- Hazard trees
- Rock fall fencing

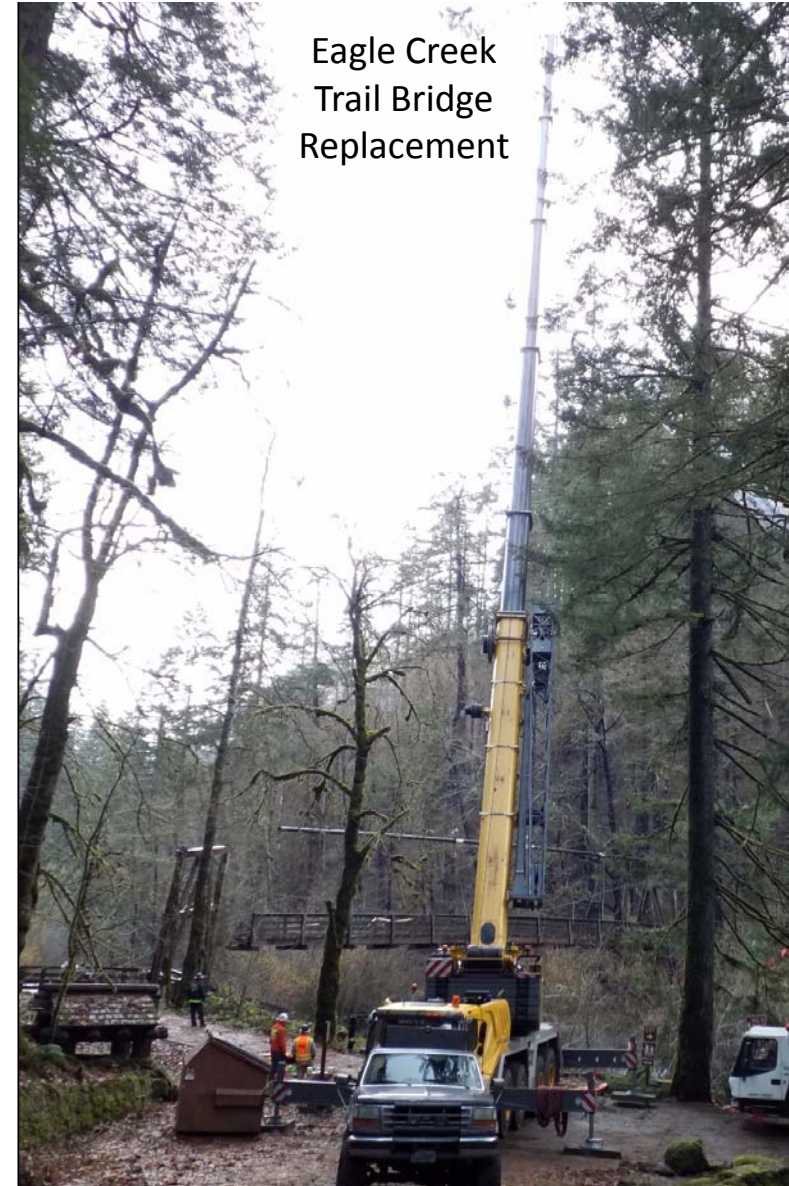
Eagle Creek  
Trail Bridge  
Replacement

- 90 Miles of Forest System Trails in Burned Area
  - BAER Implement Trail Stabilization Treatments on Steep Slopes in Burned Area – 33 ¼ Miles
- Trail Bridges
  - Eagle Creek
- Recreation Infrastructure
