#### Klickitat Fishway

One Down,

One to Go!

Yakama Nation Fisheries - YKFP

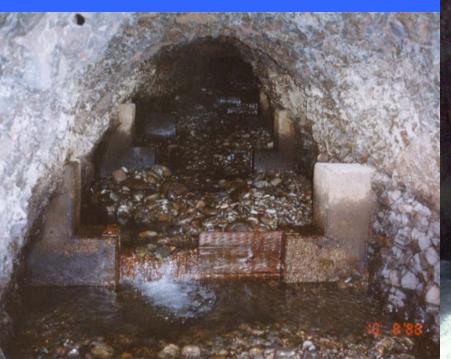
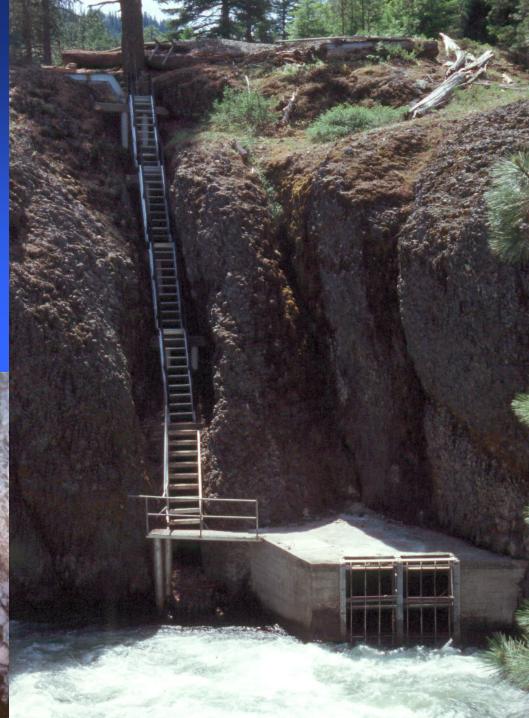
# Castile Falls 4/5 Fishway

Challenging working conditions

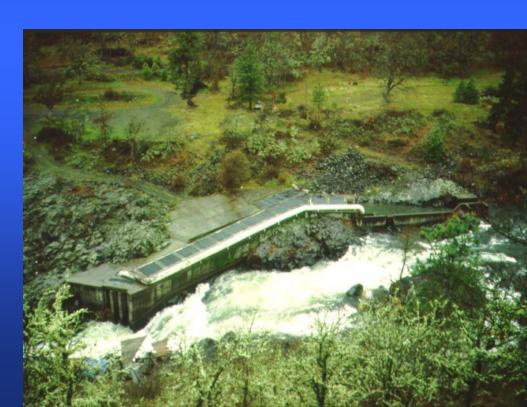
#### Lyle Fall Fishway Reconstruction

**Constructed 1952 – 1955**

150-feet in length

13 vertical slot fishway

Falls height ~ 17 feet

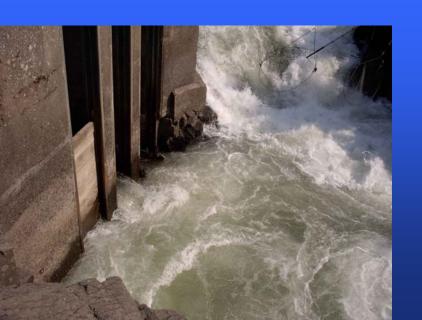
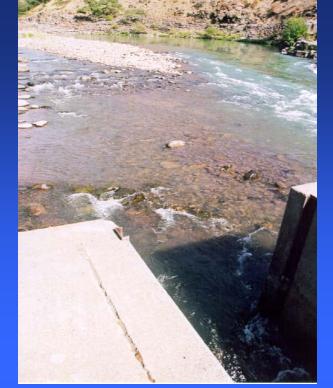
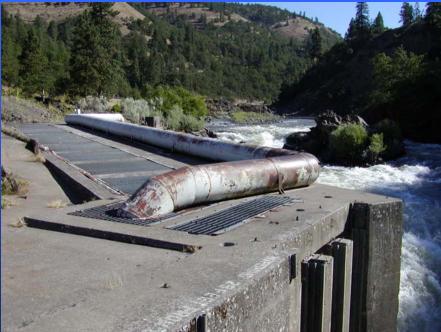
#### Lyle Falls Fishway - Current Condition

- Poorly Positioned Fishway Entrance
- Inadequate Attraction Water Supply
- Over-energized Resting Pools
- Inadequate Low Flow Water Supply
- •Gravel-impacted Fishway Exit Channel

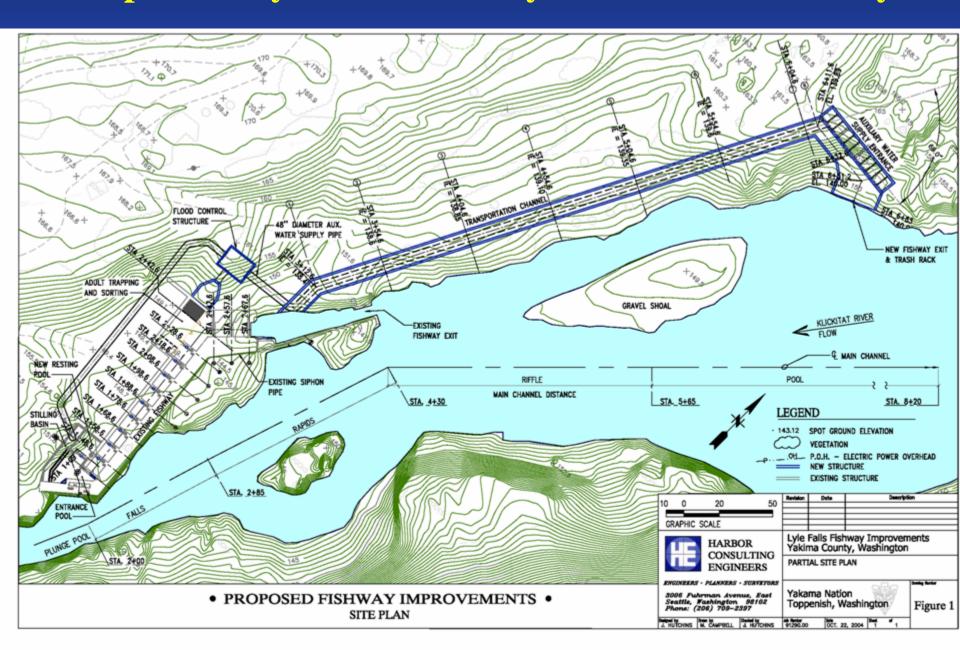
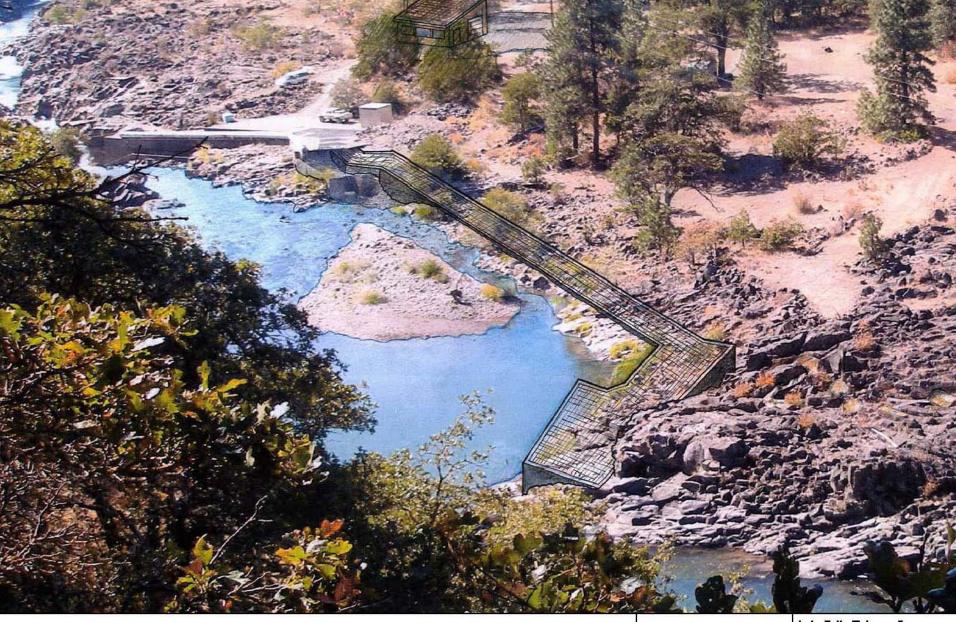
#### **Proposed - Lyle Falls Fishway & Collection Facility**

Sketch of Modified Fishway

Design Fishway to meet Federal & State Passage Criteria
