# Elwha Ecosystem Restoration Project: Plant Colonization and Establishment of the Dewatered Reservoirs after 2-3 Growing Seasons

Joshua Chenoweth  
April 15, 2014

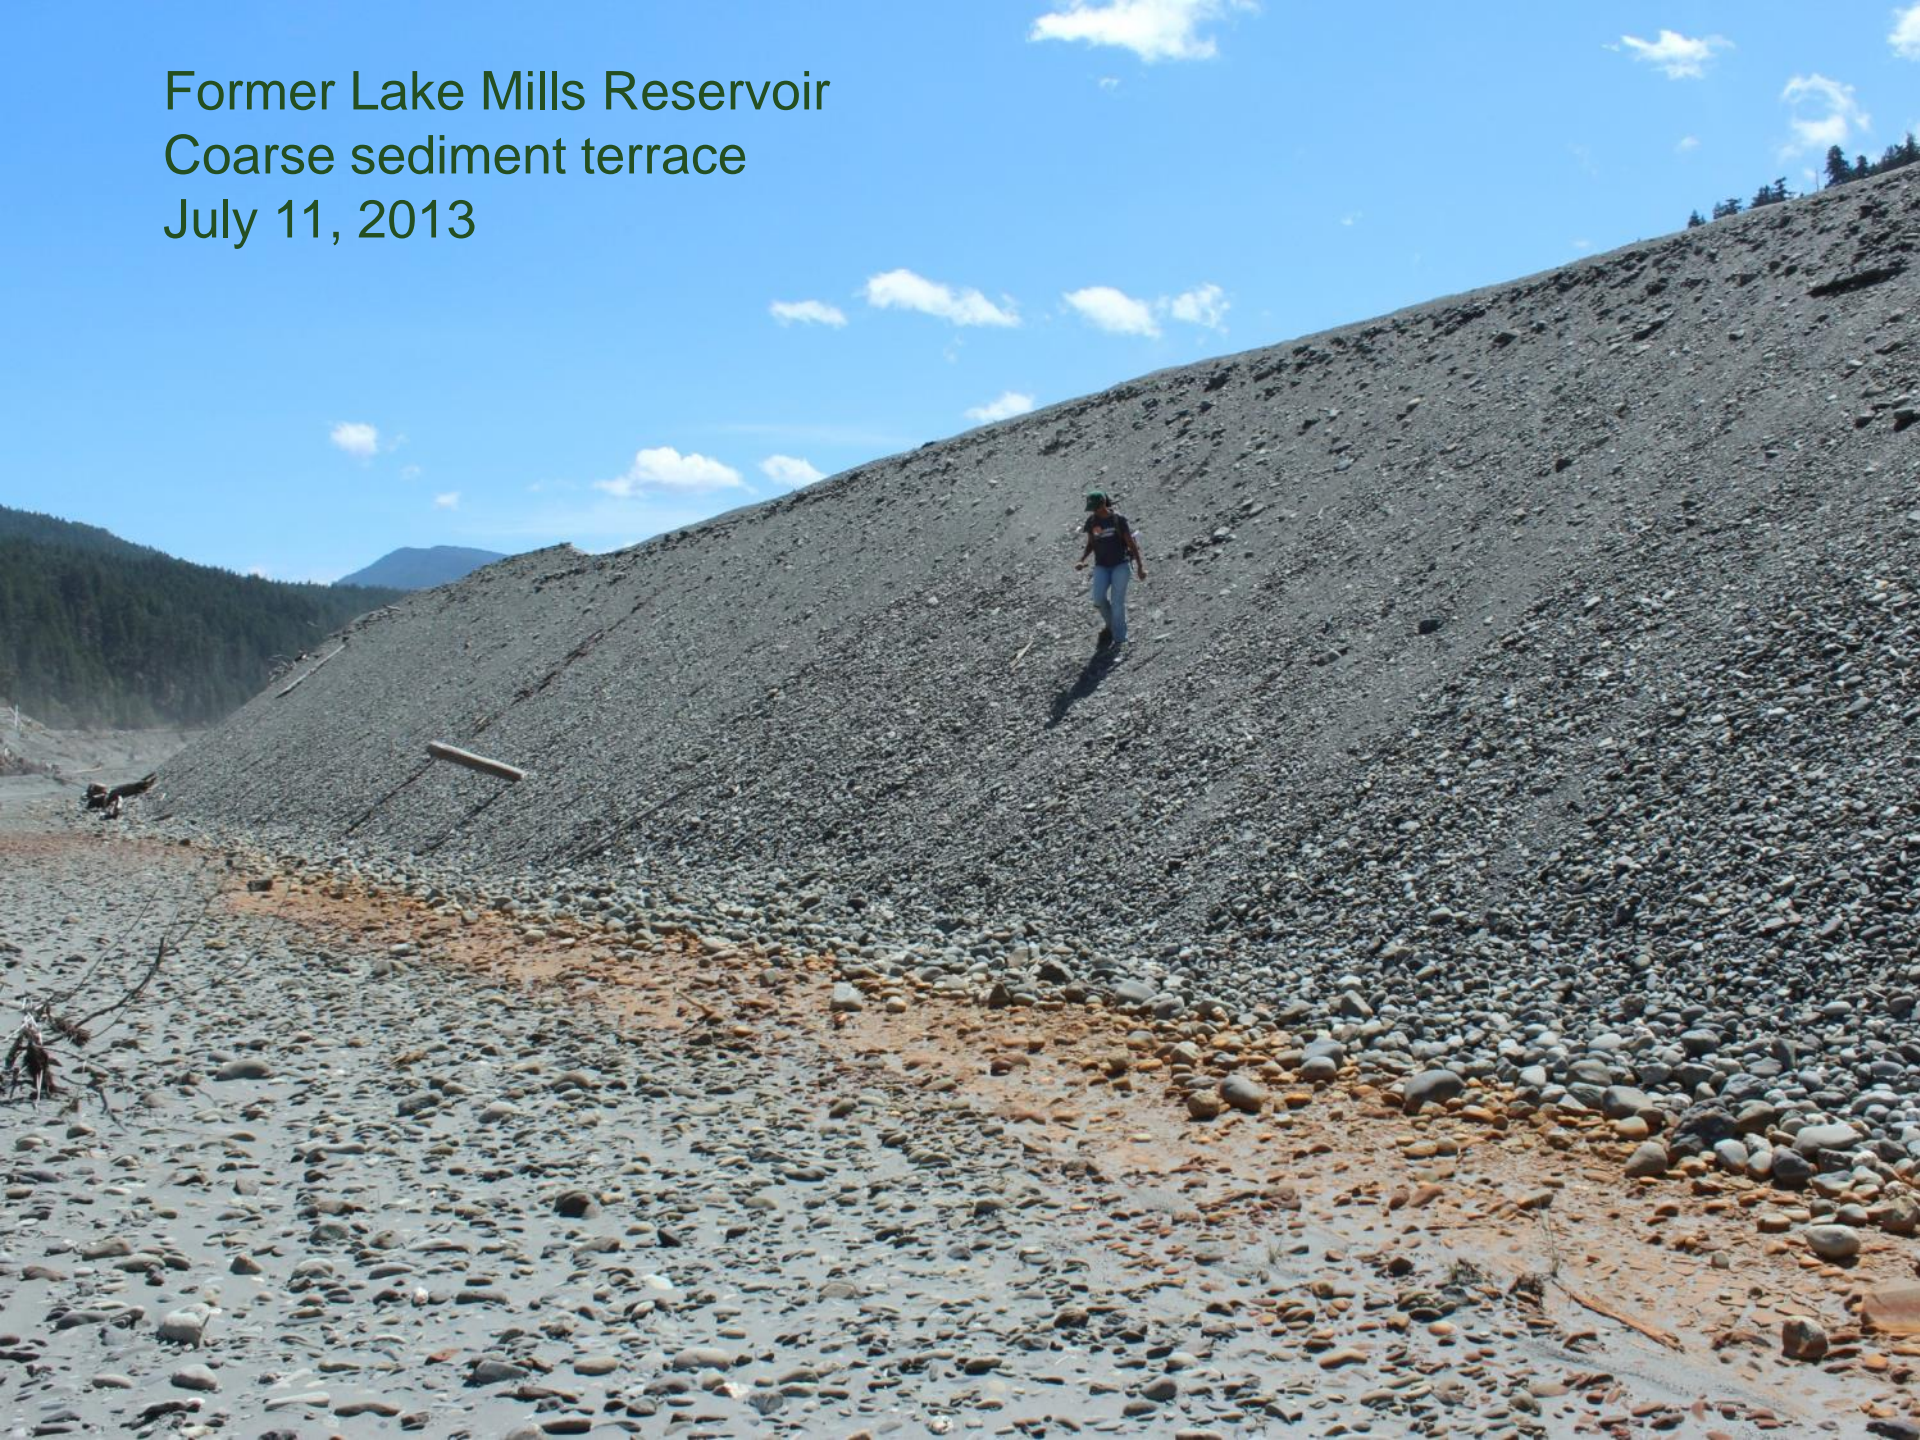
Former Lake Mills Reservoir  
Coarse sediment terrace  
July 11, 2013

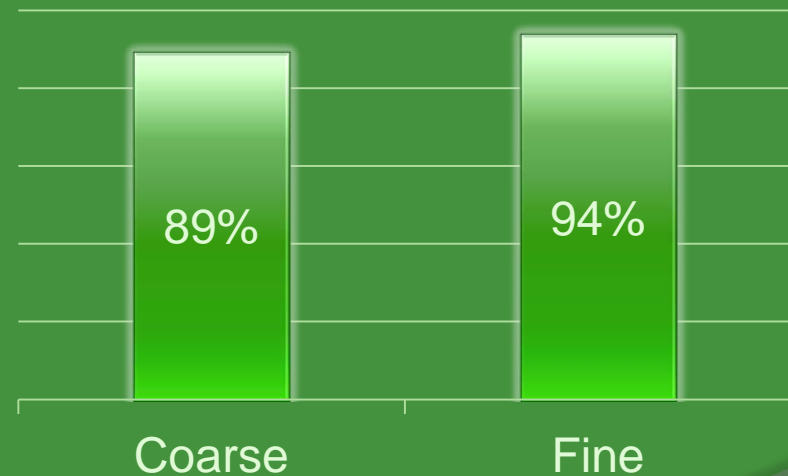
Survival rate by sediment texture (all years)

- Overall rate of survival:  
92%
  - 92% in 2012
  - 92% in 2013
- Worst performer
  - 2012: Douglas-fir (64%)
  - 2013: Scouler's willow (85%)
- Best performer:
  - 2012: Black cottonwood (99%)
  - 2013: Western white pine (98%)

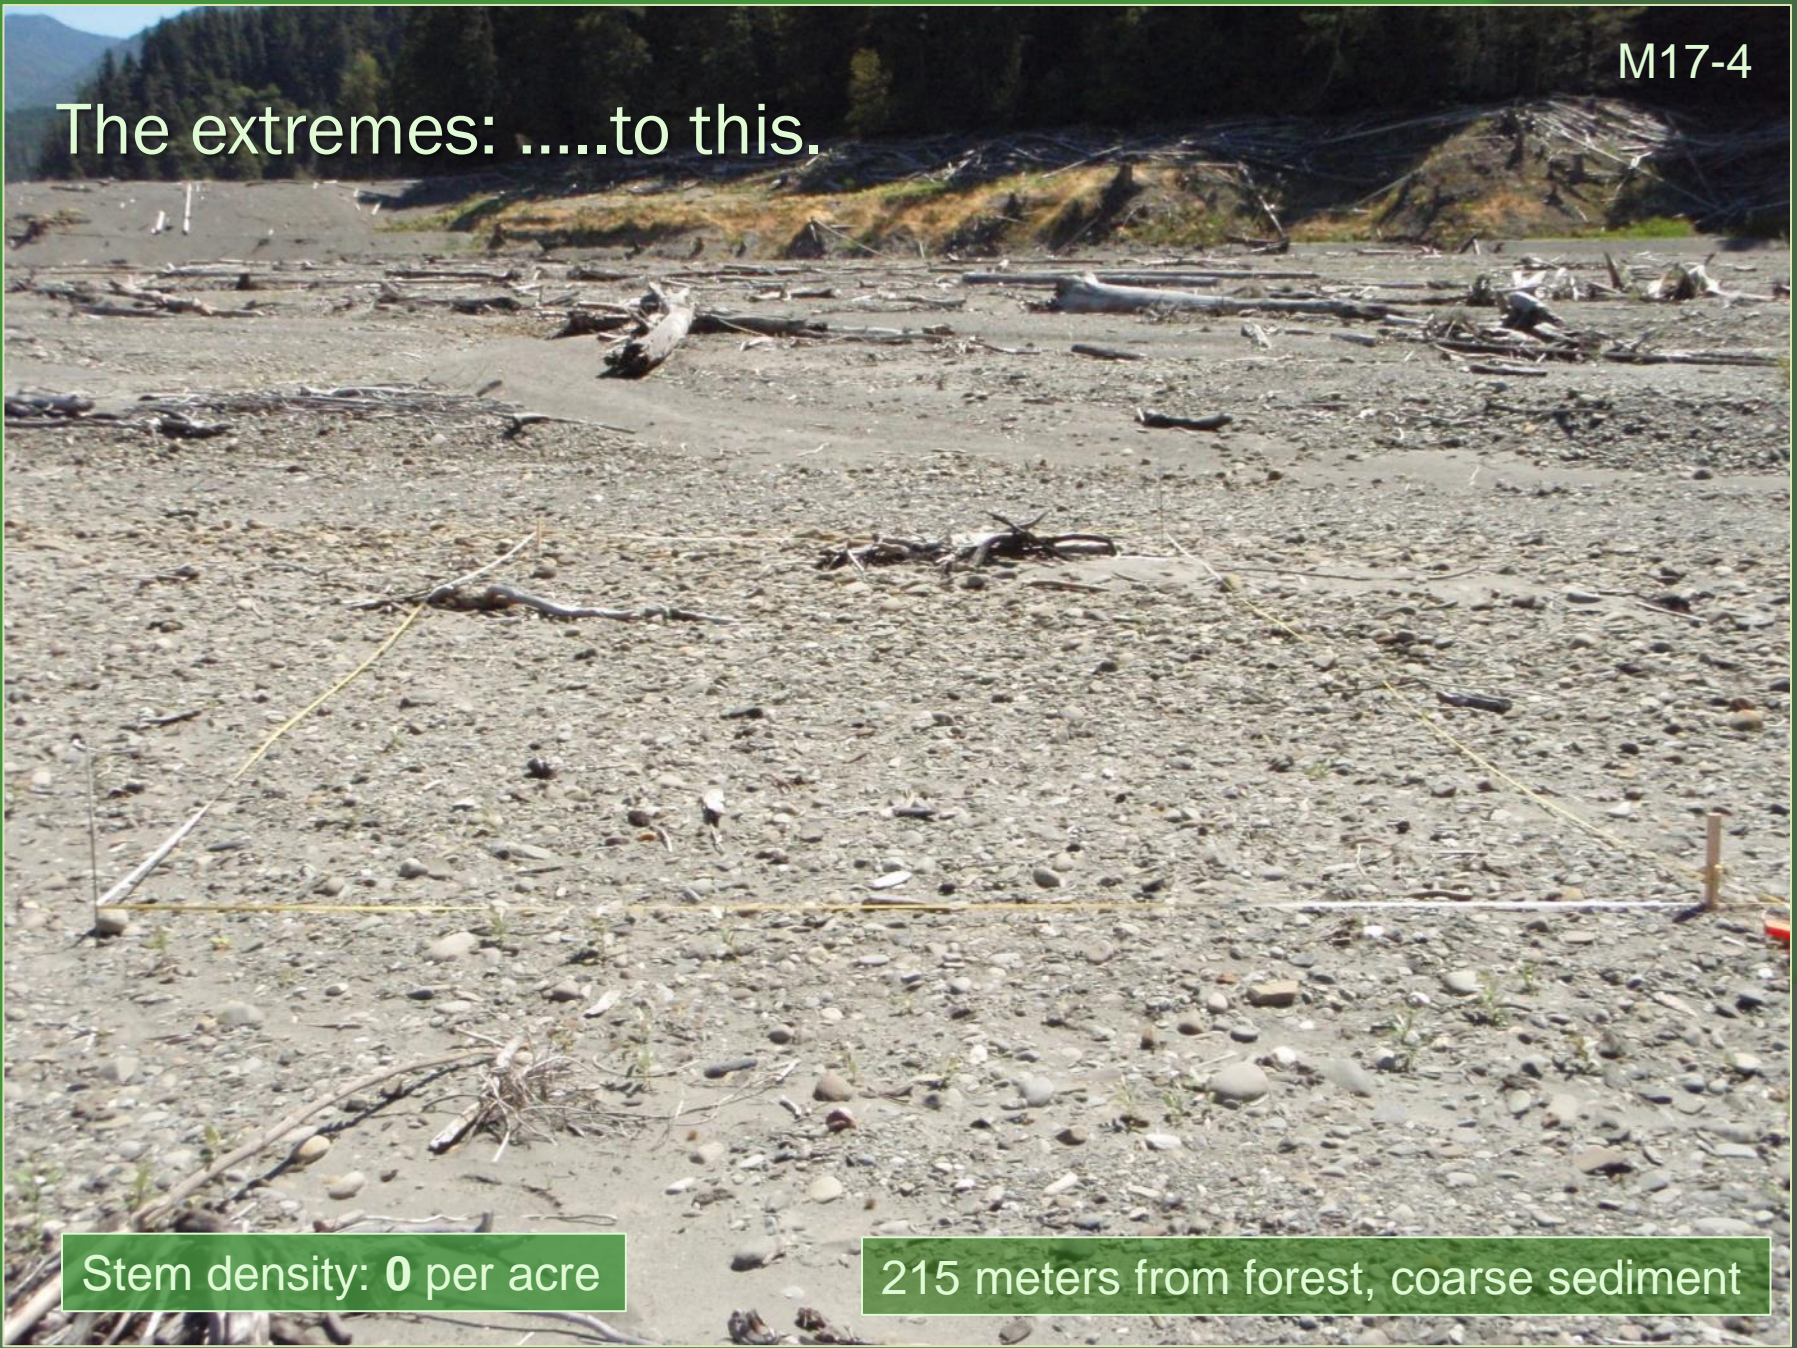
M17-4

The extremes: .....to this.

Stem density: 0 per acre

215 meters from forest, coarse sediment

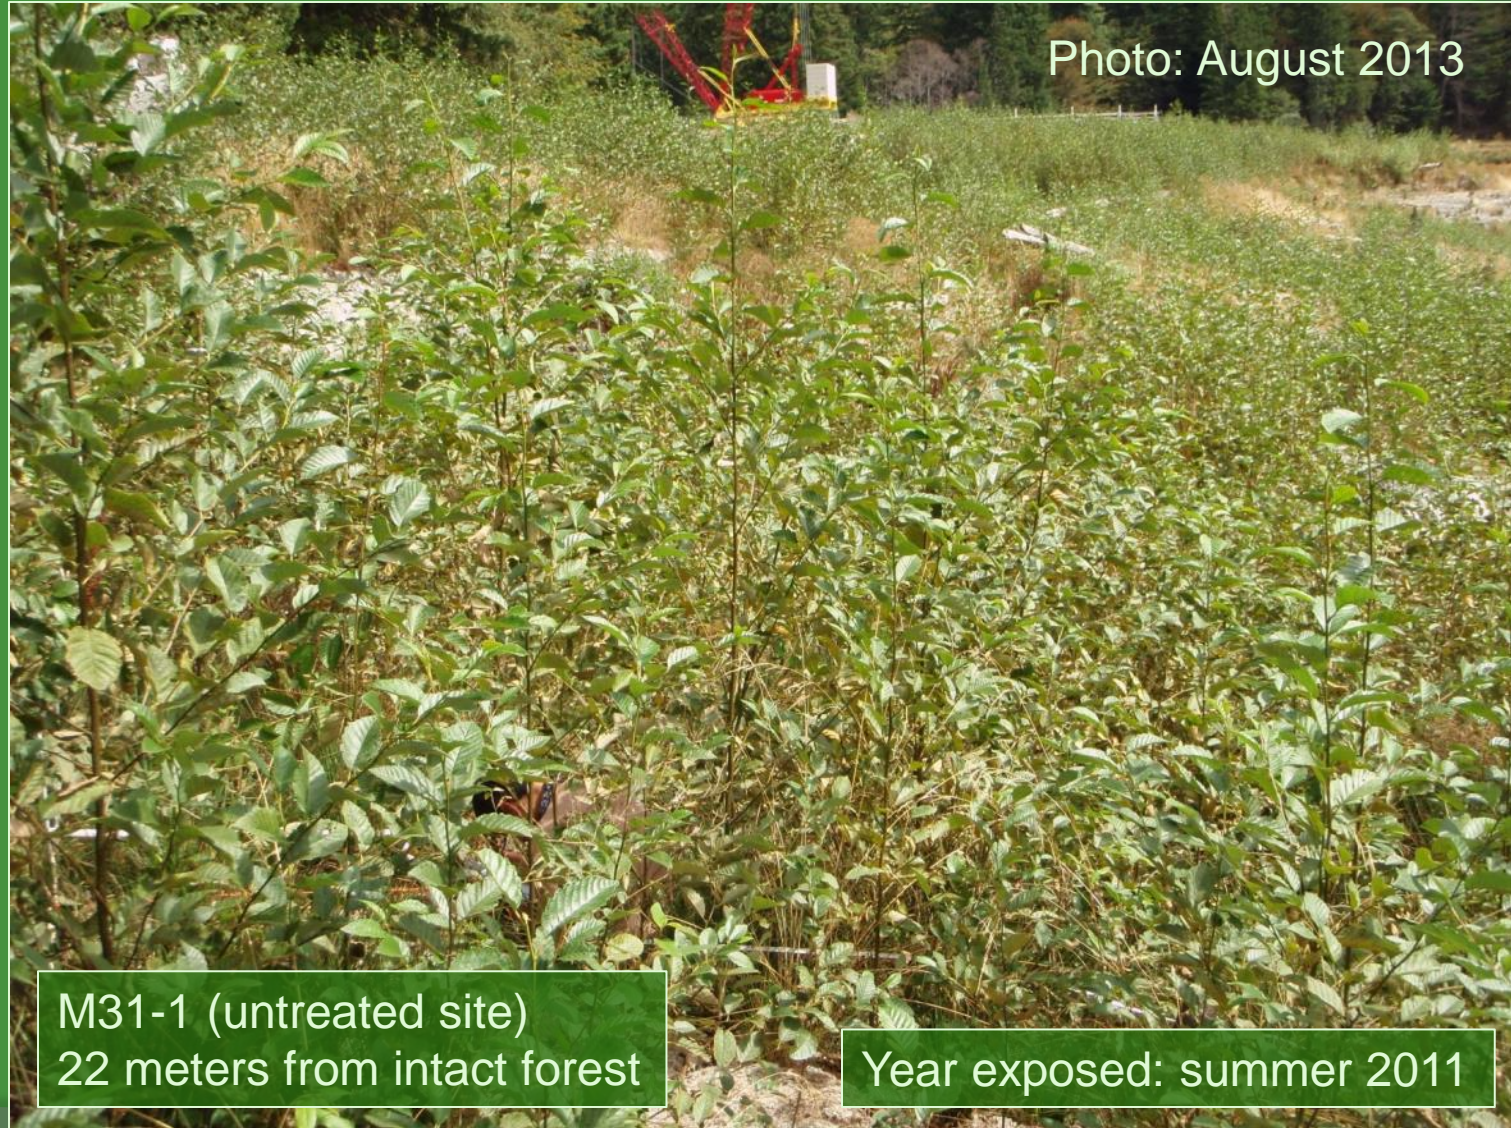
M31-1 (untreated site)  
22 meters from intact forest

Photo: August 2013

Year exposed: summer 2011

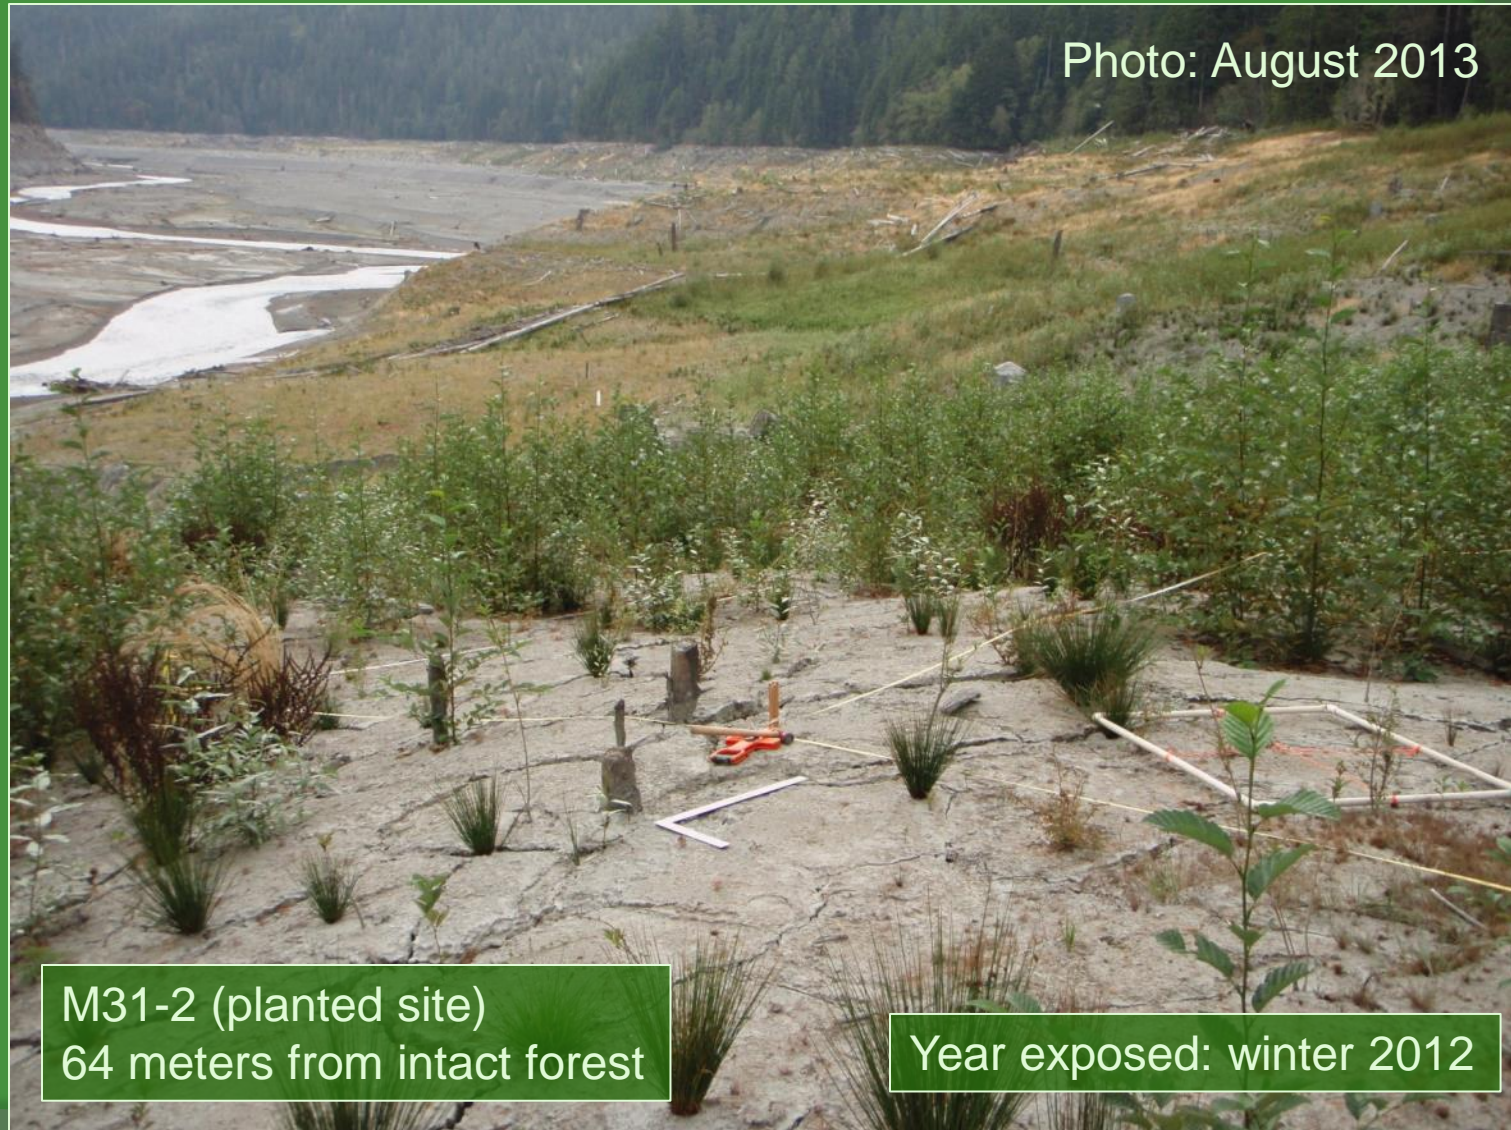
M31-2 (planted site)  
64 meters from intact forest

Photo: August 2013

Year exposed: winter 2012

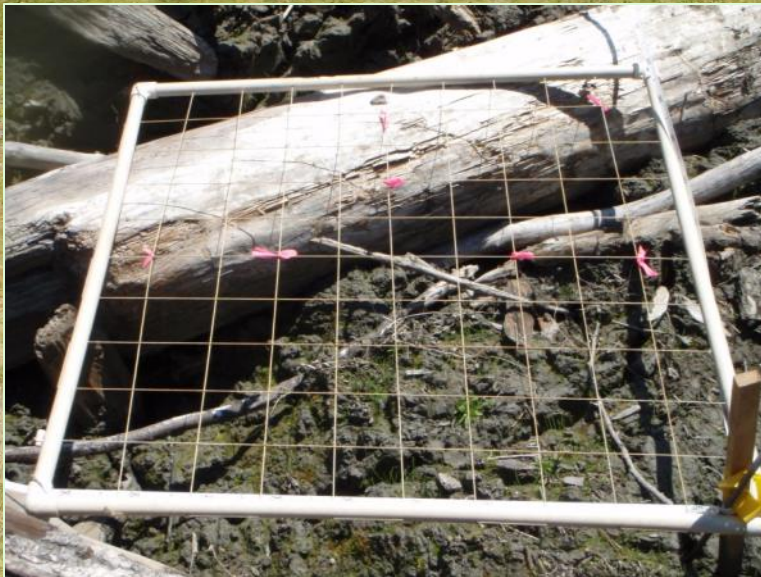
M10-1 SW: 2012

Lake Mills: 27 permanent plots	2012	2013	Difference
Cover of bare-ground	76%	26%	-50%
Cover of native woody plants	0.1%	12%	+11.9%
Cover of herbaceous plants	4.4%	50.7%	+46.3%

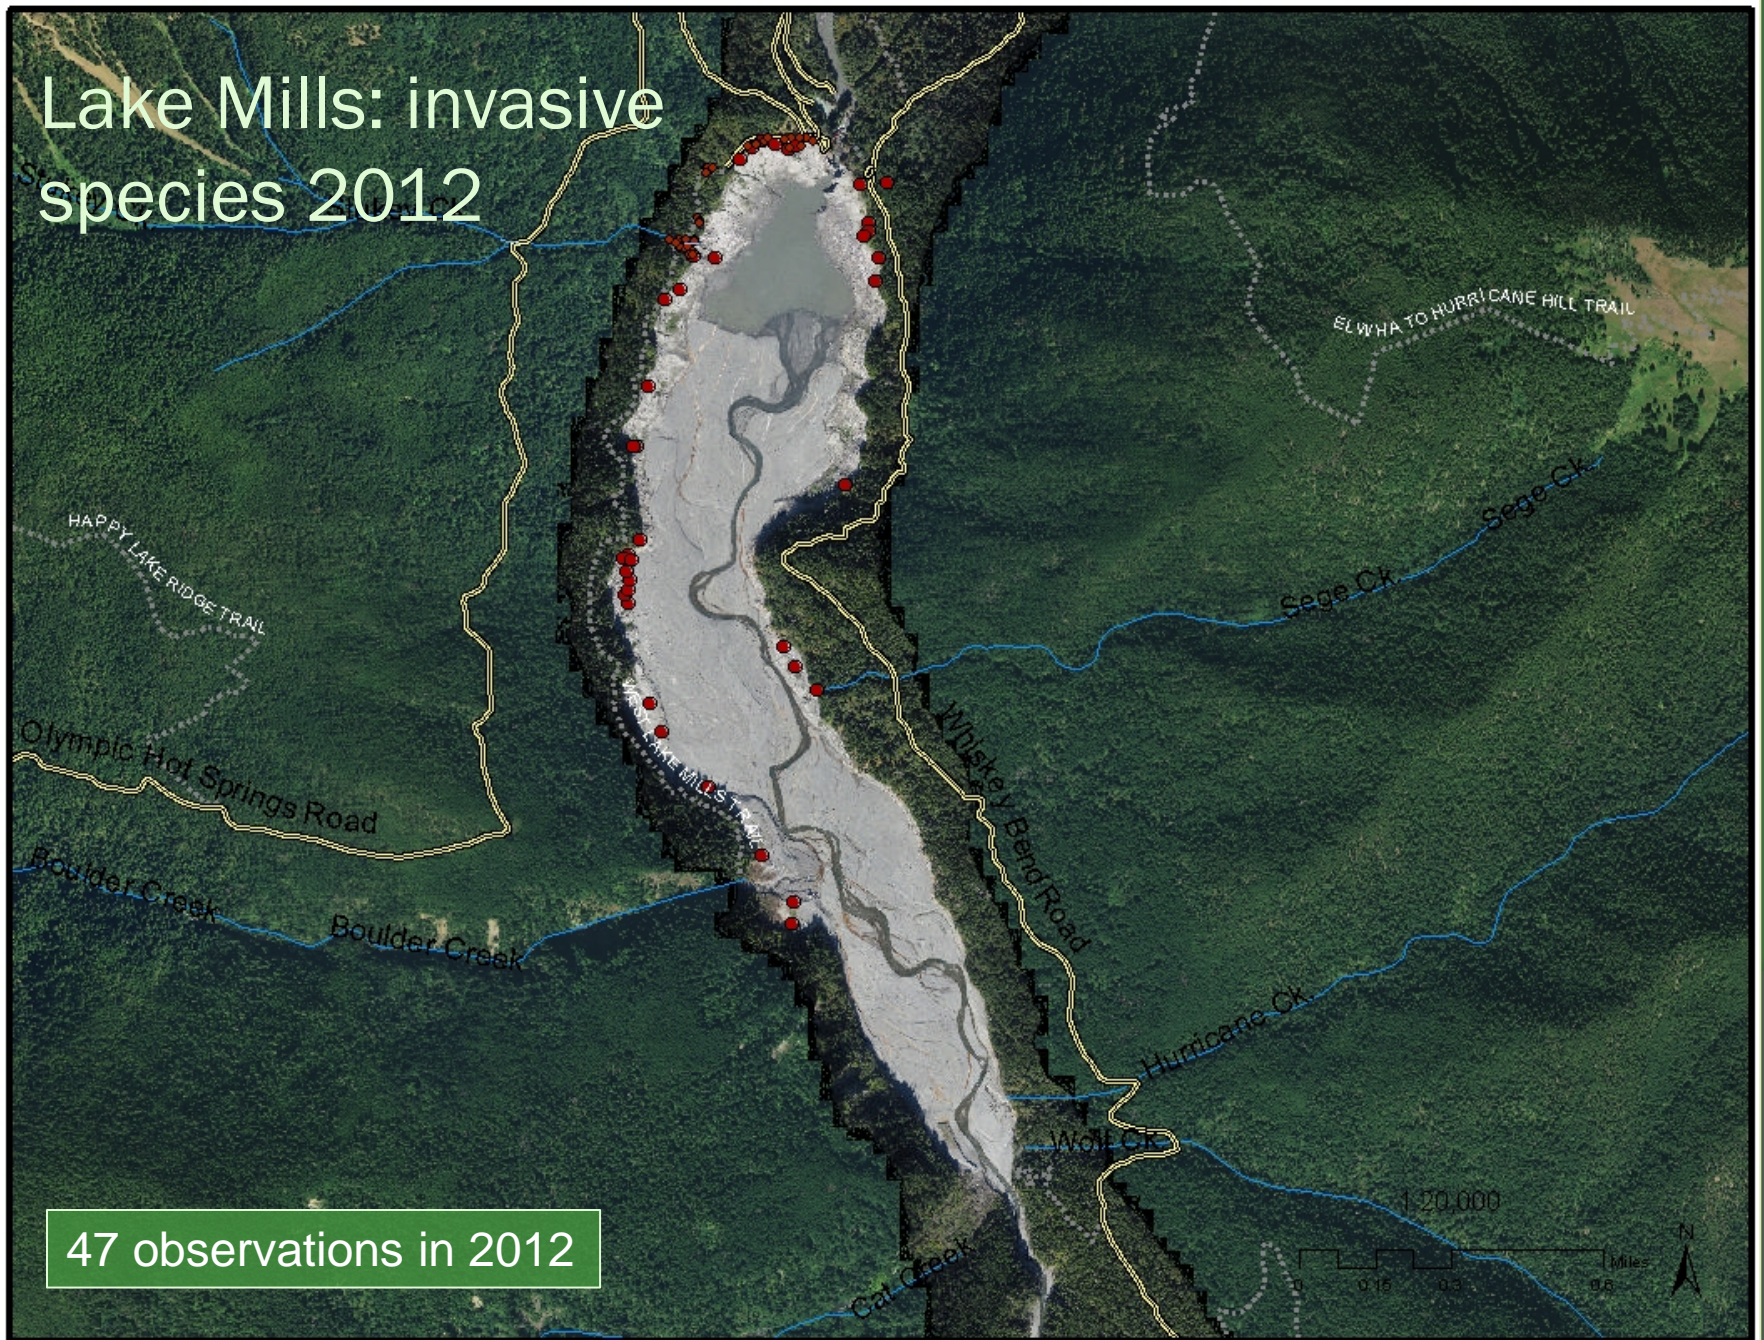
# Lake Mills: invasive species 2012

47 observations in 2012

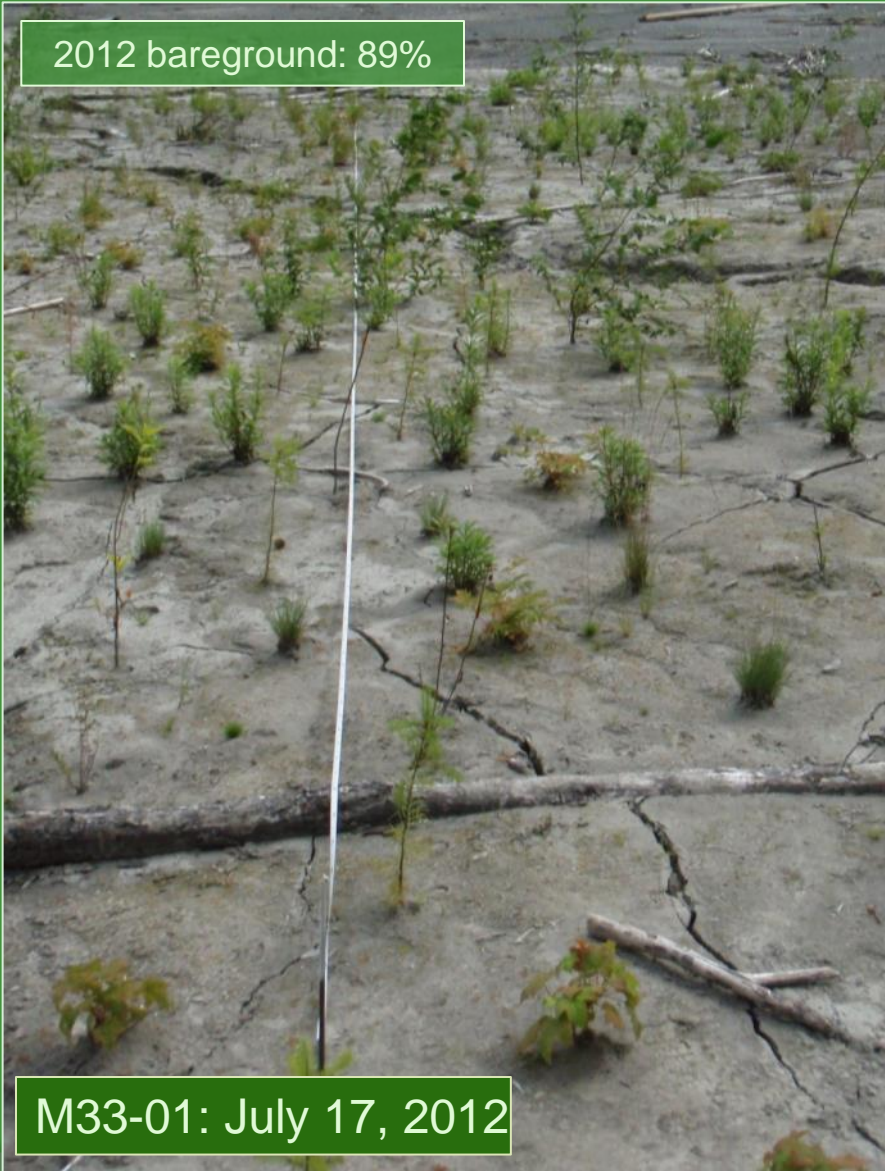
M33-01: July 17, 2012

2012 bareground: 89%

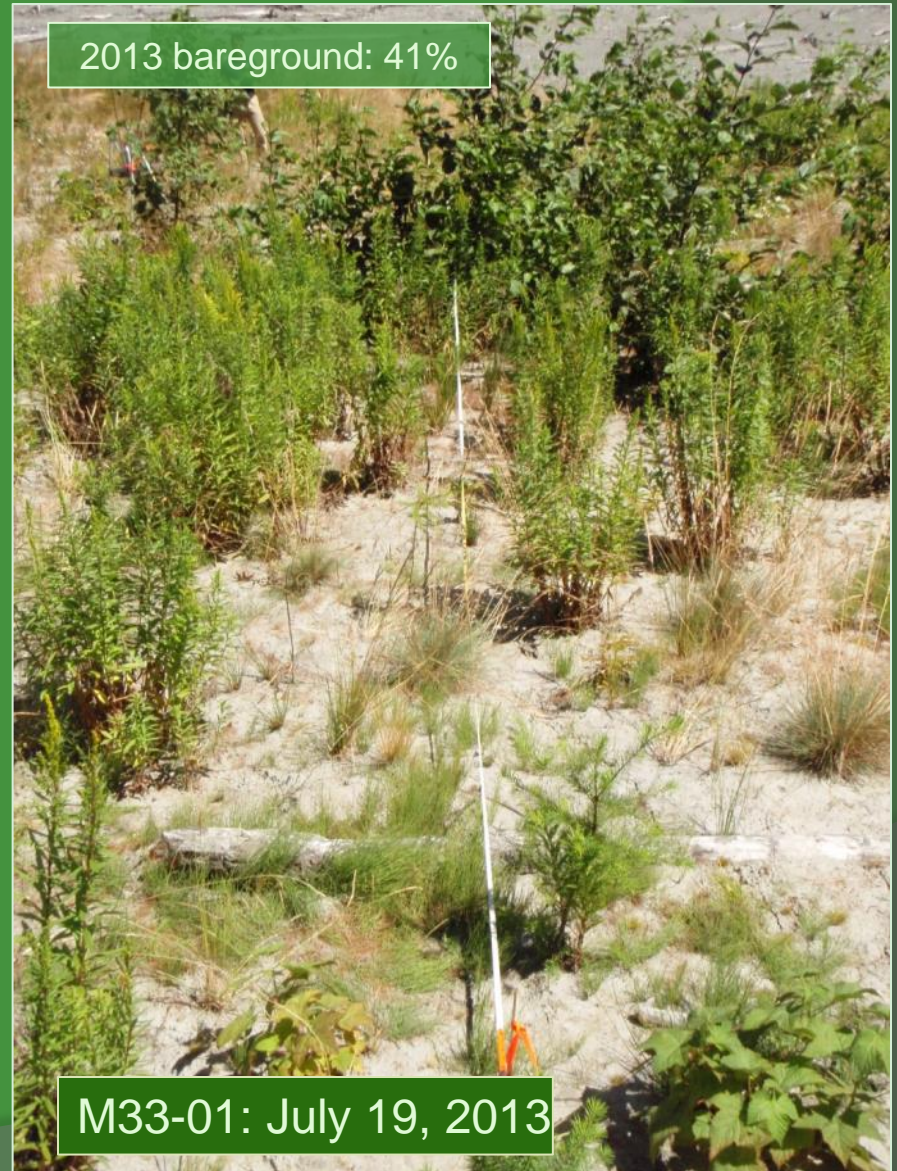
M33-01: July 19, 2013

2013 bareground: 41%

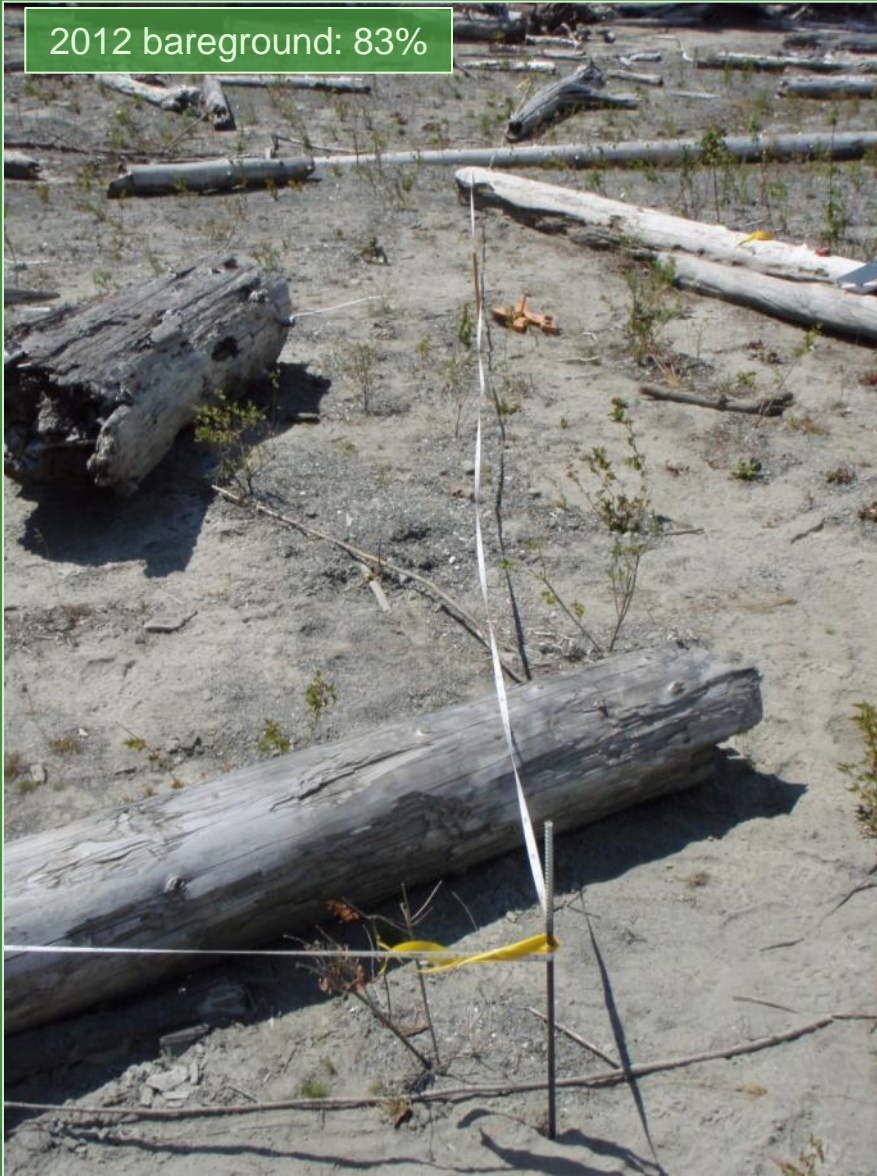
# Planted site on coarse sediments

2012 bareground: 83%

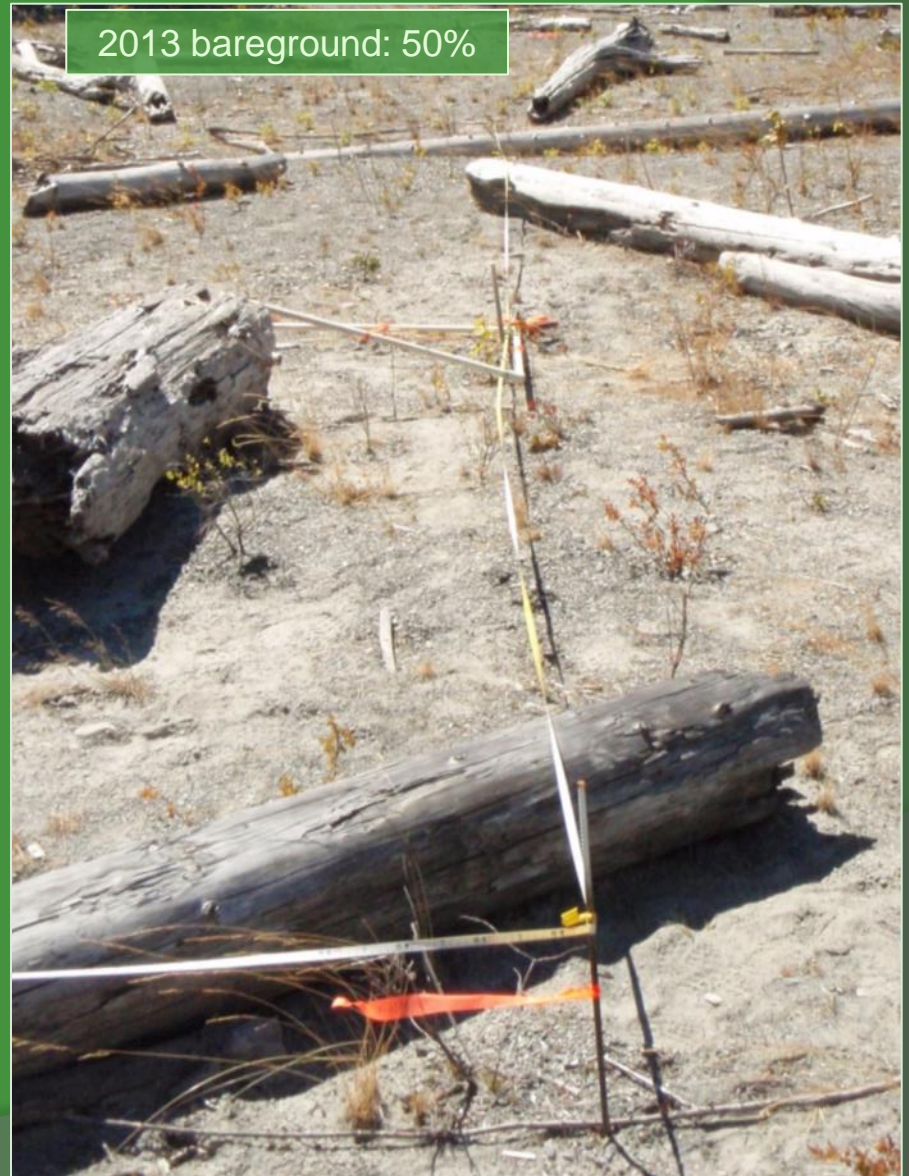
2013 bareground: 50%

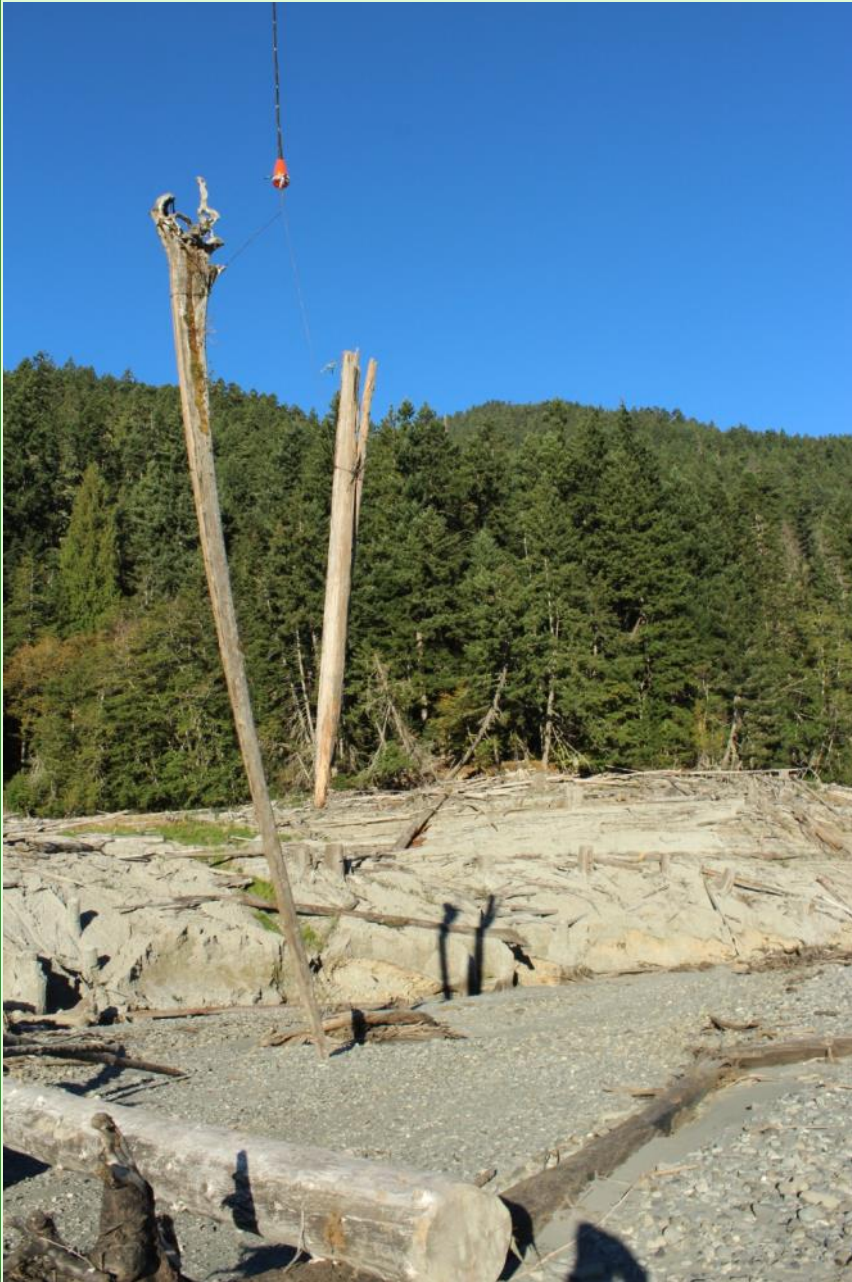
# Wood Moved in October 2012

- Vertol helicopter (Columbia Helicopter)
- 6.9 hours of operation
- 440 pieces of wood
  - 818,400 pounds
  - 9.6 acres

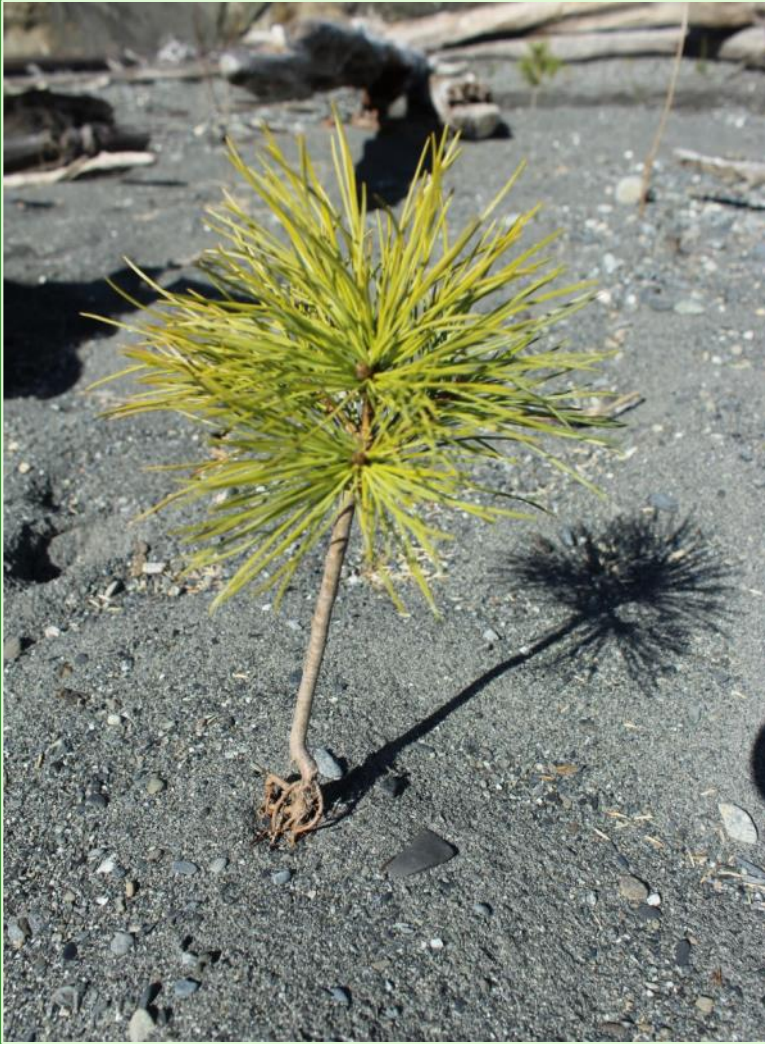
# Benefits of wood

- Safe sites for plants
  - Shade from southern or western exposure

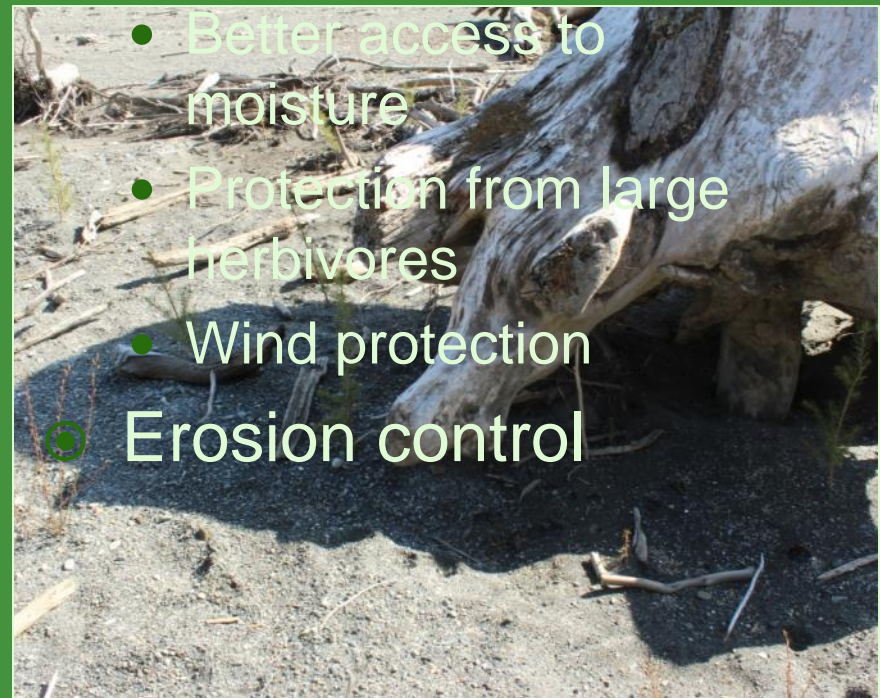
- Better access to moisture
- Protection from large herbivores
- Wind protection
- Erosion control
