Hemlock Dam Removal and Trout Creek Recovery

Presentation Outline

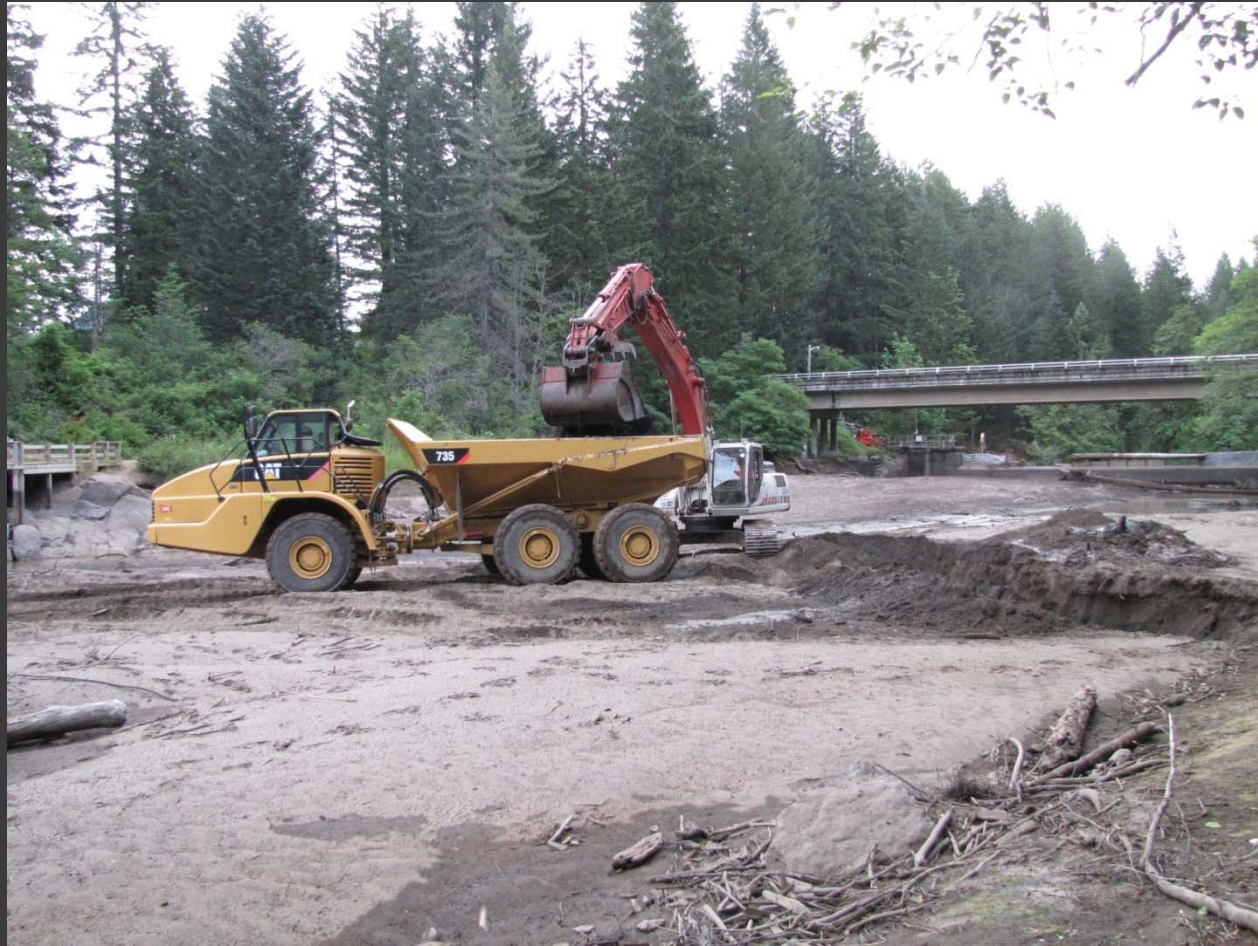
Excavation begins—55,000 cubic yards

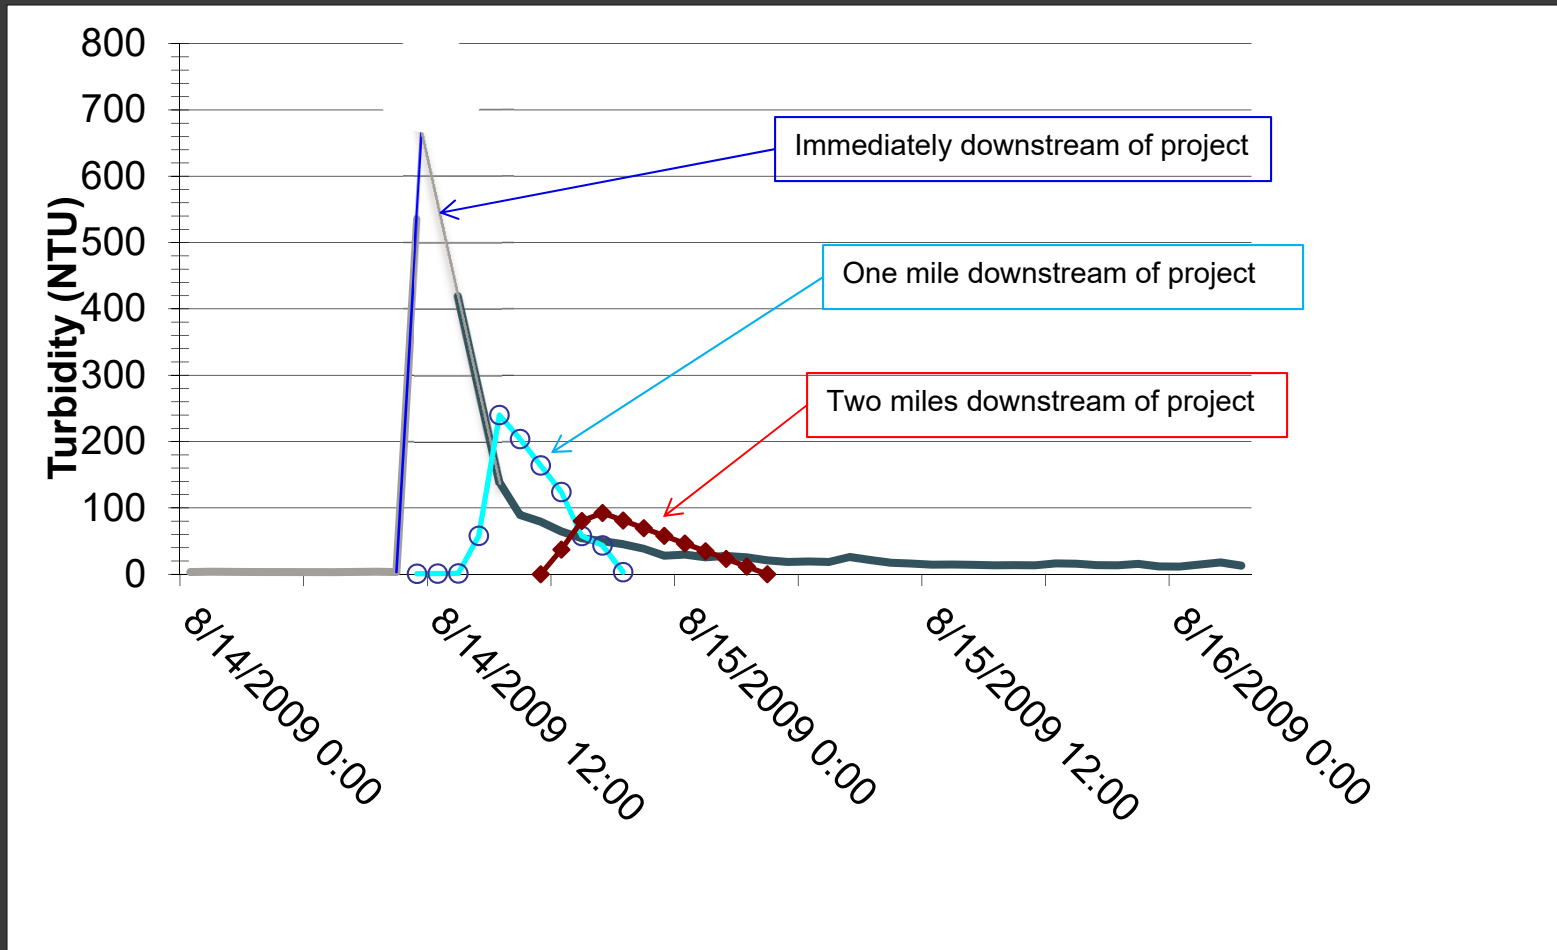
Turbidity Monitoring

48 hour period immediately after rewatering the channel

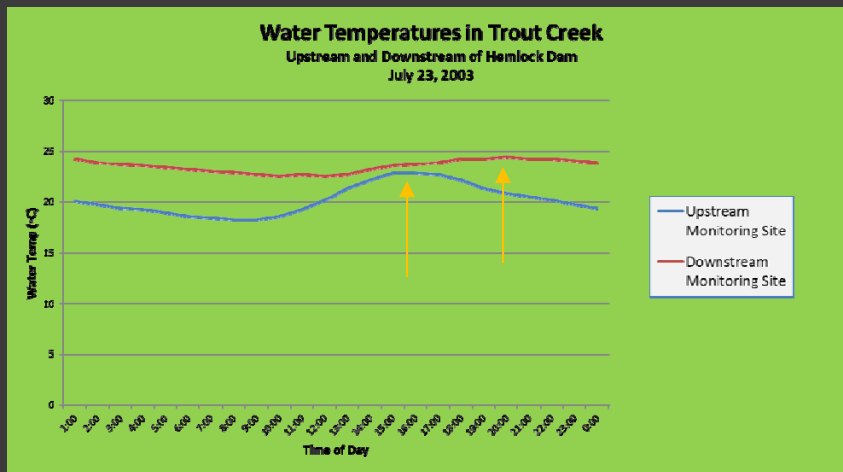
Water Temperature Monitoring Results

Before Dam Removal

Downstream:

- Higher average and peak temp
- Peak temp occurs in the evening
- Very little nighttime cooling

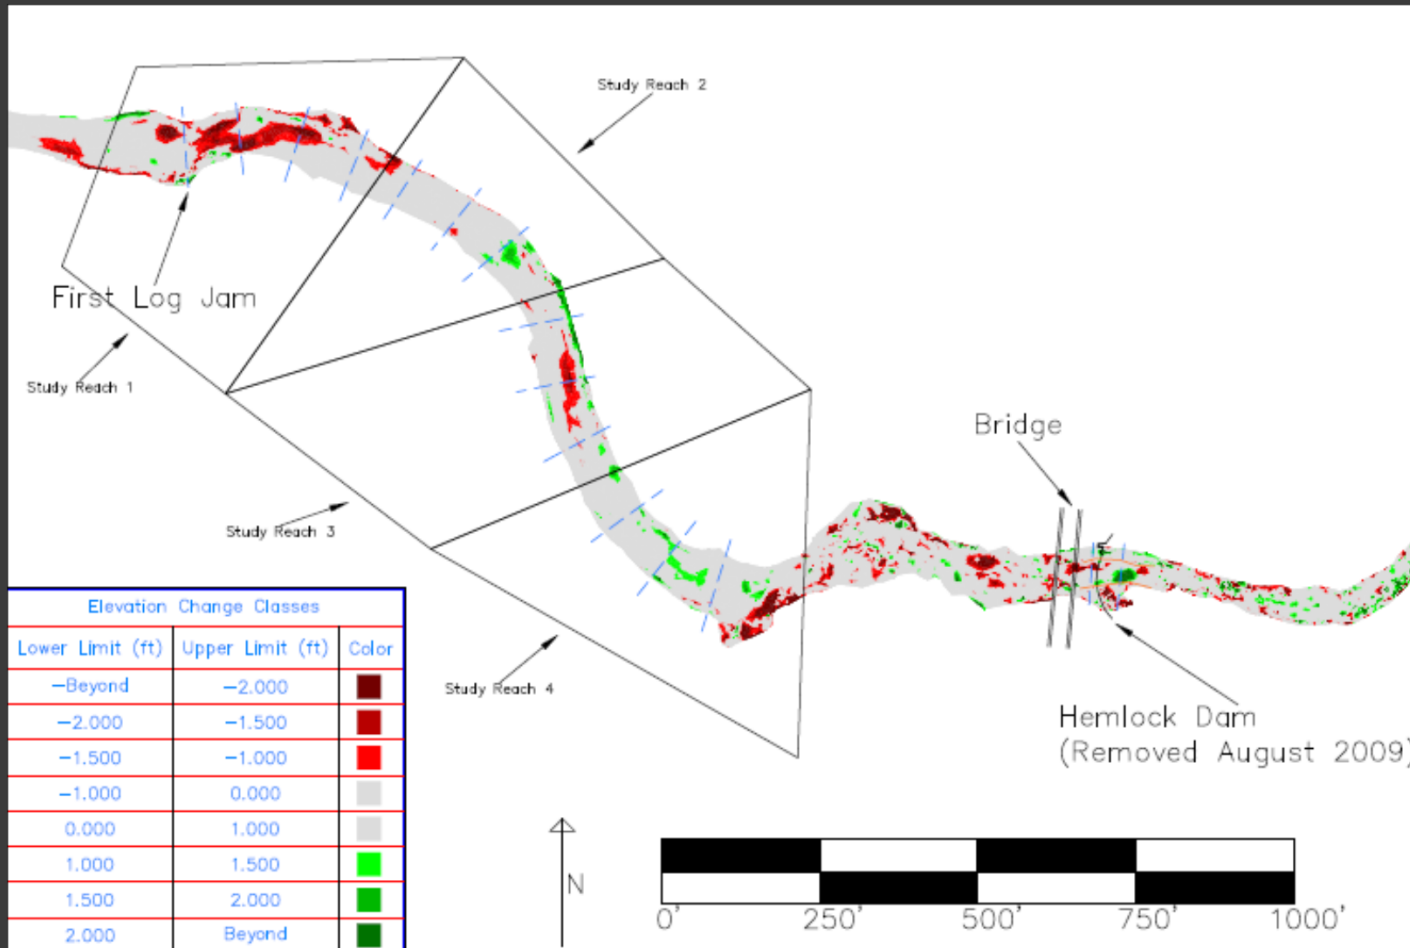
Channel change--erosion and deposition: 2009-2010 (year 1)

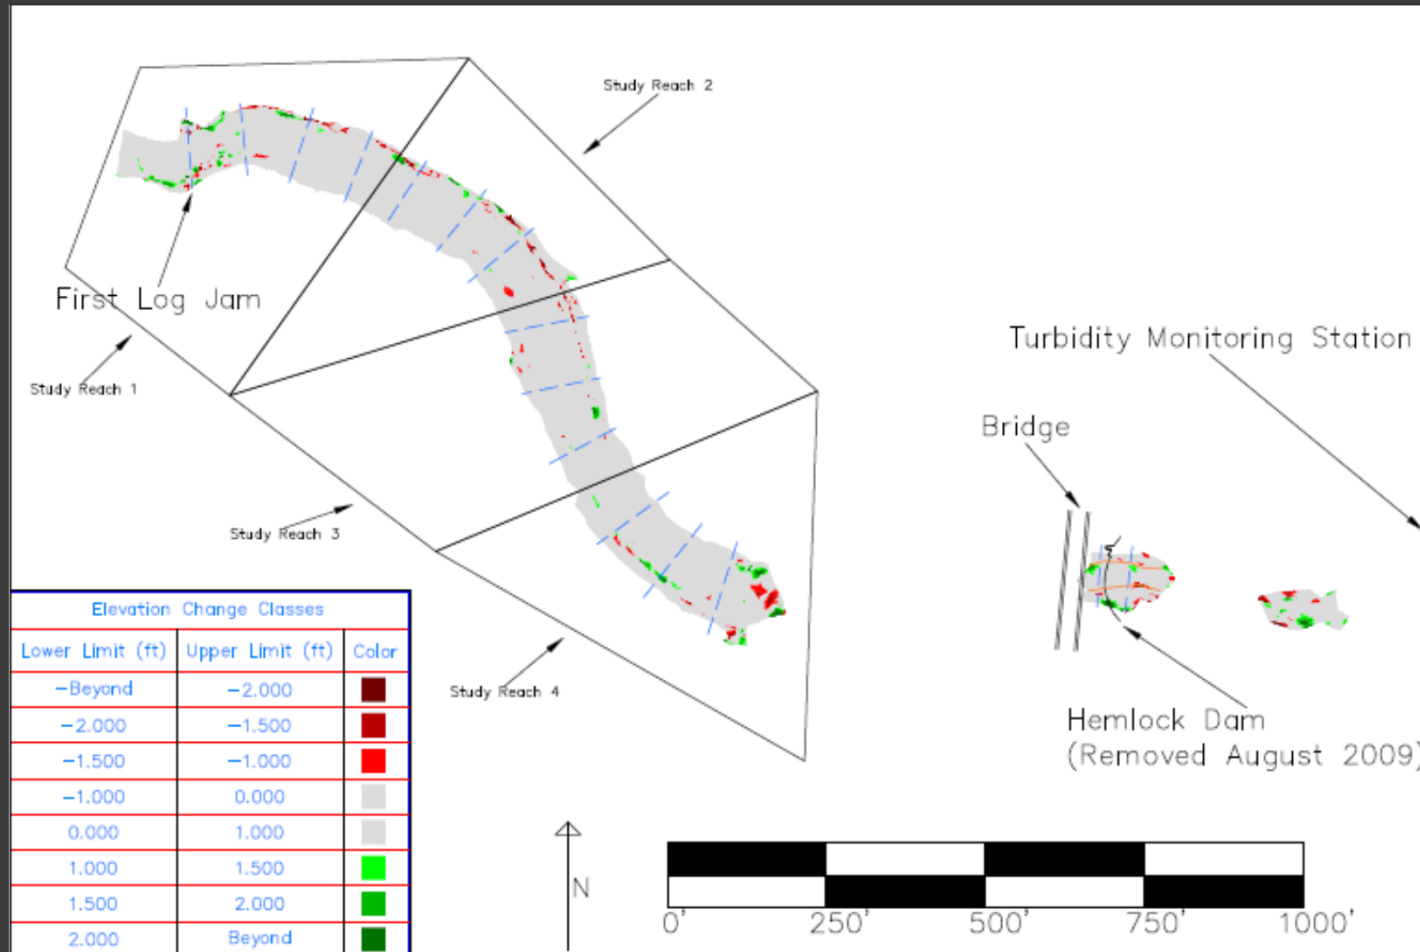
2012-2013 (year 4)

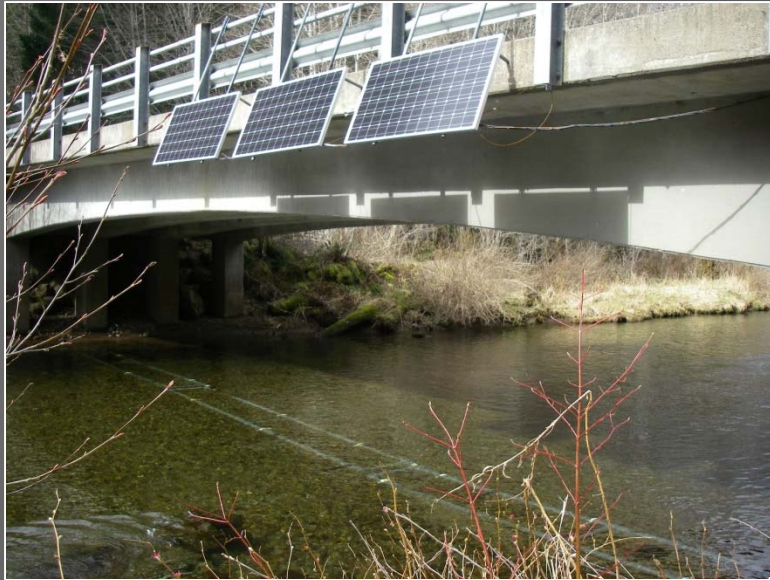
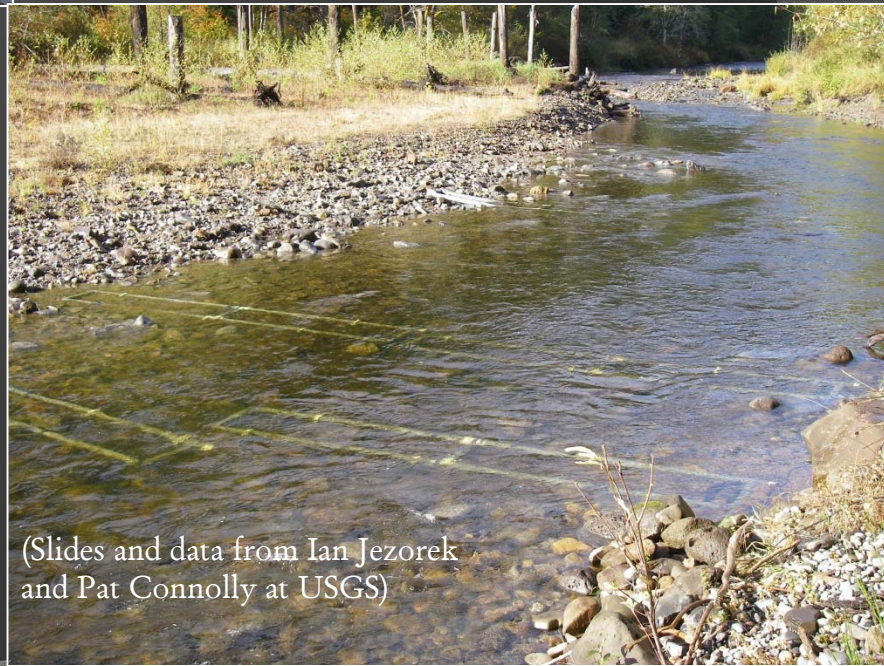
Adult steelhead monitoring—PIT Tag Arrays on Trout Creek

- Two arrays on Trout Creek:
 - within the reservoir reach
 - 5 miles upstream
- Increased precision of estimates
- Detection efficiencies for adult PIT-tagged steelhead have been in excess of 95% by the methods of Connolly et. al 2008.

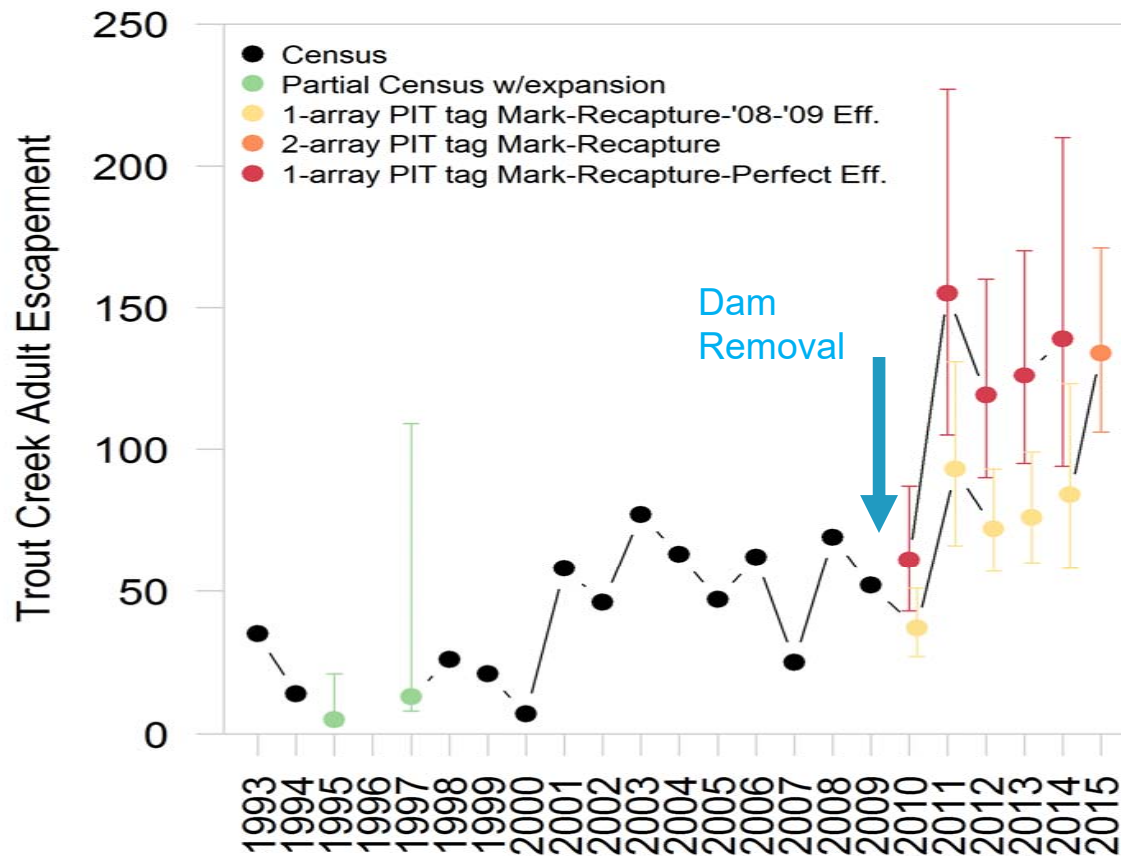
Adult Steelhead Escapement--Trout
