Habitat Restoration on the Mainstem Columbia

Klickitat & White Salmon Rivers

Fisheries and Watershed Science Conference

April 15, 2014

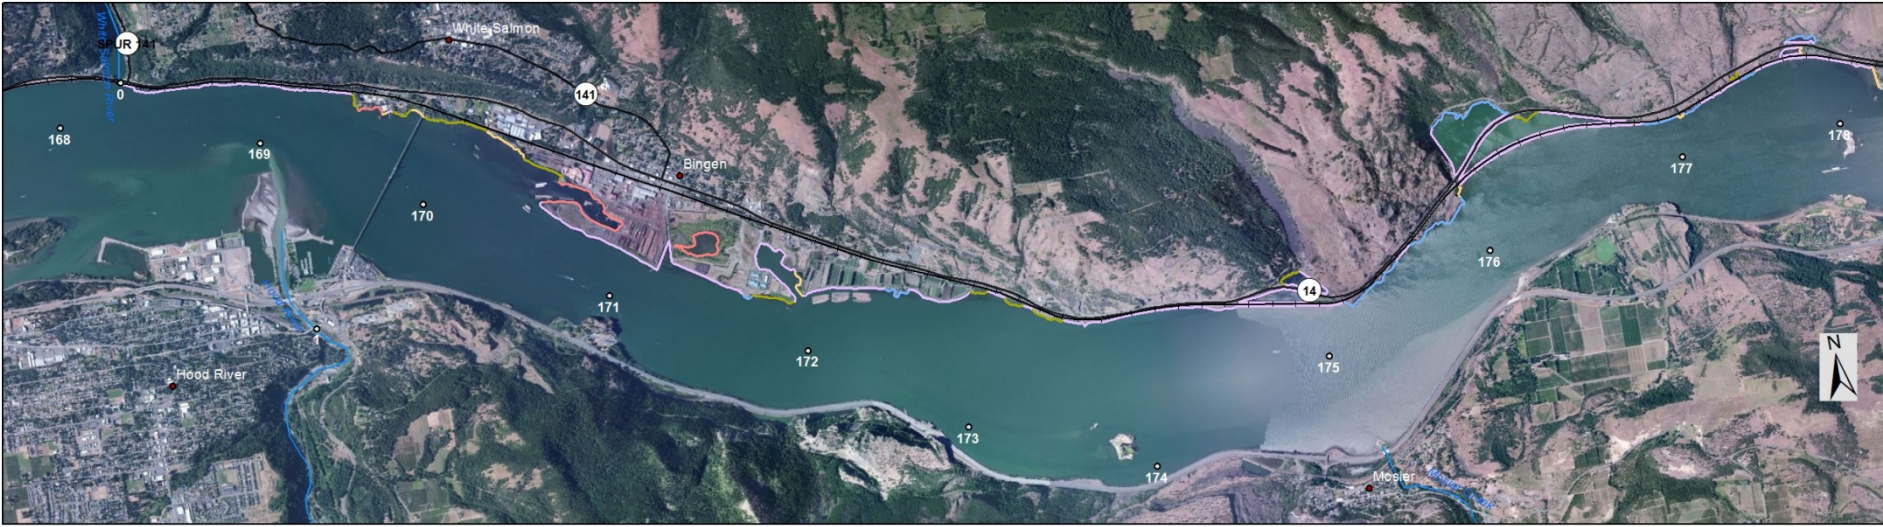
Shoreline Habitat Typing - Results for Sediment Type
River Mile 168 to 188

Sediment Type		• Cities
— bedrock	— riprap	○ River Miles
— fines	— infrastructure	— Railroad
— gravel/cobble	— unidentified	— Highways

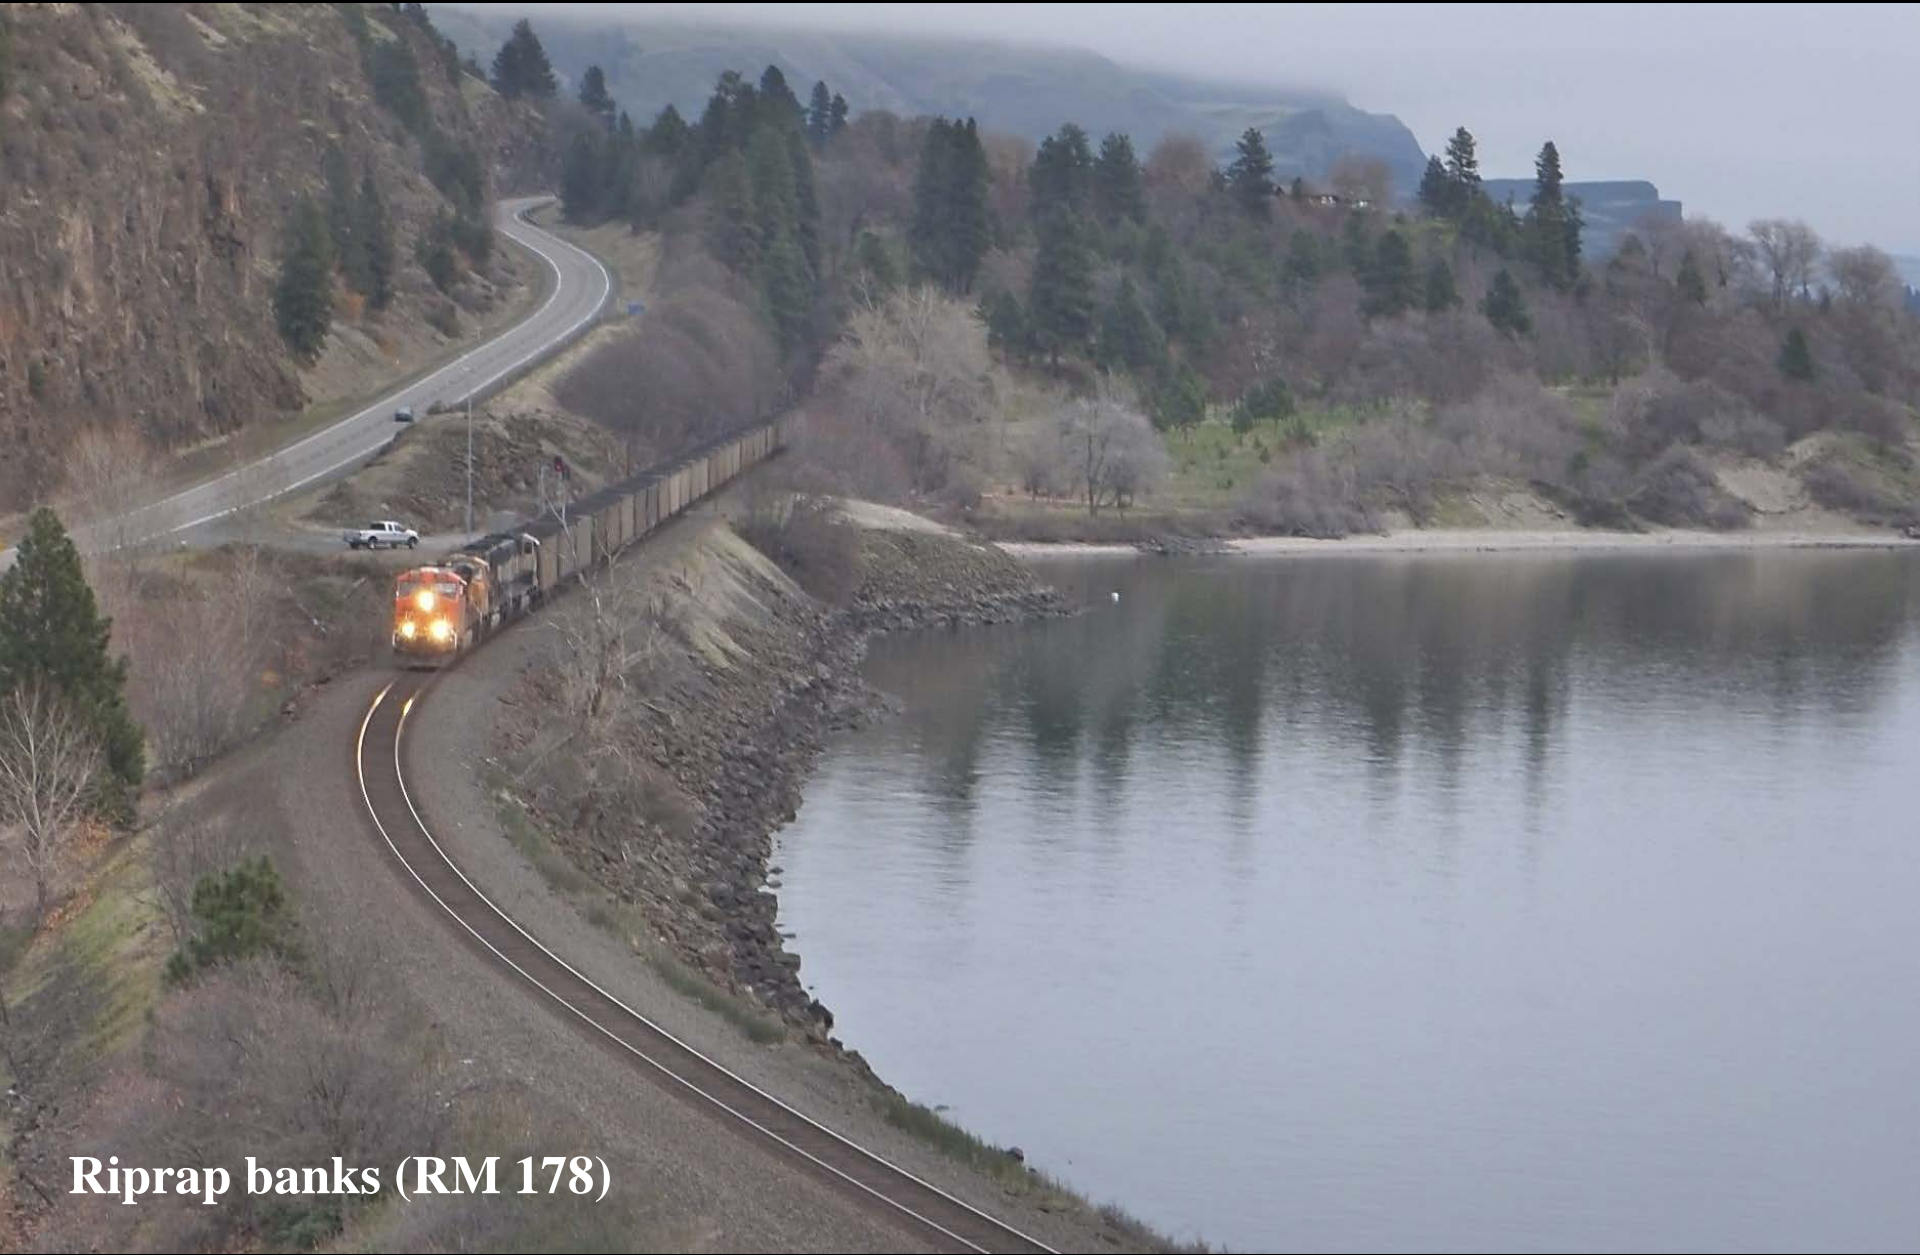
Riprap banks (RM 178)

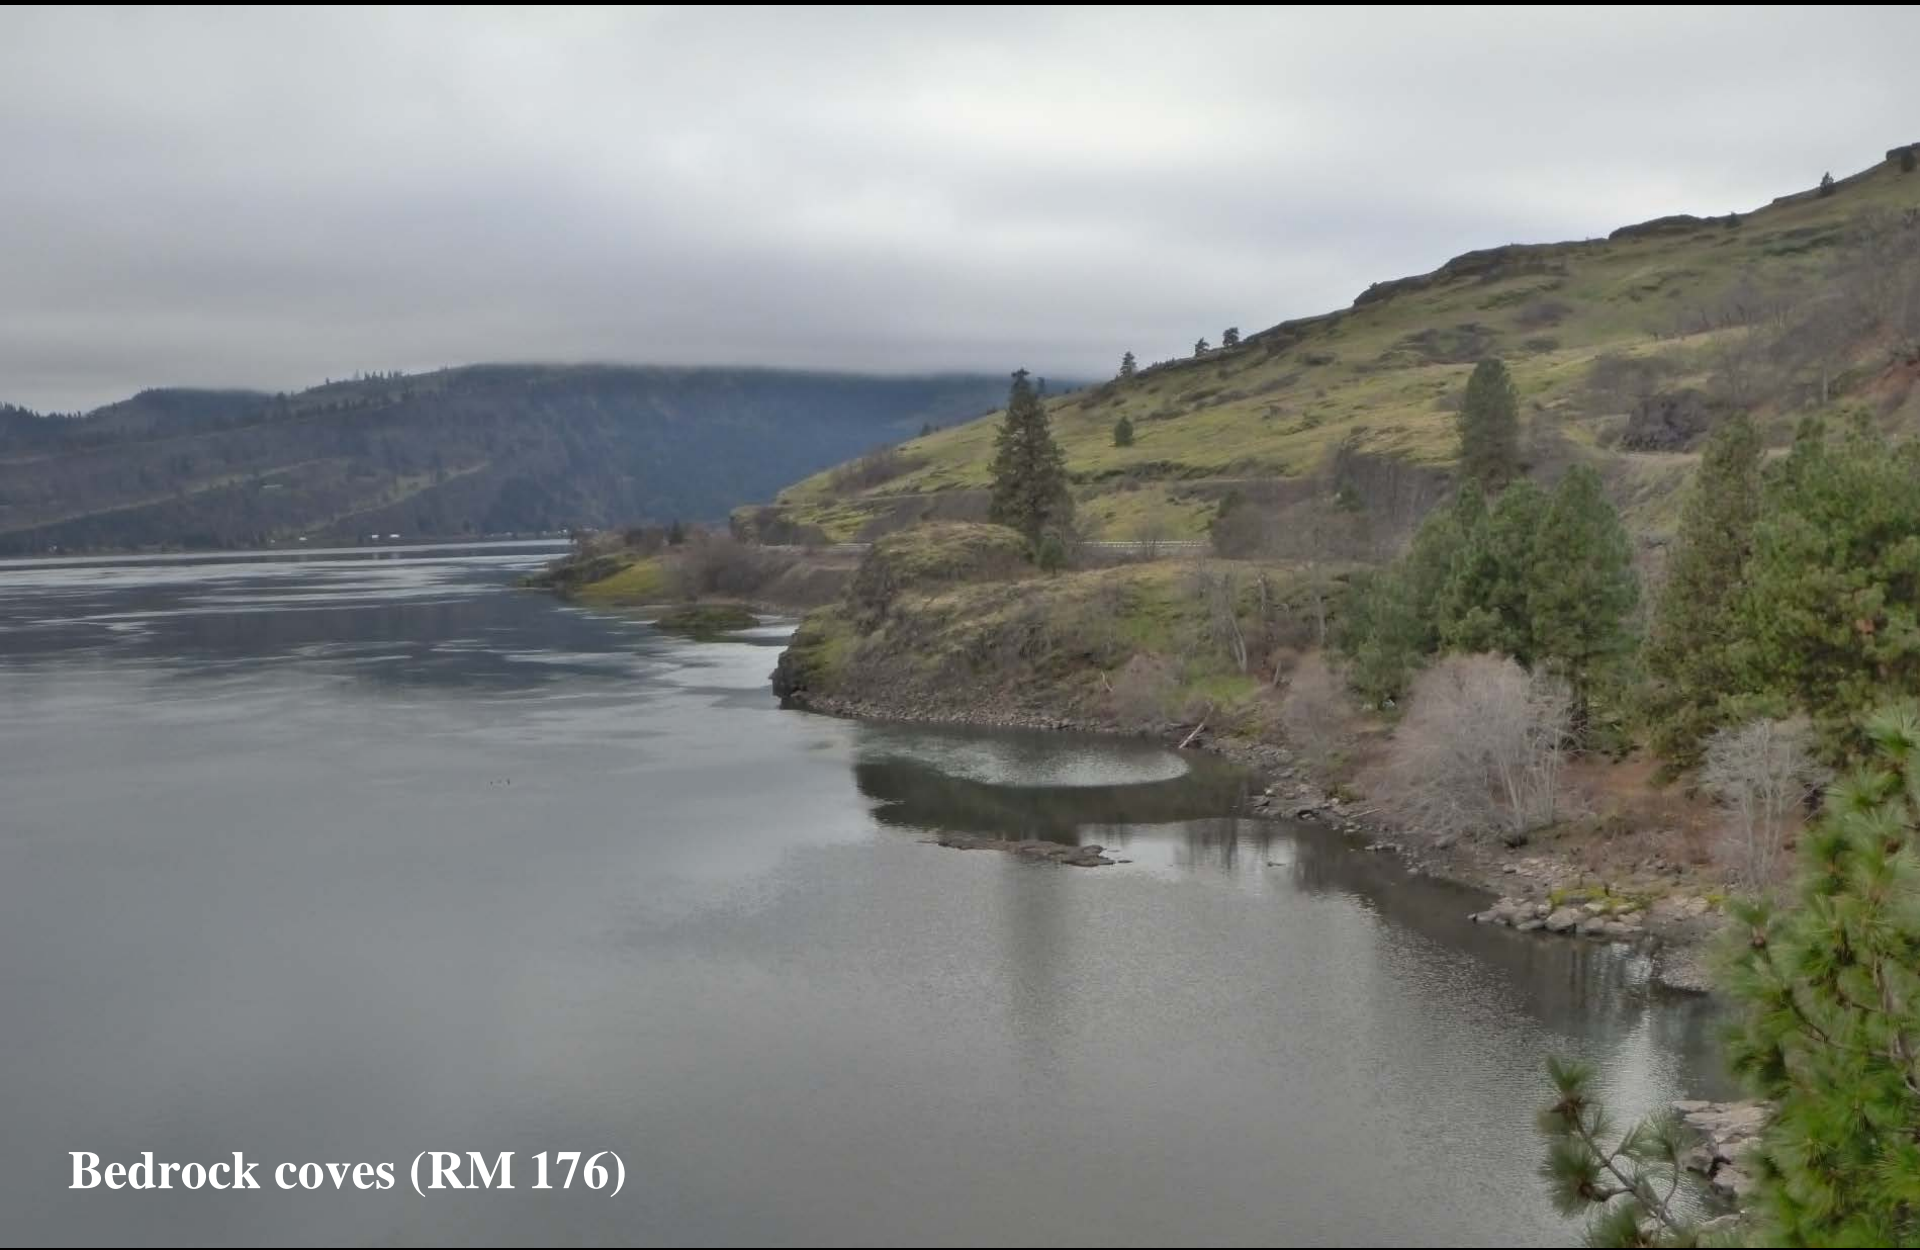
Bedrock coves (RM 176)

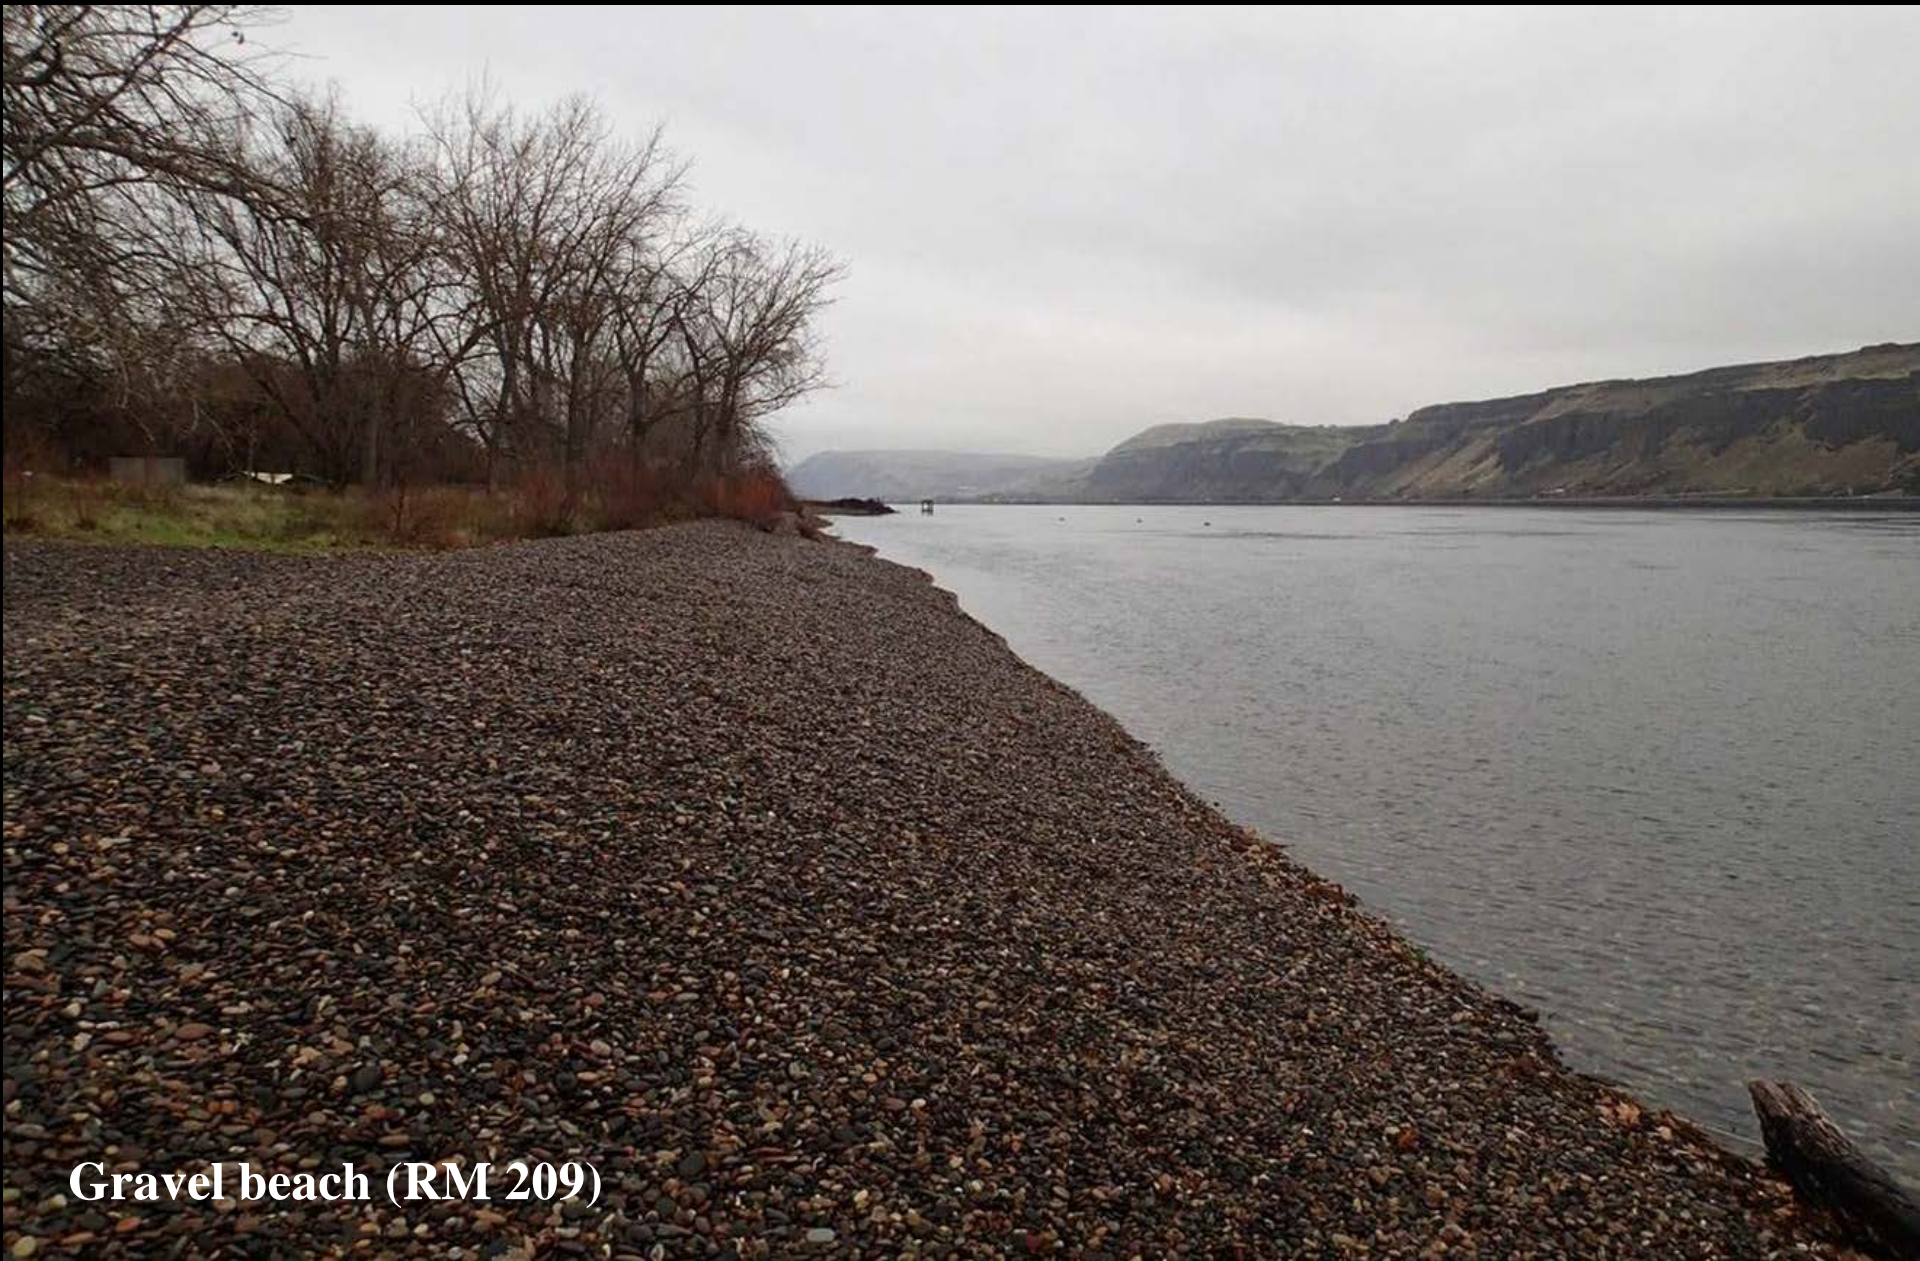
Gravel beach (RM 209)

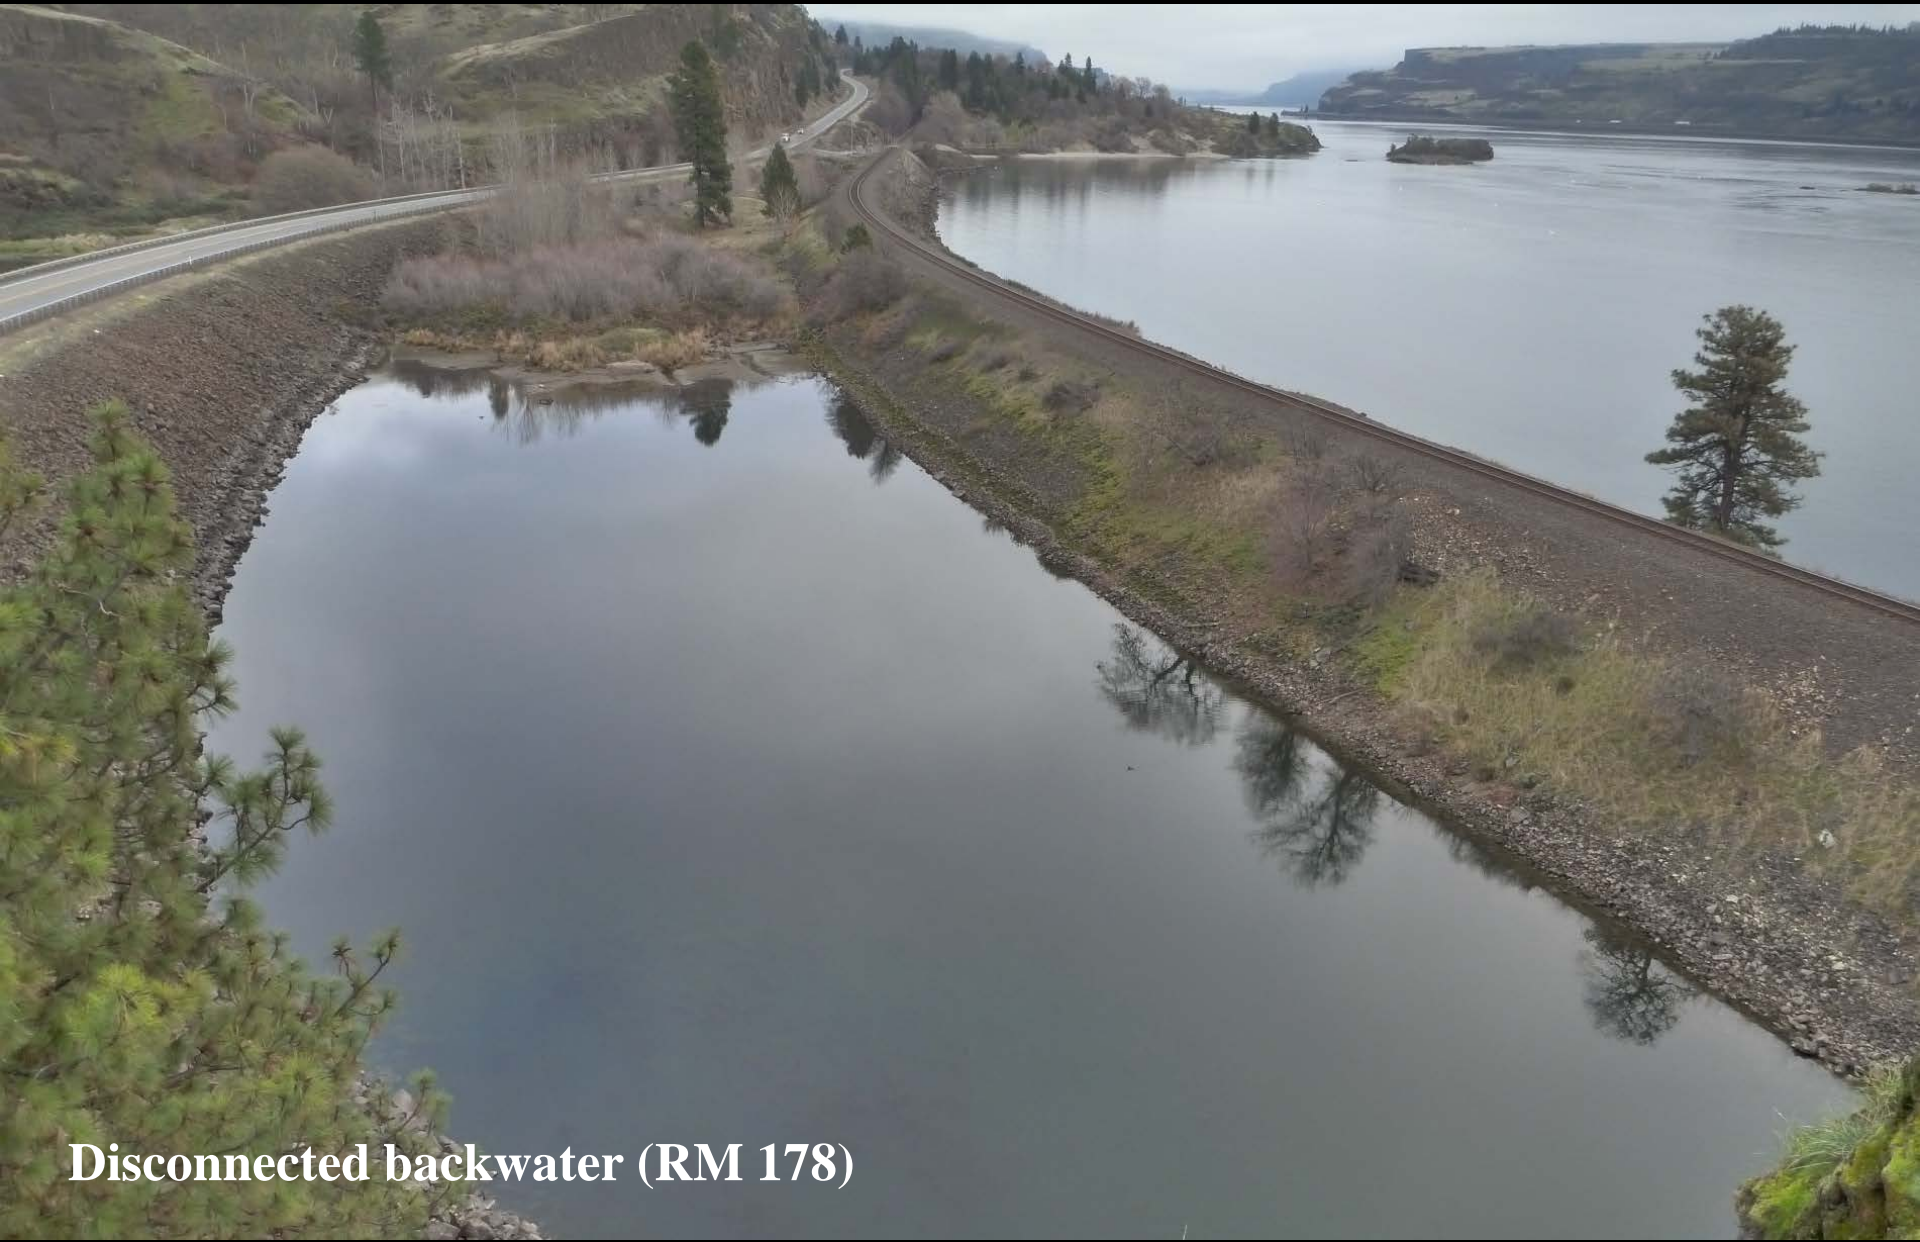
Disconnected backwater (RM 178)

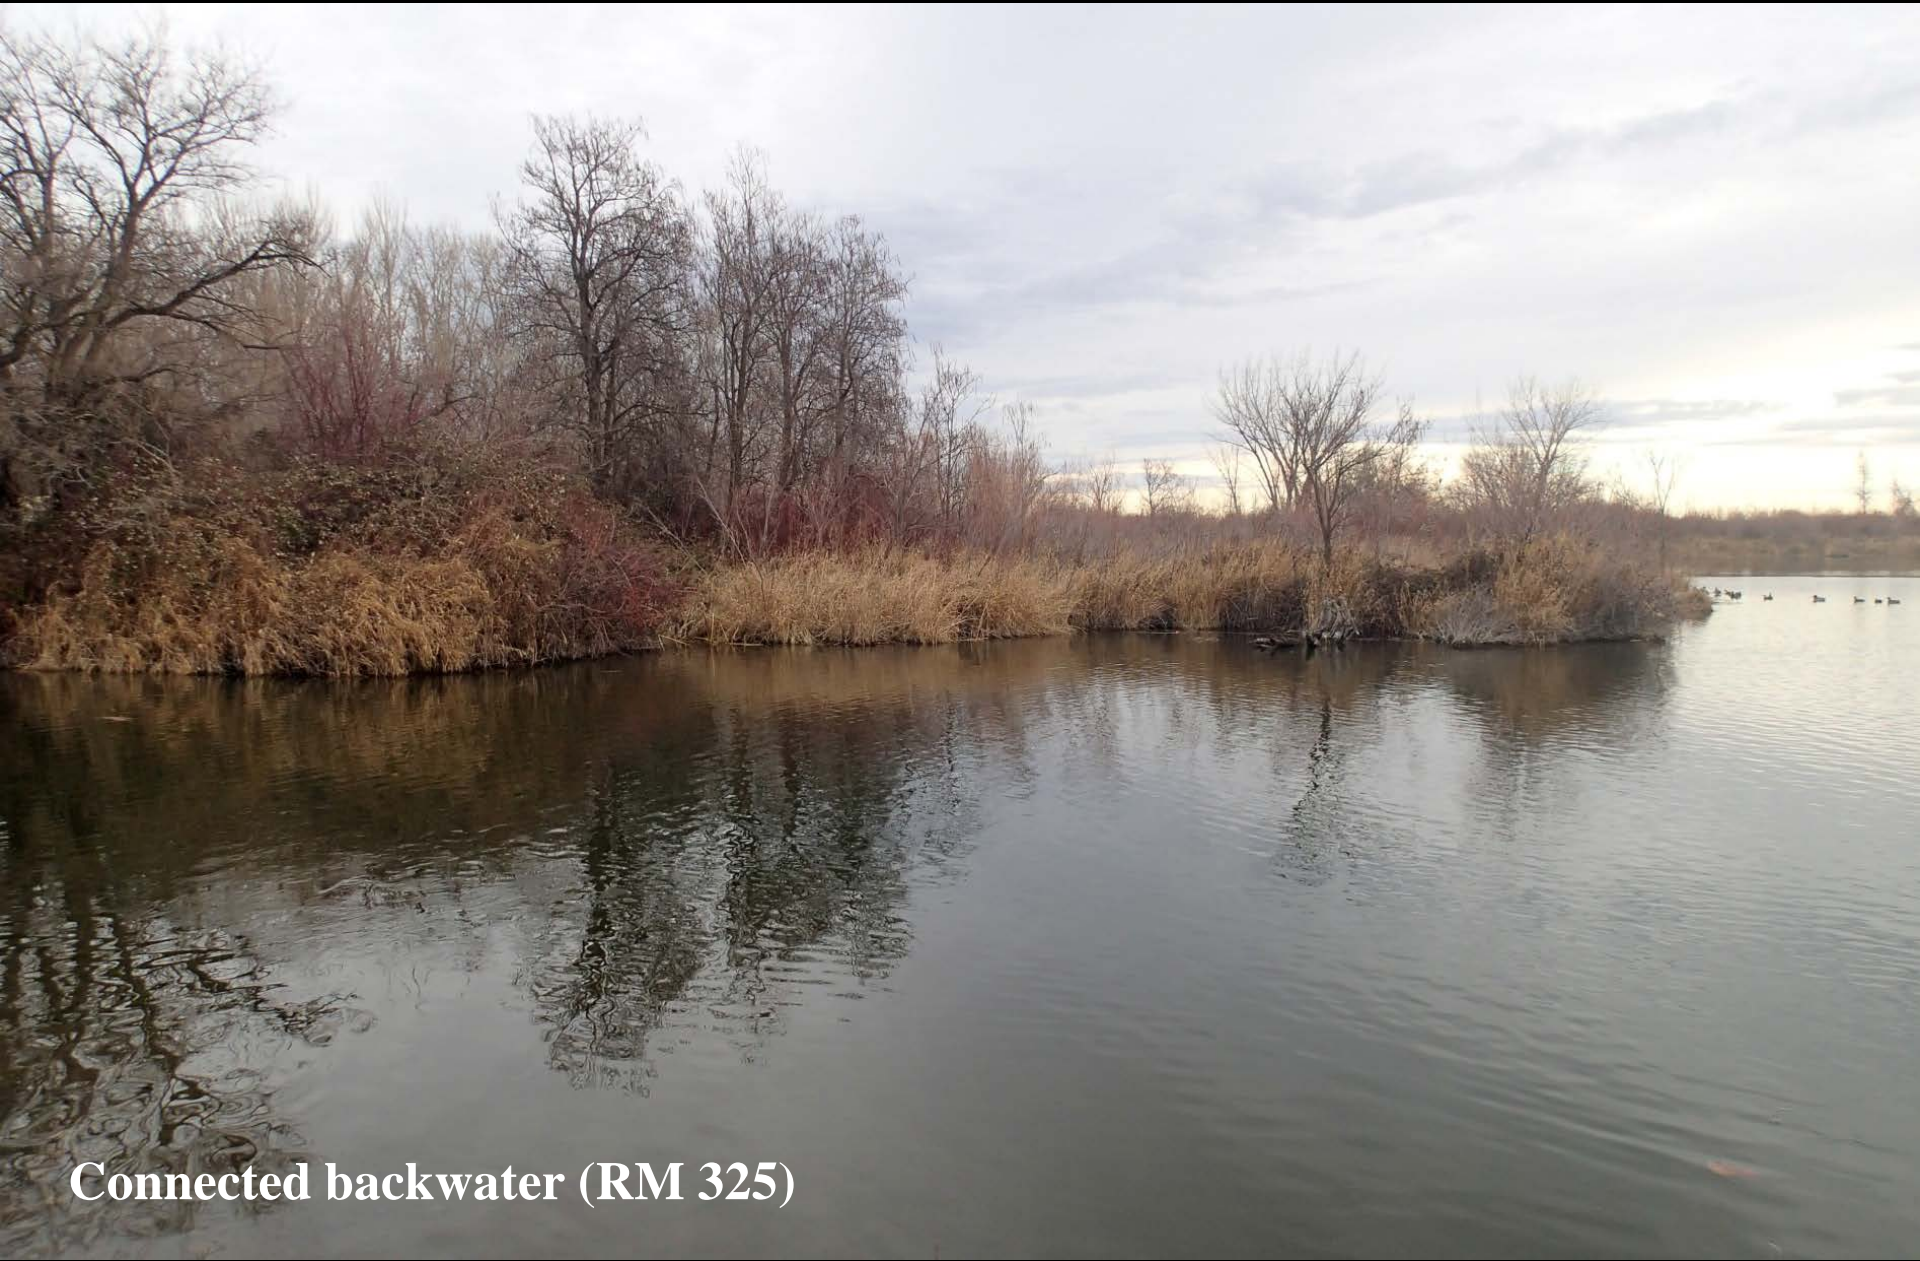
Connected backwater (RM 325)

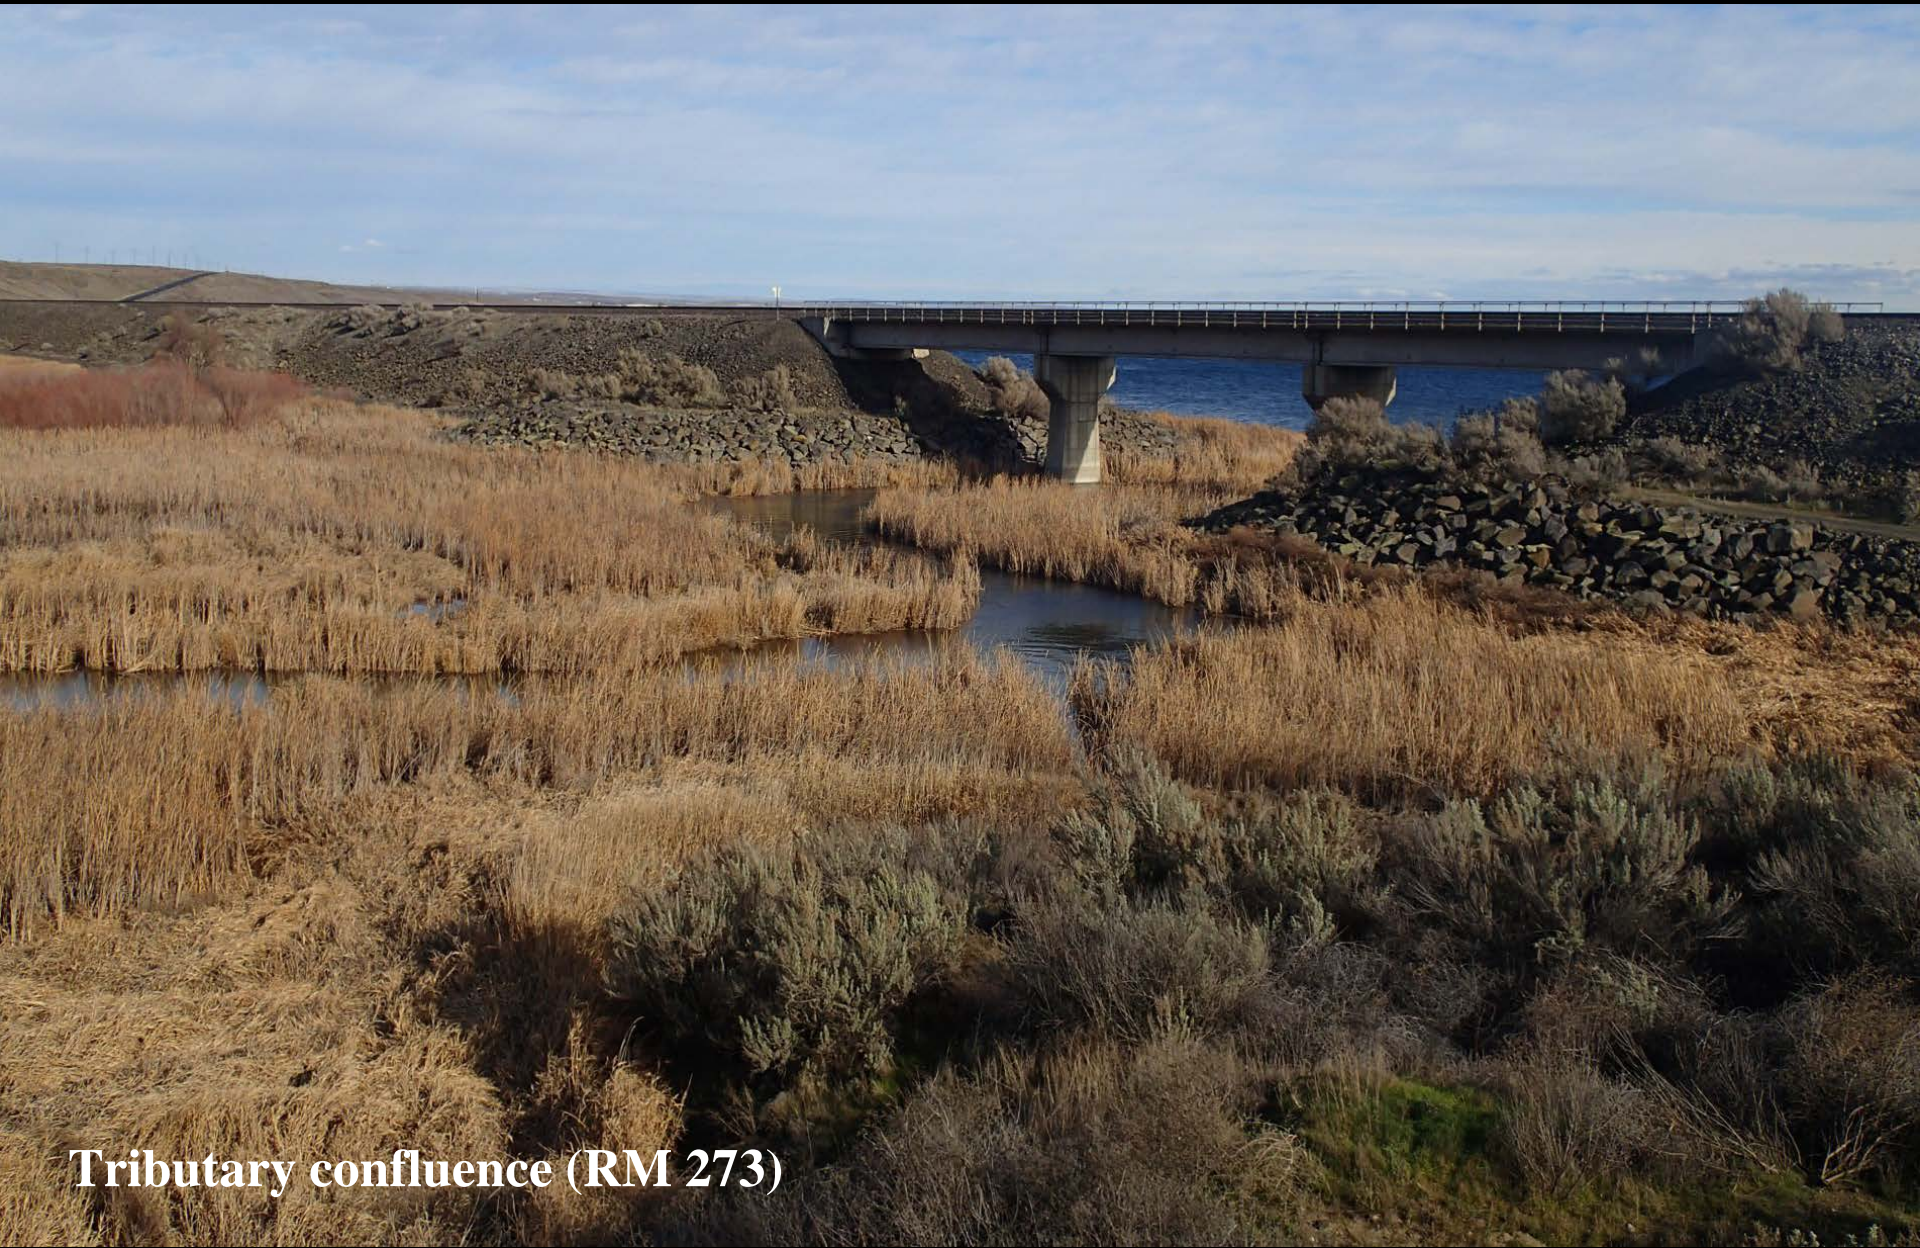
Tributary confluence (RM 273)

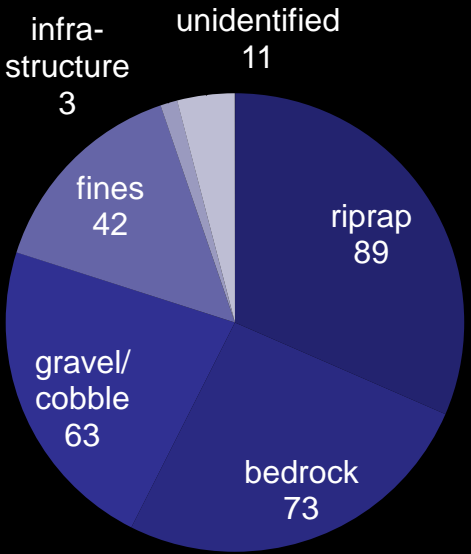
Shoreline Sediment Type (miles)

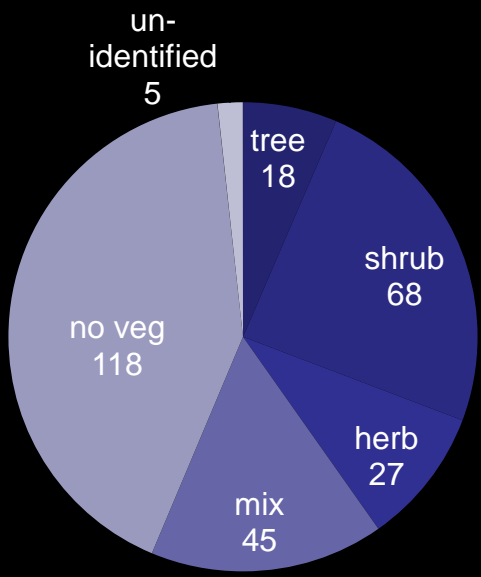
Shoreline Vegetation Type (miles)

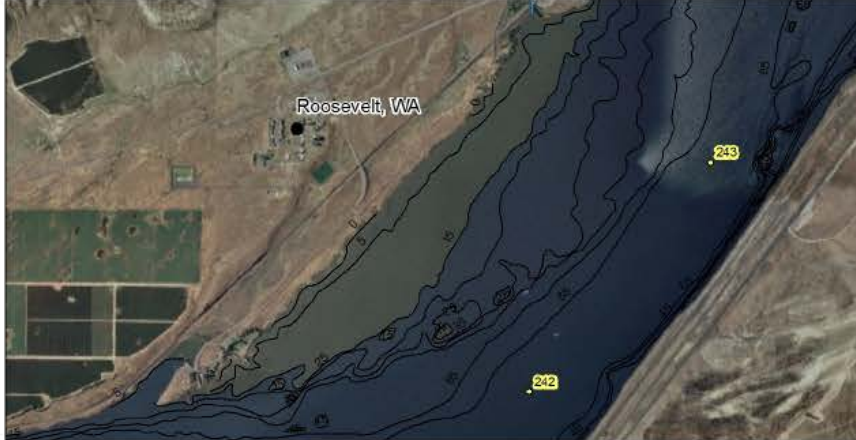
Existing Conditions

Plan View - showing existing depth contours (ft)

Concept Design Creation of Shallow Nearshore Habitat

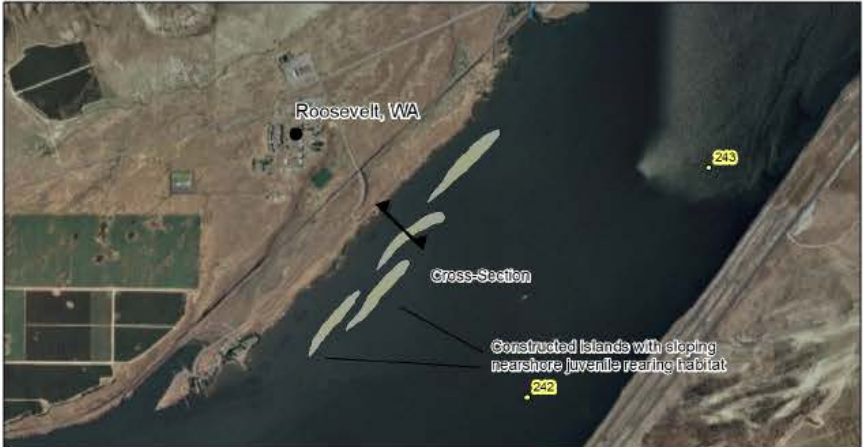
Restored Conditions

Plan View

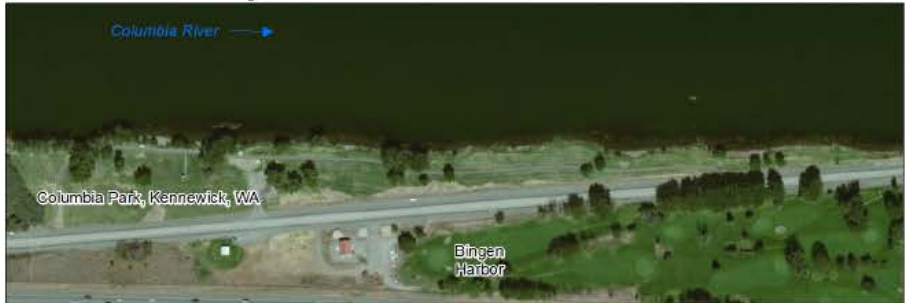
Plan View - Existing

Enhancement of Shoreline Complexity and Vegetation

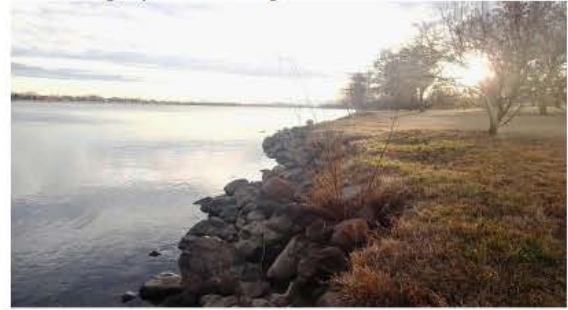
Photograph - Existing

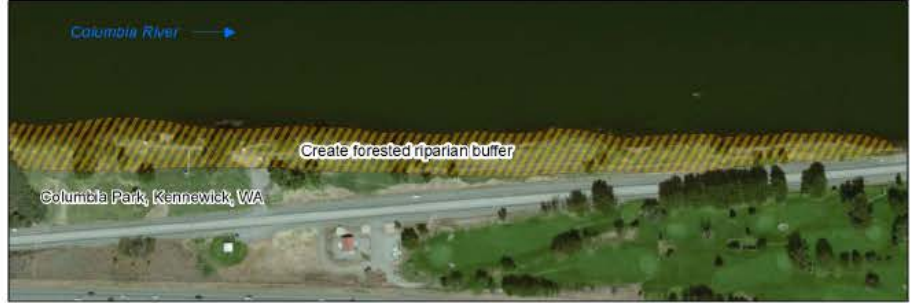
Plan View - Restored

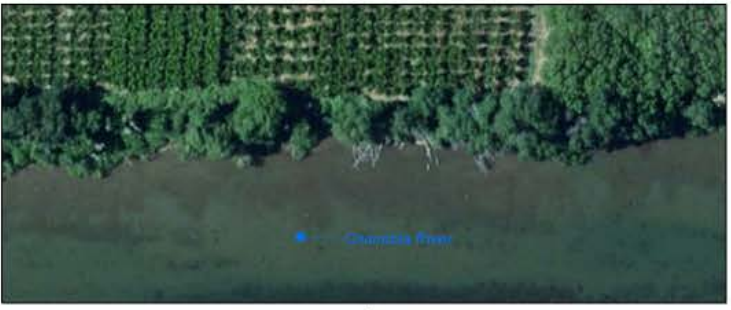
Analog Conditions

East Maryhill - River Mile 210

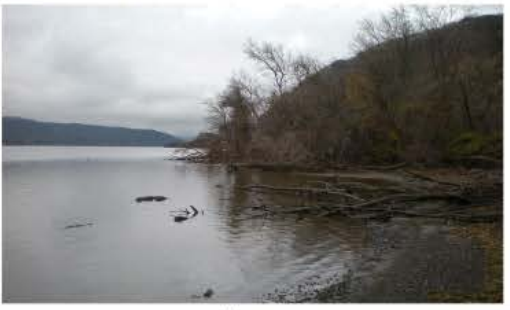
Photograph - River Mile 183

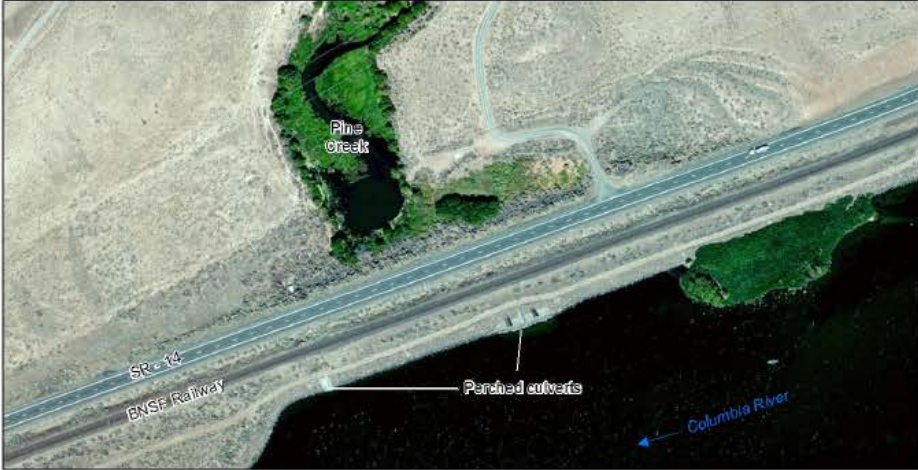
Existing Conditions

Plan View

Concept Design
Improved Tributary Fish Passage and Hydrologic Connectivity
 Note: this location is selected solely to provide an example of the concept that could be used in many potential locations. This example is not intended to advocate for a project at this particular site. Selecting a project for any specific site will require significant additional site information and coordination with landowners and other entities.

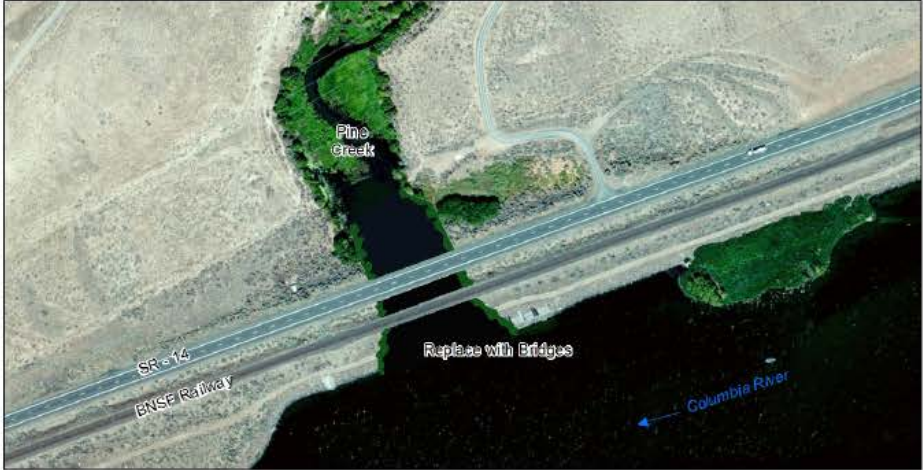
Restored Conditions

Plan View

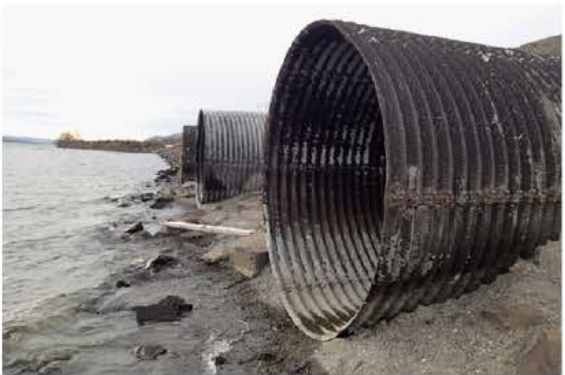
Site Photograph - culvert outlets

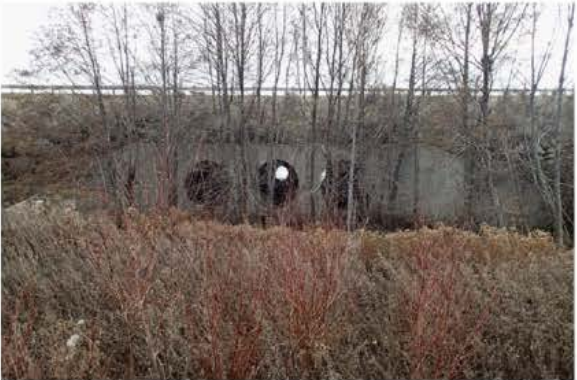
Site Photograph - culvert inlets

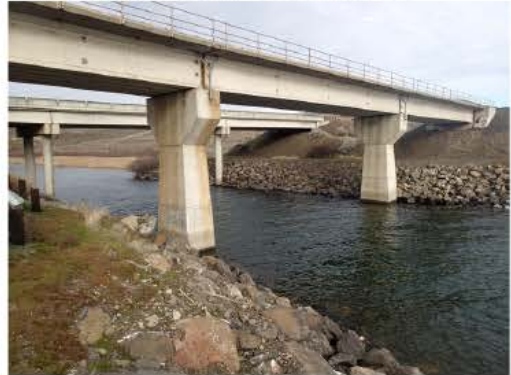
Photograph - Alder Creek RM 258

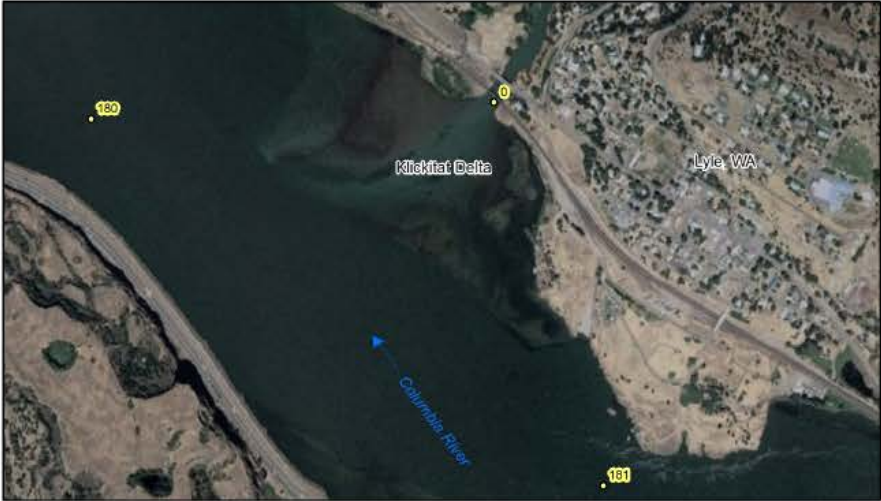
Existing Conditions

Plan View

Concept Design Restoration of Tributary Delta Form and Function

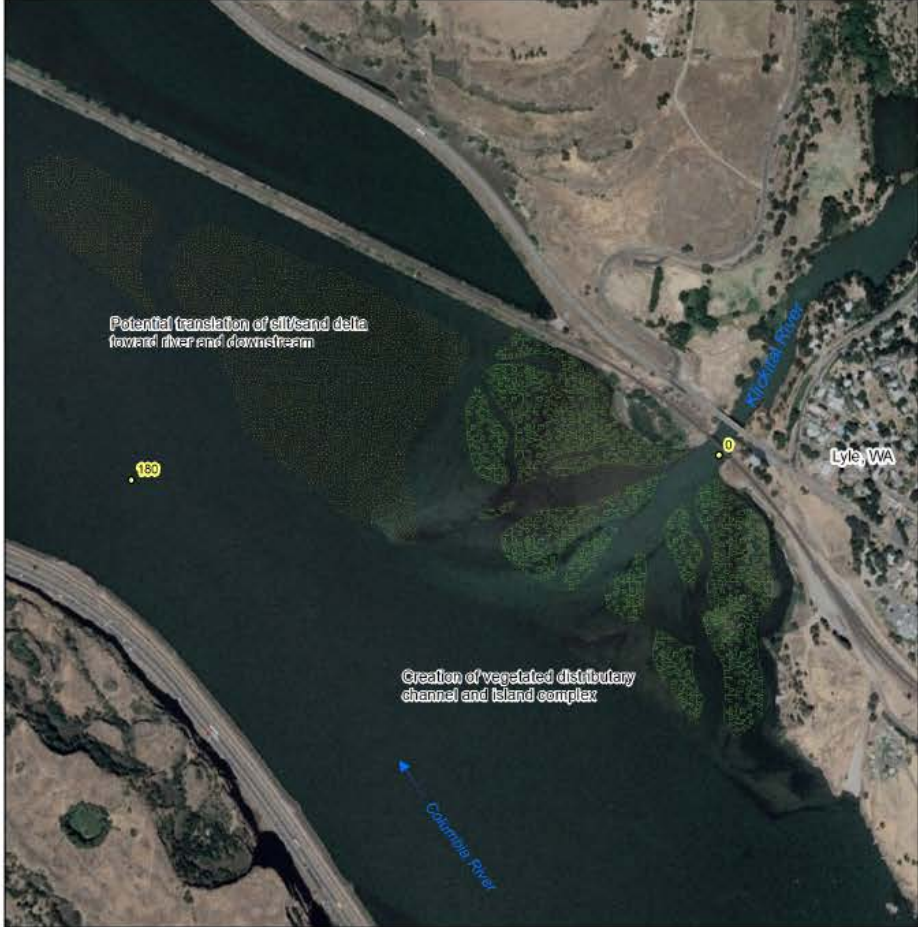
Restored Conditions

Plan View
